# St Chad's Well Stowe Lichfield Staffordshire

## Archaeological Evaluation Report

September 2006

**Client: St Chad's Foundation Trust**

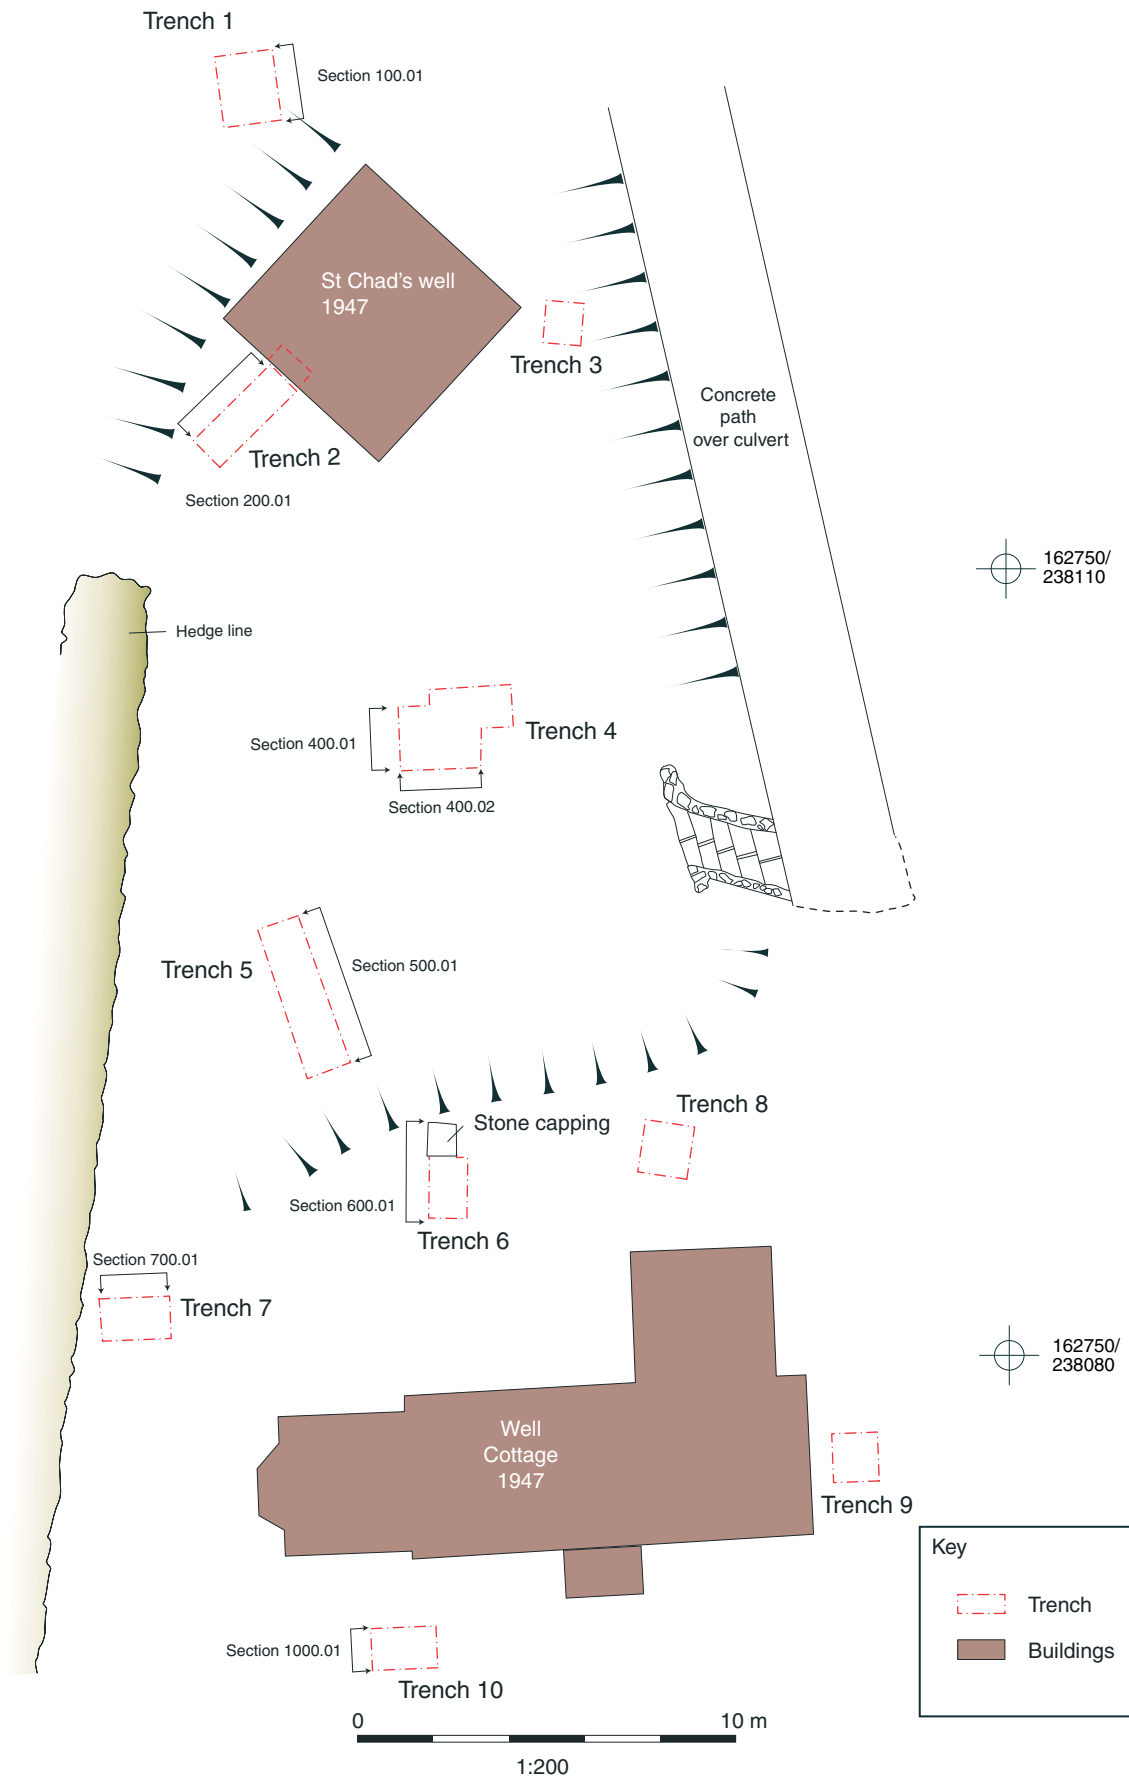
Figure 2: Trench location plan

- 3.1.1 The evaluation consisted of ten trenches, varying in size from 1 m sq. to 4 m long and 2 m wide (see Fig. 2). The overburden was removed by a mini digger fitted with a toothless ditching/grading bucket, under close archaeological supervision.

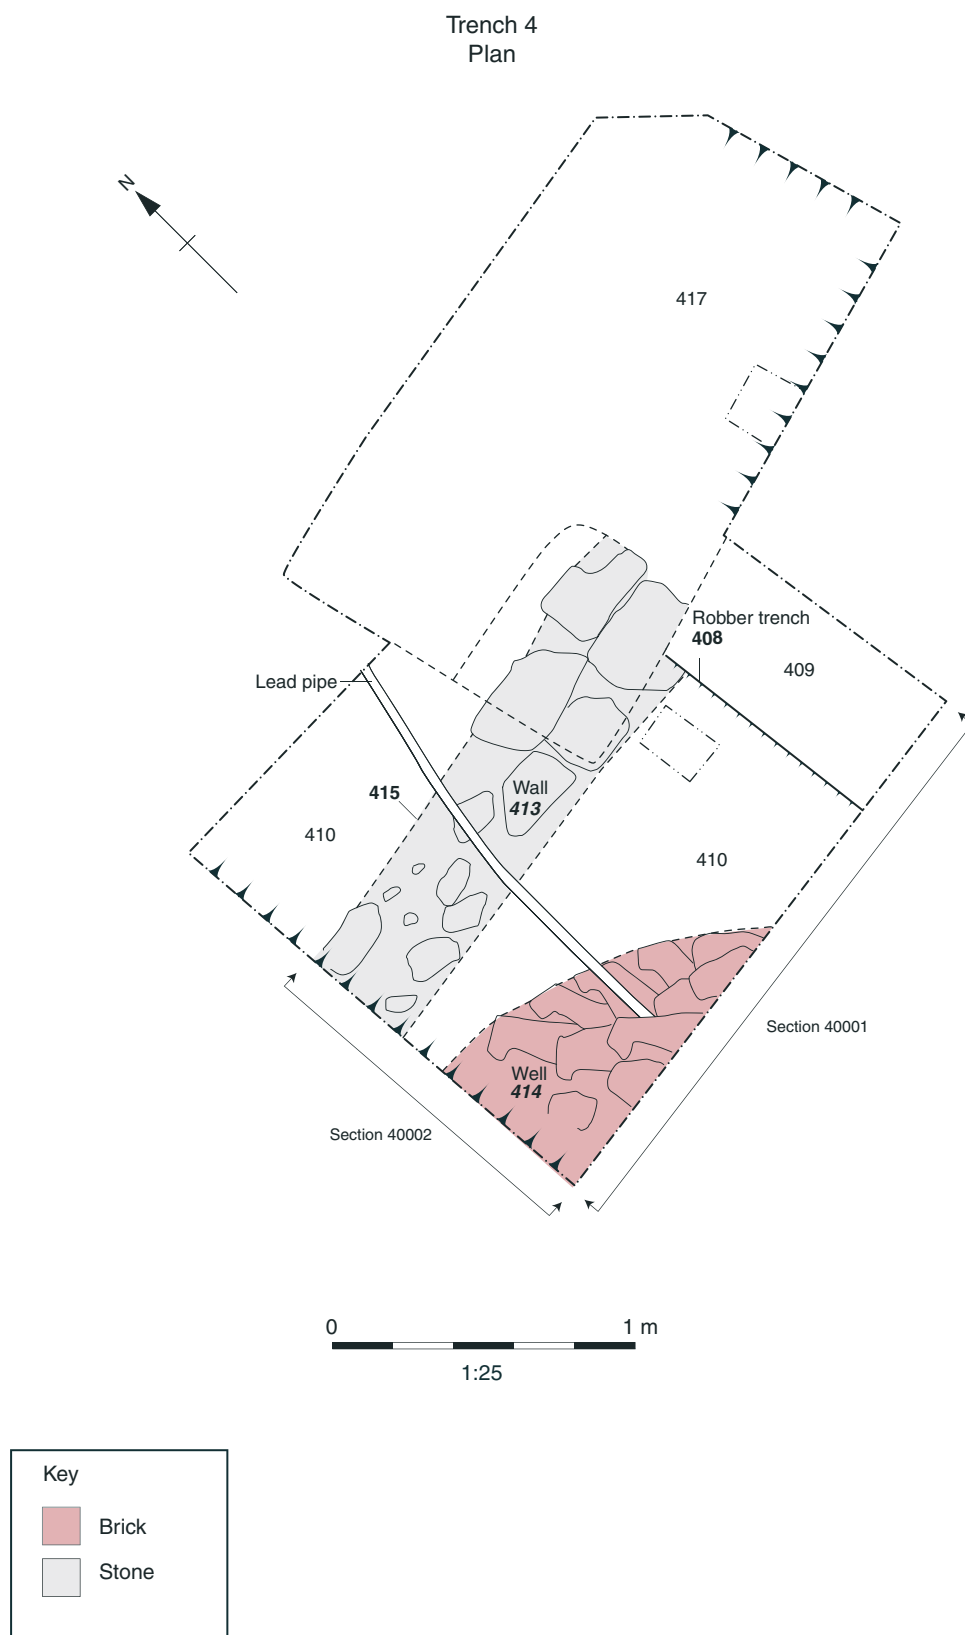
Figure 3: Trench 4; plan

- 5.1.1 Trench 4 was aligned W-E and comprised two off-set trenches measuring 1.8 m by 2 m and 1.2 m by 2 m. The natural geology was encountered at c 74.07 m OD (1.7 m below ground) and comprised mid orange brown sand (417). It was overlain by a grey brown silt sand (410), with limestone inclusions, that may have represented the remnants of a cultivation or garden soil. Clay pipe dating to the 17th century was recovered.

- 5.1.2 The possible soil (410) was cut by the foundation trench (415) for a sandstone wall (413); the wall was aligned W-E and measured 0.6 m wide. The wall comprised a single course of rough loosely bonded sandstone blocks. Soil 410 was overlain by a possible buried topsoil (409) that was cut by a wall robber trench (411) over the line of wall 413. A possible N-S aligned wall robber trench (408) was seen at the eastern end of wall 413. The trenches were 0.6 m wide and filled with stone rich sandy silts (412 and 407), 19th-century pottery and clay pipe fragments were recovered.

- 5.1.3 The robber trench fills (412 and 407) were cut by the foundations for a possible well structure (414) but the full extent of the structure was beyond the limits of the trench. The well was constructed of angular off white bricks, possibly reused coping bricks, approximately four courses high, each course constructed from either headers or stretchers. Similar bricks were seen in the overlying rubble that had traces of a reddish brown sandy mortar. The top of the structure had been disturbed and the bricks were overlain by layers of rubbly silt and sand (404-406) that contained 19th-century pottery and several curved and angular bricks, possibly from the above ground well structure.
- 5.1.4 The demolition material was overlain by modern hardcore (402-403) for the base of a path, and topsoil (401).

- 8.3.5 The extent and date of the remaining *in-situ* elements of the robbed out wall footing in Trench 4 (413) were uncertain. The robber cut (411) certainly truncated the buried soils (409 and 410), and it may be that the robbing is contemporary with the construction of the structure to the north (414). The latter is likely to represent the northern extent of the octagonal well house (see below), which Rawson's account would suggest was constructed on the site of the dried up spring. This may suggest that the robbed out wall forms part of an earlier well structure - perhaps even that drawn by Stukeley in 1736 - although the evidence for this is circumstantial and based purely on the proximity of the two structures.

- 8.5.1 The proposed pilgrim centre is located to the south of the site, and will not impact on the remains of the octagonal well, seen within Trench 4. However, St Chad's Foundation Trust may wish to make a feature of the octagonal well, in which case the site of the well should be fully excavated. Further excavation may shed further light on the function of the stone wall that predated the construction of the octagonal wall, and may also identify any earlier deposits.

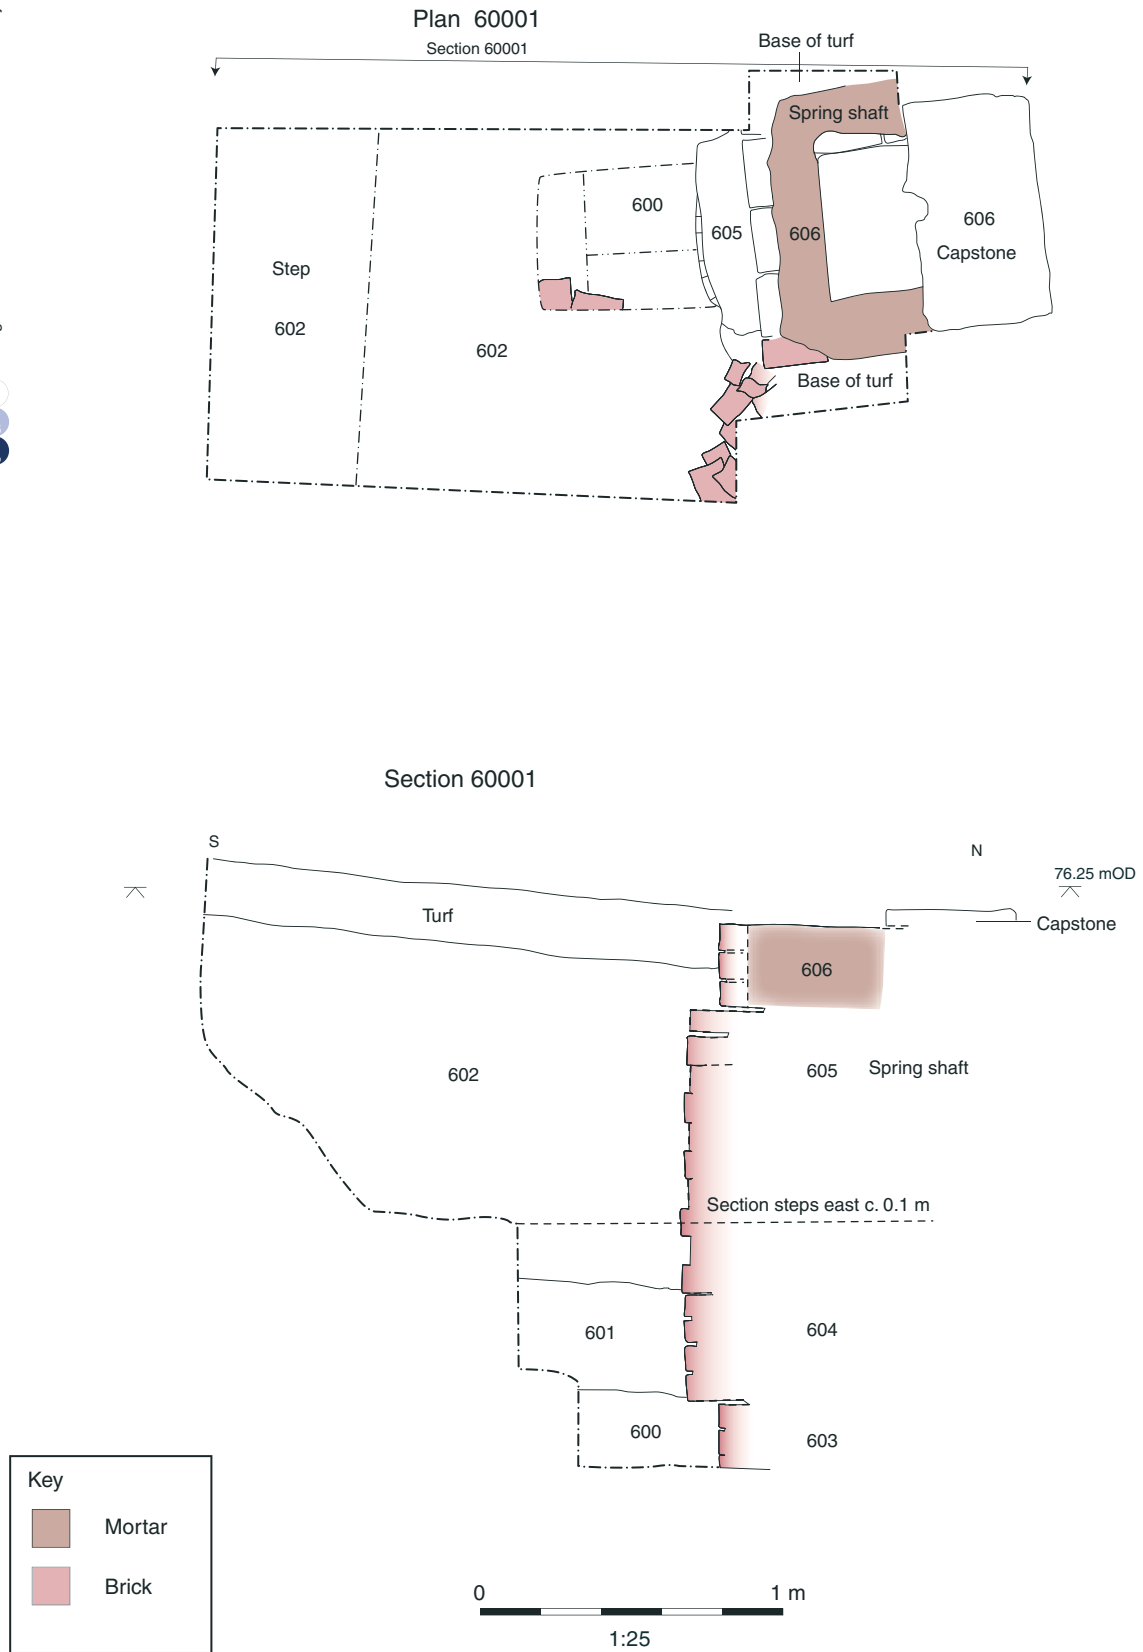
Figure 5: Trench 6; plan and section

- 5.1.5 Trench 6 was aligned N-S and measured 2.8 m by 1.2 m. It was excavated to a maximum depth of 2 m below ground (74.25 m OD) where a buried garden soil (600) and topsoil (601) were revealed. The deposits were cut by the construction trench for a circular brick shaft. The base of the shaft was constructed from three courses of 19th-century bricks and was over 1 m wide (603). The base had been disturbed and remodelled re-using the bricks from 603 (604) and a downpipe added. Over 604 lay 8 courses of 20th-century bricks and a stone collar (605), which were capped by three courses of bricks and a stone slab (606).
- 5.1.6 The upper part of the structure (605) was abutted by dumps of rubble, tarmac, silts and sands (602) that contained 19th-century pottery and glass. The deposits were probably infilling a construction cut and were overlain by the modern turf.

- 8.5.2 The brick spring shaft also lies outside the site of the proposed pilgrim centre, within the site of the proposed terrace. However, it is possible that the upper part of the shaft may be impacted on by the foundations of the building, or by any service trenches. St Chad's Foundation Trust may also wish to make a feature of the shaft. The upper portion of the shaft dates from 1923 and it may be necessary to further record the structure before it is removed.

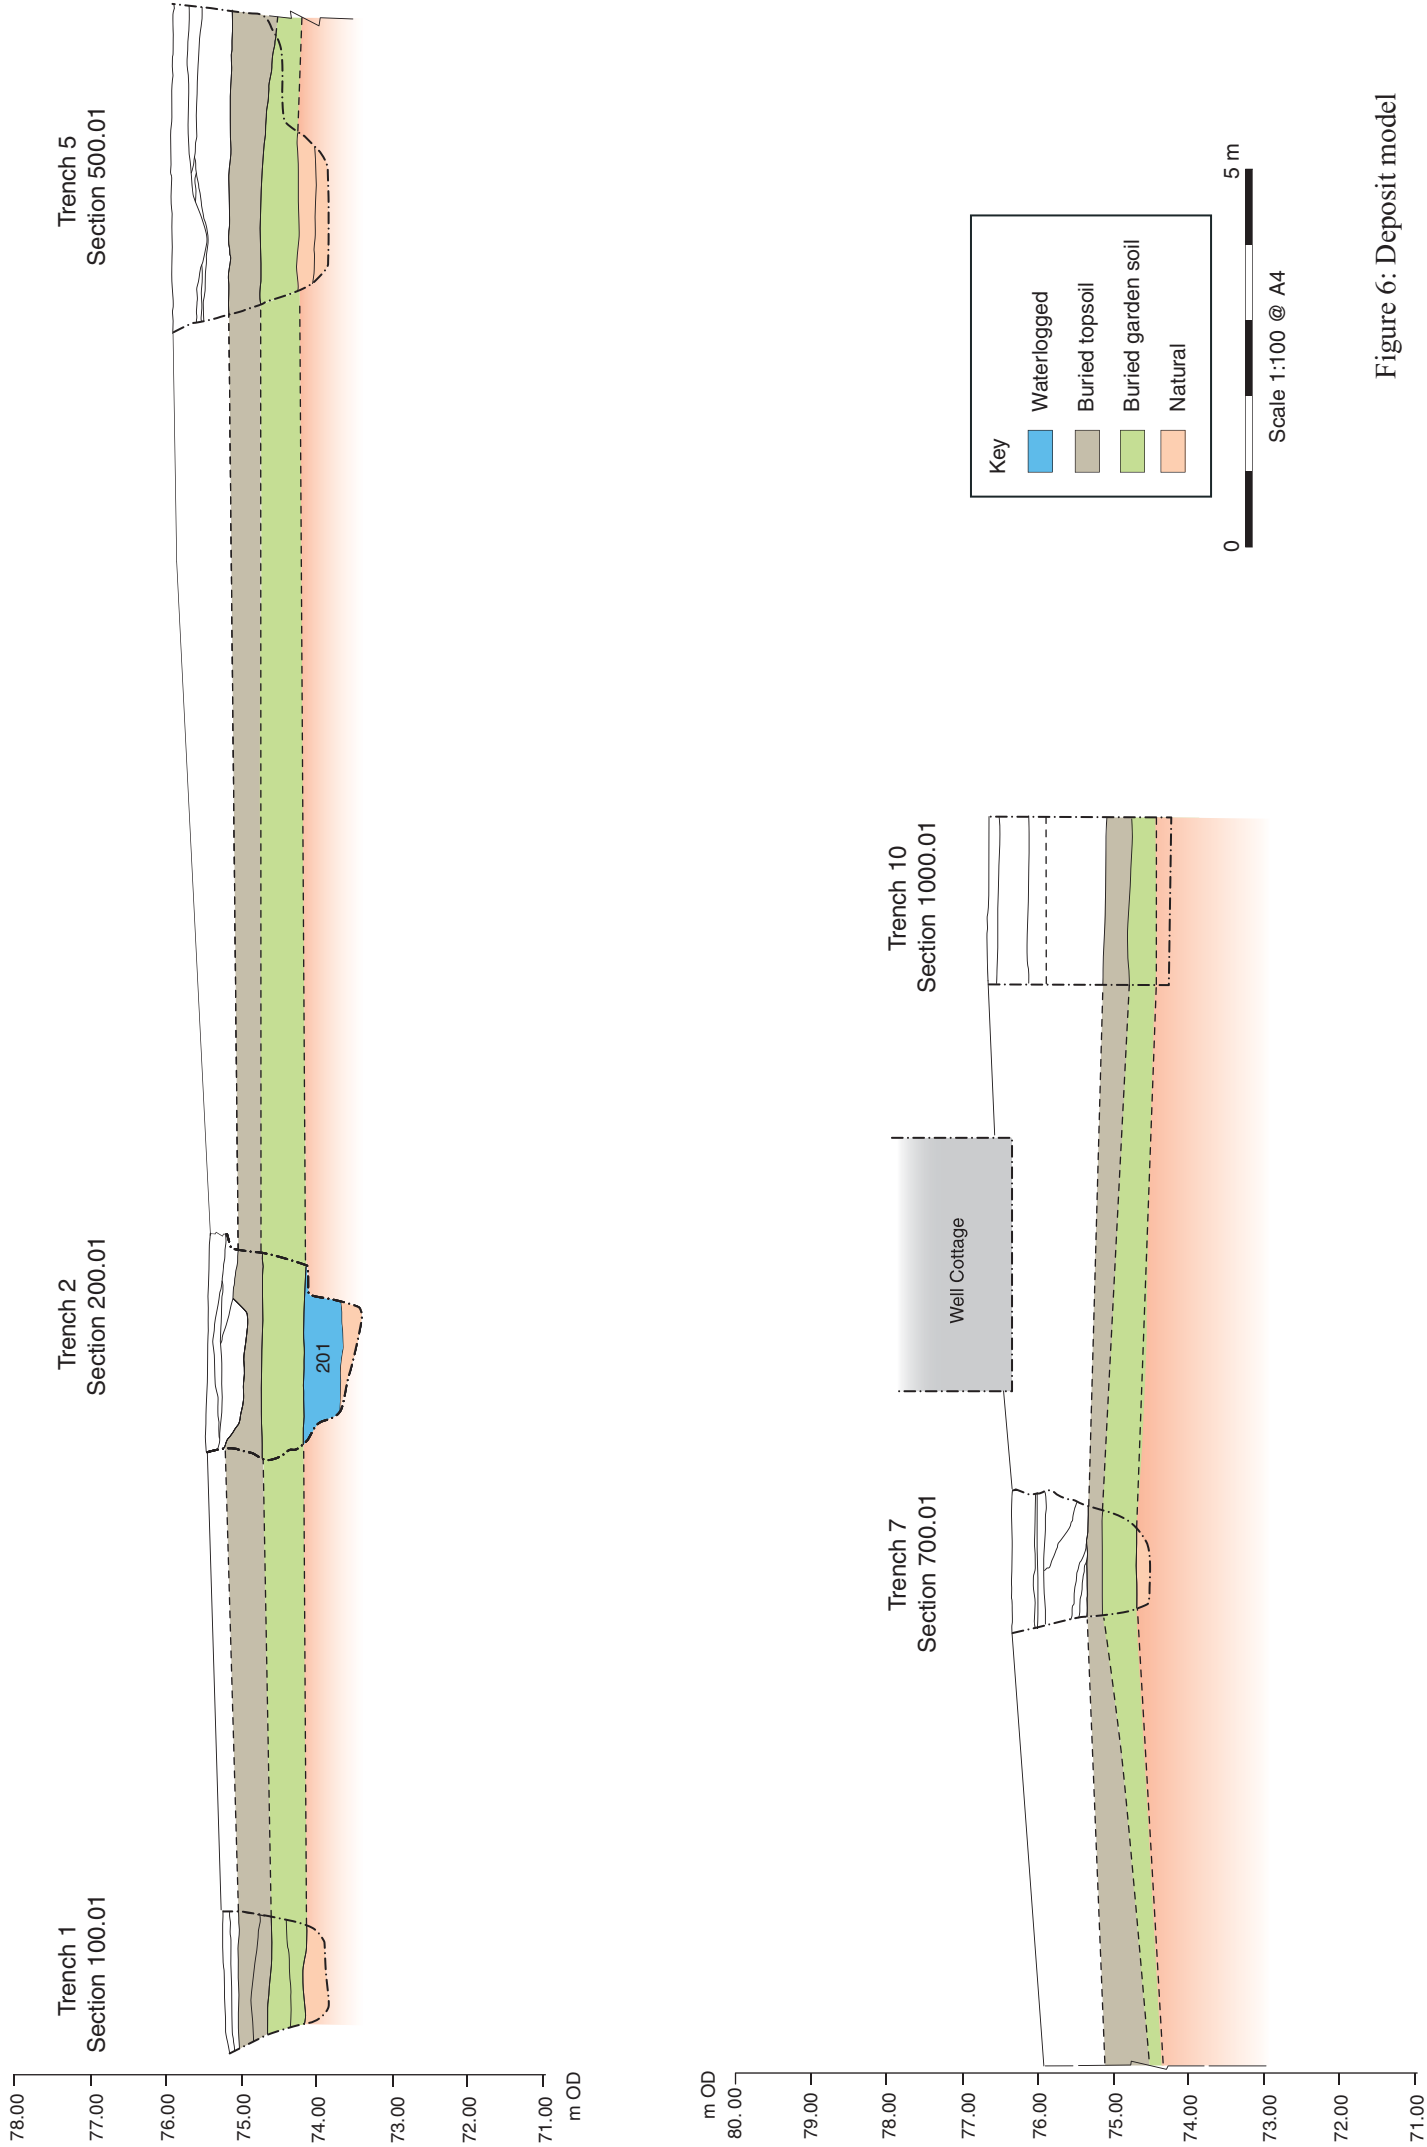
Figure 6: Deposit model

- 5.1.7 Natural sand was encountered to the south of the site at 2.15 m below ground (74.5 m OD) and to the north of the site at 1.4 m below ground (73.85 m OD). In Trench 2 it was overlain by a blueish grey waterlogged clay (201), possibly infilling a hollow. In Trench 3 there was a suggestion of a N-S aligned feature in the base of the trench but health and safety implications meant any excavation was impractical. Above the clay, and natural in the other trenches, was a layer of greyish brown sandy silt measuring between 0.3 and 0.5 m thick. This was probably a buried cultivation or garden soil, and contained 17th-18th-century pottery. It was overlain by a darker sandy loam that was up to 0.5 m thick and was probably a buried topsoil. Pottery dating to the 19th century was recovered. The topsoil was overlain by dumps of silty sand and rubble, which were c 0.3 m deep to the north and 0.8 m deep to the south. In Trench 10 approximately 1 m of brick rubble was encountered below a lens of tarmac. The rubble dumps were overlain by the existing garden soil and turf (Fig. 6).

- 8.3.2 The silty sand deposits overlying the natural geology in all the trenches was fairly consistent in composition. It did vary in thickness, perhaps reflecting an irregular interface with the underlying sand. The few finds, dated to the 17th or 18th century, suggest that the deposit represents a garden soil which may relate to the parterres or bordered plots shown on John Snape's Plan of the City and Close of Lichfield (1781).

- 8.3.3 This deposit was consistently overlain by a c 0.2 - 0.5 m thick layer of mid-dark grey clayey silt which probably represents a buried topsoil / ground surface; it was dated to the 19th century. In Trench 6, the top of this deposit (601) roughly coincided with the top of the original brickwork of the brick lined well shaft, and it seems likely that the

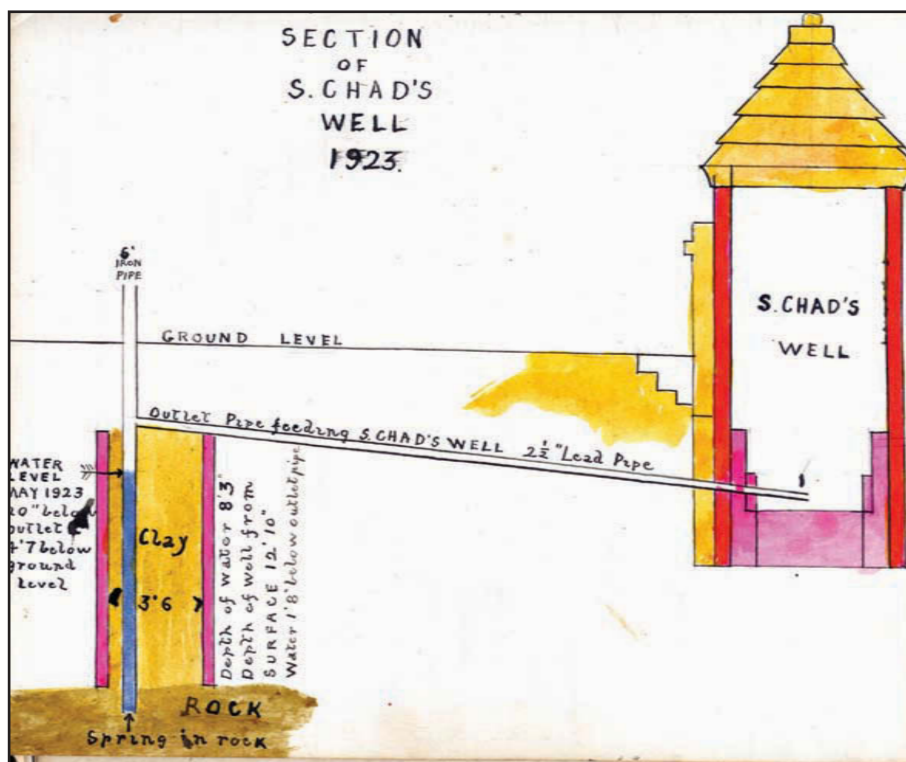
Plate 1: 1923 Elevation of St Chad's well

- 8.2.6 The 1923 survey also provides further evidence for the construction method of the new shaft in 1833. From Mr Moseley's drawing, it seems clear that a 6” iron pipe was installed within the newly excavated and brick lined well which was then infilled with clay. As the clay was removed in 1923, the capstone now seals a void some 4.2 m deep. It would also seem from these drawings that the octagonal chamber housed a relatively shallow reservoir which was fed by the ‘new’ shaft.

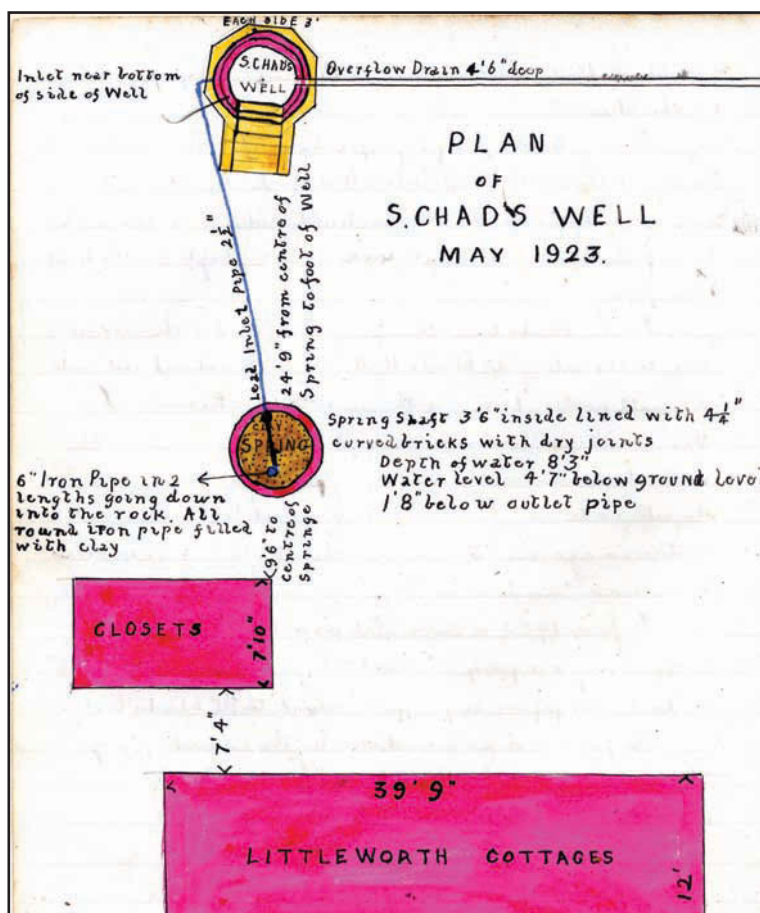
Plate 2: 1923 Plan of St Chad's Well

- 8.2.7 Despite this confusion, Mr Moseley established that the water table had dropped to such a level that it was now some 20” below the outlet pipe from the new shaft to the octagonal well house. This he attributed to “*.. the pumping operations of the Conduit Lands Trustees and South Staffordshire Waterworks Co.*” and as a solution “*... In June 1923 a stone slab was placed over the shaft to the spring and a pump installed which was connected to the lead inlet pipe and so pumped water into St Chad's Well.*”

The plan and section drawn on the succeeding pages show the spring & Well as they were found to exist in May 1923 before the alteration
