Barcroft Hall  
Cliviger, Lancashire:  
Archaeological Building Recording

### Archaeological Building Recording

### Tree-ring analysis of timbers from a building: Barcroft Hall, Cliviger, near Burnley, Lancashire

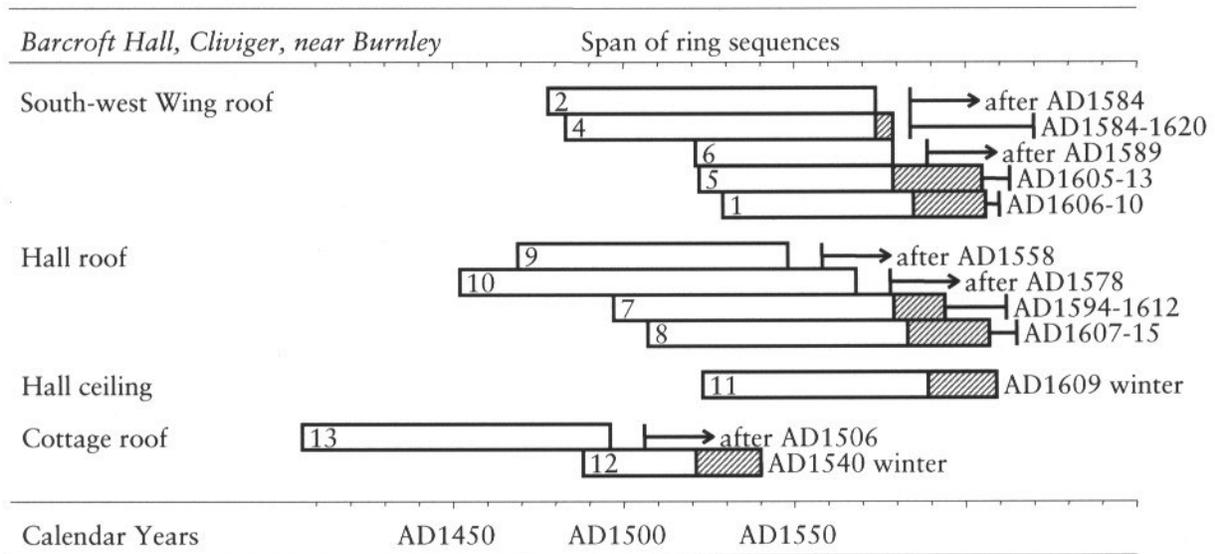
**Figure 2.** Bar diagram showing the relative and absolute positions of the dated samples from Barcroft Hall, Cliviger, near Burnley. White bars represent heartwood, hatched bars represent sapwood. The felling date, felling date range, or *terminus post quem* date is also shown for each sample as appropriate.

This initial analysis can obviously only date the rings present in the cores. The correct interpretation of those dates relies upon the nature of the final rings in the individual samples. If the sample ends in the heartwood of the original tree, a *terminus post quem* (*tpq*) for the felling of the tree is indicated by the date of the last ring plus the addition of the minimum expected number of sapwood rings that may be missing. This *tpq* may be many decades prior to the real felling date. Where some of the outer sapwood or the heartwood/sapwood boundary survives on the sample, a felling date range can be calculated using the maximum and minimum number of sapwood rings likely to have been present. Alternatively, if bark-edge survives, then a felling date can be directly utilised from the date of the last surviving ring. The sapwood estimates applied throughout this report are a minimum of 10 and maximum of 46 annual rings, where these figures indicate the 95% confidence limits of the range. These figures are applicable to medieval and modern oaks from England and Wales (author unpubl.). The dates obtained by the technique do not by themselves necessarily indicate the date of the structure from which they are derived. It is necessary to incorporate other specialist evidence concerning the reuse of timbers and any repairs before the dendrochronological dates given here can be reliably interpreted as reflecting the construction date of any component of the structure.

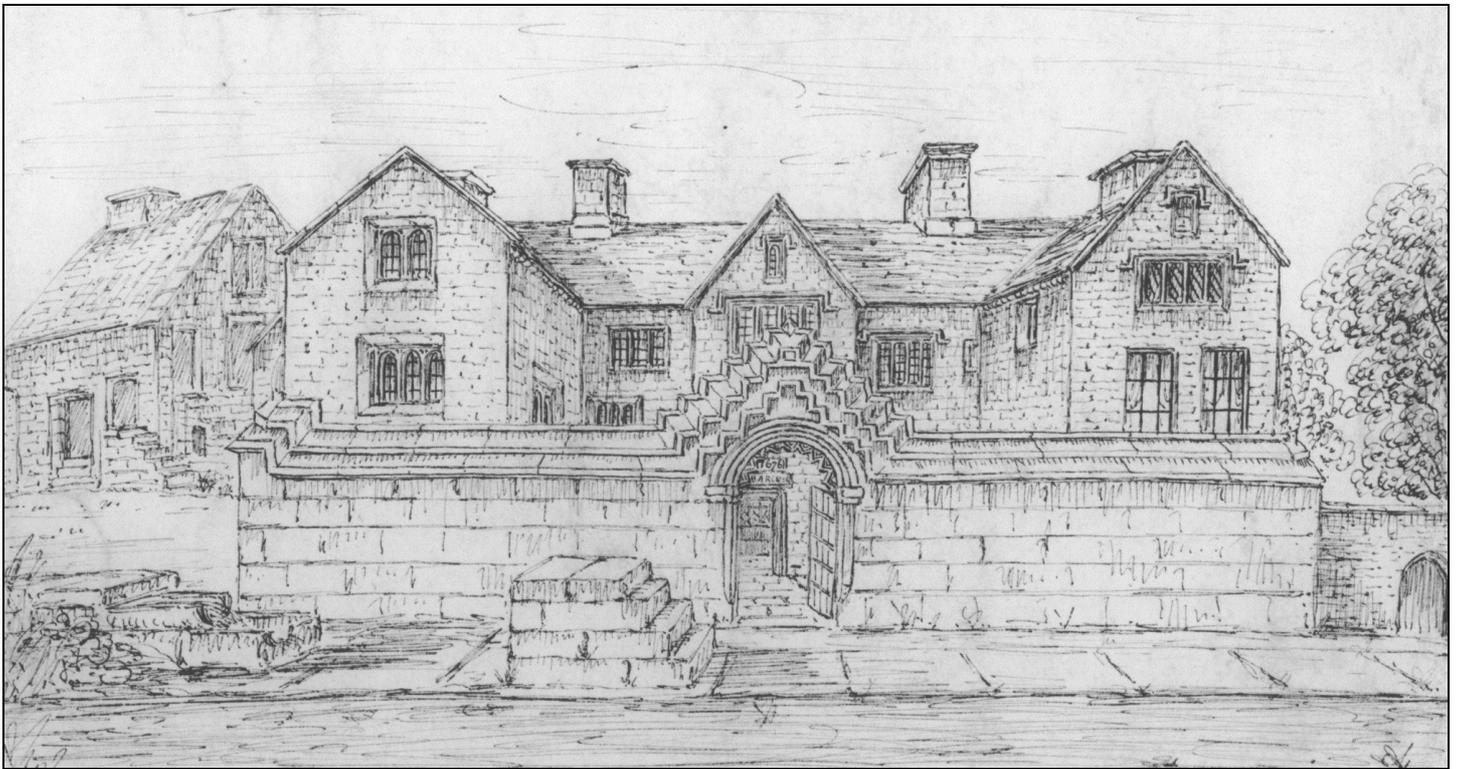
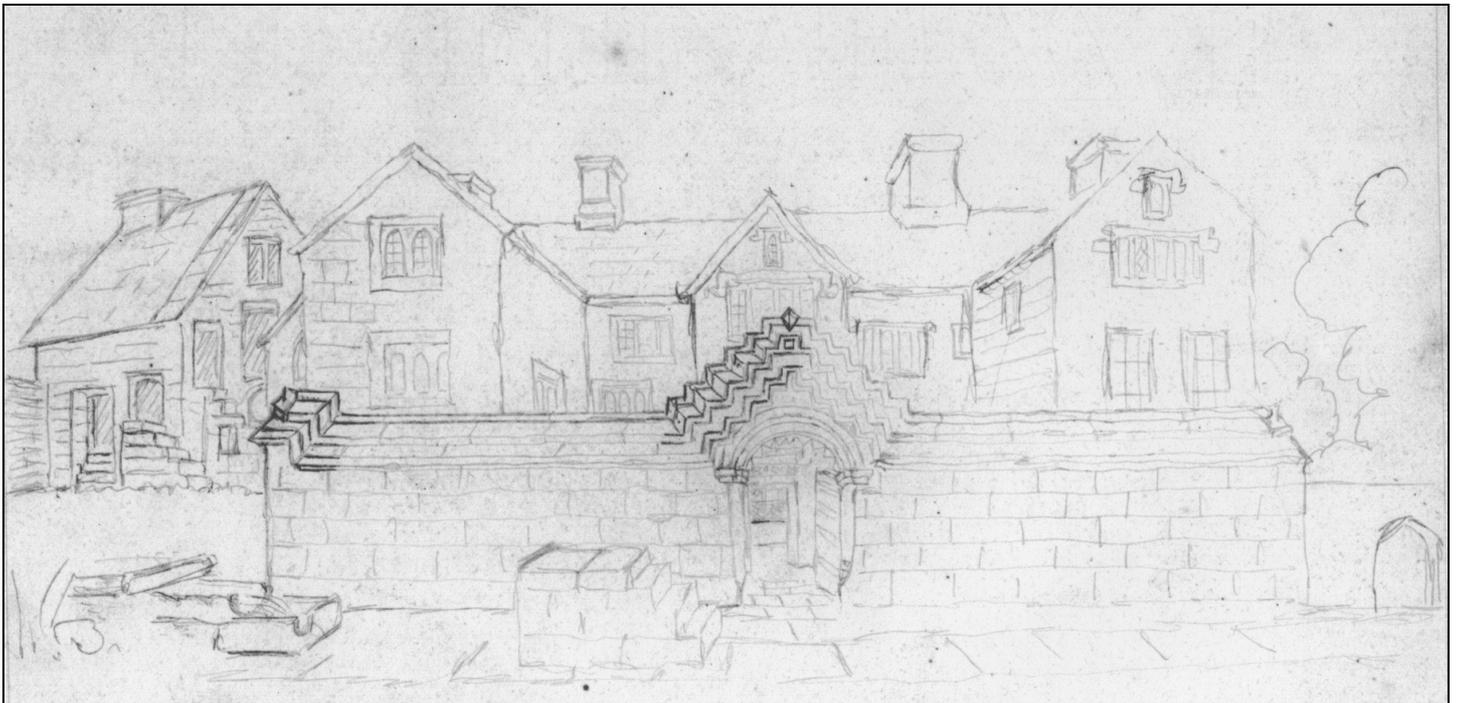
**Figure 3:** Two sketches of the hall by Samuel James Allen, probably in the 1830s  
(York City Archives: Acc 100/S06/036,037)

Both show a porch or similar on the north side of the north wing, as well as a detached building at an angle to the main range.

- 4.8 Two sketches of the Hall were made by Samuel James Allen, probably in the 1830s, which are the earliest known illustrations of Barcroft Hall (York City Archives: Acc 100/S06/036,037) (Figure 3). While these show the hall and adjoining ranges largely as they are today they also show what appears to be a lean-to porch on the north side of the north wing, beyond which is a detached, stone building standing at an angle to the main building's alignment, no longer extant. This suggests that the timber-framed hall believed to have occupied this side of the north wing had already been demolished by this date, as might be expected once its role had been taken over by the new seventeenth century hall.

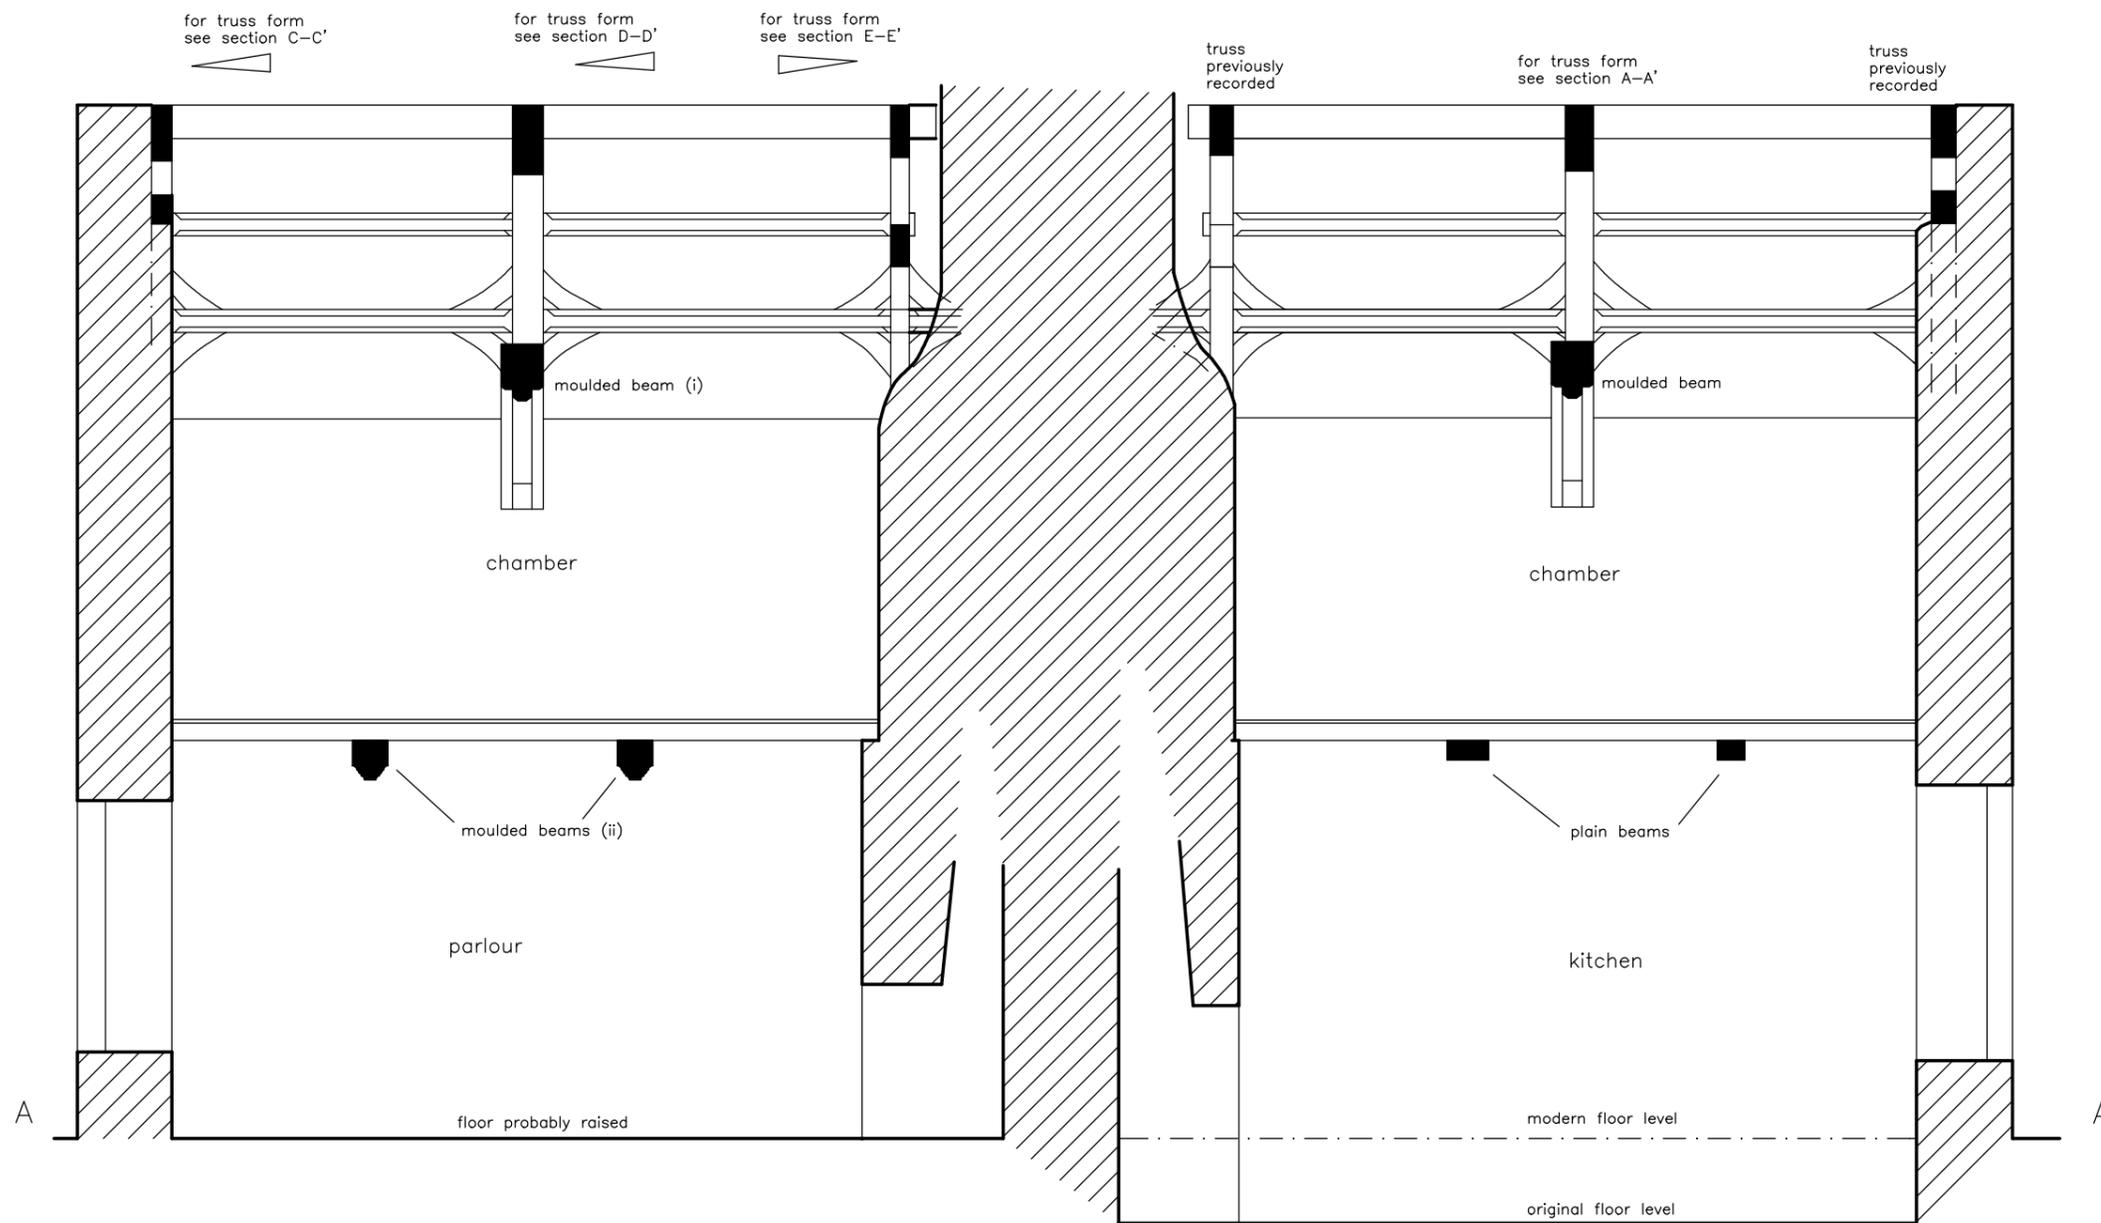
(i) detail of parlour beam moulding (1:20)

- 6.6 The parlour fireplace, not visible at the time of the RCHME survey, has its original hollow-chamfered surround, the chamfers stopped just above present floor level, which is thought to have been raised (23). To the north, the chimney breast stops short of the north wall (originally timber-framed here), and although the adjacent void is now largely rubble-filled, spanned by a beam at first floor level, it appears to contain the fragmentary remains of a stone staircase which would have given access to the first floor directly from the former hall to the north (24,25). There are clearer traces of a second staircase within a recess to the

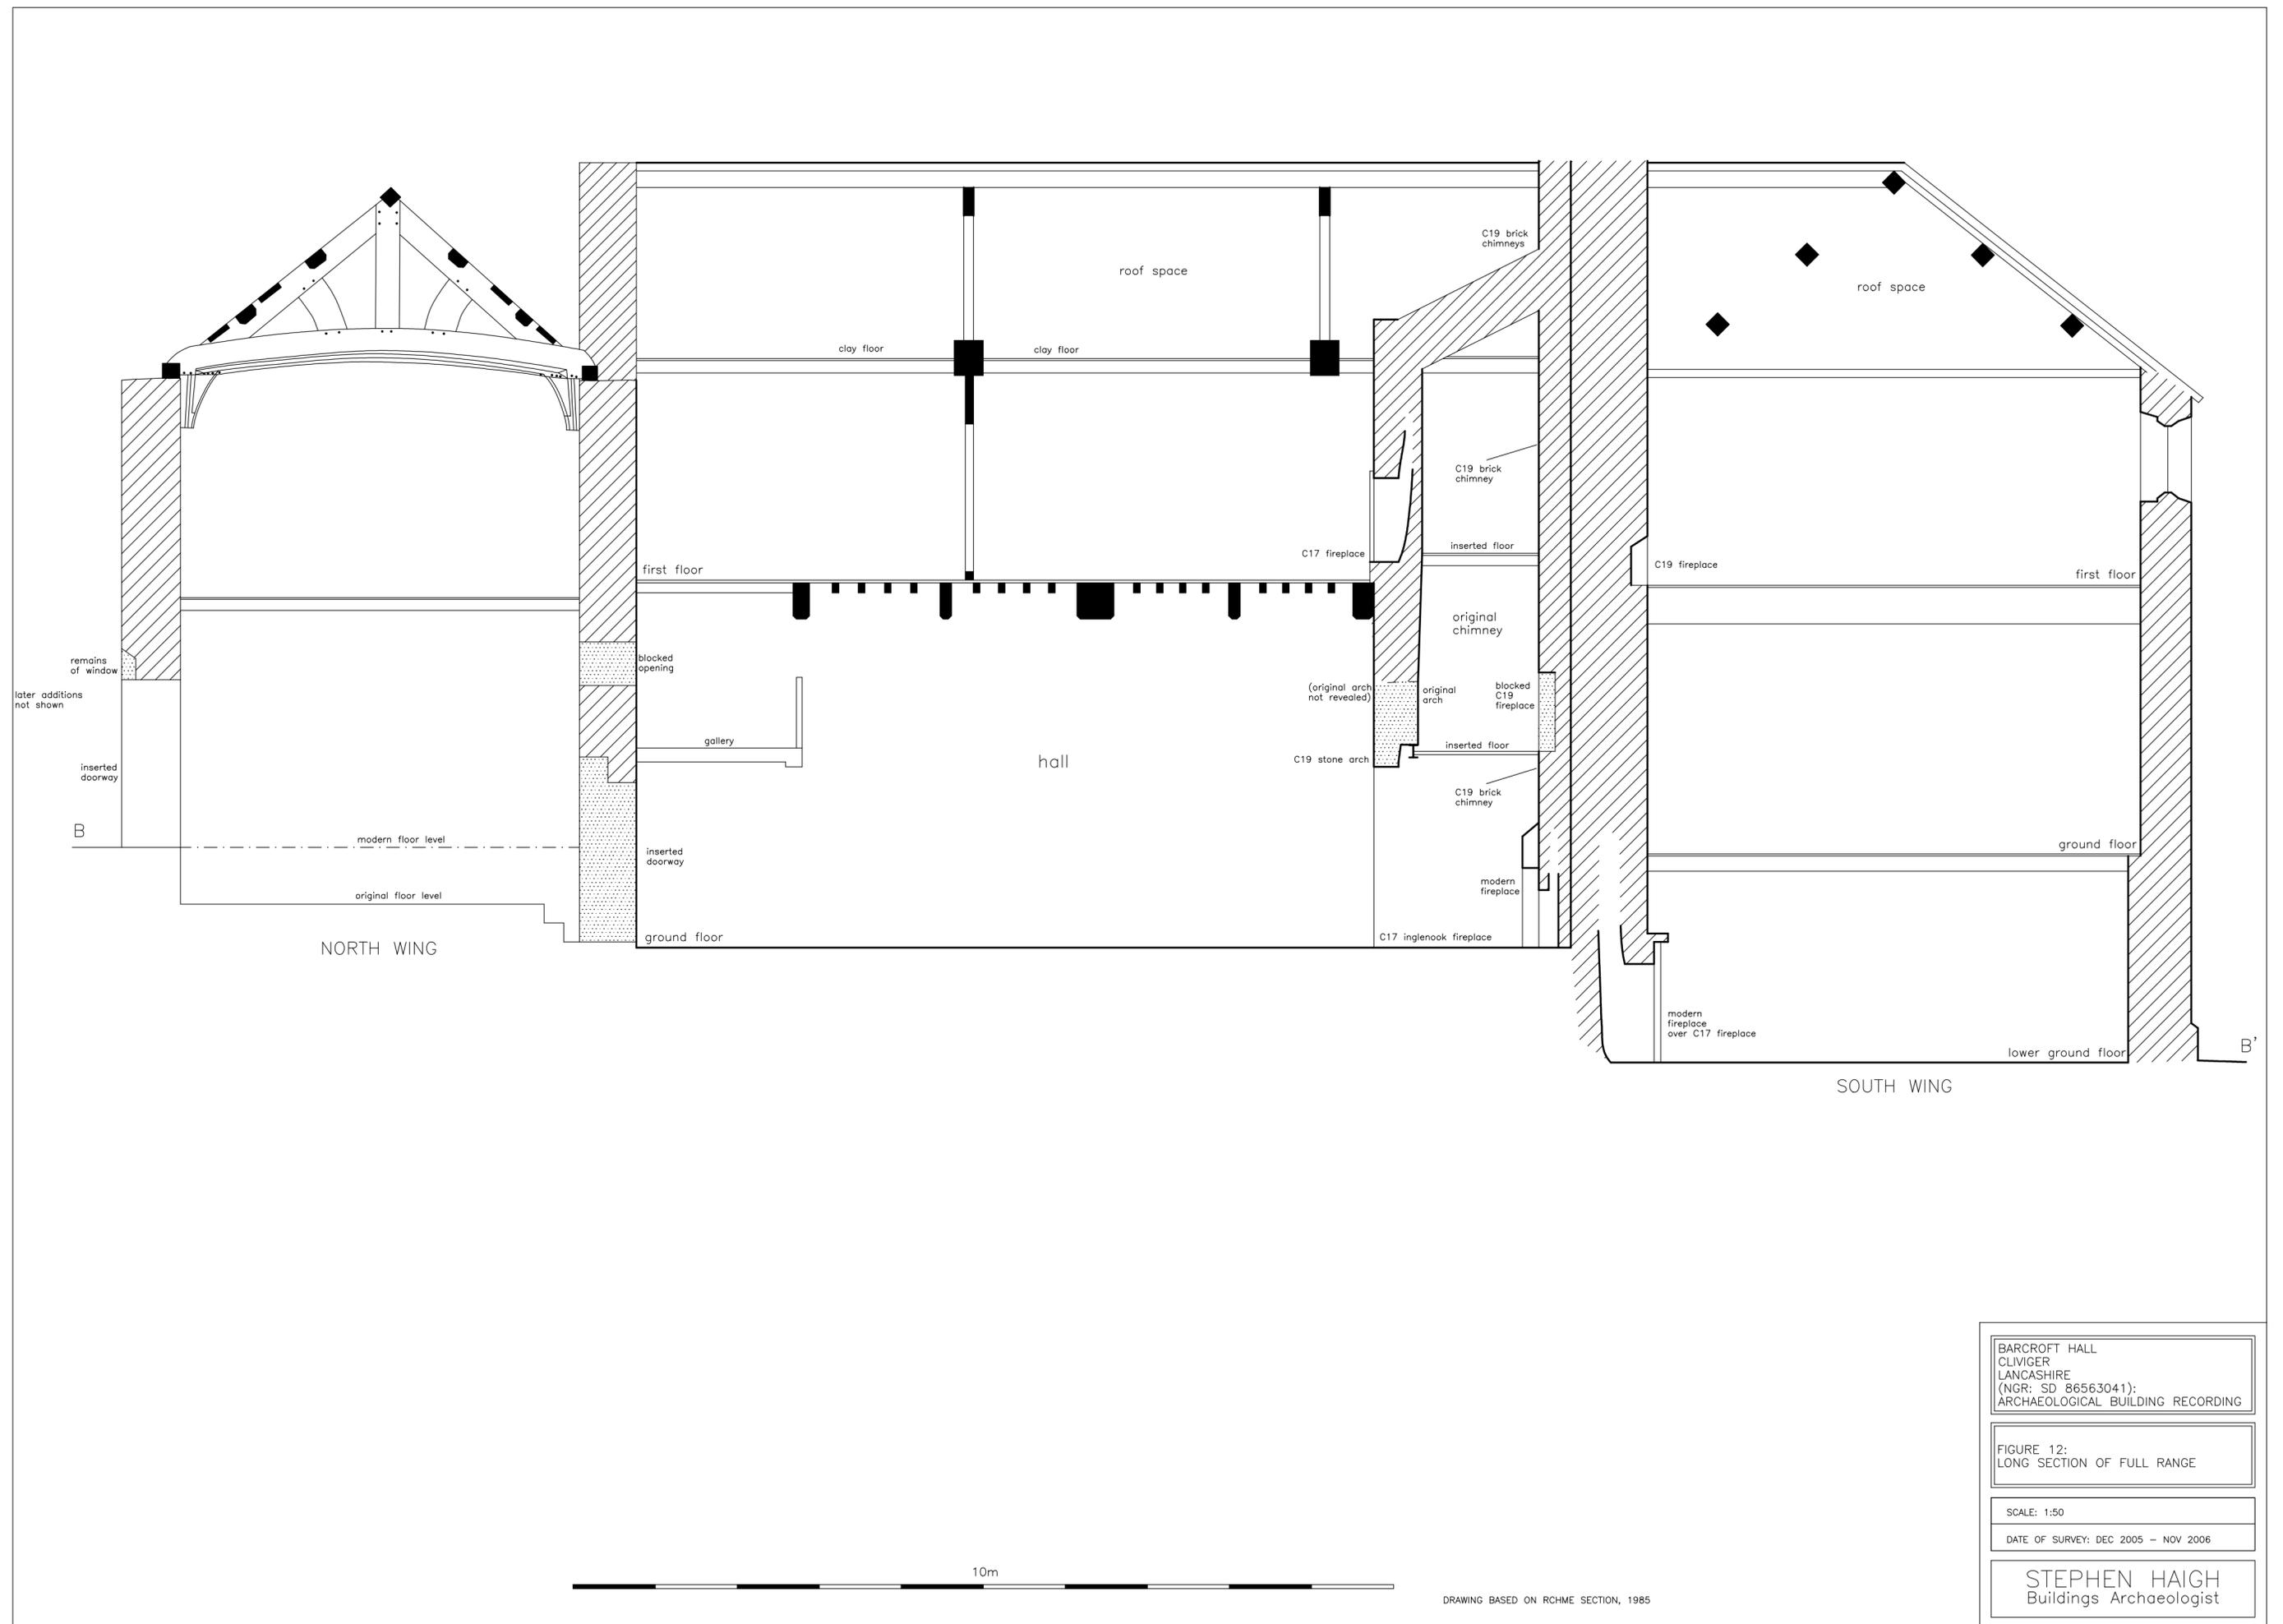
FIGURE 12:  
 LONG SECTION OF FULL RANGE

DRAWING BASED ON RCHME SECTION, 1985

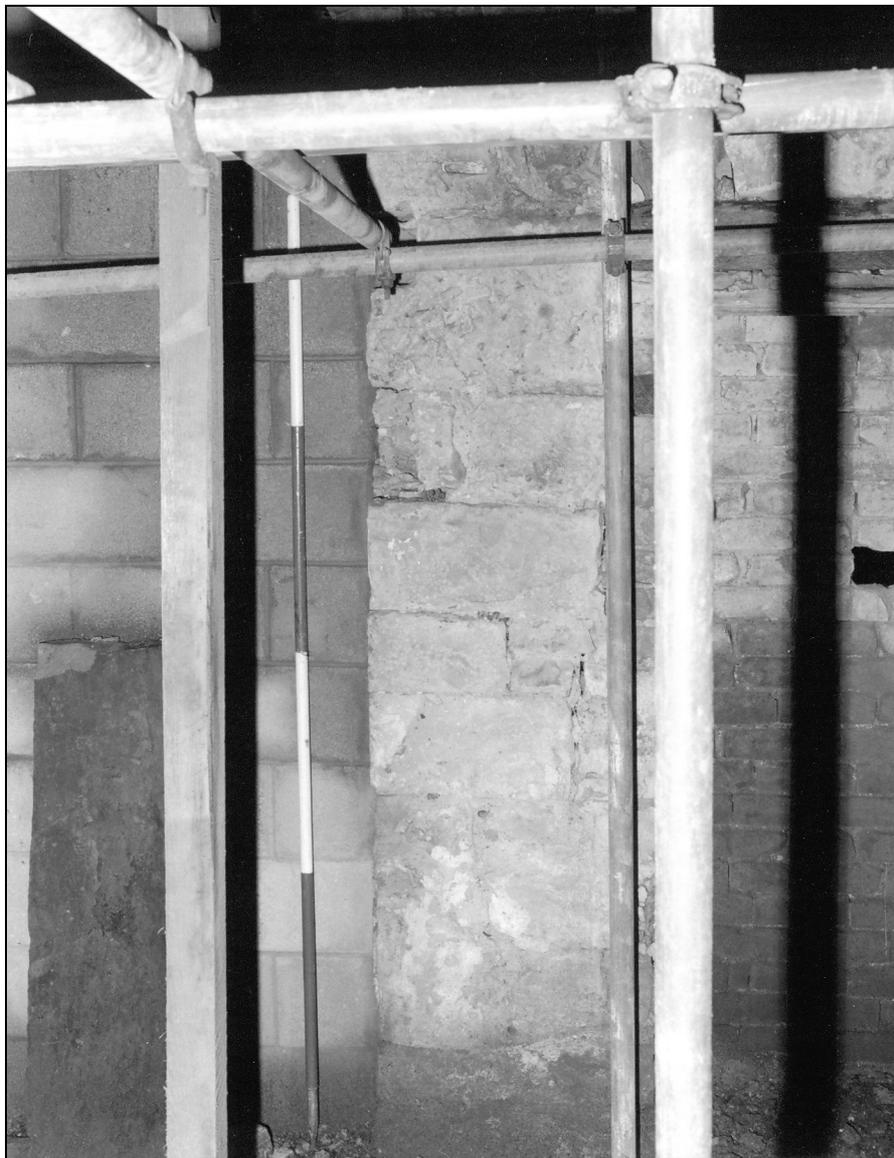
Photo 4: North wing: side of doorway in east room (taken from the south-west; 2m scale)
