Field Barn by Eller Beck
off Back Lane, Slaidburn, Lancashire:
Archaeological Building Recording

October 2007
Revised January 2008

ARCHAEOLOGICAL BUILDING RECORDING

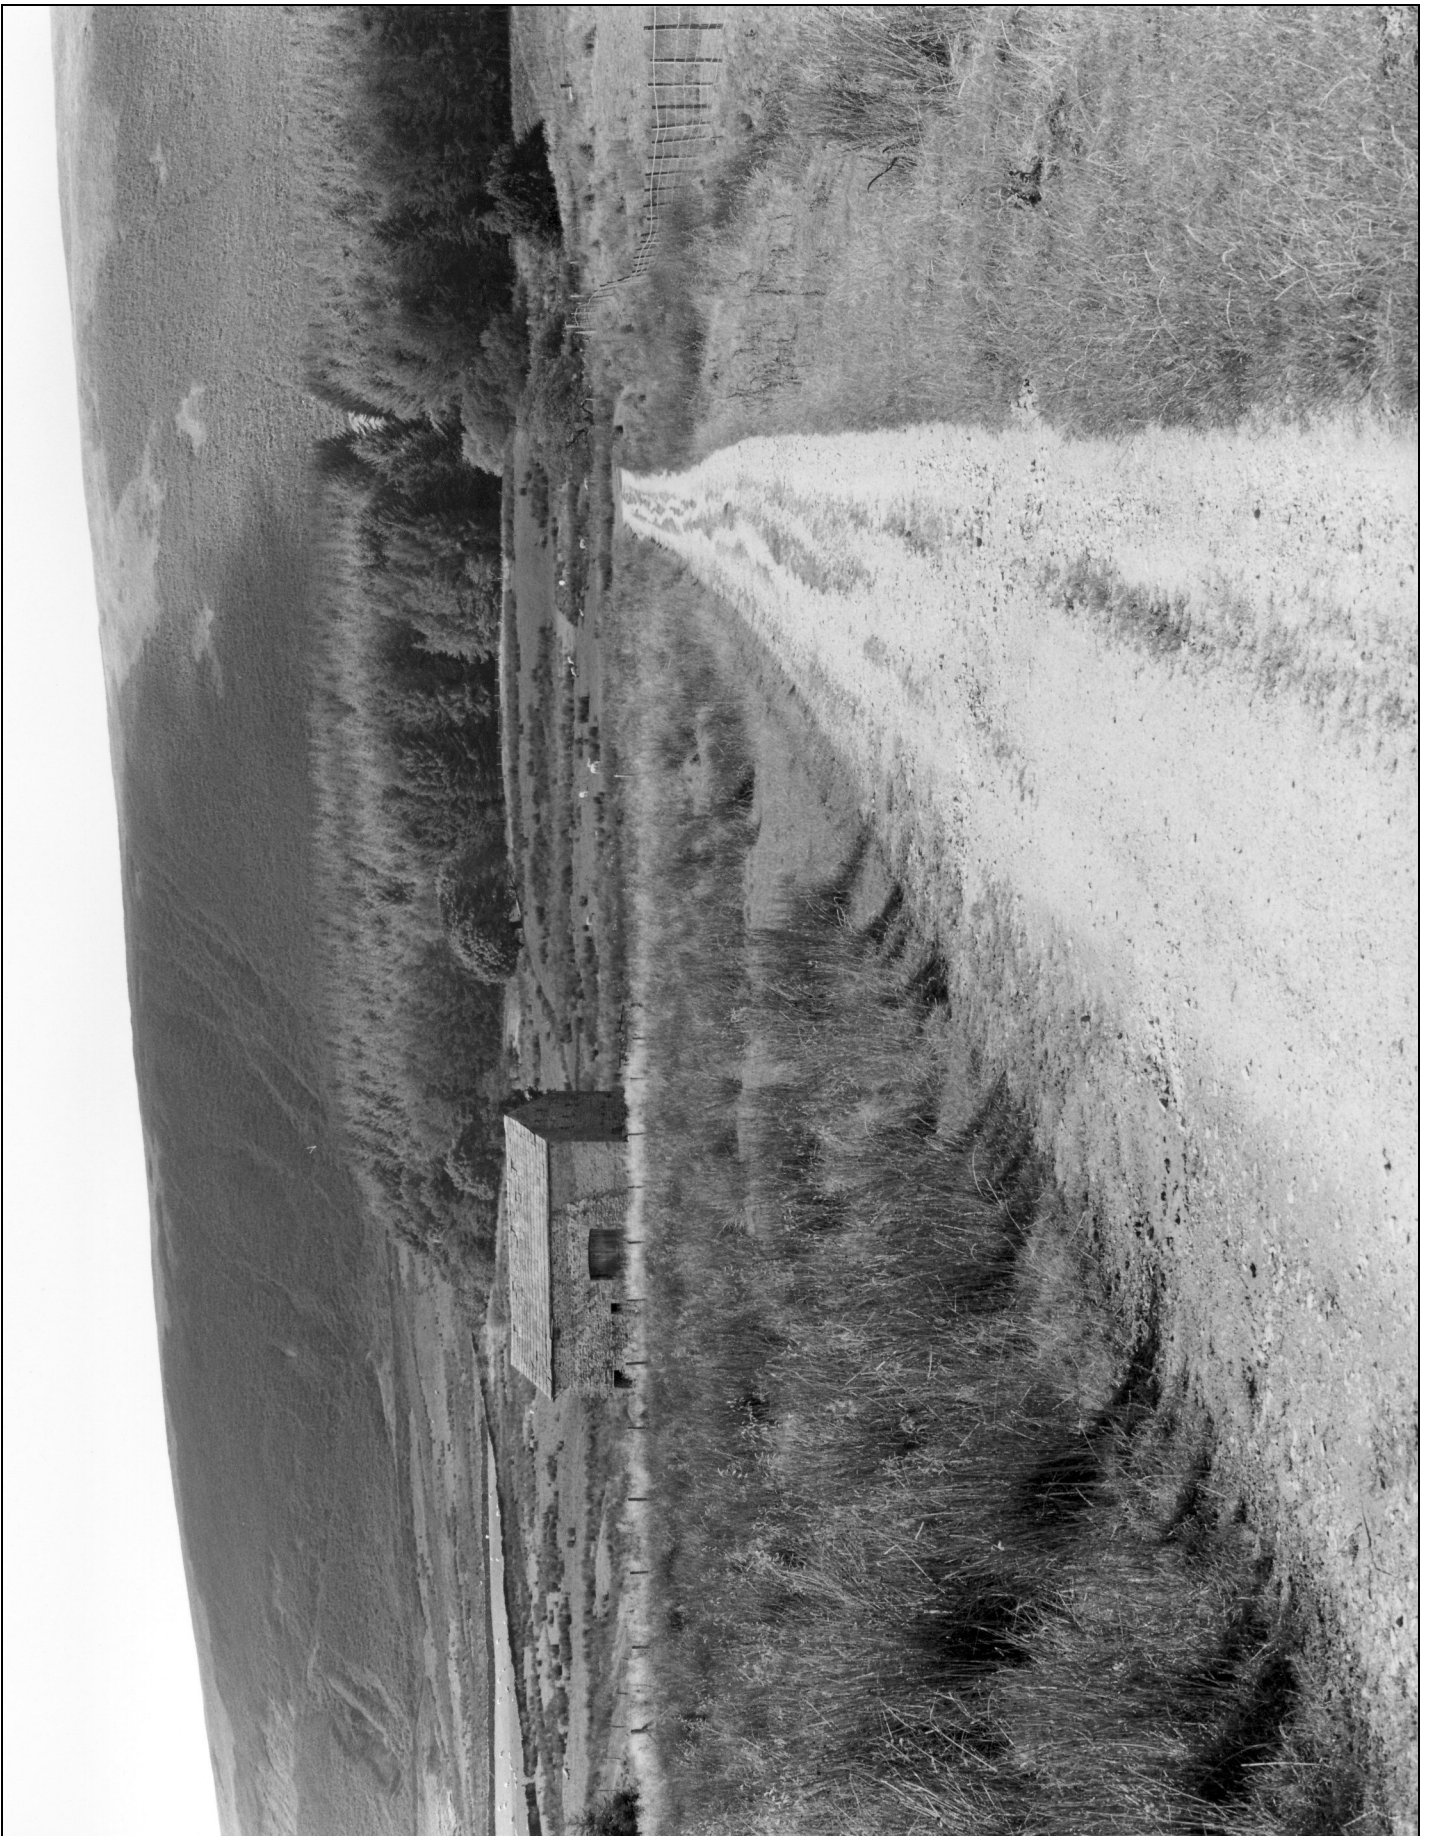
Photo 1: Distant view of the barn, from the south-east

- 6.1 The building stands within a gently sloping field of improved pasture, facing south-east with its south-west gable close to the minor watercourse called Eller Beck (**1**). It occupies a relatively level site reached by a vehicle track (**2**), and the building's forecourt has traces of setts which once would have formed a small causeway along the front elevation. A field boundary runs along the rear line of the building.

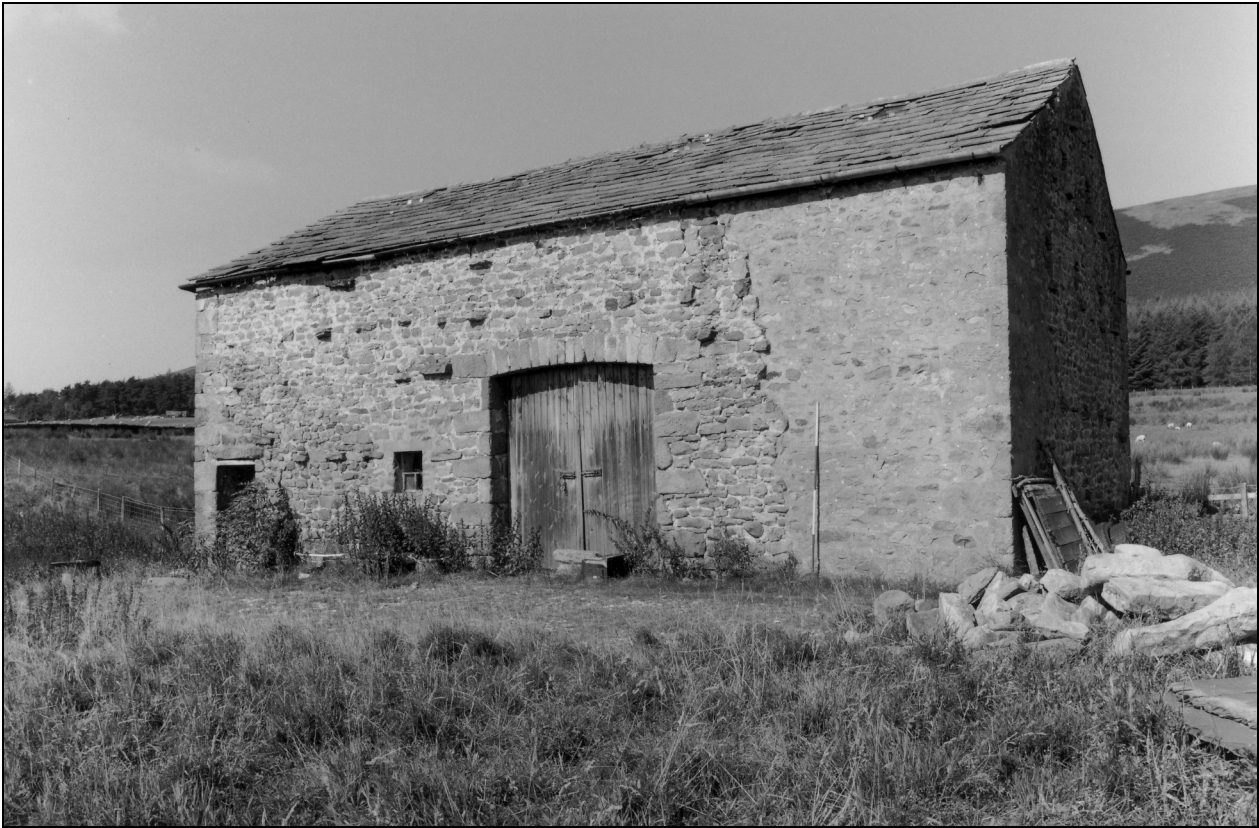
Photo 3: Front elevation, from the south-east

- 6.3 The front elevation has the main entrance to right of centre (**3**), and has plain, quoined jambs and a low arch which has dropped slightly: large enough for a cart, it contains a pair of re-boarded doors. To the left of here is a small window, the altered masonry around it indicating it has either been inserted or is an enlargement of an earlier opening. At the far end of this wall is a doorway to the shippon, plain but with a rebated jamb to hold the internally opening door.

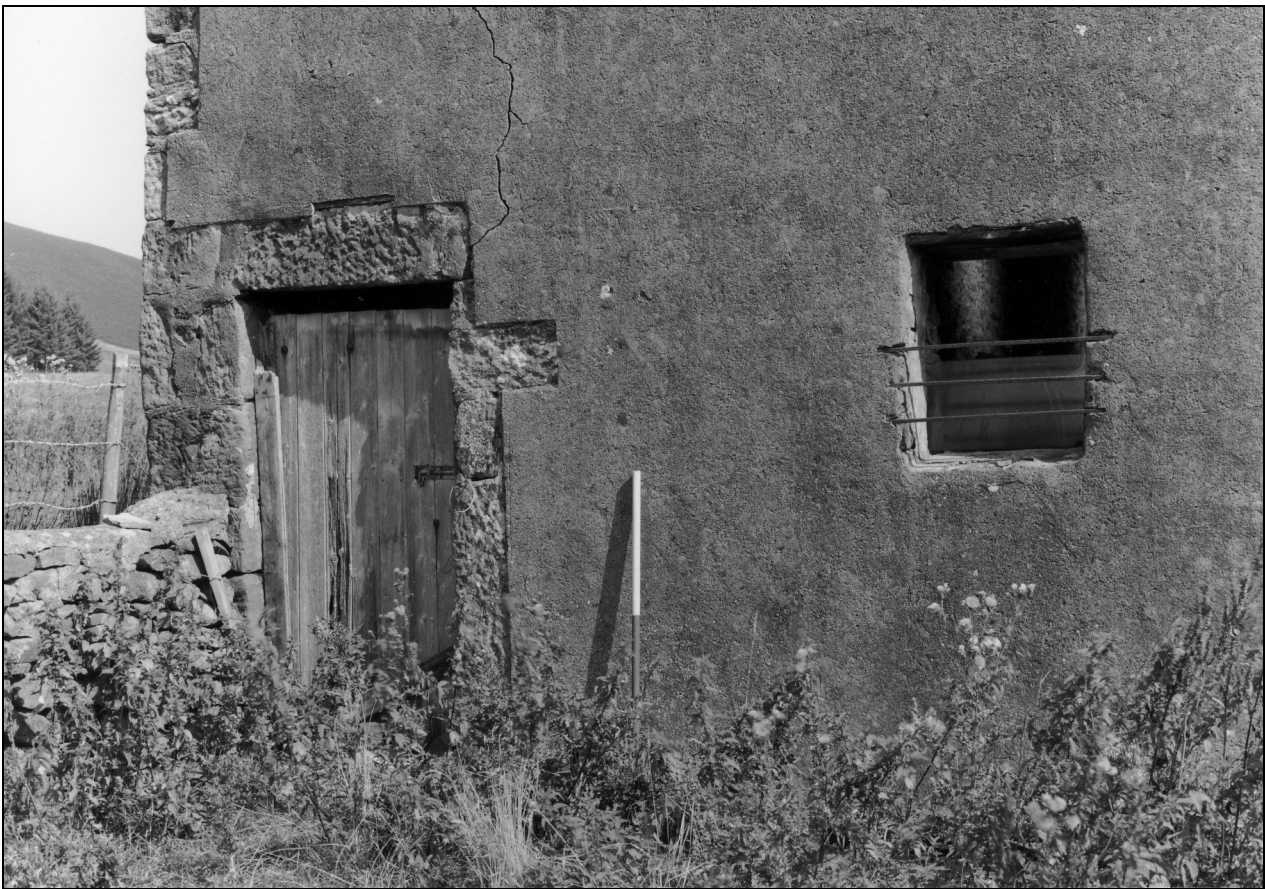
Photo 7: Detail of doorway and window in south-west gable

- 6.4 The rendered south-west gable has two openings: a doorway at the left, probably indicating a separate room within the shippon, and an adjacent opening, probably a muck-hole (**7**). The opposite north-east gable, partly rebuilt, has no

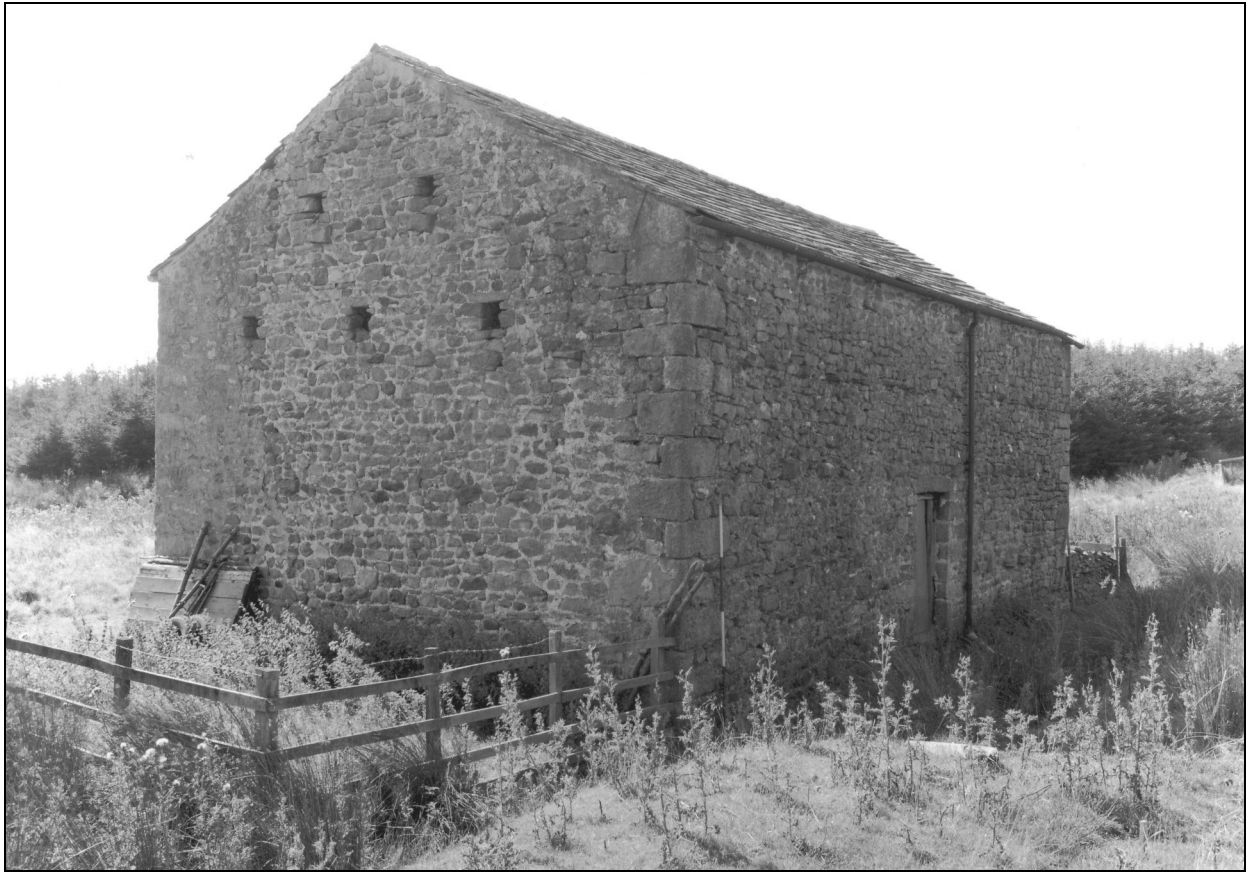
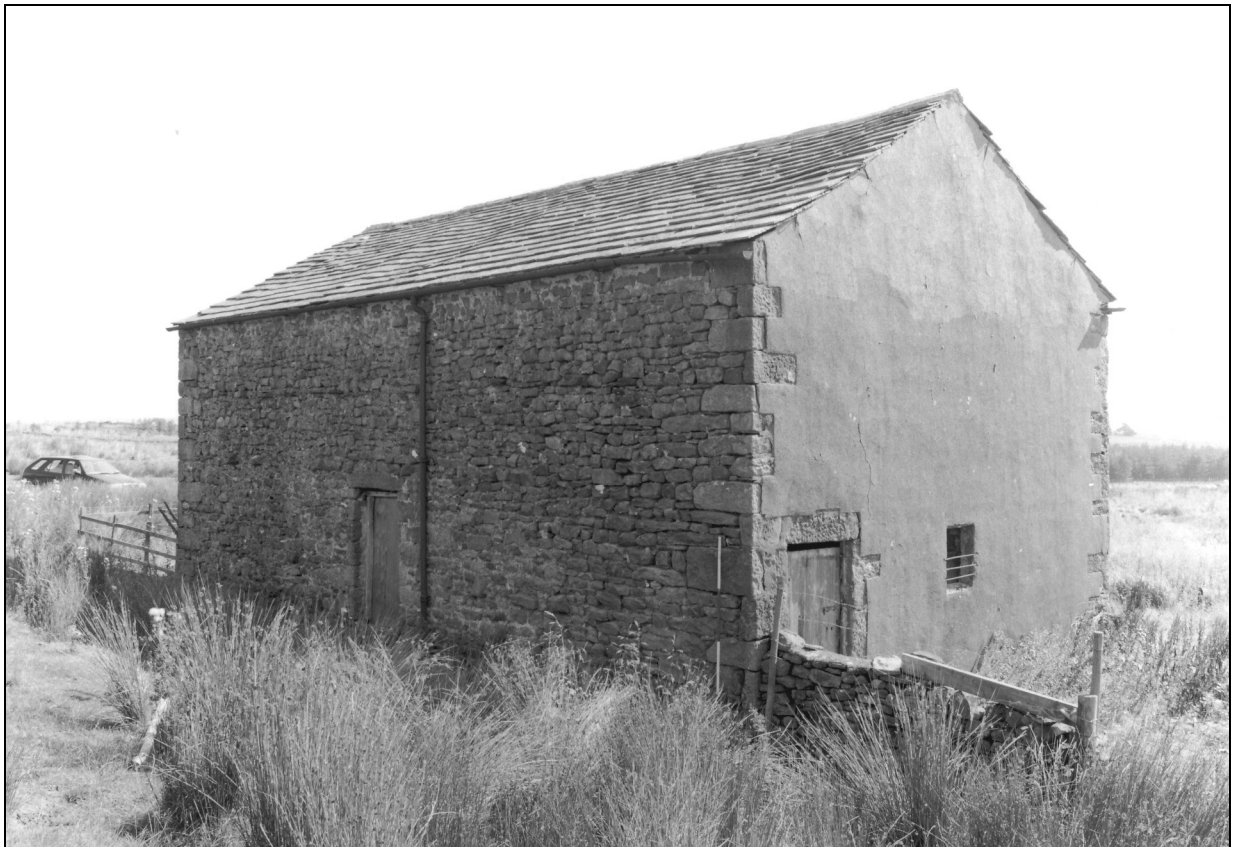
openings except for two rows of breathers or putlogs at upper level; the internal face of the south-west gable suggests that these were matched originally. To the rear, the barn has a central pedestrian doorway containing what is probably the original door (9,11).

Photo 9: The barn, from the north

Photo 11: The barn, from the west

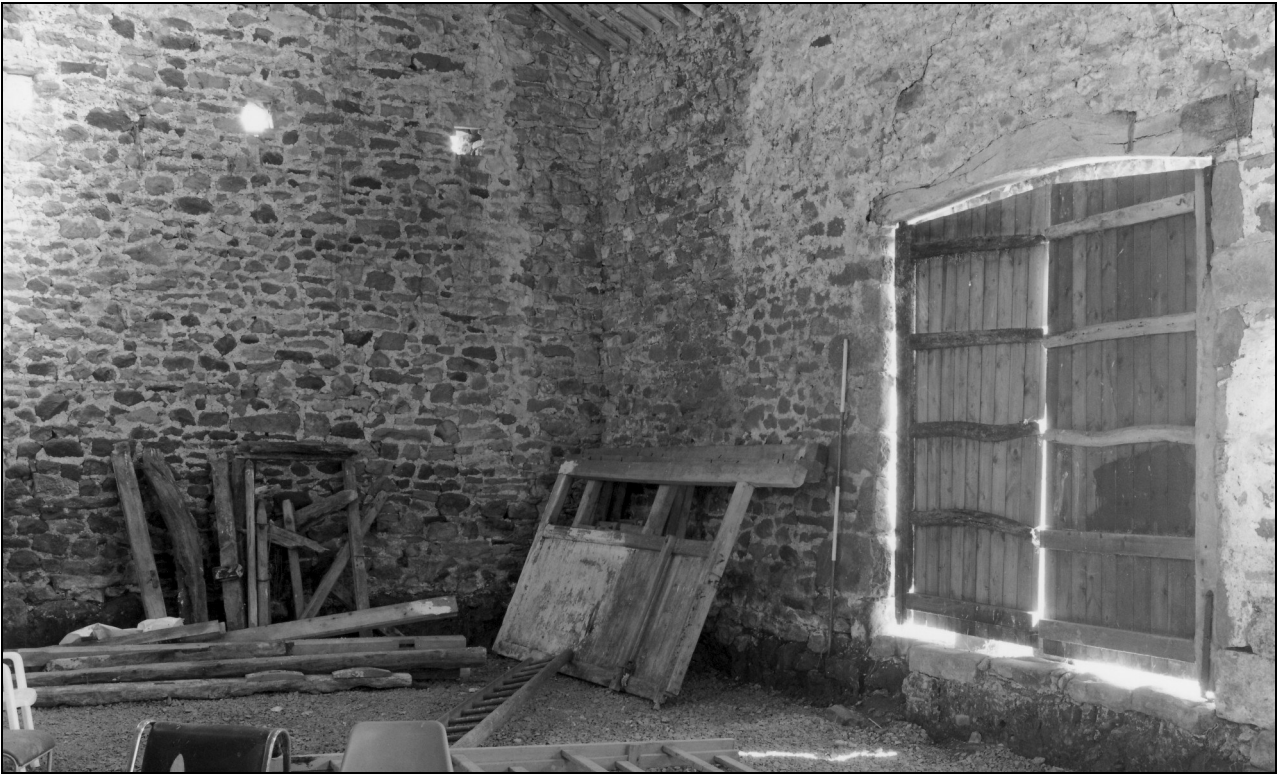
Photo 13: Interior of barn, from the west

- 6.6 The roof trusses form four unequal bays, that at the north-east forming the mewstead being longer than the other three (13). The main entrance opens into the third bay; the opening has a curved oak timber used for a lintel, which holds a pair of harr-hung doors whose frames appear to be largely original (15); more of the original rear door survives (as noted above), including the spoon-head strap hinges (16). To the north-east of here, the mewstead would have formed a storage area, and there is no indication of any subdivision or upper floor level.

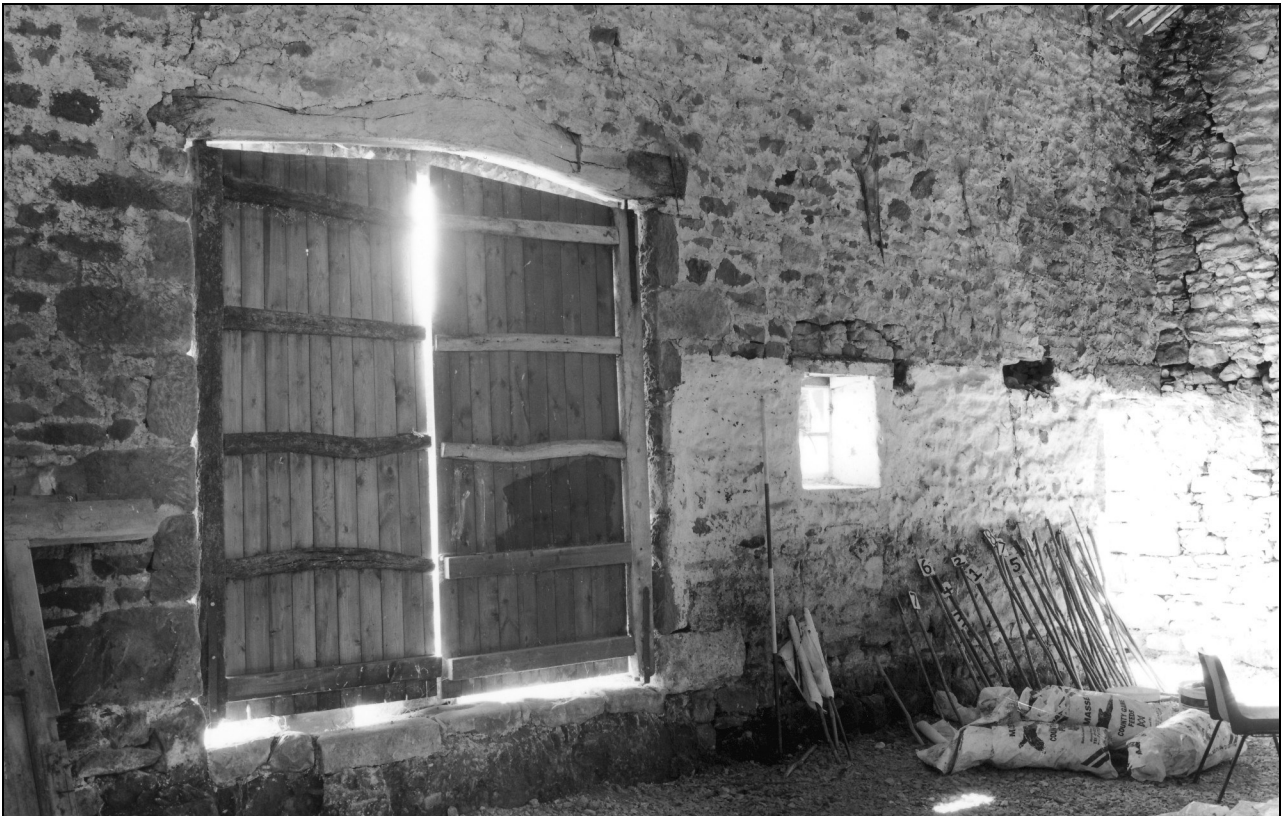
Photo 17: South-west corner of interior and main entrance

- 6.7 In the south-west end of the barn however there is good evidence for the presence of a shippon, although its precise arrangement is not clear. Whitewash to the front and rear (but not gable) walls clearly shows its former extent, but it does not appear to have comprised simply a row of stalls facing into the building. This is apparent from the beam sockets for the horizontal timbers in the long walls, of which there are two in the front and three in the rear walls, which do not align with each other (17-18). This observation, together with the presence of the gable doorway, suggests a slightly different arrangement, borne out by the form of the dismantled boskins (stall divisions) stored within the building: there are three "standard" length examples (20) and one longer one (21), the latter probably having formed a longer partition within the shippon, next to the gable entrance. These boskins are constructed entirely of softwood and are likely to be of early twentieth century date; within and next to the barn there are also the remains of earlier oak-framed and slate-panelled boskins, typical for the district, and which were probably the original fittings. The remains include a number of timbers, among which is a good example of an elbowed heel-post, with slot for the slate panel, and a tenon for the loft beam (22), and a number of other timbers with less clear functions for the most part. In addition, piles of stone lie to the
