Barn at Springside
Knotts, Bolton-by-Bowland, Lancashire:
Archaeological Building Recording

Barn at Springside Knotts, Bolton-by-Bowland, Lancashire: Archaeological Building Recording

Archaeological building recording was carried out for Mr & Mrs Stazicker in June 2007 at a barn at Springside, near Bolton-by-Bowland, Lancashire (NGR: SD 769532), before its conversion to residential and workshop use. The building is stone-built and probably of eighteenth or early nineteenth century date, and comprises a four bay barn with shippon at one end, with a second shippon at the opposite end having been removed. It has also been extended in two phases, to front and rear. The records made include a ground floor plan, a section drawing and photographs, as well as a written account.

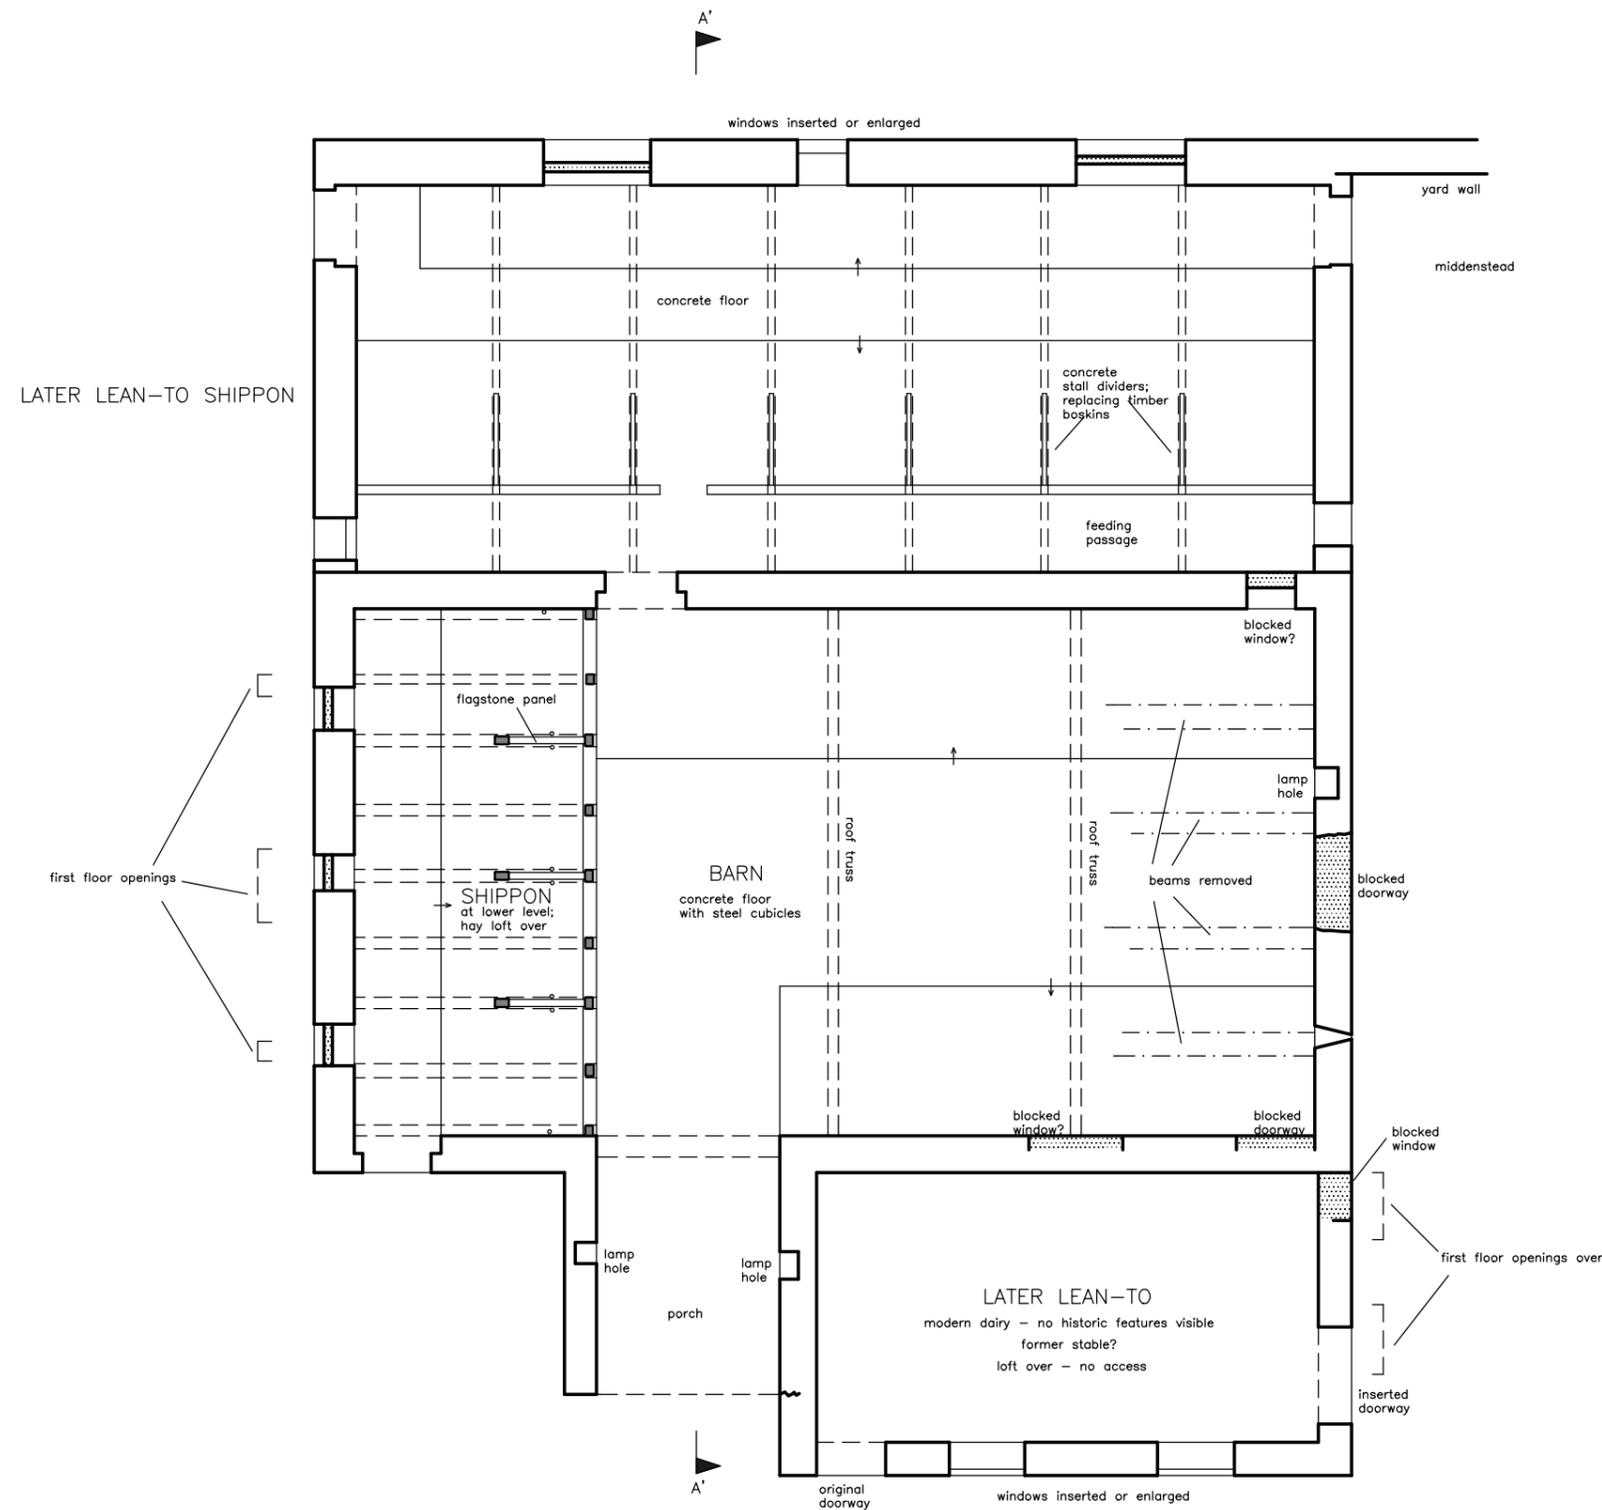
FIGURE 7:
 GROUND FLOOR PLAN

- 5.1 The archaeological building recording took place on 7 June 2007, and in accordance with the standard specification issued by the Lancashire County Archaeology Service for agricultural buildings.
- 5.2 It involved the production of a new ground floor plan and a cross-section drawing of the barn, showing all significant archaeological detail, and employing conventions based on those specified by English Heritage¹.

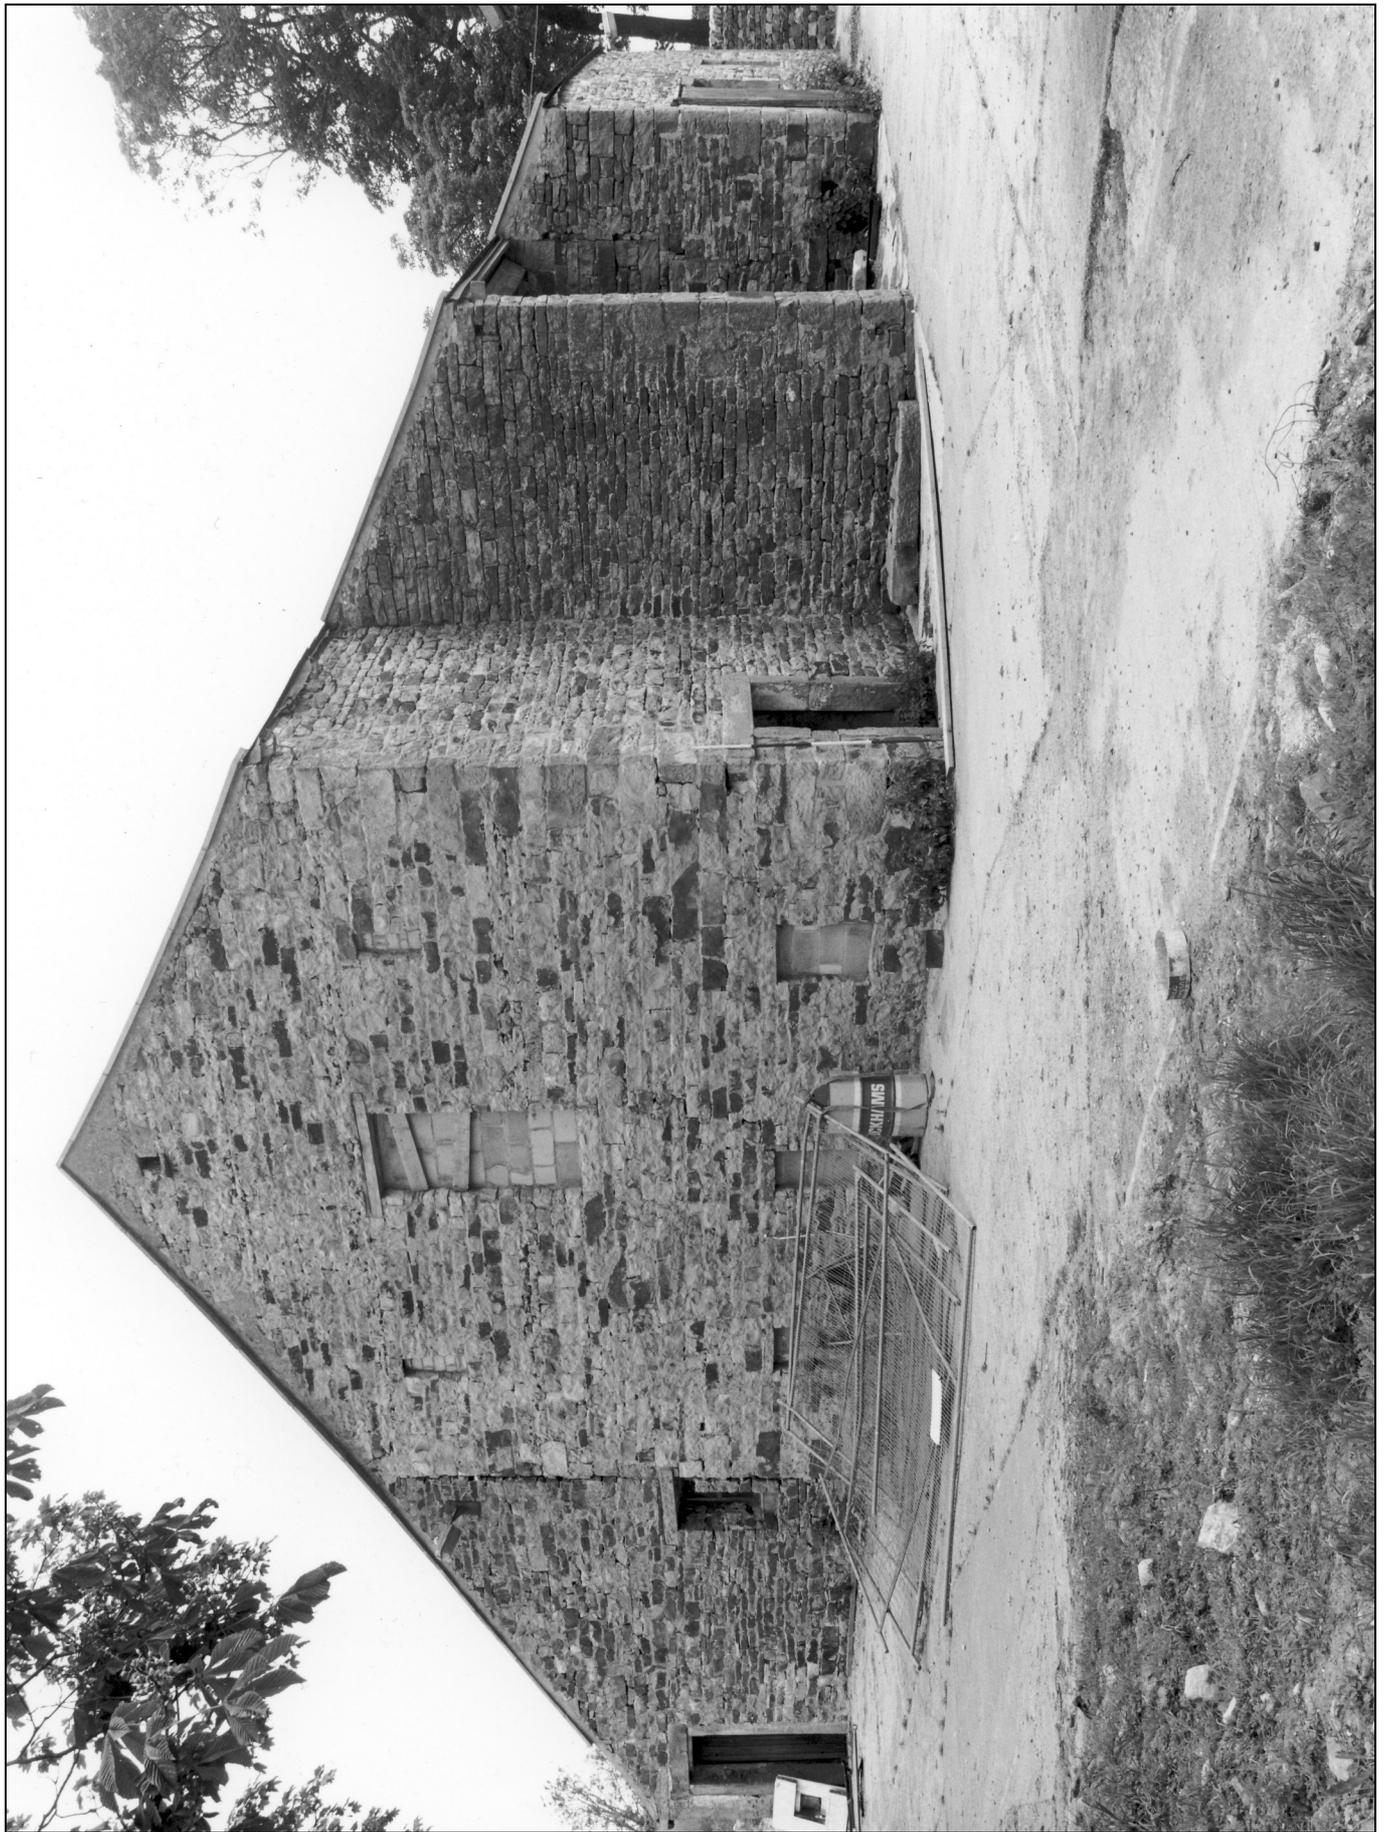
- 6.1 The barn faces south-south-east (hereafter south) and is built of local sandstone rubble laid in courses for the most part, with edge-laid quoins, plain dressings and no decorative features; its roof is now entirely of new blue slate with concrete copings, but was formerly stone slated (**1**). The south side has a projecting porch in the second bay from the left, formed by two projecting walls, of which the east one has been extended to form the west side of the later outshot or lean-to (**2,3**). The interior of the porch, which has the doors set on the main building line, and is spanned on the outer face by a modern softwood purlin, contains a recess in each of the side walls, which were probably lamp or keep-holes (**4**). To the left of the porch is a doorway to the shippon in the west end of the barn (**5**), with tie-stone jambs, and now rather low as a result of the raising of the external ground level. To the right of the porch the added outshot projects slightly; it is faced with similar sandstone rubble which is more poorly coursed than that of the main building. The doorway in its south side appears original, but the two adjacent windows are secondary (or enlarged), and relate to the later use of this room as a dairy, but it is likely that this was originally a stable (**6**).

Photo 1: The barn from the south-west

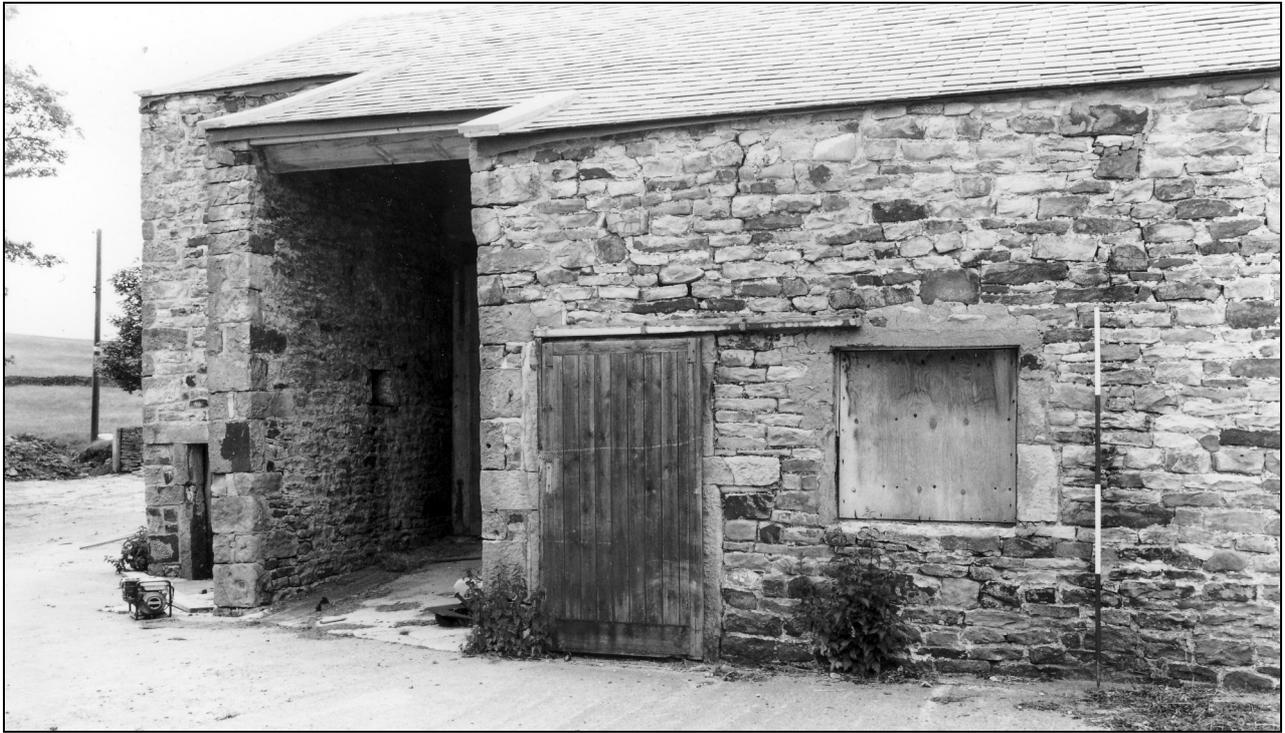
Photo 2: Entrance to porch, and south lean-to

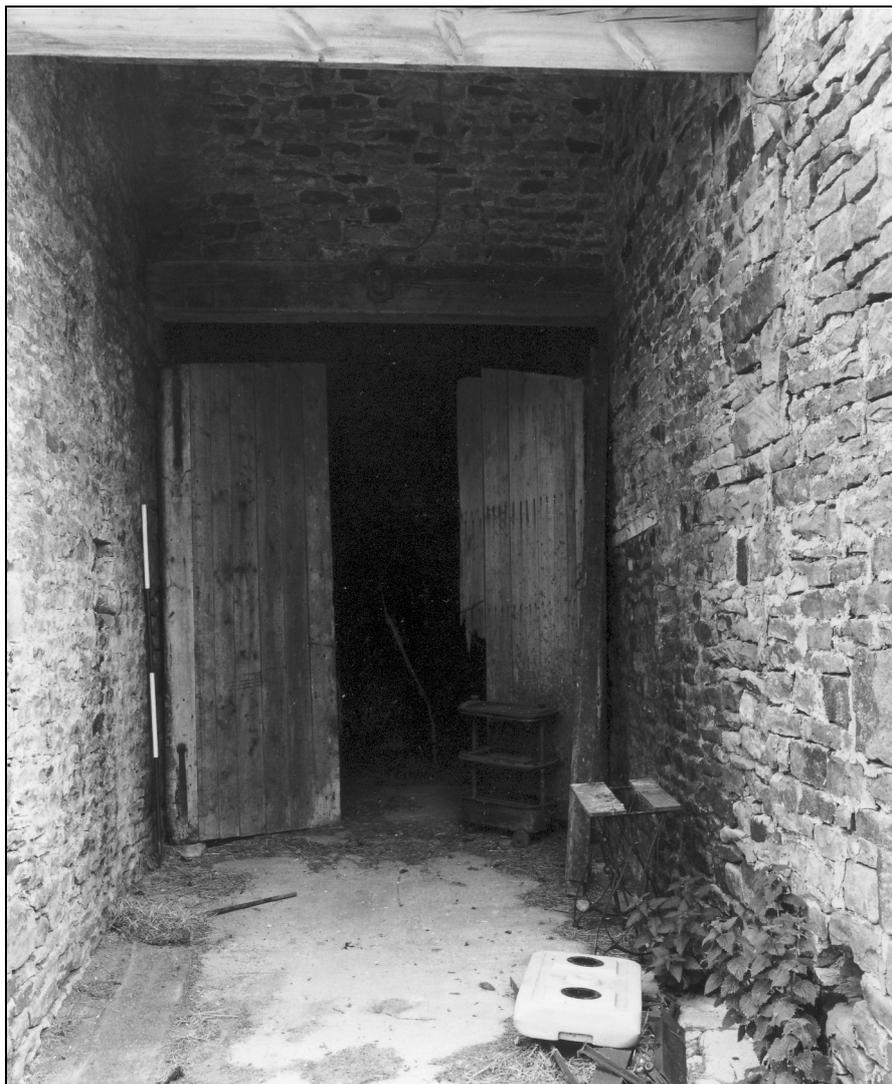
Photo 4: View into porch, from the south

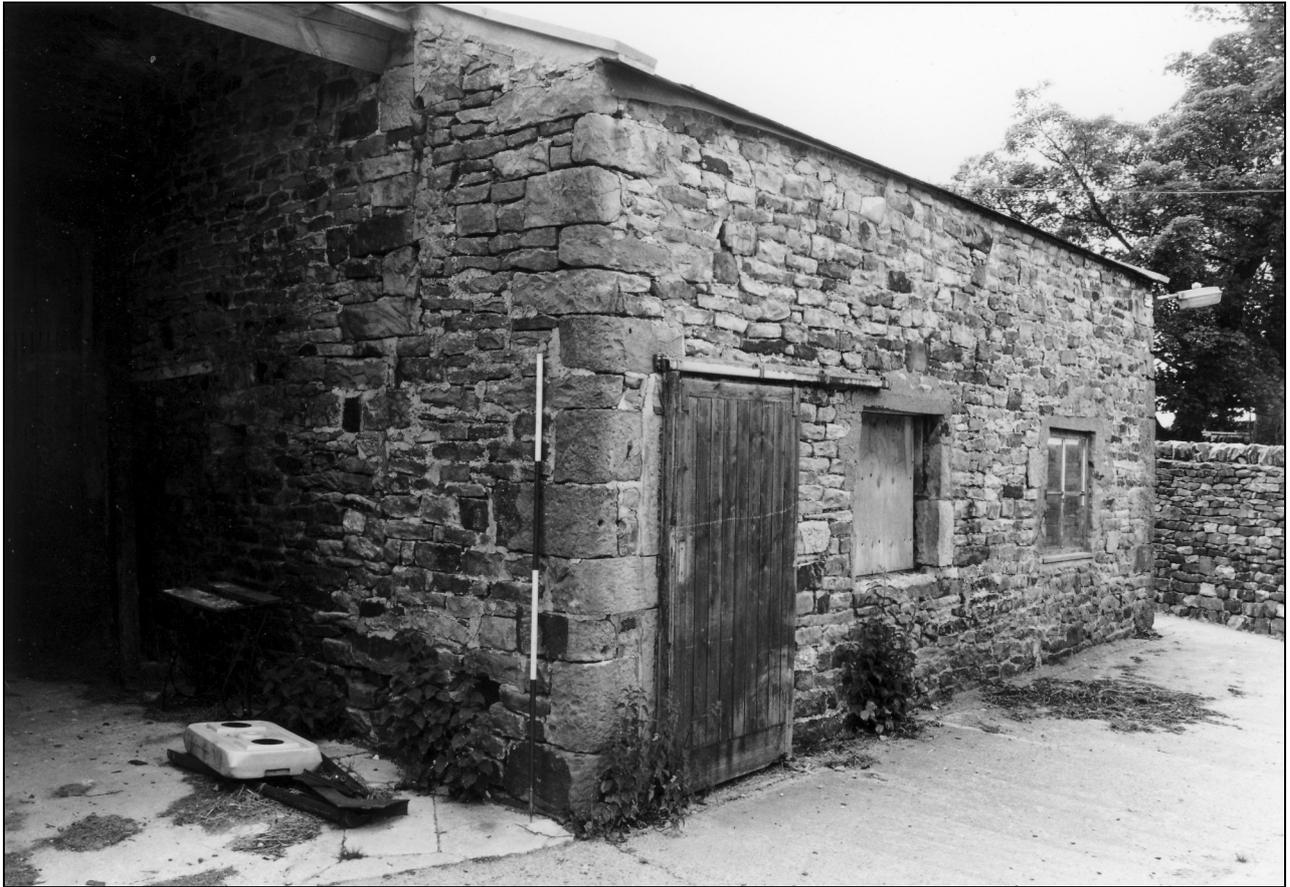
Photo 6: South elevation of south lean-to or outshut, from the west

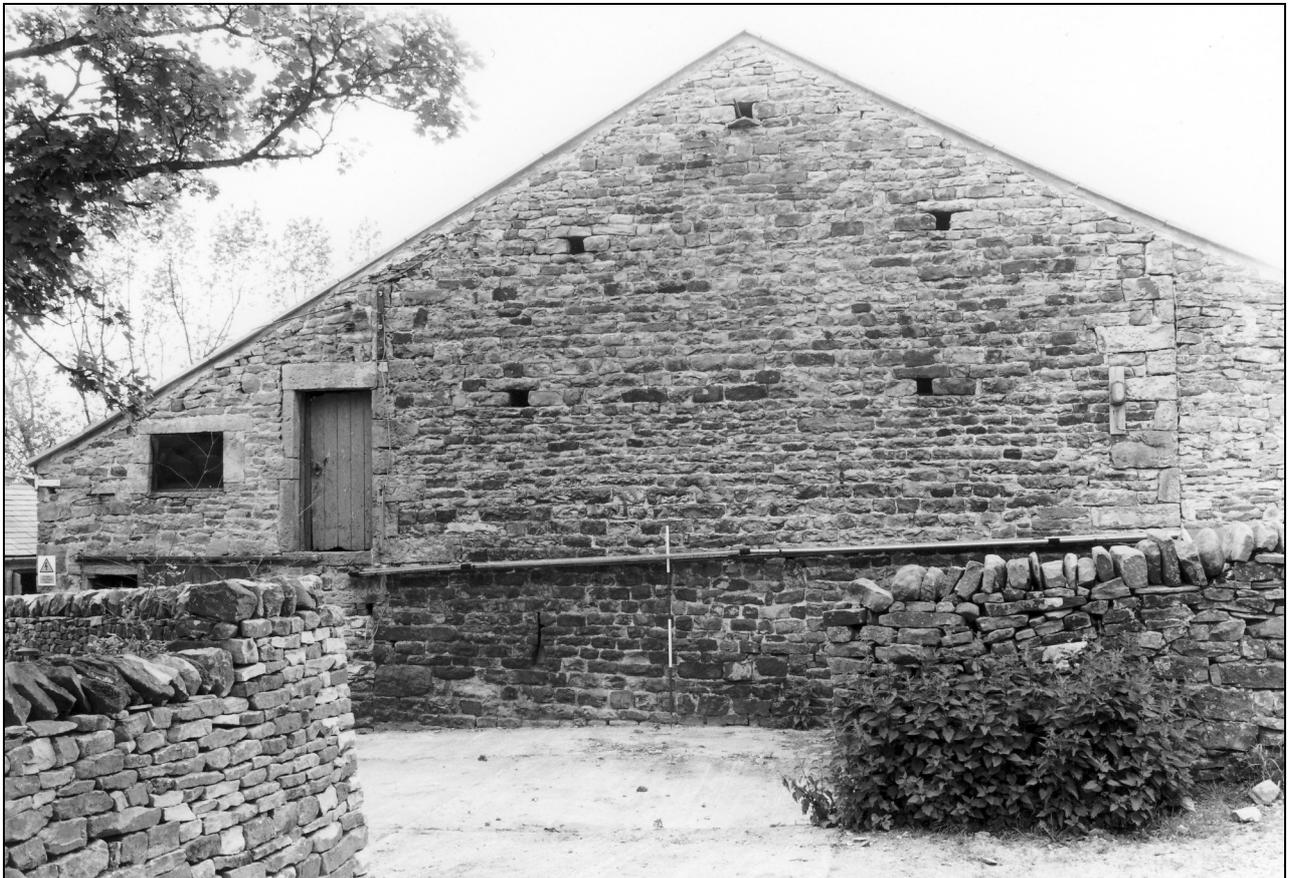
- 6.2 Turning to the east elevation of the building (**7**), the gable of the original barn is readily distinguishable from the additions to front and rear (**8**). At ground floor level there is a central blocked doorway, in a rather unusual position for such an opening in a barn, and to the left of it is a breather, while higher up are various putlogs, and an owl hole with landing ledge. The outshot to the south has an inserted doorway and blocked window at ground floor level, and above an original entrance and window to a loft (**9**). To the north, the rear outshot is faced with random rubble, and incorporates a doorway and window (**10**). The rear wall of this structure is continuous with the yard wall which curves round to form a middenstead.

Photo 8: East gable of barn

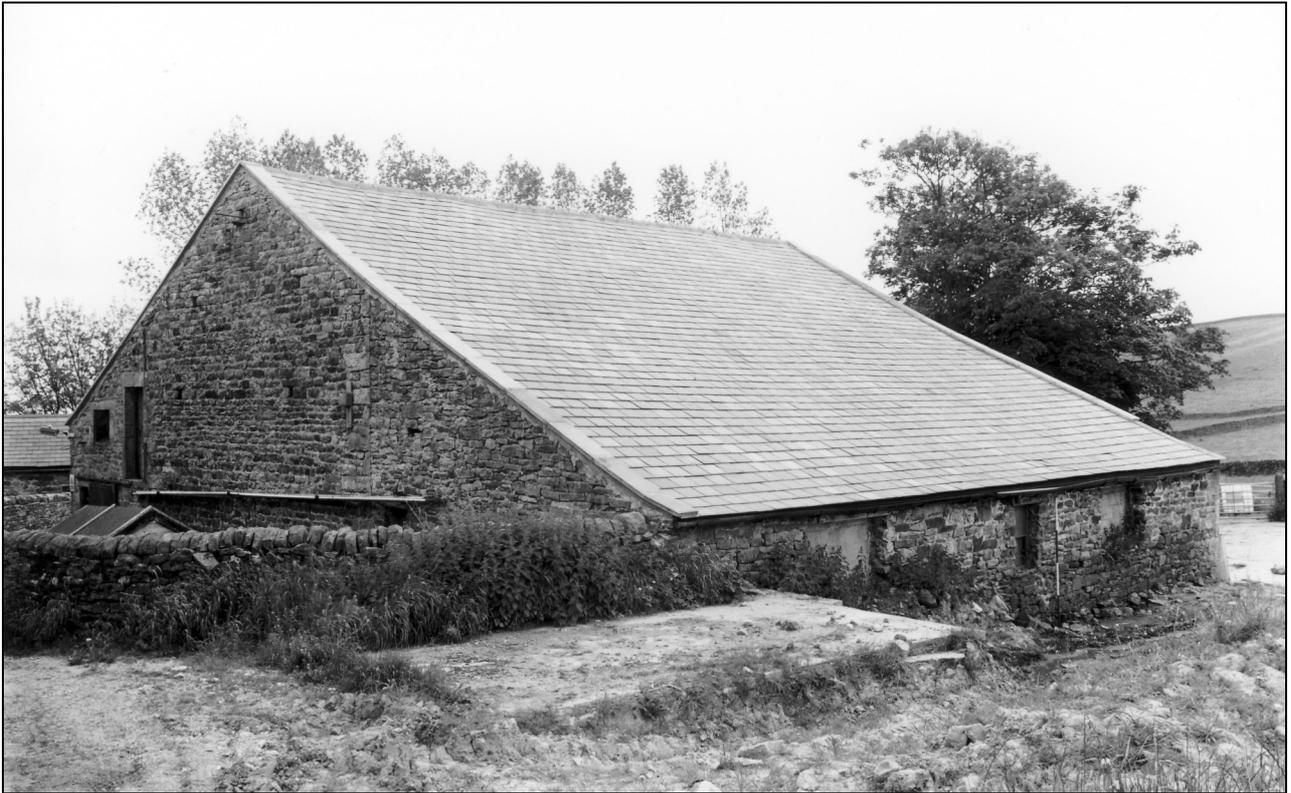
- 6.3 The rear of the building is formed by the rear wall of this later outshot, which is rather roughly built and contains three windows, all apparently enlarged to their present sizes, and two of them now blocked (**11,12**). Inside this outshot, the

Photo 11: View of the barn, from the north-east

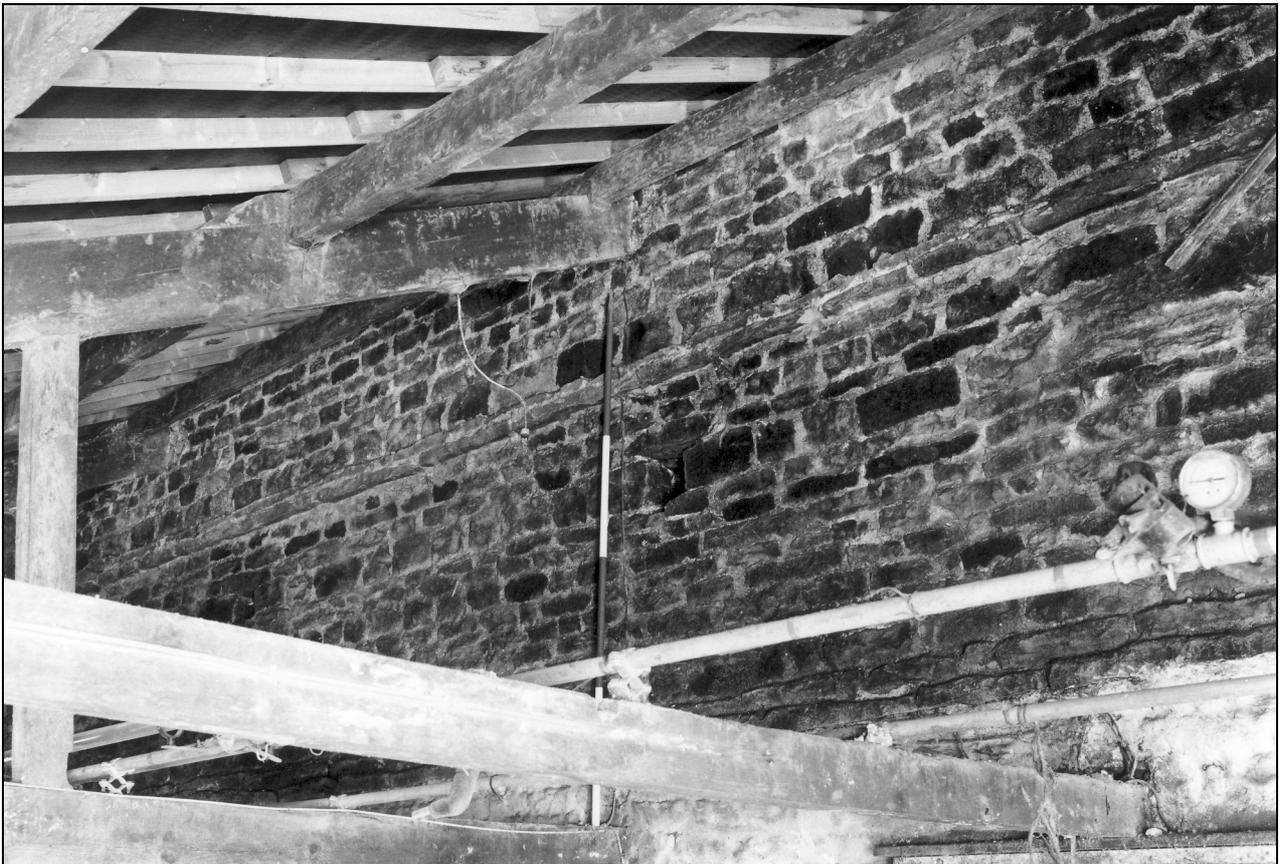
rear of the barn itself is visible, where it contains a “winnowing” doorway with tie-stone jambs, and two string courses or drip bands (13,14), not present on any other elevations (although apparently hacked off from the west gable, which appears also to have had a coat of render removed (15)). The west side of the building has been altered in other ways: the three ground floor windows may be original, as may be the two irregularly spaced ventilators at first floor level, but the upper level doorway is clearly secondary. The owl hole at the apex has a ledge to match that in the east gable.

Photo 13: Detail of string courses in north side of barn, now within north lean-to, from the north-west

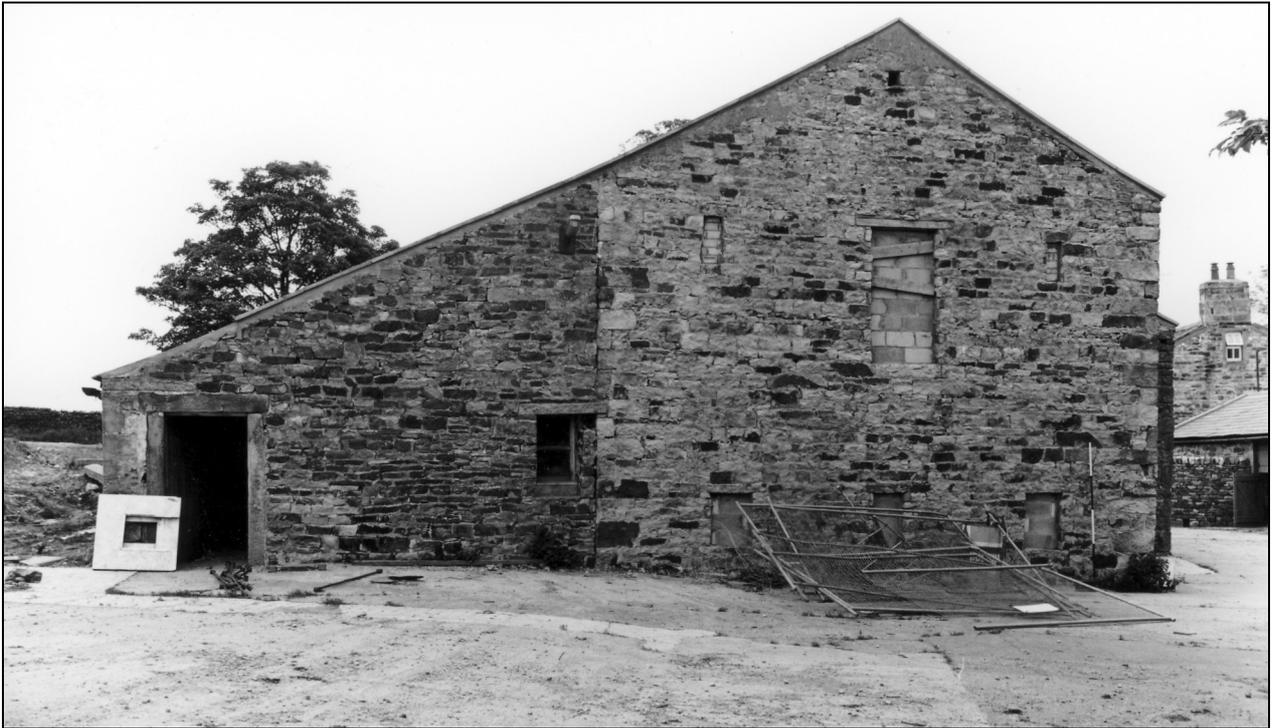
Photo 15: West gable of barn and rear lean-to or outshut

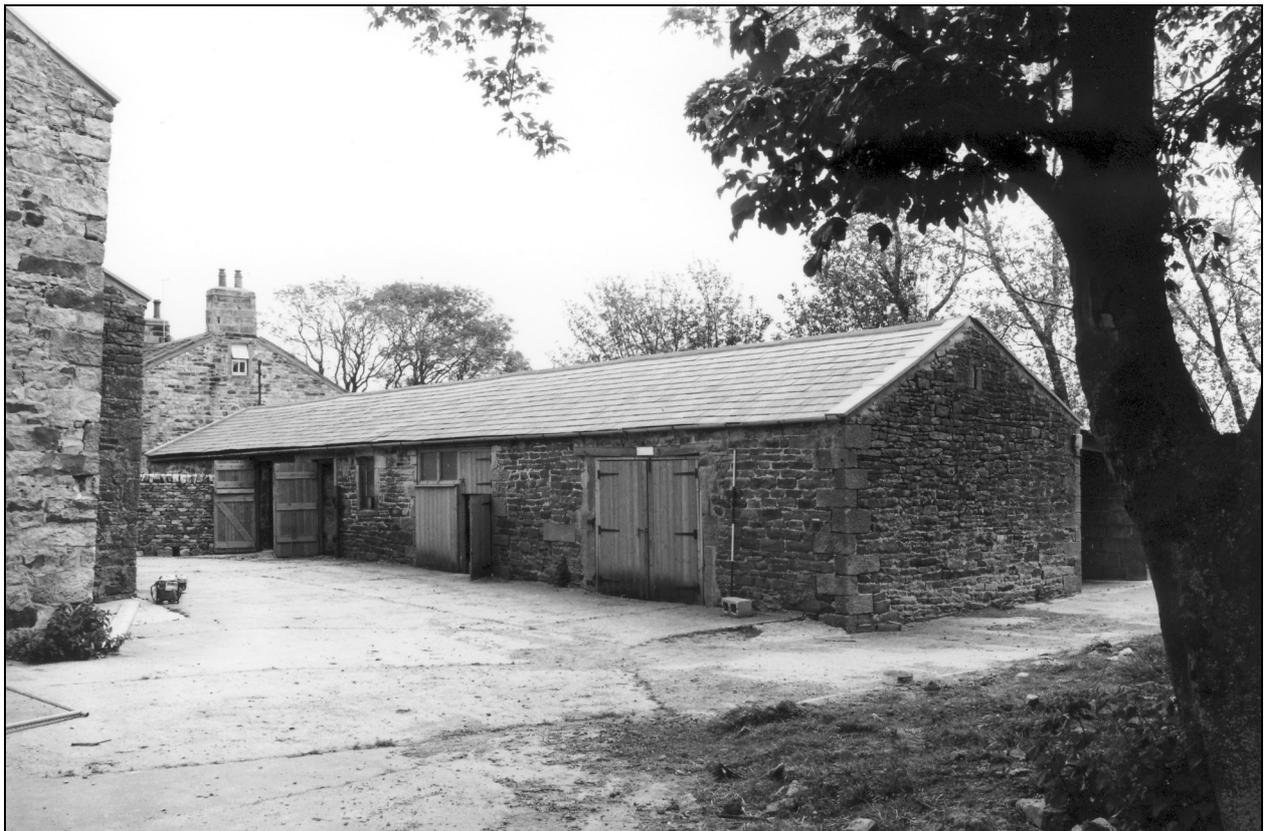
- 6.4 To the south of the barn stands a row of single storey outbuildings, also newly re-roofed and with modern doors for the most part (16,17), and a modern agricultural shed on their south side. These were not recorded other than by external photography.

Photo 17: The range of outbuildings, from the north-west

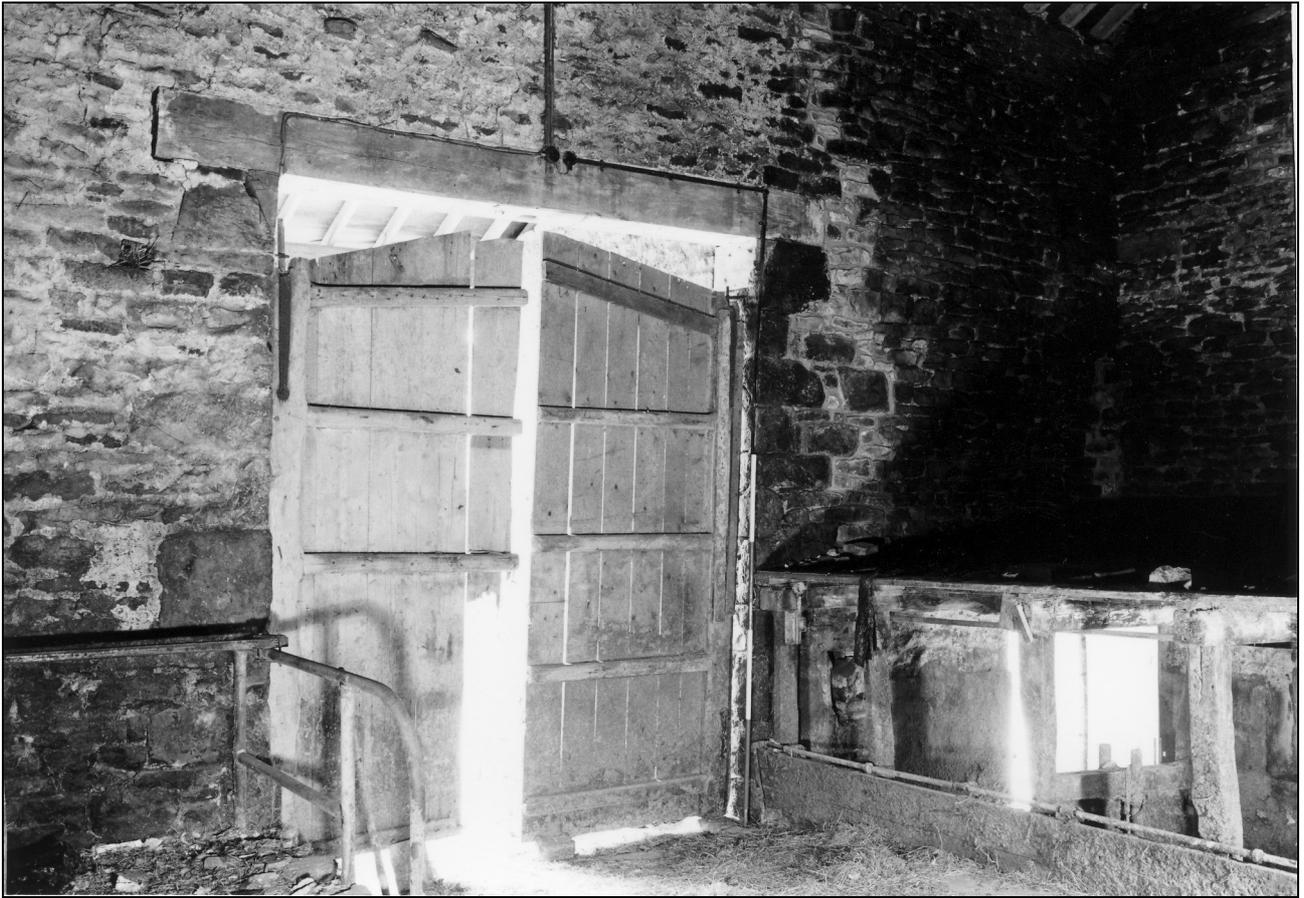
- 6.5 Of the pair of large doors in the main entrance to the barn (18), the east one is probably original and bears incised graffiti including a geometric “flower”, as well as various initials, but no clear dates (19). To judge from the shape of the doors and the softwood lintel, this doorway originally had a stone arch. It would have opened onto a threshing bay which contains an arched winnowing doorway in the rear wall (20), which is unusual for the district, where openings of this size are generally spanned by stone or timber lintels, arches usually being confined to large doorways. The main space within the barn comprises this threshing bay and the two bays to the east, all now with concrete floor, modern steel cubicles and open to the roof (21), but there is evidence for an earlier arrangement at the east end. Here, the central doorway (also with arch) in the east gable (22), appears to have served a shippon, with six blocked sockets in the wall above no doubt evidence for a former loft, the length of which is not now apparent. Other features associated with this include a recess to the north of the doorway (23), a blocked doorway and window in the south side (24), and a blocked window or muck hole in the north-east corner (25). Whether this former shippon and hay loft were original is not clear, but it seems likely that they were created as an adaptation, given the presence of the other shippon at the west end.

Photo 18: Interior view of main entrance to barn, from the north-east

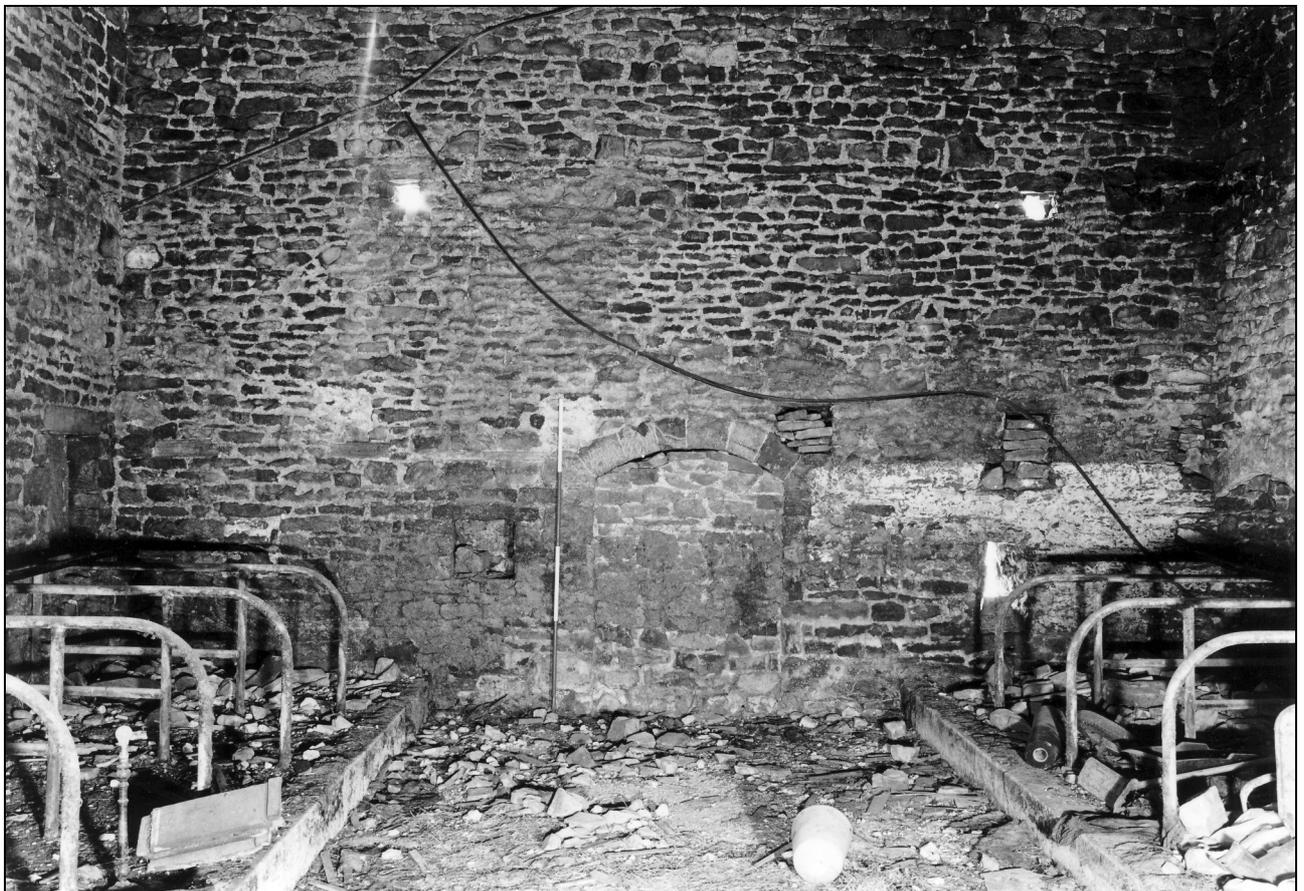
Photo 22: Interior of the barn, from the west, showing blocked doorway in east gable and evidence for former loft

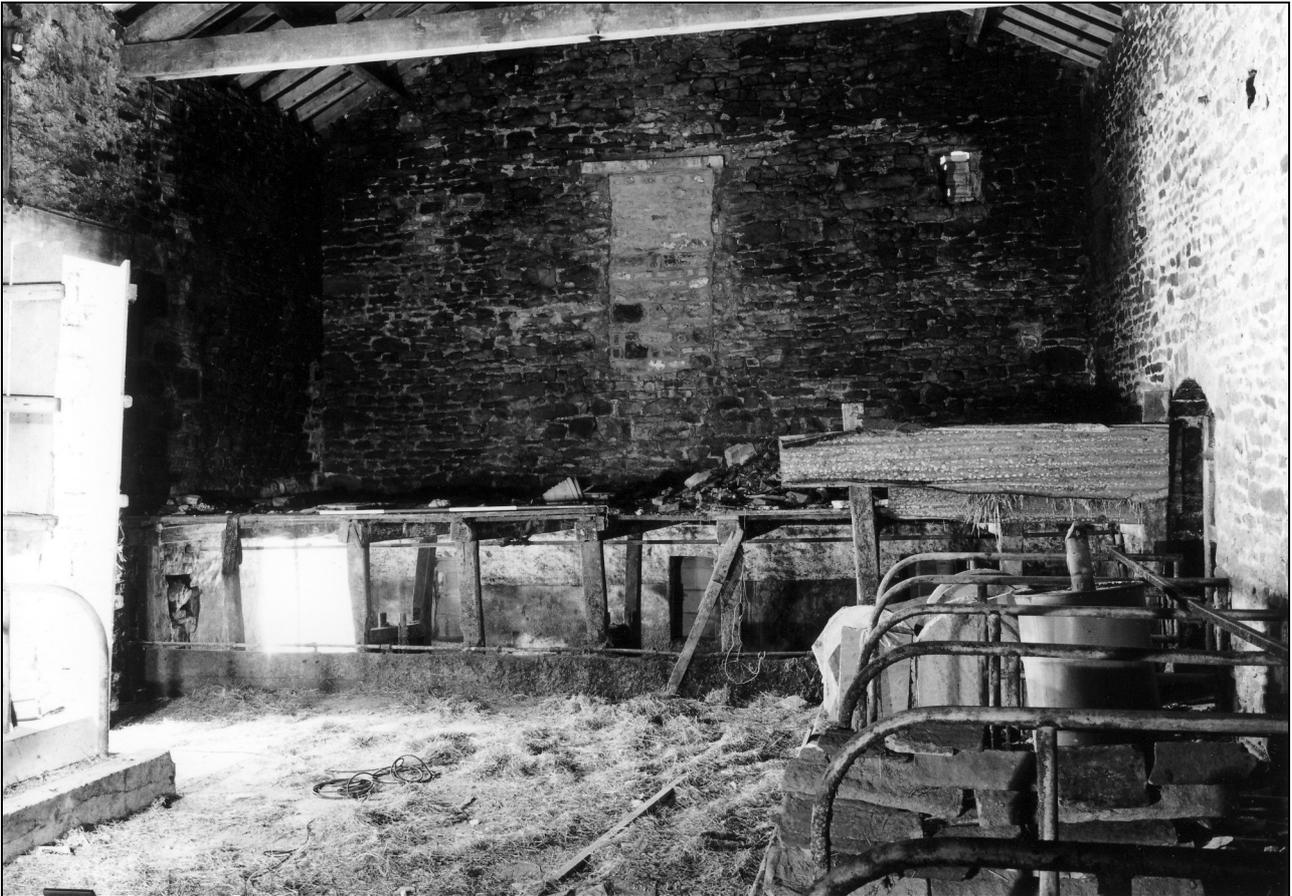
- 6.6 The principal, surviving shippon in the west end of the barn is in a more characteristic position within the building, and at a slightly lower level than the threshing floor, from which it is separated by a low stone retaining wall and modern timber boards (26,27). It is entered from the south doorway, which opens into the *group* or manure channel in the floor, which has been laid with concrete (28-30). There are three boskins forming four pairs of stalls, the boskins having flagstone panels, and elbowed heel posts of softwood (30,31), apparently cut to shape rather than bent or made with naturally curving timber, as is usually the case with oak examples in the district, which suggests they are

Photo 26: Interior of the barn, from the east, showing shippon at west end

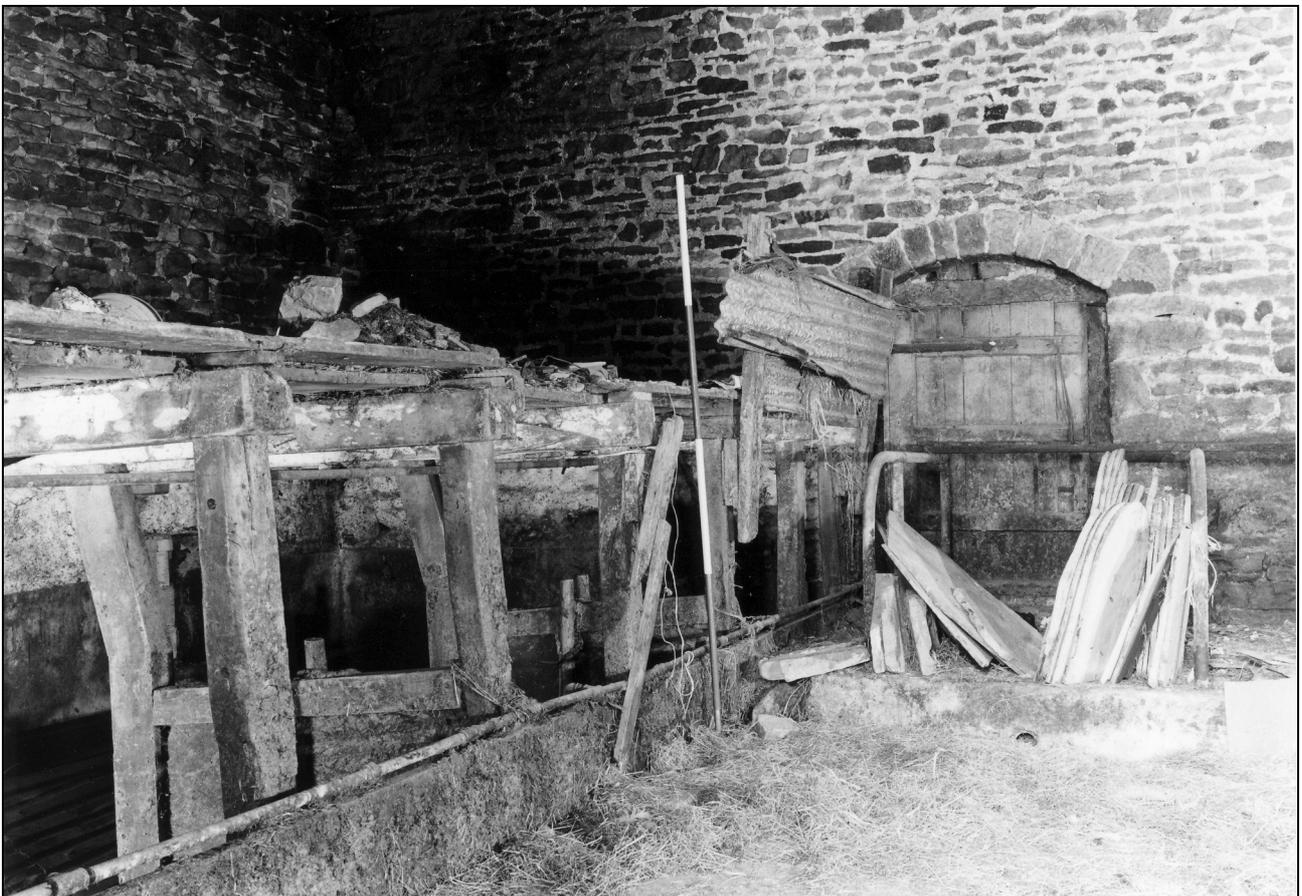
Photo 27: East side of shippon facing into barn, from the south-east

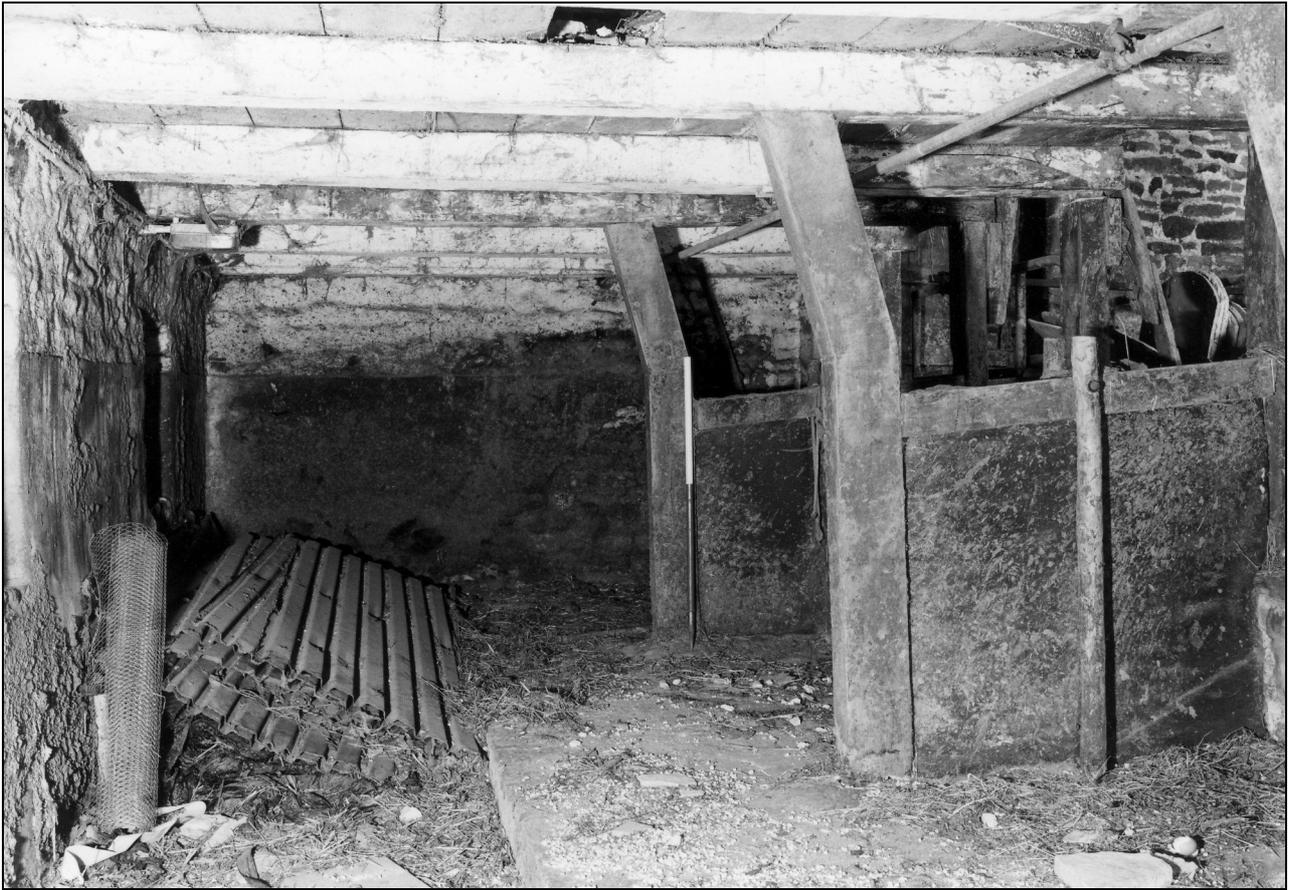
Photo 28: Interior of shippon at west end of barn, from the south
