Barn at Springside
Knotts, Bolton-by-Bowland, Lancashire:
Archaeological Building Recording

Barn at Springside Knotts, Bolton-by-Bowland, Lancashire: Archaeological Building Recording

Archaeological building recording was carried out for Mr & Mrs Stazicker in June 2007 at a barn at Springside, near Bolton-by-Bowland, Lancashire (NGR: SD 769532), before its conversion to residential and workshop use. The building is stone-built and probably of eighteenth or early nineteenth century date, and comprises a four bay barn with shippon at one end, with a second shippon at the opposite end having been removed. It has also been extended in two phases, to front and rear. The records made include a ground floor plan, a section drawing and photographs, as well as a written account.

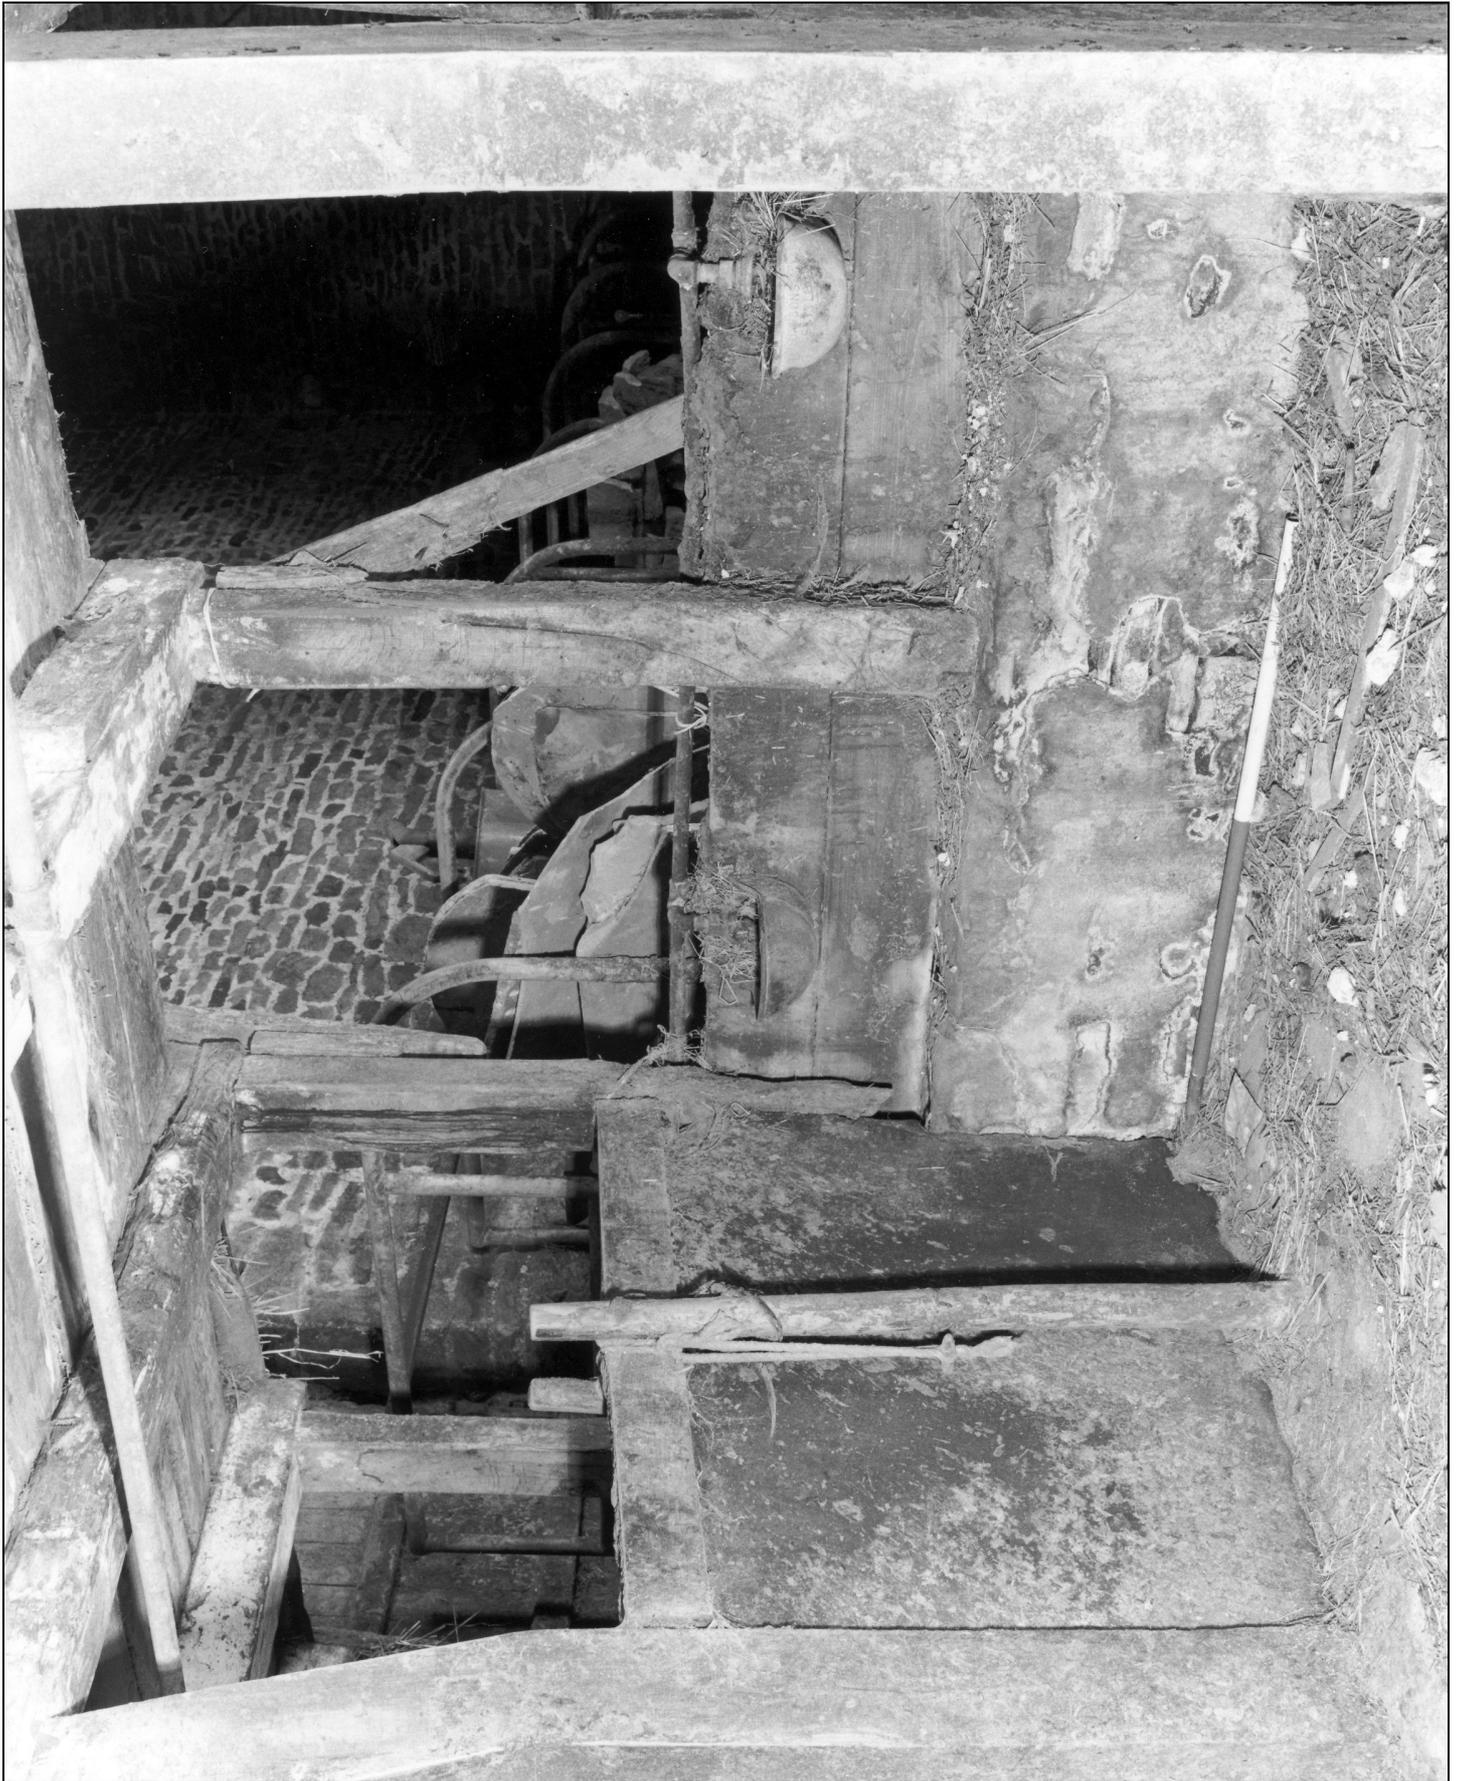
Photo 31: Detail of stalls and boskin in shippon, from the south-west

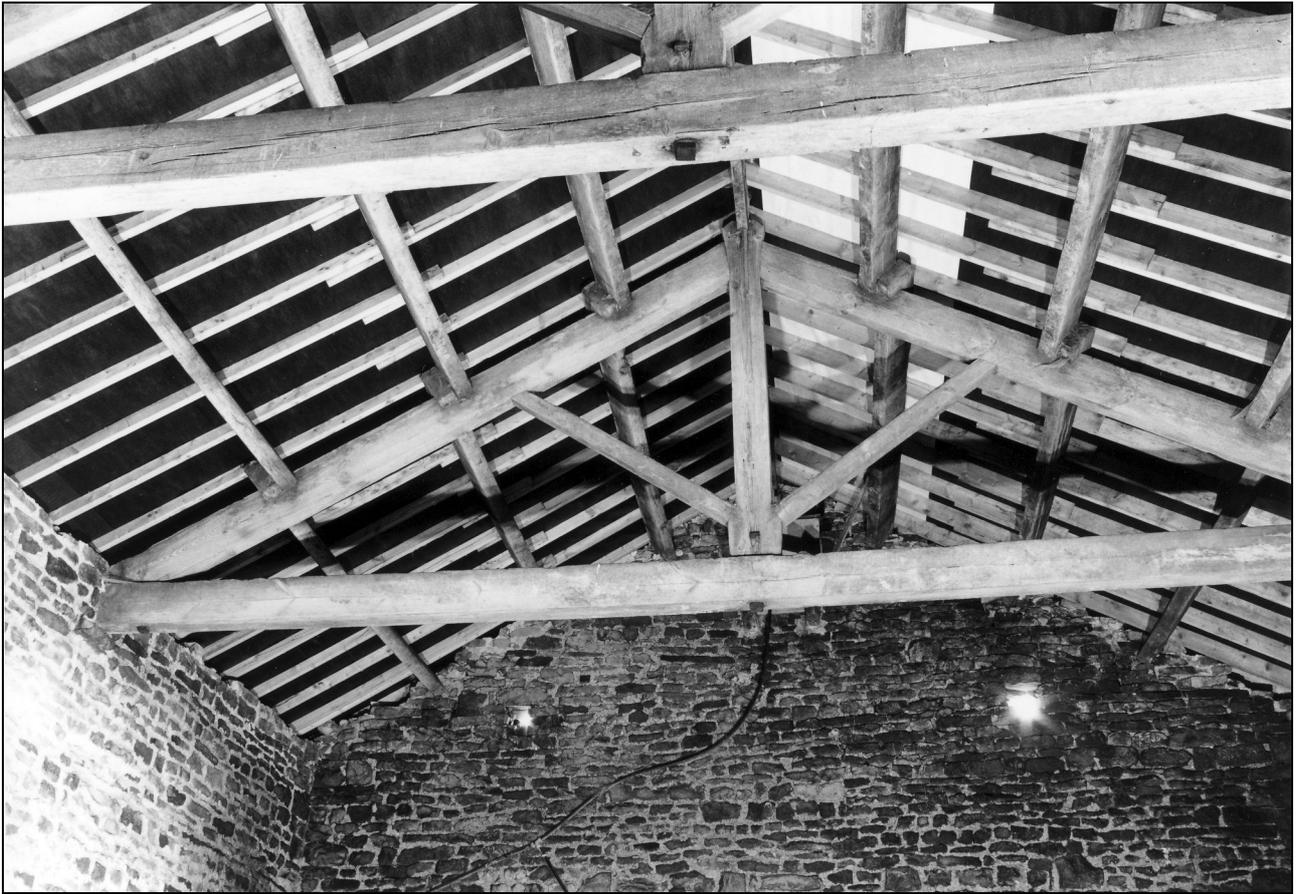
- 6.7 The barn has three roof trusses, all of king-post form with bolted posts and of square-sawn softwood, and with staggered, trenched purlins (**33**). There is no clear evidence that these are replacements but it seems likely, given the use of oak in the shippon and hay loft, and the very regular form of the trusses, which suggests they are of nineteenth or even early twentieth century date.

Photo 33: Roof truss at east end of barn, from the west

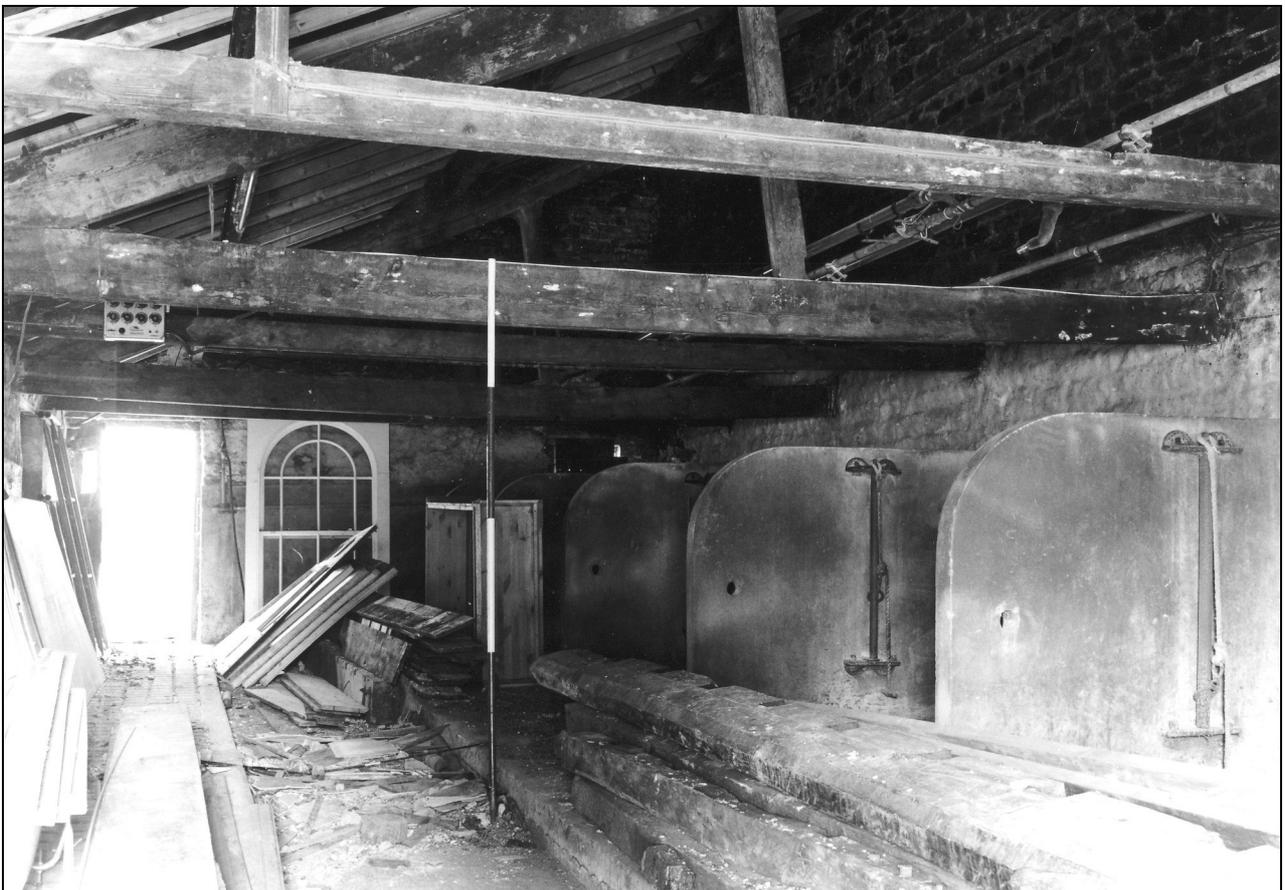
- 6.9 The rear outshot forms a large shippon, and probably dates to the late nineteenth century (as shown on Figure 4). It has concrete boskins for fourteen head of cattle (**33**), but these replaced timber boskins in exactly the same positions, as can be deduced from mortices in the undersides of the half trusses. The floor is also of concrete, and a low breeze block wall separates the stalls from a feeding passage running along the rear wall of the barn.

Photo 34: Interior of shippon in north outshot, from the west
