Barn at Stang Top  
Roughlee, Lancashire:  
Archaeological Building Recording

November 2006

Archaeological building recording was carried out for Alison Pickles in September 2006 at a barn at Stang Top, Roughlee, Lancashire (NGR: SD 835413), before the conversion of part of it to residential use. The barn stands next to a cottage, is stone-built and five bays long and probably dates to the early nineteenth century. The records made include floor plans, a section and photographs, as well as a written account.

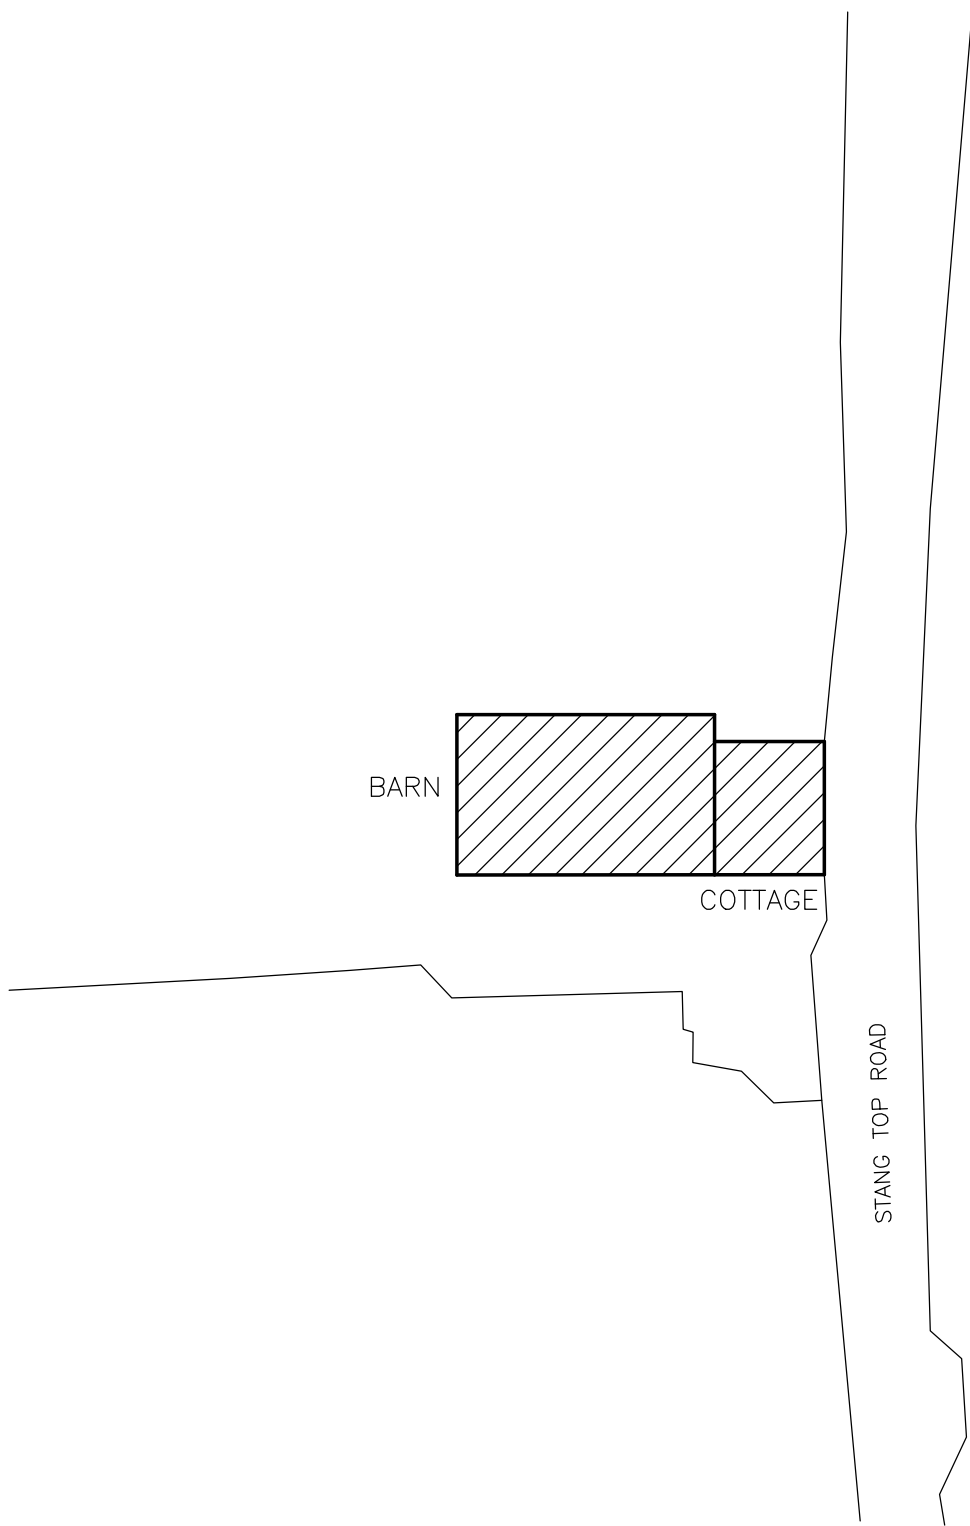
FIGURE 2:  
SITE PLAN

- 2.1 Stang Top stands on the west side of Stang Top Road, in Barley-with-Wheatley Booth civil parish, about 1km north-west of Roughlee and 4km north-west of Nelson town centre, in Lancashire (Figure 1).
- 2.2 The site is a former small farmstead which comprises a single range of buildings, comprising a cottage at the east end and the barn running to the west (Figure 2); it ceased to be used for farming during the second half of the twentieth century.

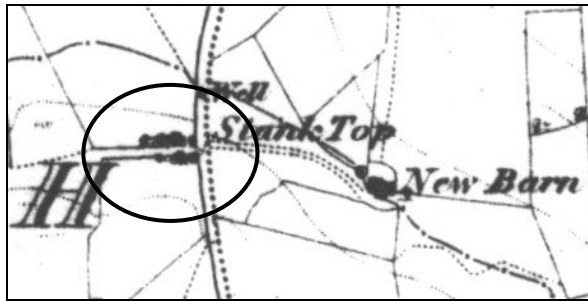
- 4.2 Little is known of the history of Stang Top but Ordnance Survey maps appear to show that the barn and cottage have stood there since before 1844, when the survey for the first edition Ordnance Survey 6" to the mile map was carried out (Figure 3); at that time it was known as Stank Top. The OS 1:2500 maps of 1893, 1912 and 1932 (Figures 4 - 6) name it Stang Top, and show it as at present, albeit with a small detached building to the west, probably a privy, which has now been demolished.

**Figure 3:** Extract from Ordnance Survey 1848 6" to mile map (surveyed 1844)  
Sheet no: Lancashire, 48

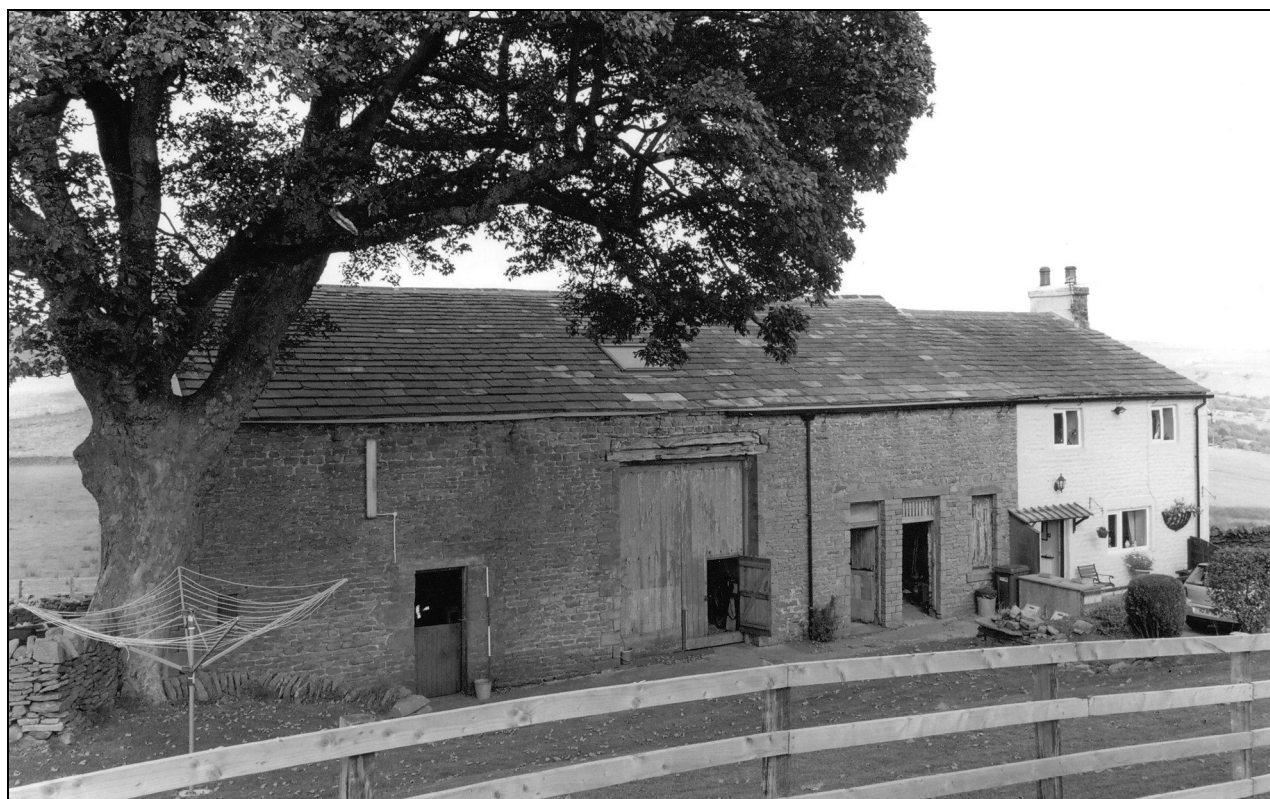
- 6.1 The barn forms the larger, west part of the range (1,2), and measures 18.5m long and 10.2m wide, slightly wider than the adjoining cottage. It is built from local gritstone laid in irregular courses, with squared quoins and plain dressings, while the recently re-laid roof is of stone slate with stone ridge. At the right hand end the front elevation clearly butts up to and is later than the quoins of the cottage (3).

Photo 2: The barn and cottage, from the south-west

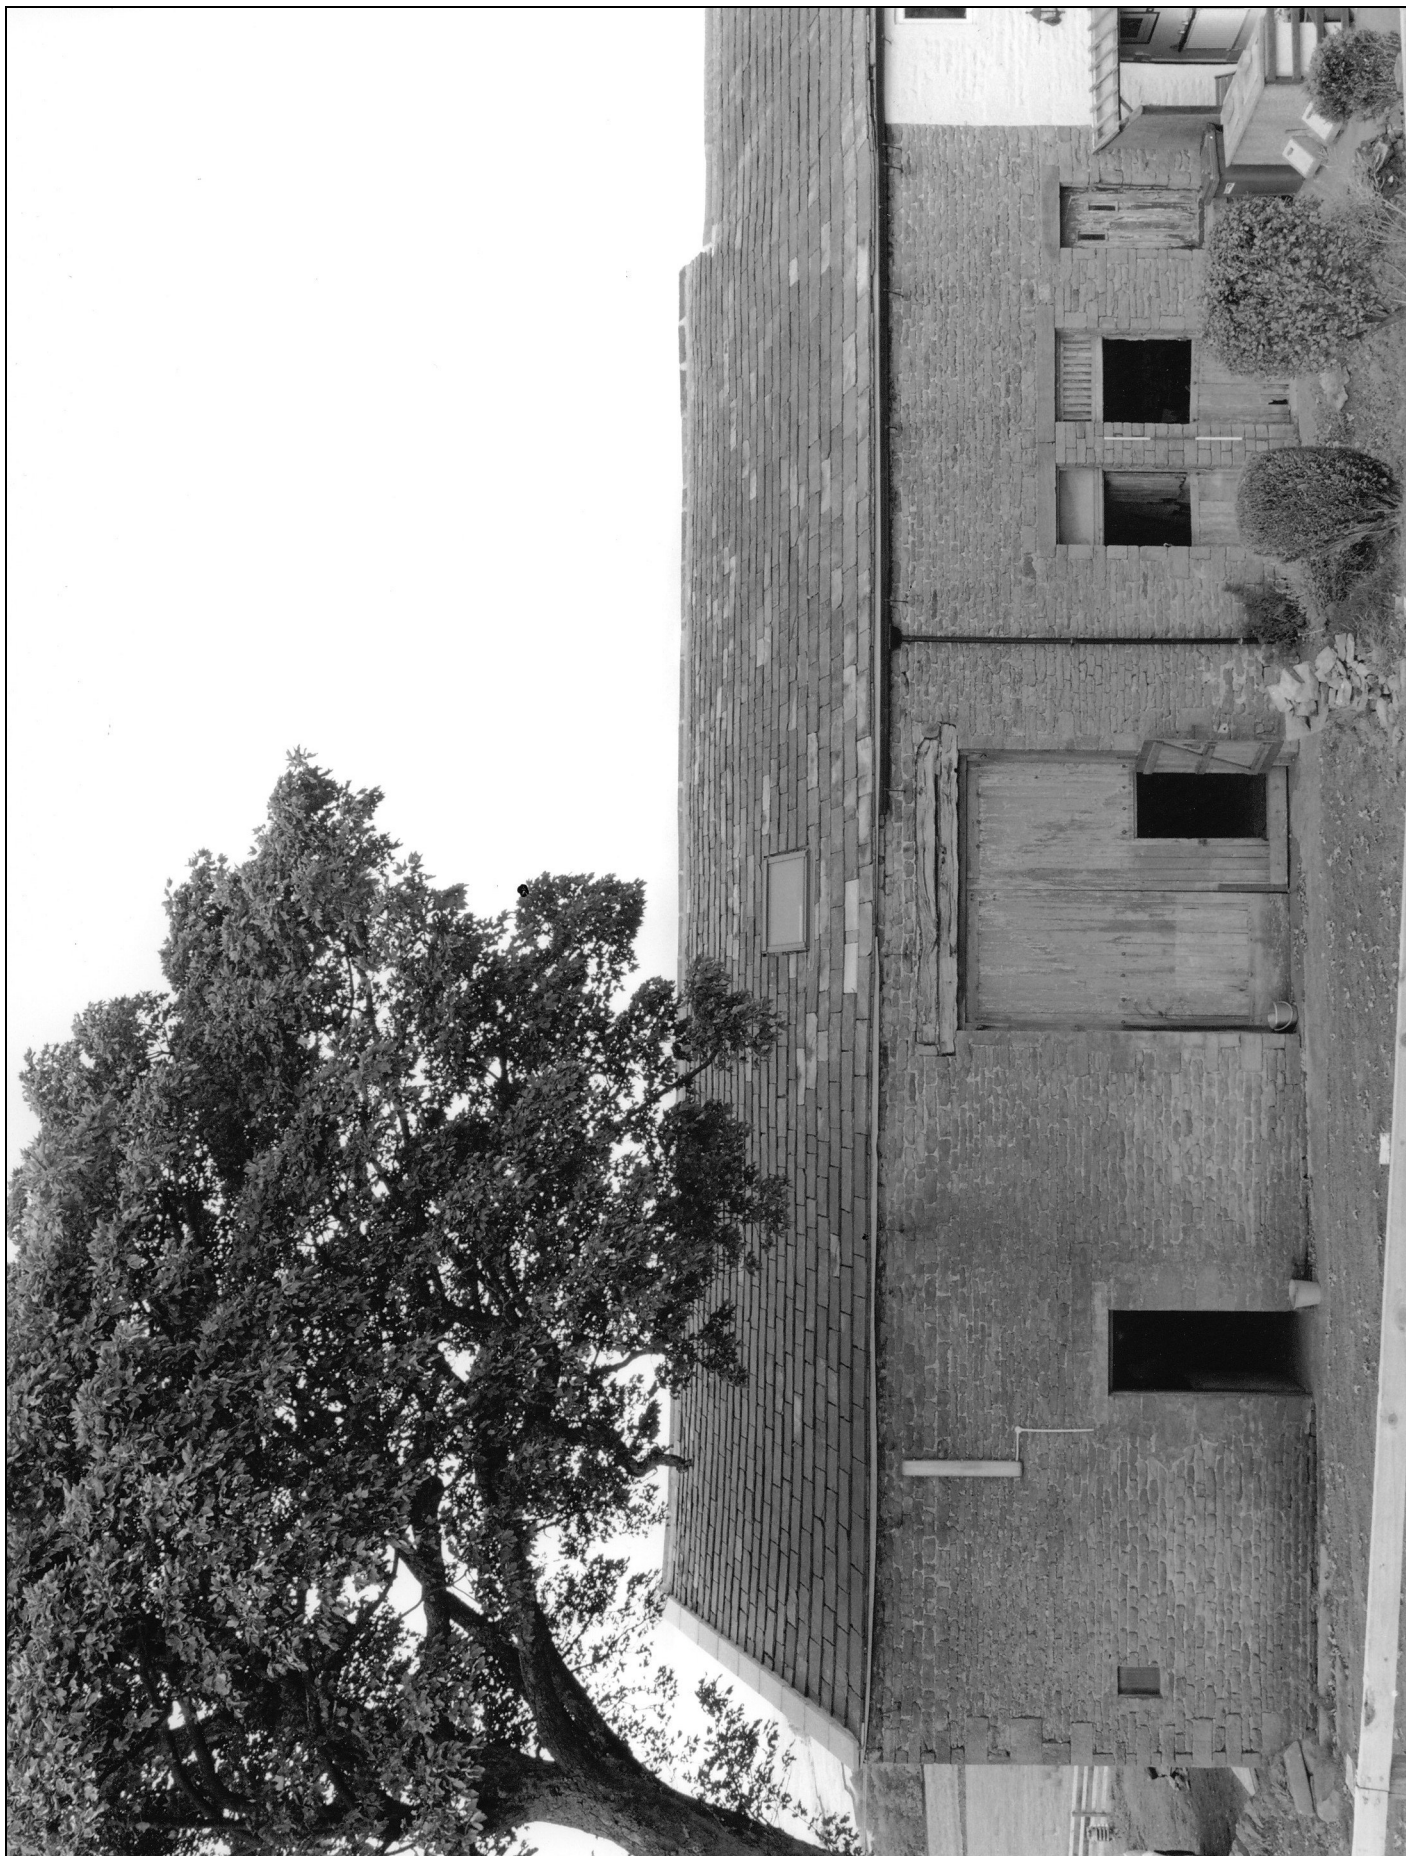
Photo 3: Front elevation of the barn, from the south

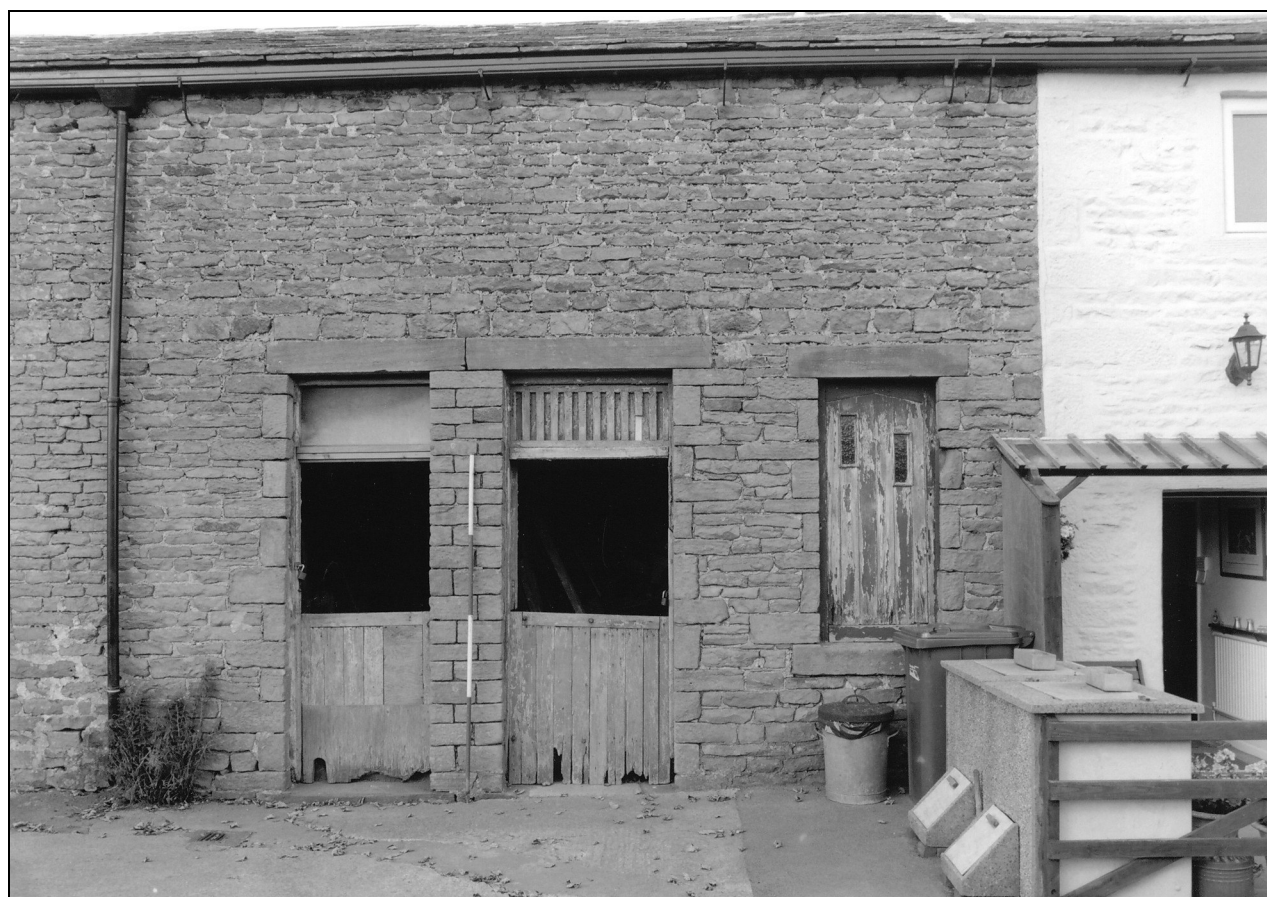
- 6.2 The openings in the front elevation reflect the divisions inside the barn which create a number of different areas. The large, central cart entrance with double timber lintel and quoined jambs leads into the threshing bay (4), and to the right of it is a pair of narrow doorways giving access to a small shippon and stable, the latter also with a tall, narrow window (5). To the left of the cart entrance is another doorway, in this case of secondary date, which appears to have replaced a window (6), as the disturbed masonry and redundant lintel indicate; this alteration arises from the re-orientation of the shippon in this end of the building. A small, now glazed, opening to the left of this doorway is probably a former ventilator.

Photo 5: Doorways and window to small shippon and stable, in front elevation

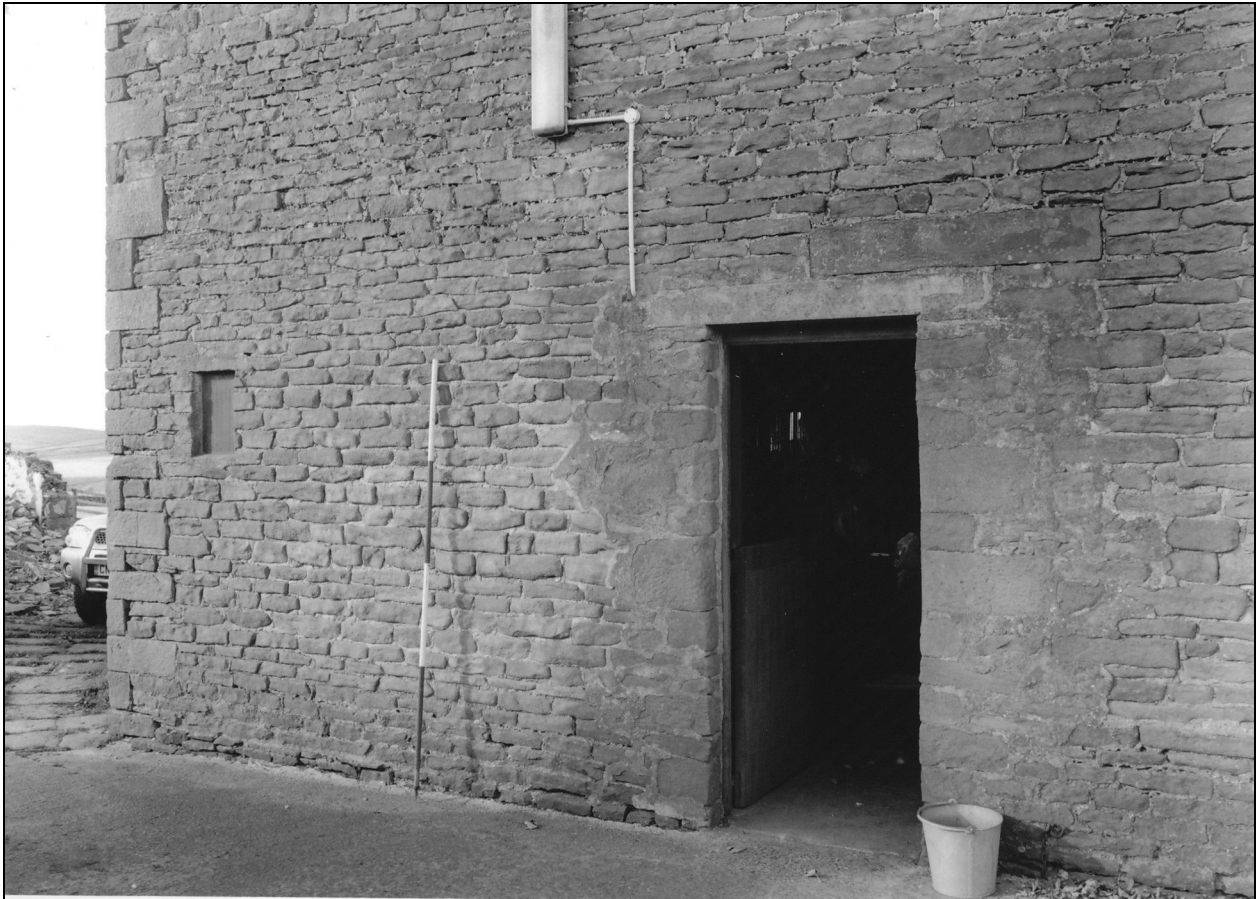
Photo 6: Inserted doorway to shippon in south elevation of barn

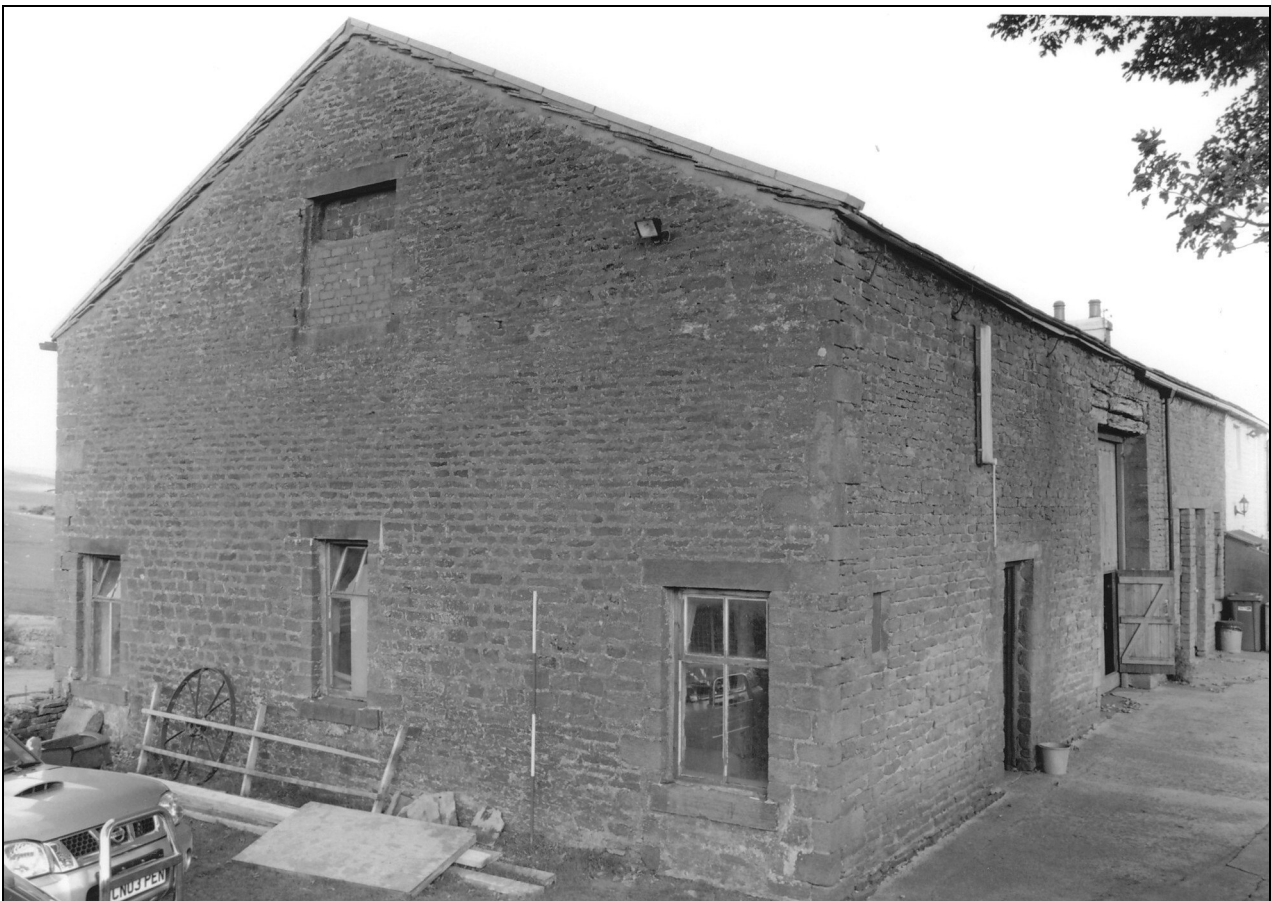
- 6.3 The west gable has three ground floor openings, all windows now (7), but the two outer ones were formerly doorways which would originally have led into the passages running along the rear of stalls in the shippon. There is also a blocked forking hole at first floor level.

Photo 7: The barn, from the south-west

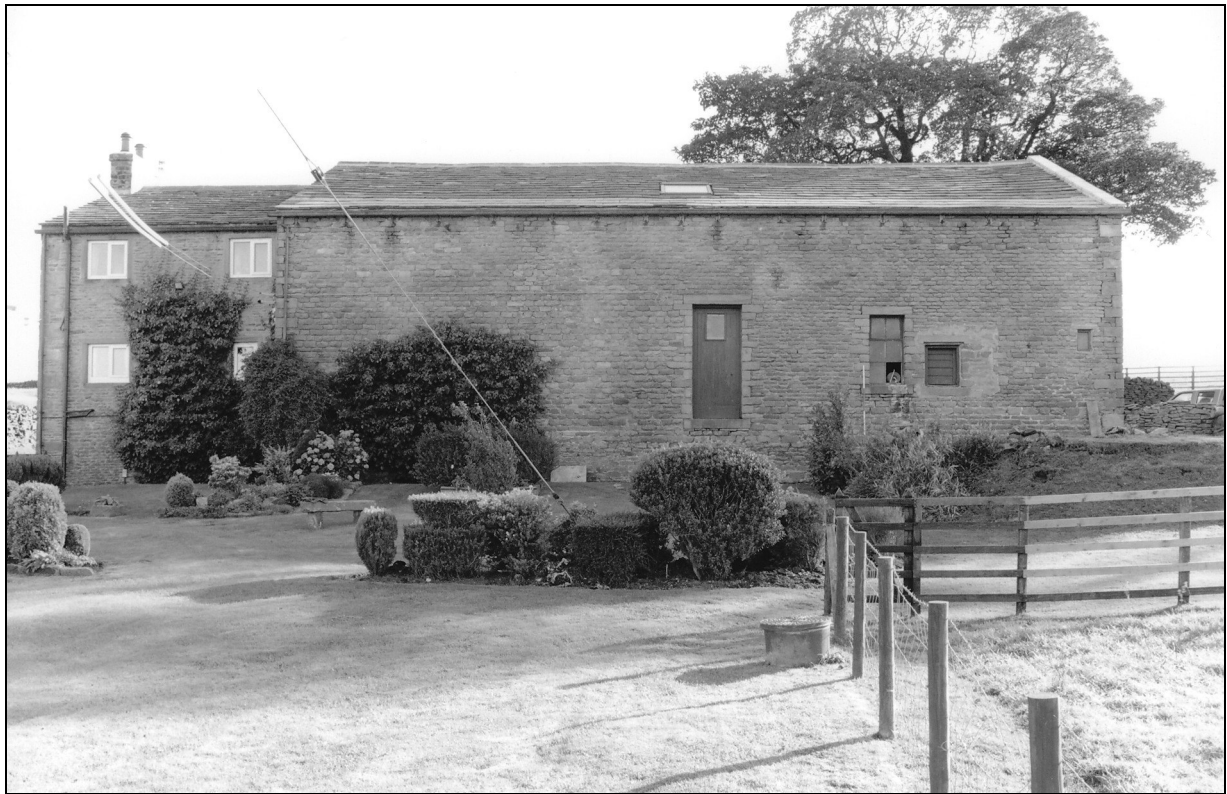
- 6.4 The barn's rear elevation (8) also shows signs of alteration. The doorway at the rear of the threshing bay is intact (9), as is the tall window to the right of it, but the smaller adjacent opening is clearly secondary and is a muck-hole no doubt put in when the west shippon was re-arranged. There is also a small window next to the north-west quoins matching that on the front elevation (10). The remains of a building at the foot of this wall are evidently of mid twentieth century date as no structure is shown here on the 1932 map, but the earlier maps show an L-shaped wall here, which probably enclosed a middenstead.

Photo 8: Rear elevation of the barn and cottage, from the north

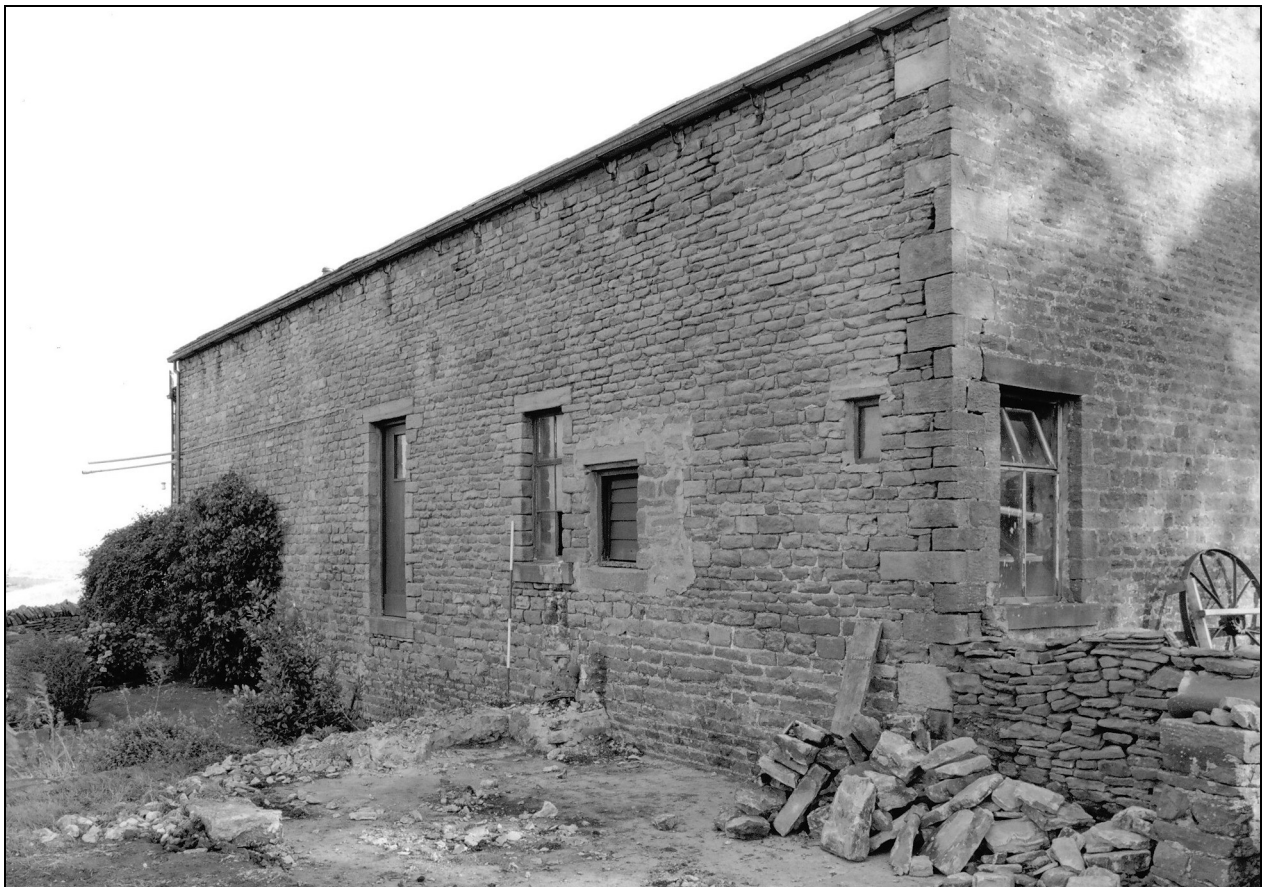
Photo 10: Rear elevation of the barn, from the north-west

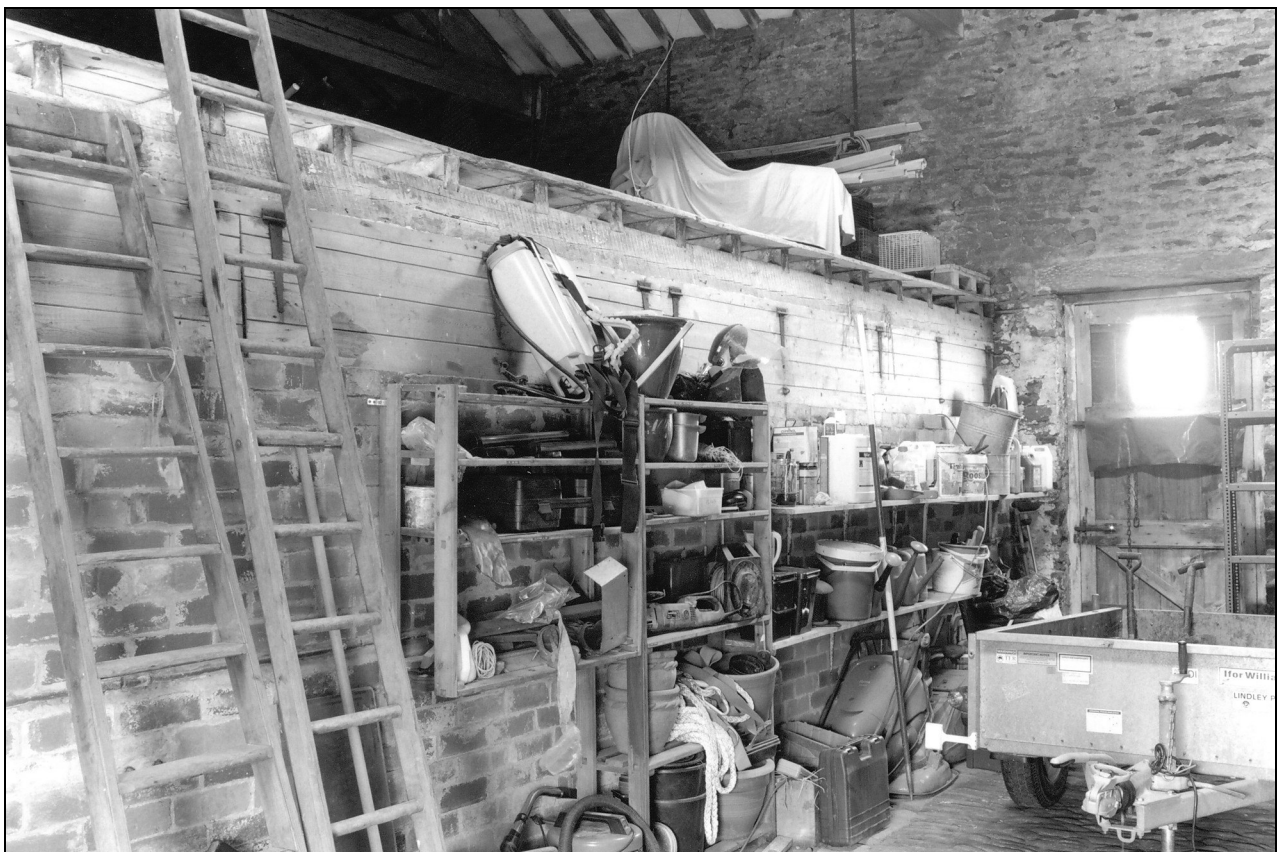
- 6.5 The threshing bay in the centre of the barn has a good pitched stone floor (11,12) and is open to the roof, but has only a small amount of storage area adjacent in the north-east corner (13), as animal housing occupies approximately three fifths of the building on the ground floor to either side of the threshing floor, enclosed by a relatively modern brick wall on the west side (14), and by a thin

- 6.7 The larger shippon in the west end of the building now has stalls facing outwards with a central muck passage, but originally the arrangement would have been at right angles to this, with a central feeding passage running east-west; this re-organisation may have been carried out in line with prevailing ideas concerning disease prevention, probably in the early twentieth century. The present arrangement is for sixteen cows in paired standings with softwood boskins (23-27), and at the south side there is access both to a feeding passage next to the west gable, and through the brick wall in the east side. Feeding of the animals in the east-facing standings would have been through the hinged, shuttered opening which runs along the top of the brick wall (14), and there is a trap door giving access to the hay loft overhead, over the west feeding passage.

Photo 14: Secondary brick wall with hinged shutters, on west side of threshing bay, from the south-east

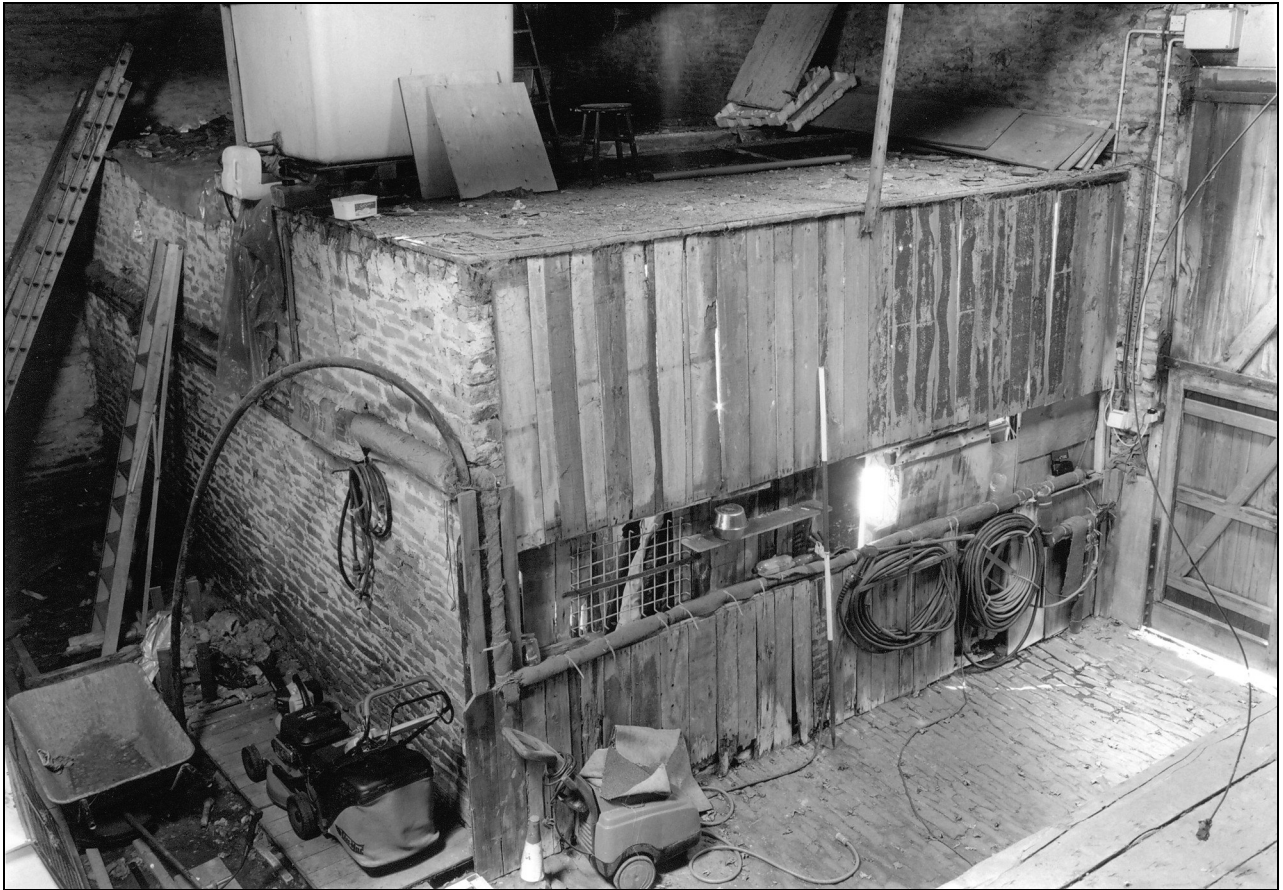
rubble wall and timber partition on the east side (15), the latter with a horizontal slot to allow feeding.

Photo 15: View of stable and small shippon, from above

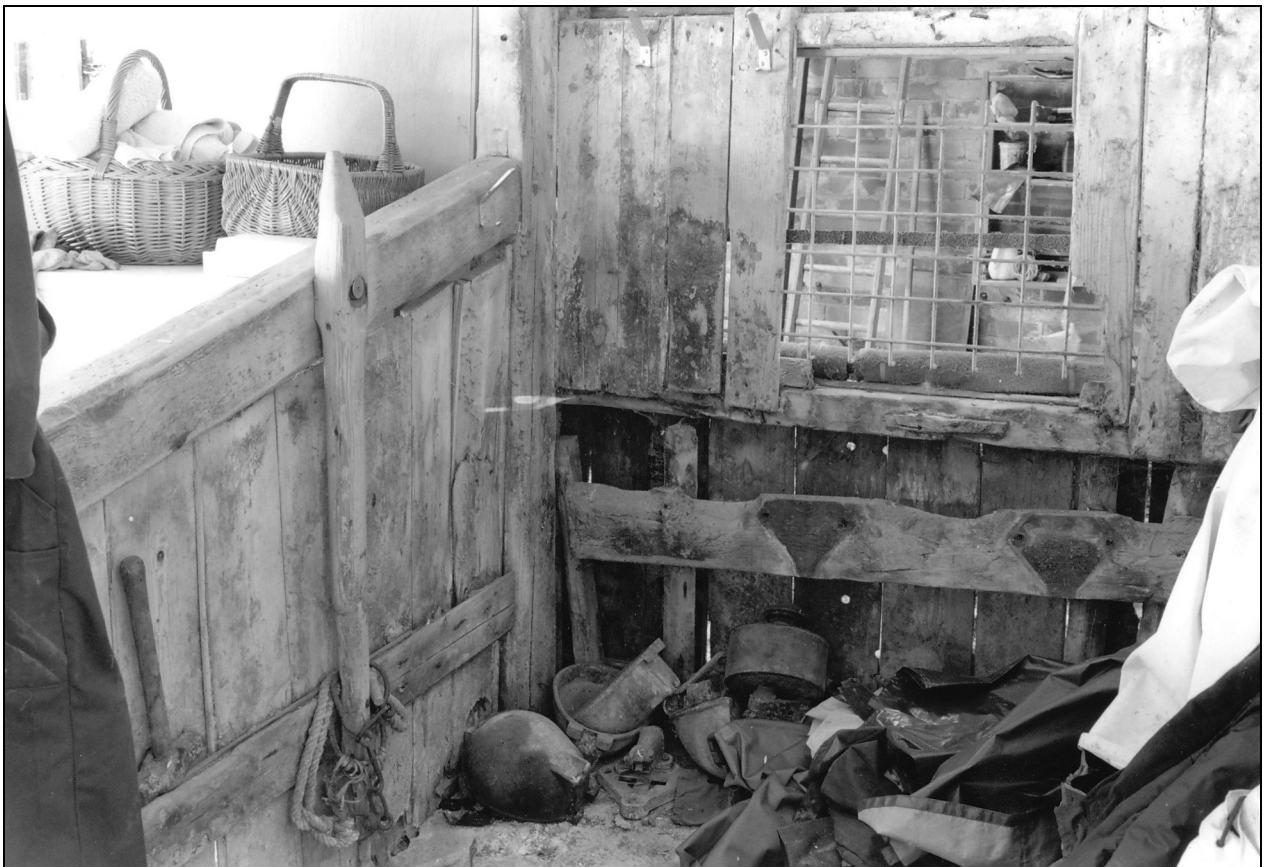
- 6.6 The small shippon in the east half of the building (16,17) has two stall dividers or boskins constructed from softwood (18,19) creating standings for six young beasts. The floor is mostly of stone flags and cobbles, but has been repaired with concrete. In the adjacent stable (20), which is closest to the cottage, the stone floor is largely intact and has a grooved drainage channel at the rear, and central gullies to each of the two stalls (21). The division between the stalls has been removed but its former position is clear (22), and there is a timber base to a manger or trough, as well as an iron hay rack fixed to the wall. A ceiling which serves as a hay loft runs over both shippon and stable.

Photo 18: Detail of stall in small shippon, from the north-east

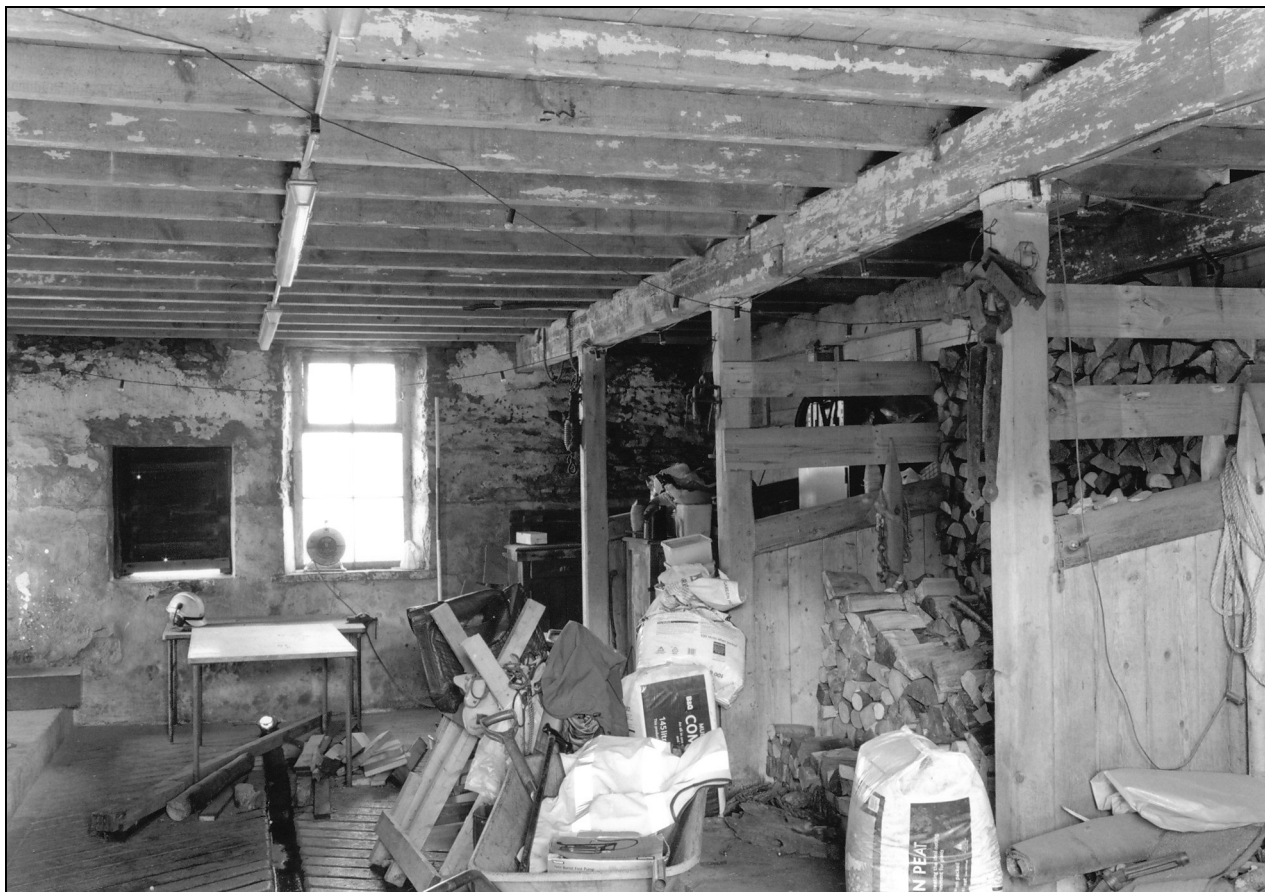
Photo 26: Interior of main shippon, from the south

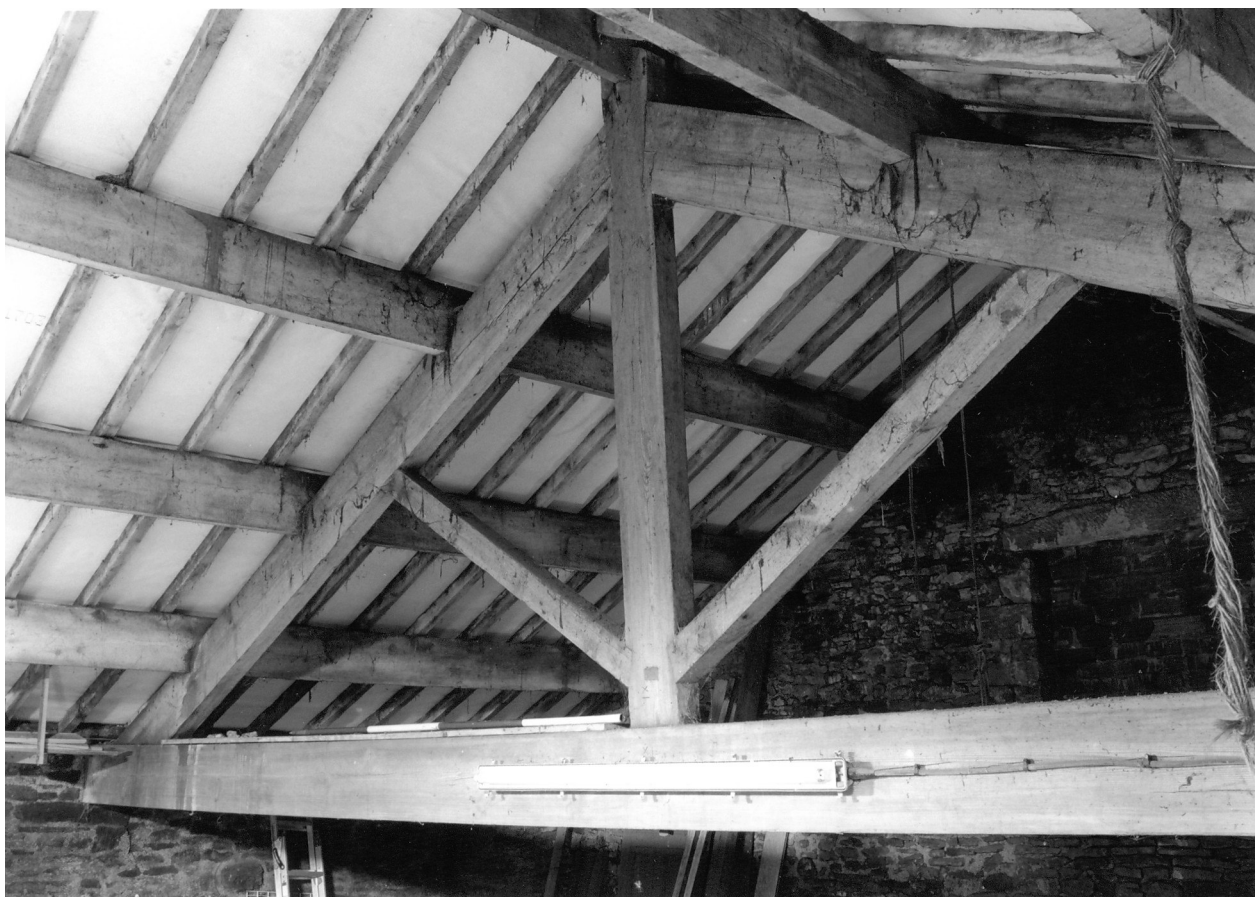
- 6.8 The barn roof is of five bays, carried on four roof trusses constructed from square-sawn softwood with bolted king-posts and raking struts (28), and trenched purlins. This is a standard design for buildings of this type in the nineteenth century.

Photo 28: Roof truss in barn, from the north-east
