Barn at Higher Green Hill Farm
Salterforth, Lancashire:
Archaeological Building Recording

Archaeological building recording was carried out for Mr Howard Bradley in September 2006 at a barn at Higher Green Hill Farm, Salterforth, Lancashire (NGR: SD 886450), before its conversion to holiday cottages. The barn is stone-built and five bays long, of uncertain date but largely rebuilt in the nineteenth century and altered in the twentieth; it adjoins a two storey building containing a former farm office, as well as other buildings at the rear. The records made include floor plans, a section and photographs, as well as a written account.

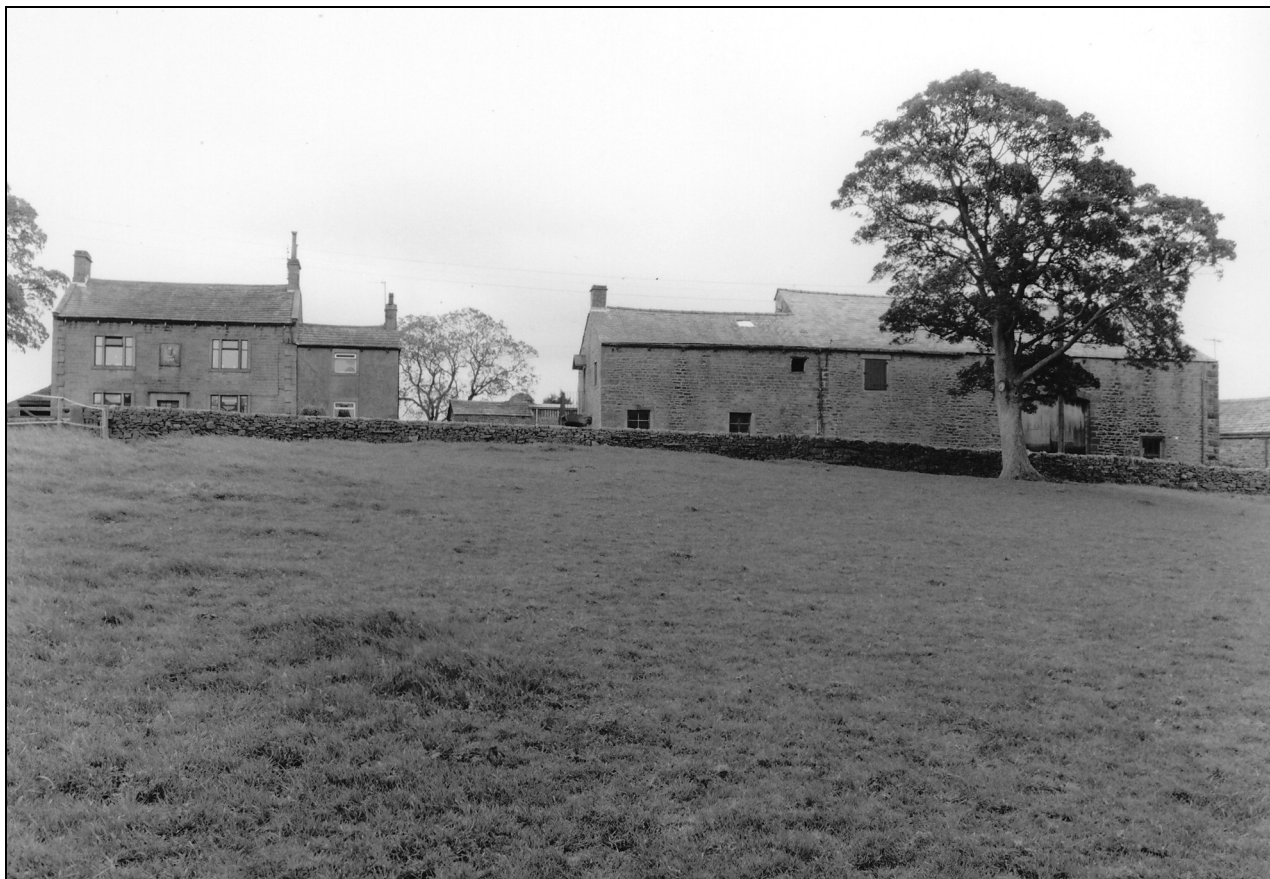
Photo 1: View of the farmhouse and barn range, from the west

- 6.1 The barn range is a large stone-built structure which faces west immediately onto Salterforth Lane (**1**), the barn the south part and the office the north part (**2,3**). It has an overall length of 27.2m and the barn measures 12.2m wide, the office 7.4m wide, but the rear lean-to continues further to the east.

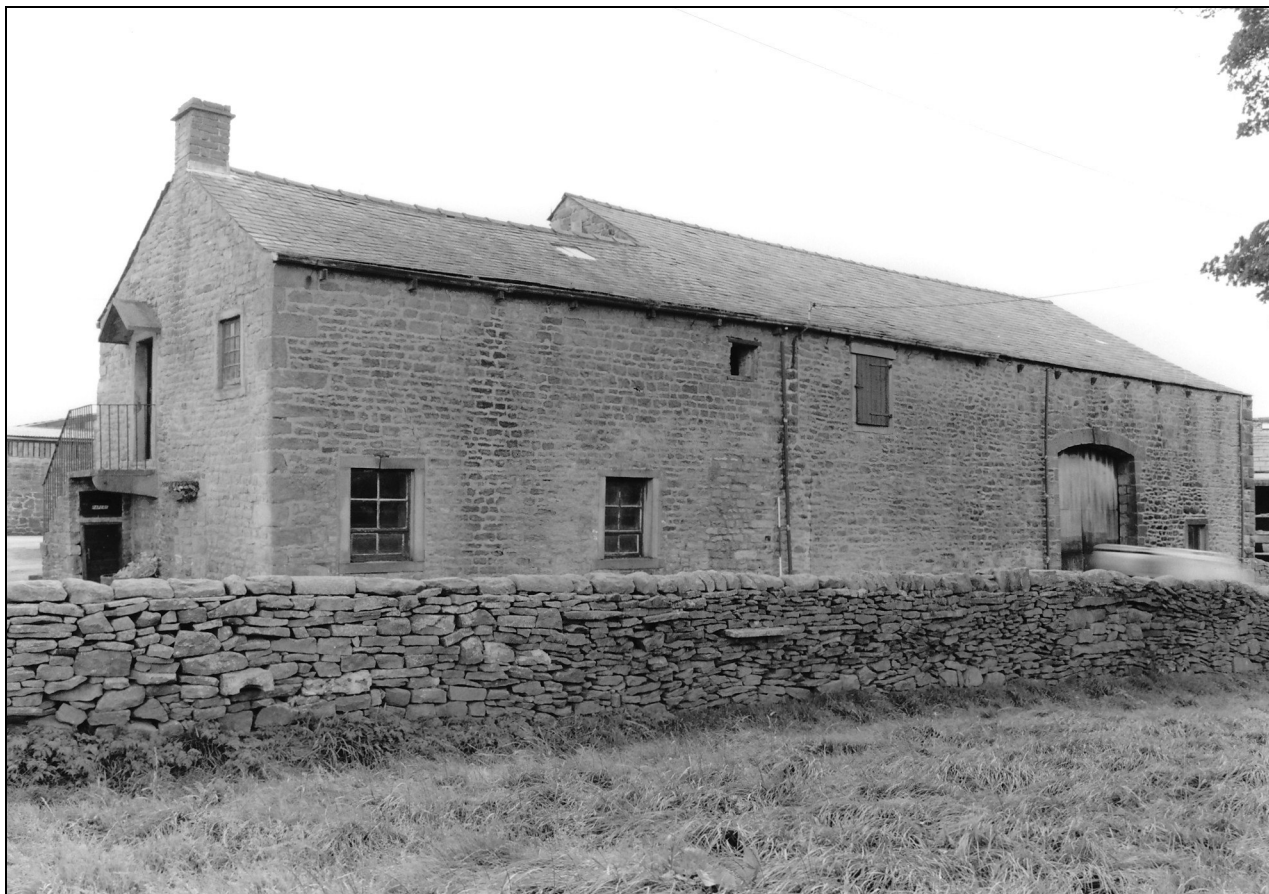
Photo 3: The barn and office, from the north-west

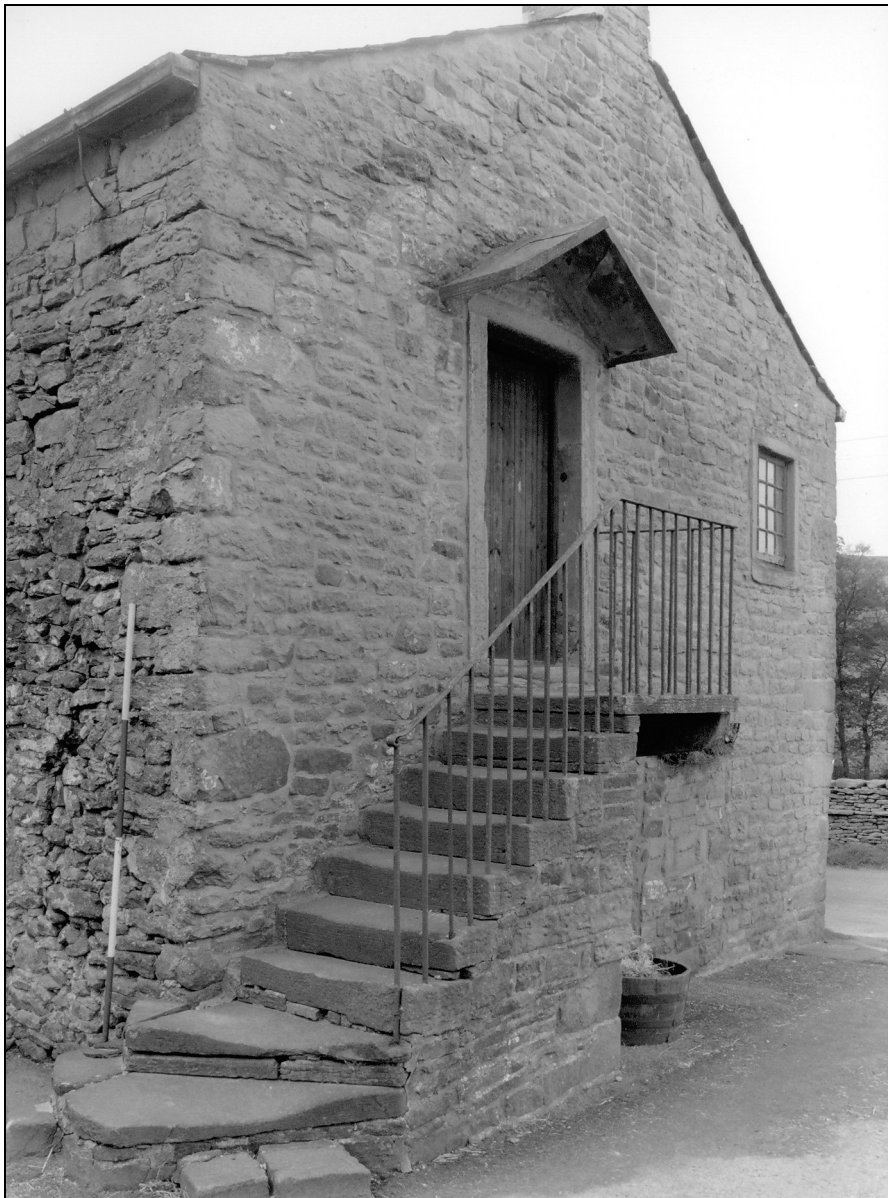
Photo 9: North gable of the office and detail of steps, from the north-east

- 6.4 The north gable of the range (**7-9**) is of similar, roughly coursed gritstone rubble and there is a clear break where the roof has been raised and its pitch made more shallow, around 1m below the present eaves. The arrangement of stone steps leading to the first floor doorway, the first floor window, and the stone chimney stack all appear to be secondary to this gable, with a blocked ground floor window and doorway probably the original openings. The present doorway and window have monolithic ashlar surrounds, the doorway with a pair of

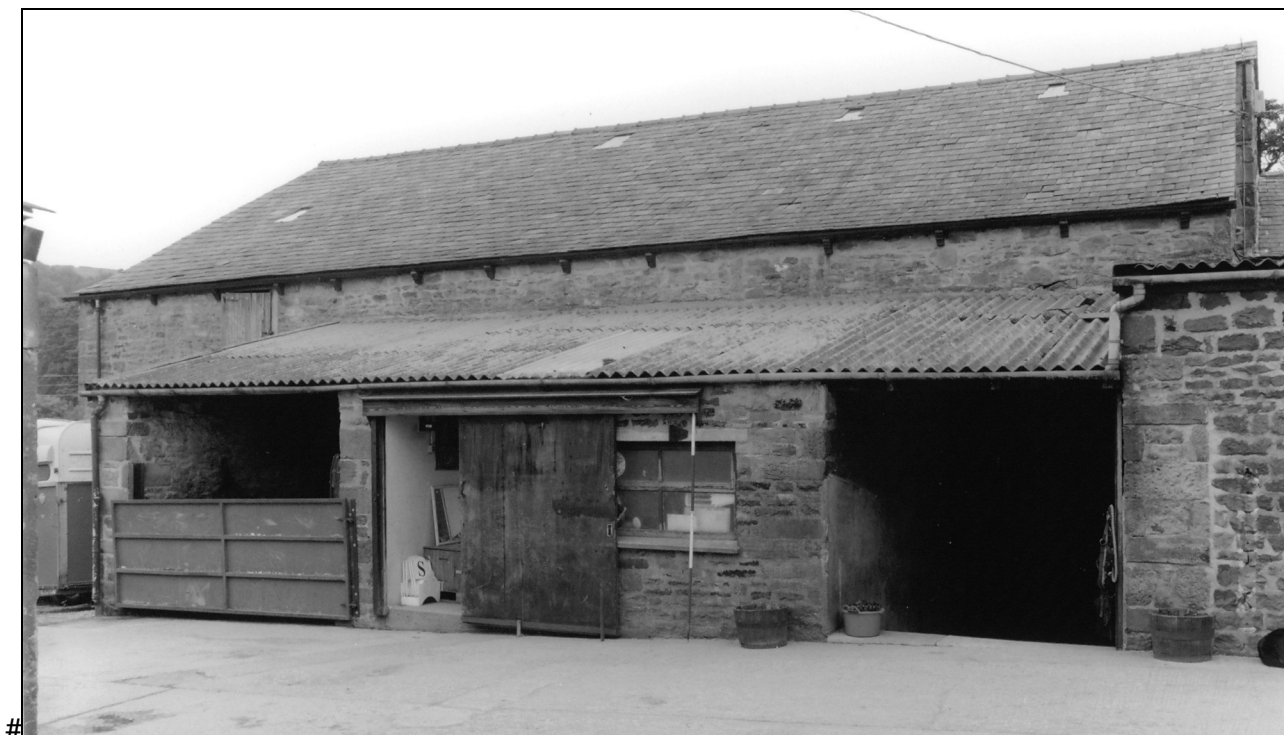
Photo 12: Rear elevation of the barn and lean-tos, from the north-east

- 6.6 The visible parts of the barn's rear elevation are confined to a low strip below the eaves (12) (which have the same terracotta gutter brackets as the front elevation), and an area to the south of the lean-tos, where the masonry is of random rubble and contains a ground floor window and first floor forking hole (13). The lean-tos themselves are not of historic interest, and are clearly of twentieth century date as they are not shown on the 1909 map (Figure 5).

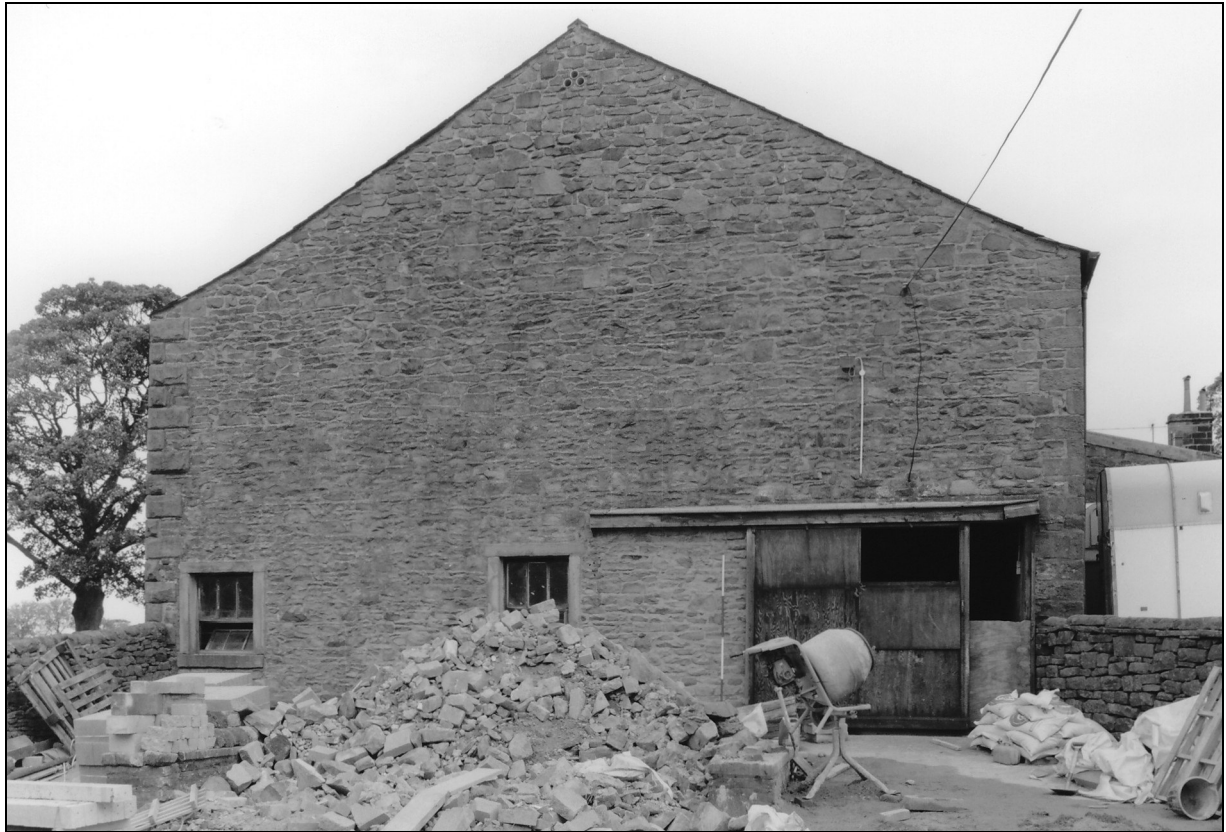
- 6.7 The barn's south gable (14) is of similar appearance to the west side and probably of the same date; it has plain quoins to the rear and although some rebuilding is evident at the top of the wall, this probably results from repairs in the late C20, recalled by Mr Bradley.

Photo 14: South gable of the barn

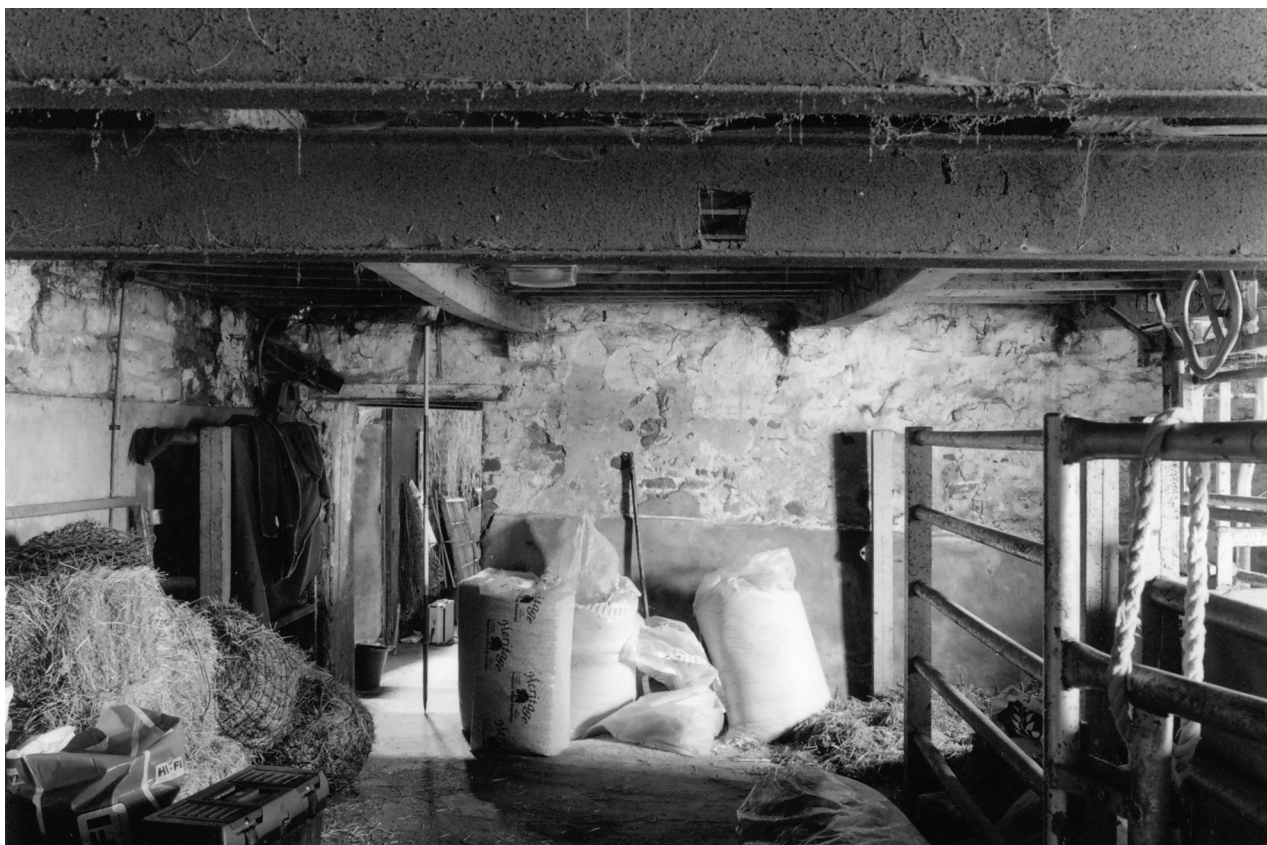
- 6.10 In the north end of the range the ground floor has been opened up to form an extension to the barn, used for livestock housing (22); a dividing wall has been removed and replaced with steel beams, and this area is now only accessible from within the barn. The first floor is of more interest however: although essentially only a large loft (23), it contains a fireplace with dressed stone surround and grate in the north side (24-26), which give rise to its being termed in this report the "office"; however it might alternatively have formed a living space for servants, or a tack room associated with a stable, and there is also a tradition that it was used as a dance hall in the early twentieth century. The room is open to the roof, with a single king-post truss of nineteenth century character (27).

Photo 22: Ground floor room below office, from the north

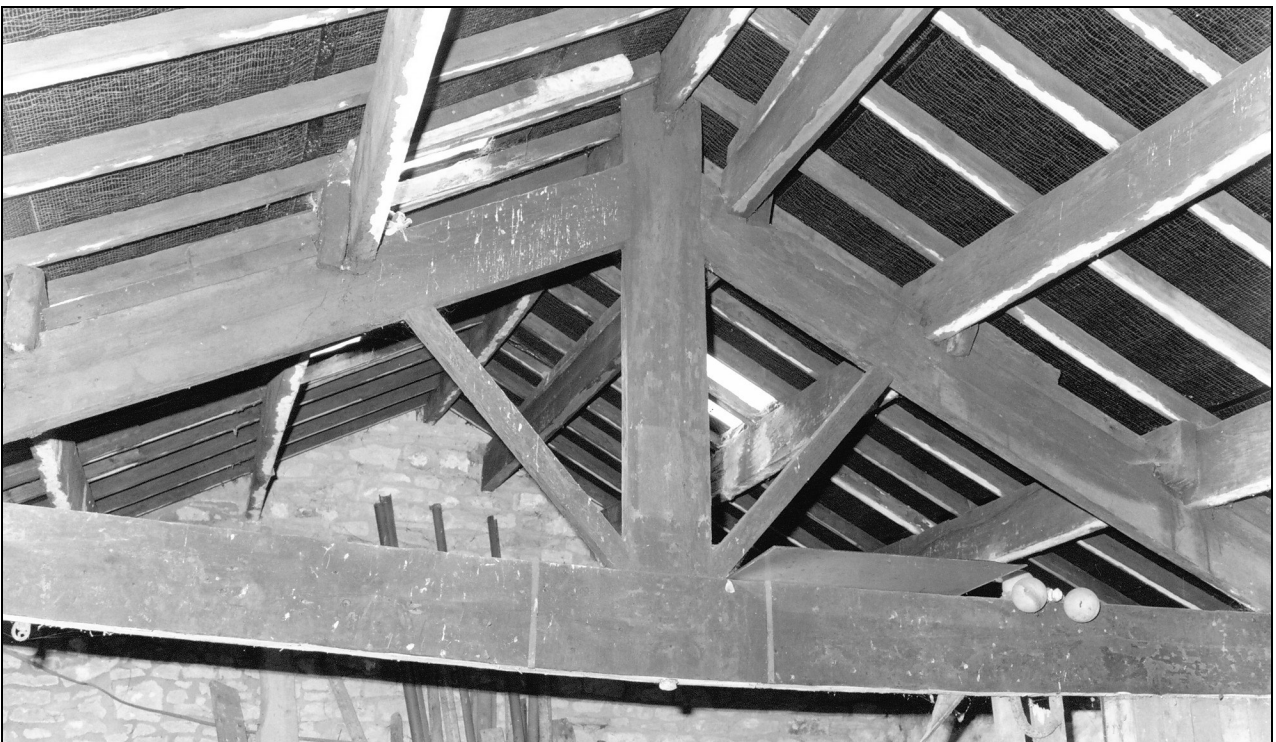
Photo 27: Roof truss in office, from the north
