Former Methodist Chapel and Chapel House
Chapel Street, Slaidburn, Lancashire:
Archaeological Building Recording

Archaeological building recording was carried out in December 2005 at the disused Methodist chapel and adjoining house at Slaidburn (NGR: SD 71285230), for the Slaidburn Property Trust, before the demolition of a rear wing and the conversion of the remainder to a village hall. The chapel was built in 1821 by the Wesleyans, and was refurbished and extended by the addition of a school to the rear in 1889. It is a characteristically plain, nineteenth century non-conformist building. The records made include floor plans, a section and photographs, as well as a written account.

**FORMER METHODIST CHAPEL AND CHAPEL HOUSE, CHAPEL STREET,
SLAIDBURN, LANCASHIRE:**

ARCHAEOLOGICAL BUILDING RECORDING

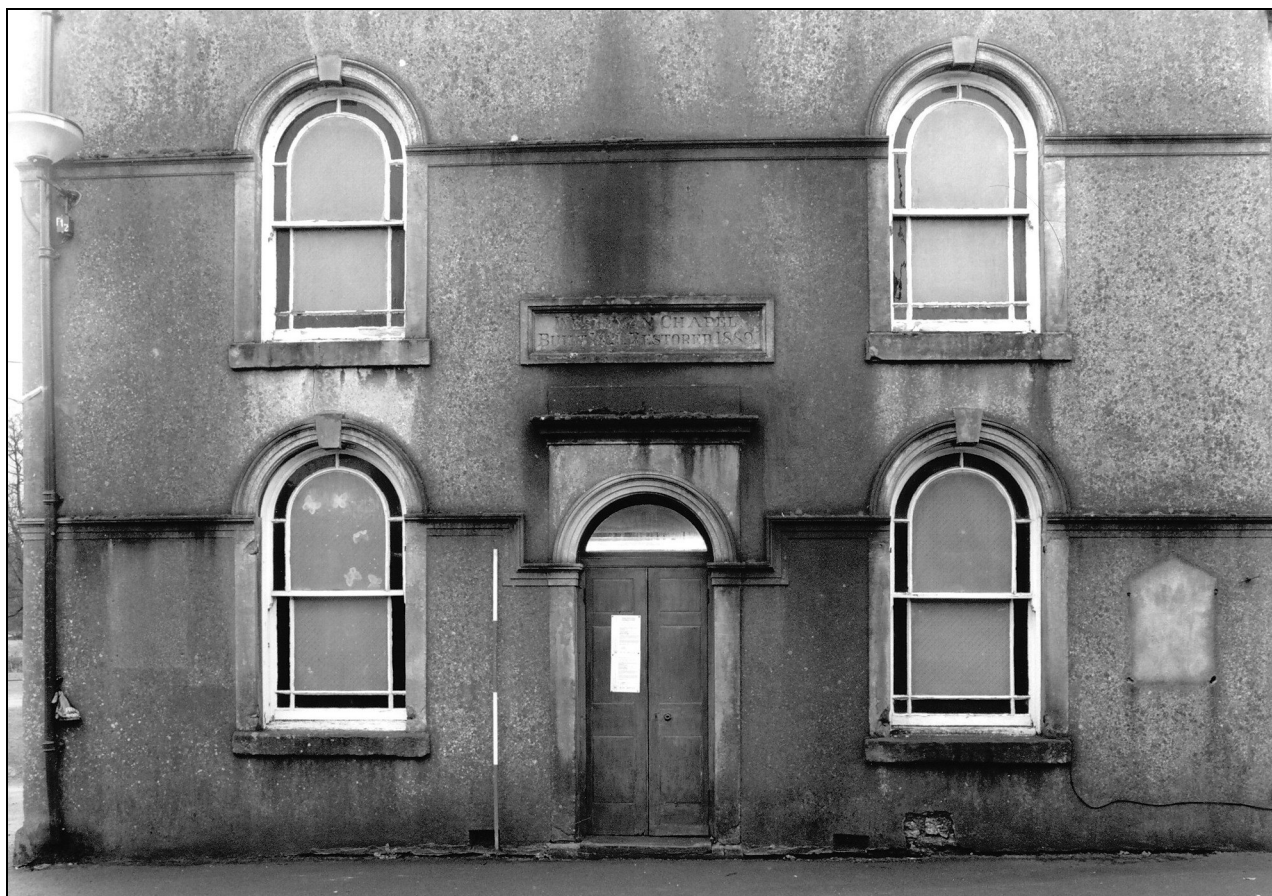
Photo 7: Front (north-east) elevation of the chapel

- 6.2 The chapel's front elevation (7) has a central doorway with semi-circular head, with a moulded cement cornice and impost band running to the flanking windows and beyond. The sandstone door jambs are monolithic with a milled surface, and the arch is also of stone, and the twin doors are of flush panel design with plain fanlight (8). The inscribed stone over reads "Wesleyan Chapel built 1821 restored 1889" (9). The windows to either side, on both ground and first floor, have similar plain sandstone jambs and sills, with moulded arch and keystone; the ground floor openings have the remains of hinges for shutters (10). These openings may have their original form, but it is possible that the arched heads were added in 1889; the sashes within them have moulded architraves and coloured glass in the margins, and no doubt date to 1889. Two notice boards appear to have been removed from the front elevation (and are itemised in the sale catalogue of 4 December 2005).

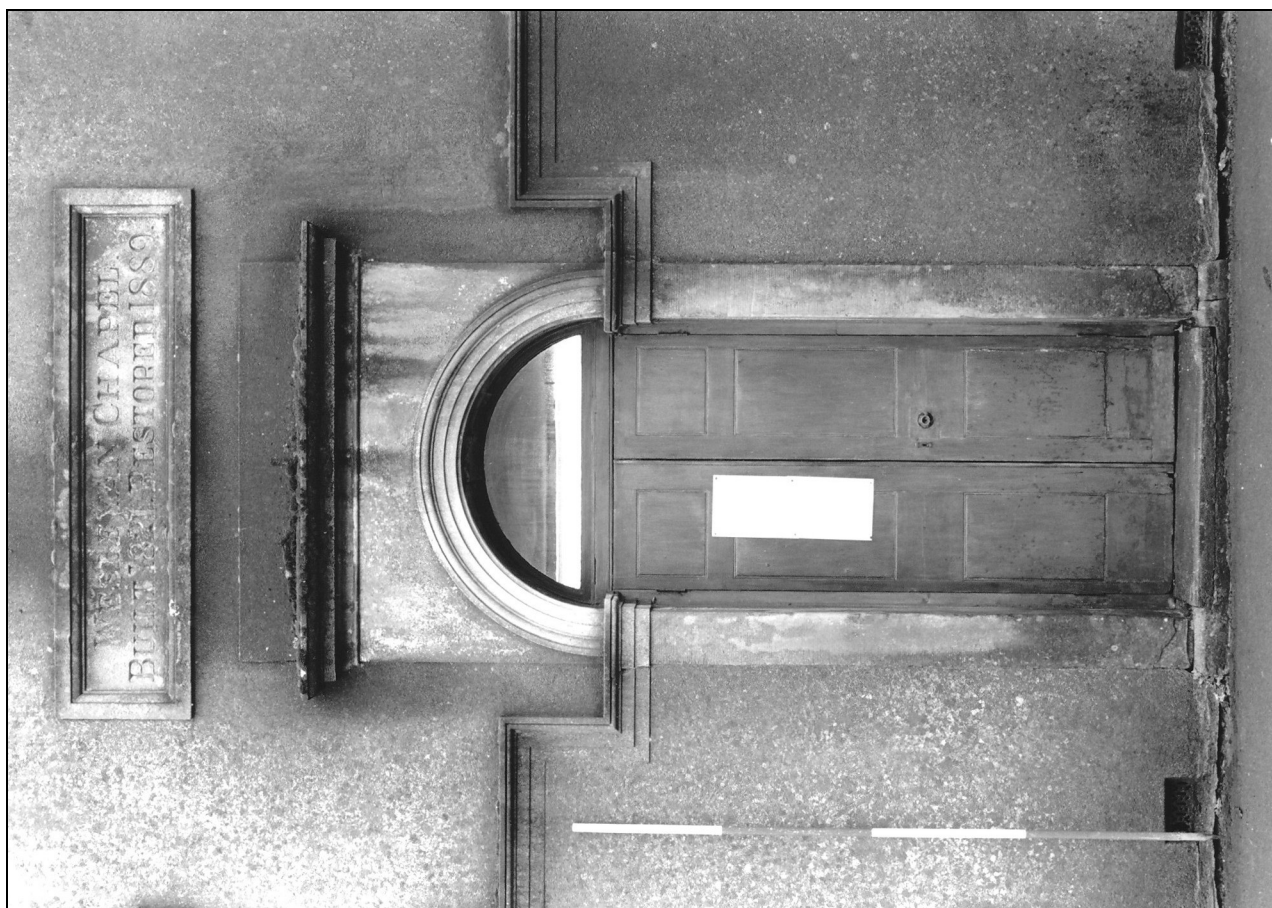
Photo 8: Detail of front doorway to the chapel, north-east elevation

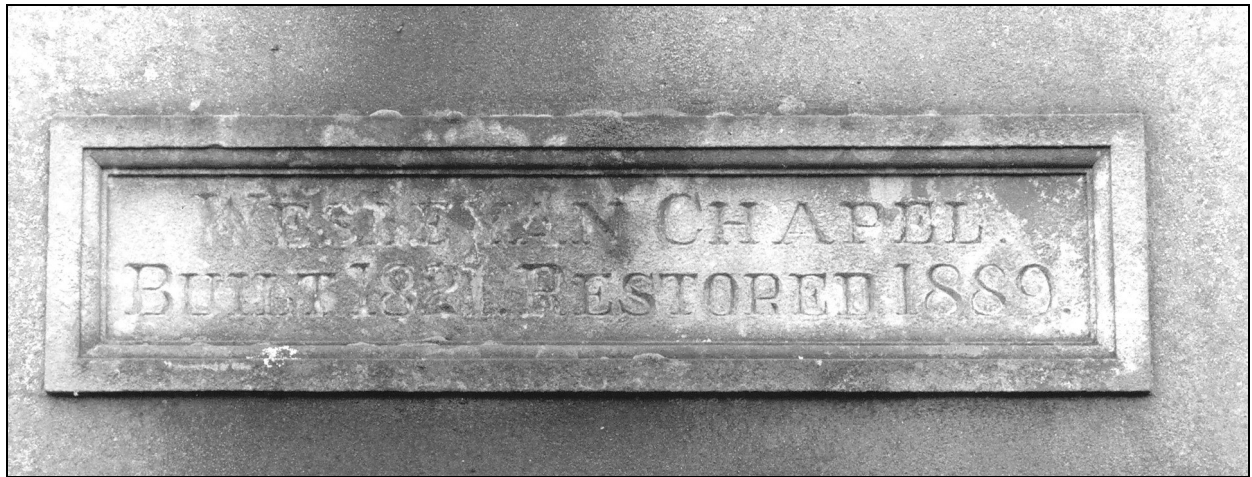
Photo 9: Detail of inscribed stone above front doorway to the chapel ("WESLEYAN CHAPEL BUILT 1821 RESTORED 1889")

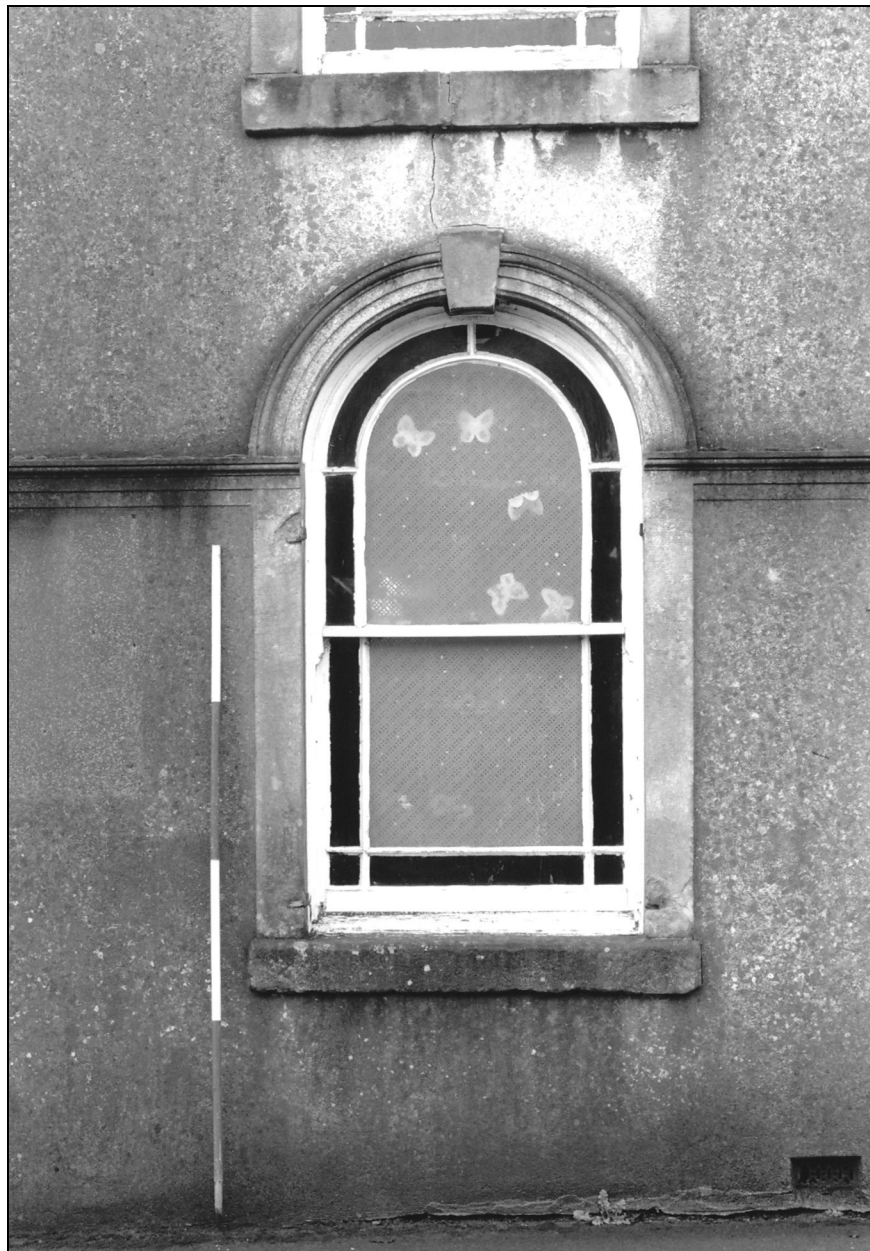
Photo 10: Detail of typical window to the chapel, front elevation

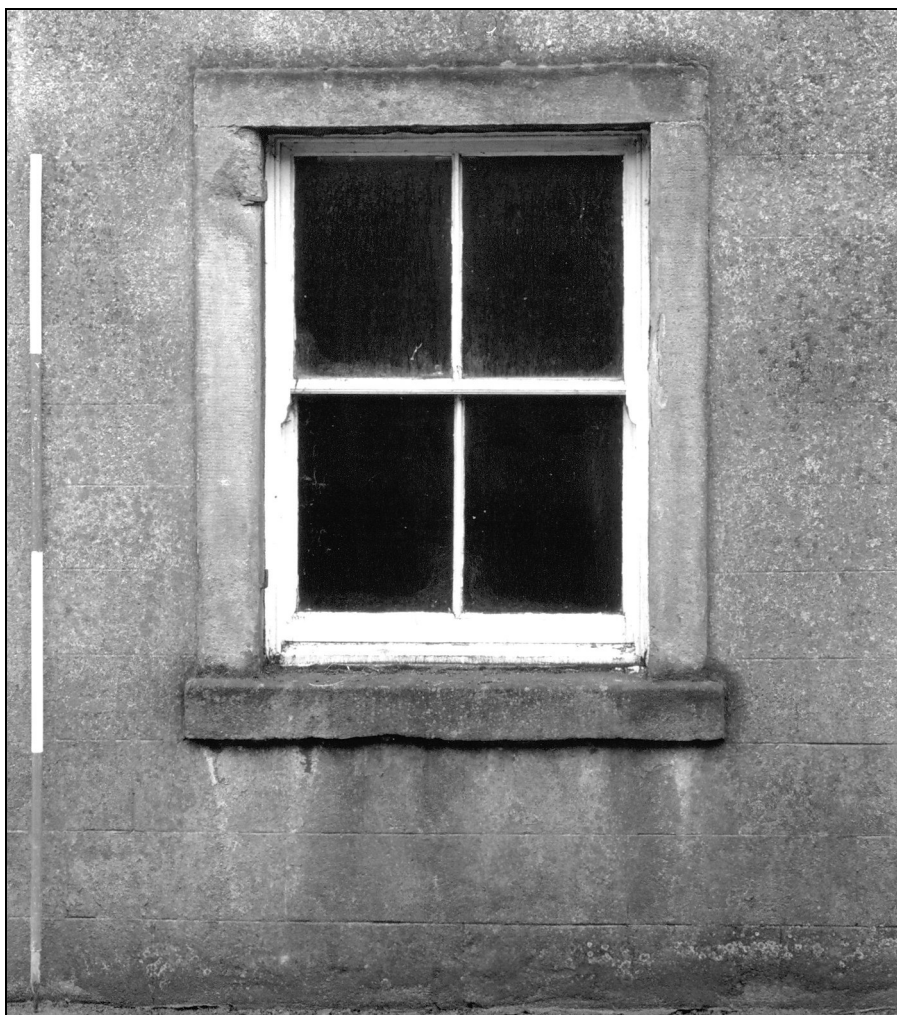
Photo 12: Detail of typical window to Chapel House, front elevation

- 6.3 The front of the adjoining Chapel House, added in 1824, is essentially similar but less ornate. It has a plain doorway with sandstone jambs which match the windows (11), but there is also a shallow canopy over the entrance consisting of two large flagstones. The ground floor windows have shutter hinges, and the cement render which covers the elevation is scored to imitate ashlar (12).

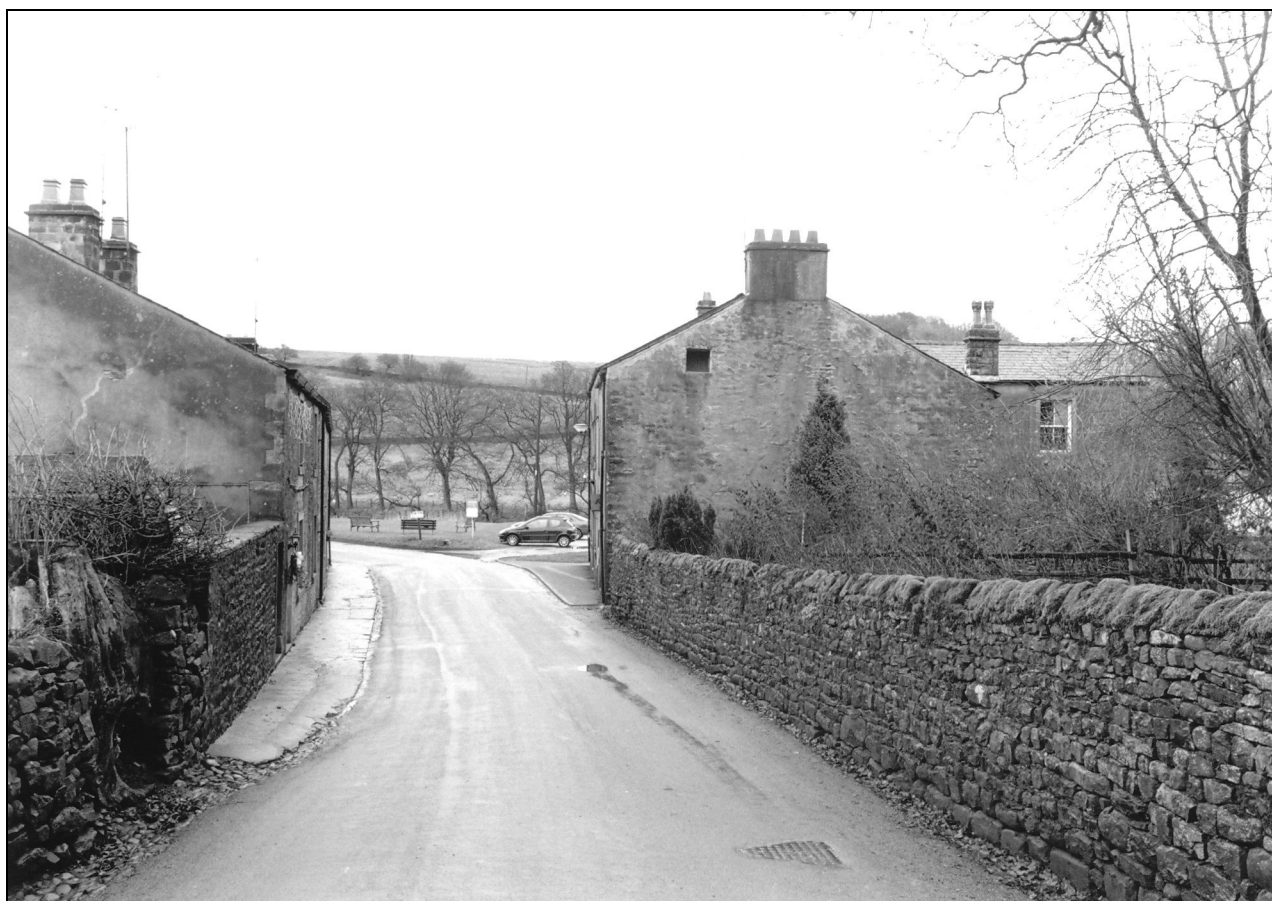
Photo 13: View down Chapel Street towards Chapel House (on right)

- 6.5 The house's north-west side is of random rubble, heavily pointed (13,14); the only opening is a shuttered hole at attic level. To the rear, a modern porch has been added at the foot, enclosing the rear entrance (15), and there are three window openings of various sizes (16), perhaps altered although the render masks the stonework which might indicate clearly any blocked openings. The house also has a pair of central windows at first floor level, with drip moulds over, and a row of plain stone gutter brackets to the eaves.

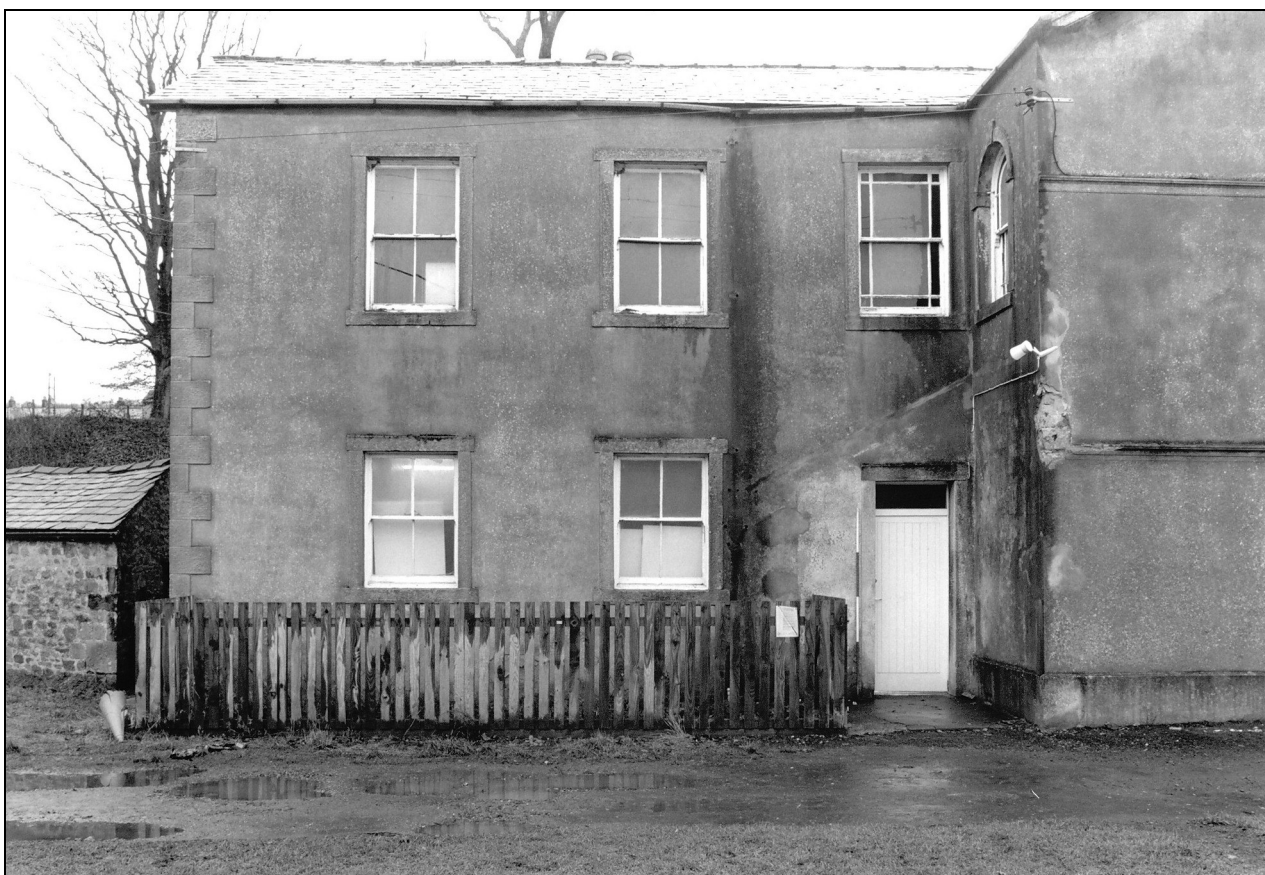
Photo 19: South-east elevation of Sunday school

- 6.7 The Sunday school wing faces south-east and is three bays long; it is also rendered except at the quoins, with blue slate roof and tile ridge (19). The entrance is next to the chapel, a tall doorway with monolithic sandstone jambs bearing a coarser tooling (20), and at one time clearly enclosed within a lean-to porch. Another tablet or stone appears to have been situated at ground level in this elevation next to the doorway, and there is a third such mark further along the wall. All the window openings are of plain rectangular form (21), with surrounds of similar stone jambs and sills, and sashes. The sash next to the chapel at first floor level has coloured margin lights like those elsewhere in the chapel, and reflects the fact that this lights a gallery to the chapel, rather than the Sunday school.

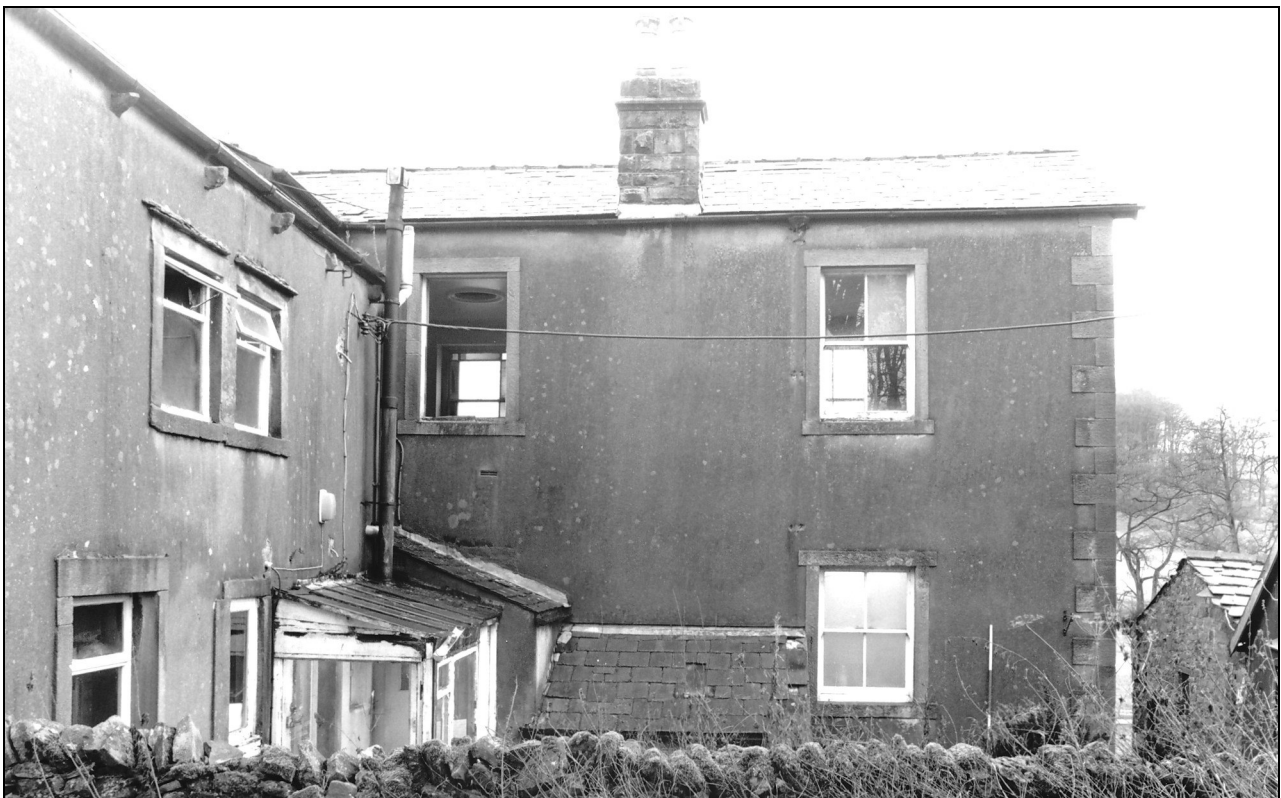
Photo 23: North-west elevation of Sunday school

- 6.8 The south-west gable is blind, but the north-west side of the school has three similar windows, perhaps with a fourth altered to form the present doorway into the corner lean-to. This wall also has a central chimney stack (23). As with the front of this wing, the first floor window lighting the chapel gallery (now removed) was coloured. The lean-tos at the foot of this wall comprise a porch and a brick-built boiler house (24), indicating a change of heating from open fires to central heating, probably in the early twentieth century.

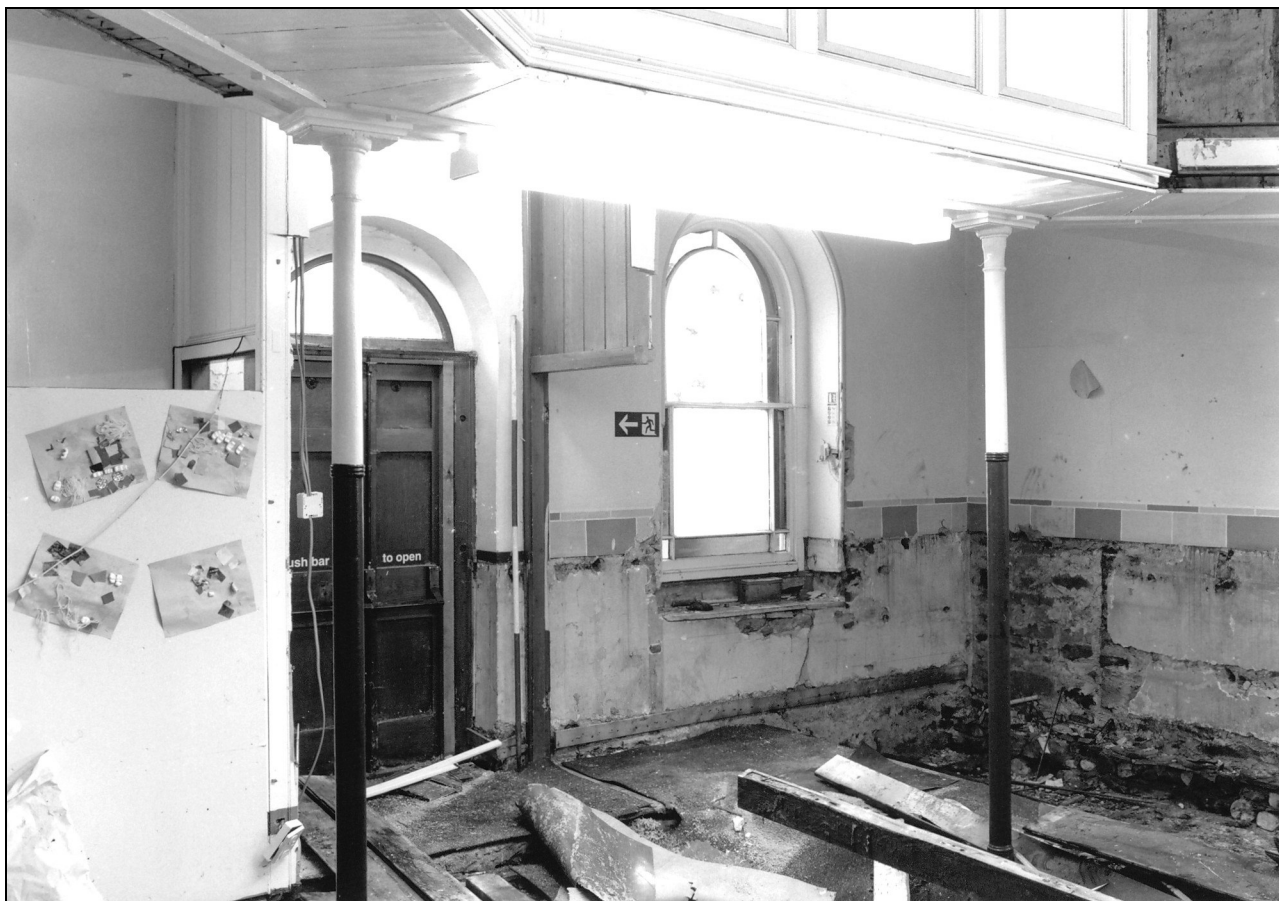
Photo 28: Interior of chapel: ground floor, from the west

held rows of pews facing a pulpit at the south-west side, although it is not possible now to determine the seating plan. A pair of cast iron columns support the three-sided gallery which comprises the upper floor (28,29), but apart from a memorial stone at one side there are very few features of note remaining in this area (30). At the south-west side, a doorway leads into the school (31), and next to this is some tongue-and-grooved panelling to the lower parts of the walls, as is commonly found in Victorian buildings of this type (33). The memorial is to the Reverend Richard Fletcher (1828 – 1907) (34); there is a second, detached example to John Illingworth (d1858), who campaigned over rights to land in the parish (Spencer 2003, 67), but the former location of this within the building is not known.

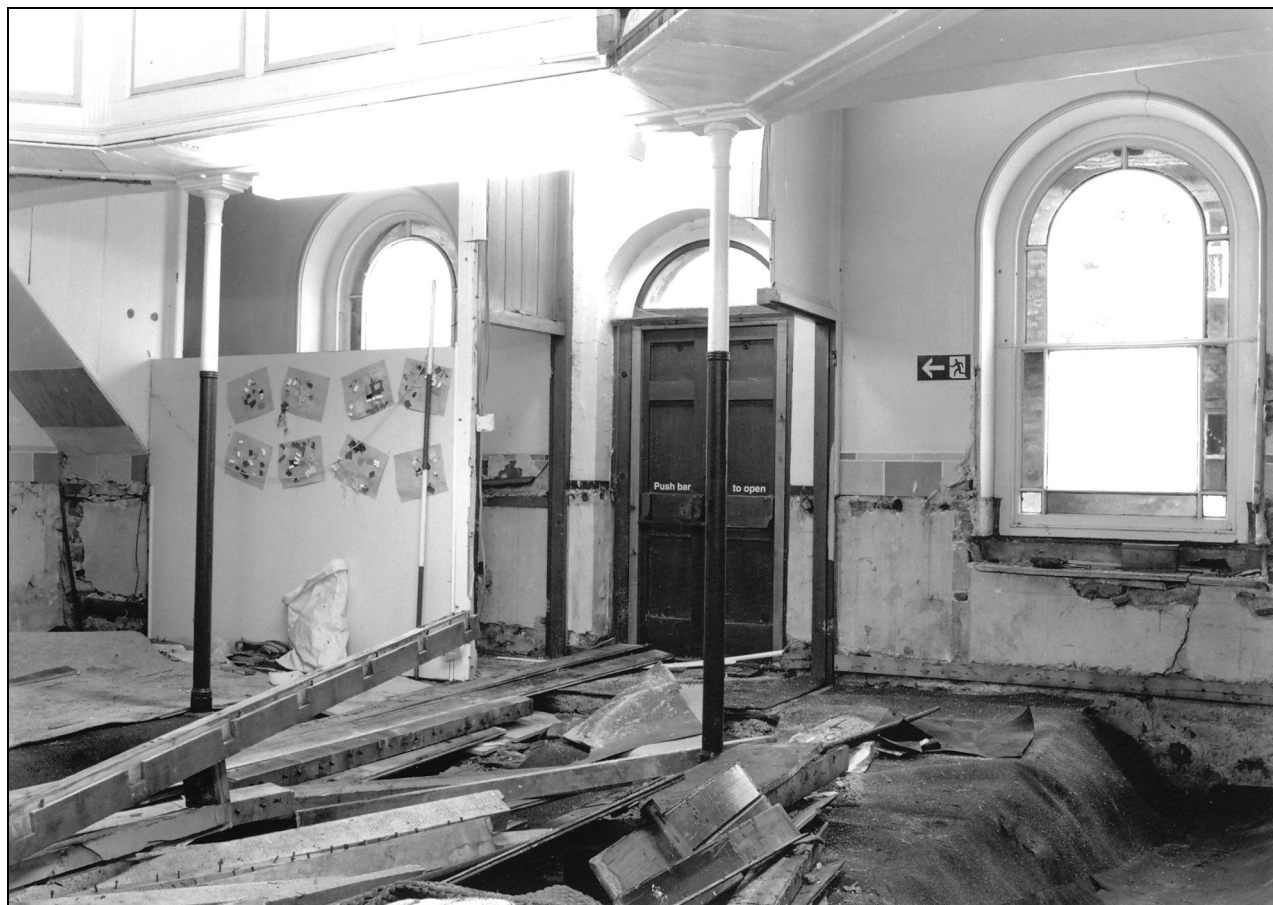
Photo 29: Interior of chapel: ground floor, from the south, showing remains of lobby and columns supporting gallery

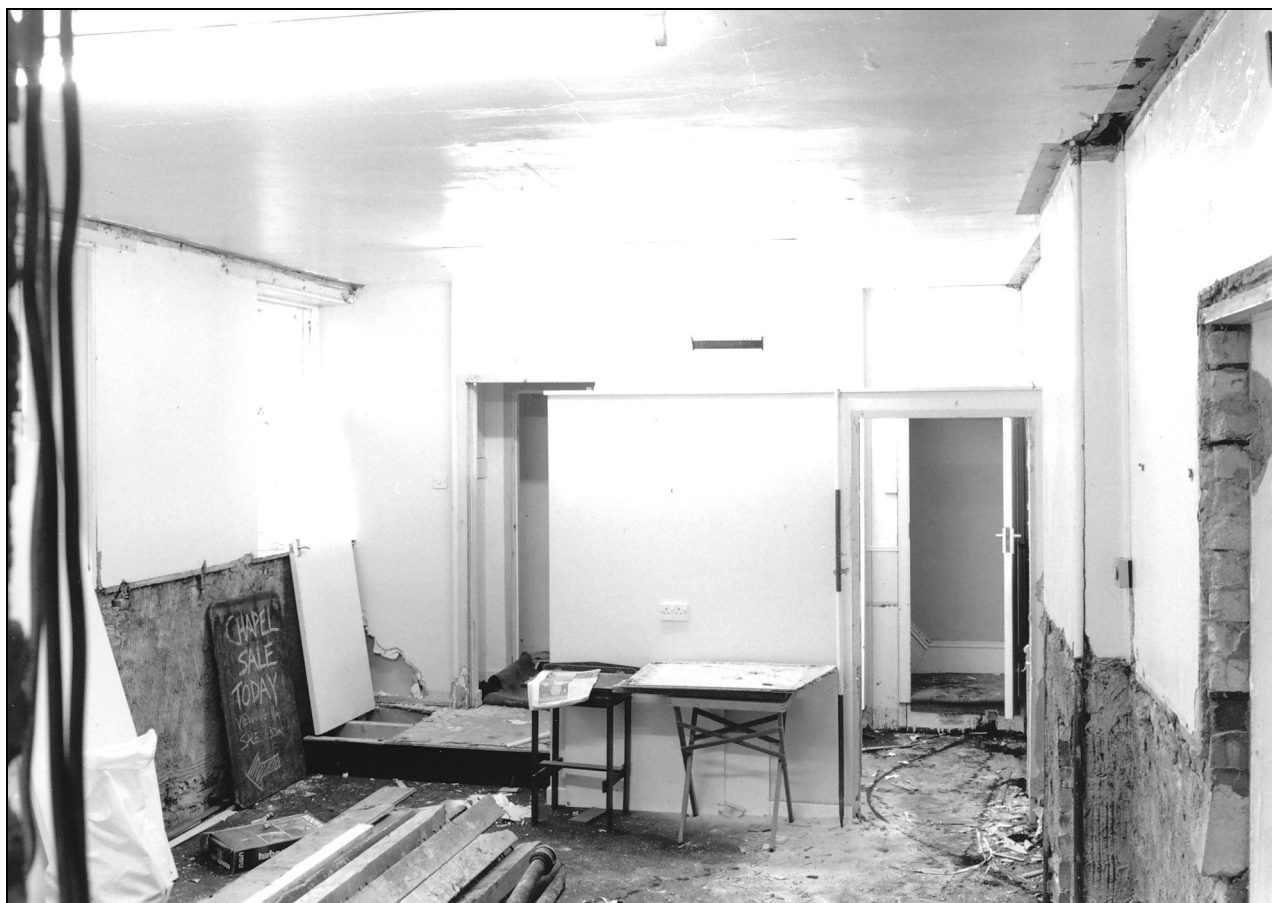
Photo 48: Interior of Sunday school: ground floor classroom, from the north-east, with modern partitions

- 6.12 In the school wing, the ground floor classroom has some modern plasterboard partitions, but appears originally to have formed a single area, with panelled walls and a fireplace in the north-west side (48,49), later superseded by central heating. The first floor, reached by plain stairs enclosed at the south-west end of the room (50,51) has, as noted above, a movable partition separating the classroom from the gallery (52,53), perhaps so children could hear the service separately. This room also had a fireplace as well as central heating; it has a plain ceiling in contrast to the corniced ceiling over the gallery. There is no means of access into the roof space, in either the gallery or school wing.

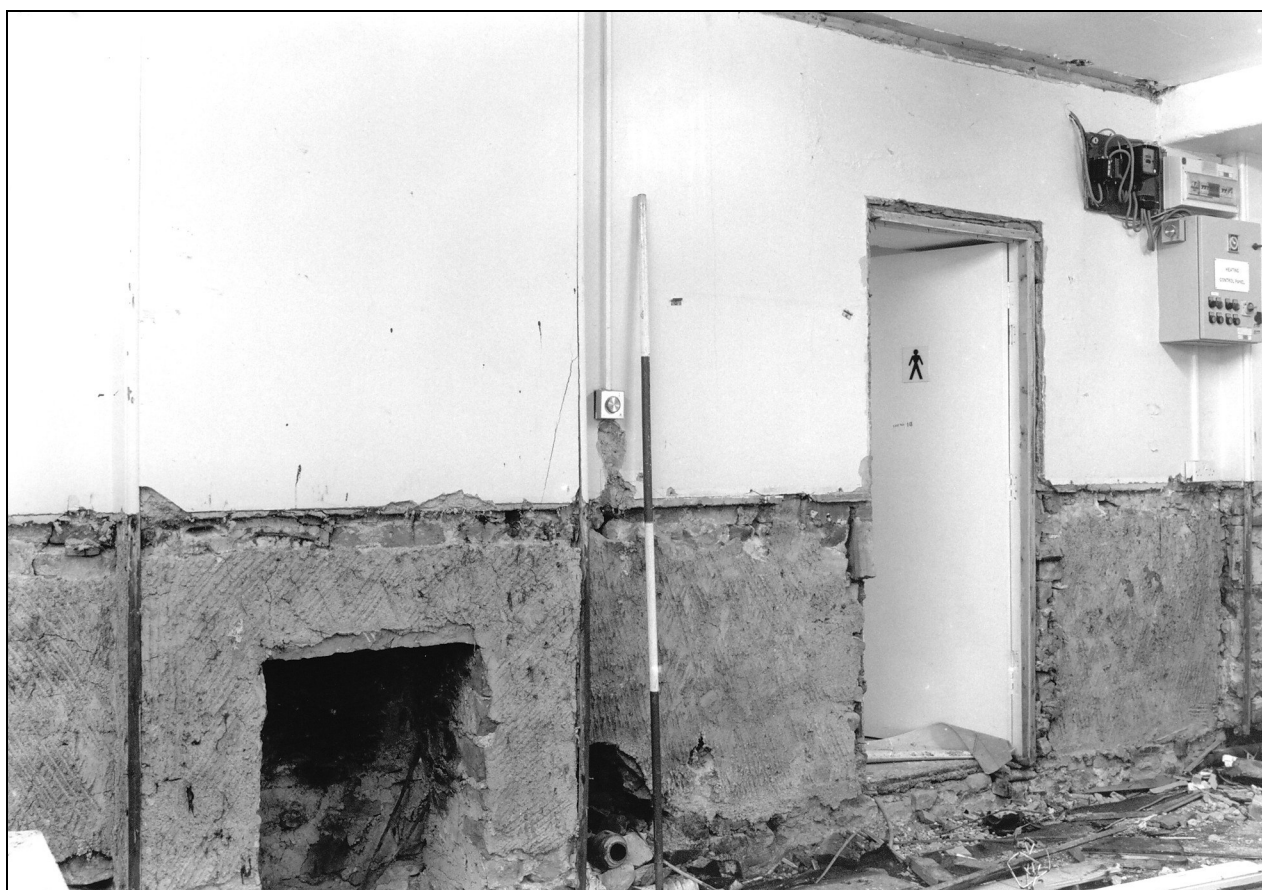
Photo 49: Interior of Sunday school: chimney breast in ground floor classroom, from the south

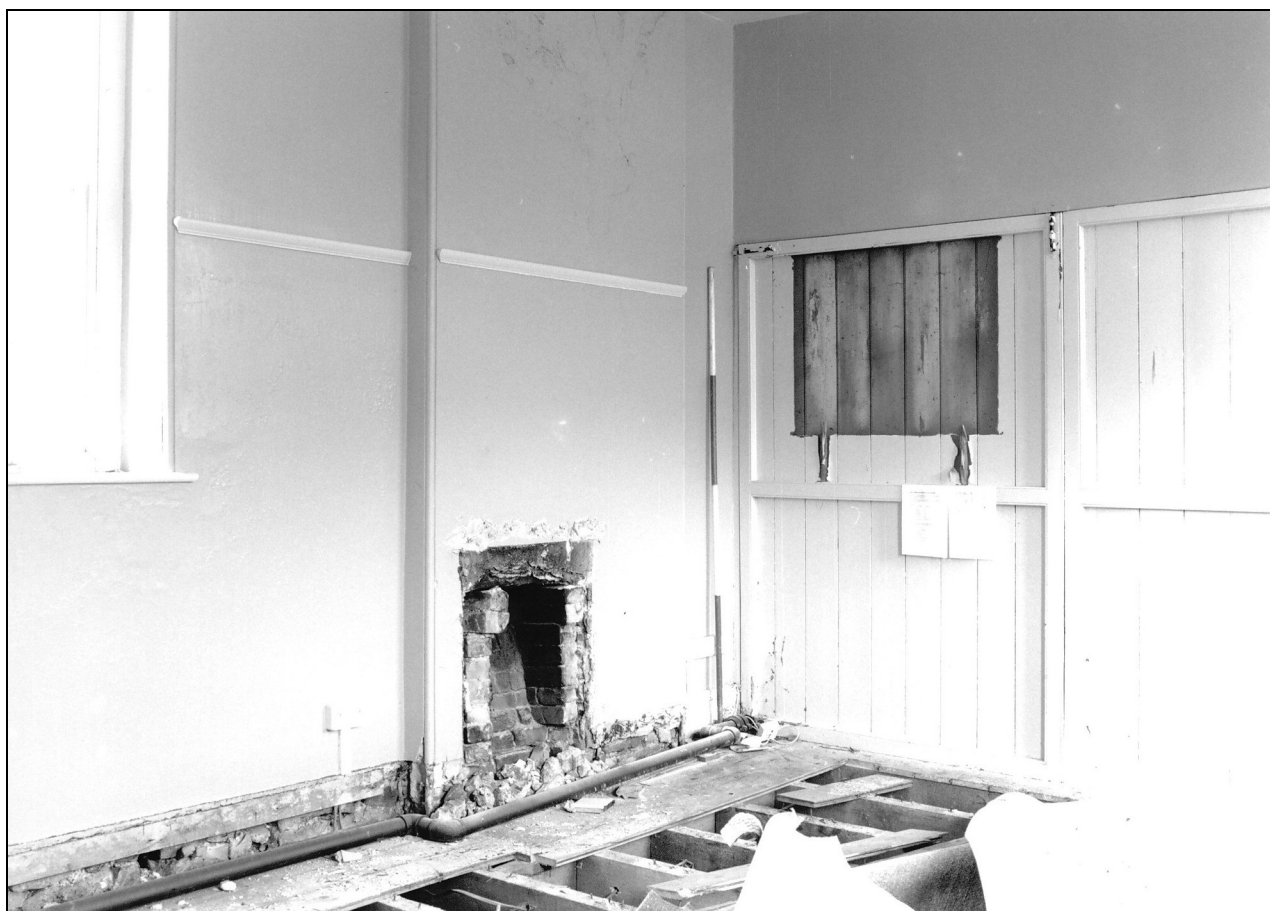
Photo 52: Interior of Sunday school: first floor classroom, from the south, showing remains of fireplace and movable partitions
