Barn at Lower Croft House  
Jinny Lane, Roughlee, Lancashire:  
Archaeological Building Recording

February 2006

STEPHEN HAIGH

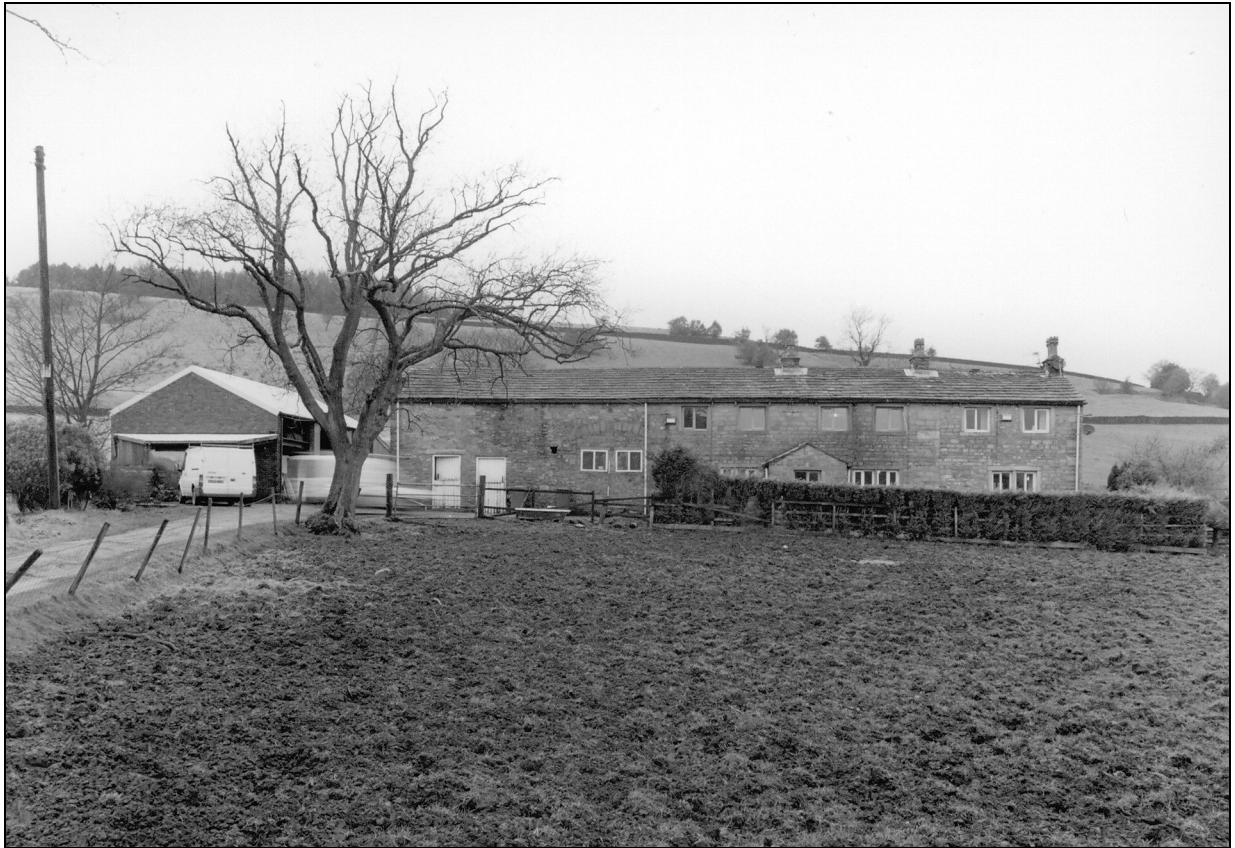
- 6.1 The main farm range faces south-east **(1)** and has a collection of twentieth century buildings to the north-west, of various forms although none appear to be of particular interest **(2,3)**. The farmhouse is fronted with coursed squared sandstone, and has plain, square-faced window jambs and shaped stone gutter brackets at the eaves **(4)**. The barn appears to have been added to the house, although there is no straight joint other than that formed by the jamb of the former cart entrance; it is built from poorer quality rubble, and has plain stone gutter brackets **(5)**. The lack of a straight joint suggests that there was some rebuilding of masonry at the corner of the house when the barn was added. This is also the case at the left end of the barn, where some keying in of later masonry has taken place above the pair of doorways, on the addition of the otherwise brick-built shippon **(6)**. The roof to the front elevation is of stone slates for its full length however, indicating that it has been re-slatted.

Photo 1: View of the farm from the south-east

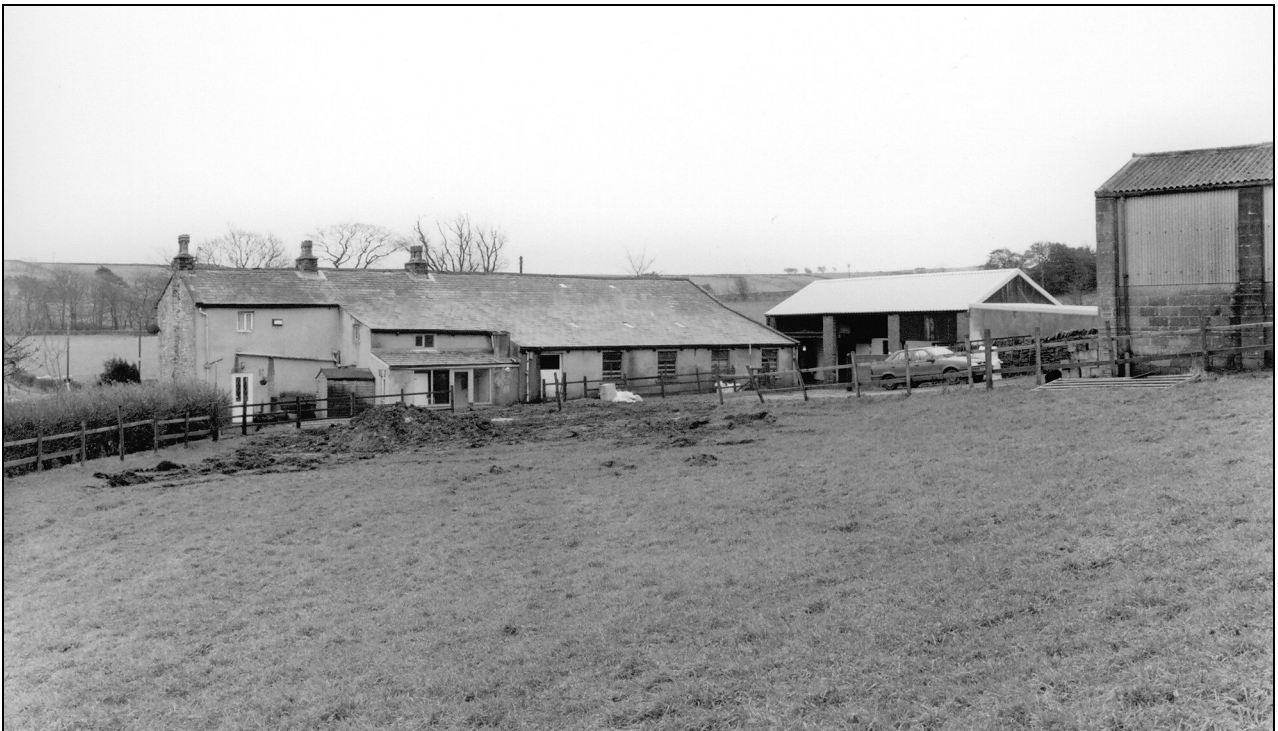
Photo 2: View of the farm from the north

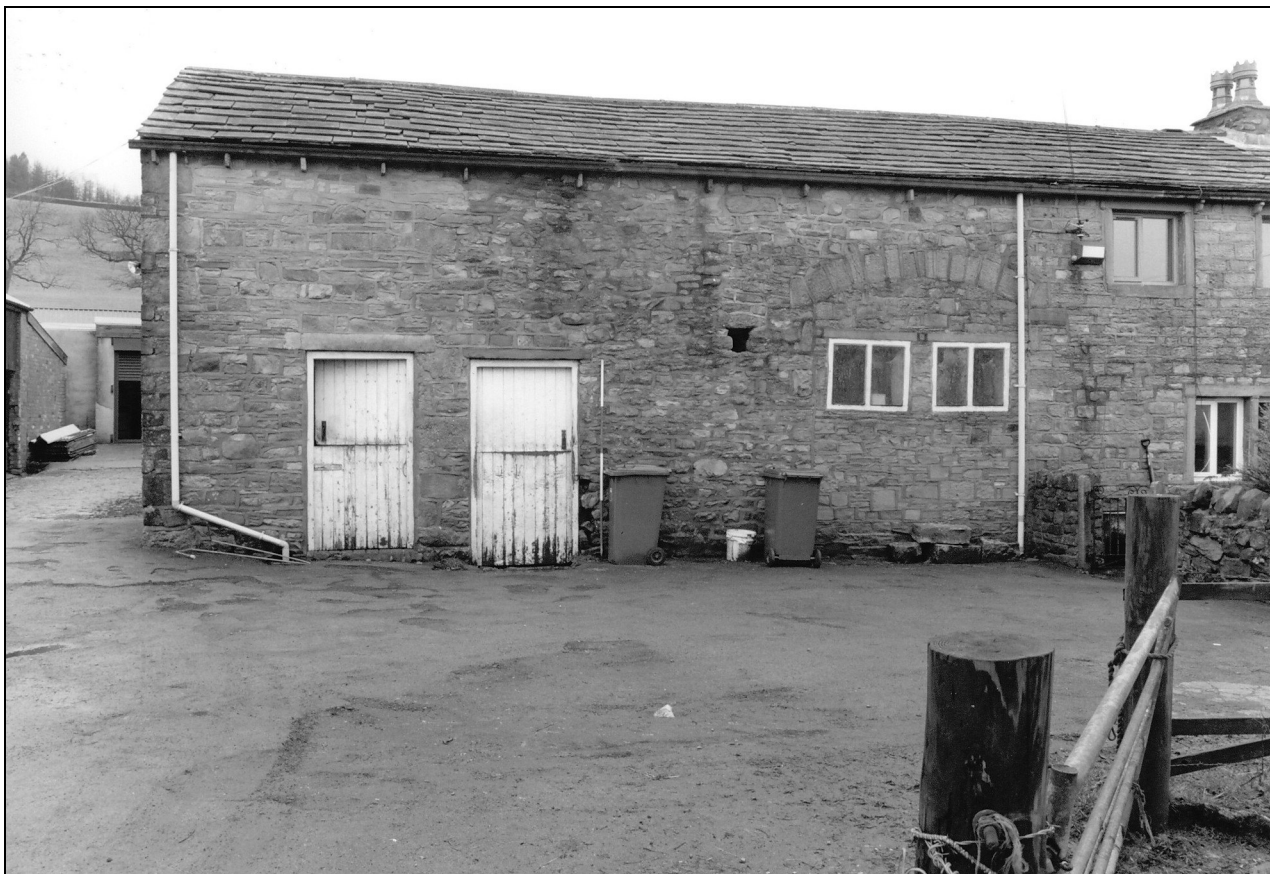
Photo 5: Front elevation of the barn, from the south-east

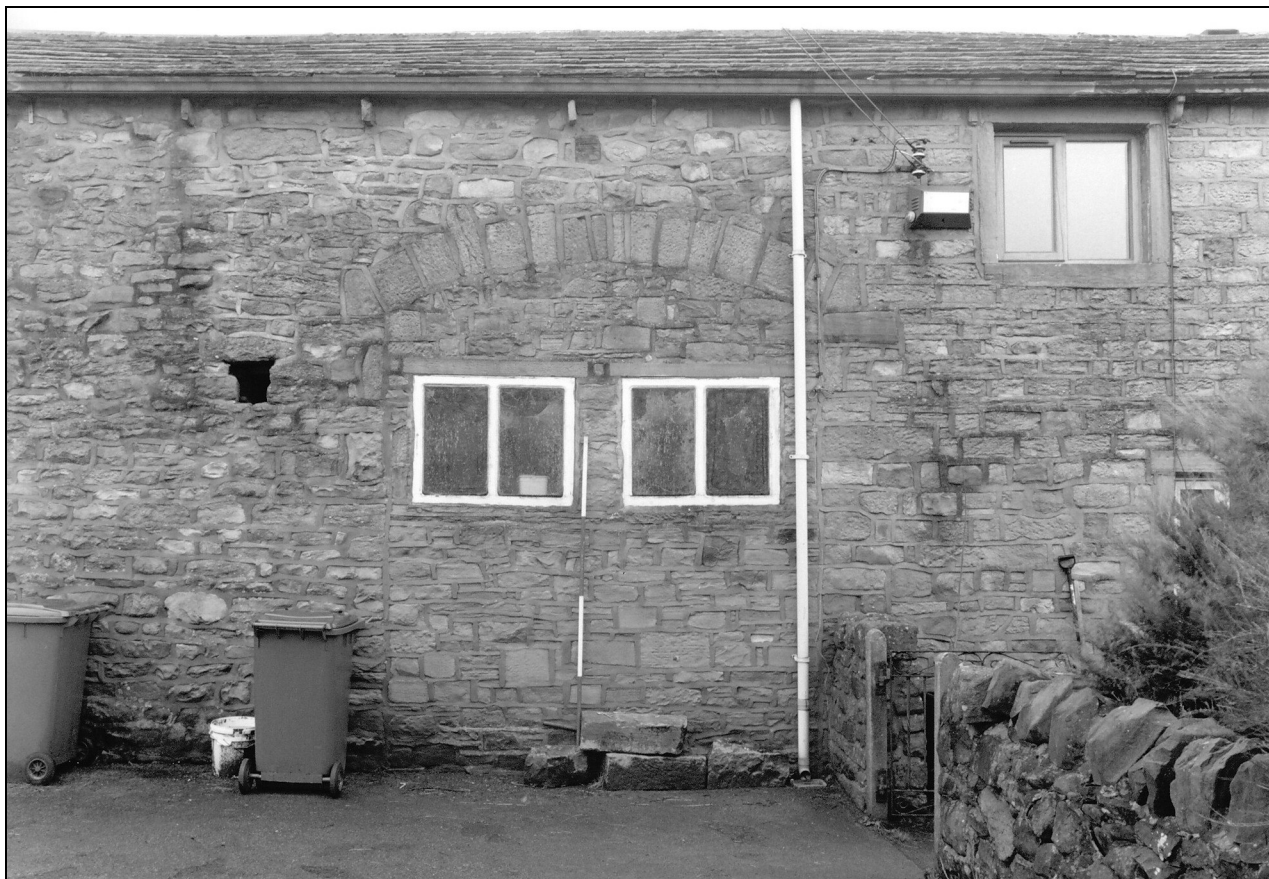
- 6.2 The openings in the front elevation of the barn include the former cart entrance with shallow segmental arch of roughly tooled voussoirs, now largely infilled but incorporating a pair of windows **(7)**. To the left is an original pedestrian doorway with thin sandstone lintel, giving access into the barn, and a second doorway with concrete lintel within the later part of the building, which uses the barn's quoins as its jamb. This leads into a loose box in the corner of the building.

Photo 7: Blocked doorway to barn in front elevation, from the south-east

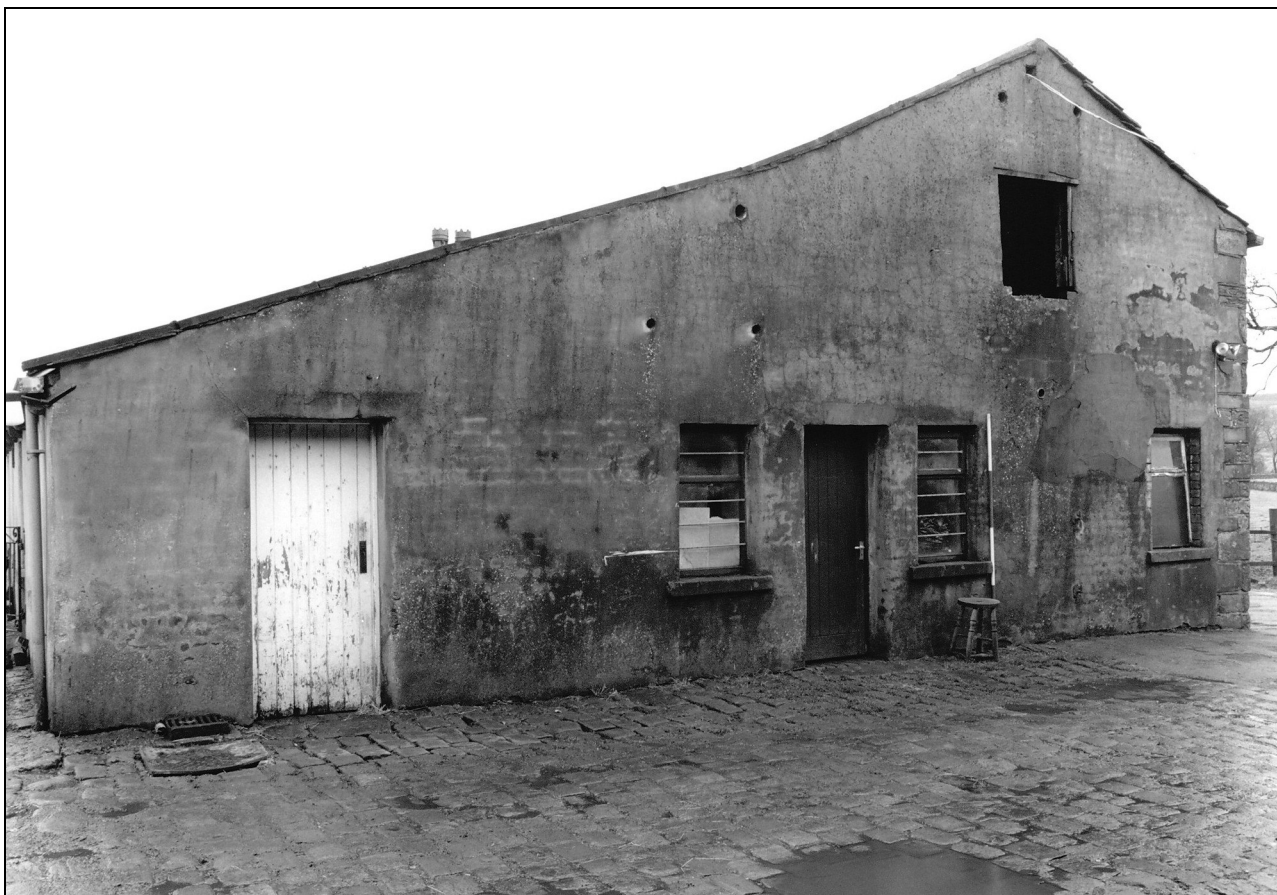
- 6.3 The south-west end of the building is all rendered brickwork apart from the stone quoins to the front elevation **(8)**. The left door leads into the rear shippon, and the central doorway flanked by windows into a small room, perhaps built as a dairy, but its walls completely lined with modern materials.

Photo 8: South-west elevation of added shippon, from the west

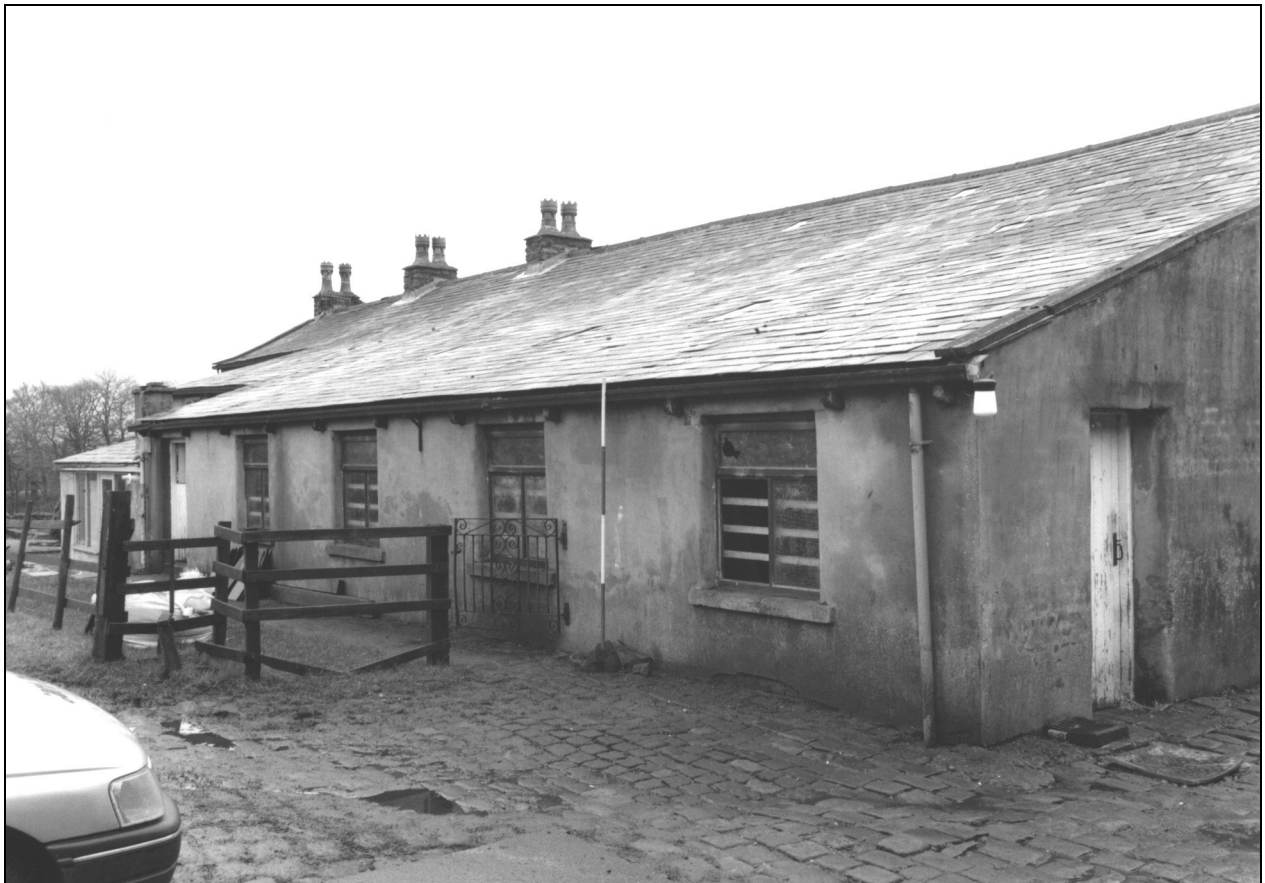
- 6.4 The rear of the shippon, which is L-shaped in plan, is also of rendered brickwork, with large windows and a doorway at the left end **(9,10)**. The guttering is carried on shaped bricks, and the roof to both barn and shippon is of blue slate, with a slight change in pitch between the two parts. Within the shippon, the rear elevation and south-west gable of the barn remain largely unaltered **(11)**; there is a rear doorway opposite the blocked cart entrance, and a smaller doorway at the corner, now blocked **(12)**, while a large first floor opening in the south-west gable of the barn is clearly an inserted or enlarged doorway **(13)**.

Photo 9: Rear elevation of added shippon, from the west

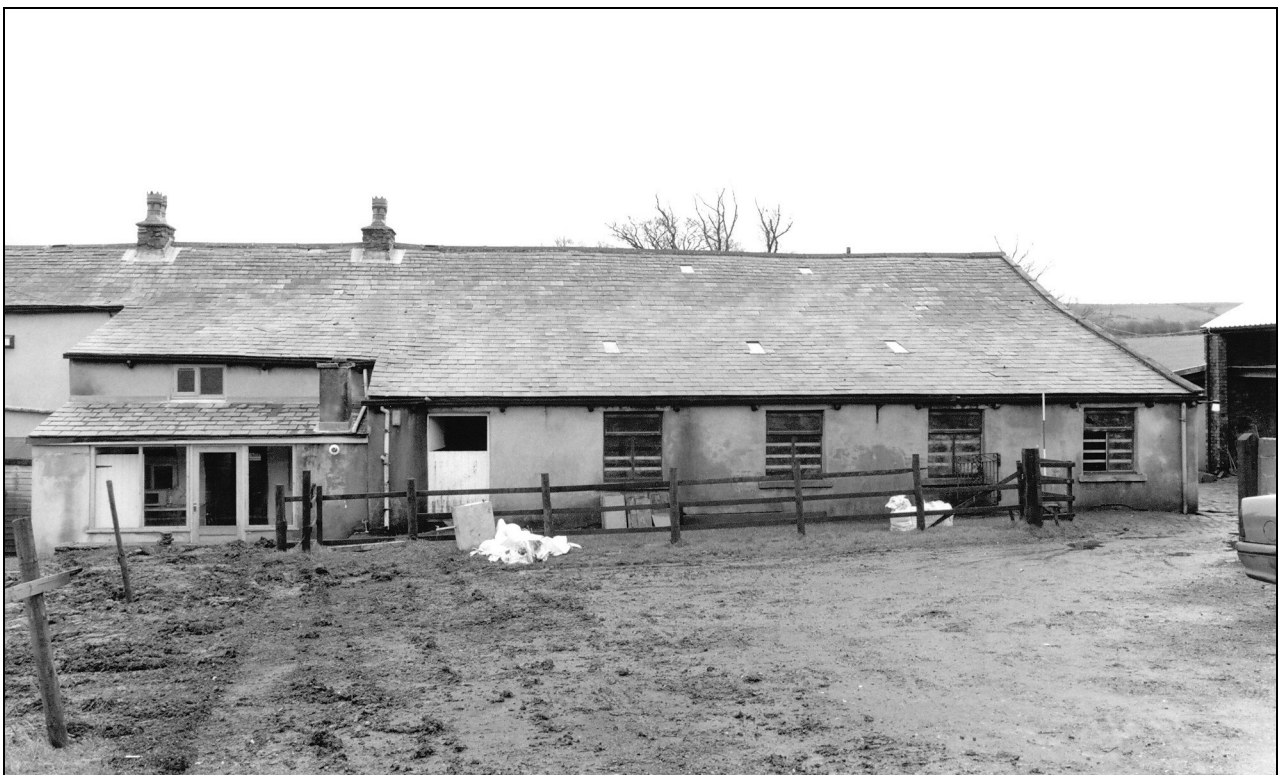
Photo 10: Rear of barn and shippon, from the north-west

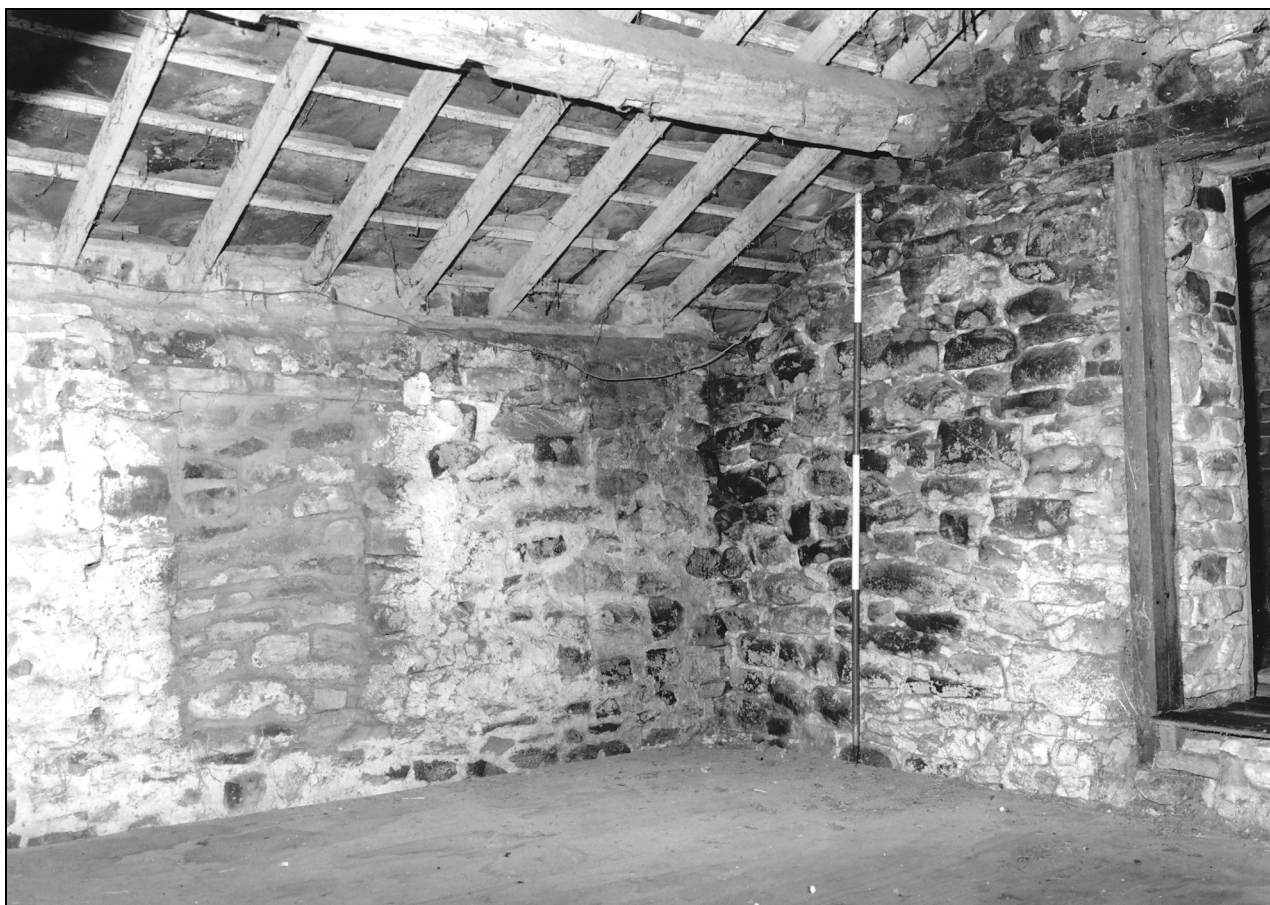
perhaps three or four cows or horses, facing north-east; there is very little original evidence for this however. The loft over now extends throughout this area but originally was probably confined to the south-west end, as it cuts across the cart entrance in the front elevation (14,15). The timber steps are associated with this later loft (16). Within the south-west end features suggestive of a shippon are confined to the lamp-hole in the wall and the opposing doorways to front and rear (17,18), but there are also some rather primitive harness pegs in the wall which suggest use as a stable. On the first floor level a blocked forking hole is not evident externally, indicating rebuilding in the front elevation, probably recent (19).

Photo 19: Hay loft in barn, from the north

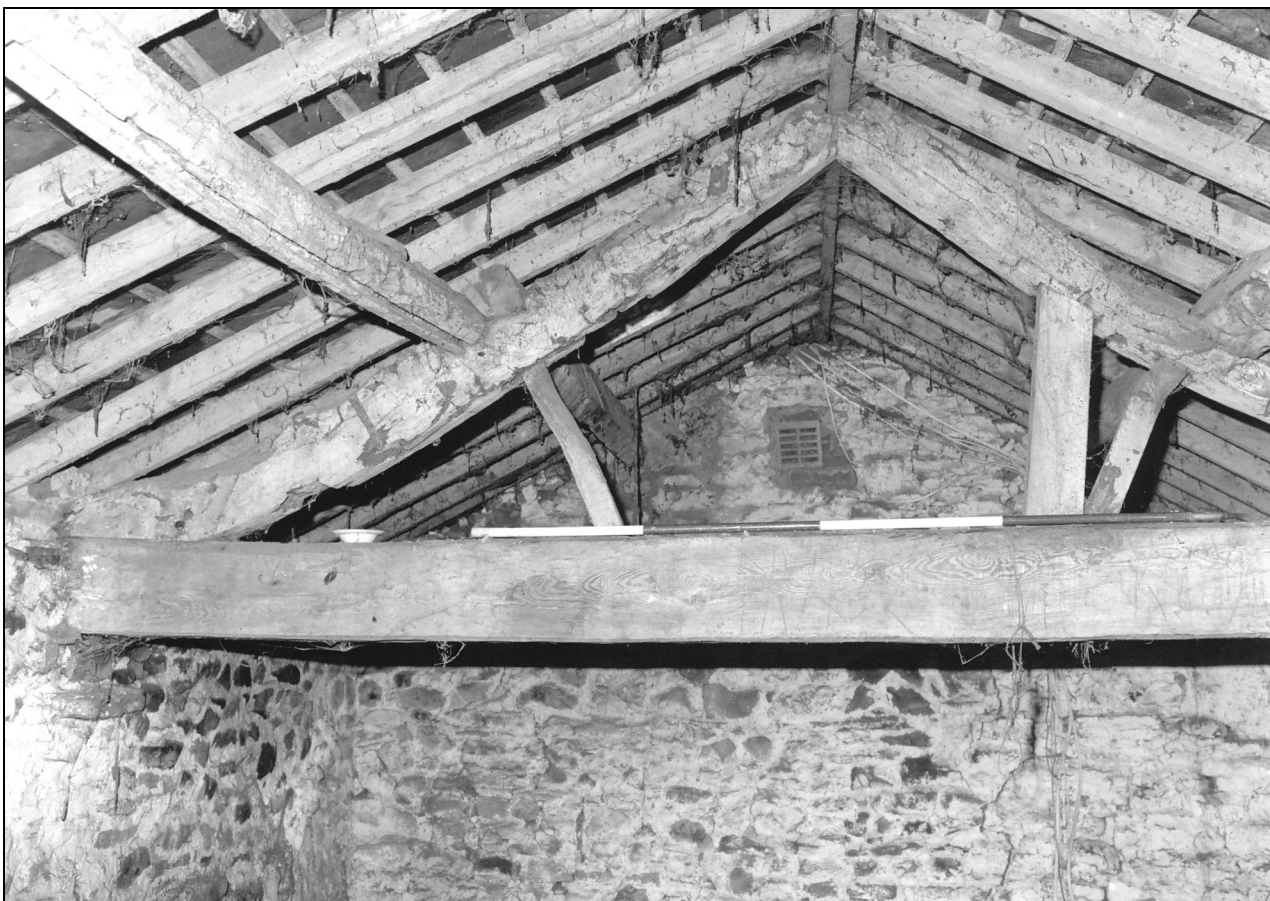
- 6.6 There is a single roof truss to the barn: it has a tie-beam of pitch pine but the other components are local hardwood, some of them re-used, probably from a cruck framed building. The principal rafters are halved and pegged at the apex with a modern ridge board; the purlins are mostly of oak and one has clear signs of previous usage (21,22). There are two slender raking struts, with a third added to the north-west side (23,24).

Photo 21: Roof truss in barn, from the south-west

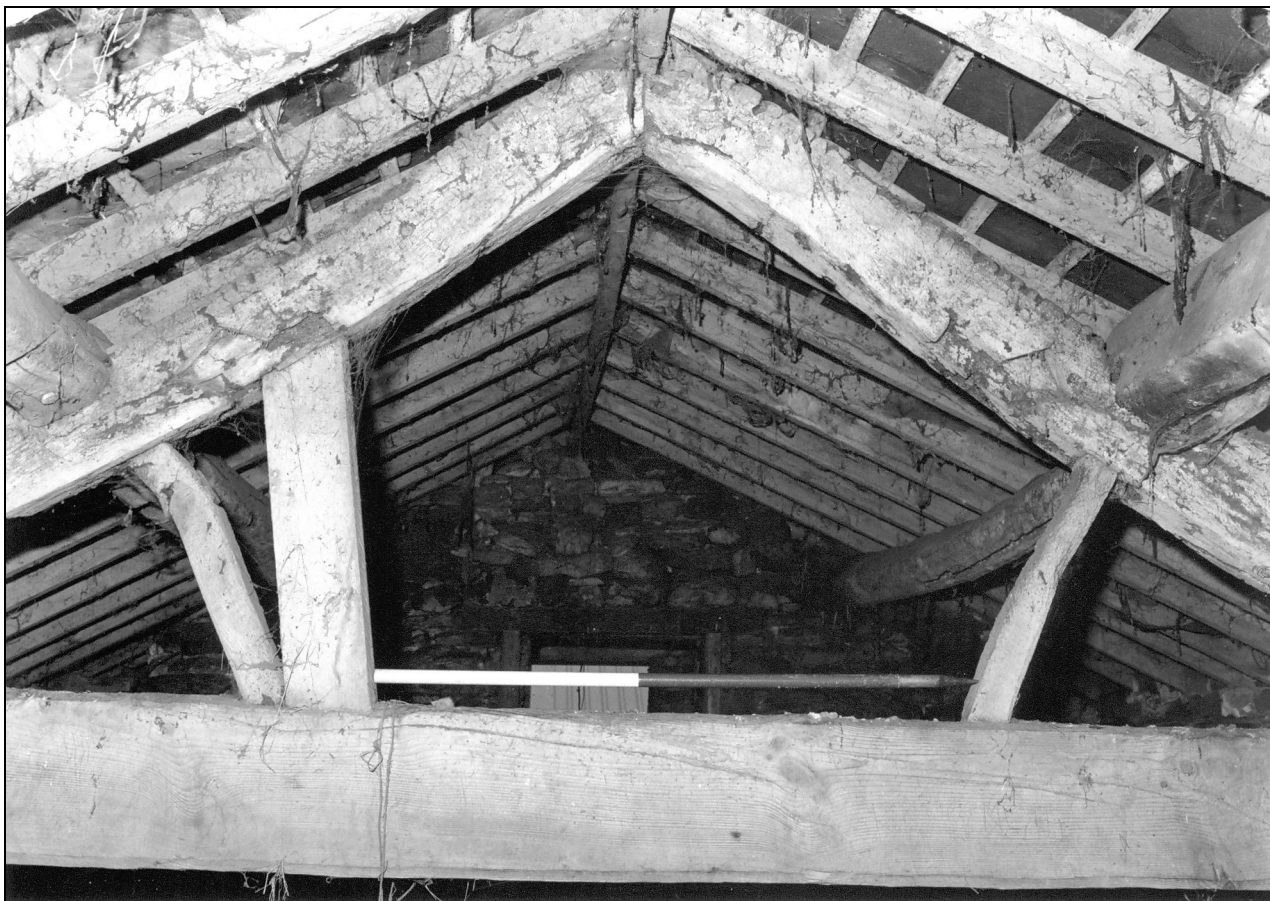
Photo 23: Centre of roof truss in barn, from the north-east

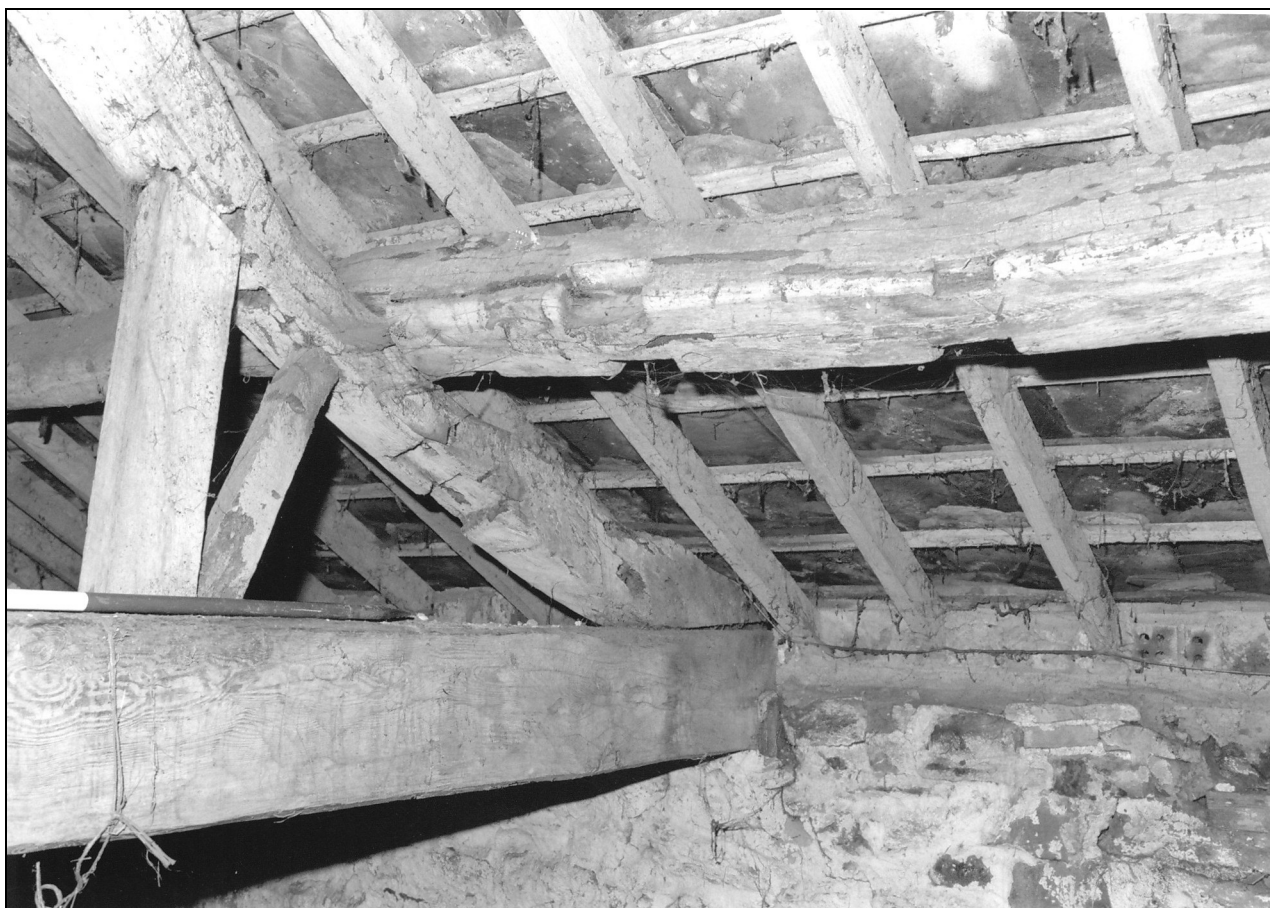
Photo 24: Detail of purlin and north end of roof truss in barn, from the east

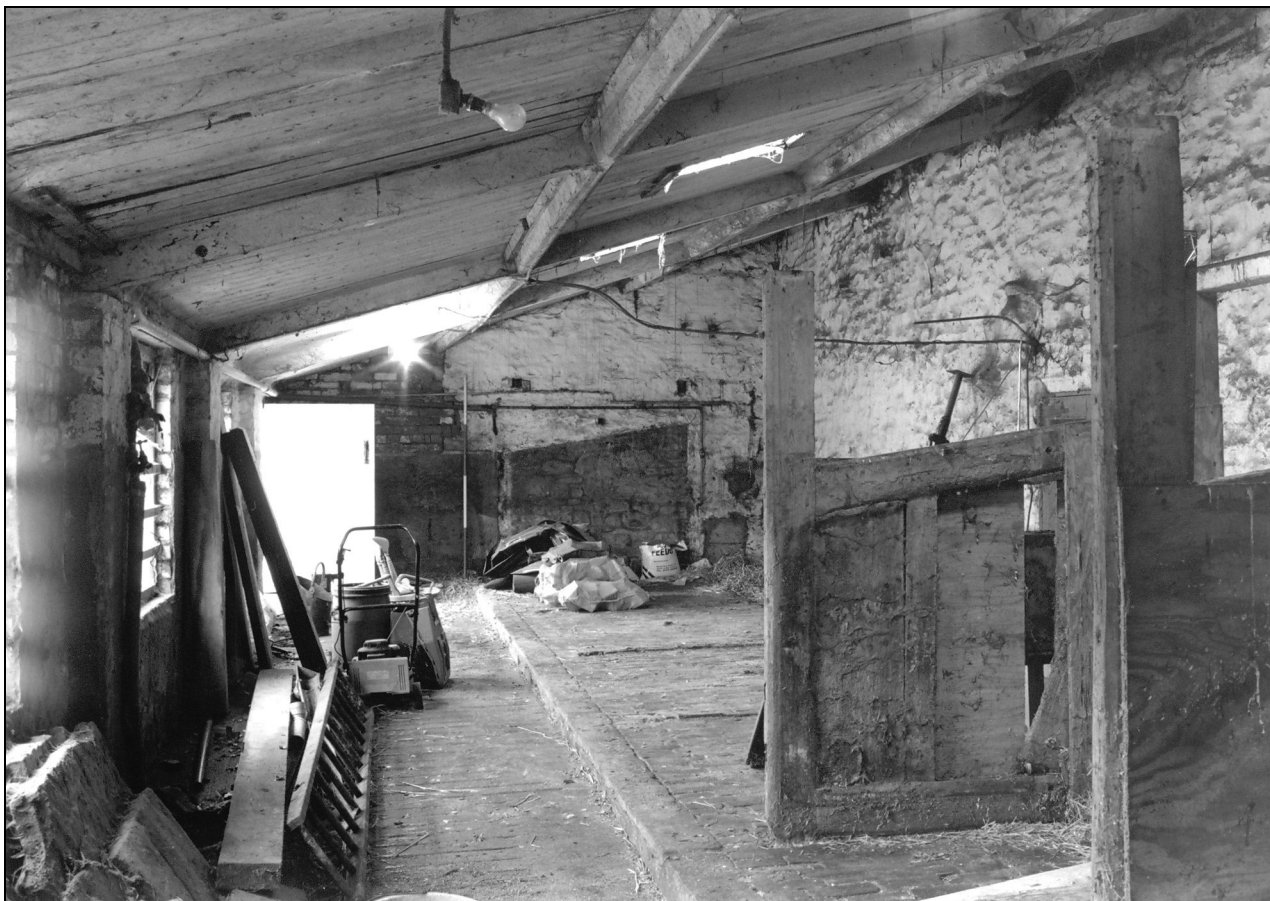
- 6.7 The interior of the shippon, built between 1910 and 1929, is laid out in characteristic fashion with a single row of stalls facing onto a feeding passage (25). The floor is of concrete with brick standings to the stalls, which accommodated thirteen animals in pairs, with a single stall at the south-west end. Only two of the stall divisions remain in place, and these are of softwood construction (26,27). The shippon roof is of lean-to design with a planked underside. It extends over the additional bay created beyond the south-west gable of the barn, where there is a small loft (28).

Photo 25: Interior of added shippon, from the south-west

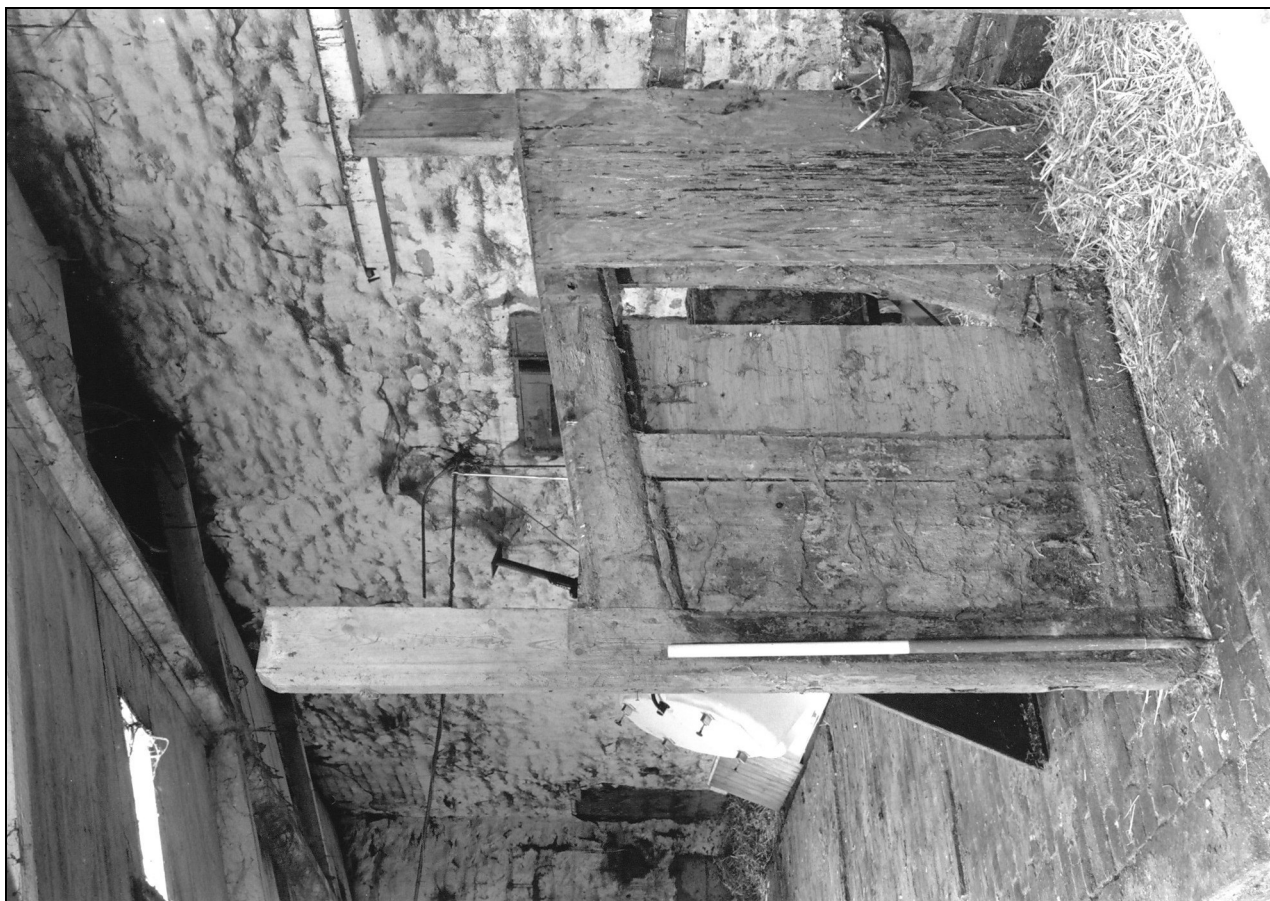
Photo 26: Detail of stall divider in added shippon, from the west
