Barn at Lower Houses
Haddings Lane
Newchurch-in-Pendle, Lancashire:
Archaeological Building Recording

Archaeological building recording was carried out in July 2006 at a barn at Lower Houses, near Newchurch-in-Pendle, Lancashire (NGR: SD 809379), for the executors of Dorothy Nutter, before the conversion of the building to residential use. The barn was originally three bays long but was extended to five bays, and has later additions; the core is likely to be of eighteenth century date. The records made include floor plans, a section and photographs, as well as a written account containing some historical information.

- 1.1 This report presents the results of archaeological building recording of a barn at Lower Houses, a farm near Newchurch-in-Pendle, Lancashire, carried out in July 2006. The work was commissioned by the executors of Dorothy Nutter, to fulfil a condition of planning consent from Pendle Borough Council, for the conversion of the building to residential use.

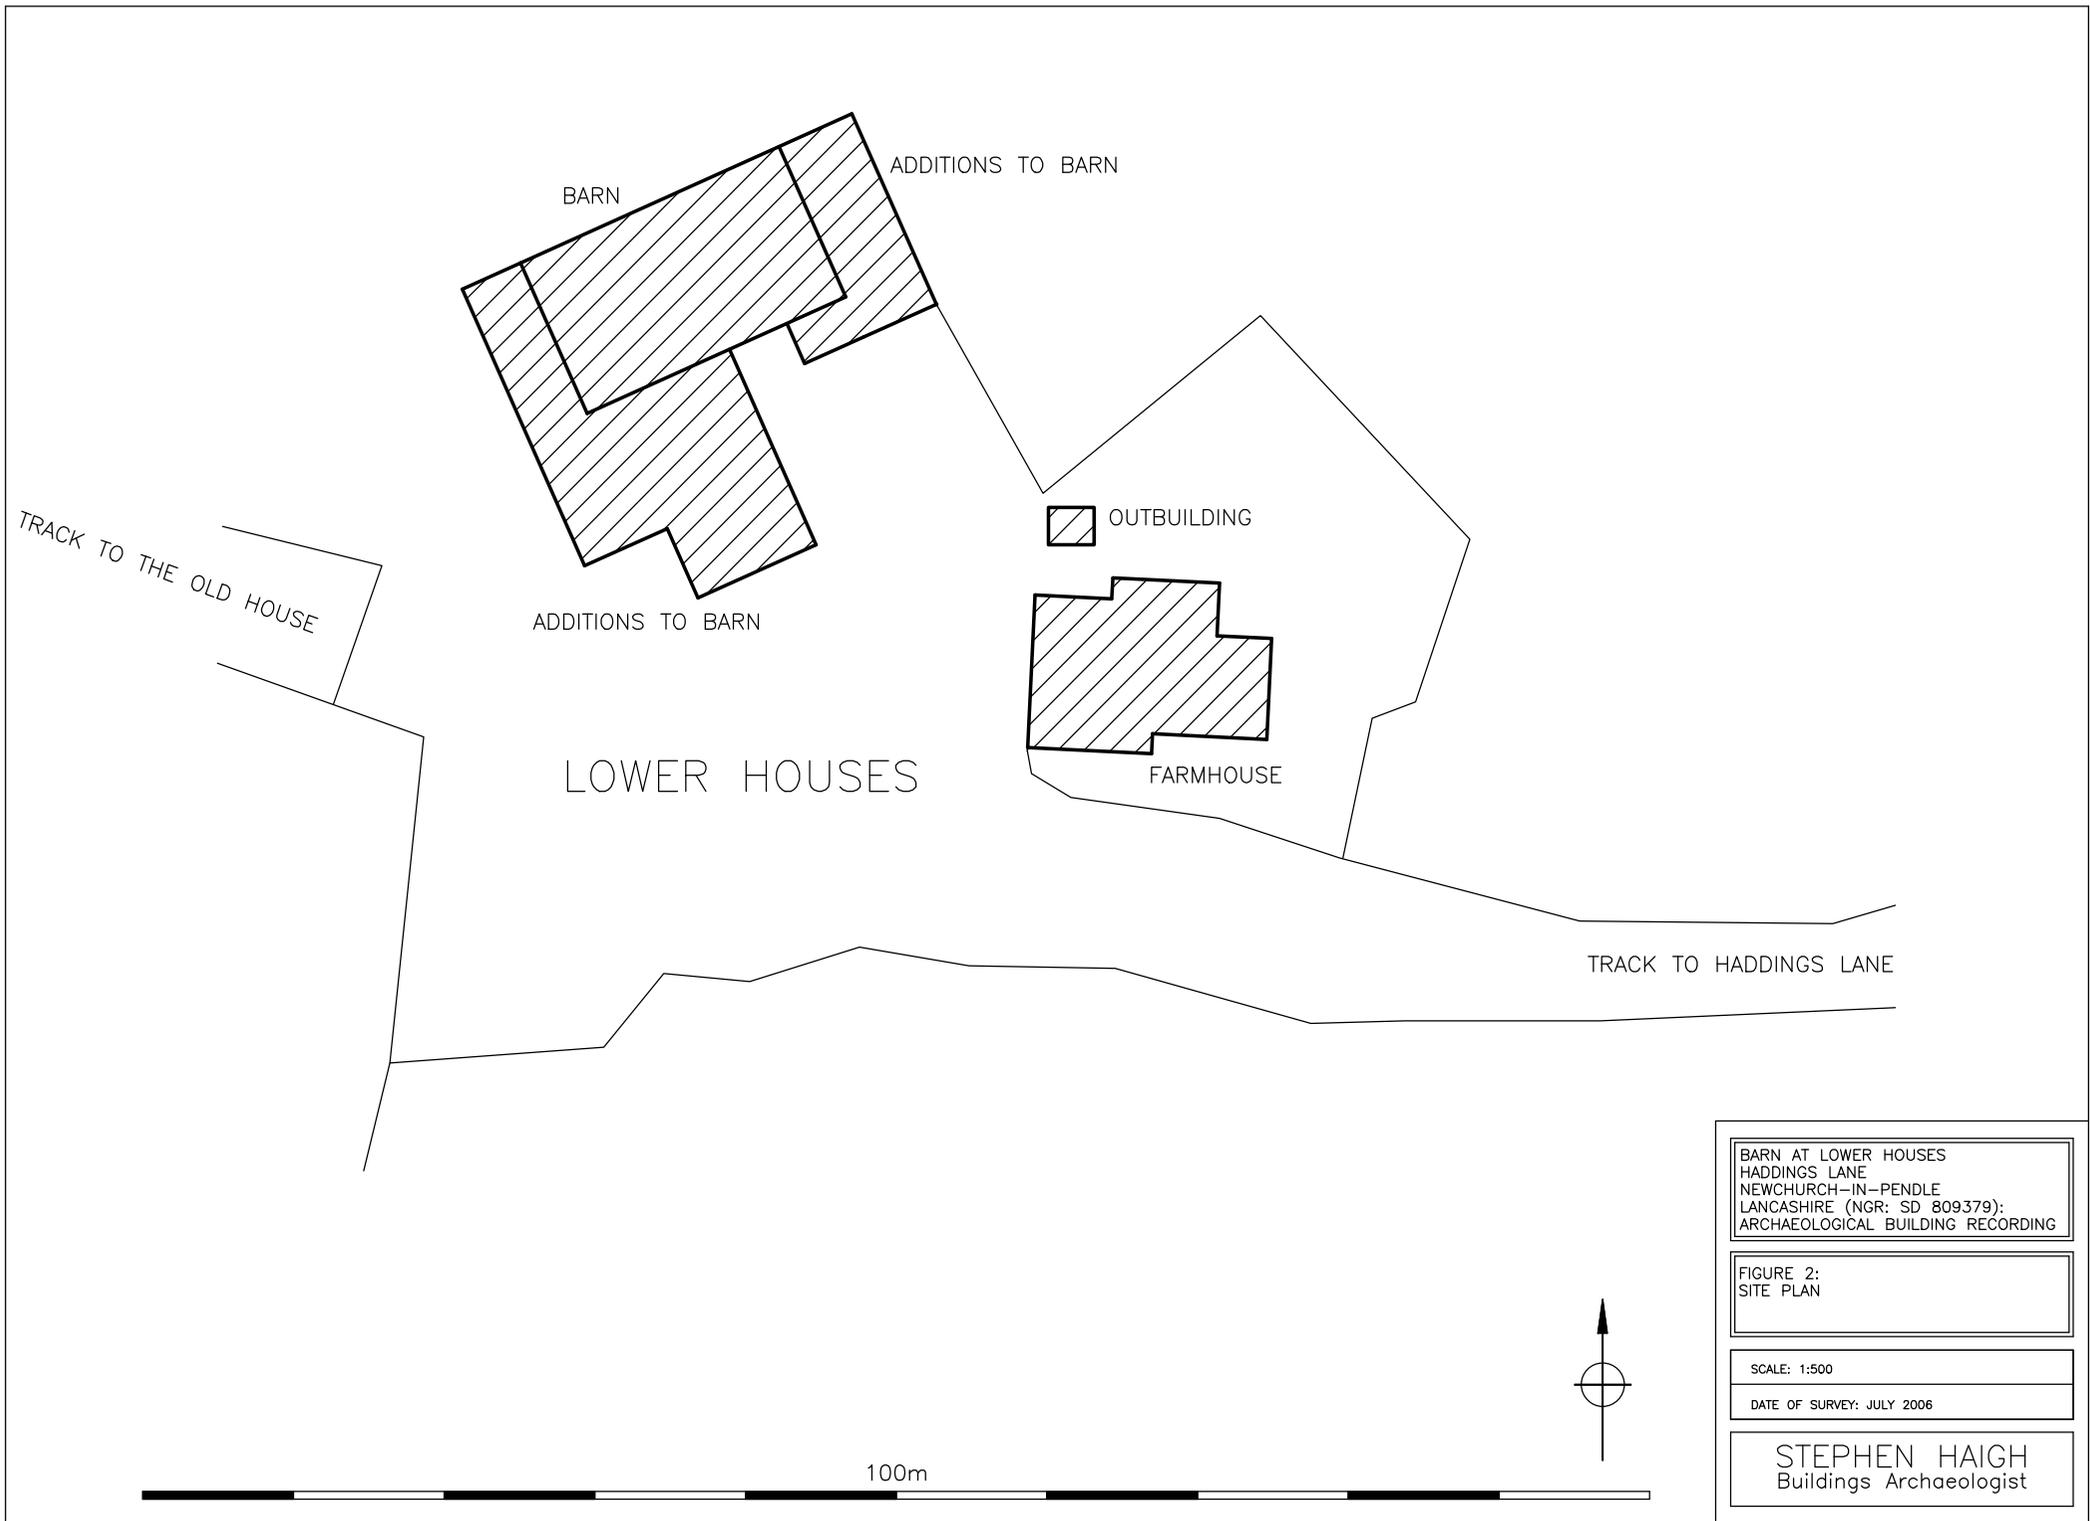
FIGURE 2:
 SITE PLAN

BARN

ADDITIONS TO BARN

FARMHOUSE

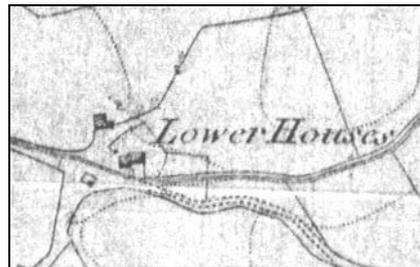
Figure 3: Extract from Ordnance Survey 1848 6" to mile map (surveyed 1844)
Sheet no: Lancashire 56

- 4.1 Little is known of the history of the barn but Ordnance Survey maps contribute to an understanding of its development. The first edition 6" to the mile map of 1848 (Figure 3) shows the farmhouse and barn named as "Lower Houses", with the barn depicted as an L-shaped structure. The larger scale 1:2500 map of 1893 (Figure 4i) shows the barn as a rectangular building facing a yard to its south-east, and measuring approximately 18m long and 12m wide, ie with different proportions from those shown on the earlier map. The 1912 edition shows no change (Figure 4ii) but by 1932 the building had been extended by the addition of a range along the south-west end (Figure 4iii).

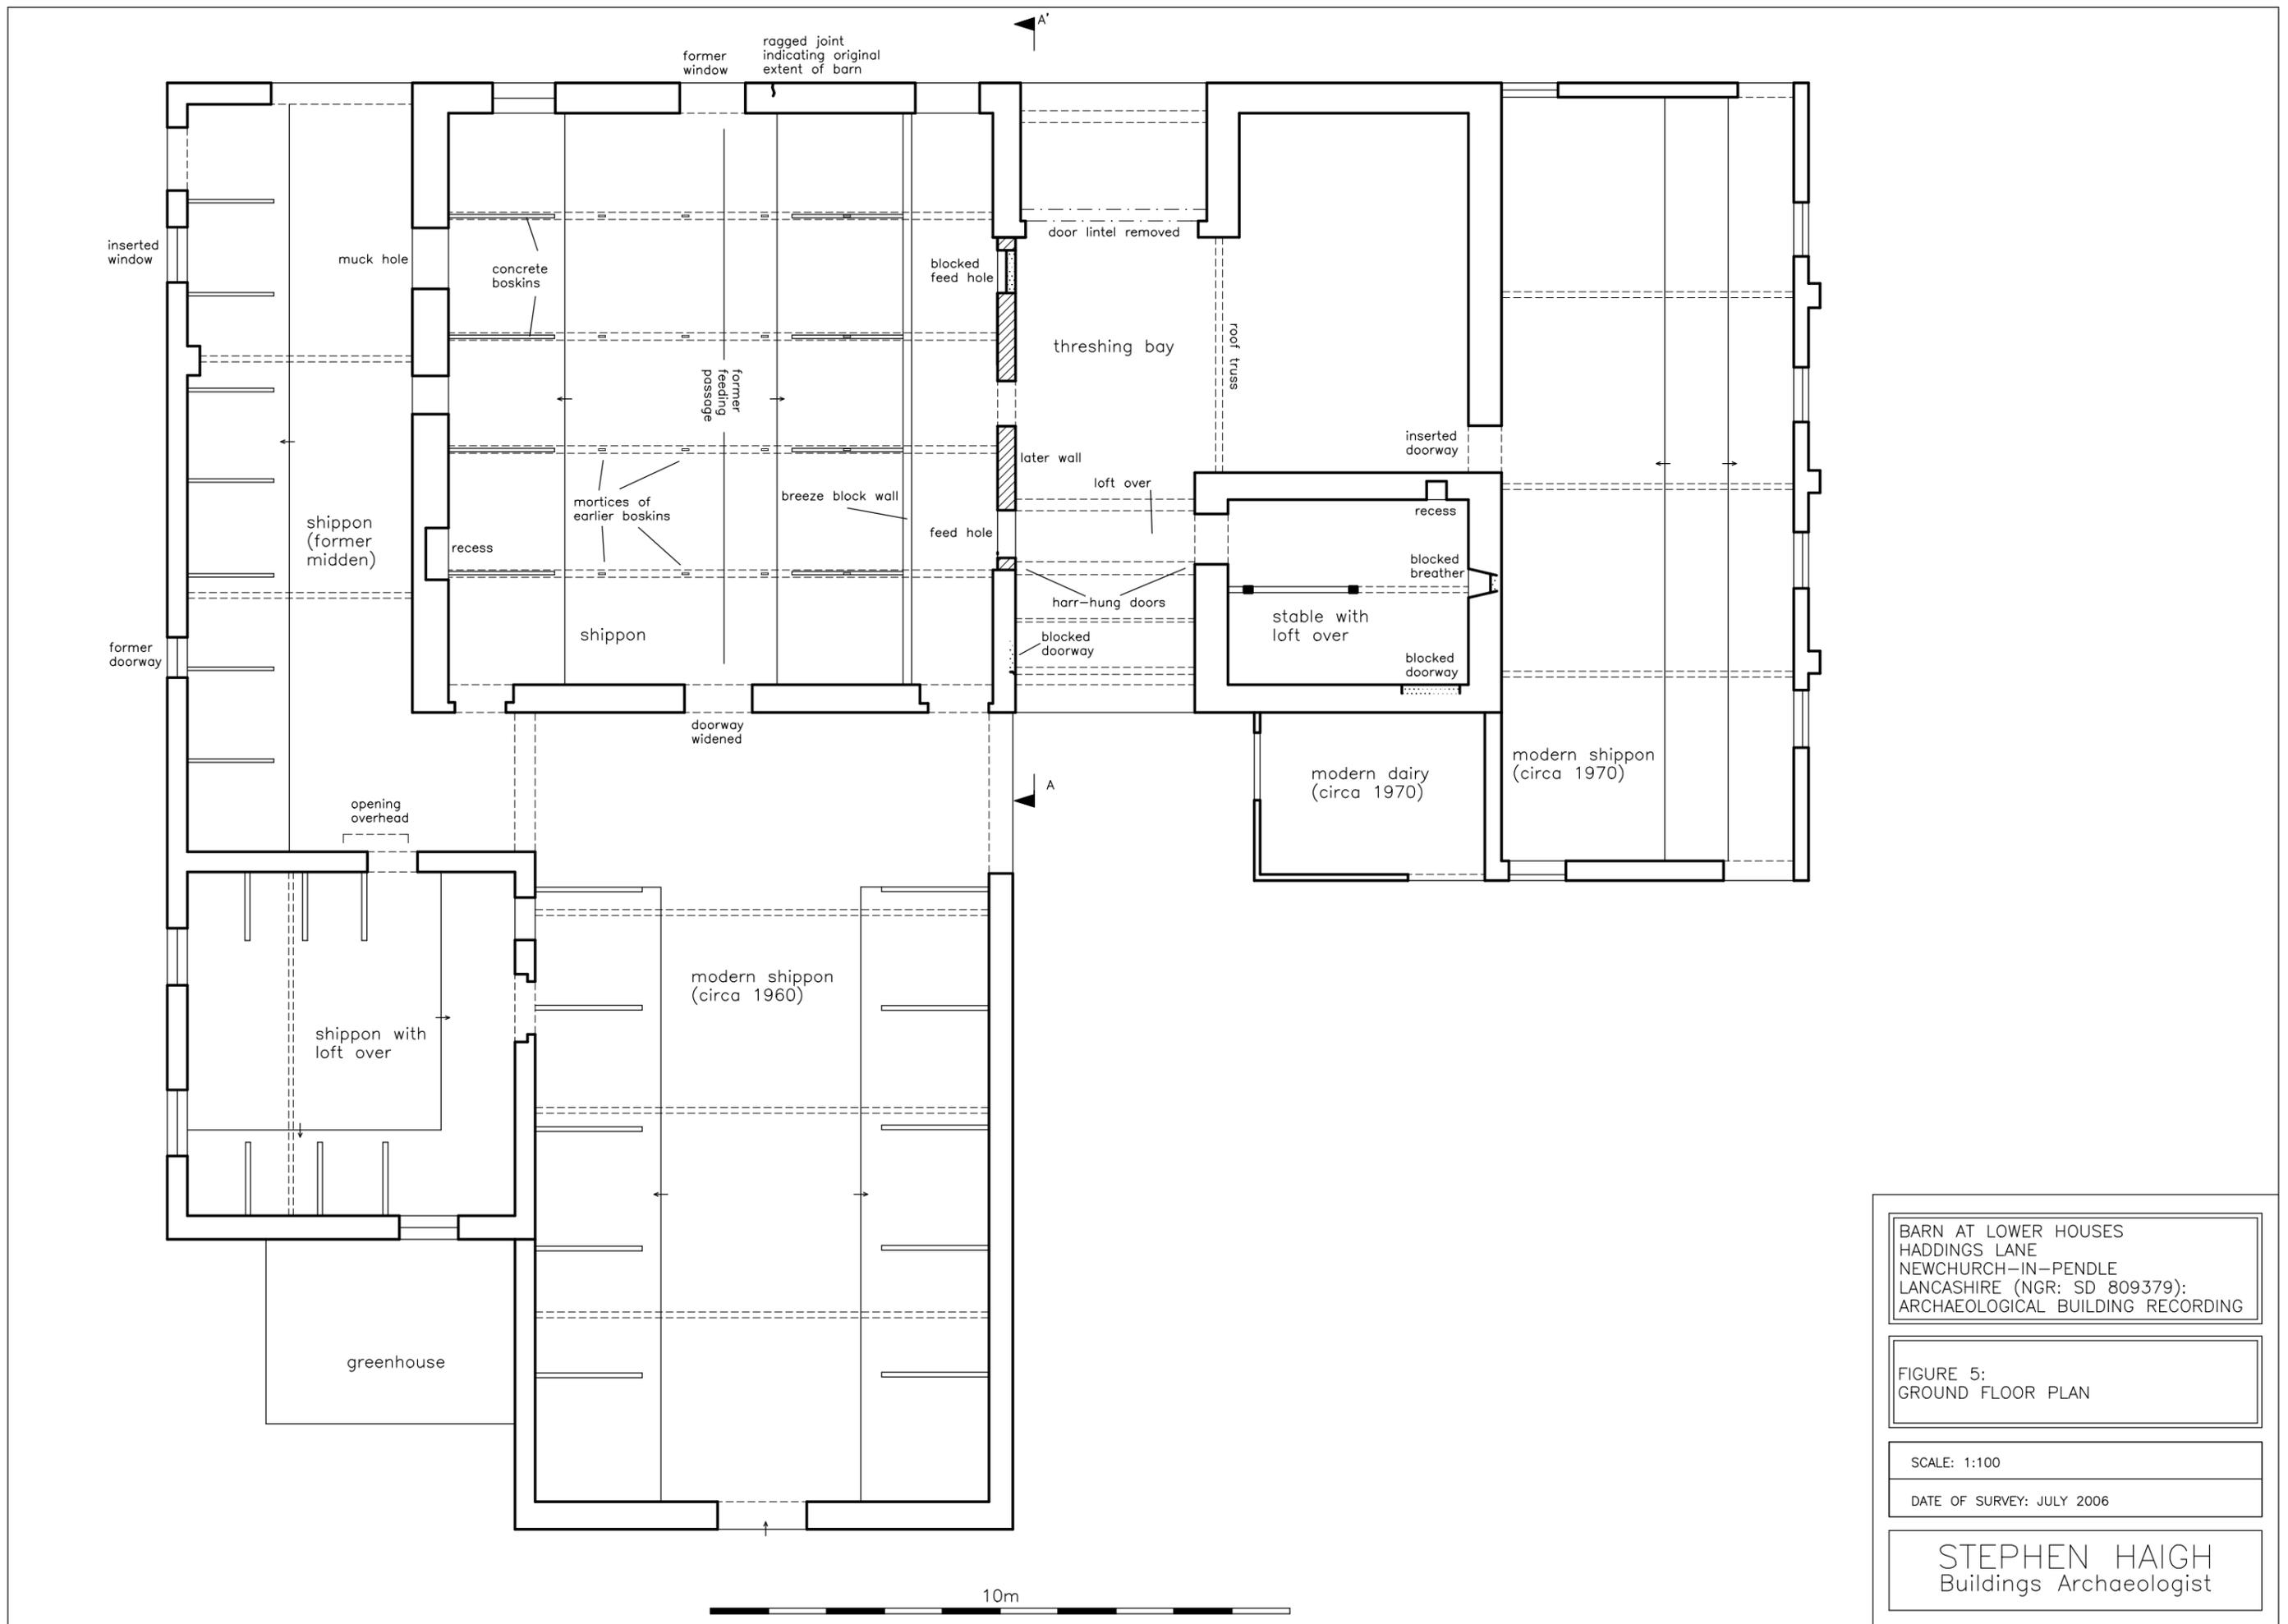
FIGURE 5:
 GROUND FLOOR PLAN

- 5.1 The archaeological building recording took place on 21 July 2006, and in accordance with a method statement approved by the Lancashire County Archaeology Service. It involved the production of floor plans and a section drawing of the building, showing all significant archaeological detail, and employing conventions based on those specified by English Heritage¹. The plans are based on a survey by Frank Belshaw.

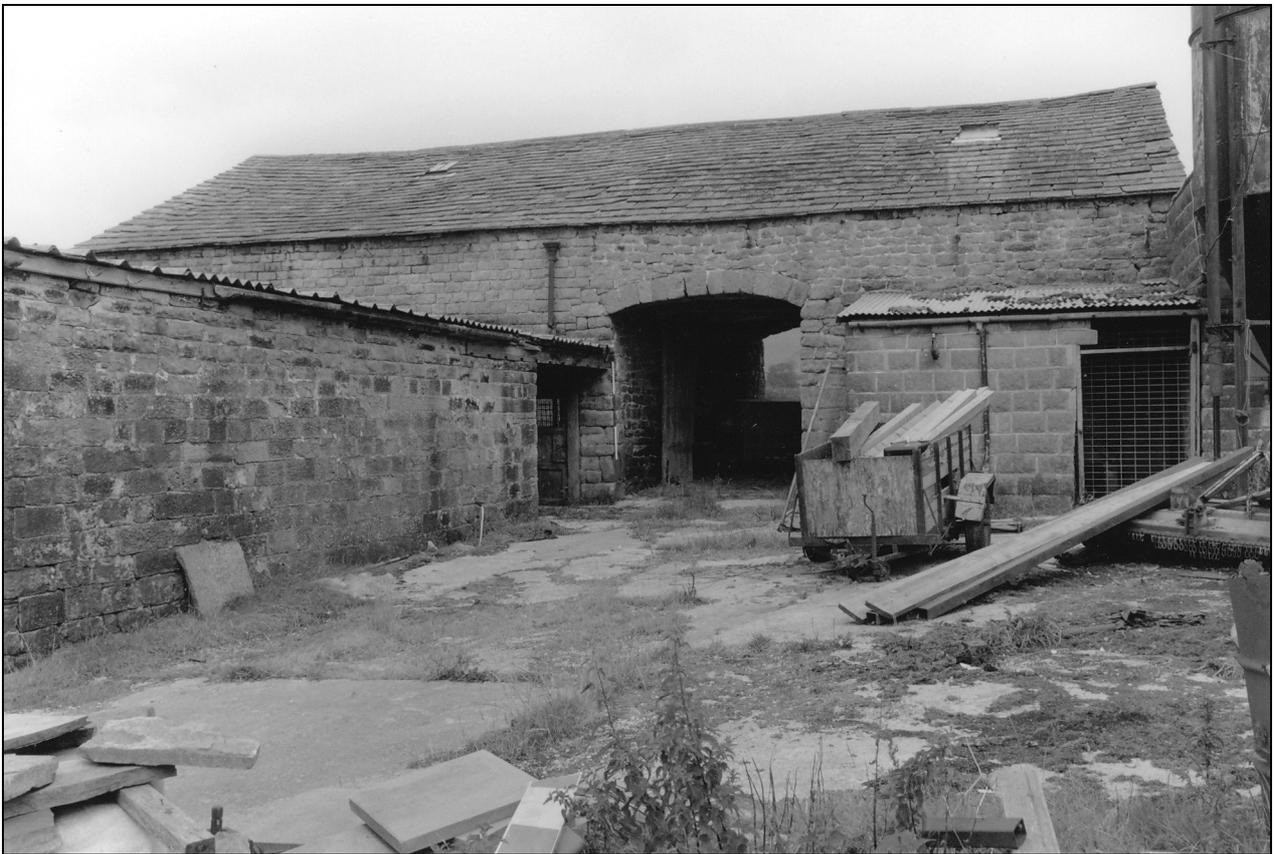
Photo 2: The barn, from the south-east

- 6.2 The front elevation of the main part of the building is largely hidden by later accretions to either side of the arched cart entrance (2), but this side of the building has two types of masonry. Around the cart entrance, and to the right of it, the walling is of squared gritstone rubble, laid in rough courses with prominent watershot profile and with large quoins (3), with the arch itself composed of plain voussoirs. At a high level in this wall just to the left of this doorway, is a ragged joint with more regularly squared and coursed stonework to the left, which is clearly later, although in this middle bay appears to represent rebuilding rather than extension. Beneath the roof of the later shed at this end of the elevation are three ground floor doorways (4), contemporary with the more modern stonework: they appear all to have had plain monolithic jambs originally, with the middle entrance having given access to a feeding passage within a shippon, and the two flanking doorways having led into the standings which faced onto this passage. To the right of the cart entrance within the modern lean-to sheds at the other end of the building, the elevation is rendered and no features are visible, although a blocked doorway to the stable can be identified from within the barn.

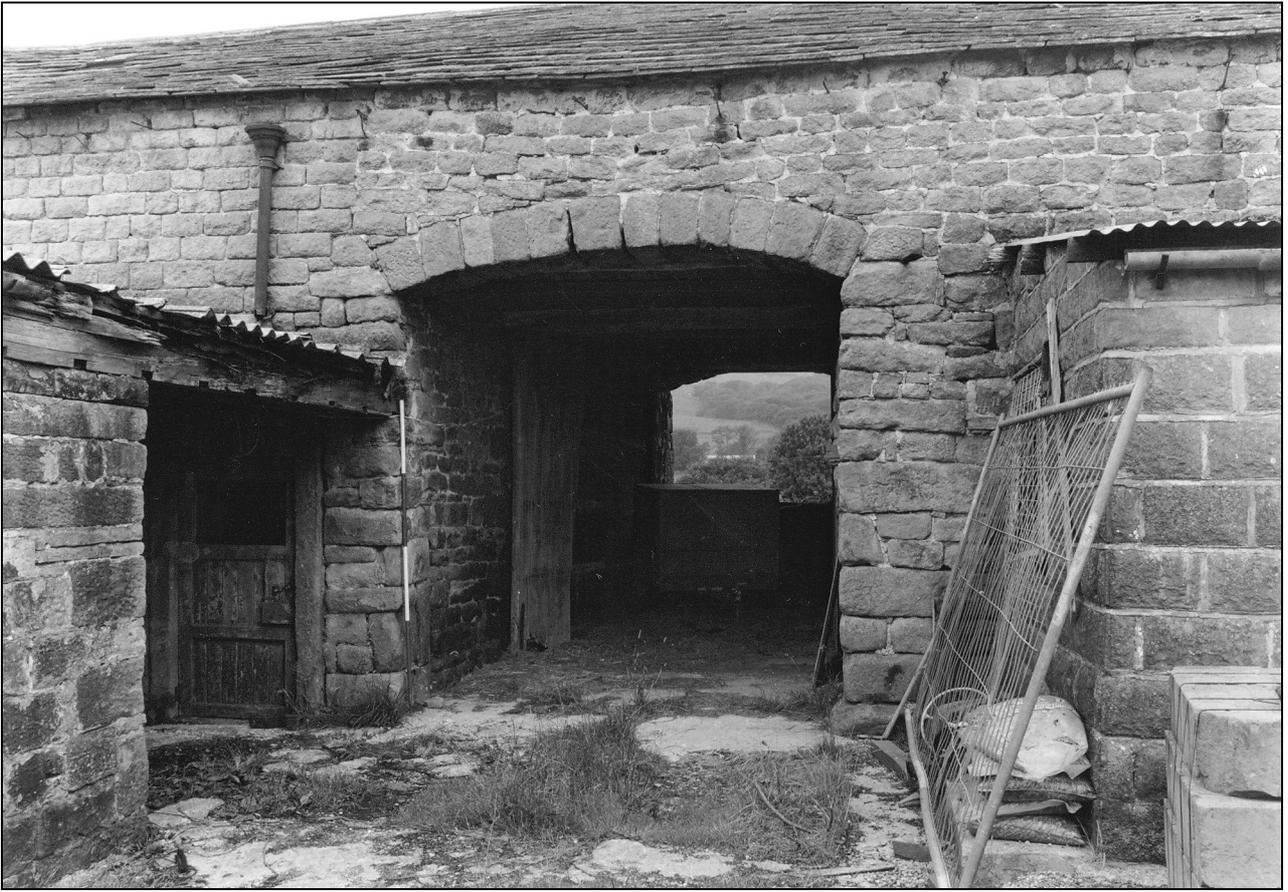
Photo 3: Cart entrance in south-east elevation, between later additions

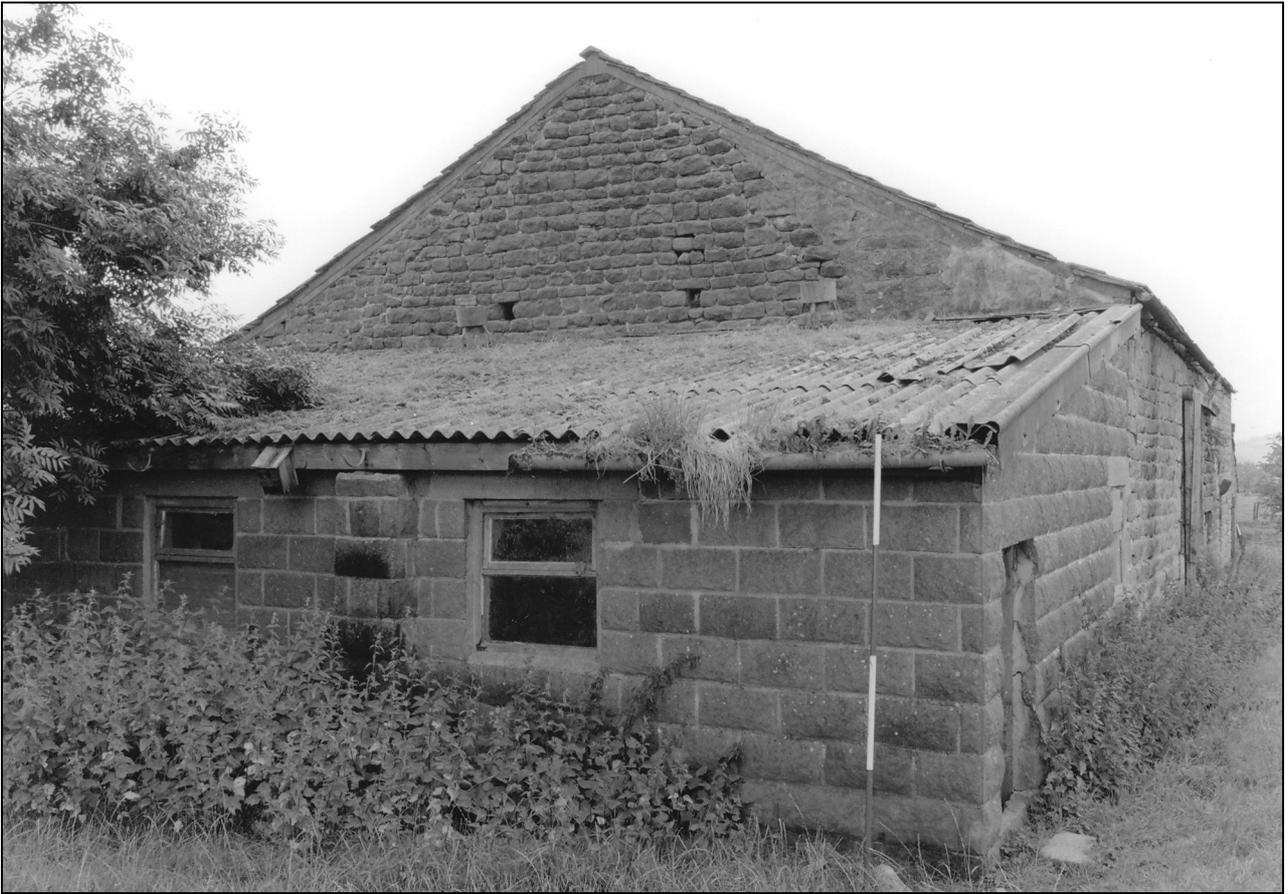
- 6.3 Similarly the north-east gable of the barn is largely obscured by modern render within the adjoining lean-to, but above the roof of this (5) an earlier roof-line can be discerned, showing that the barn had a steeper roof and narrower width at one time (6), characteristic of a cruck-framed building. The earlier masonry within this gable is of coursed rubble similar to that elsewhere however, with the later stonework above being more random in nature.

Photo 6: North-east gable showing earlier roof-line, and modern building below

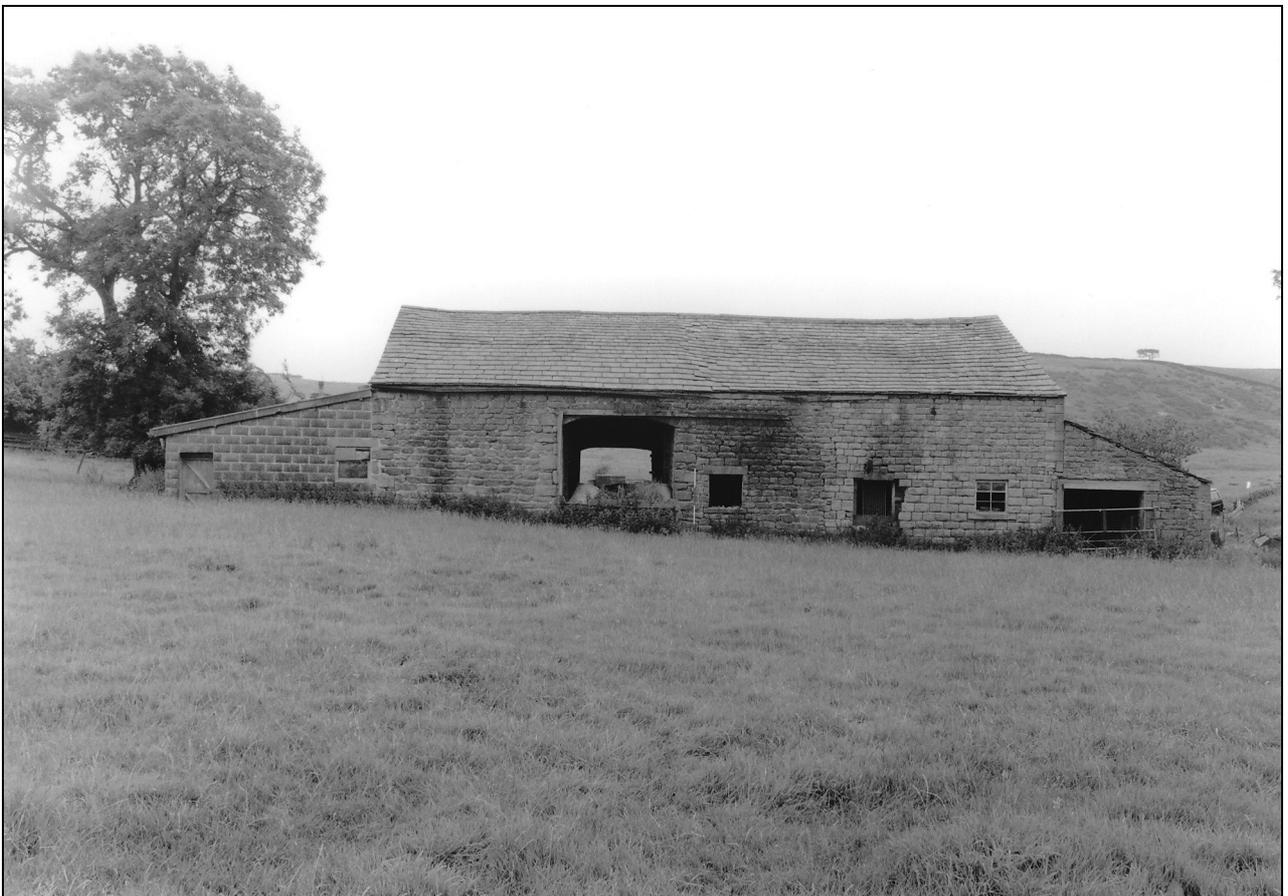
- 6.4 The barn's north-west elevation faces out onto the field (7,8), and is not masked by additions; it has a similar cart entrance with segmental arch of gritstone voussoirs, which would have been central to the original three bays (9,10). To the right of this is a window opening, probably inserted, and beyond this a ragged joint representing the approximate position of the original south-west gable (11), with the masonry changing to a more evenly coursed, better squared stone comparable to that on the south-east side, and the quoins at the end are very regularly shaped. The doorway and window within this area of masonry serve the shippon.

Photo 7: General view of the barn from the north-west

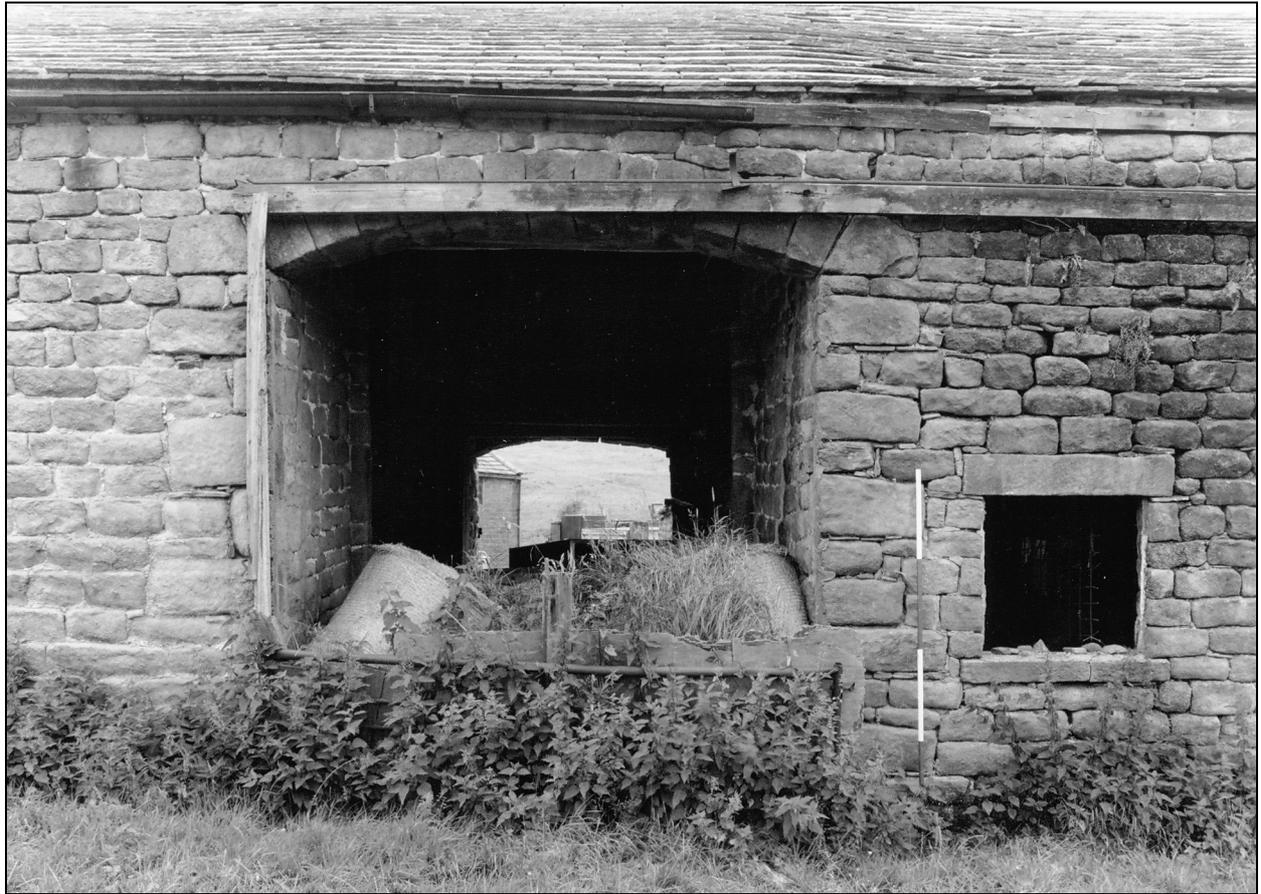
Photo 10: Cart entrance in north-west elevation

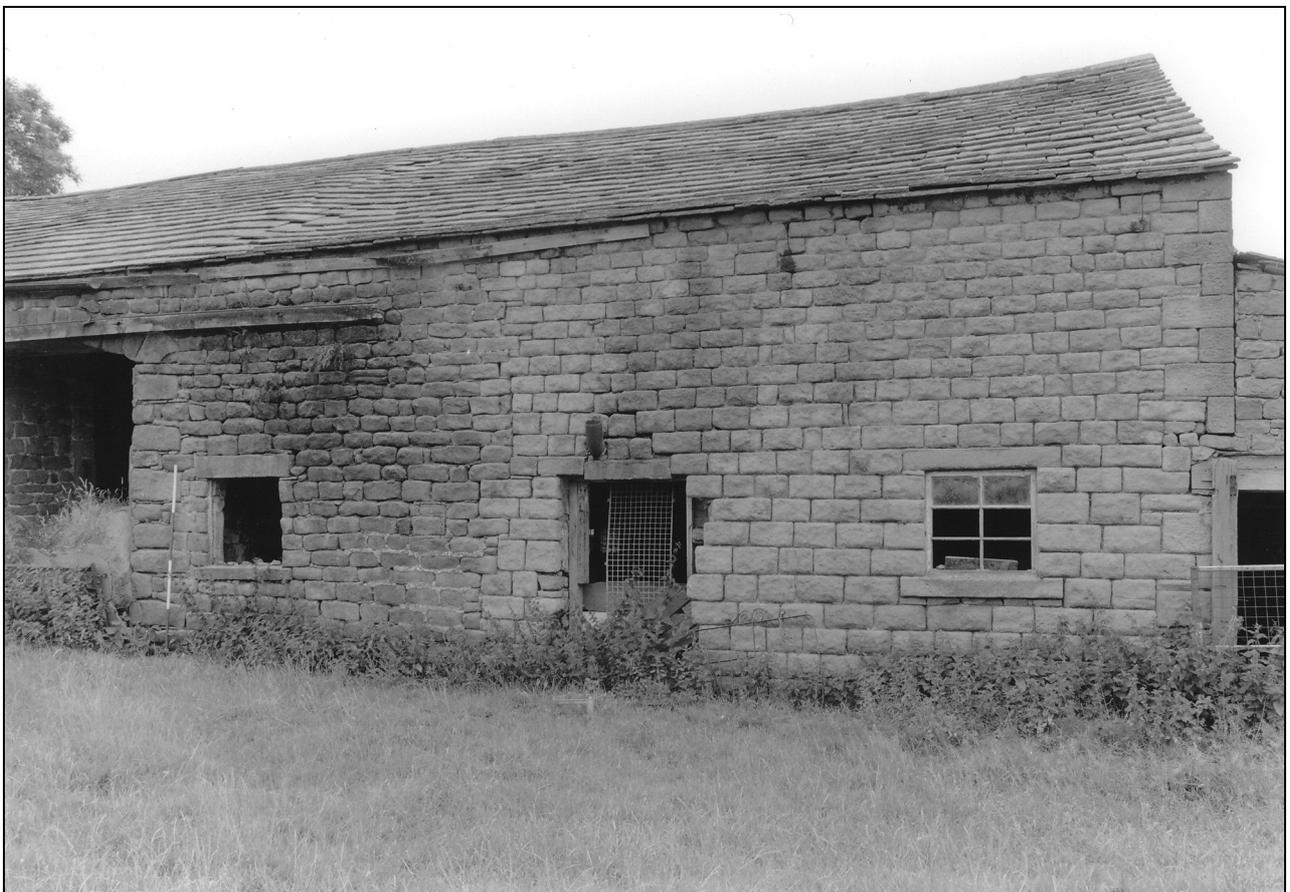
Photo 11: Right-hand part of north-west elevation, showing change in stonework

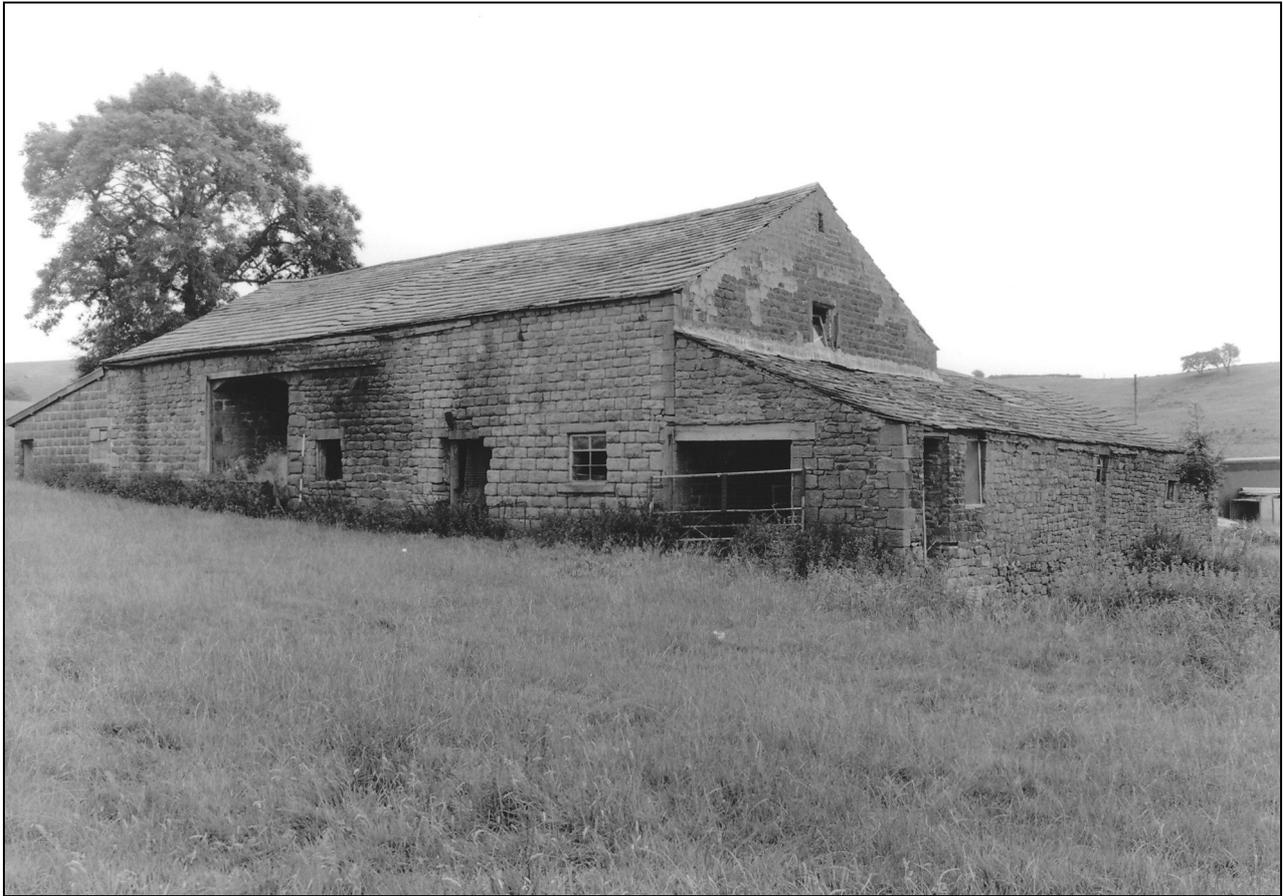
- 6.5 The main building's south-west gable has been built against by a single storey lean-to which maps show to have been added between 1910 and 1932 (12). Within this the regular, coursed stonework of the gable is visible (13) and contains two openings, both windows or muck holes, with plain stone dressings (14). Above the lean-to roof are a forking hole and a narrow, plain owl hole.

Photo 12: General view of the barn from the west

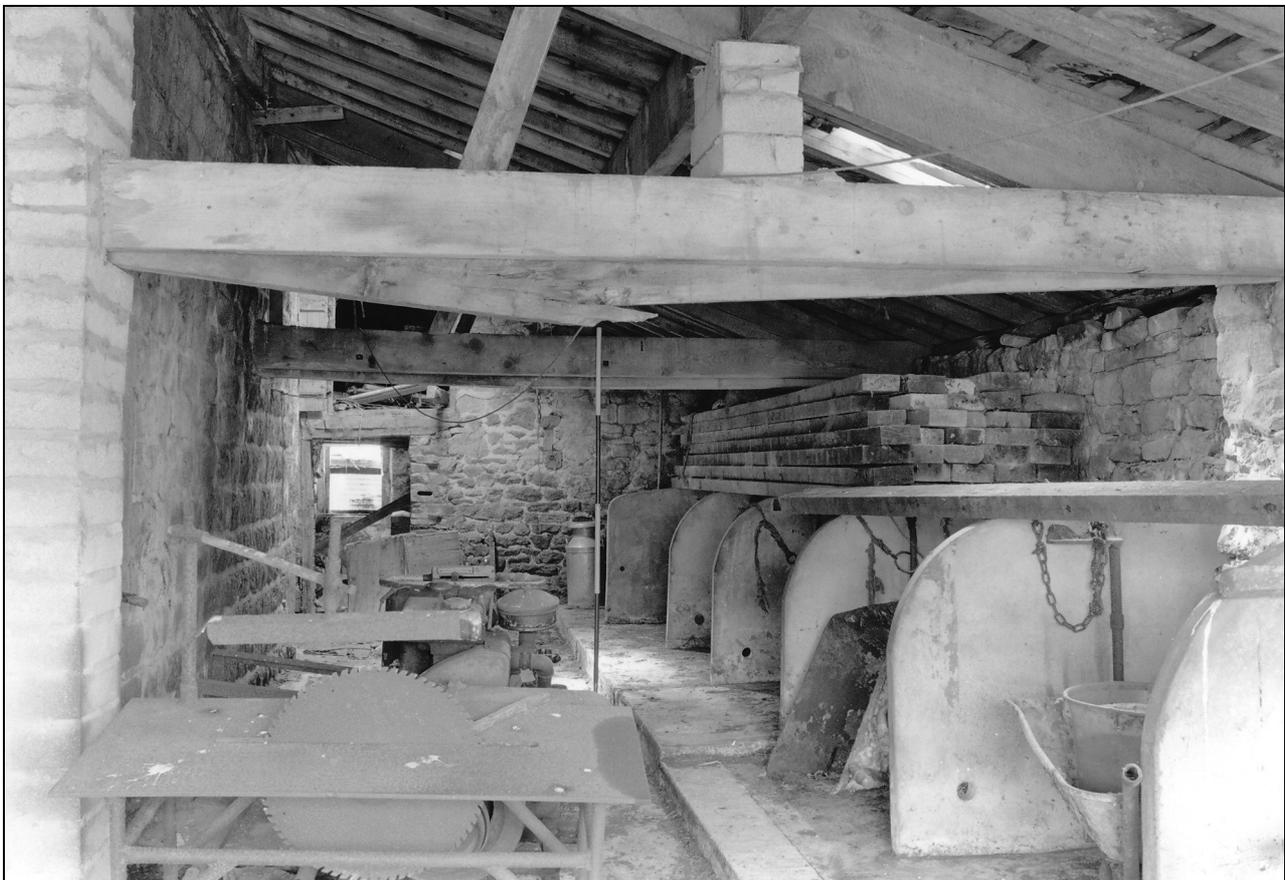
Photo 13: Interior of lean-to at south-west gable

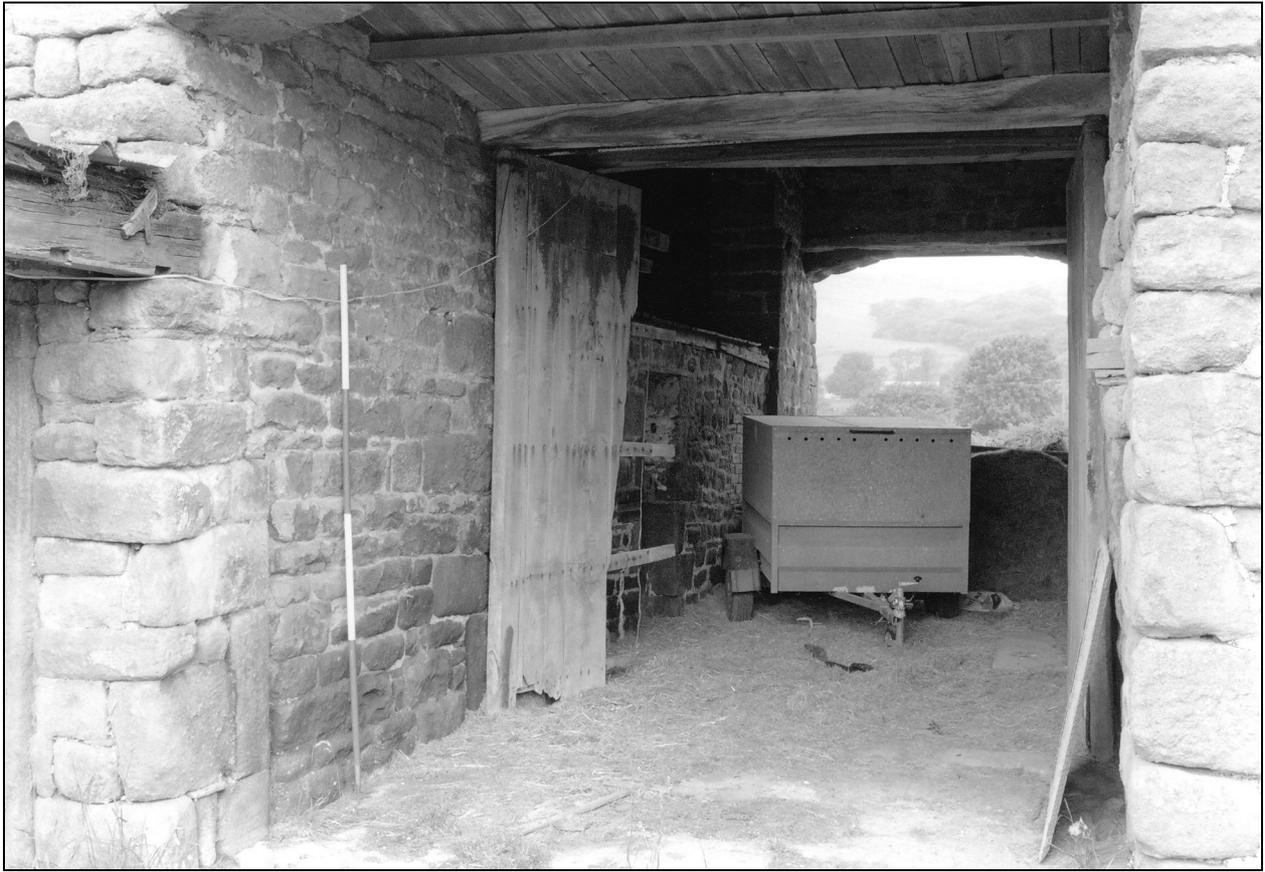
- 6.6 The cart entrance in the south-east elevation of the barn leads into a threshing bay with the other cart entrance directly opposite (15); the floor of this area is obscured. Short cross-walls project some way into the building to create “porches”, with the doors set inside. In the south-east side the doors remain in place and are harr-hung, the hinges at the top set into a cross-beam which also supports a loft, and outside the doors, but within the porch, a chamfered door jamb indicates an earlier opening to the south-west, with a plain opening to a stable opposite. The different character of these openings suggest the cross-walls have been subject to some rebuilding. In the north-west porch the arrangement is less well-preserved, with the loft and doors having been removed (16).

Photo 15: View into threshing bay, through south-east cart entrance

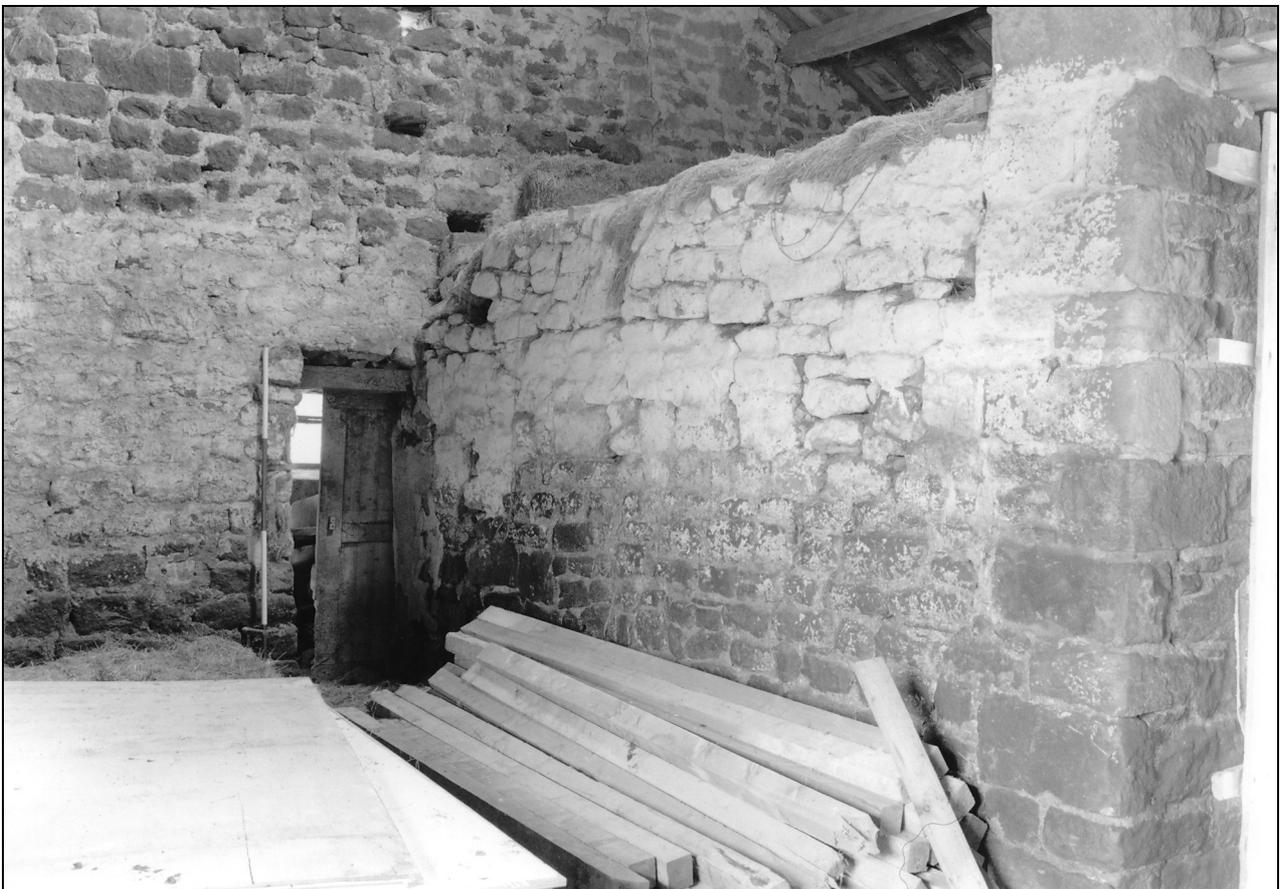
- 6.7 The single bay to the north-east of the threshing bay contains a storage area open to the roof (17), with a stable at one side contained within a stone wall which also supports a hay loft (18). At one time the stable, which is for two horses, would have been accessible through the doorway in the south-east elevation. It contains a single stall divider, constructed from planed softwood and probably of early twentieth century date (19,20), as well as a wall recess and blocked breather (21).

Photo 18: Wall enclosing stable in south-east corner of barn

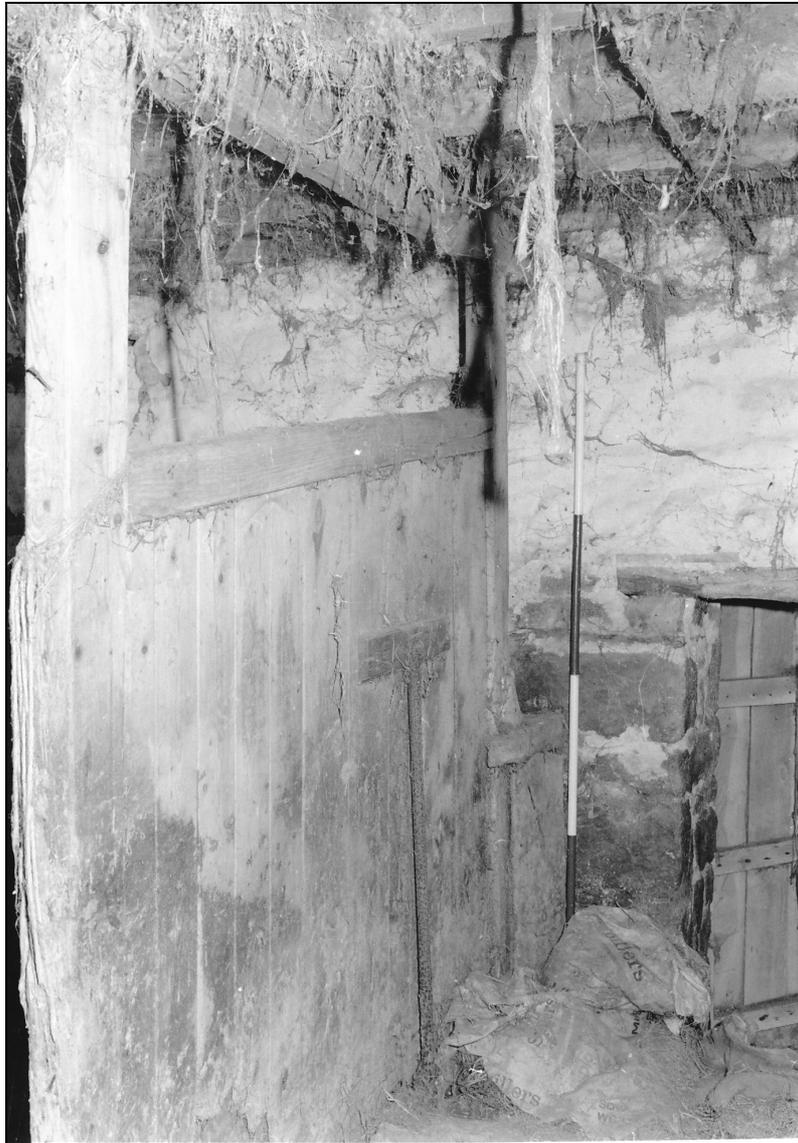
Photo 20: Stall divider in stable, from the east

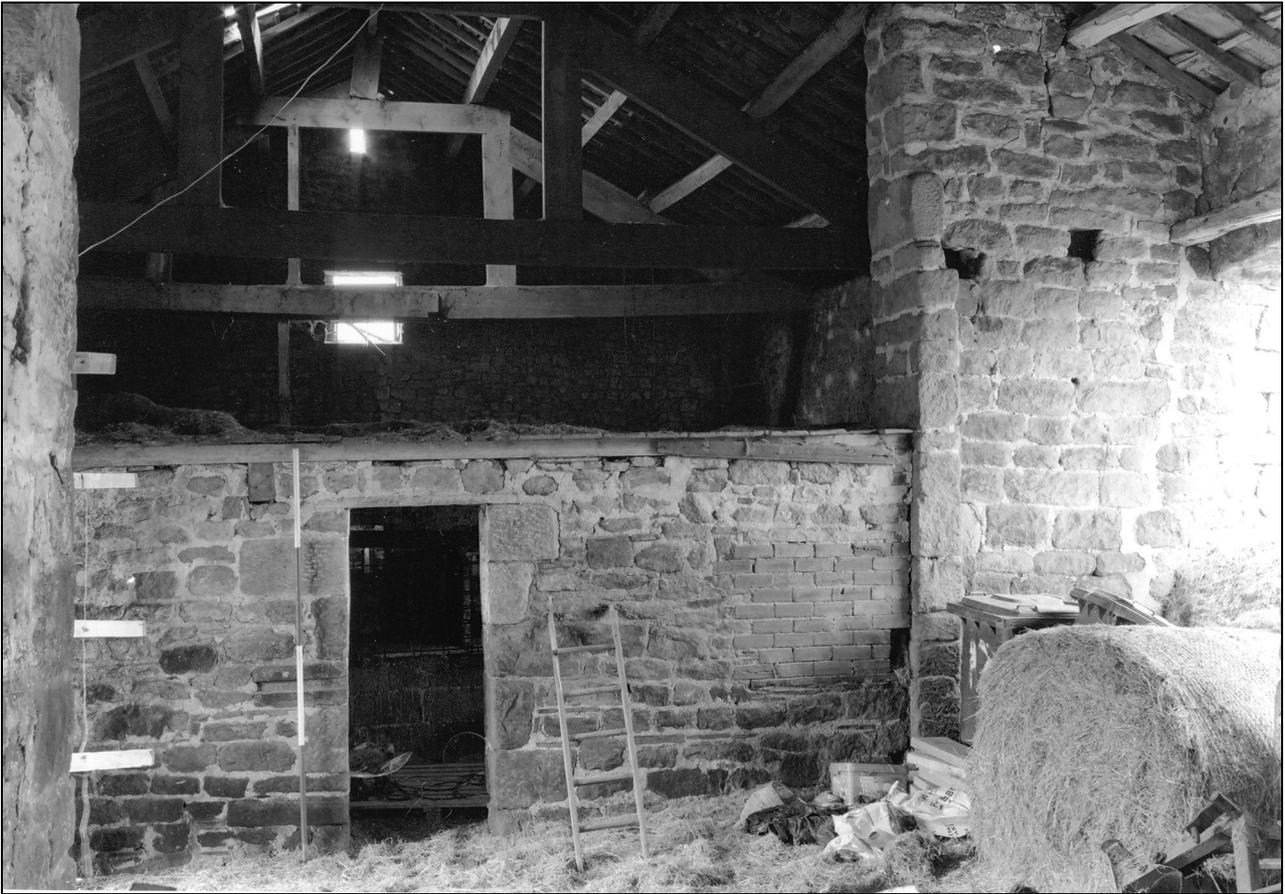
- 6.8 On the south-west side of the threshing bay a secondary, rubble wall linking the porch walls encloses a shippon and supports the edge of a hay loft extending to the south-west gable (22,23). The wall contains a central doorway with feed holes to either side (one of them now infilled with brickwork), which suggest an earlier arrangement within the shippon of a single row of standings facing north-west towards the threshing bay. The present arrangement, which dates from the early or mid twentieth century, comprises two rows of outward-facing standings separated by concrete boskins (24-26), but these clearly replaced another layout, as indicated by the mortices for timber posts in the beams overhead. That arrangement comprised a central feeding passage with standings facing onto it, but was superseded by the present one, which was believed to be less likely to allow transmission of disease. It is thought likely that the earliest shippon layout (with a single row of standings) was used until the extension of the barn to five bays.

Photo 22: Threshing bay and cross-wall to shippon, from the north-east

Photo 23: Threshing bay and cross-wall to shippon, from the south-east
