Barn at Lower Houses
Haddings Lane
Newchurch-in-Pendle, Lancashire:
Archaeological Building Recording

Archaeological building recording was carried out in July 2006 at a barn at Lower Houses, near Newchurch-in-Pendle, Lancashire (NGR: SD 809379), for the executors of Dorothy Nutter, before the conversion of the building to residential use. The barn was originally three bays long but was extended to five bays, and has later additions; the core is likely to be of eighteenth century date. The records made include floor plans, a section and photographs, as well as a written account containing some historical information.

- 1.1 This report presents the results of archaeological building recording of a barn at Lower Houses, a farm near Newchurch-in-Pendle, Lancashire, carried out in July 2006. The work was commissioned by the executors of Dorothy Nutter, to fulfil a condition of planning consent from Pendle Borough Council, for the conversion of the building to residential use.

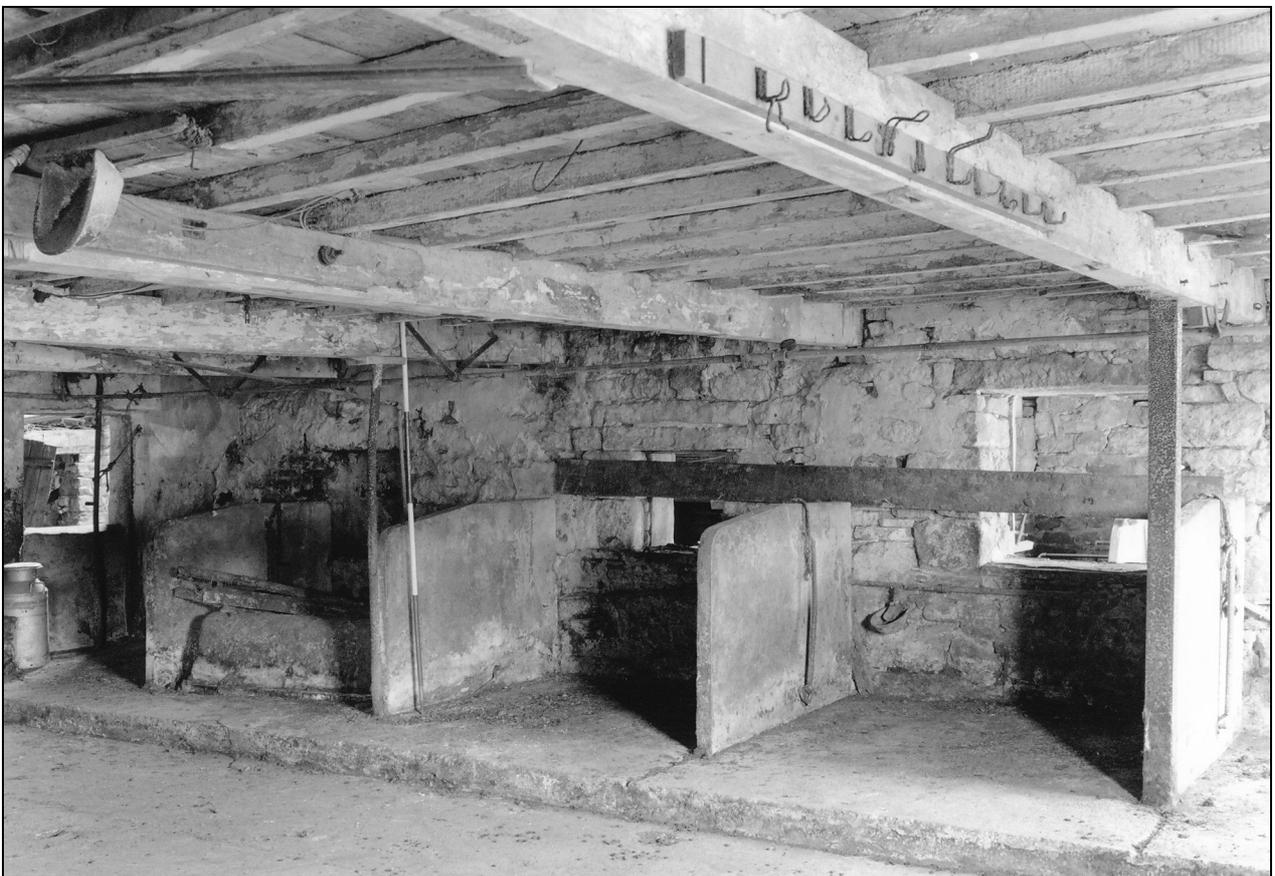
- 6.8 On the south-west side of the threshing bay a secondary, rubble wall linking the porch walls encloses a shippon and supports the edge of a hay loft extending to the south-west gable (22,23). The wall contains a central doorway with feed holes to either side (one of them now infilled with brickwork), which suggest an earlier arrangement within the shippon of a single row of standings facing north-west towards the threshing bay. The present arrangement, which dates from the early or mid twentieth century, comprises two rows of outward-facing standings separated by concrete boskins (24-26), but these clearly replaced another layout, as indicated by the mortices for timber posts in the beams overhead. That arrangement comprised a central feeding passage with standings facing onto it, but was superseded by the present one, which was believed to be less likely to allow transmission of disease. It is thought likely that the earliest shippon layout (with a single row of standings) was used until the extension of the barn to five bays.

Photo 24: Interior of main shippon, from the north-east

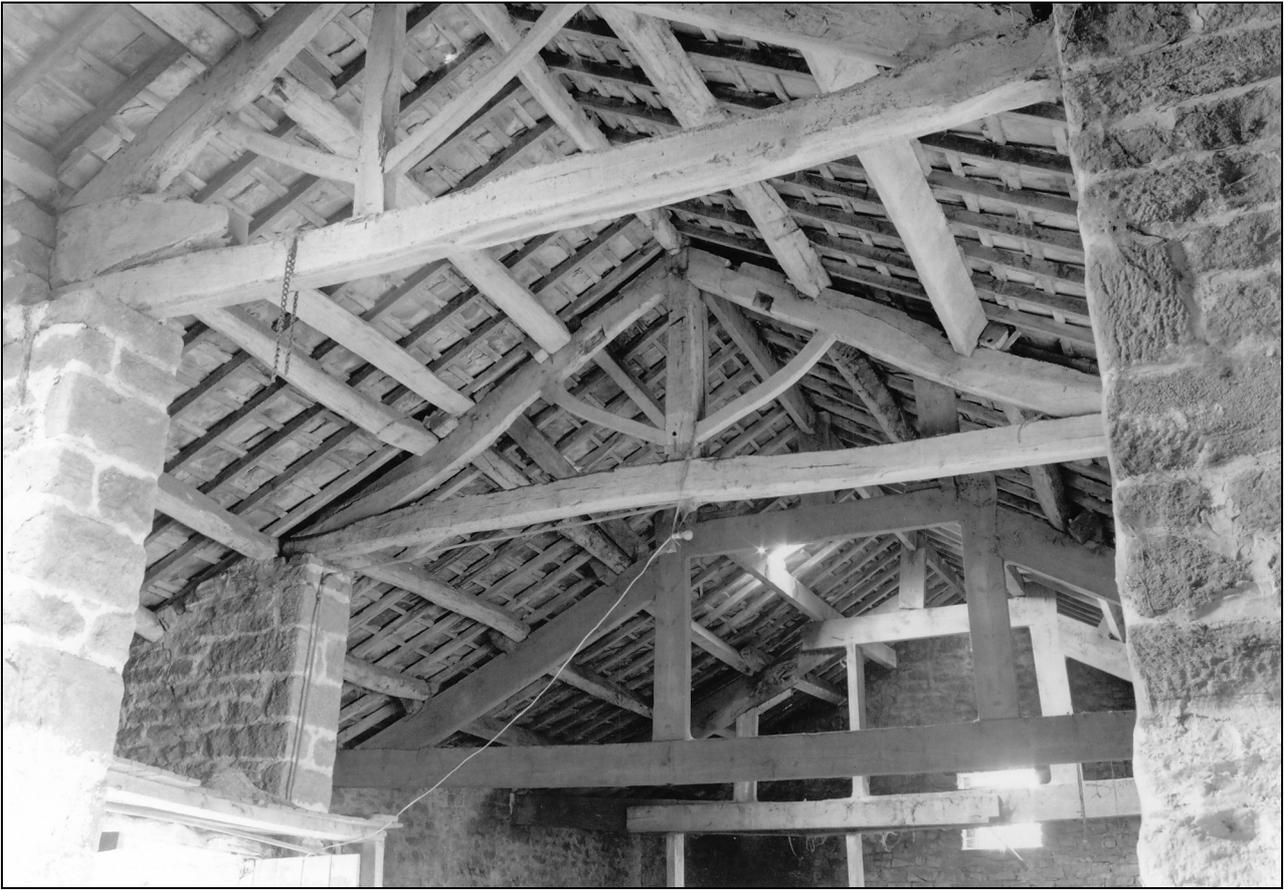
- 6.9 The roof structure of the three-bay barn comprised two trusses of relatively short span, running between the cross-walls next to the threshing bay (27). These are of pegged king-post form, and constructed from hardwood. The principal rafters have slightly curved profiles and halvings which suggest they are derived from crucks, and are supported by curved struts rising from the feet of the king-posts. The staggered purlins associated with these trusses are mostly also of oak, although supplemented by square-sawn softwood.

Photo 27: Roof trusses in barn, from the north-east

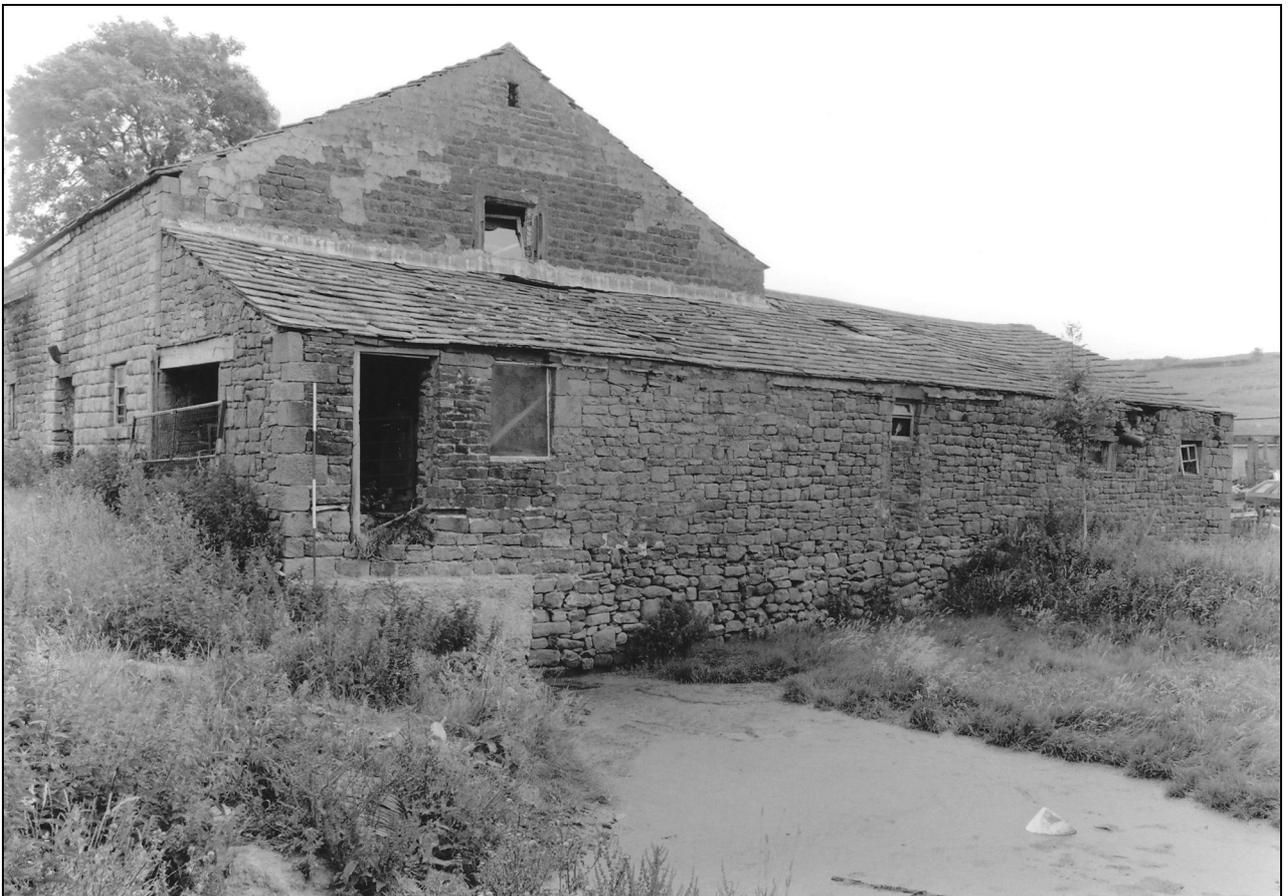
- 6.11 The subsequent additions to the barn include a long narrow building along the south-west end, which according to the maps, was built between 1910 and 1932. This is built of rubble with stone slate roof, and generally poor dressings (29,30), but appears to incorporate a low wall which is shown on the earlier maps and which probably comprised a middenstead, and in fact part of the building may have continued to be used for this purpose, with a roof to preserve the value of the manure. The lean-to has two parts: the north-west end has a wide doorway opening into the field and now contains a row of concrete boskins (13), while to the south-east, the wider part forms another small shippon, originally entered from the north-east side (31) and with a low hay loft (32). This is in very poor condition and prevented entry into the area, but there do not appear to be any features of interest within the building. The addition to the east of this building, with gritstone walls and a single pitch asbestos roof, was built in the 1960s as additional cow housing and is not of historic interest (33,34).

Photo 29: Lean-to along south-west gable of barn, from the west

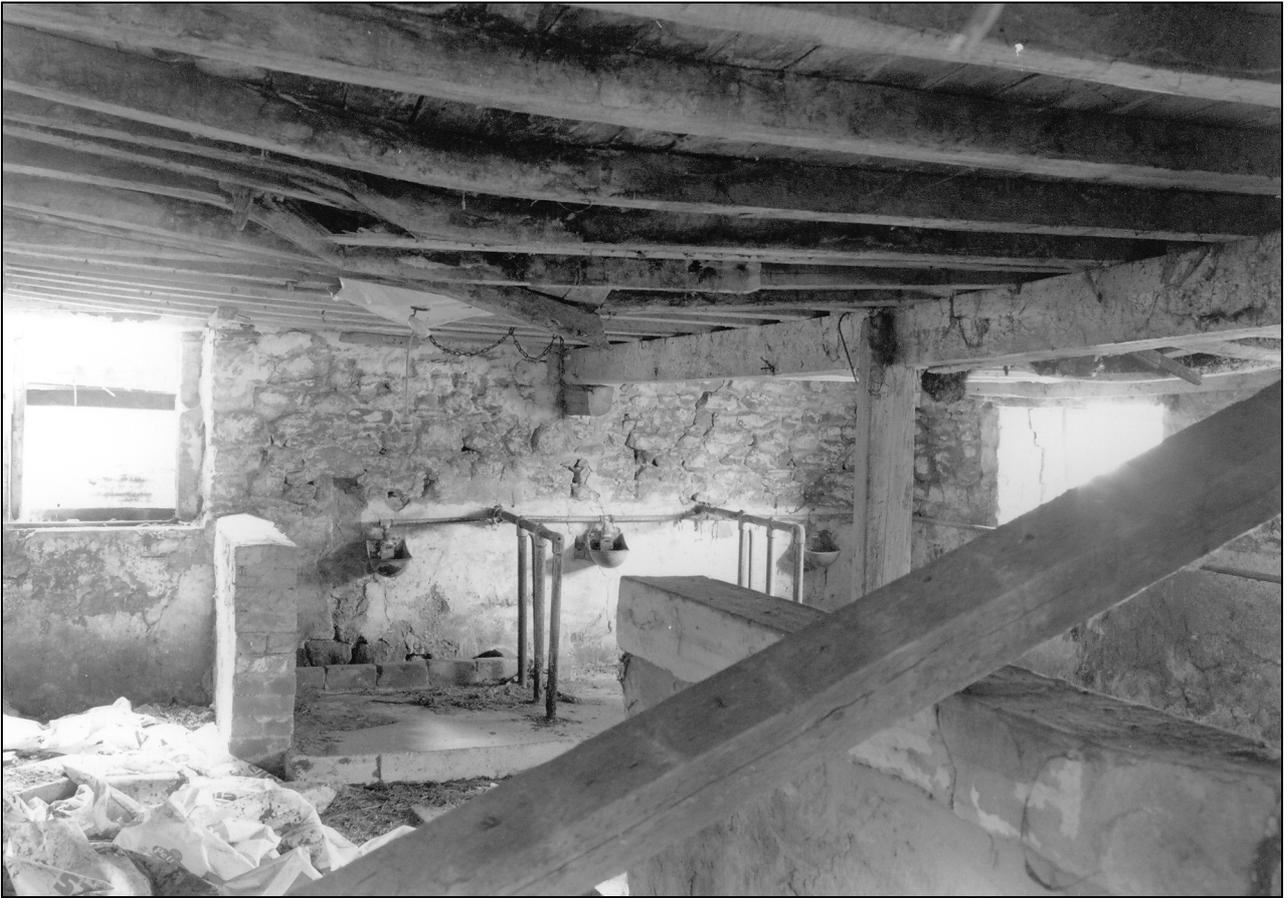
Photo 32: Interior of early twentieth century shippon, from the north

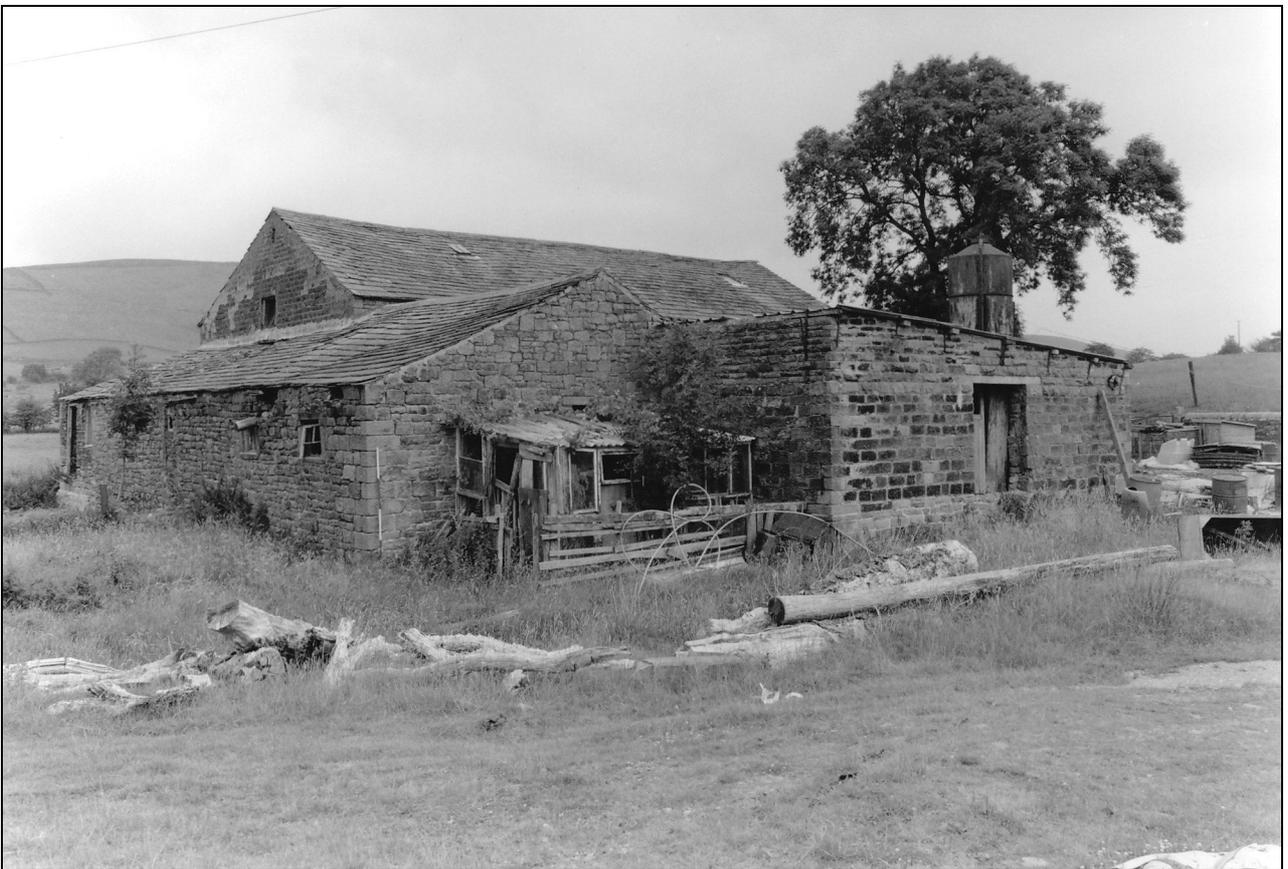
Photo 33: Twentieth century additions to barn, from the south
