Part of Lumb Holes Mill
Cowpe Road, Waterfoot, Rossendale, Lancashire:
Archaeological Building Recording

Archaeological Building Recording

Archaeological building recording was carried out in August 2006 at Lumb Holes Mill, a former woollen mill at Waterfoot, Rossendale, Lancashire (NGR: SD 83522132), for the developers Colway Contracts Ltd. Work was confined to the end of a two storey building, representing a small part of the former mill complex, dating to between 1847 and 1891 but of uncertain function and which is to be converted to residential use. The records made include floor plans, a section and photographs, as well as a written account.

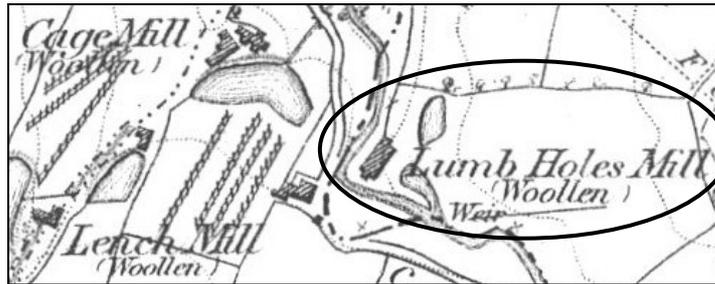
Figure 3: Extract from Ordnance Survey
1849 6" to mile map (surveyed 1844-7)
Sheet no: Lancashire 72

The present building had not been built by this date.

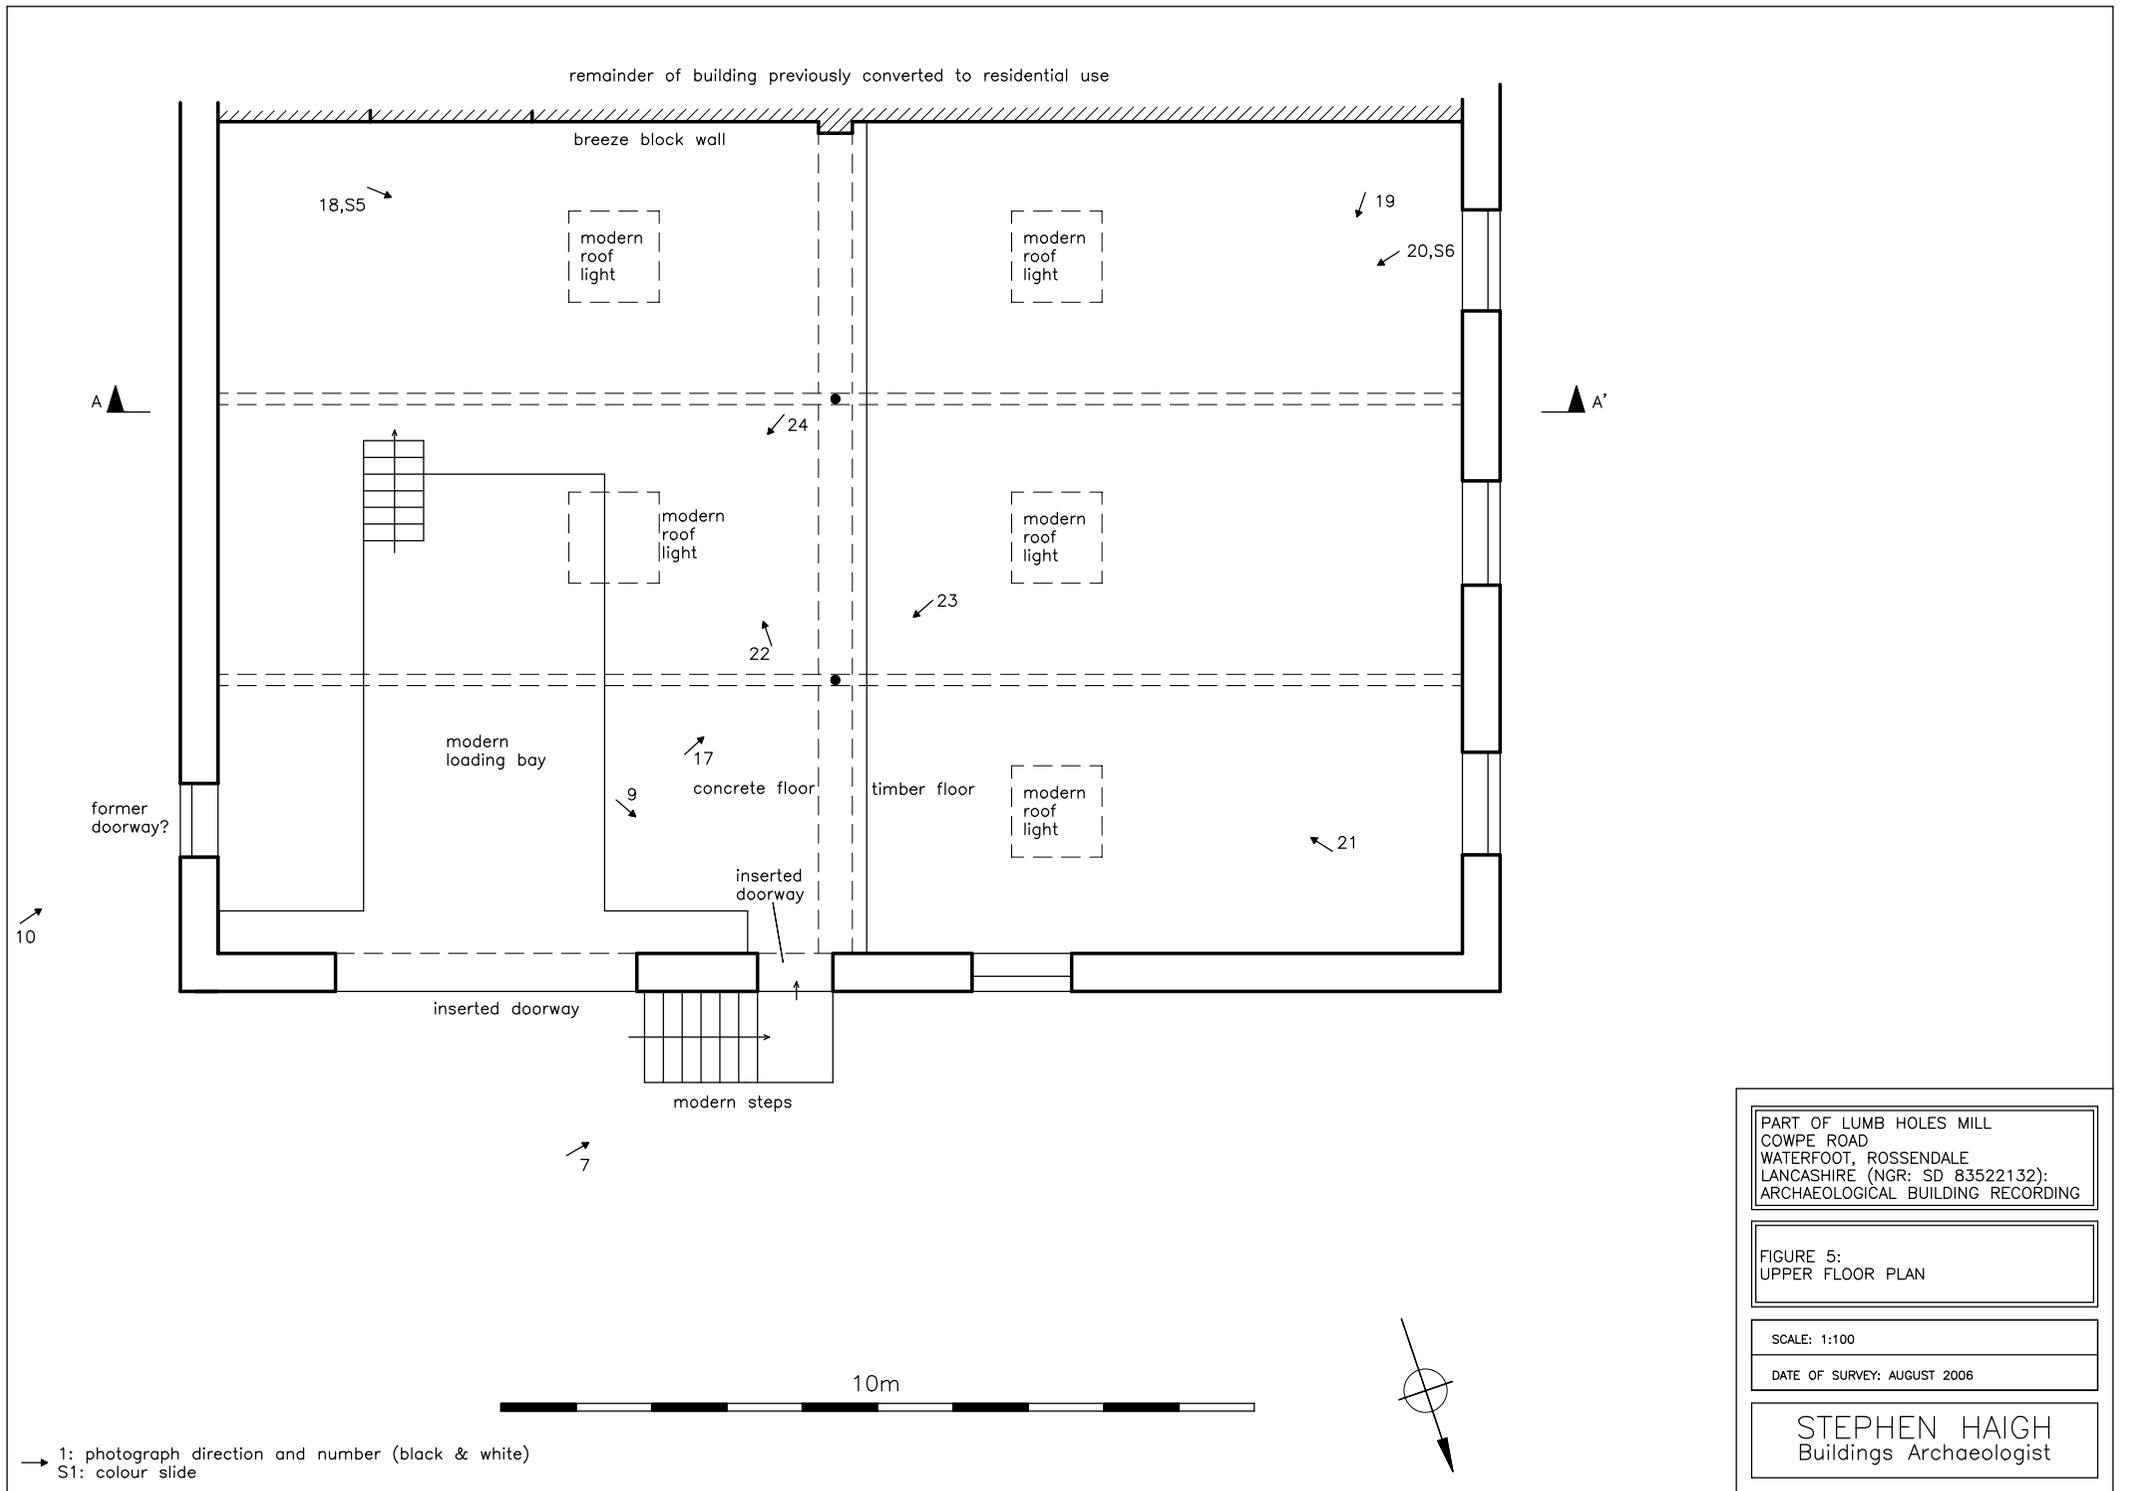
FIGURE 5:
 UPPER FLOOR PLAN

- 6.4 The upper floor has twice the width; there is a timber floor over the area of the lower floor but the remainder is of concrete and incorporates a modern loading

bay at a lower level (17-22). The interior wall faces are again of rubble with breeze block to the south and no early fixtures or fittings; the present iron stove is a modern insertion.

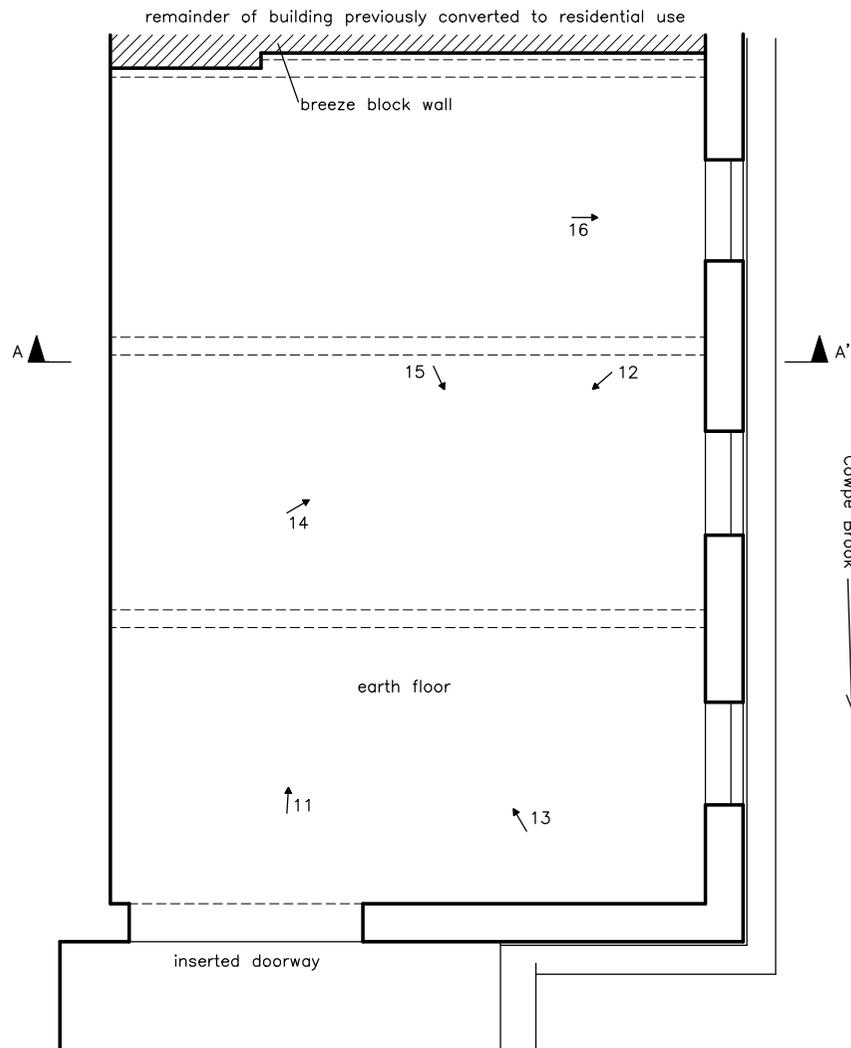
PART OF LUMB HOLES MILL COWPE ROAD WATERFOOT, ROSSENDALE LANCASHIRE (NGR: SD 83522132): ARCHAEOLOGICAL BUILDING RECORDING
FIGURE 6: LOWER FLOOR PLAN
SCALE: 1:100
DATE OF SURVEY: AUGUST 2006
STEPHEN HAIGH Buildings Archaeologist

- 6.3 The lower floor forms a single space truncated to the south by a breeze block wall enclosing the residential areas **(11)**; the retaining wall to the east is of rubble **(12,13)**. The floor is of earth, albeit with areas of modern concrete, while above, stout beams carry the upper floor **(14,15)**. There are no features indicating that power was transmitted into or through this area, nor any other indications of the original purpose of the building, and it is possible that it was used simply as a warehouse.

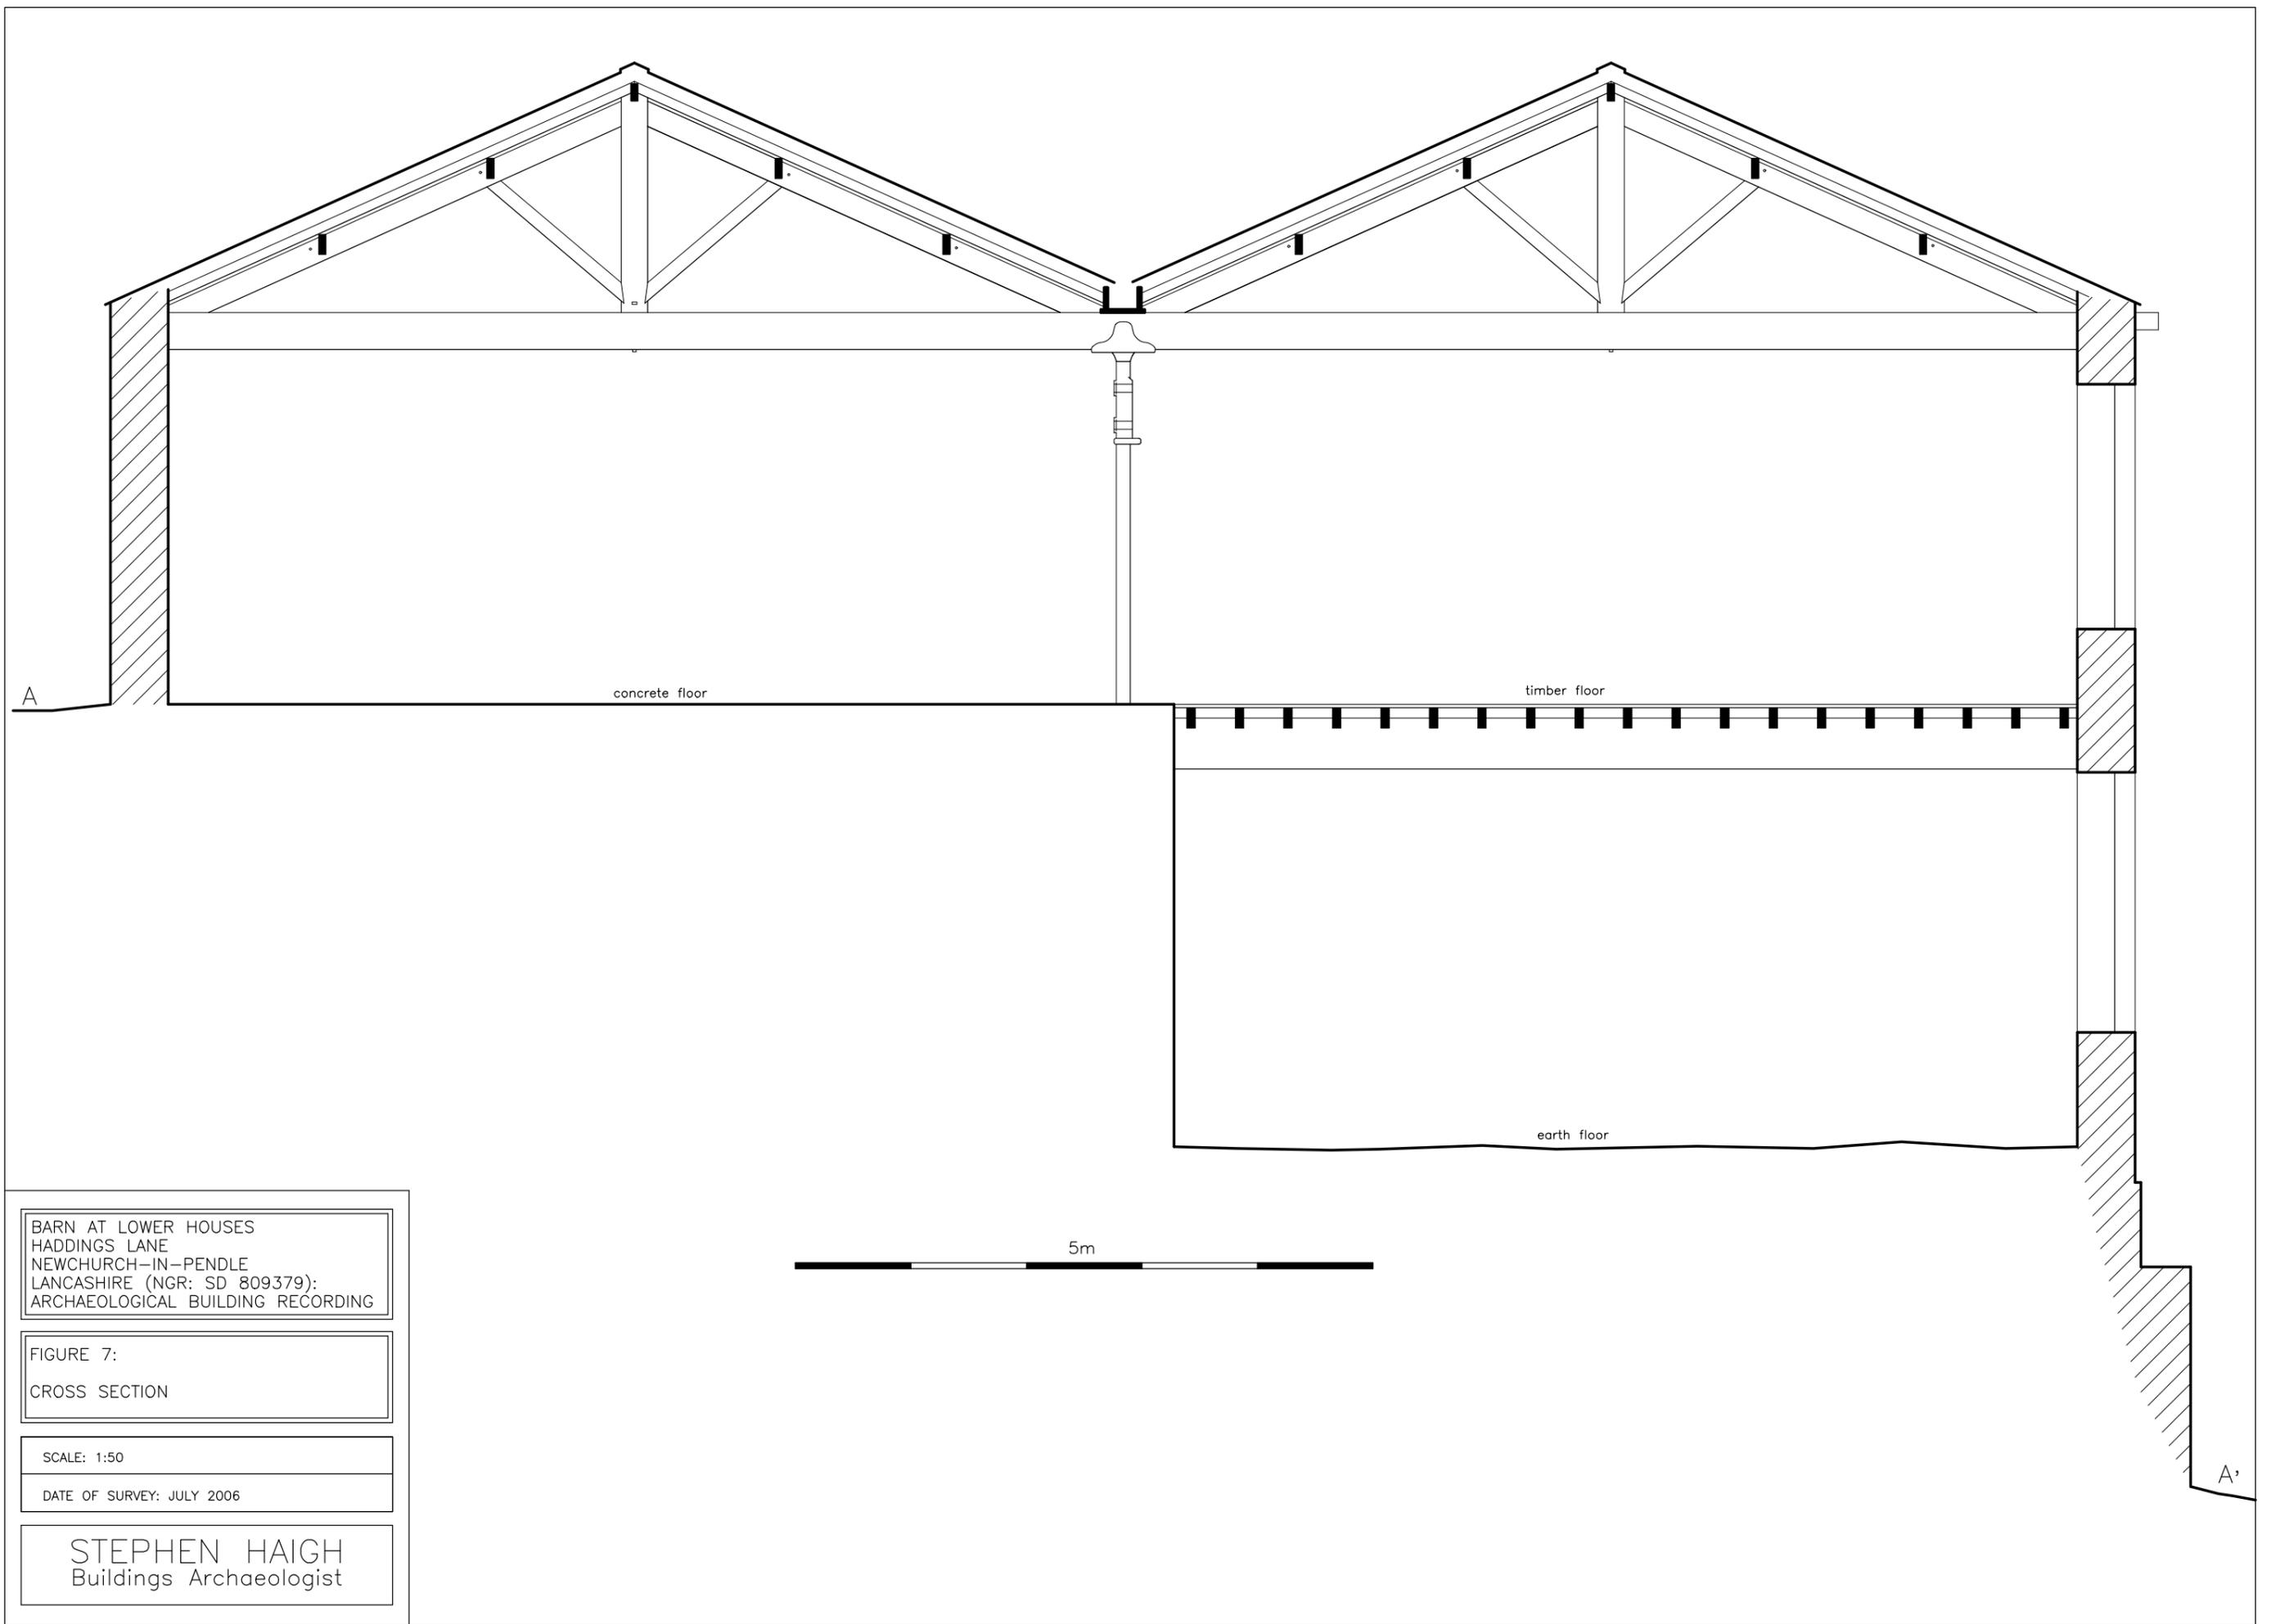
FIGURE 7:
 CROSS SECTION

- 6.5 The twin-span roof has a central cast iron valley gutter, supported by two columns (and presumably more to the south), which have bolting faces on their west sides. However there is no bearing in the north wall and it is doubtful that the columns were used to support shafting, which leads to the same conclusion as for the lower floor, that this area was used for storage.
- 6.6 The roof trusses are of standard bolted king-post form with raking struts, and butt purlins held in place by bolts; three of the four roof pitches have been replaced, two of them with modern roof lights.

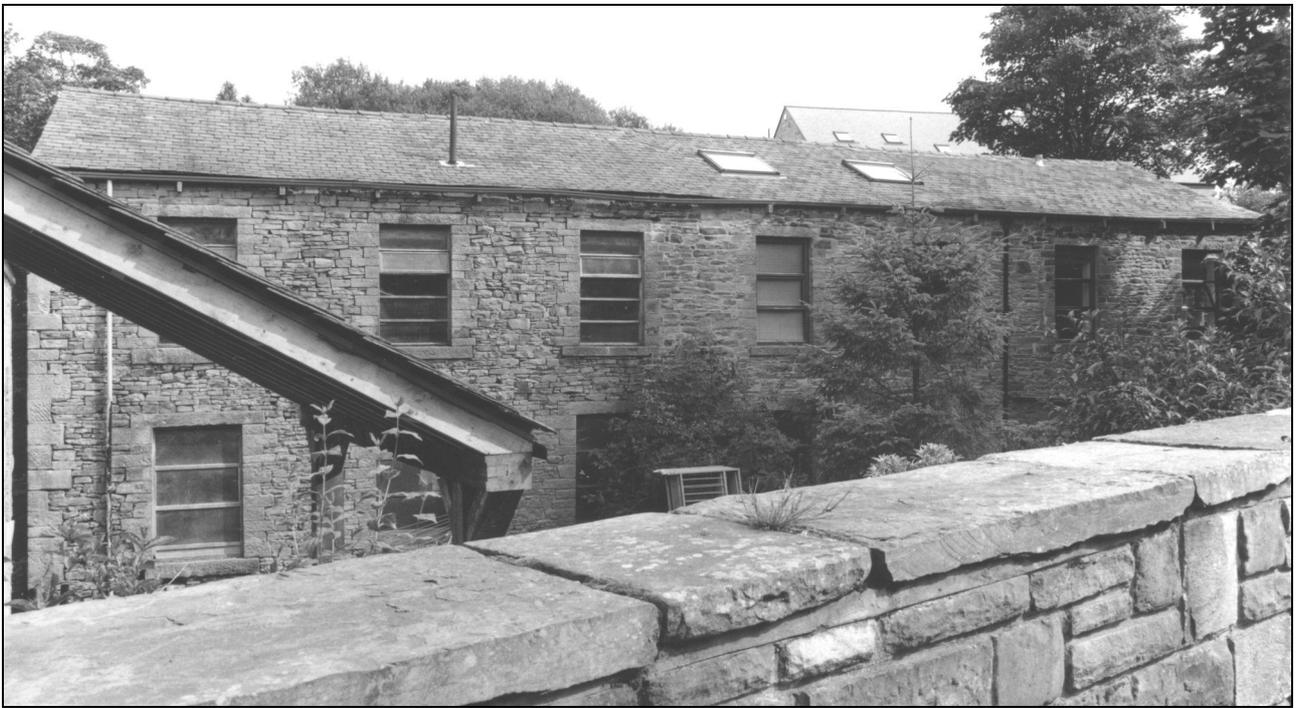
Photo 1: West elevation of building, across the Cowpe Brook

- 6.1 The building recorded is approximately 25m by 18m in plan and partly two storeys high **(1)**. It is situated on the east bank of the Cowpe Brook, where the sloping ground means that the lower floor is confined to the west half **(2)**, while the upper floor is of the full width. The walls are of random gritstone rubble with plain dressings bearing a variety of tooling; these include plain sills and lintels to window openings, and square profile eaves brackets, while the twin-span roof is covered with blue slate and has tile ridges; there are modern roof lights in the residential parts of the building, and earlier but nonetheless secondary roof lights in the northern end of the building.

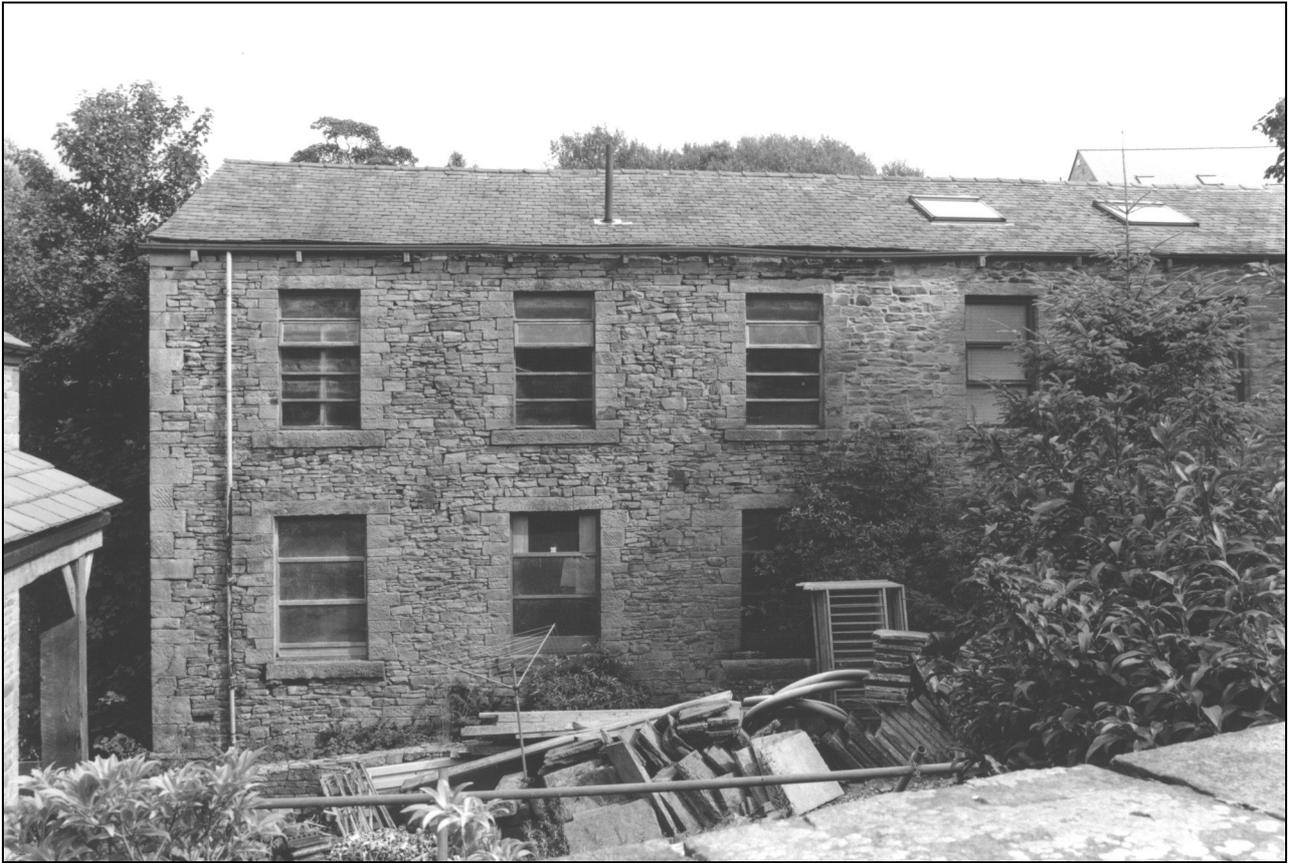
Photo 3: West elevation, across the Cowpe Brook

- 6.2 The three northern bays of the building have large, regularly spaced windows facing west on both the lower and upper floors **(3,4,5)**, and a single window in the west part of the north elevation, but the three doorways in this side of the building are all inserted, and probably date from the twentieth century **(6,7,8)**. Two of them are vehicular entrances, while the third, reached up a short flight of concrete steps, has a decorated panelled door which appears to have been re-used **(9)**. There are also small, rectangular ventilation openings near the two roof ridges. In the east side of the building is a single window opening, which appears to have been a doorway at one time **(10)**.
