**CITADEL CORPS COMPLEX, CASTLE STREET, ABERDEEN
ARCHAEOLOGICAL REPORT**

**Alison Cameron
Aberdeen City Council Archaeological Unit
February 2008**

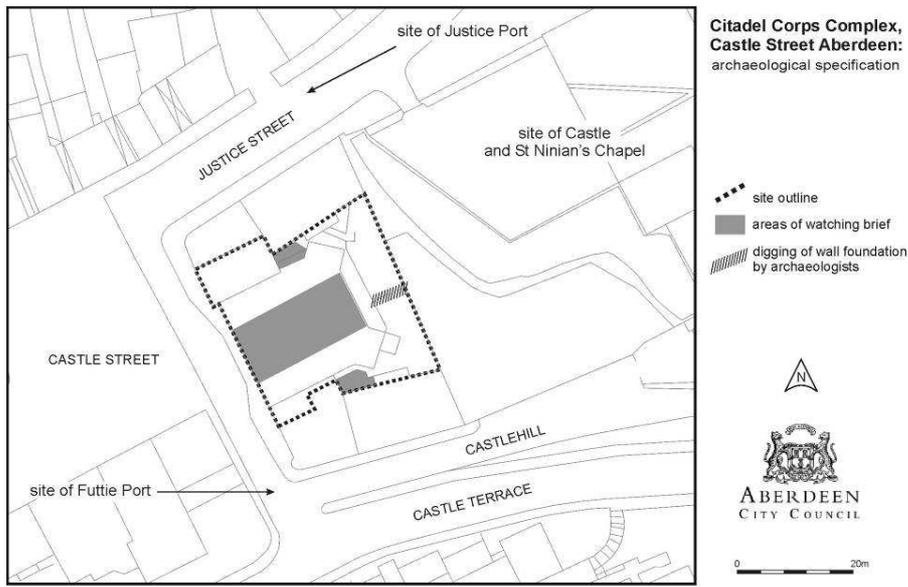
III 5 Plan of areas for archaeological evaluation

A watching brief was maintained on three areas (Ill 5; areas of watching brief); no evidence of archaeological layers or features were encountered during this work. A network of drains, sewers and other services were encountered in the exterior areas to the north and south of the standing building; these had destroyed any archaeological remains which may have survived the construction of the Citadel in 1893.

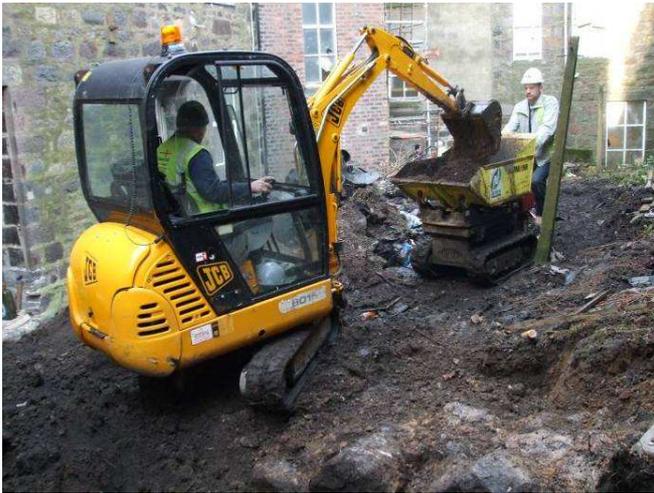
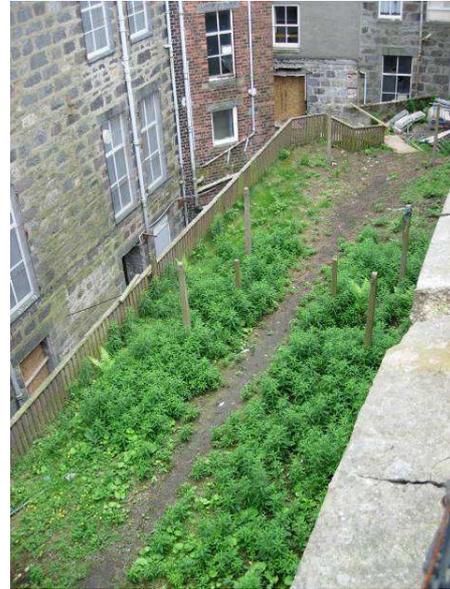
Ill 6 Small JCB machine excavating around wall AA and clearing debris from the site (left), the site prior to the excavation (right)

The open area to the east of the standing building was scraped by small JCB machine (Ill 6) and two areas were excavated for the construction of boundary walls to the Citadel Corps garden area. During the excavation of the south-most trench, a wall was uncovered. This was recorded and then covered up as it was not being disturbed by the current work.

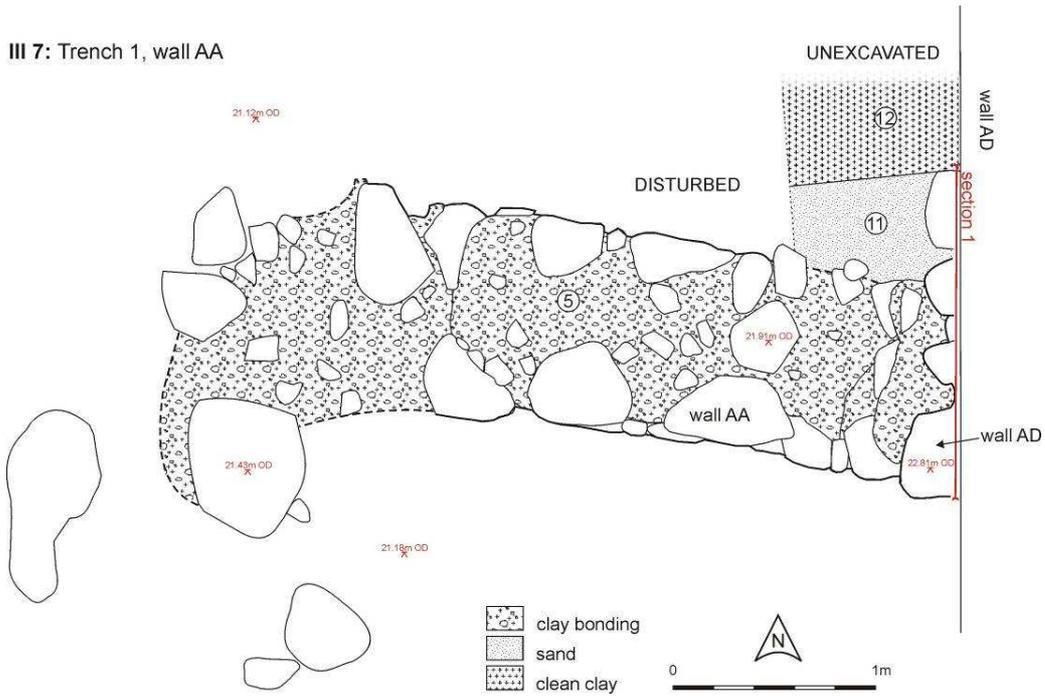
III 7: Trench 1, wall AA

The earliest feature excavated was wall (or wall foundation, see below), AA (Ils 7 and 8) which was 1m wide and survived to a depth of at least 0.80m (although it continued below the excavated level). It was aligned approximately on an E-W orientation and was constructed of large and small fieldstones with an inner core of small packing stones, all bonded with a light brown gravelly clay, similar to the surrounding natural subsoil. A fragment of oyster shell was found in the bonding material during the cleaning of the wall. The wall was cut into the natural subsoil and an accumulation of garden soils (layers 2 and 3), containing sherds of medieval (13th-15th century) pottery, had built up on its south side.

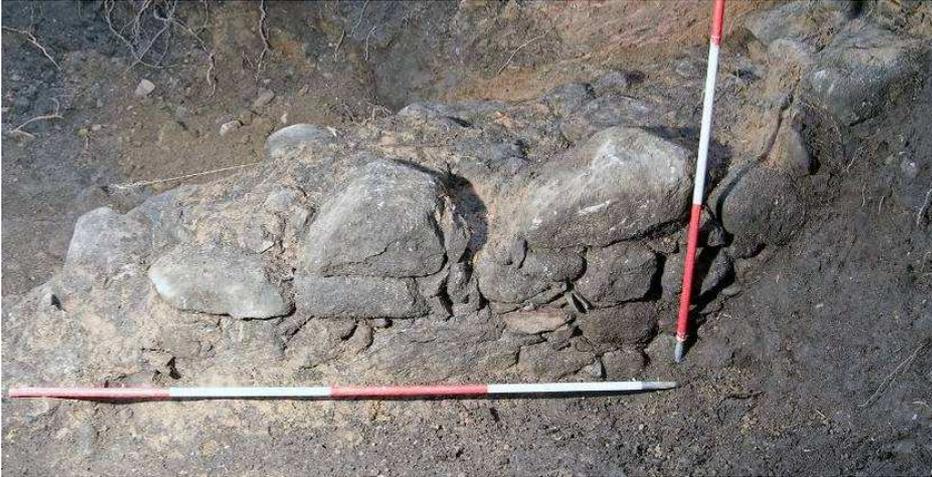
III 9 Wall AA, south face showing larger facing stones

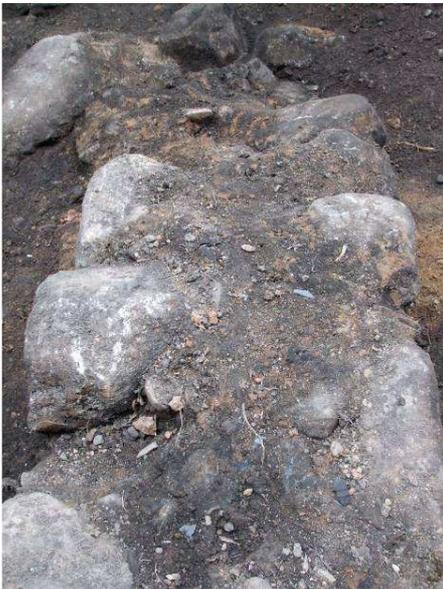
III 10 The top of wall AA

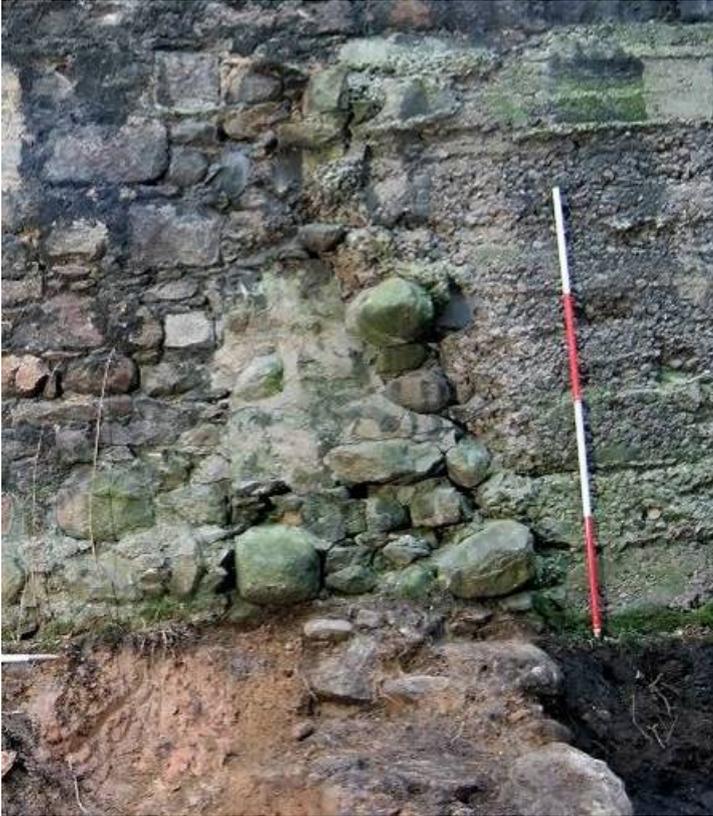
Ill 11 Section showing wall AA (foreground) and wall AD built into boundary wall (see Ill 8)

Upstanding wall AD was later built into a N-S boundary wall AF; this probably occurred during the construction of the Citadel in the 1890s. Lonray's Court was removed at this time and AA/AD demolished (see Ills 11, 12 and 13). The remnants of AA and AD can be seen on the section (Ills 8 and 11); Rubble wall AF appears to be infill blocking off Lonray's Court – perhaps the walls were still in use on the east side of the boundary wall and so wholesale demolition could not occur. The height of this wall was also raised at this time (AG) and the remainder of the wall repaired by the construction wooden shuttering on the west face of the wall and pouring stony concrete behind it. This can clearly be seen on the right of Ills 8 and 11). This phase probably took place during the construction of the Citadel in the 1890s; the project's architect reported that other stony concrete had been found in the basement of the Citadel building (Roger Legge pers comm.).

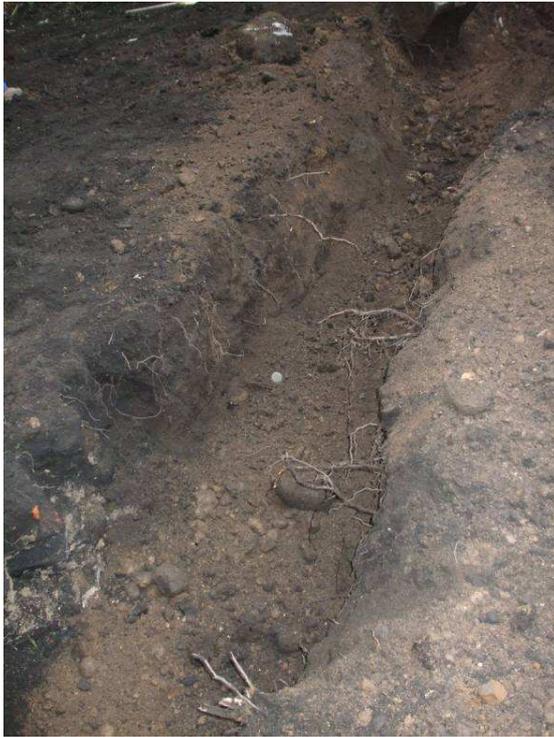
III 14 Trench 2

The wall foundation trench dug on the north side of the open area (Trench 2) contained loam, mortar and brick to a depth of 0.40m; it is likely that this area was backfilled in the relatively recent past, probably during the construction of the Citadel in the 1890s. No earlier layers or features were recorded in this trench.

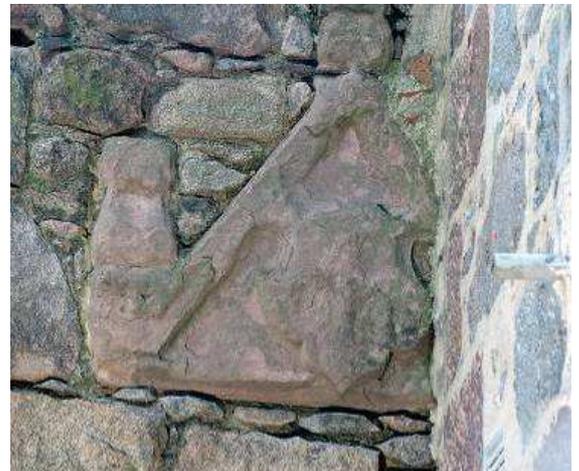
An armorial panel was recorded at the south end of the boundary wall AG. It had been built into heightened wall AG, probably in the 1890s although this may have occurred in the 20th century. Further details of this stone are available in the City of Aberdeen Sites and Monuments Record.

III 15 Armorial panel (right) Aberdeen City Council Sites and Monuments number NJ90NW 1148.
