Dunbar Parish Church Lift Shaft Report

23 – 24 July 2012

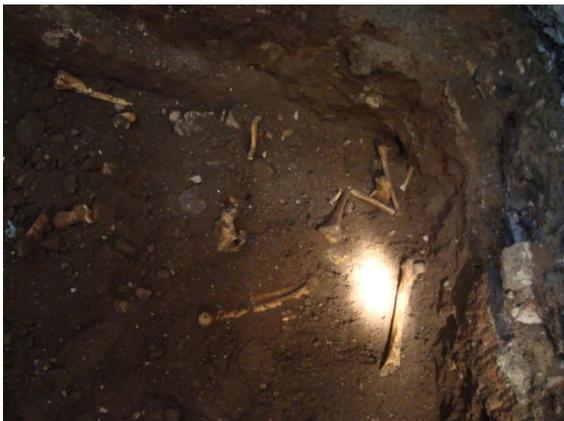
The bones lay within loose mid brown sandy silt, which contained mortar fragments and sandstone blocks and rubble; also some window glass, an iron nail and an oyster shell. They were found at a depth of 0.8m below the present floor layer, which was laid in 1992 and 0.54m below the old floor of the church.

Initial view of the bones

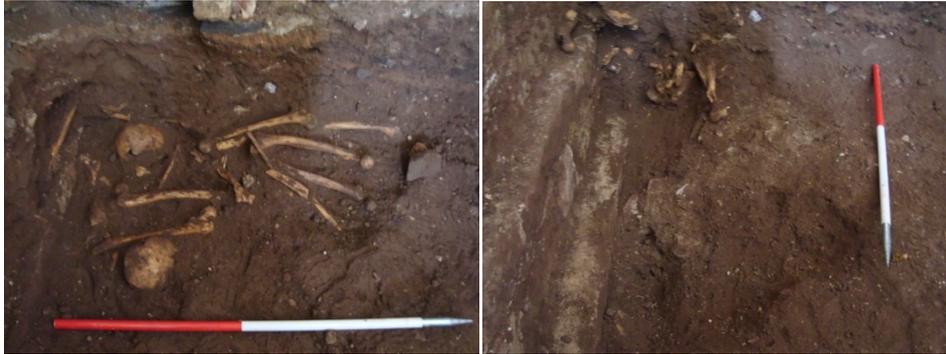
The loose soil was removed and more bones were revealed. They appeared to lie in an area of looser soil against the foundations of the western wall, in the north-western corner of the trench, although there was no clear cut (drawing 1). Two skulls and four femurs were visible, along with other bones, all disarticulated. The looser soil was removed along with the bones. This revealed

two small depressions within the more compacted soil below, along with a deposit of mortar and stony rubble (drawing 2). The depressions were up to 0.3m in depth but very irregular in shape.

Bones after cleaning

View of trench after excavation of bones

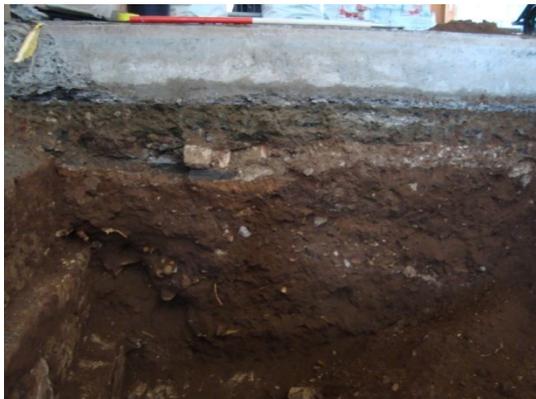
In section (drawing 3), the bones appear to have been placed up against the western foundations and a number of other tip lines suggest that they are one of a series of demolition deposits found beneath the original foundation for the floor.

South facing section, after removal of bones in section

The trench was excavated to a depth of 1.5m (drawing 3). At the base of the trench was compacted mid brown sandy silt (8), with occasional bone fragments, mortar and stones. This appeared to be a graveyard soil. On the western side of the trench was a deposit of loose mid brown sandy silt (7) containing frequent human bones, the deposit was up to 0.3m in depth. This material was found within two shallow depressions, although there were no clear cuts due to the presence of human bones within the graveyard soil below. Above this was a layer of stony silt and rubble (6), which was up to 0.1m thick and sloped from west to east, with a smaller band of pinkish sand (5) above.

Above this was a layer of dark brown compact sandy silt (4). No bones were present in this layer, which is interpreted as a levelling layer. Above this was a layer of compact sandstone rubble (3) around 0.08m in depth, thought to be the foundation for the original floor of the present church. The old floor (2) and the new concrete floor (1) lay above this.

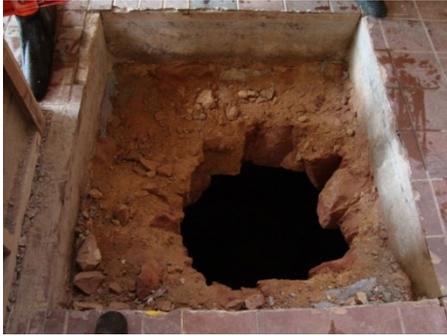
In addition to the human remains, a small trench against the south wall of the church revealed the vaulted sandstone roof of the crypt below.

The roof of the crypt as revealed beneath the present floor (looking west)
