**St Andrew's Kirk, Gullane, SM 757: Archaeological
Investigation Report (Clean and record)**

East Lothian Council Archaeology Service
25th March 2014

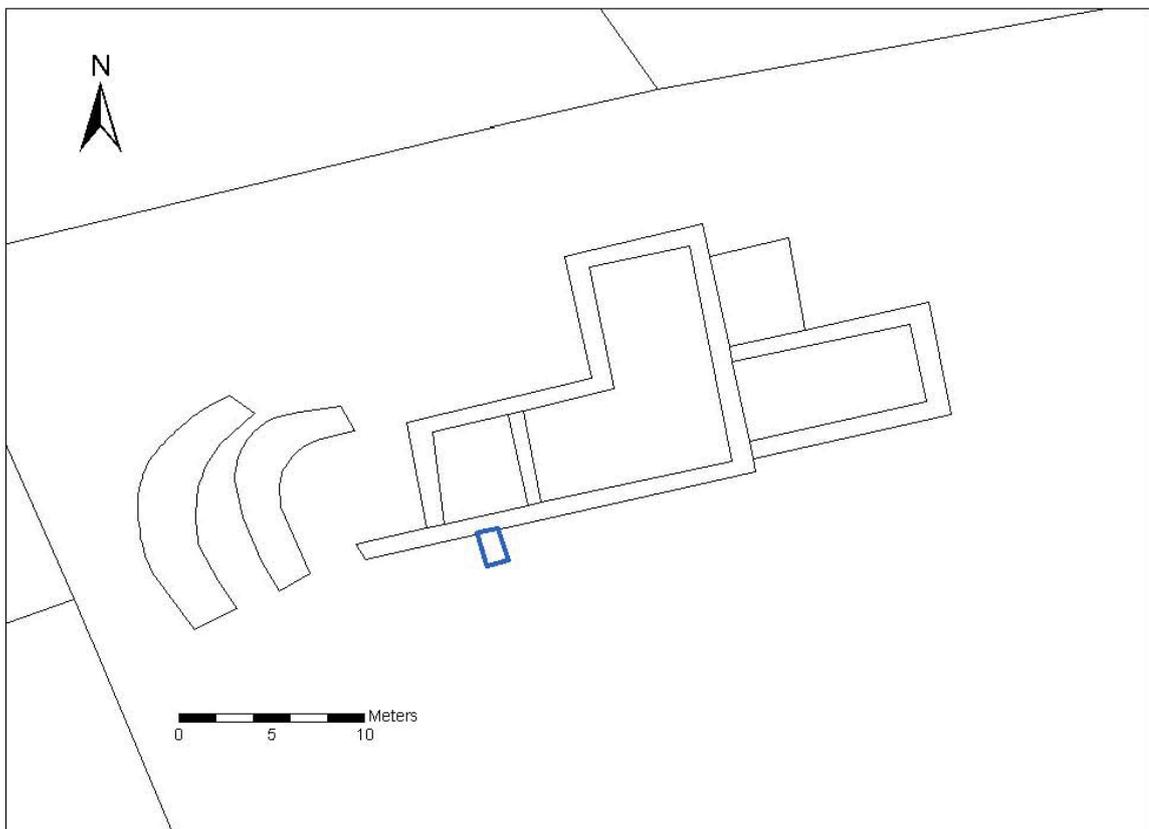
Illus 2: Trench location (outlined in blue) 1:250

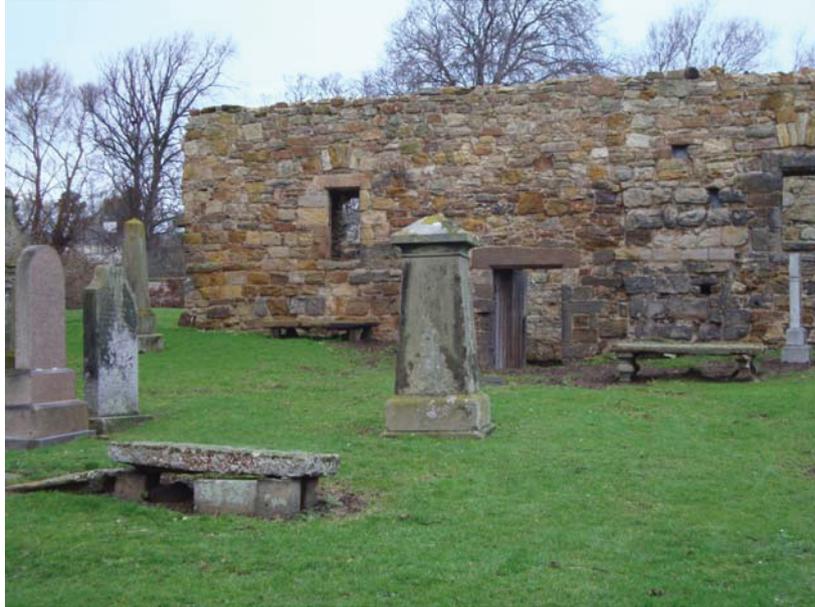
Illus 3: Location of new pedestrian access steps, in front of door

A free-standing pedestrian access down into the entrance at the western end of the church on the south side (Illus 2 & 3; NT48029 82700) was created in December 2013. This is intended to provide a safe way to get to the entrance, and improve access to the interior of the church. This report summarises the archaeological works undertaken as part of the Scheduled Monument Consent application submitted by East Lothian Council Amenity Services for the works.

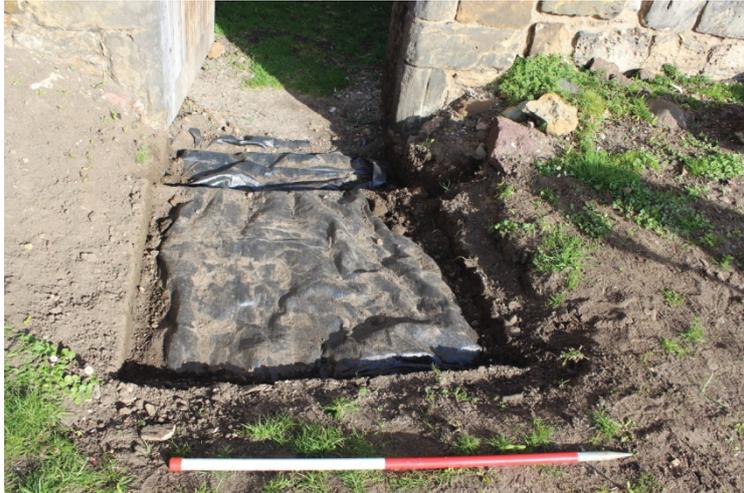
The free-standing pedestrian access to the church was removed to allow the archaeologist access to the area where ground-disturbance took place (Illus 4). The area was cleaned by hand to reveal the undisturbed soil surface and the vertical sections were straightened and cleaned to expose the stratigraphy.

Illus 4: The trench after removal of free-standing wooden steps

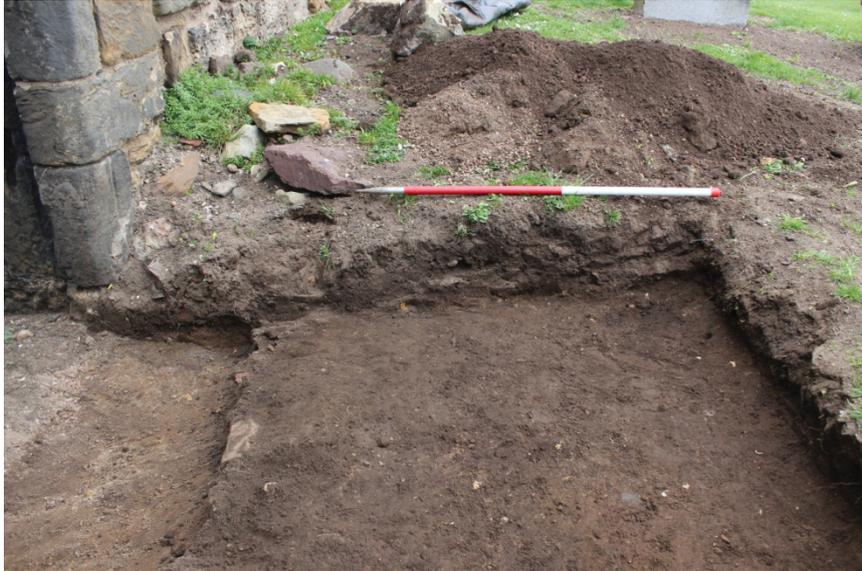
The re-deposited topsoil and pink gravel were removed by hand and the trench was then cleaned and recorded (Illus 5). The area beneath the top step was up to 0.28m in depth and exposed the topsoil [001] comprising dark brown sandy silt with occasional small stones and bone fragments. The lower step was a maximum 0.38m in depth and exposed up to 0.10m of the underlying subsoil [002], comprising light brown silty sand with occasional gravel, shell and small bone fragments. No archaeological features were exposed within the trench.

Illus 5: West-facing section of trench, showing topsoil [001] beneath top step and subsoil [002] beneath bottom step

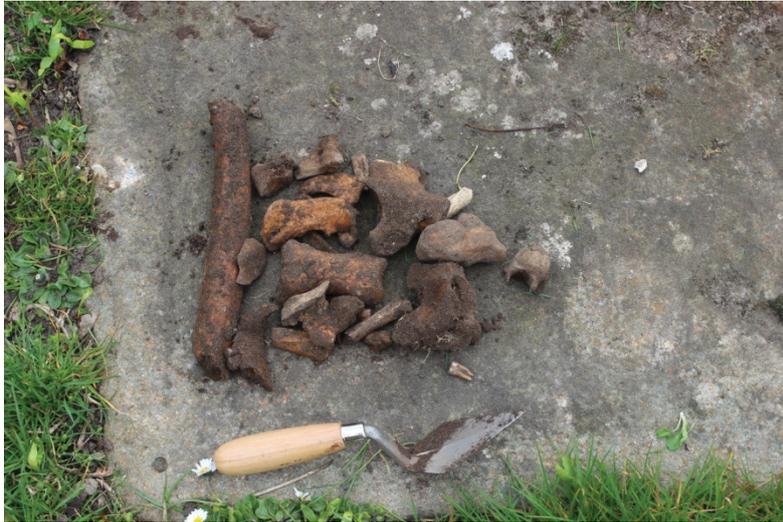
Several fragments of disarticulated human bone were recovered from the re-deposited topsoil (Illus 6); these were reburied within the trench. A fragment of tile, two fragments of 19th century pottery and a small horseshoe were also recovered but not retained.

Illus 6: Disarticulated bone recovered from topsoil

The archaeological investigation revealed that no archaeological features or deposits were disturbed as part of the works; the disarticulated bone recovered from the topsoil would not be unexpected within a graveyard soil. Following the investigation the free standing wooden steps were placed back into position and the soil carefully compacted. Grass seed was applied to the bare areas of soil to allow the soil to bond and prevent future weather or pedestrian traffic related erosion of the surface.
