ST LEONARDS SEWAGE TREATMENT WORKS, LAUNCESTON, CORNWALL

Results of an archaeological trench evaluation

Document No: ACD1172/2/0

Date: July 2015

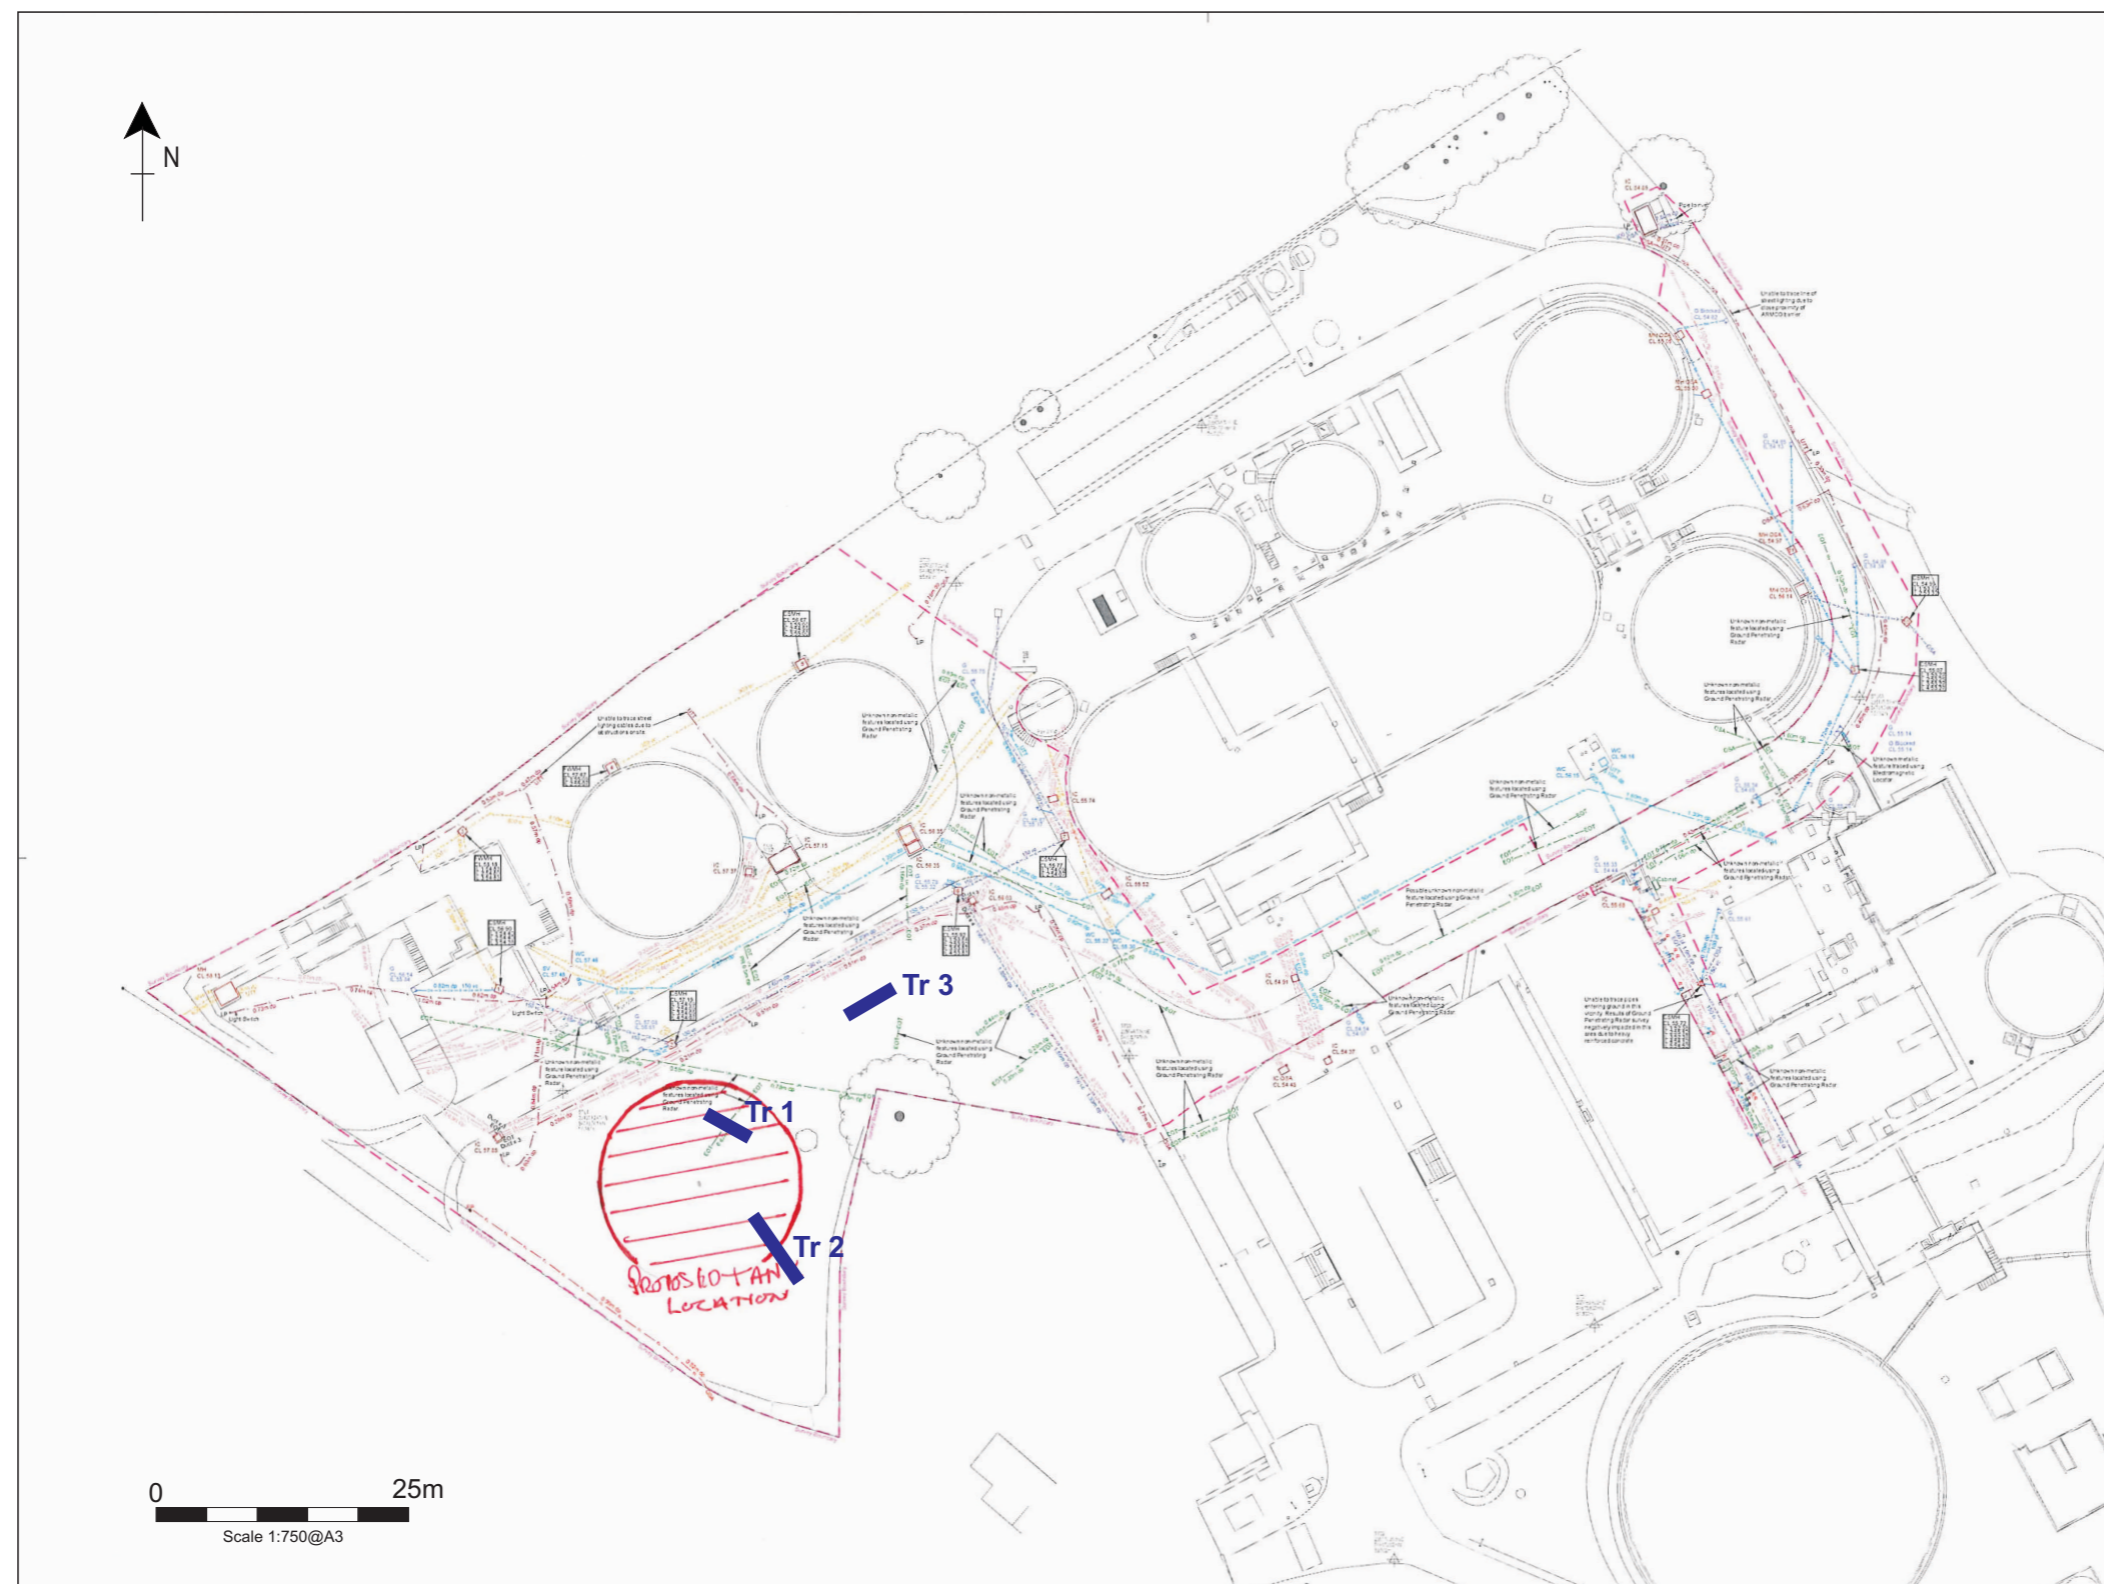
TITLE
Fig. 2: Location of trenches

A total of three trenches was excavated, each measuring up to 8m long by 1.5m wide; two trenches were located within the area of the proposed new tank with the third located to the east to investigate a second location for a potential second smaller tank (Fig. 2). The site was found to contain no surviving deposits of archaeological interest and provided a record only of the modern use of the site. The trench deposit descriptions are provided in detail below. All finds observed were of modern date and the majority were not collected; a sample that was collected is described separately in section 6 below.

- 2.2** The area was investigated for the *Time Team* television programme in 1996, and included a geophysical survey (ECO3865) and trial trench excavation (ECO2320). Within the STW the geophysical survey (GSB Prospection 1996) did not locate any anomalies that could be conclusively related to the leper hospital. The excavations established the limits of the cemetery but suggested that the hospital buildings lay beneath the Launceston Sewage Works. The excavation of an inhumation provided a radiocarbon date contemporary with the hospital. A watching brief south of the River Kensey in 2001 (in one of the supposed locations for the hospital) did not identify any medieval features (ECO658; Muir 2001). A previous survey of the development area by Ground Penetrating Radar (GPR) revealed a few linear anomalies interpreted as non-metallic (see Fig. 2).

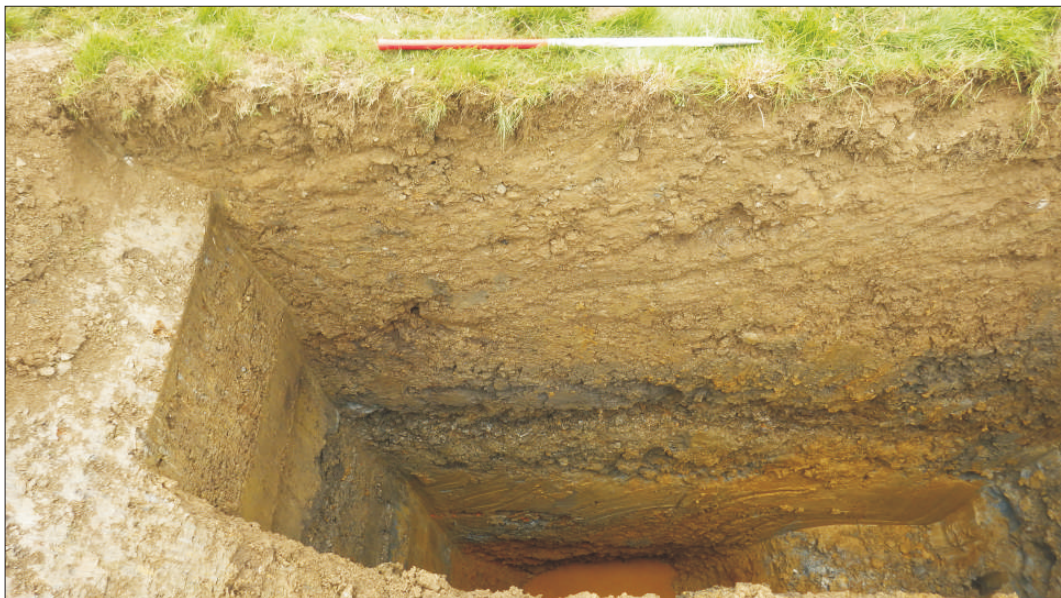
Plate 2: Trench 1, southeast-facing section (scale 1m)

Trench 1 was located in the centre of the development area. It was aligned approximately NW-SE and excavated to a maximum depth of 4.8m. The deposit sequence was as follows:

Context	Description	Depth	Interpretation
100	Light grey to light grey brown silty clay loam, containing a single large unworked stone	0-0.20m	Topsoil
101	Light grey silty clay	0.20-0.33m	Subsoil
102	Light grey and yellowish brown silty clay	0.33-1.53m	Made ground
103	Dark blue to grey silty clay	1.53-1.93m	Organic-rich redeposited alluvium
104	Dark yellow sandy silt and gravel	1.93-2.93m	Stoney alluvium

105	Light yellow/grey/blue fine silty clay	2.93-3.73m	Alluvium
106	Dark yellow and dark yellowish brown sand and gravel	3.73-4.80m+	Possible river terrace deposit

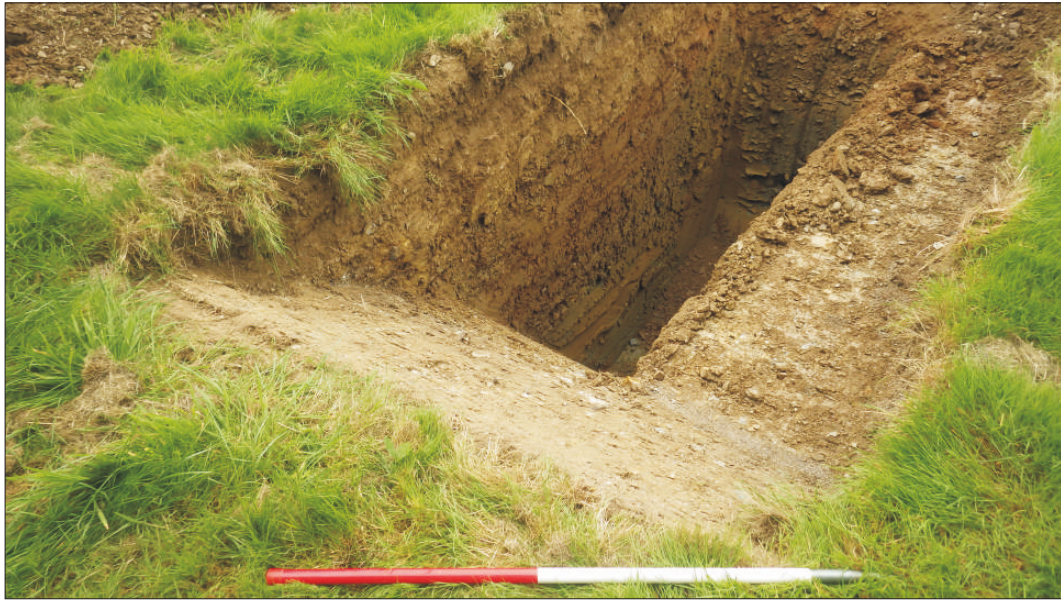
Plate 3: Trench 2, northeast-facing section (scale 1m)

Trench 2 was located in the southwest side of the proposed development. It was aligned NW-SE and excavated to a maximum depth of 4.5m. The deposit sequence was as follows:

Context	Description	Depth	Interpretation
200	Light grey to light grey brown silty clay loam	0-0.20m	Topsoil
201	Light grey silty clay	0.20-0.30m	Subsoil
202	Light grey and yellowish brown silty clay	0.30-0.60m	Made ground
203	Light grey and brown sandy silt	0.60-0.90m	Made ground
204	Dark blue to grey silty clay	0.90-1.90m	Organic-rich redeposited alluvium
205	Light brown and dark yellowish brown fine silty clay. Worked wood containing modern nails was found in this deposit	1.90-2.40m	Alluvium
206	Yellow to dark yellow fine clay	2.40m+	Alluvium

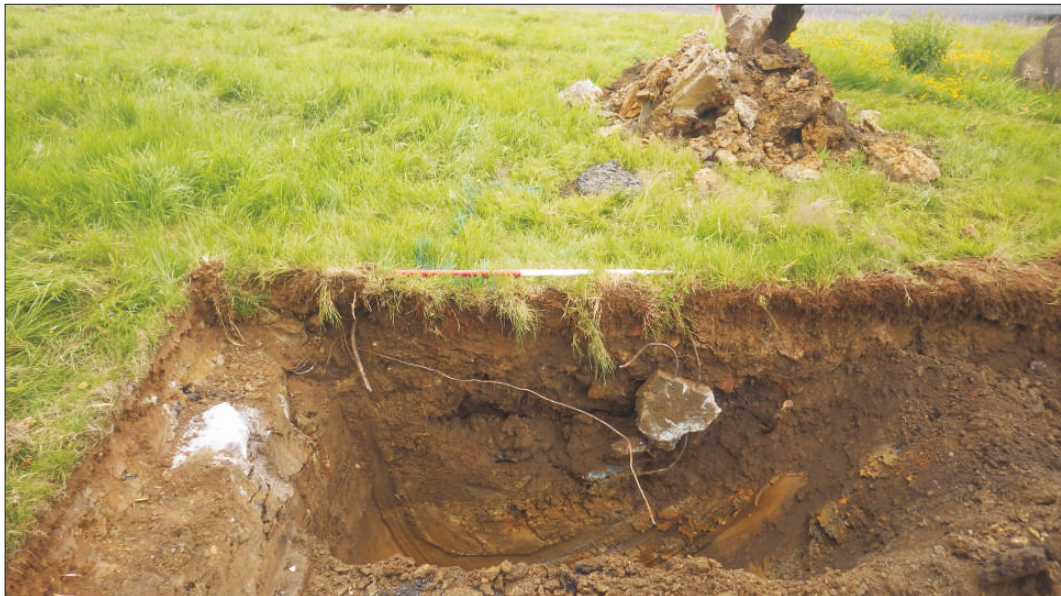
Plate 4: Trench 3, southeast-facing section (scale 1m)

Trench 3 was located in the northeast side of development area. It was aligned approximately NE-SW and excavated to a maximum depth of 4.10m. The deposit sequence was as follows:

Context	Description	Depth	Interpretation
300	Light grey to light grey brown silty clay loam	0-0.20m	Topsoil
301	Light grey silty clay	0.20-0.30m	Subsoil
302	Tarmac underlain by a silty sand containing metal, glass, potentially asbestos-containing material and fragmented plastic and concrete drainage pipe	0.30-1.50m	Made ground
303	Yellow to dark yellowish brown fine clay	1.50-4.00m	Alluvium
304	Dark yellow sand and gravel	4.00m+	Possible river terrace deposit

7.2 A possible buried soil (103/204) must be of relatively recent date since 204 overlays redeposited alluvium 205 which contained modern wood. These and the overlying made ground deposits containing modern material indicate at least two phases of former landscaping, with the tarmac (302) indicating a buried area of former hard standing in the northeast part of the proposed development area.
