# **Westcott Barton, Thelbridge, near Tiverton, Devon.**

*An Archaeological Building Assessment.*

April 2007

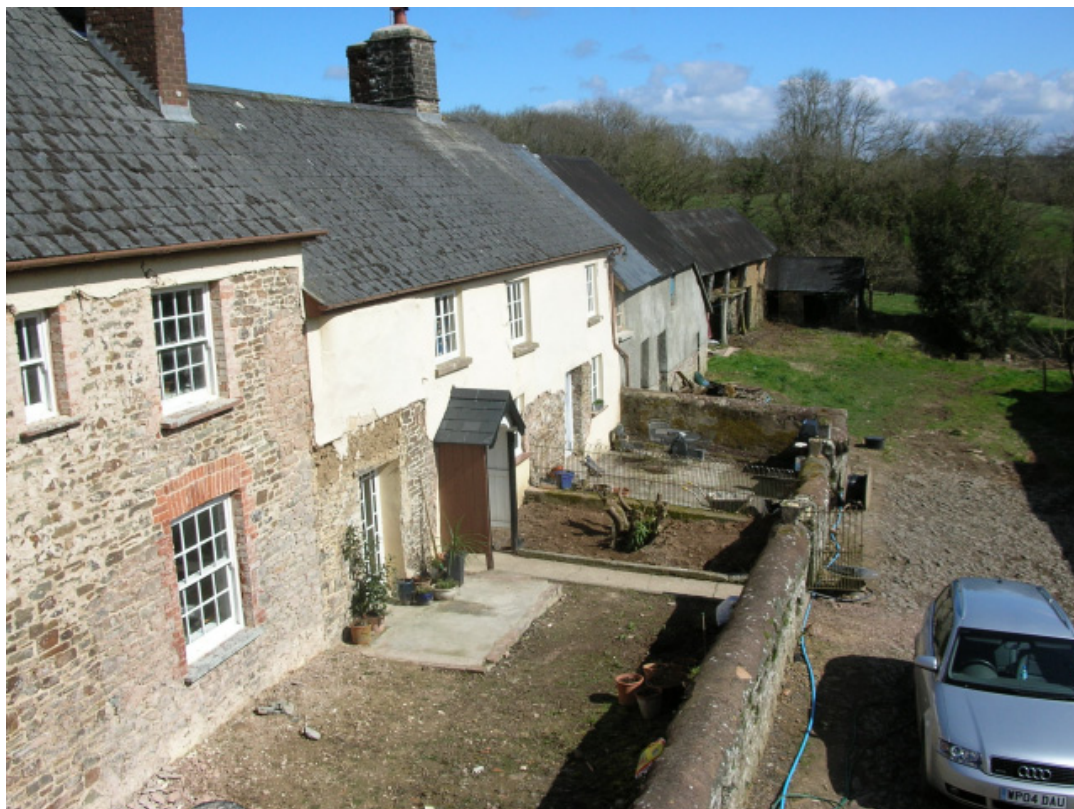
**Plate 1.** The north range from the south-west consisting of central farmhouse with byre and hayloft to the right, later extension to the left, and linhay barn to the right with outbuildings

- 6.4. At the western end of the southern elevation (where the original farmhouse meets the later western extension), the render curves around at first floor level where the wall once met the thatched roof (**Plate 1**). The first floor is still rendered, however much of it has been removed from the ground floor, revealing an area of cob walling above the level of the French doors (**Plate 1**). Otherwise, with the exception of an area of rubble walling below the cob, the ground floor of the south elevation has undergone repair and re-facing in rubble, which obscures the location of any earlier openings.

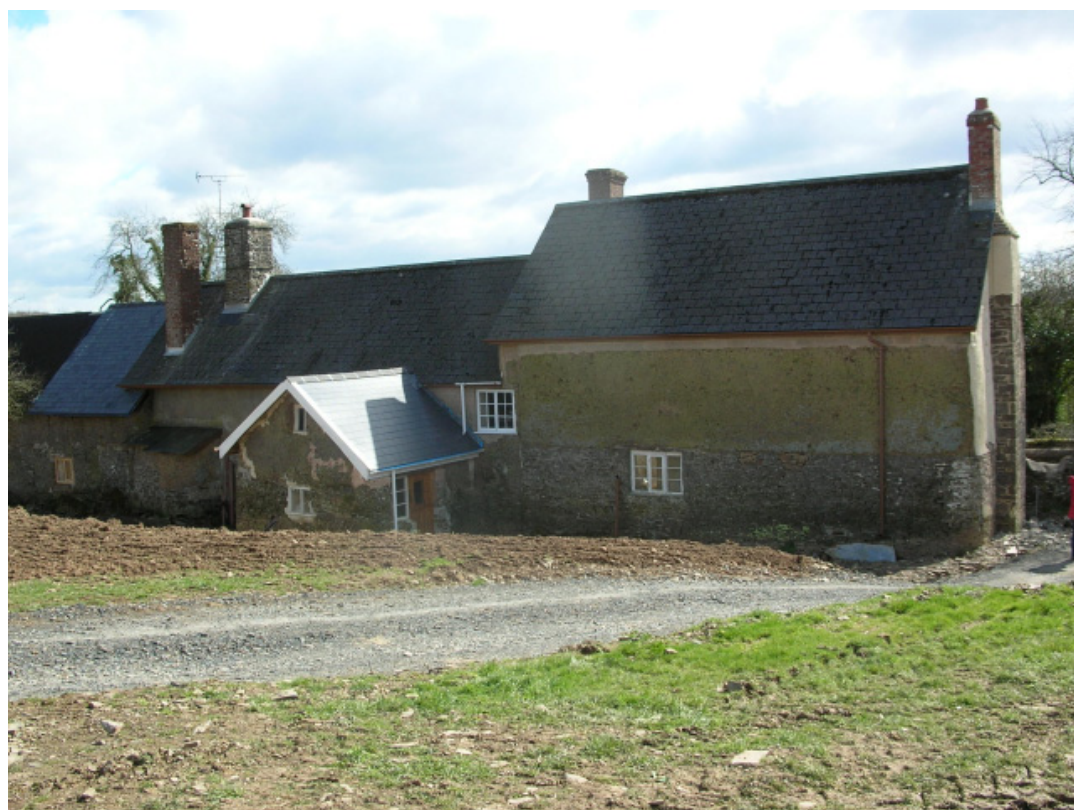
**Plate 2.** North range from the north-west, with central farmhouse to the left, dairy to the north, and later extension to the right

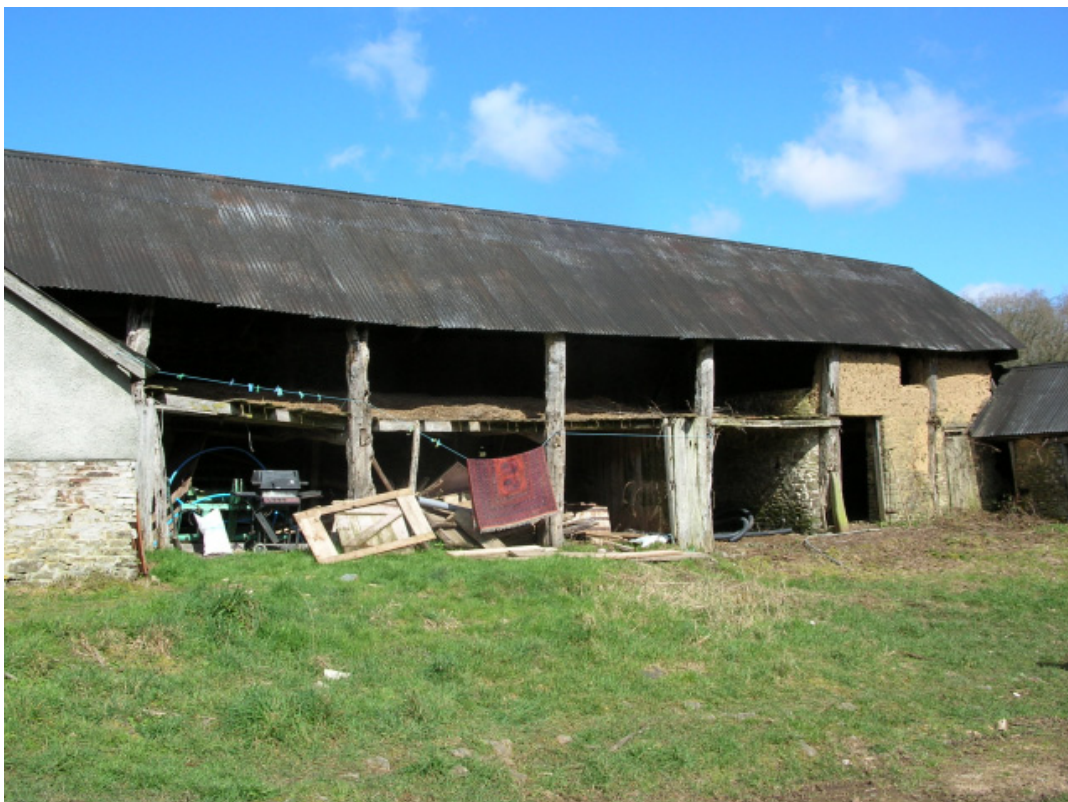
**Plate 3.** Linhay barn of the north range from the south south-west, with small outbuilding to the left in front of the western bay, and outbuilding at right angles from the eastern bay

- 6.18. At the eastern end is a narrow lean-to, which extends towards the south at right angles to the linhay (**Plate 3**). The eastern cob and rubble wall of the linhay has been partially demolished in order to create access to the eastern building. The north wall of the linhay is of solid rubble and cob walling, although a small circular rubble infill is present in the north wall towards the east.

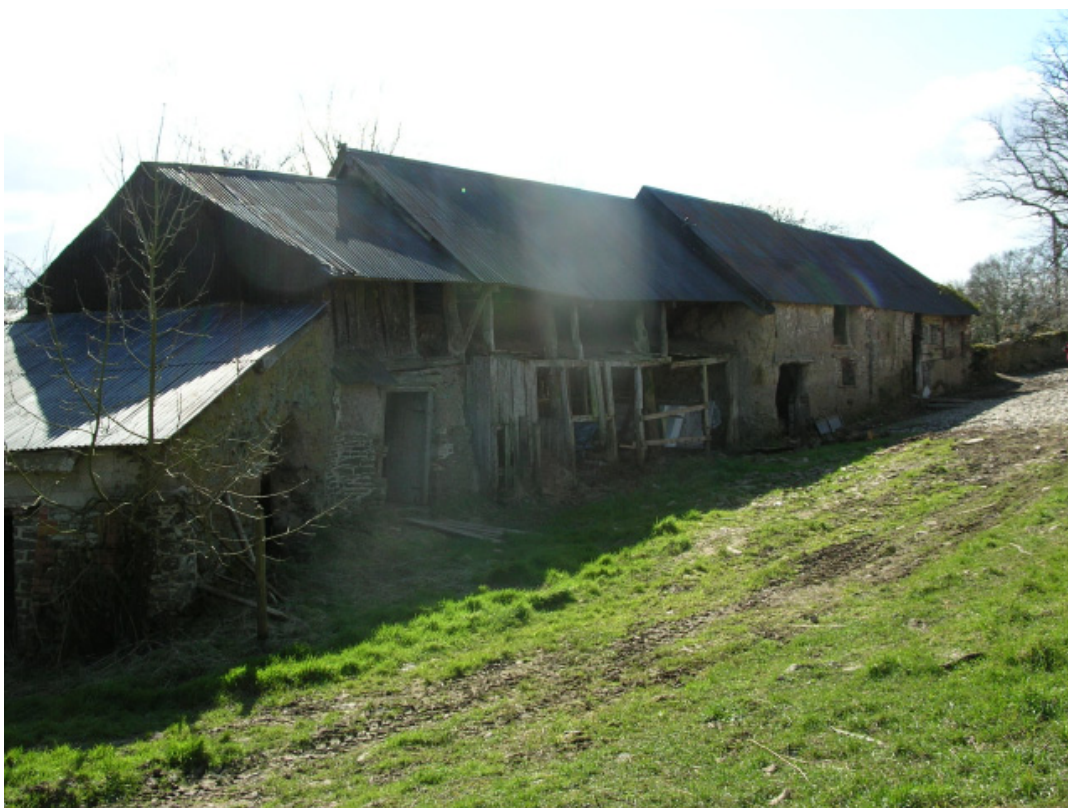
**Plate 4.** South range from the north-east, with byre and hayloft to the right, linhay to the left, and outbuilding at an angle to the linhay

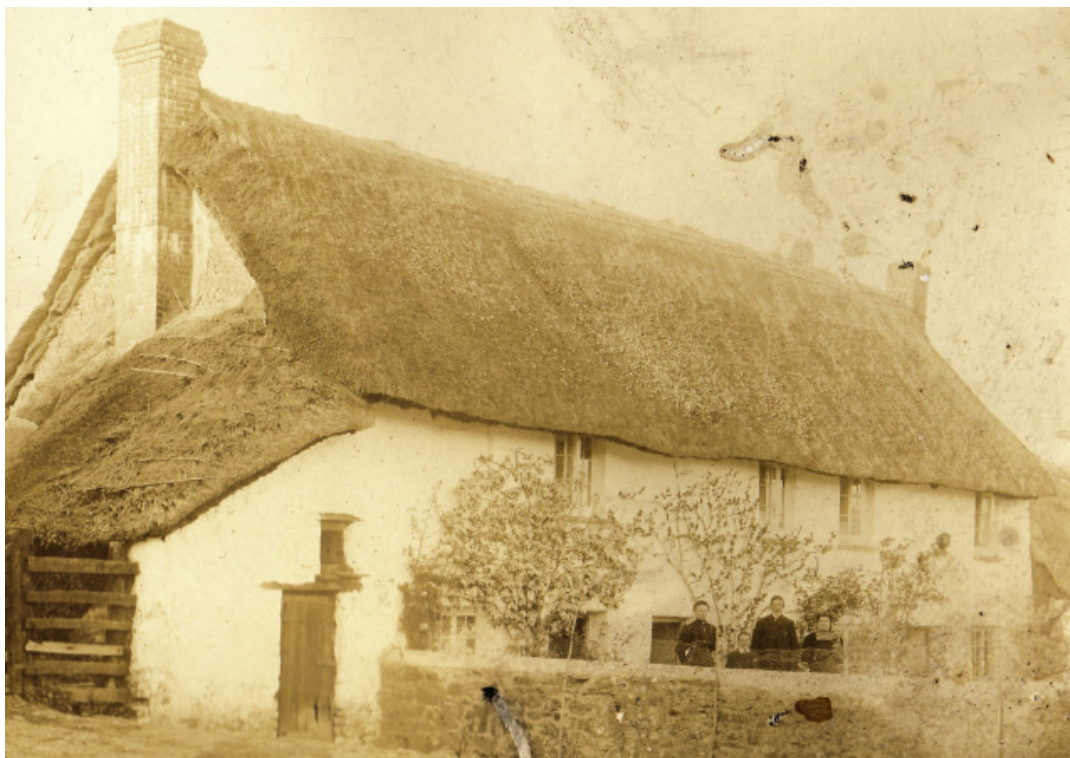
**Plate 5.** Late 19<sup>th</sup> century photograph of Westcott Barton farmhouse from the south-west, showing central farmhouse and extension to the left with lean-to. The family in the foreground are probably the Blackford family.

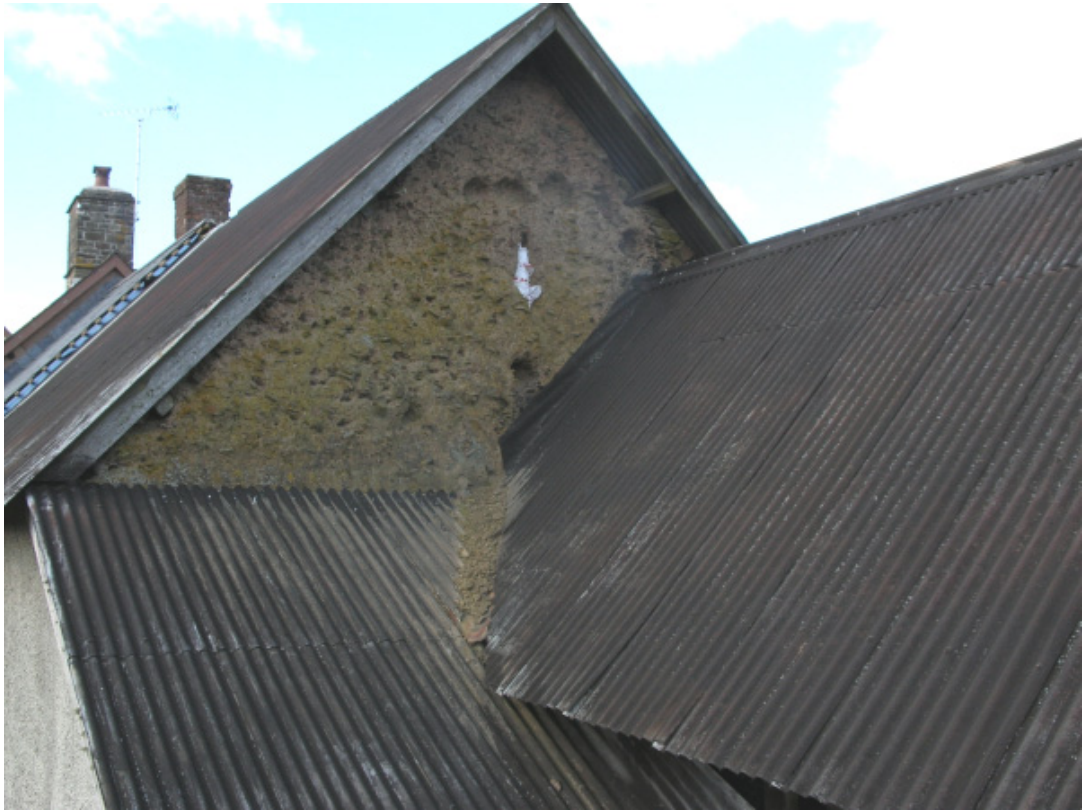
**Plate 7.** Eastern gable of hayloft, constructed of cob with ventilation slit in centre

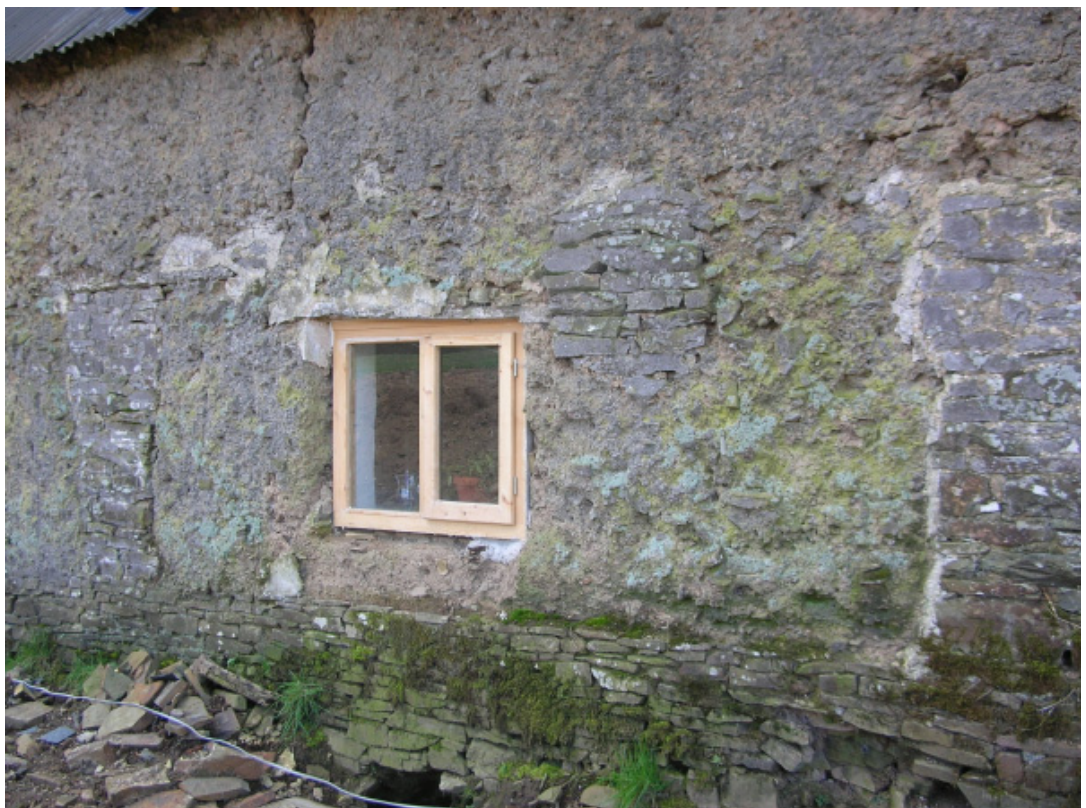
**Plate 8.** Three rubble-filled blocked openings at eastern end of north elevation of original building, from the north-west

- 6.6. At the eastern end of the north elevation is a narrow blocked rectangular opening with lintel above, a small blocked rectangular opening to the west of the modern window (**Plate 8**), and a blocked 1.28m wide rectangular opening in the approximate location of the well within the kitchen (**Plate 9**). None of these openings cut through the low rubble wall, but are visible as rubble blockings within the cob. The service end of the central farmhouse is slightly offset from the location of the original cross-passage (see **Figure 5**). At the northern end of the cross-passage are two semi-circular chimneys associated with the bread oven and smoking chamber (see **Figure 5**). The north wall of the hall has undergone extensive remedial work to the cob, probably associated with the later construction of the stair turret (**Plate 10**). The square rectangular dairy building (**Plate 4**) was added later than the stairwell, as it abutts the stonework, and the cob is at a different level.

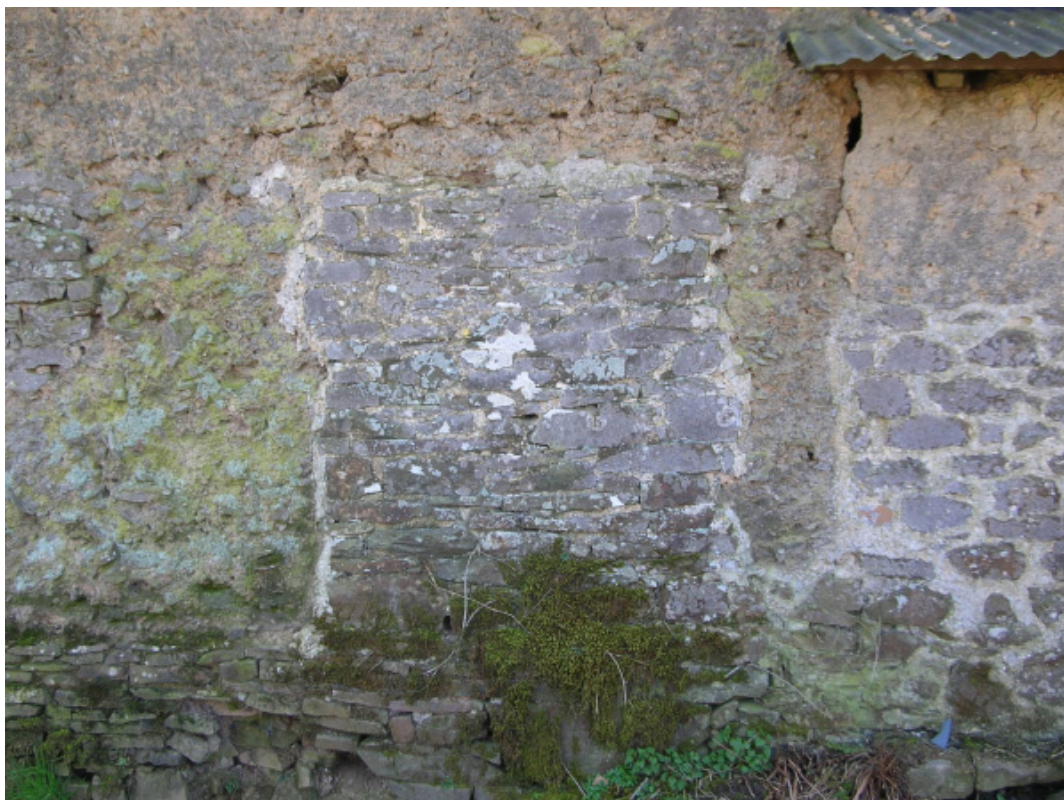
**Plate 9.** Rectangular blocked opening in north elevation of original building, to the left of one of the bread oven and smoking chamber chimneys

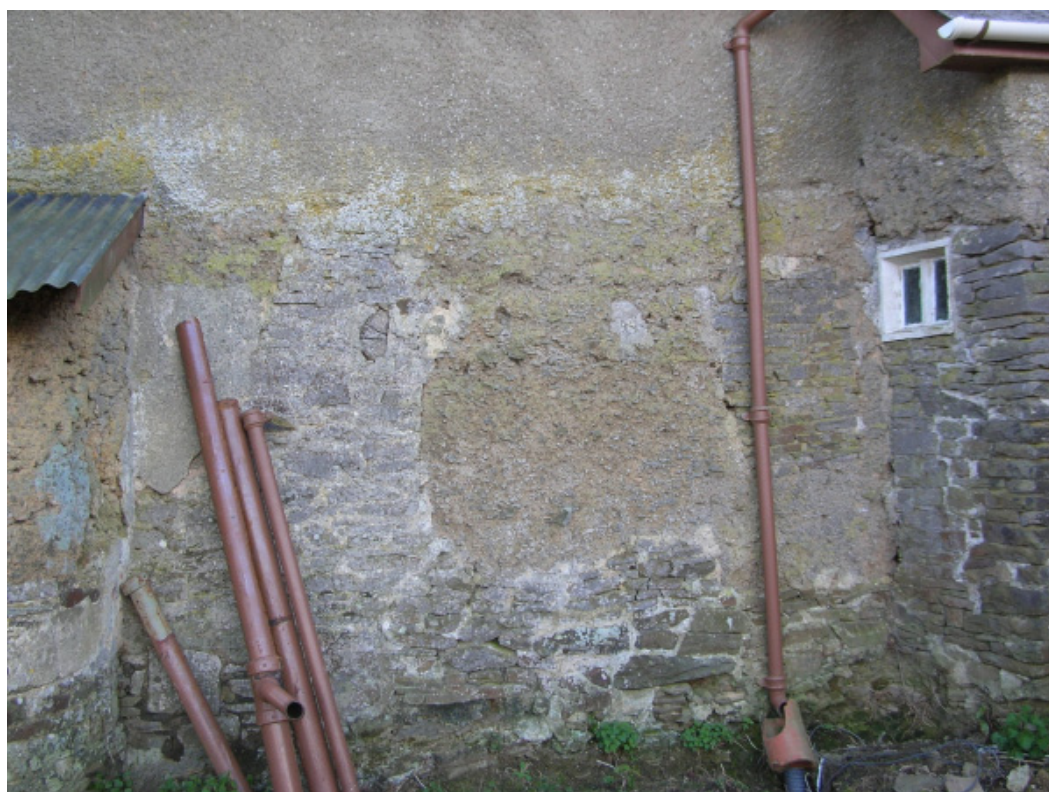
**Plate 10.** North elevation of original building, between the bread oven and smoking chamber chimneys to the left and the stair turret to the right, showing remedial work in the cob walling

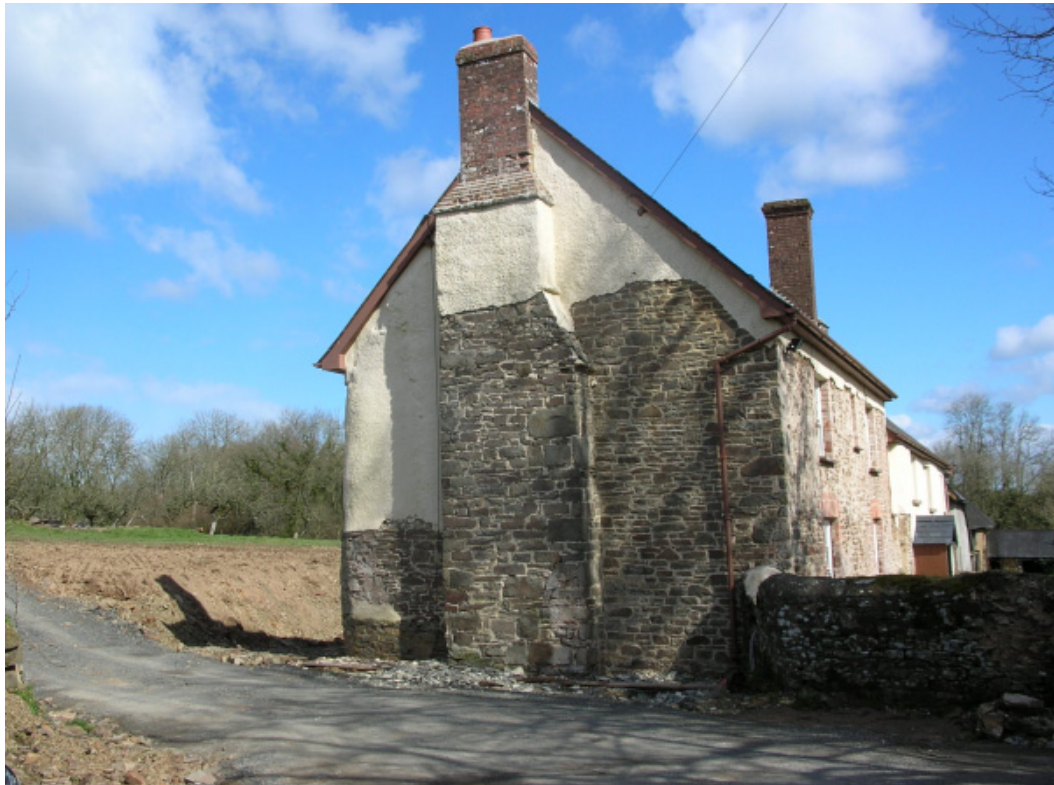
**Plate 11.** Gable end of western extension, from the south-west west

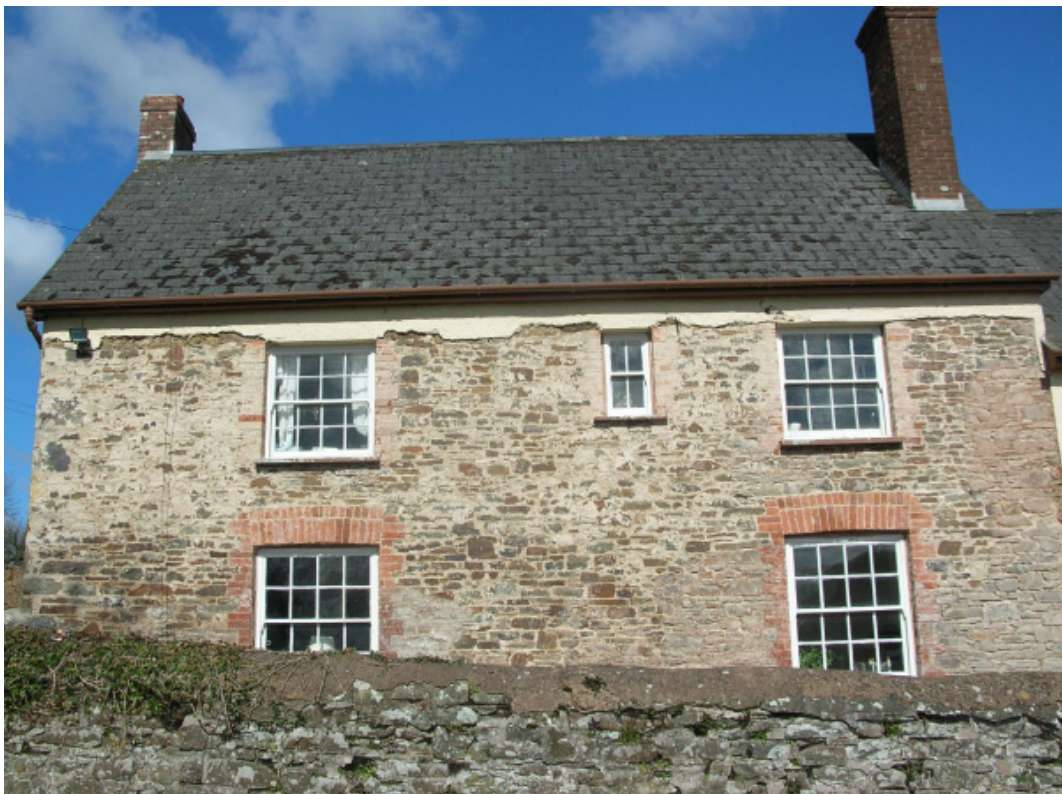
**Plate 12.** Front (south) elevation of later western extension

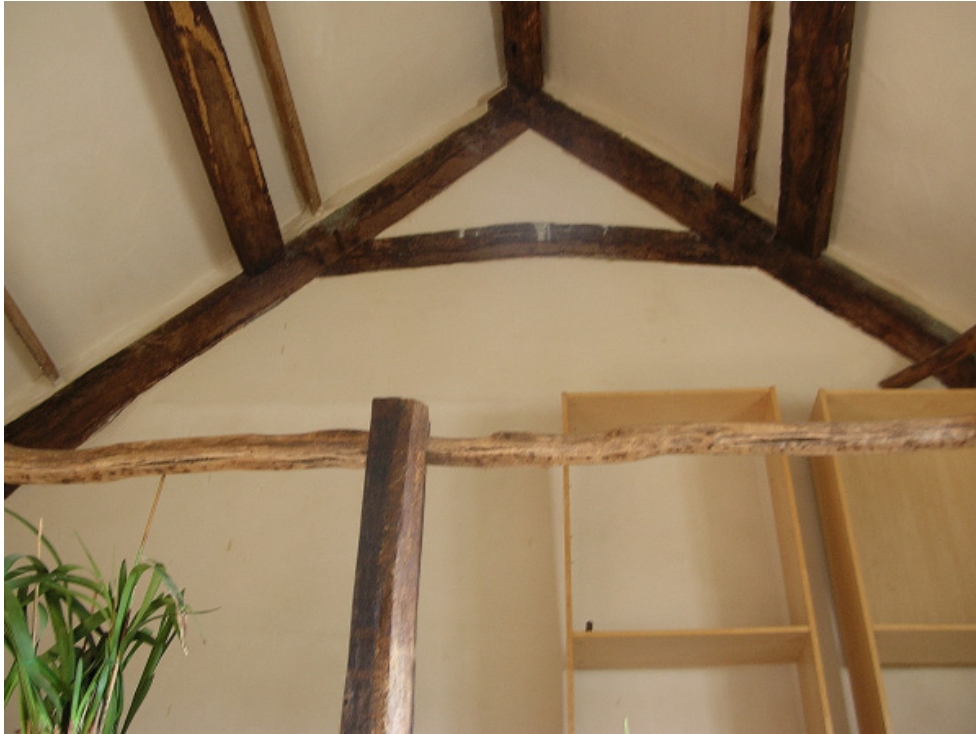
**Plate 13.** Partition between the gallery and the hayloft, from the west

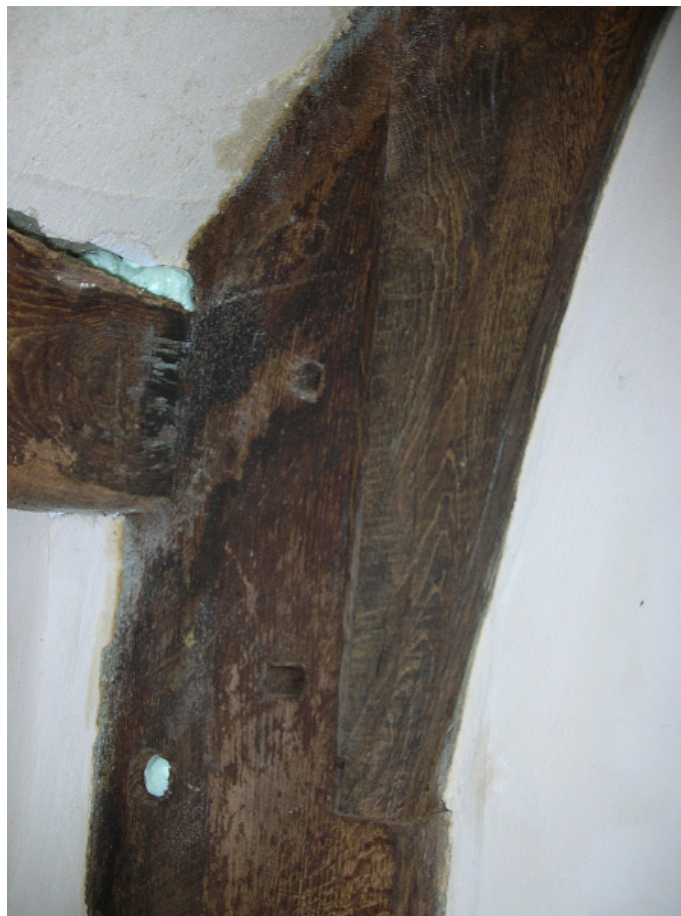
**Plate 14.** Cruck hip with pegs and protruding wall plate in the north-east corner of the gallery

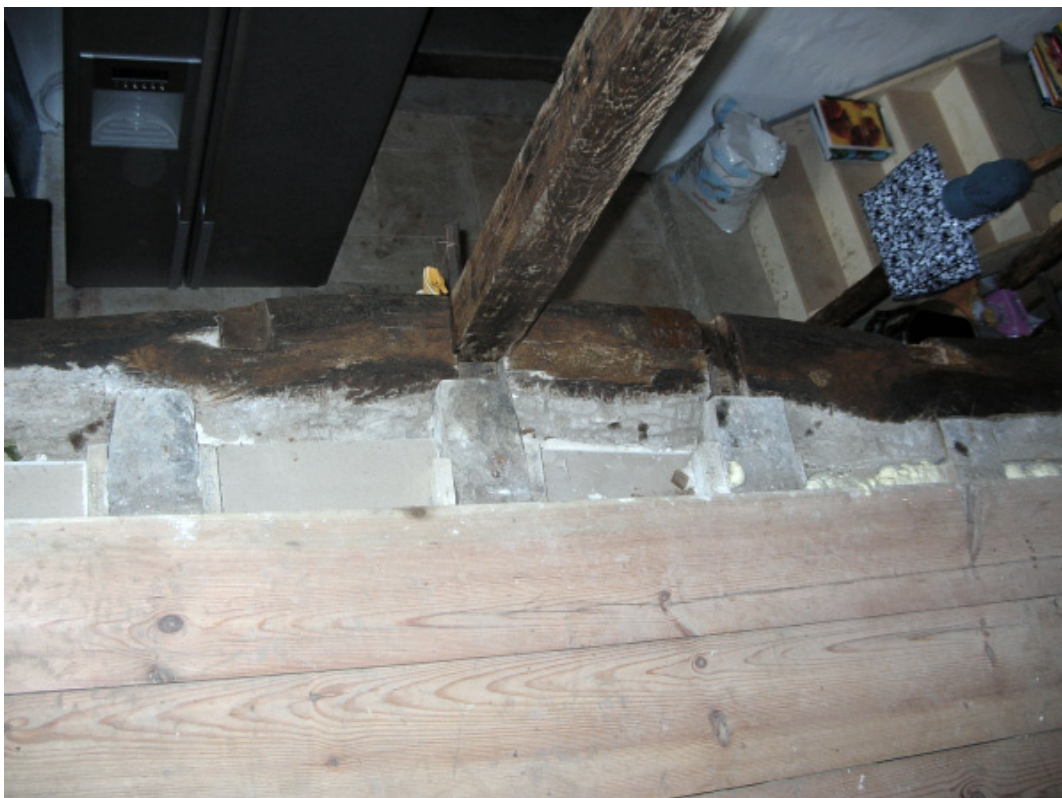
**Plate 15.** View from gallery looking down into the kitchen, from the east. Note the beam slots in the crossbeam pointing towards the west

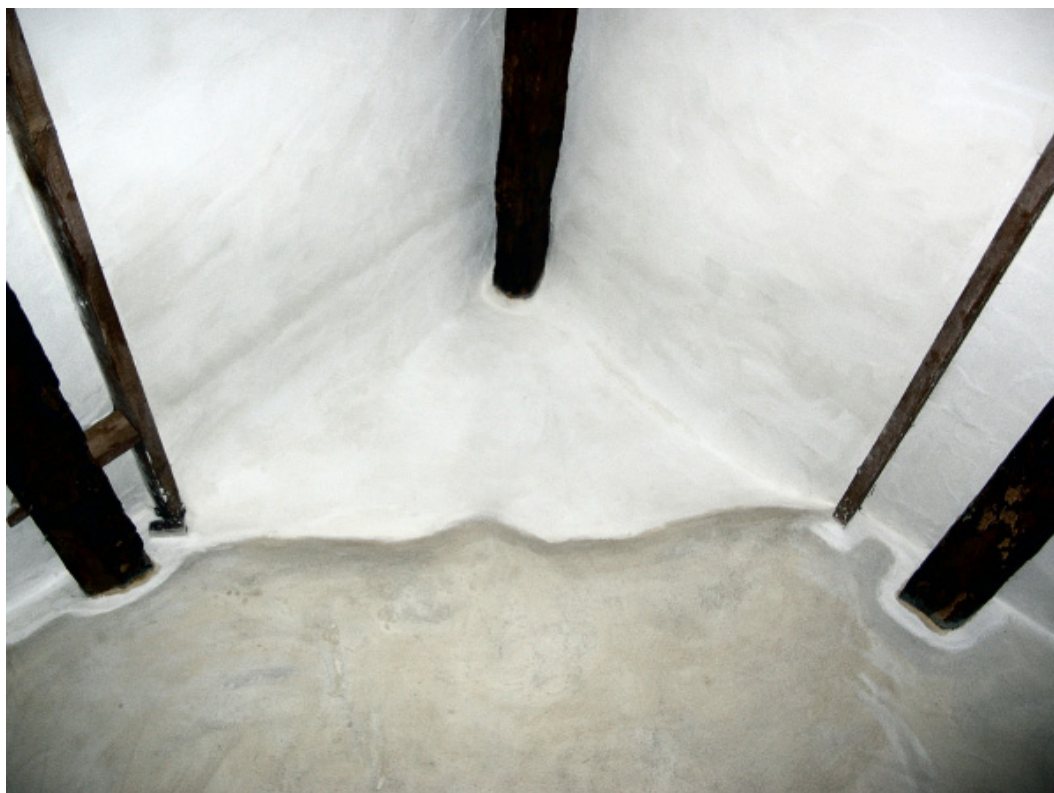
**Plate 16.** Wall between the service end and the cross-passage, from the east. Note the change in the depth of the render above the purlins

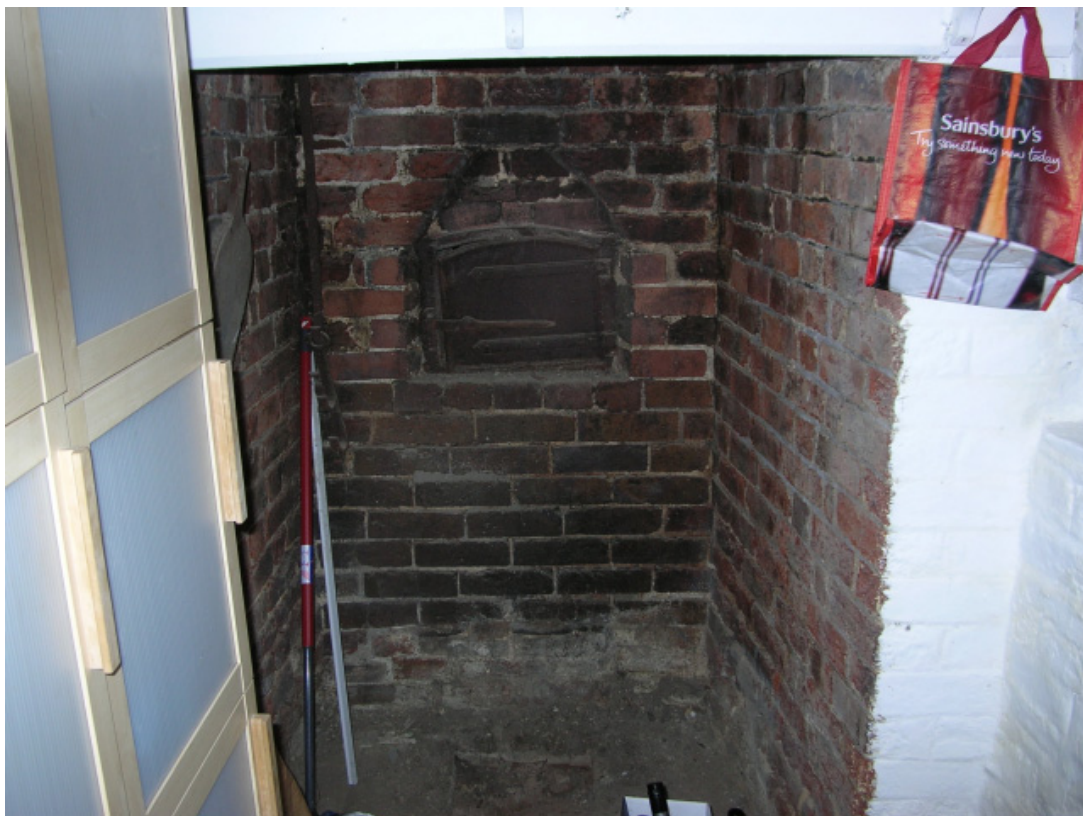
**Plate 17.** Bread oven and smoking chamber at the northern end of the cross-passage, with part of the original rubble wall to the right

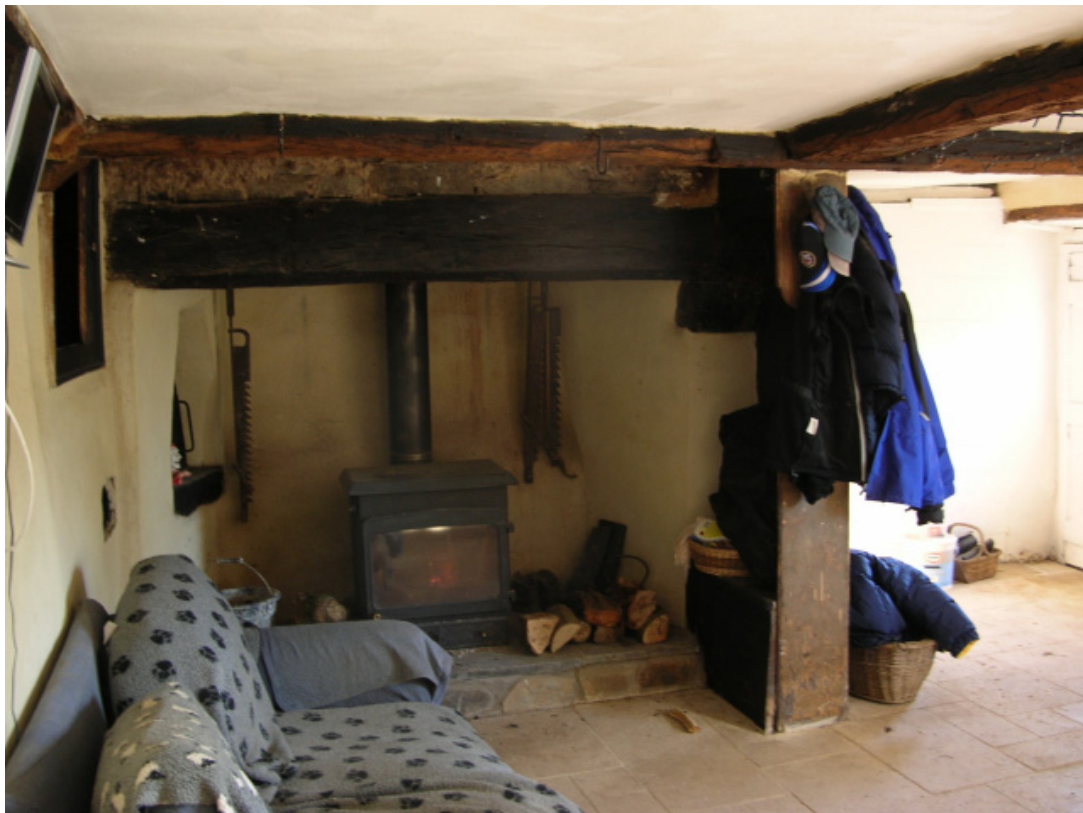
**Plate 18.** Fireplace and crossbeams within the hall from the west

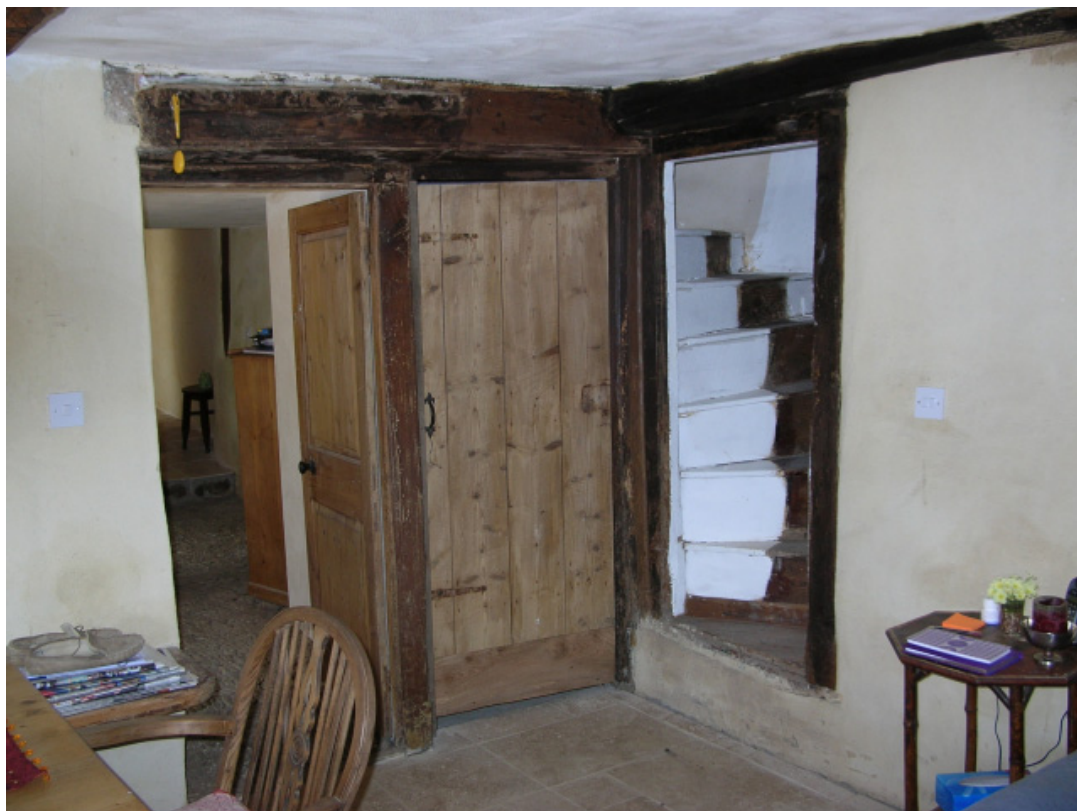
**Plate 19.** Spiral staircase and doorways leading to lobby and inner room, in the north-west corner of the hall, from the south-east

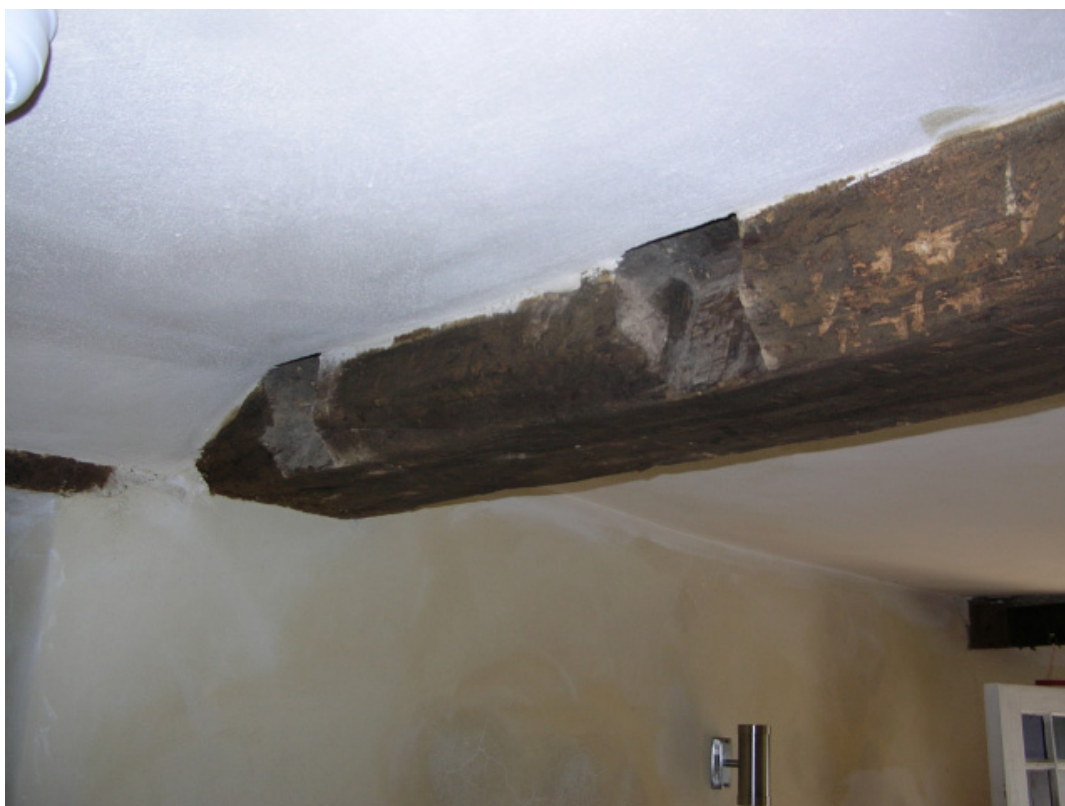
**Plate 20.** Two vertical beam slots within the east to west crossbeam in the inner room, from the north-west

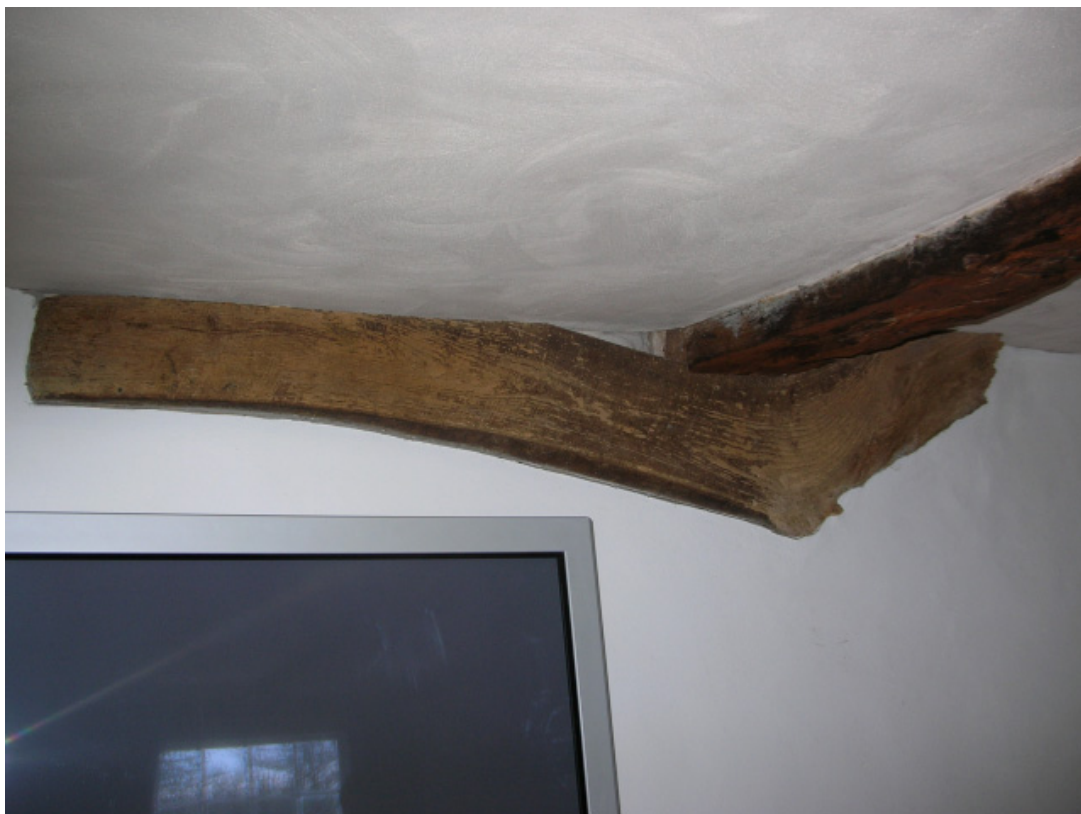
**Plate 21.** Re-used cruck blade supporting the crossbeam in the lounge of the western extension, from the south

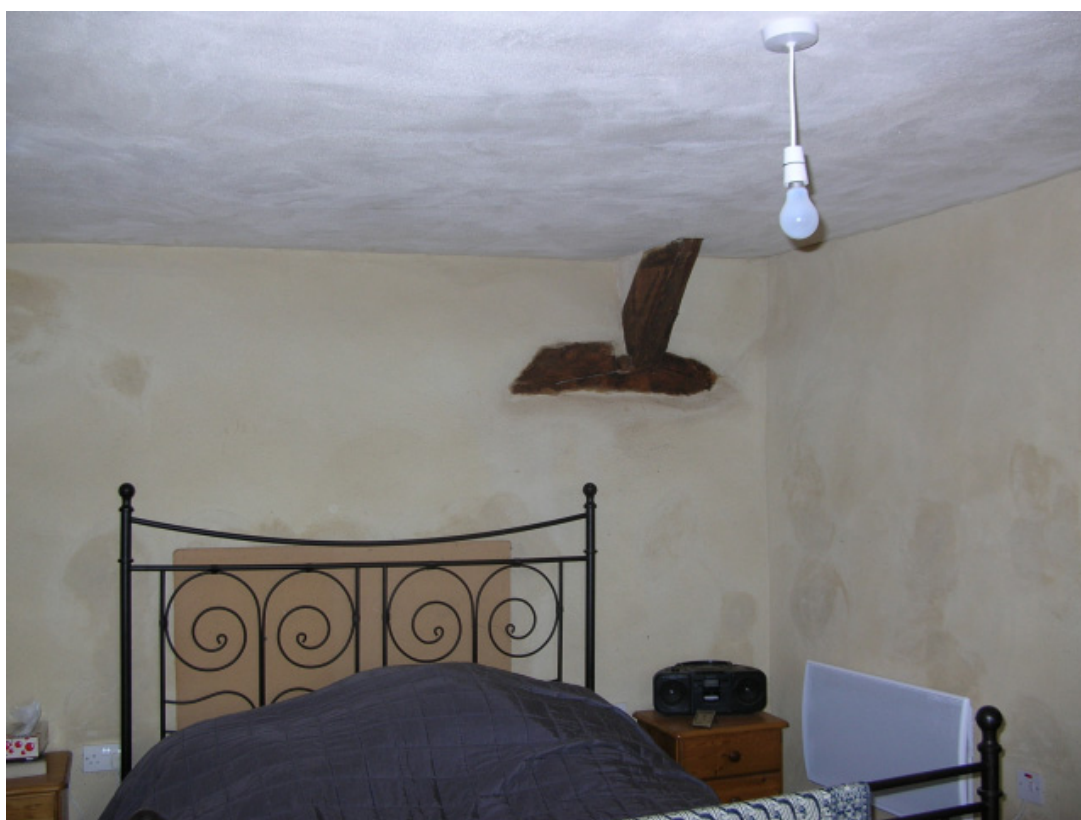
**Plate 22.** Junction of A-frame rafter and wall plate visible in the northern wall of the eastern bedroom within the western extension

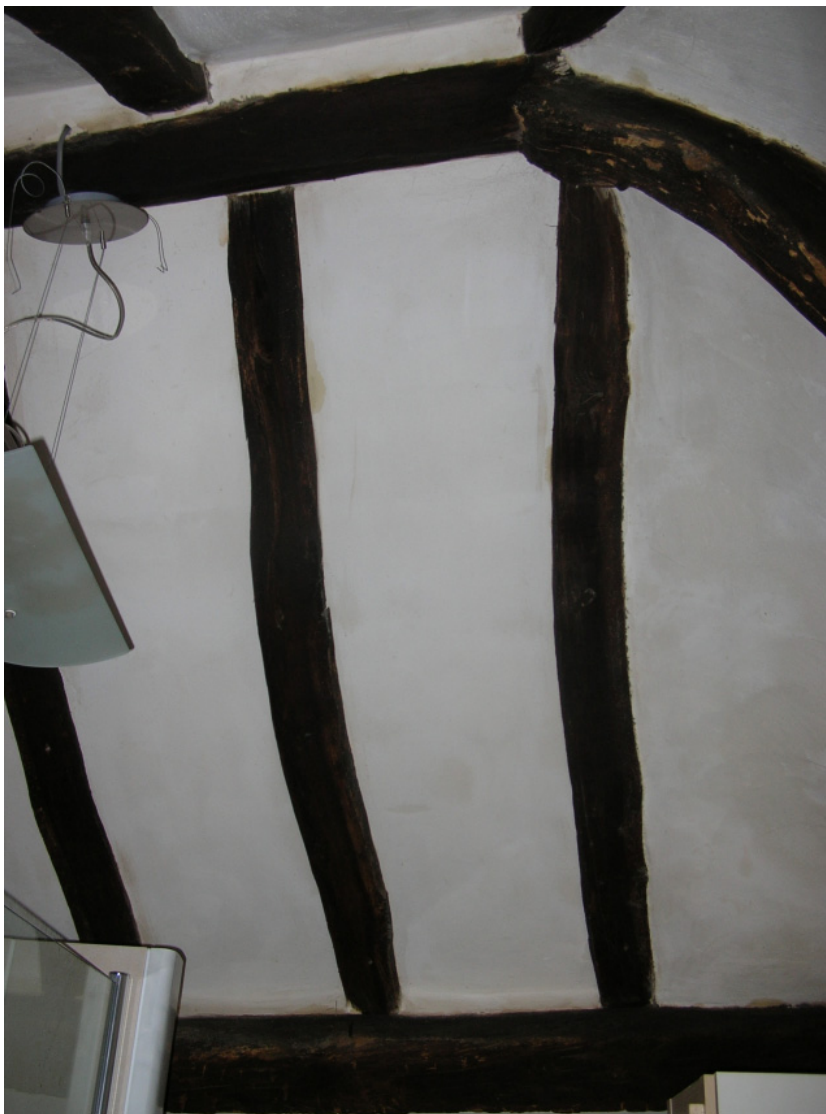
**Plate 23.** The side-pegged jointed cruck roof trusses within the bathroom (above the inner room), from the north

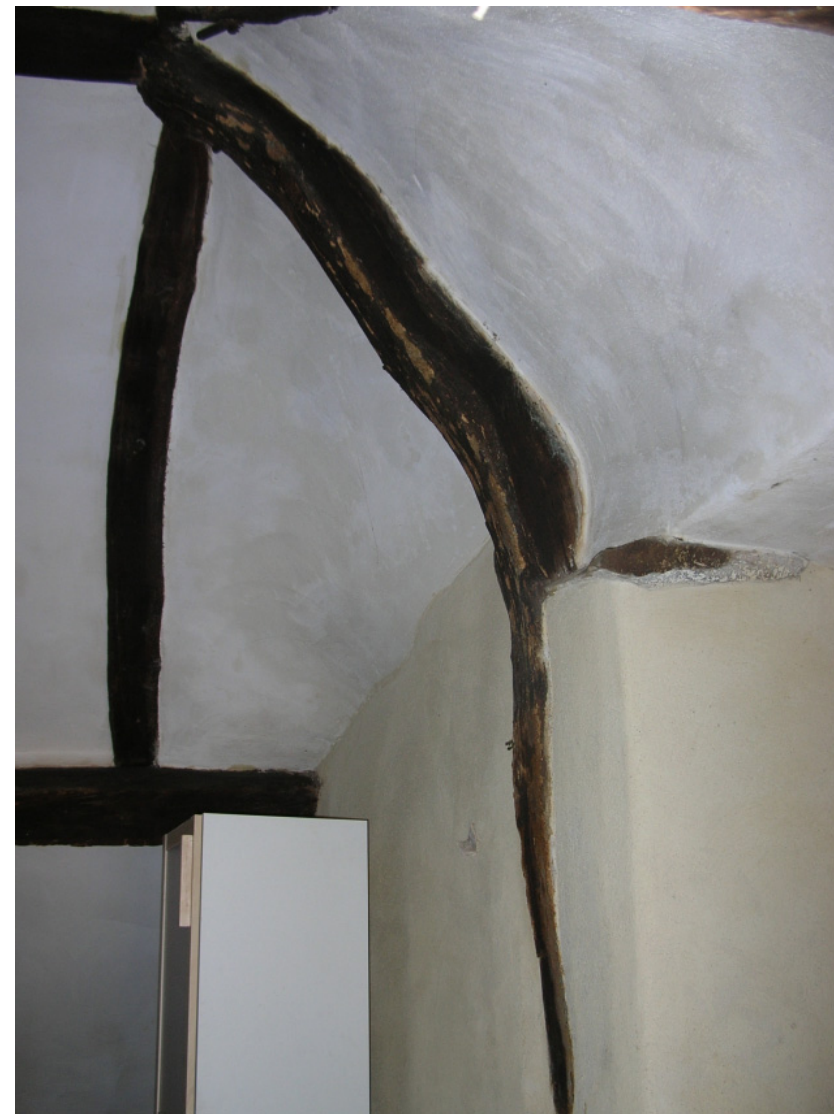
**Plate 24.** The curved King Post supporting the ridge pole of the roof above the bathroom (above the inner room), from the north

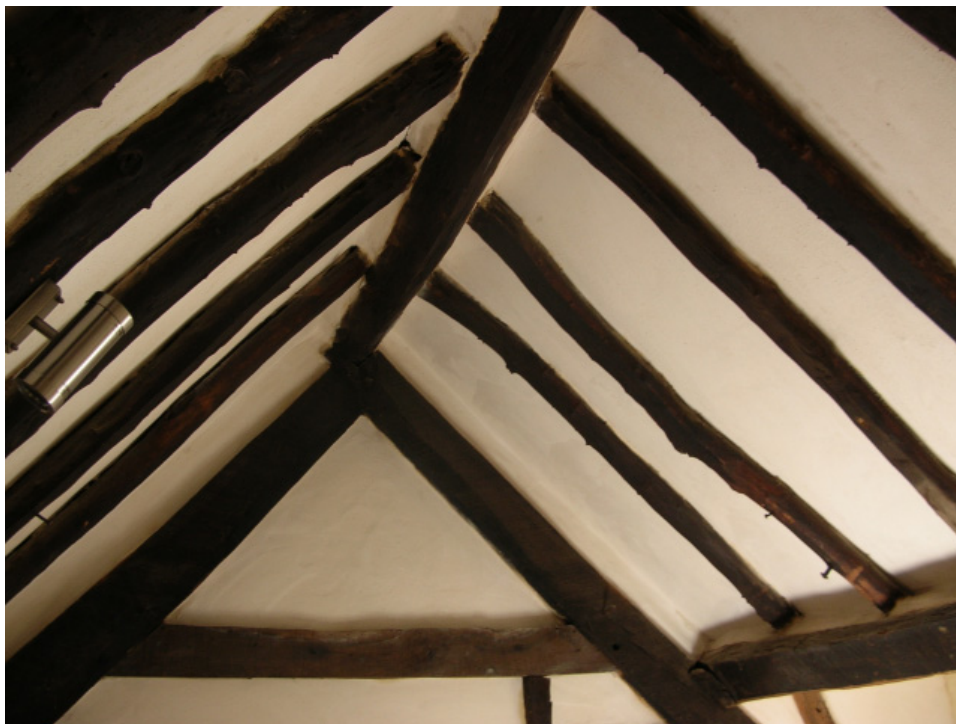
**Plate 25.** Roof of side-pegged jointed cruck construction in the main bedroom above the hall, from the west

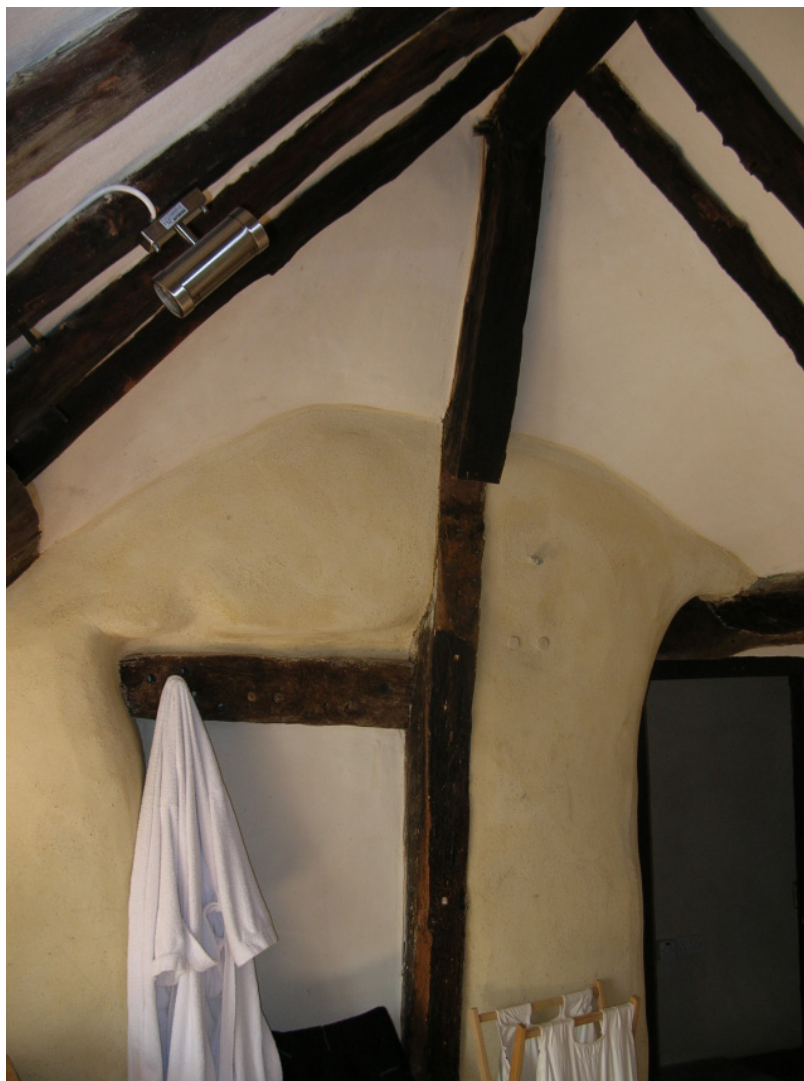
**Plate 27.** East facing wall of the main bedroom showing two lapped vertical timbers supporting the ridge pole, and a blocked doorway, from the south-east
