# **Westcott Barton, Thelbridge, near Tiverton, Devon.**

*An Archaeological Building Assessment.*

April 2007

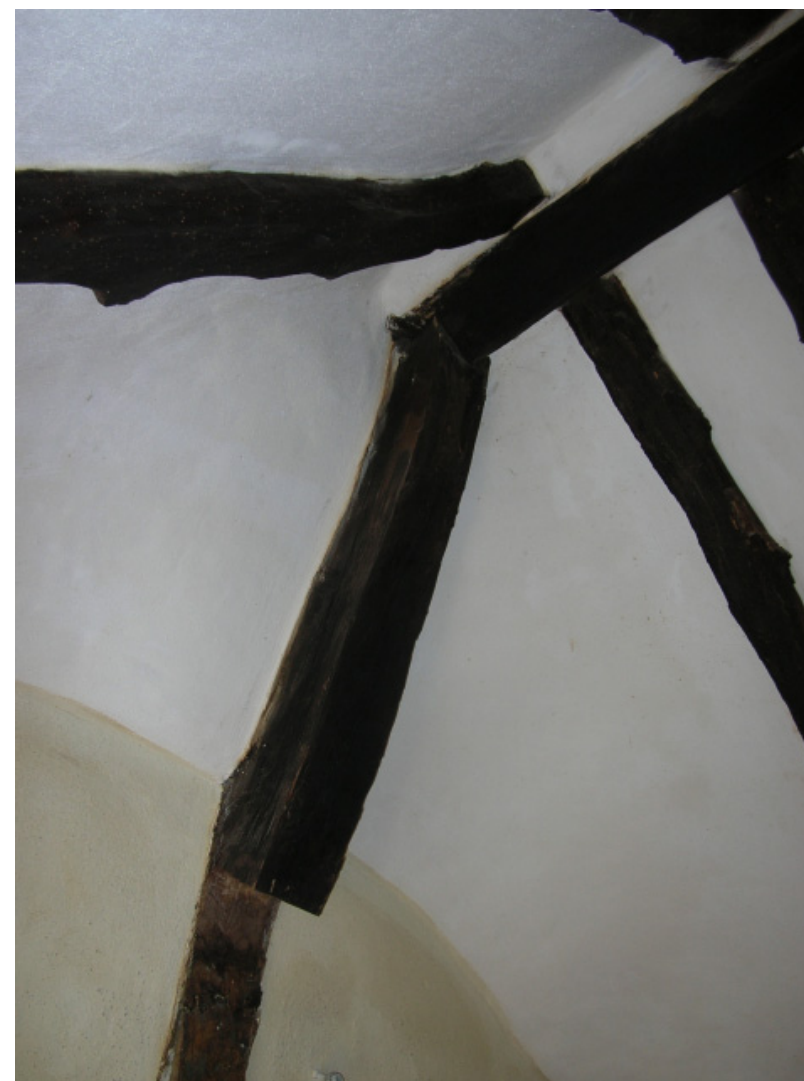
**Plate 28.** Close-up of two lapped vertical timbers supporting the ridge pole in the east facing wall of the main bedroom, from the south-east

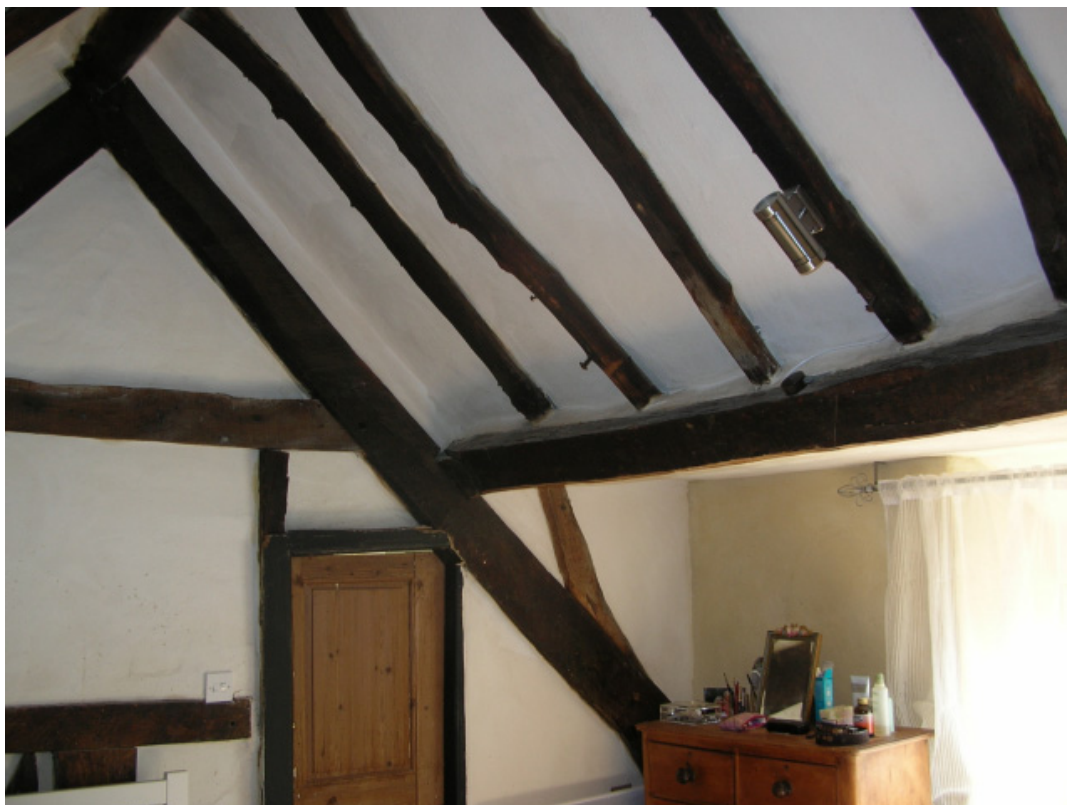
**Plate 29.** The main bedroom above the hall from the north-west, showing the extra room created between the original eaves and purlins after the eaves were raised

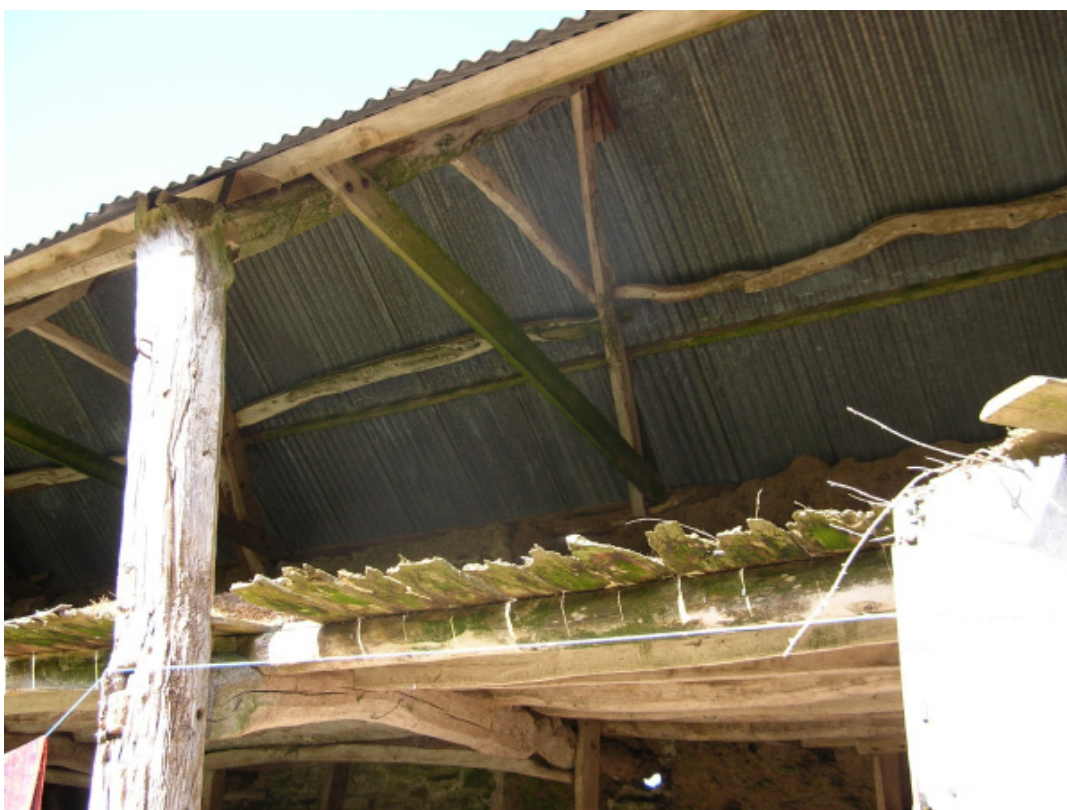
**Plate 30.** The linhay barn hayloft and roof of the northern range, from the south-east, showing the A-frame roof with pegged lap-jointed collars

- 6.17. The linhay barn is attached to the eastern end of the byre and hayloft (**Figure 5**). The south side of the linhay is open-fronted and of seven bays, although the western bay is obscured by a later lean-to structure attached to the byre, and the two eastern bays have been infilled to create stabling (**Plate 3**). The roof is supported on massive oak posts resting on stone pads, and crossbeams at first floor height supporting a hayloft. The A-frame roof trusses have pegged lap-jointed collars (see **Plate 30**).

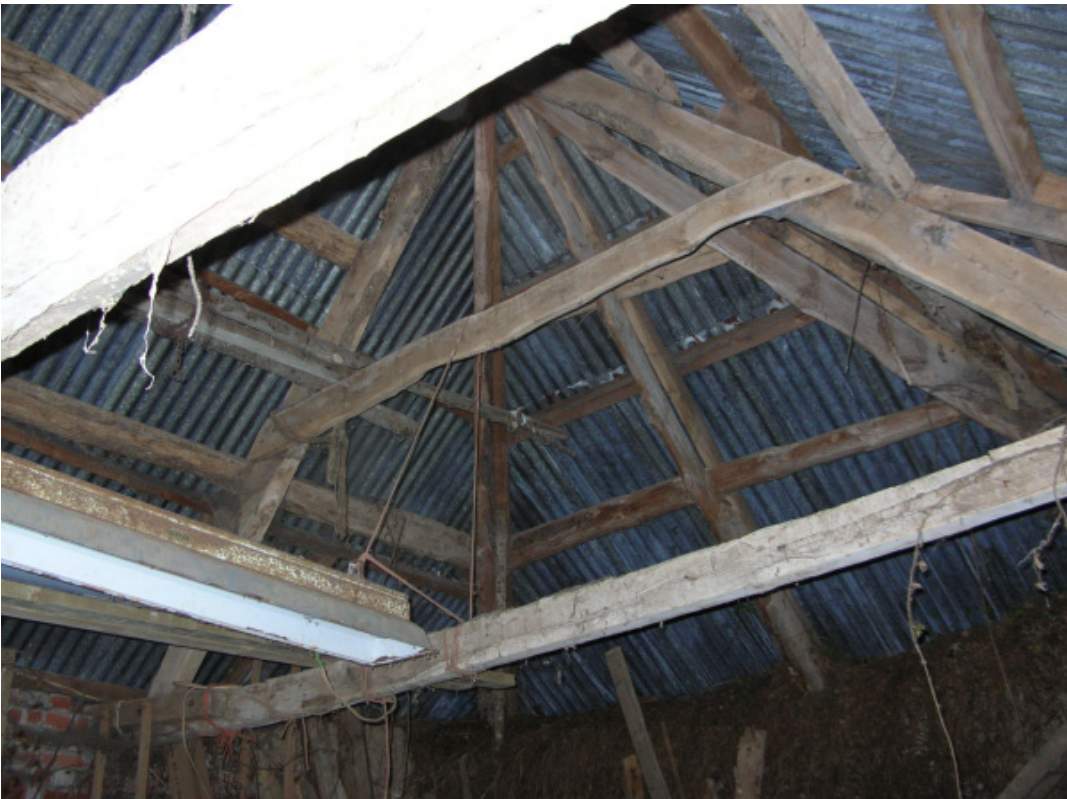
**Plate 32.** A-frame truss roof with pegged lap-jointed collars within the byre of the southern range, from the north-east

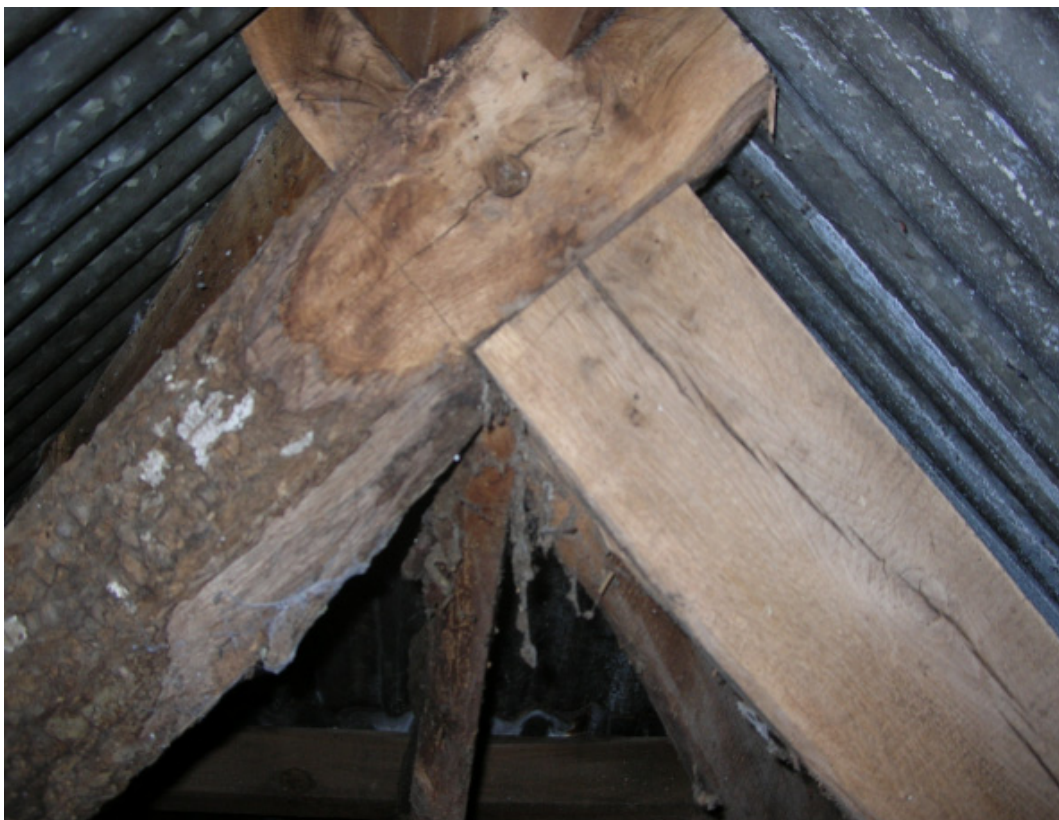
**Plate 33.** Close-up of a the ridge element of the A-frame truss roof with pegged lap-jointed collars within the byre of the southern range

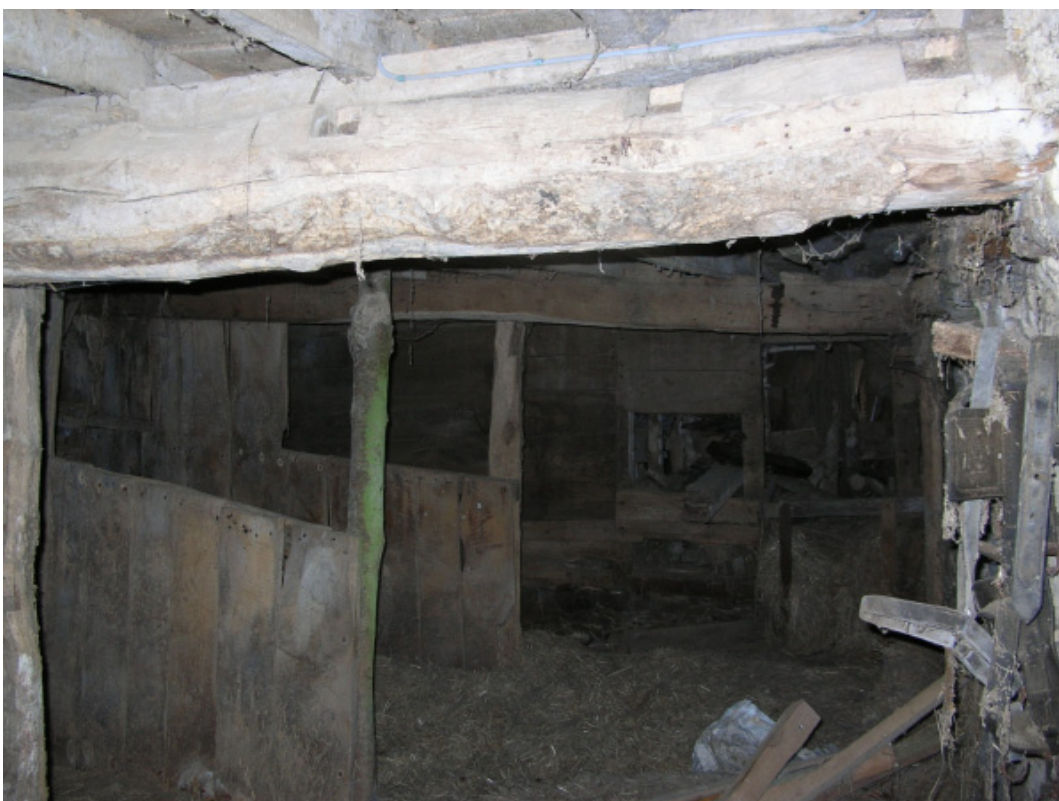
**Plate 34.** Original crossbeam of southern byre with joist slots, below new crossbeam supporting hayloft floor, from the north-east

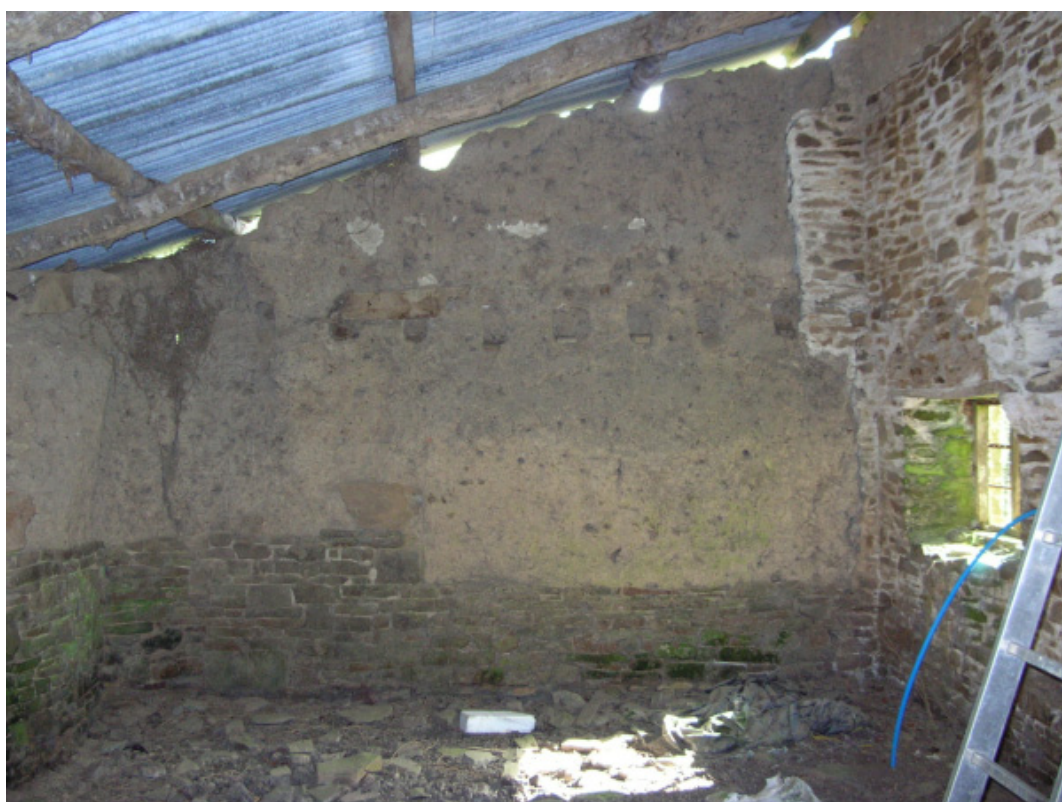
**Plate 36.** Interior of angled building at east end of southern linhay showing joist holes in cob wall, and rubble wall on the right, from the north-west
