Redundant Barns, Tackbear Manor, Bridgerule, Devon.

An Archaeological Programme of Works: Historic Building Recording and
Watching Brief

COAS reference: COAS/SBR/07/TBD

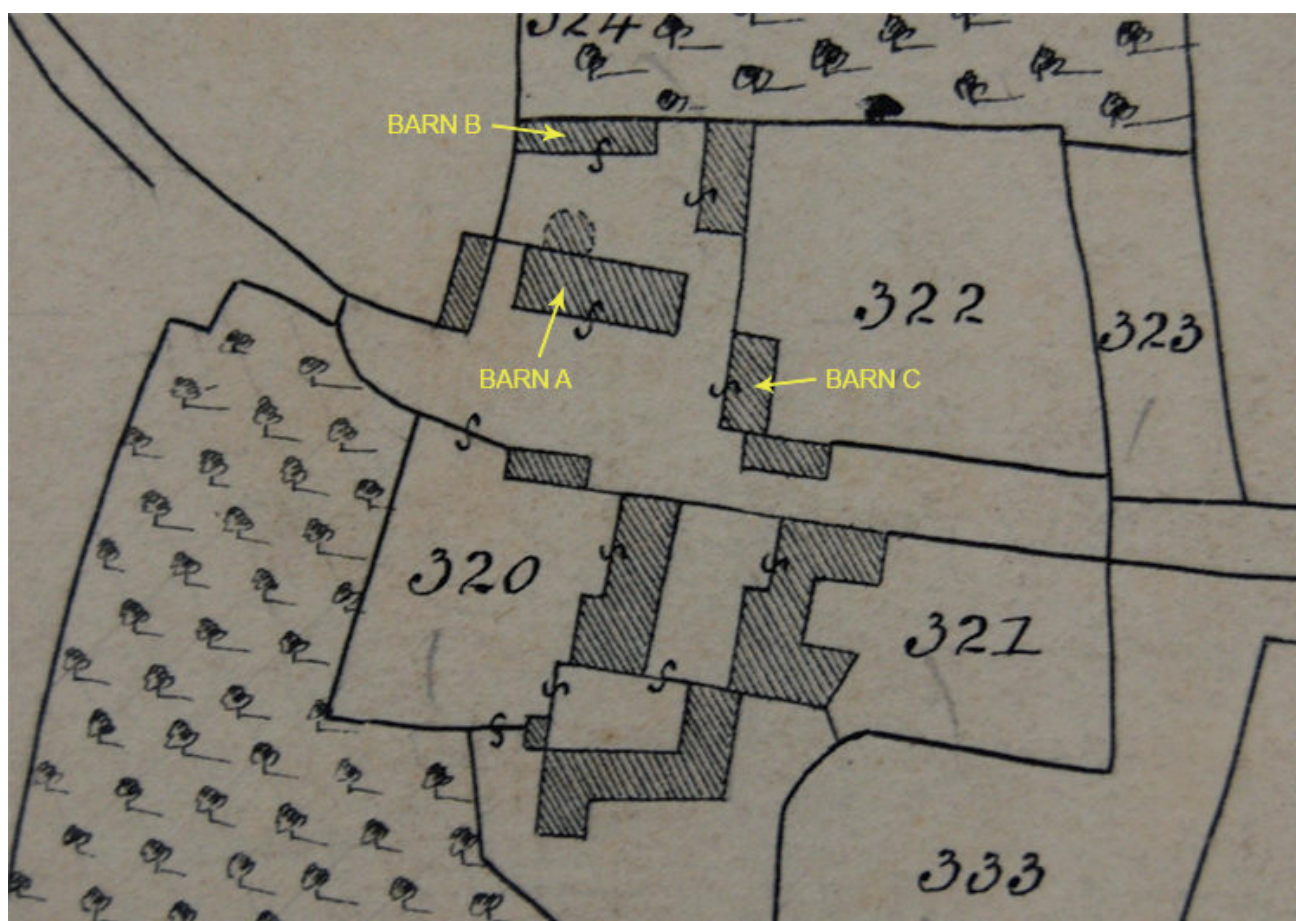
Figure 2. Extract from Bridgerule West Tithe Map 1842

- 4.10. The location and arrangement of the buildings represented on this map (**Figure 2**) is broadly similar to what remains today, with the barns grouped to the west and north of the manor house. The buildings to the north of the house clearly represent barns 'A', 'B' and 'C' minus

more recent attachments/extensions. The building illustrated to the west of barn 'A' and the substantial building to the south of the manor house are no longer extant. The written apportionment that accompanies the tithe map describes, *inter alia*, the owners, occupants and land use at the time of the survey and is summarised for the area adjacent to the buildings in **Table 2**.

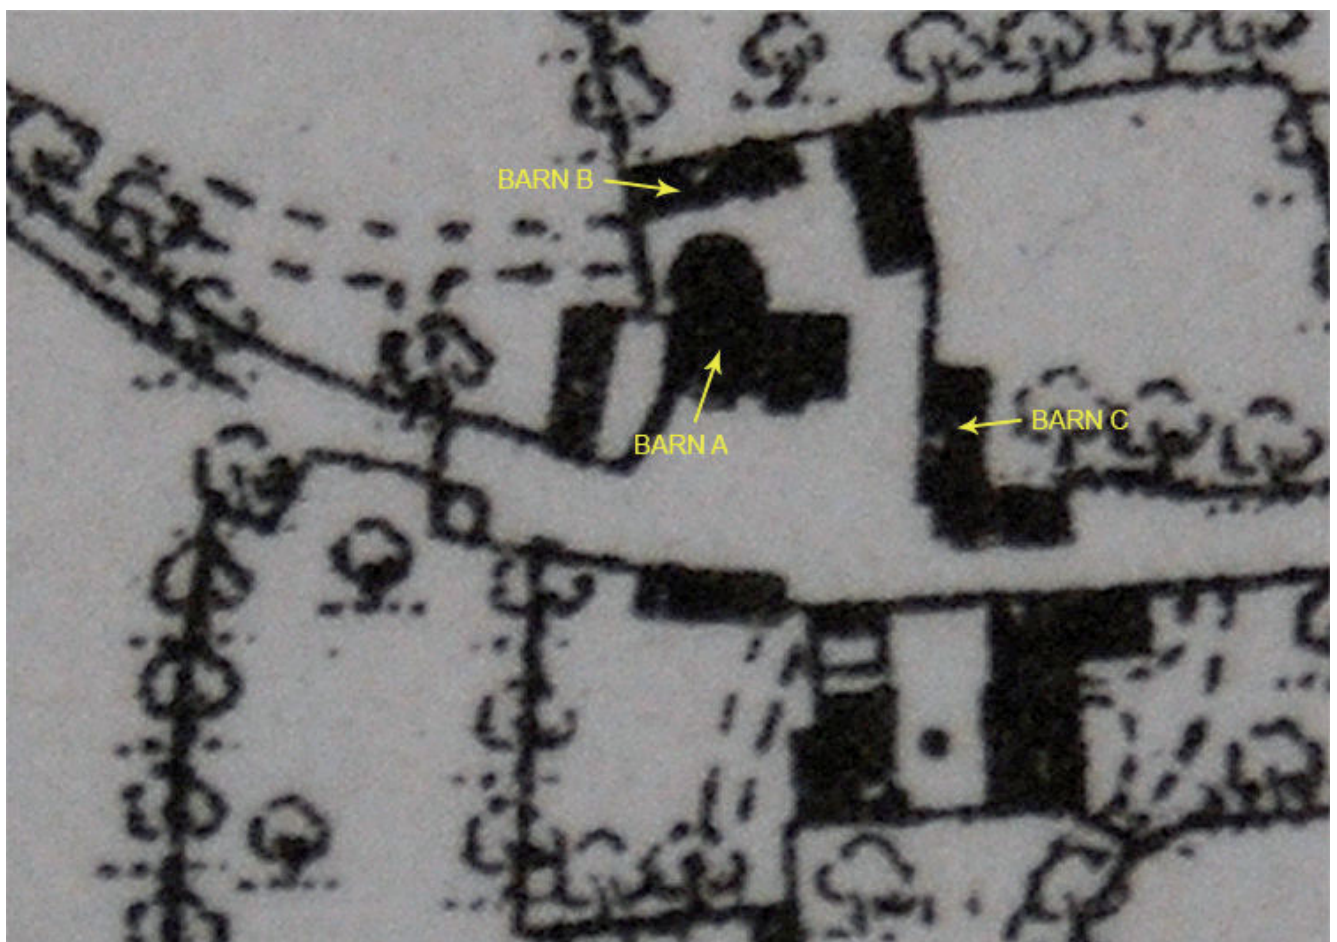
Figure 3. Extract from 6 inch 1st edition Ordnance Survey Map, 1889

- 4.12. This survey illustrates several changes from the earlier Tithe Map - the range of buildings attached to the south side of the manor house are no longer present and a wing on the south side of the building has also been removed (**Figure 3**).

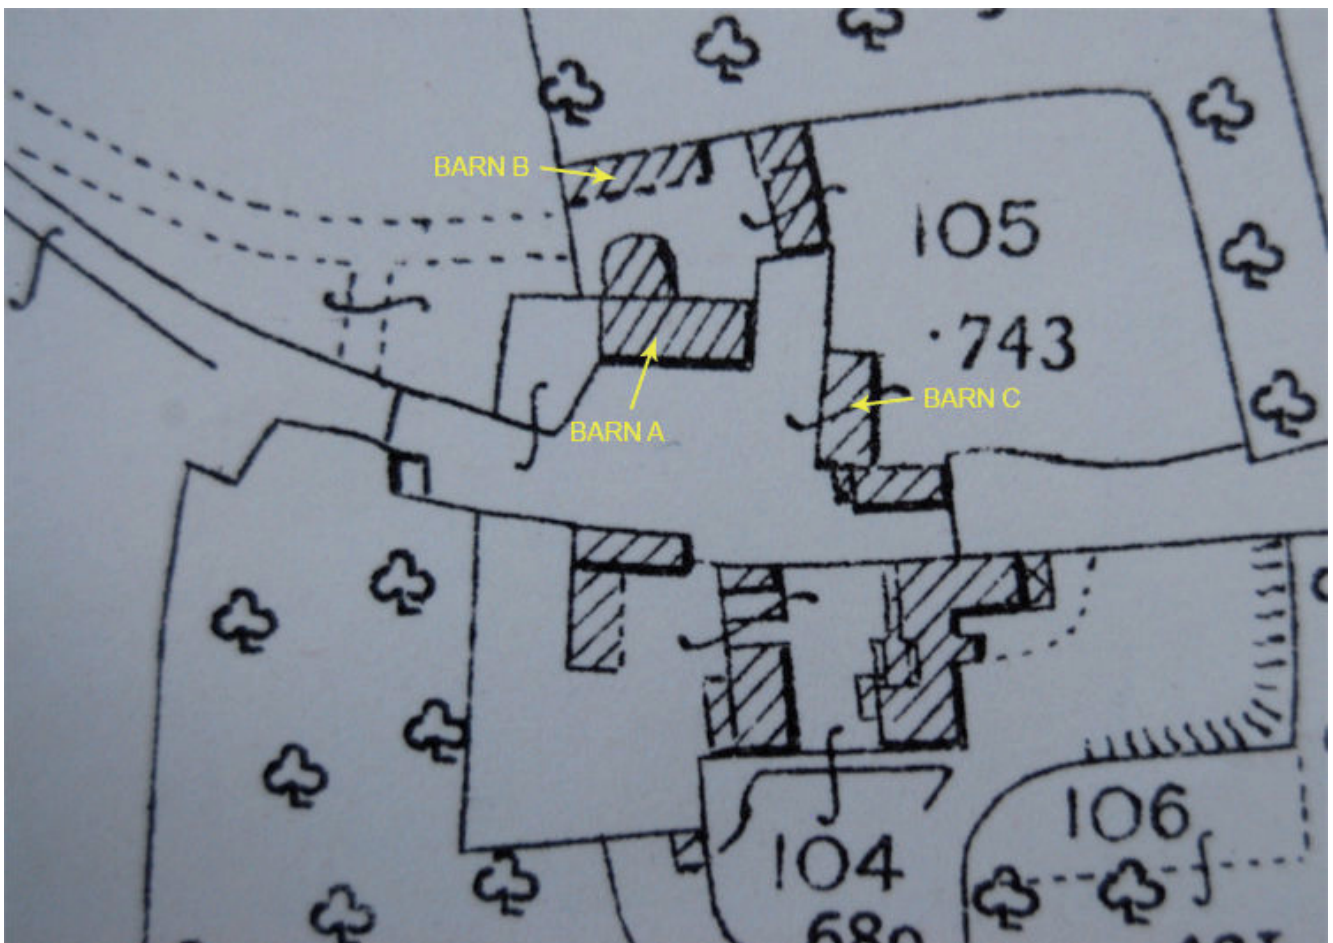
Figure 4. Extract from 25 inch 2nd edition Ordnance Survey Map, 1906

- 4.13. This survey illustrates no major changes from the earlier survey with the exception of an addition/extension to barn 'E' (**Figure 4**).

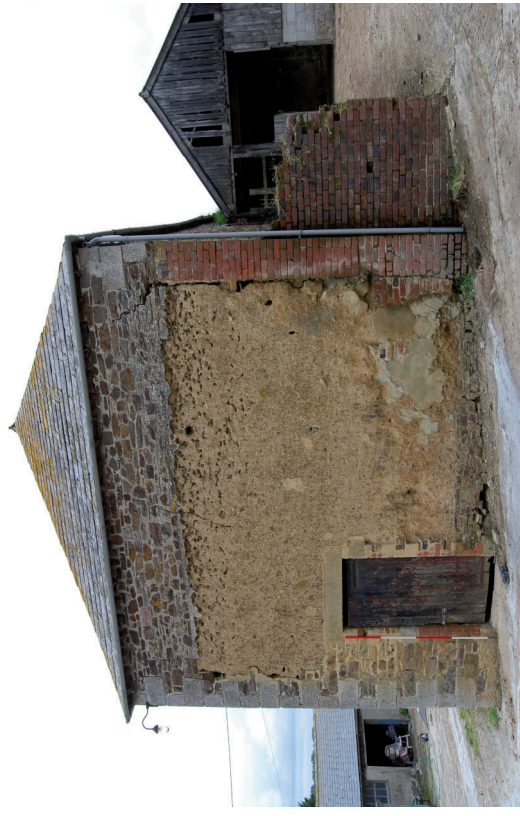
Plate 4. View 5.

- 9.2. The earliest recognisable phase of Tackbear Manor barns is represented by the cob walling (Phase 1) present in one wall of each of the barns and in the building adjoining the north wall of Barn A (see **Figure 8; Plate 4**). Cob walling was a traditional Devon building technique from the 14th to 19th centuries (Beacham 2001, 18), providing a broad date range for the barns. However, the presence of these buildings on the Bridgerule Tithe Map of 1844 (see **Figure 2**) confirms they were built prior to this date, and examination of the historic maps shows there has been little alteration to the ground plan with two significant exceptions. The northern and eastern ranges of Barn B are shown as separate buildings on the 1906 OS map (see **Figure 3**), however they are now connected by an extension creating an L-shaped plan. The 1844 tithe map (see **Figure 2**) shows a round structure attached to the north wall of Barn A, while the 1889 OS map (see **Figure 3**) and 1906 OS map (see **Figure 4**) (both based on a survey of 1883) show a larger sub-rectangular building with slightly rounded corners. The round structure

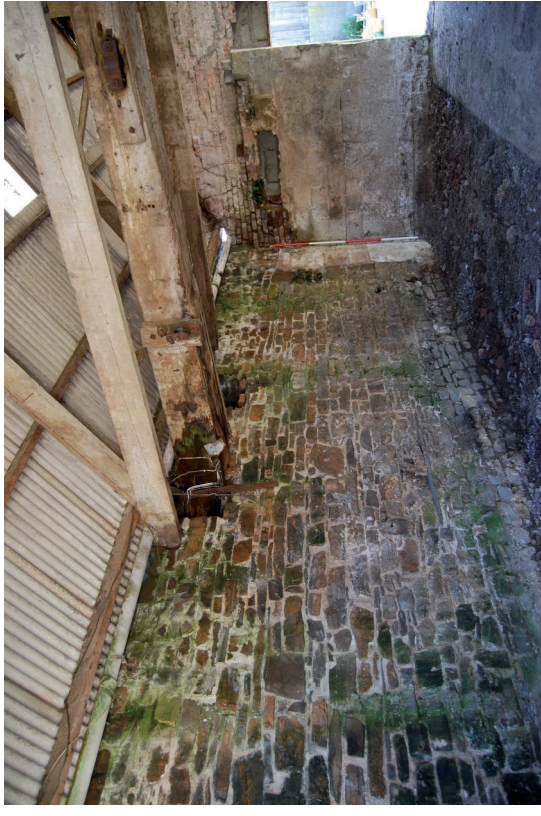
Plate 10. View 37.

was probably a horse-engine house, an innovation thought to have arrived in Devon after its invention and development in Scotland during the late 18th century (*ibid.*, 68). The location of this building on the higher ground to the north of the barn would have enabled the horse-engine to drive the granary machinery on the first floor of the barn. The round structure was replaced by the sub-rectangular structure and significant re-building was undertaken by Glubb in 1905, although a patch of cob walling in the western elevation survives perhaps from the earlier round structure. The existing building is rectangular, probably a result of recent modernisation although the plan on the 1906 OS map may not be accurate. The use of horse-engines continued into the early 20th century (*ibid.*), however the function of the sub-rectangular/rectangular structure cannot be ascertained. The only possible remains of the horse-engine consist of a beam in the north wall of the engine house (**Plate 9**). Similar beams took the upper bearing of the spindle and held the whole device steady (*ibid.*). Also, there is an in-filling of rubble above a thin wooden (?) plank in the wall between the engine house and the barn (**Plate 10**), which may indicate the position of the drive shaft between the two buildings.

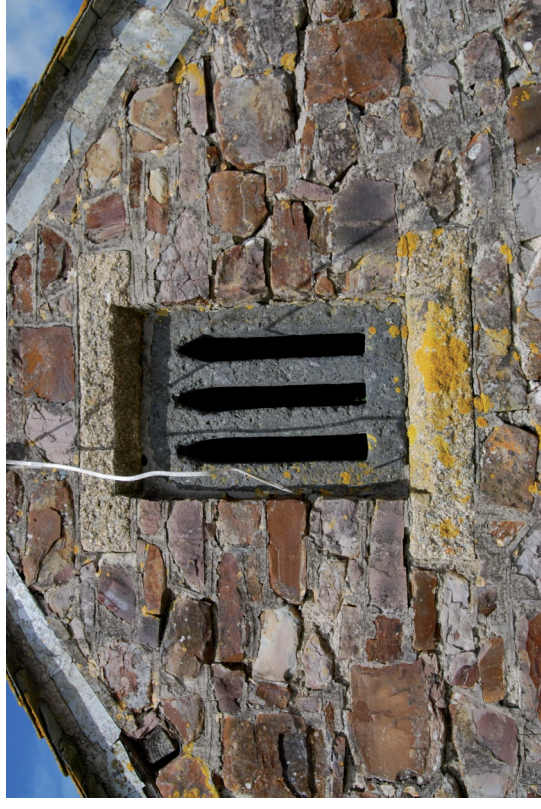
Plate 29. View 23

- 9.3. The restorations undertaken by Glubb were extensive (Phase 2): a plaque in Barn A dates the completion of this building to 1905, and as all three barns are of a similar style it can be concluded that the work was of a similar date. Repairs to cob buildings were often in rubble, brick and more recently concrete blocks as it was difficult to repair cob with cob and achieve a proper bond (*ibid.*, 22). Indeed, the barns are predominantly of coursed rubble (local red sandstone); this may be a facing material concealing cob walling beneath. The roofs of the barns are also broadly contemporary with the restoration, as A-frames and king-post trusses succeeded the jointed-cruck roofs commonly used until the early 19th century (*ibid.*, 64). The form of the windows and doorways in all three barns are at odds with the functional purpose of the buildings in which they are sited. There is an original window in the south gable of Barn C (**Plate 50**) with splayed jambs in the cob walling. However, the other doors and window surrounds are of granite, and include a mullion window (**Plate 39**), chamfered, segmental arch doorways with hoodmoulds (**Plate 13**) and windows with hoodmoulds (**Plate 14**). These features are Jacobean and have been reused, perhaps from the south-east wing of the manor house which was demolished in 1858. Indeed, material from this wing was reused in the 1937 western extension of the manor house (HER monument ref: 7122), indicating ready availability. The small ventilation windows (**Plates 29, 34 and 35**) were probably reset from the earlier barn fabric.

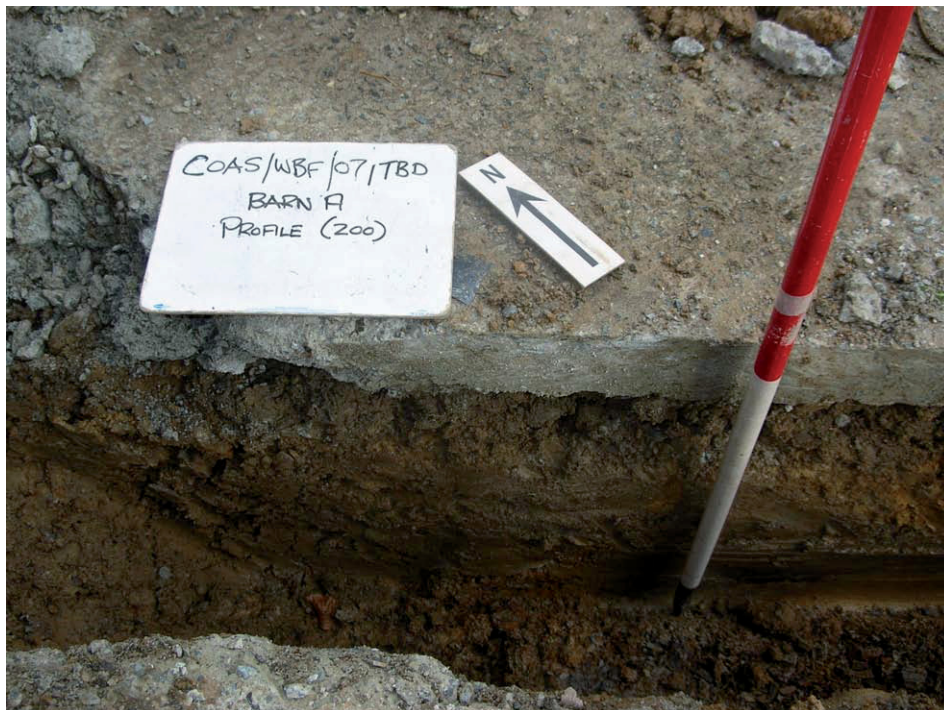
Plate 53. Profile 200

- 7.3. Observation of numerous profiles within the utility trenches indicated that earlier groundworks associated with the laying of the present day concrete farm yard had for the most part truncated any earlier deposits. Representative soil profiles (**Plate 53**) were recorded at three locations, with a generic sequence of concrete (200),(300),(400) over a base of hardcore (201), (301), (401) over natural clay (202), (302), (402).

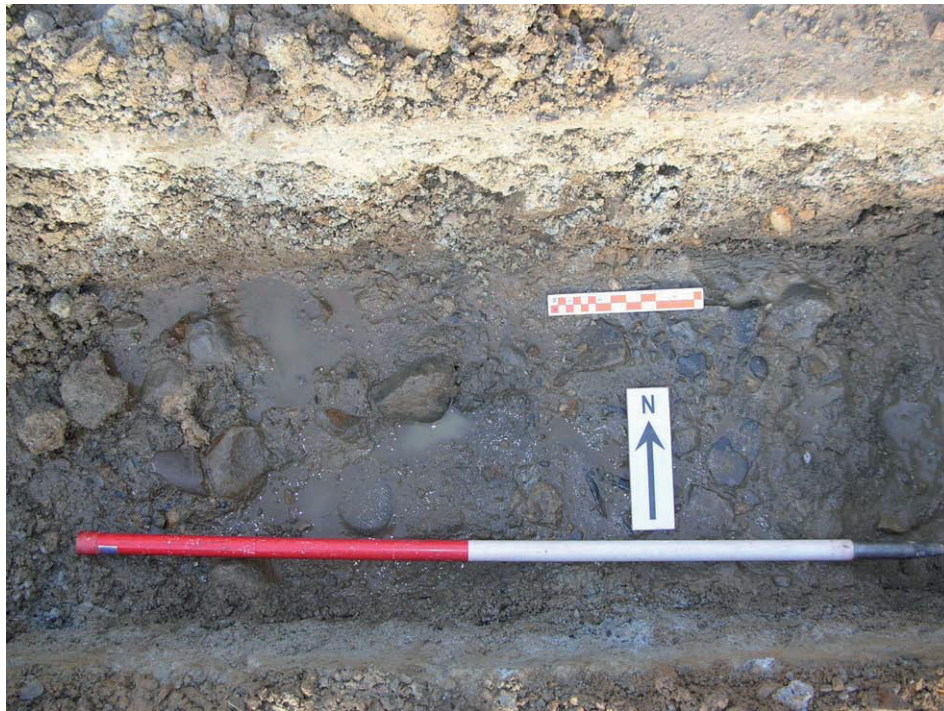
Plate 54. Vertical view of cobble layer (100)

- 7.4. An area of badly eroded cobbles (100)(101) was recorded to the west of barn 'B'. This consisted of a single layer 0.1m thick of stone cobbles (maximum dimension 0.3m) set into the natural clay (**Plate 54**).
