Friends Meeting House, York Street, Bath, Bath & North-East Somerset.

An Archaeological Watching Brief.

An Archaeological Watching Brief for Wessex Water plc

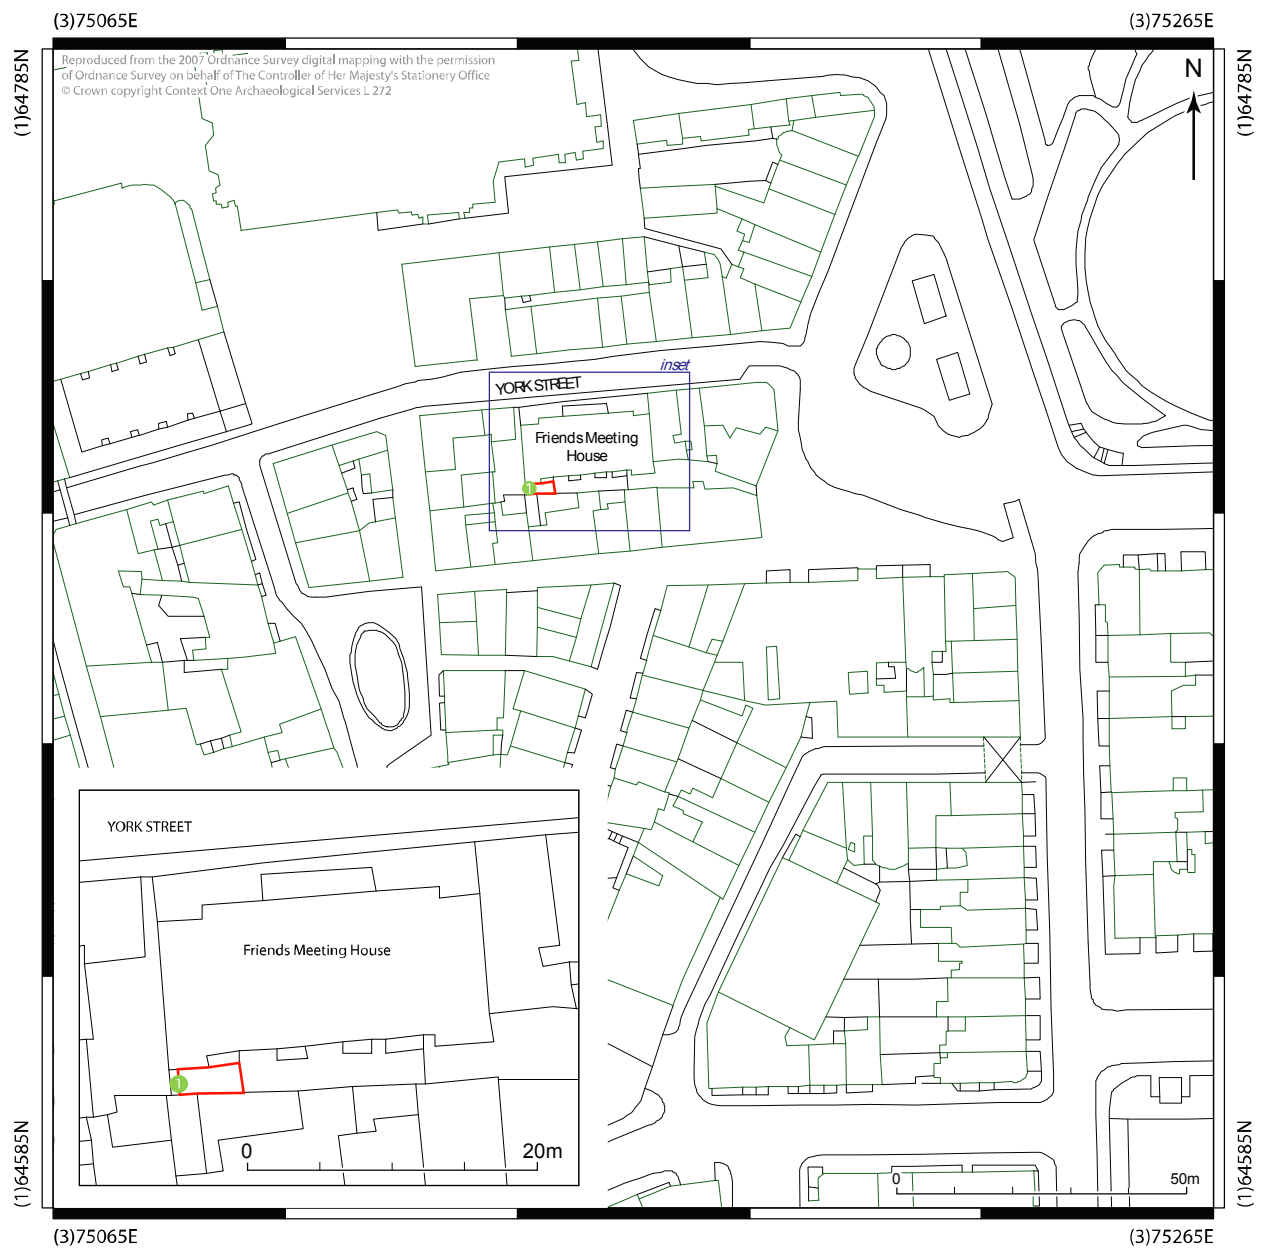
trench location

profile location	PROJECT TITLE Friends Meeting House, York Street, Bath, Bath and North-East Somerset		
	FIGURE TITLE Detailed site setting showing location of replacement sewer and profile		
	SCALE as shown	PROJECT CODE COAS/WBF/07/FYB	FIGURE NO. 2

- 5.1. A hand dug trench was excavated (c. 3m long by c. 1.5m wide by c. 2.9m deep) on the southern side of the building, to locate the existing sewer pipe to be replaced (**Figure 2**). The width of the trench was defined by the southern wall of the Friends Meeting House to the north, and by the northern wall of the adjacent building, to the south.

- 6.1. The following deposits were encountered (deposit numbers are enclosed by standard brackets). A representative profile of the deposit matrix was taken at the eastern extent of the trench (**Figure 2**). A simple sequence of 19th/20th century flagstones (100) overlying 19th century backfill (101) was observed throughout the trench.
- 6.2. A number of the flagstones (100) had been set into mortar. The backfill (101) which overlay the existing sewer pipe consisted of soft silt/clay/sand, with a moderate amount of small to large, rounded and angular stone inclusions.
- 6.3. Perpendicular to the walls of the existing buildings, stone buttresses were observed in the lower section of both the eastern and western extents of the trench.
