Walled Garden at Upton House Country Park, Upton, Poole, Dorset.

An Archaeological Field Evaluation.

for Poole Borough Council Leisure Services

February 2007

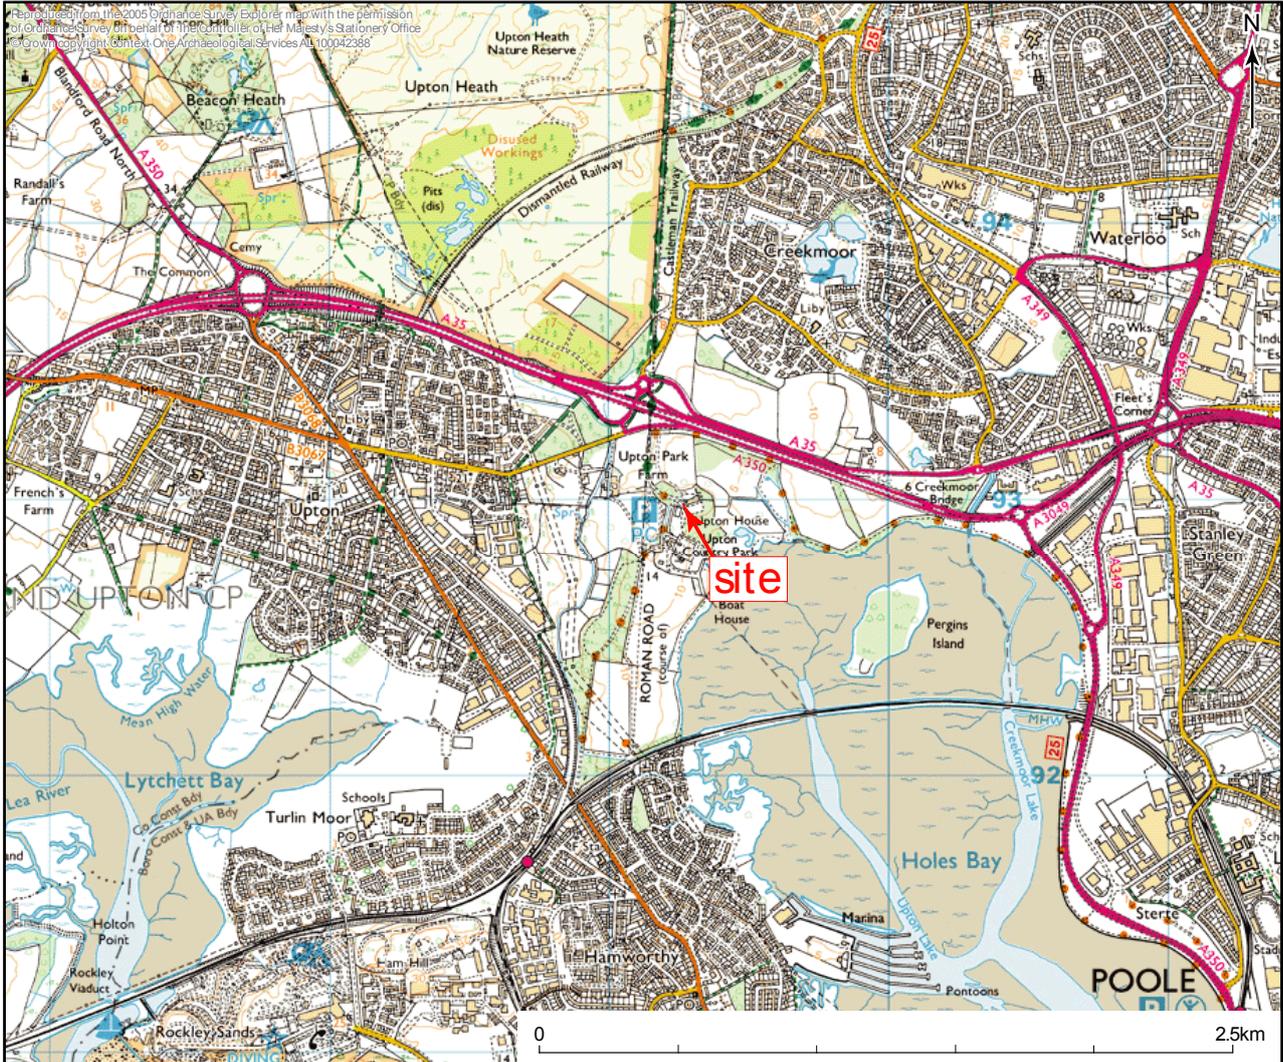
<p>PROJECT TITLE Walled Garden, Upton House Country Park, Upton, Poole, Dorset</p>		
<p>FIGURE TITLE Site setting</p>		
<p>SCALE 1:25,000@A4</p>	<p>PROJECT CODE OOAS/EVA/06/UHD</p>	<p>FIGURE NO. 1</p>

- 3.1. Upton Country Park is located to the immediate south of the A35 trunk road, approximately 1.5km east of Upton and c. 4.5km north-west of Poole in Dorset. The Walled Garden (centred on NGR SY 99275 92825) is situated c. 150m south of Upton House, and is bounded by a brick wall on all sides. The site occupies an area of flat ground that gently rises from c. 9m above Ordnance Datum (AOD) on the south-east of the site to c. 11.50m AOD on the north-west. The site is currently under lawn with a border of plants against the walls, a vegetable plot in the south-east corner with an adjacent polytunnel near the south-western edge of the garden. The underlying solid geology is Palaeogene, Barton Bracklesham and Bagshot Beds (British Geological Survey 2001).

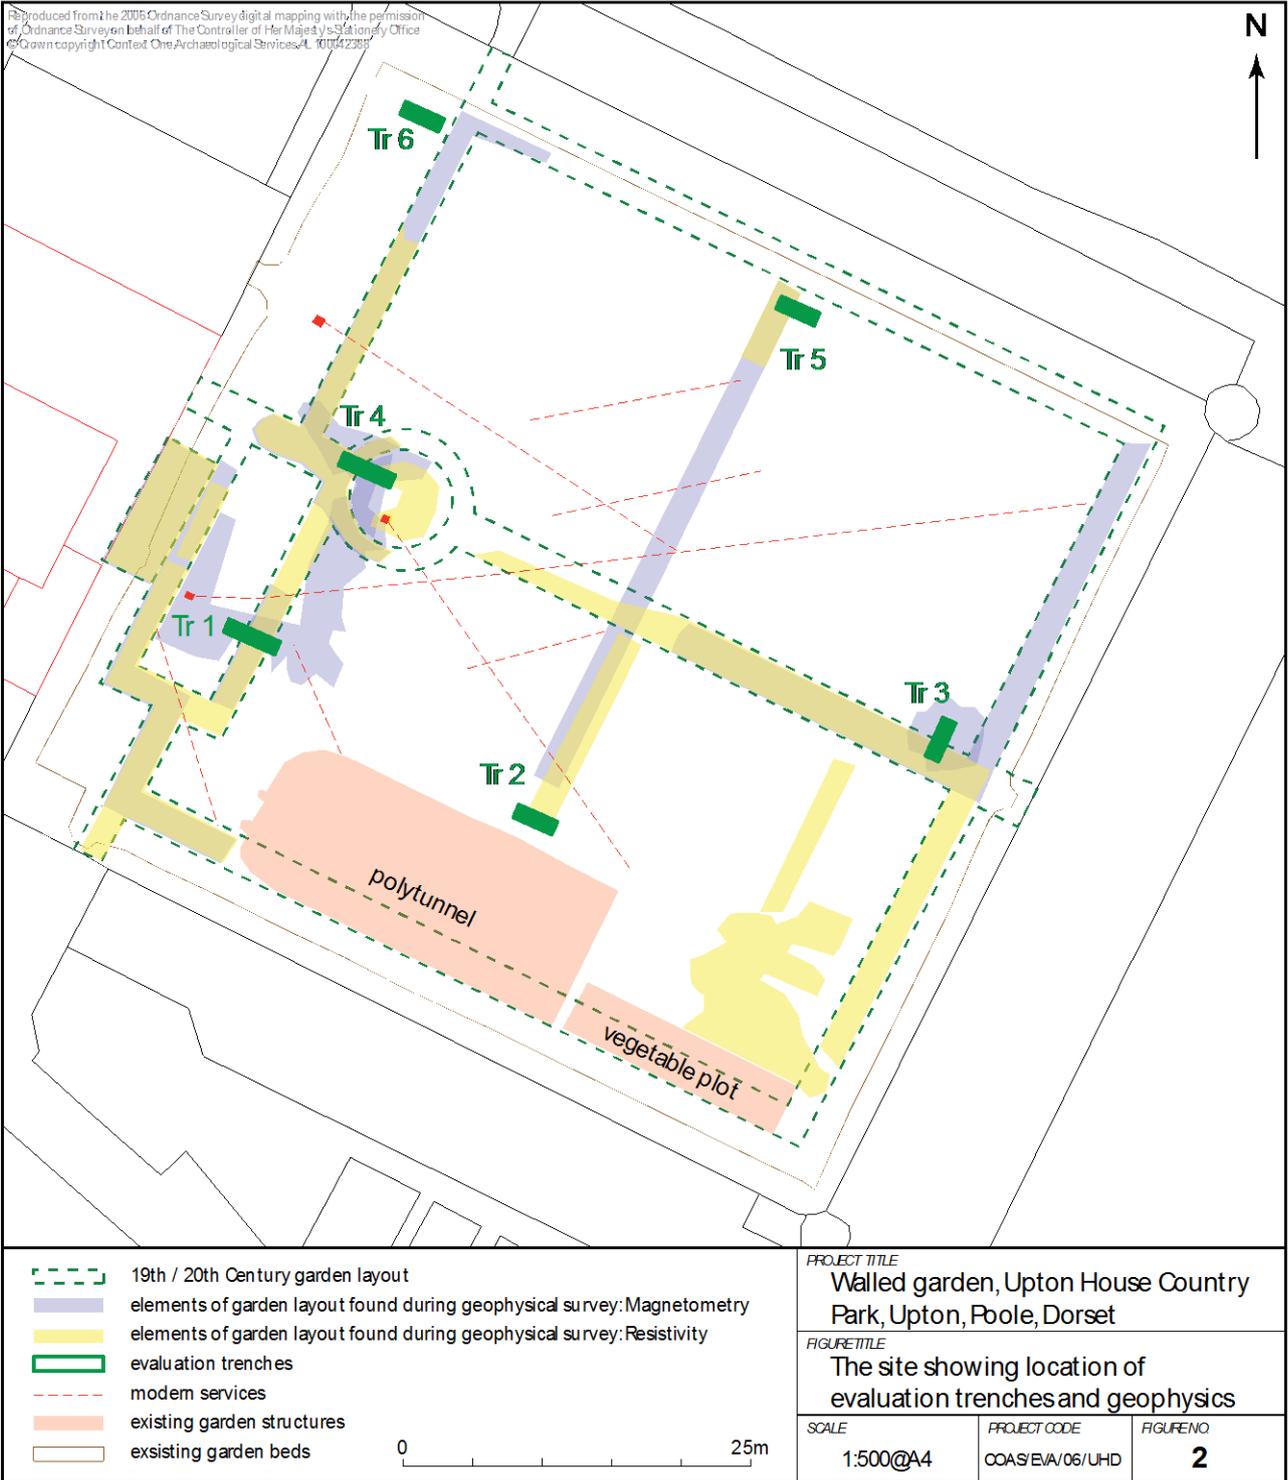
- 4.12. As the first stage in the archaeological assessment of the Wall Garden, COAS carried out a geophysical survey of this area. This was a combination of resistivity and magnetometry, which clearly identified elements of the former garden layout that is known to have survived until the mid 20th century. This included pathways, the line of a possible foundation of a former glasshouse, and a possible structure.

- 5.2. Six rectangular trenches were excavated with a 1.5-ton, 360° tracked mechanical excavator equipped with a 1.0m toothless bucket. The six trenches (numbered consecutively from 1-6) were positioned at various locations within the Walled Garden, and were targeted on specific geophysical anomalies, which were interpreted as former garden features. The locations of the trenches are shown on **Figure 2**, and the dimensions of each trench are shown below in **Table 1**.

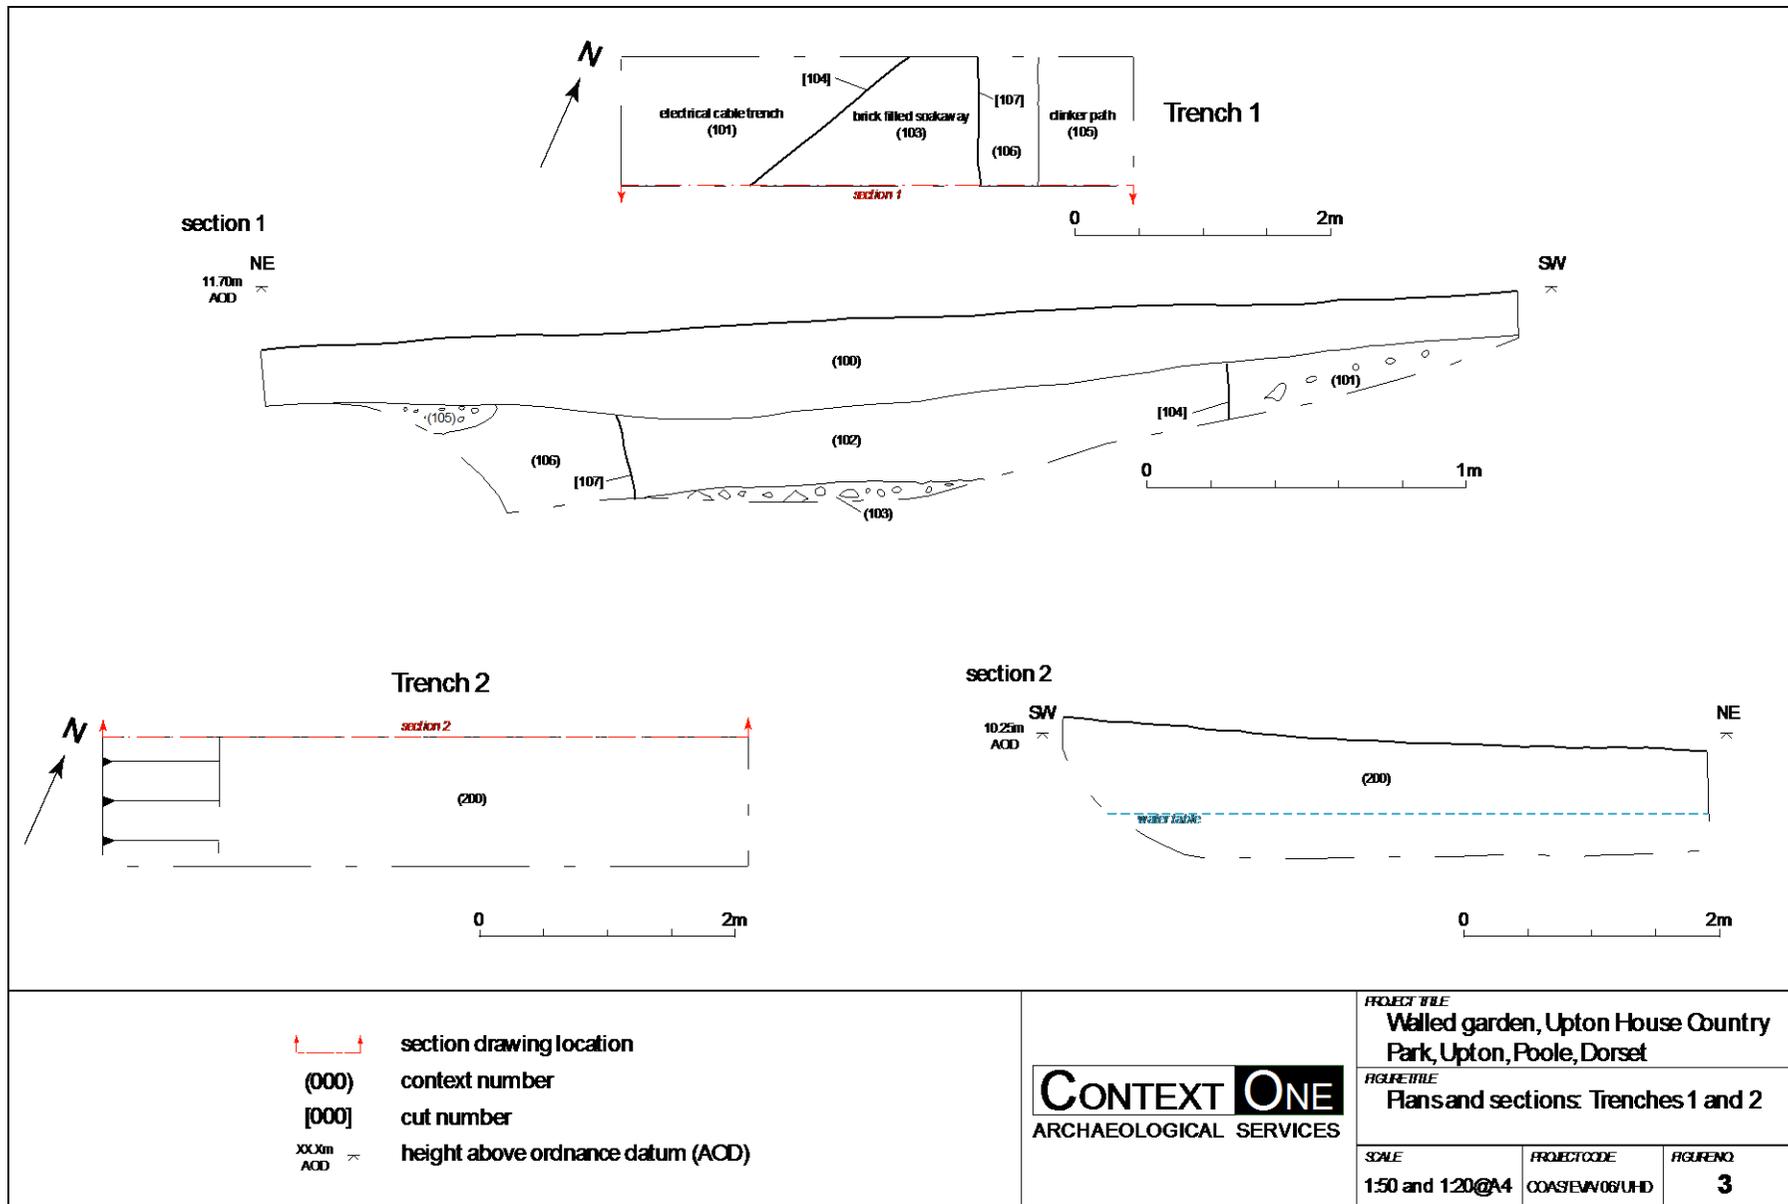
Scale plans of Trenches 1-6 have been reproduced at a scale of 1:50 and the associated Sections 1-6 respectively are reproduced at a scale of 1:20 in **Figures 3-5**. Levels are presented with a height above Ordnance Datum.

- 6.3 Below the topsoil horizon (100), was the cut and fill of a modern northeast-southwest orientated electric cable trench [104] with fill (101). The cable trench [104] truncated the western side of a north-south aligned soakaway drain [107] with upper fill (102) and lower fill (103). The drain [107] in turn ran parallel to and alongside a garden path of clinker (105). Both cuts [107], [104], and the path (105) overlay a possible buried ploughsoil horizon (106).

- 6.4 A single context (200) was recorded within this trench. This was a deep topsoil horizon that extended to the limits of excavation.

- 6.5 Lying directly below the topsoil horizon (300) were the remnants of a gravel path surface (301). Possibly cutting this pathway, (although the exact stratigraphical relationship was unclear) was the cut of a north-south orientated planting bed [304] with fill (303). Below the gravel path (301), and cut by the planting bed [304] was the buried ploughsoil horizon (302), which in turn overlay the natural sand horizon (305) at the base of the trench. A metal stake was found within the topsoil (300) during the geophysical survey, which produced a magnetic "spike" in this area.

- 6.6 Below the topsoil horizon (400) in Trench 4 was encountered a deep layer of redeposited natural sand (401).
