HAREWOOD CASTLE, HAREWOOD,
WEST YORKSHIRE

ARCHAEOLOGICAL AND ARCHITECTURAL
SURVEY AND RECORDING

VOLUME 3: APPENDICES

Report no: 2003/212.R01
Version: Final
Date: November 2012
Author: Shaun Richardson & Ed Dennison

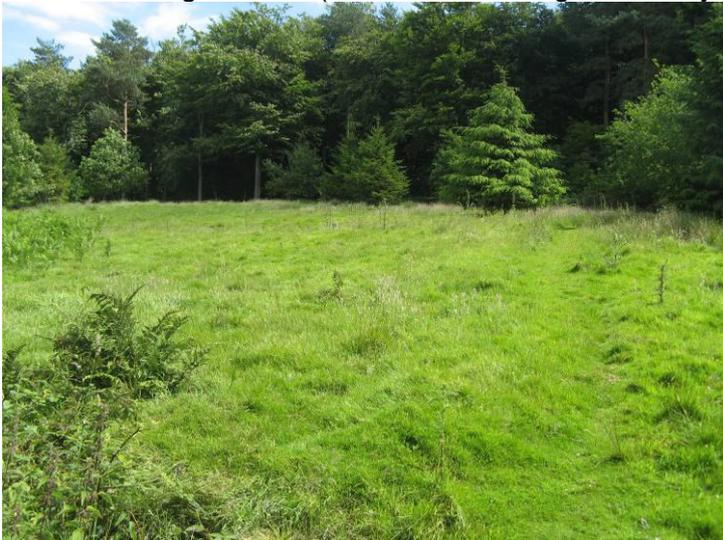
Plate 2 Acid grassland (refer to the Ecological Survey Report 2000 for further details)

- 5.2.1 It is recommended that the short-turf communities representative of U1 acid grassland (Plate 2) and much taller tussocks of MG10 soft-rush pasture (Target Note 6) are maintained. To this end any encroaching tall ruderals (bracken and bramble) should be controlled as and when appropriate.

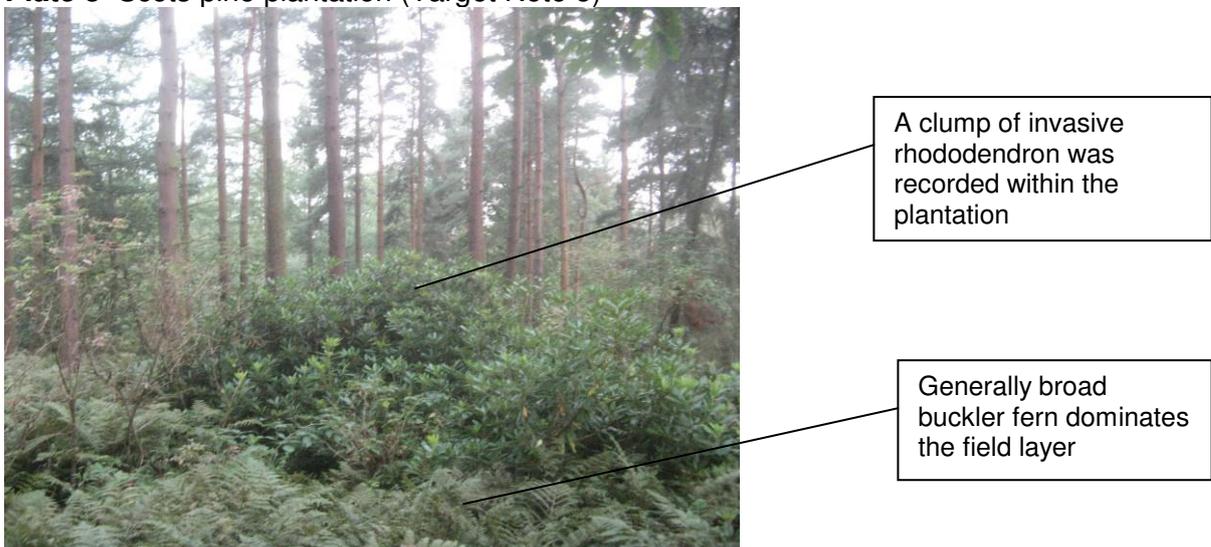
Plate 3 Scots pine plantation (Target Note 5)

- 3.1.11 The field layer was dominated by broad buckler fern *Dryopteris dilatata* although a few saplings of silver birch *Betula pendula* were also noted together with a small clump of rhododendron *Rhododendron ponticum* (Plate 3). Occasional other plants recorded included wood sorrel *Oxalis acetosella*, foxglove *Digitalis purpurea*, bramble *Rubus fruticosus*, soft rush *Juncus effusus*, Yorkshire fog *Holcus lanatus* and creeping soft grass *Holcus mollis*. A mix of bare ground and pine needles, however, generally covered the ground floor. Fallen trunks, branches and twigs occupied c. 5% of the field layer.

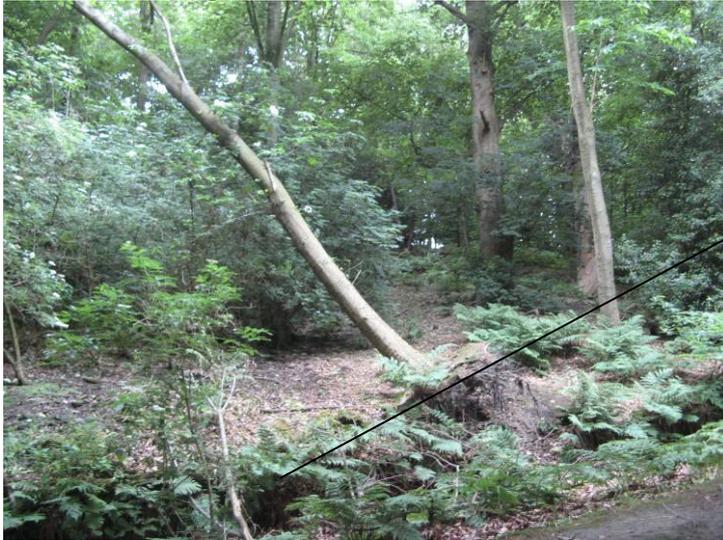
Plate 4 Leaning trunk of a semi-mature sweet chestnut on the wall of the Ha-Ha

Ha-Ha wall hidden
beneath vegetation
