ST MARY'S CHURCH,  
STUDLEY ROYAL, NORTH YORKSHIRE

ARCHAEOLOGICAL WATCHING BRIEF

Report no: 2005/265.R01  
Version: Final  
Date: March 2006  
Author: Ed Dennison & Shaun Richardson

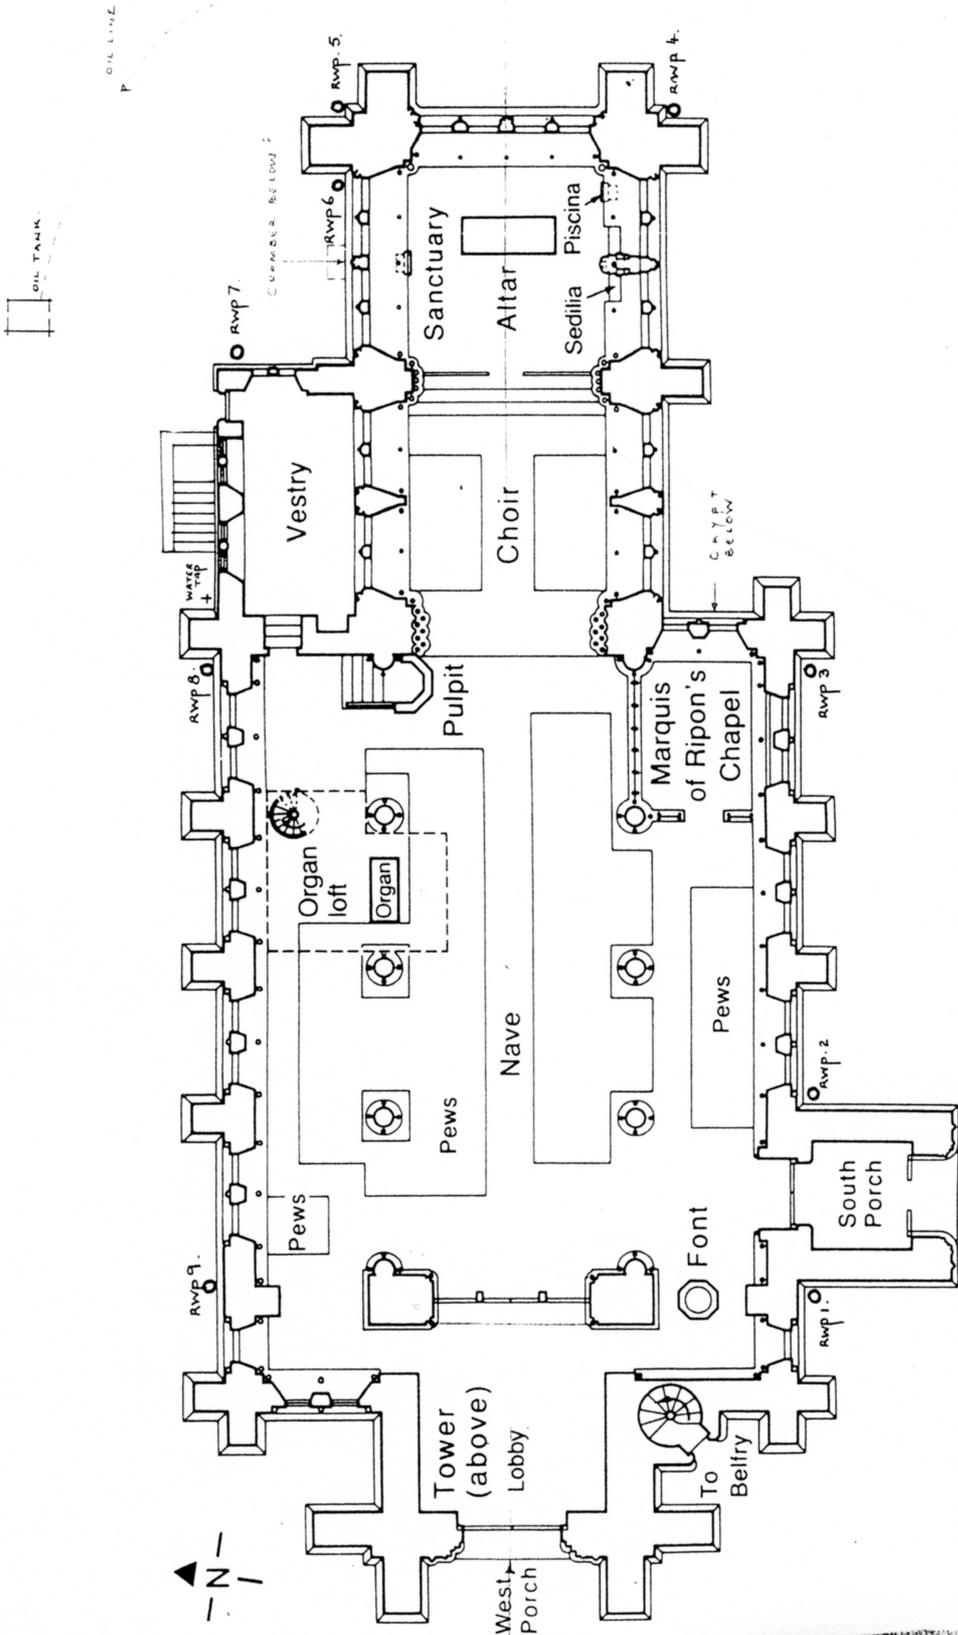
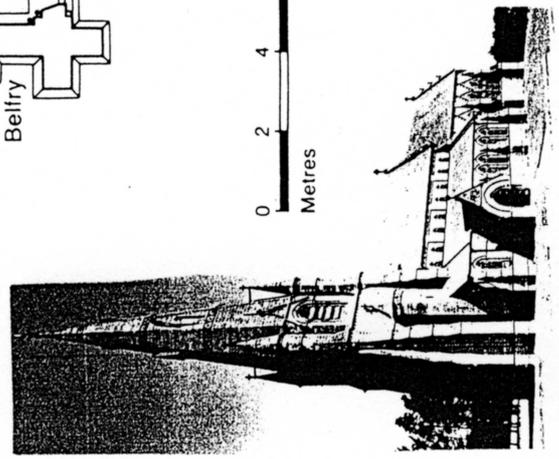
PROJECT ST MARY'S CHURCH, STUDLEY ROYAL	
TITLE CHURCH PLAN	
SCALE AS SHOWN	DATE MAR 2006
EDAS FIGURE 2

- 3.2 The church has a simple plan form, comprising a 4-bay aisled nave, a 2-bay chancel, a south porch, and a two-stage west tower with spire above the west porch, with a vestry at the east end of the north aisle (see figure 2). The church is noted for its High Victorian architecture which includes extravagant scrolled and figured ironwork on the south and west doors, and polygonal spirelets and elaborate crocketed hood-moulds on the outside. Inside, there is an extravagant use of decorative and coloured stone and marbles, and painted and gilded details, the latter with the theme of Paradise lost and regained. The Marquis of Ripon's chapel lies at the east end of the south aisle, and the Marchioness was buried here in 1908. There appear never to have been any burials within the surrounding churchyard.

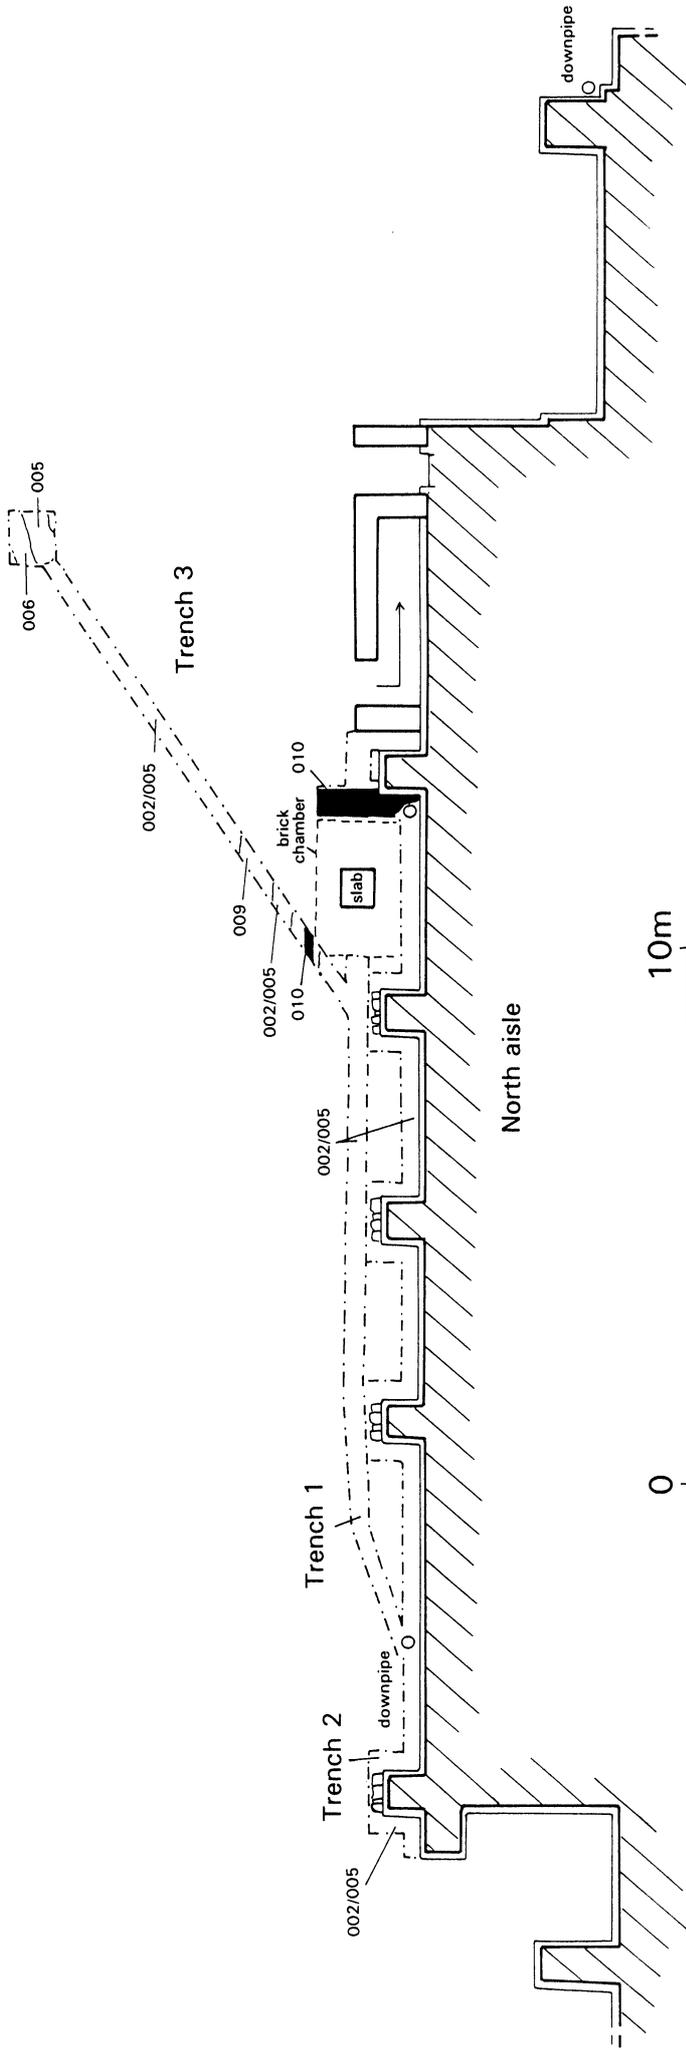
Trench plan

- 5.1 Trench 1 ran virtually parallel to the north side of the north aisle of the church, c.1.5m beyond the wall face (see plate 1). It started towards the west end, adjacent to a rainwater downpipe and ran c.13.00m to the east, where a buried brick-lined chamber was encountered (see below). A short continuation of the trench ran to the east of the chamber, returning to the south to reach an external water tap. The trench was 0.40m wide and was excavated to a maximum depth of 0.40m below existing ground level (BGL) along its entire length.

- 5.4 Trench 2 ran along the north edge of the north aisle of the nave, following the line of the external buttresses, from the north-west corner of the church eastwards as far as a low wall which surrounded some steps leading down to a boiler house located beneath the vestry. The trench was 0.40m wide and was excavated to a maximum depth of 0.40m below existing ground level (BGL) along its entire length.

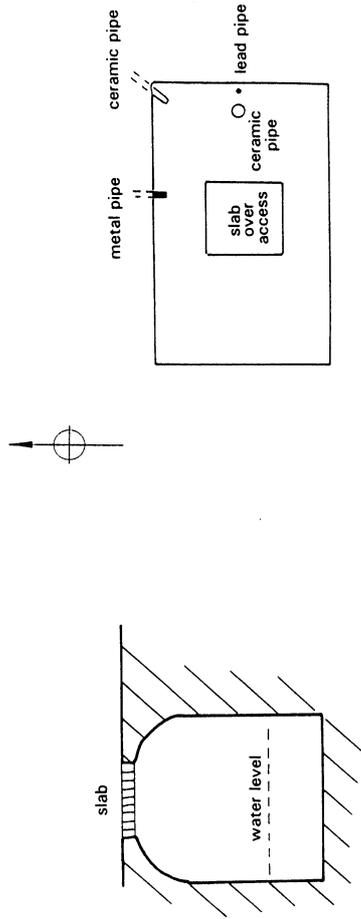
Underground chamber

- 5.3 At its east end, the drainpipe had discharged into a buried brick-lined chamber (010) set between the north aisle's two easternmost buttresses. This chamber was accessed through an opening in its roof covered by a sandstone slab or capstone. Health and Safety concerns meant that the interior could not be inspected in detail, but it was established that the chamber was rectangular in plan, with internal

measurements of 2.65m long (east-west) by 1.65m wide (north-south), and a height of 1.74m from the floor to the apex of the barrel-vaulted roof. At the time of the watching brief, there was 0.50m depth of water in the base of the chamber. A number of pipes were visible entering or exiting the chamber. The main outflow was apparently formed by a vertical ceramic pipe rising out of the east end of the floor; at the time of the watching brief, the open upper end was set some way above the internal water level. A lead pipe ran down the east wall adjacent to the vertical ceramic pipe, whilst a further ceramic pipe and metal pipe projected from the north wall. The chamber was built throughout of red hand-made bricks (average dimensions 225mm by 110mm by 70mm) laid in stretcher bond and set with a buff lime mortar; the east wall was shown to be c.0.3m wide but the north wall, revealed in Trench 3, was slightly narrower although disturbed.

- 6.2 The watching brief exposed little in the way of new information relating to the structure of the church. As might have been expected, stepped footings were revealed in Trench 2 beneath some of the aisle buttresses. The barrel-vaulted rectangular brick-built chamber exposed in Trench 1 would appear to be contemporary with the church itself, and it may have been an underground water tank, possibly to serve the adjacent boiler room. The number of metal and ceramic pipes visible within the chamber indicate that there are further drains / pipe-runs crossing the churchyard which were not exposed and located during the watching brief.

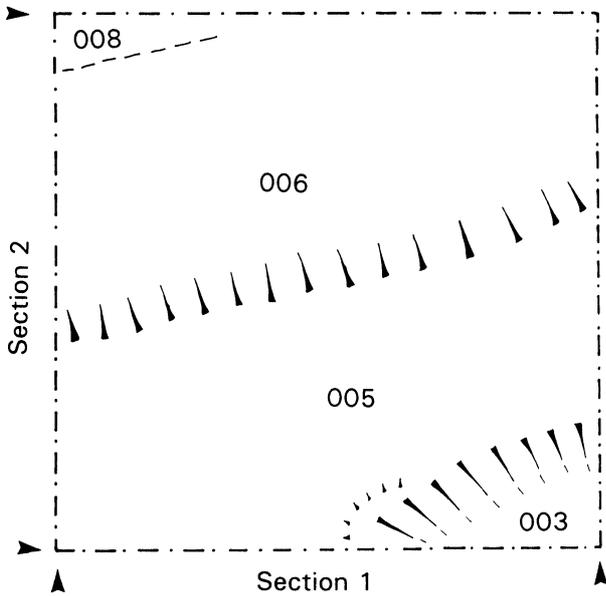
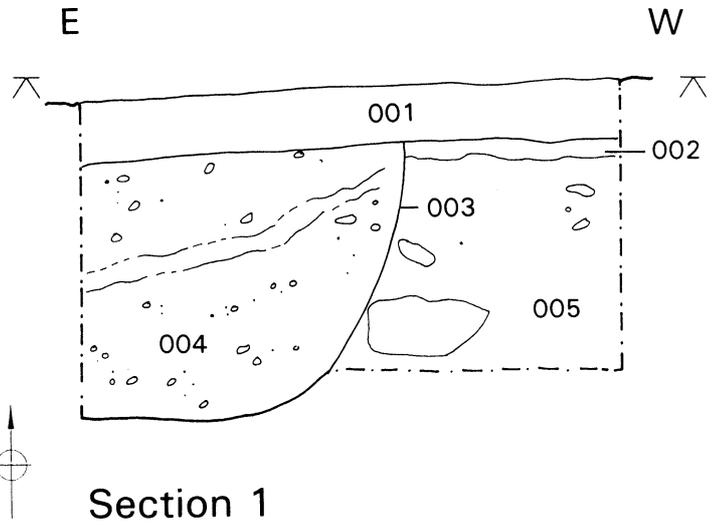
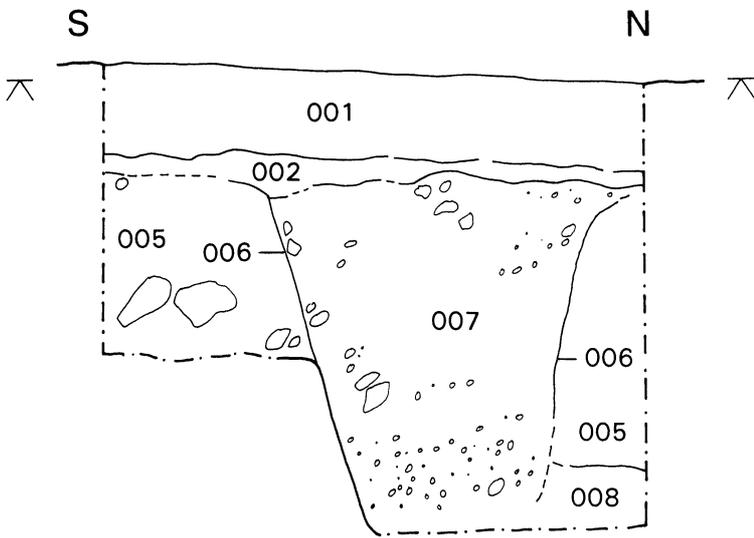
Soakaway pit

- 5.8 Within the excavation for the soakaway, the band of reddish-brown clay (002) was cut by a steep-sided pit-like feature (003), visible in the north-facing and west-facing sections only. The fill of this pit (004) appeared to comprise three ill-defined layers – the upper fill, a compacted silt loam containing angular pieces of sandstone rubble, overlay a thin band of reddish-brown clay similar in appearance to context 002. This in turn overlay a mixed deposit of red-brown clay, silt loam topsoil and gravel.

- 5.9 A second feature (006) crossed the north side of the soakaway pit, comprising a steep-sided linear cut, aligned north-east/south-west and 0.70m wide at the top (see plate 3). Unlike the pit-like feature (003), the linear cut was sealed by the reddish-brown clay (002). The cut narrowed towards its base, which was not clearly defined and which may have continued below the base of the soakaway. The fill of the cut (007) was a mixed deposit comprising contexts 001, 002 and 005 in equal proportion; in its lower part, the fill contained a high proportion of angular stone gravel.

- 5.10 Both cut features noted in the soakaway had been dug into the hard-packed angular stone rubble (005), which the section showed to be 0.55m thick. This rubble contained a very high proportion of mudstone within the soakaway, far higher than was seen in Trenches 1 or 2. The rubble overlay a presumed natural deposit (008) of firm red-brown silty clay, the top of which lay 0.72m BGL. The soakaway pit was subsequently filled with gravel and the ground surface reinstated.

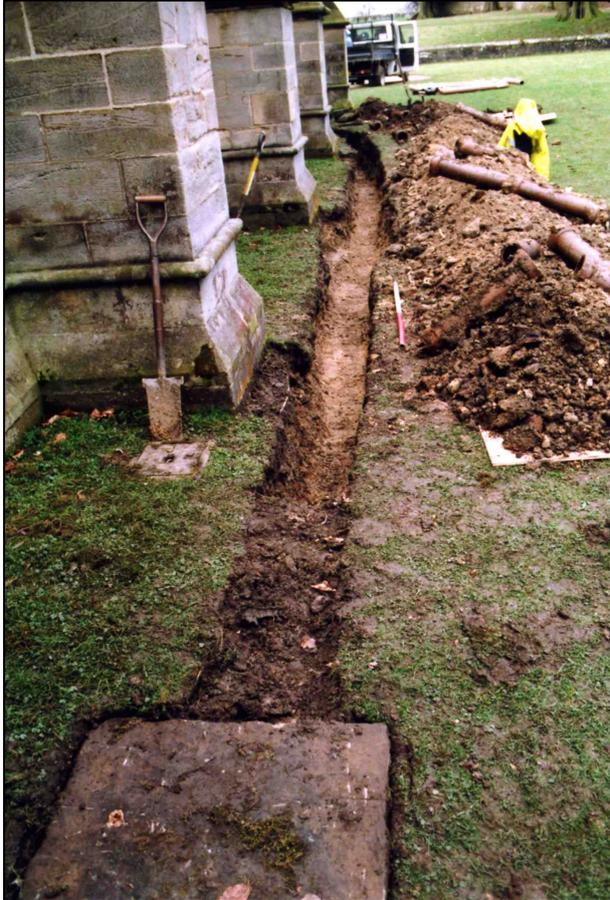
- 5.2 Following the removal of the turf and topsoil (001), which was 0.12m deep, a very shallow, intermittent layer of reddish-brown clay (002), only 0.02-0.03m thick, was exposed. This was found to overlay the line of a disused 0.10m diameter glazed ceramic drainpipe, which followed the alignment of Trench 1 almost exactly. The drainpipe was contained within a deposit of hard-packed angular pieces of sandstone / mudstone rubble (005) set within a gritty yellowish sand, mostly derived from decayed stone; the rubble contained very occasional fragments of abraded red brick, none of which were complete enough to obtain finished size measurements from. The sandstone / mudstone rubble continued beneath the base of the trench. The exposed ceramic drainpipe was removed from the trench and the ground reinstated.

Plate 1: View along Trench 1 after removal of ceramic pipe, with cap stone to underground chamber in foreground, looking west.

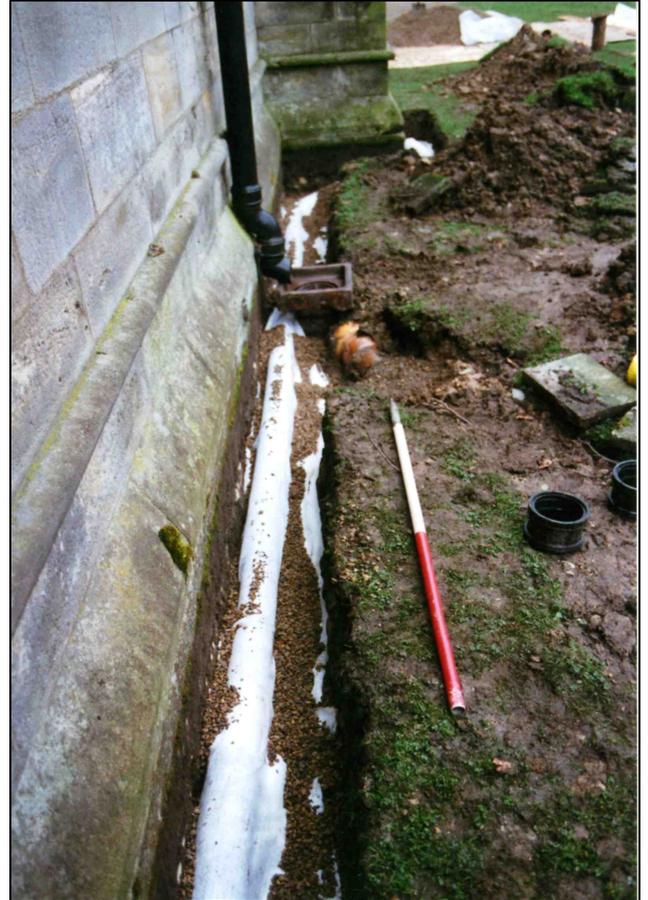
- 5.5 The same overall sequence of deposits (001, 002 and 005) exposed in Trench 1 were noted in Trench 2, apart from the ceramic pipe within context 005. Trench 2 also revealed that the rock-faced masonry footings visible elsewhere around the base of the church were present at the base of the north aisle, commencing c.0.55m below the level of the chamfered plinth here. As might have been expected, the buttresses to the north aisle were revealed to have stepped footings beneath the rock-faced masonry. The trench was filled with a new PVC land drain wrapped in geotextile, and the trench infilled with gravel (see plate 2).

Plate 2: View of Trench 2 after insertion of new pipe and partial backfilling, looking west.

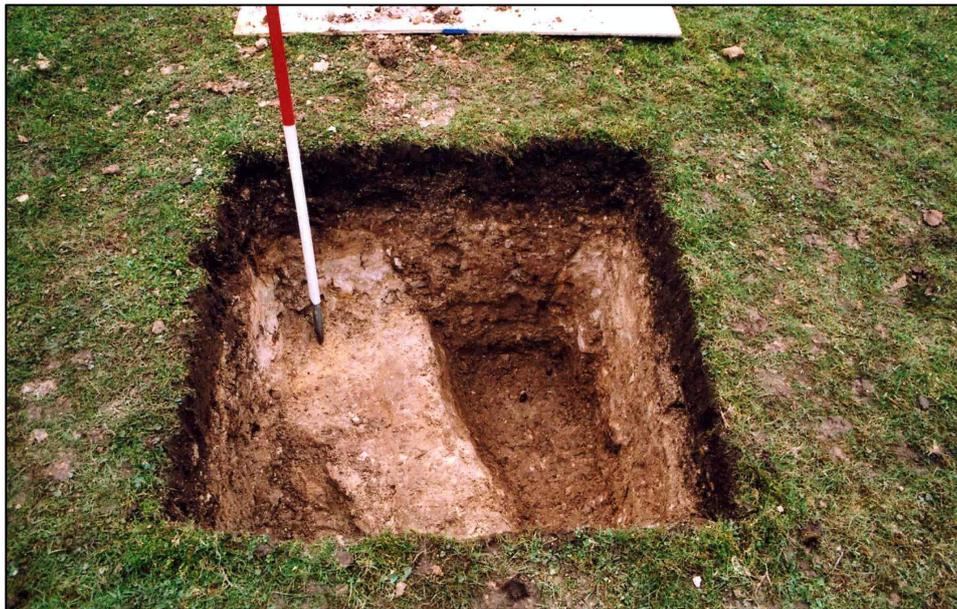
- 5.6 Trench 3 ran north-east from the eastern end of Trench 1 towards a soakaway pit located to the north of the vestry. The north-east/south-west aligned trench was 10m long, and was 0.40m wide and 0.40m deep below existing ground level (BGL) along its entire length. It terminated in a 1.0m square soakaway pit which was excavated to a maximum depth of 1.0m BGL (see plate 3).

Plate 3: West side of soakaway pit at end of Trench 3, looking west.
