ST MARY THE VIRGIN CHURCH,
CHURCH LANE, BEIGHTON,
SOUTH YORKSHIRE

ARCHAEOLOGICAL WATCHING BRIEF

Report no: 2007/321.R01
Version: Final
Date: March 2009
Author: Shaun Richardson & Ed Dennison

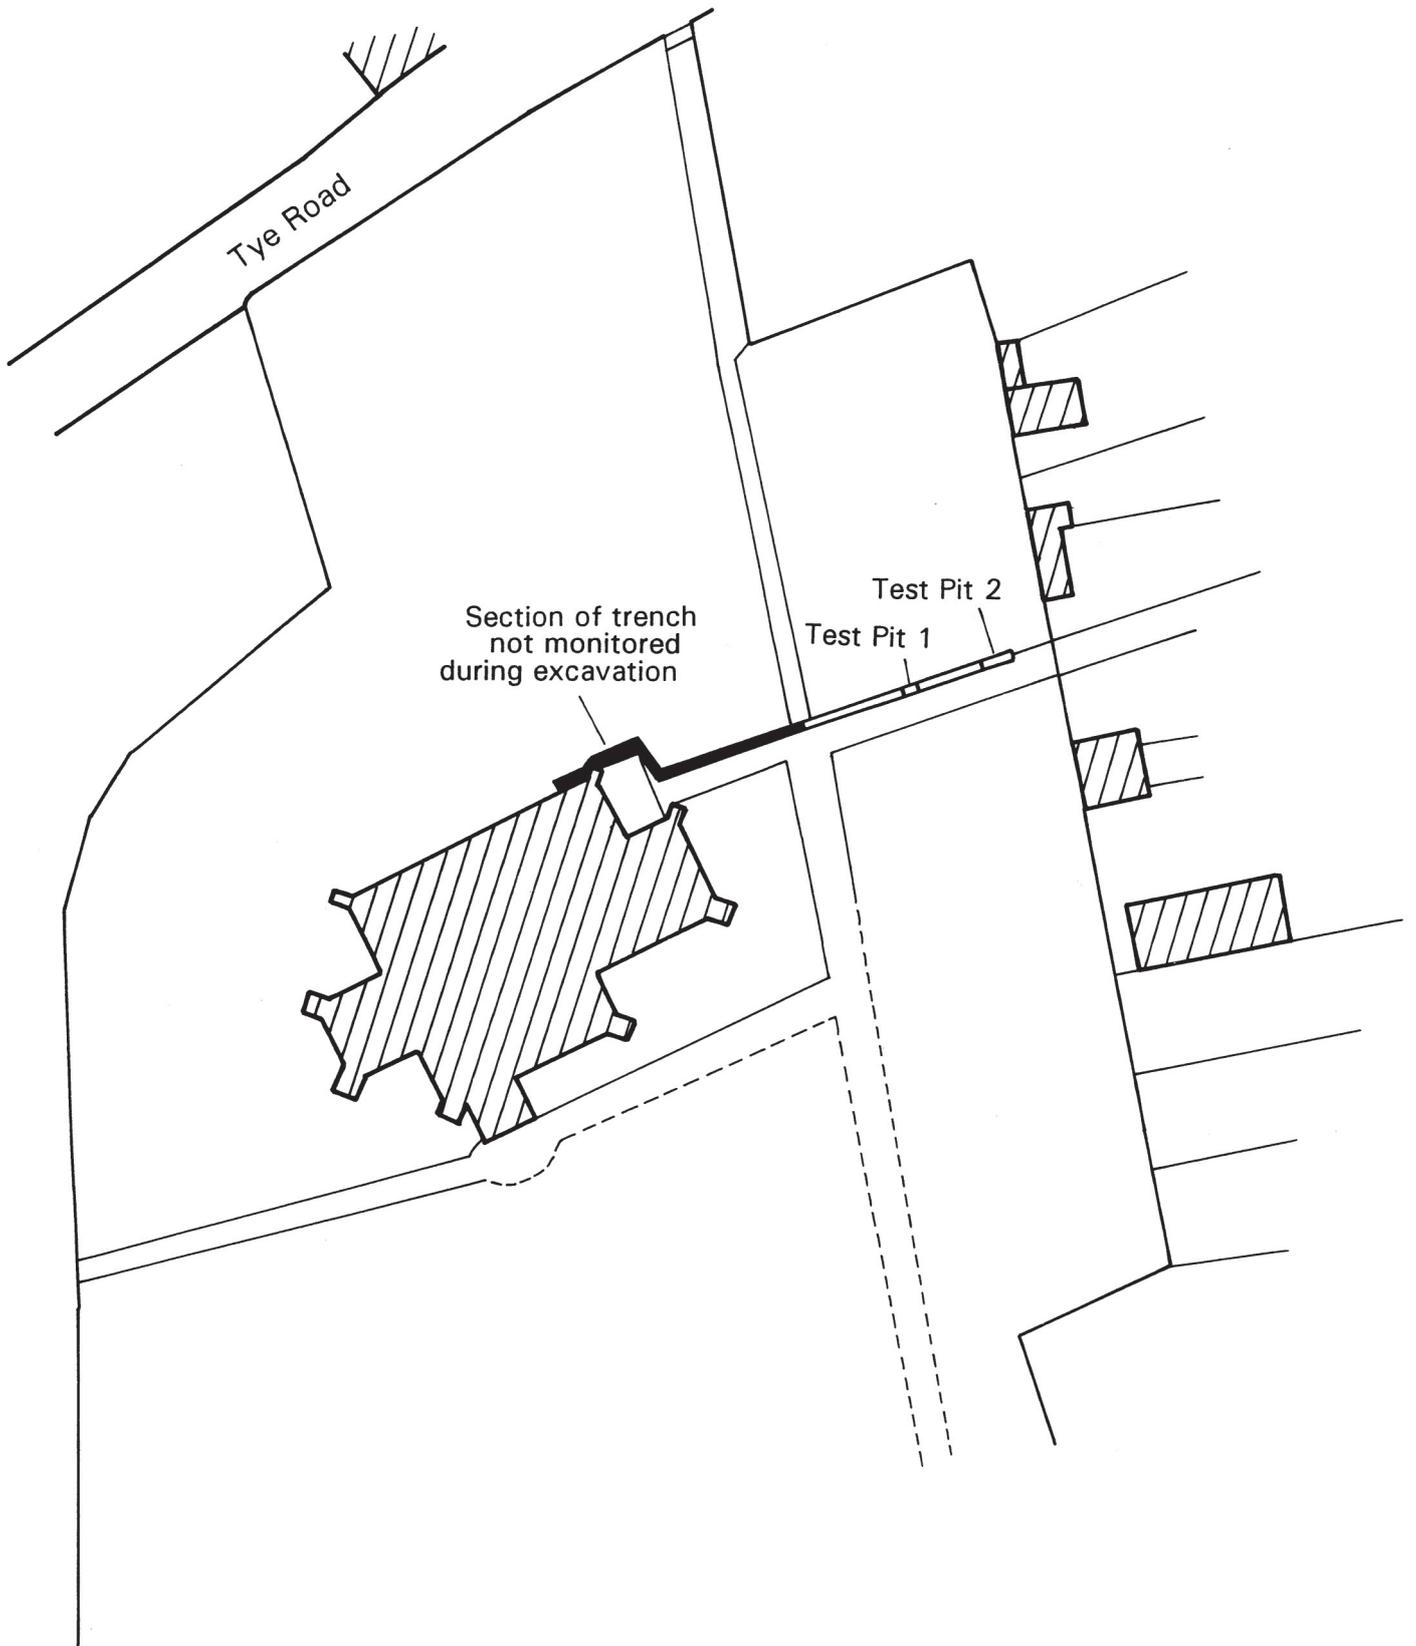
PROJECT		ST MARY'S CHURCH, BEIGHTON	
TITLE		EXTERNAL DRAINAGE TRENCH	
SCALE	AS SHOWN	DATE	MAR 2009
EDAS		FIGURE	3

- 5.1 As noted above, the external drainage trench was excavated by hand in several different stages, and some of the sections were not subject to archaeological monitoring. The westernmost c.2m of the trench was excavated before the 4th January 2008; it was on average 0.35m wide and dug to a maximum depth of 0.65m below ground level (BGL) (55.68m AOD). The alignment ran past the buttress at the north-east corner of the north aisle, along the side of an area of concrete, and then returned to the south for c.5.0m; at the point of the southward return, a small inspection chamber was installed, although this did not require any excavation below the maximum 0.65m depth of the trench here.

- 5.2 At the south end of the southward return, a second small inspection chamber was installed, and then the trench resumed its approximate north-east/south-west alignment for a further c.25m, with the ground surface through this part of the churchyard sloping gently downwards from west to east. The trench ran along the north side of an existing tarmaced footpath, with an average width of 0.40m. At the western end of this section, the trench was excavated to a maximum depth of 0.75m BGL (55.30m AOD). Two small test pits were archaeologically-excavated towards the centre and east end of this section (see plate 2). The central test pit (Pit A) was 1.00m long (east-west) by 0.40m wide (north-south), and was excavated to a maximum depth of 0.60m BGL (55.05m AOD). The eastern test pit (Pit B) was 2.30m long (east-west) by 0.40m, and was excavated to a maximum depth of 0.70m BGL (54.20m AOD).

- 5.3 In all parts of the drainage trench, a similar sequence of deposits was observed. The turf and brown/black sandy silt topsoil (001) averaged between 0.10m to 0.50m deep which, in the western part of the trench, overlay a compacted dark brown/black sandy silt (002) with frequent pieces of angular stone rubble up to 0.15m in length. This subsoil deposit was up to 0.55m deep and continued below the base of this part of the trench. It faded out at the point where the trench made its second return to run parallel to a footpath, perhaps because its surface had dipped here, following the general downward slope of the ground. In the eastern section of the trench, the brown/black sandy silt (002) was apparently replaced by a thin layer of compacted brown sand (003), only 0.05m deep, which may have been associated with the installation of an old electric cable contained within a pipe, running the whole length of the trench's eastern section. The upper surface of the pipe was set on average 0.40m BGL and was covered by a line of special bricks marking its alignment. The pipe appeared to be set into a 0.40m deep layer of compacted mid-brown sandy silt (004) which contained frequent inclusions of angular sandstone/mudstone rubble up to 0.20m long, although no clear cut was visible. The mid-brown sandy silt (004) continued below the base of the trench - it may have been a layer of levelling material associated with the 19th century rebuilding phase.

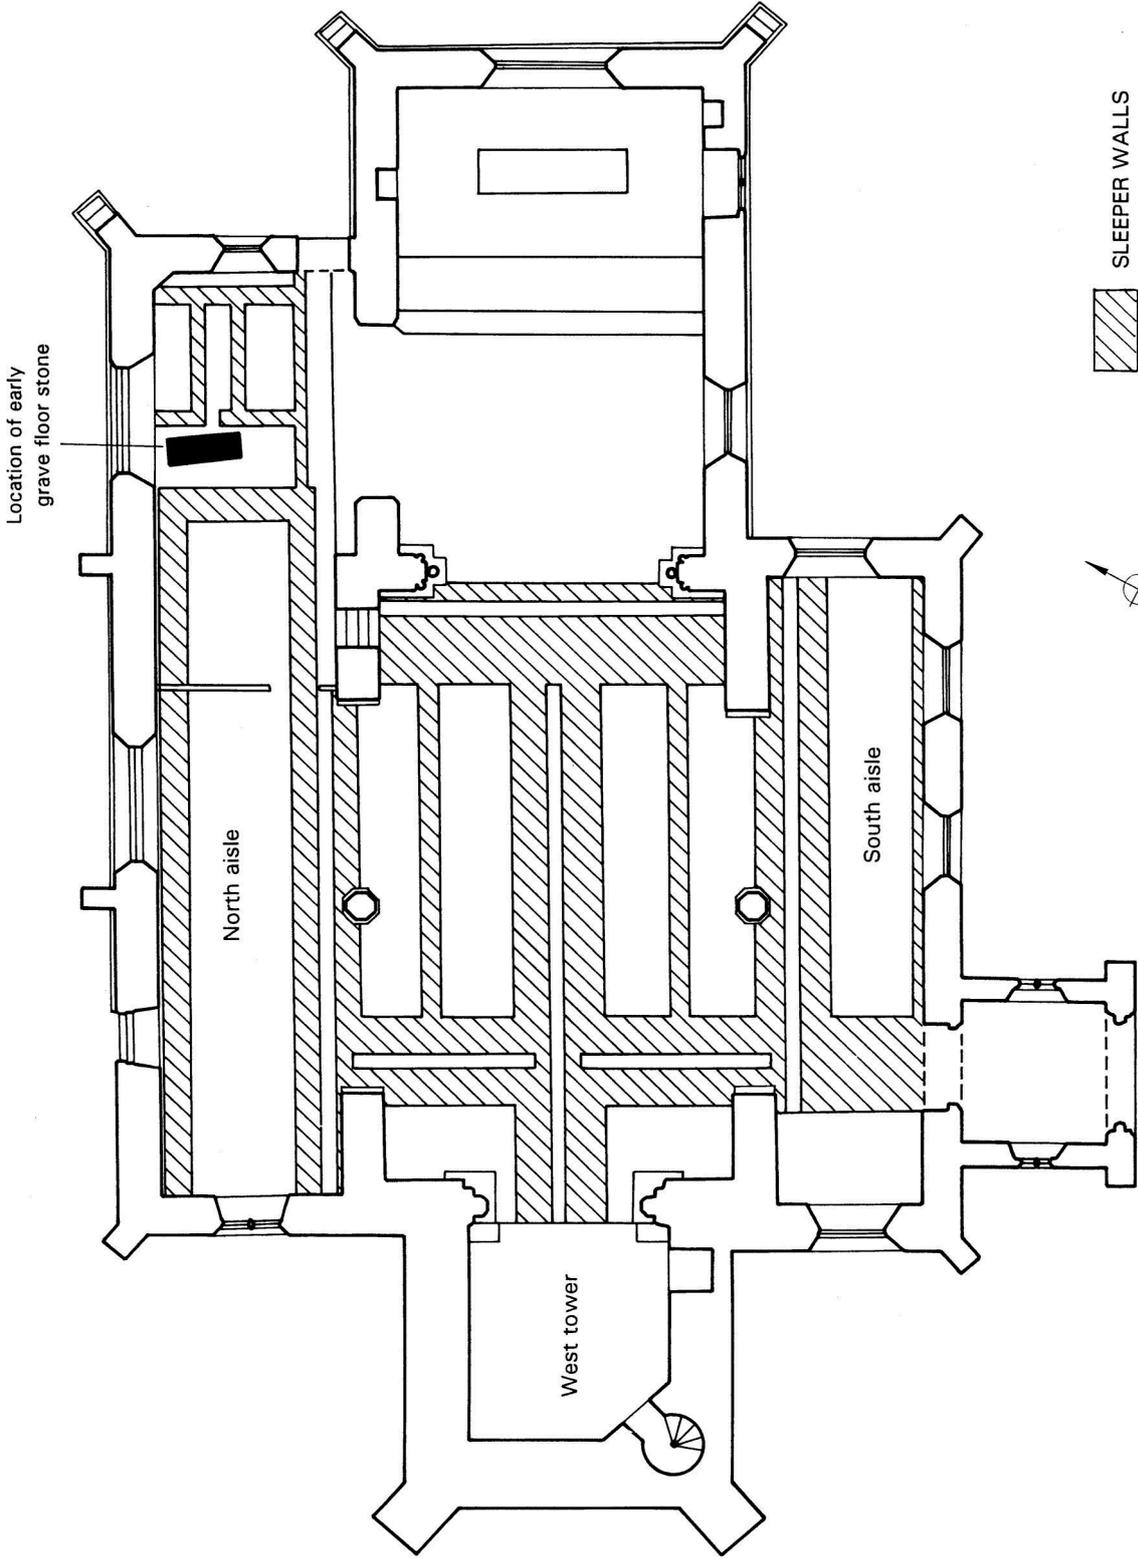
PROJECT	ST MARY'S CHURCH, BEIGHTON		
TITLE	LOCATION OF SLEEPER WALLS		
SCALE	AS SHOWN	DATE	MAR 2009
	EDAS	FIGURE	4

- 5.7 The majority of the 19th century sleeper walls ran parallel to the long axis of the nave and aisles, linked by a lesser number of substantial cross-walls (see figure 4 and plate 4). All of the sleeper walls were built of a mixture of stone rubble with some brick and, despite careful examination, no re-used architectural fragments or other materials of historic interest were noted. The ground between the walls was formed by a dry loose orange-brown silty sand (005), up to 0.95m thick and containing frequent stone rubble. Again, a careful examination revealed no earlier material incorporated within this deposit, and only a very few pieces of *ex situ* human bone were recovered during the ground reduction works.

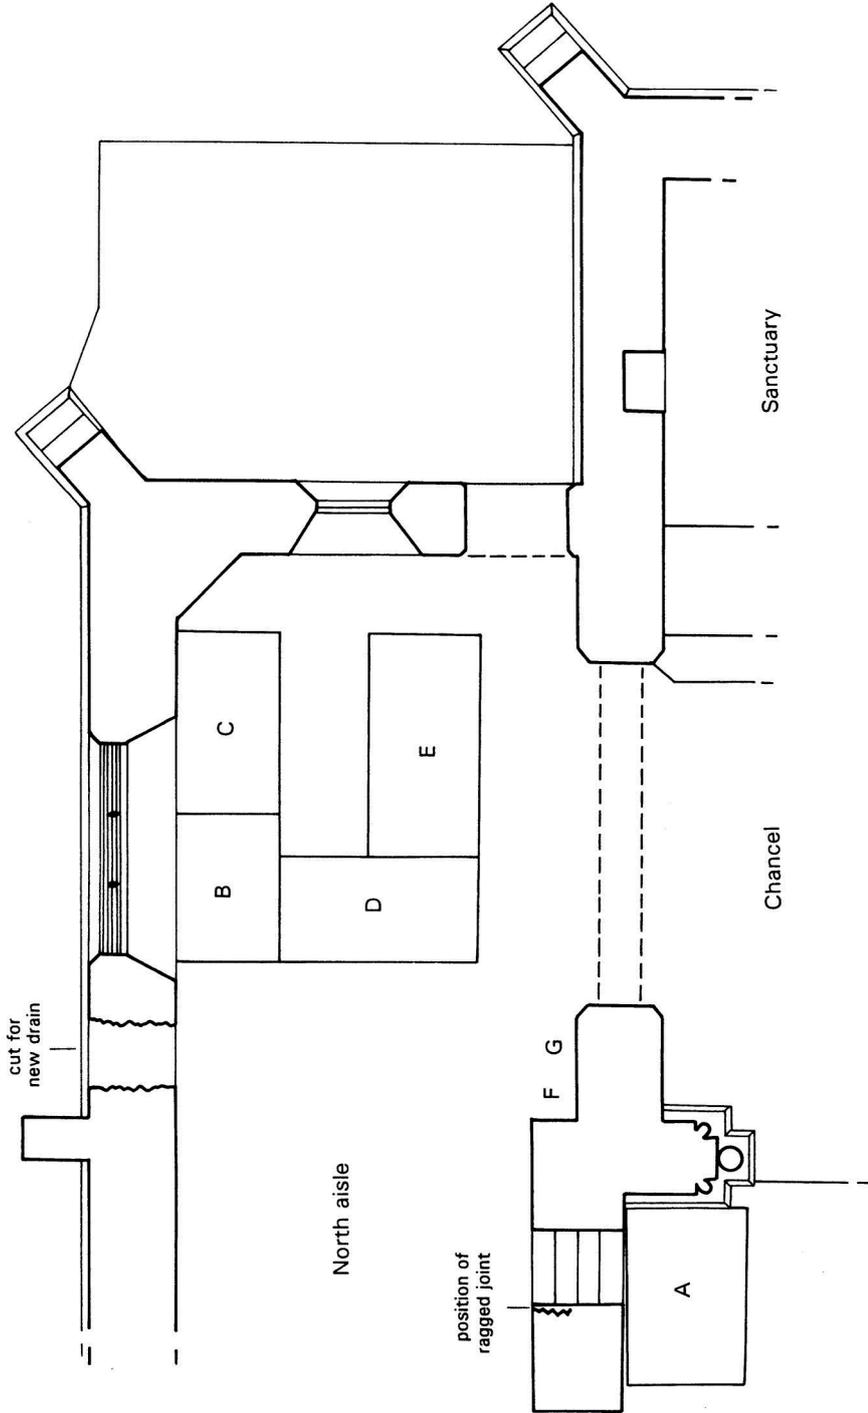
PROJECT	ST MARY'S CHURCH, BEIGHTON		
TITLE	RECORDED GRAVE STONES		
SCALE	AS SHOWN	DATE	MAR 2009
	EDAS	FIGURE	5

- 5.10 The remaining four gravestones (B to E) were all located in the former chantry chapel area at the east end of the north aisle. Gravestone B measured 1.40m long (east-west) by 0.92m wide (north-south) and appeared only part complete, although the inscription was very worn and no longer legible. Gravestone C measured 1.70m long (east-west) by 0.95m wide (north-south), and the inscription

was again very worn, the only line that could be clearly made out being "... of John ...". Gravestone D measured 1.80m long (north-south) by 1.00m wide (east-west) and had a shallow recess with a semi-circular profile around the edges; this once framed the inscription, which was unfortunately illegible.

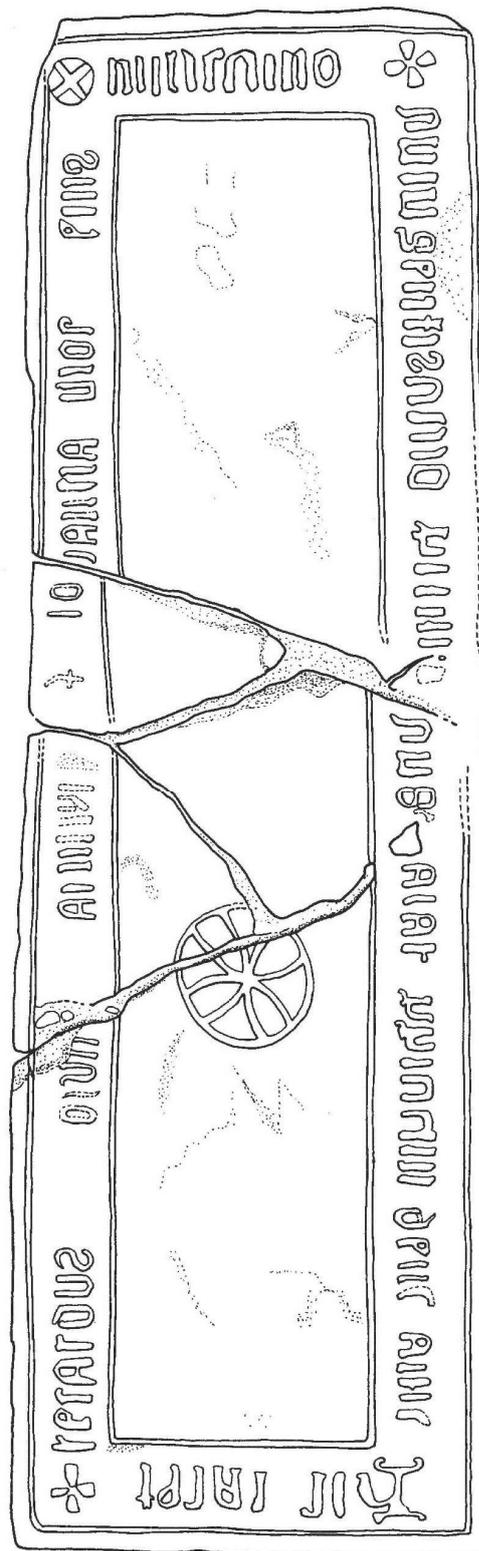
PROJECT		ST MARY'S CHURCH, BEIGHTON	
TITLE		SKETCH OF EARLY FLOOR STONE	
SCALE	NTS	DATE	MAR 2009
EDAS		FIGURE	6

underside was chamfered. The marginal inscription of the stone was in Latin and carved in a shallowly incised Gothic script (see plate 6 and figure 6). The inscription was set within a border formed by two parallel incised lines; the outer line on the east side was apparently never carved, although its position was marked out using a dark paint or other substance. At three of the four corners of the margin, the inscription was punctuated by incised crosses. The cross at the north-west corner more closely resembles a saltire, carved in shallow relief within a sunken circle. There was a fourth cross in the approximate centre of the stone, formed by intersecting curves contained within a shallowly-incised circle, vaguely reminiscent of some of the cross paté examples recorded on 12th century cross slab grave covers in West Yorkshire (Ryder 1991, 50-51), although the floor stone itself is much later (see below).

Dimensions:
 Maximum length 1.88m
 Maximum width 0.56m

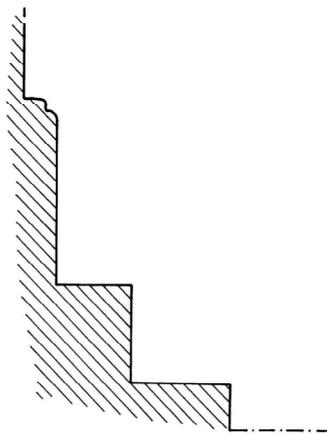
- 5.22 The reduction in ground level allowed the bases of the piers and responds of the north and south arcades to be examined in more detail than had previously been possible (see figure 7). The pier bases were both of similar form, octagonal in plan with stepped footings. The bases of the east and west responds were stepped and double-chamfered; the upper chamfer was set 1.56m below the base of the respond corbel. In contrast, the respond bases of the south arcade incorporated only a single chamfer, the tops of which were set 1.33m below the bases of the respond corbels. The chamfer to the east respond appeared to be a 19th century replacement of the original.

Typical profile of base of north and south arcade piers

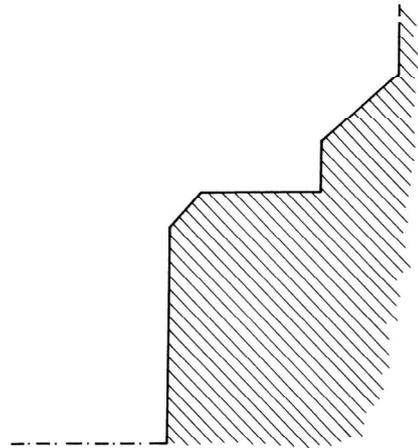
Typical profile of base of east and west responds of north arcade

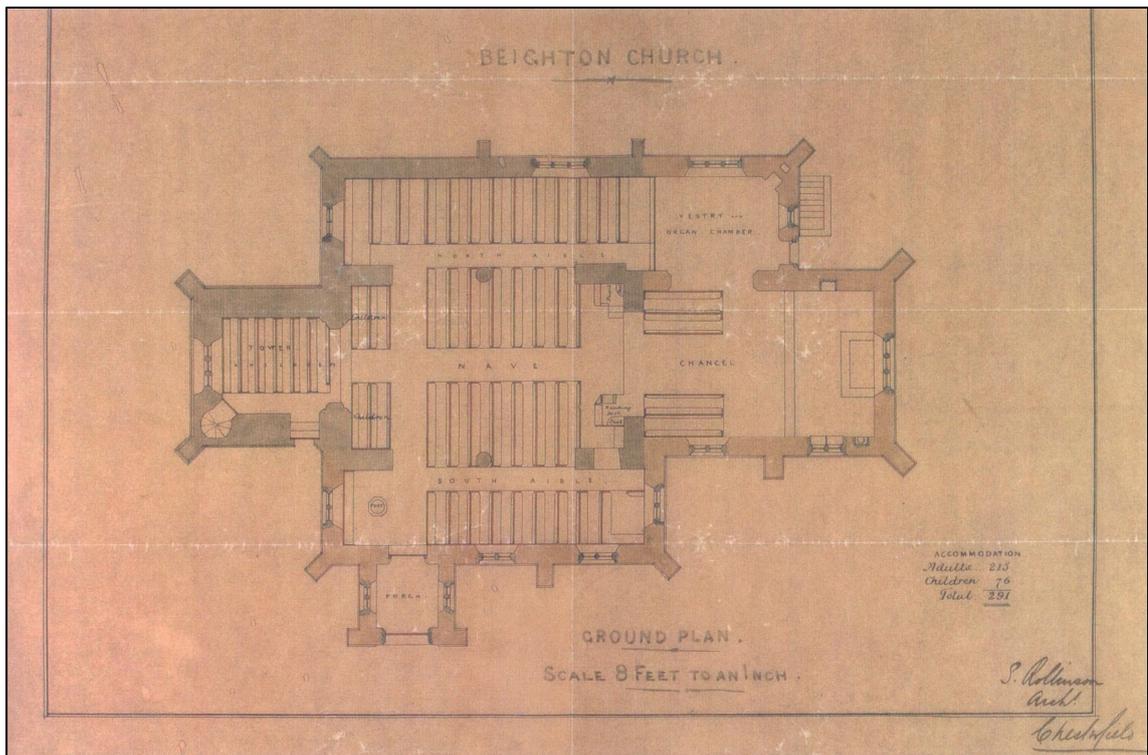
- 3.7 According to the records of the works which survive, the chancel walls and those of the south aisle were taken down and rebuilt on the original footprint, the clerestory windows to the nave were removed, and a gallery at the west end of the church was taken out; the extent of these works is shown on a plan produced by Rollinson in 1867 (see plate 1). The pitch of the nave and chancel roofs was also altered, and an area in the north-east corner formerly housing a chantry chapel was demolished and rebuilt. Cox noted that the floor had been substantially raised so that it was half way up the arcade piers, and as part of the works “hundreds of loads of gravel” were carted out to restore it to its proper, lower, level (Cox 1875, 86). Bench pews replaced the former box pews, allowing for the accommodation of 291 people. The scale of the works attracted some criticism in the local press, but the church was reopened in December 1868 (Richards 1991, 8-9).

Plate 1: Rollinson's plan of 1867 showing the extent of Victorian rebuilding (supplied by Eiden Minns & Co Ltd).

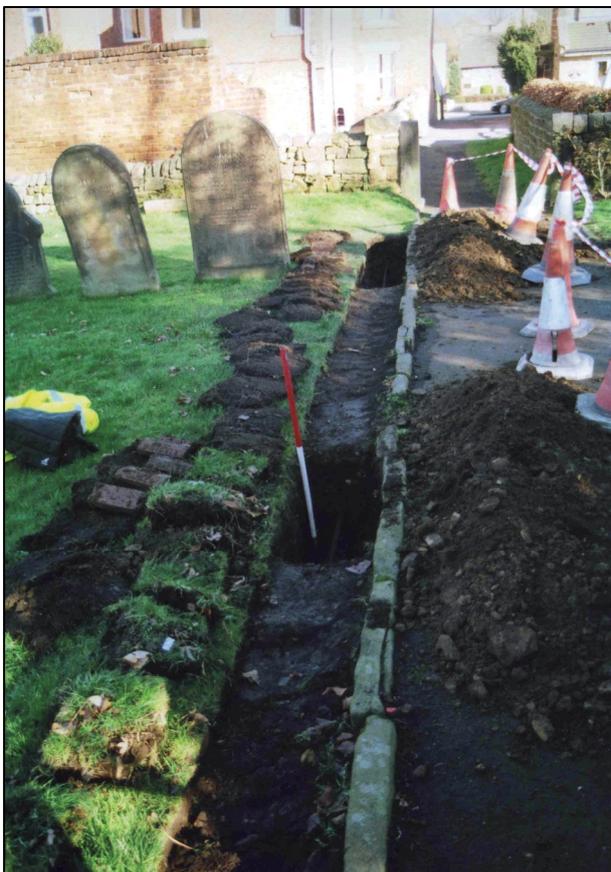
- 5.4 No archaeological features of interest were observed within the trench, and neither was any disarticulated human bone recovered, even in the carefully hand excavated test pits. Given this, and the fact that the eastern section of the trench followed the line of an earlier service pipe which would have disturbed any *in situ* features that might have once been present, it was decided after the excavation of the two test pits to discontinue the watching brief during the external works.

Plate 2: External drainage trench under excavation, showing the two test pits, looking east.

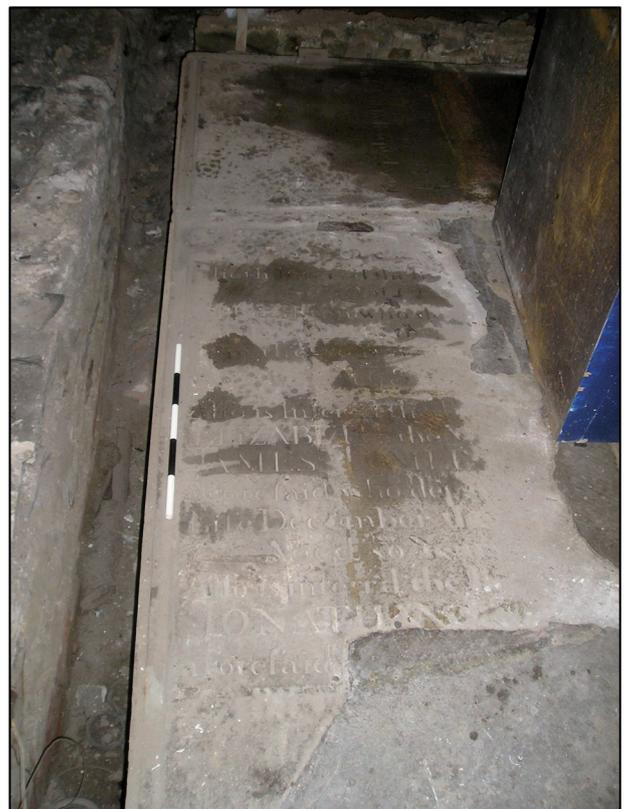
- 5.11 The fourth gravestone in this area (Gravestone E) was better preserved than the other three (see plate 3). It measured 2.05m long (east-west) by 1.00m wide (north-south), the edges being moulded, with quarter circle insets containing flower (or sun?) motifs in low relief at both corners of the head. The inscription (now only partly legible) read:

Plate 3: Gravestone E, looking west.

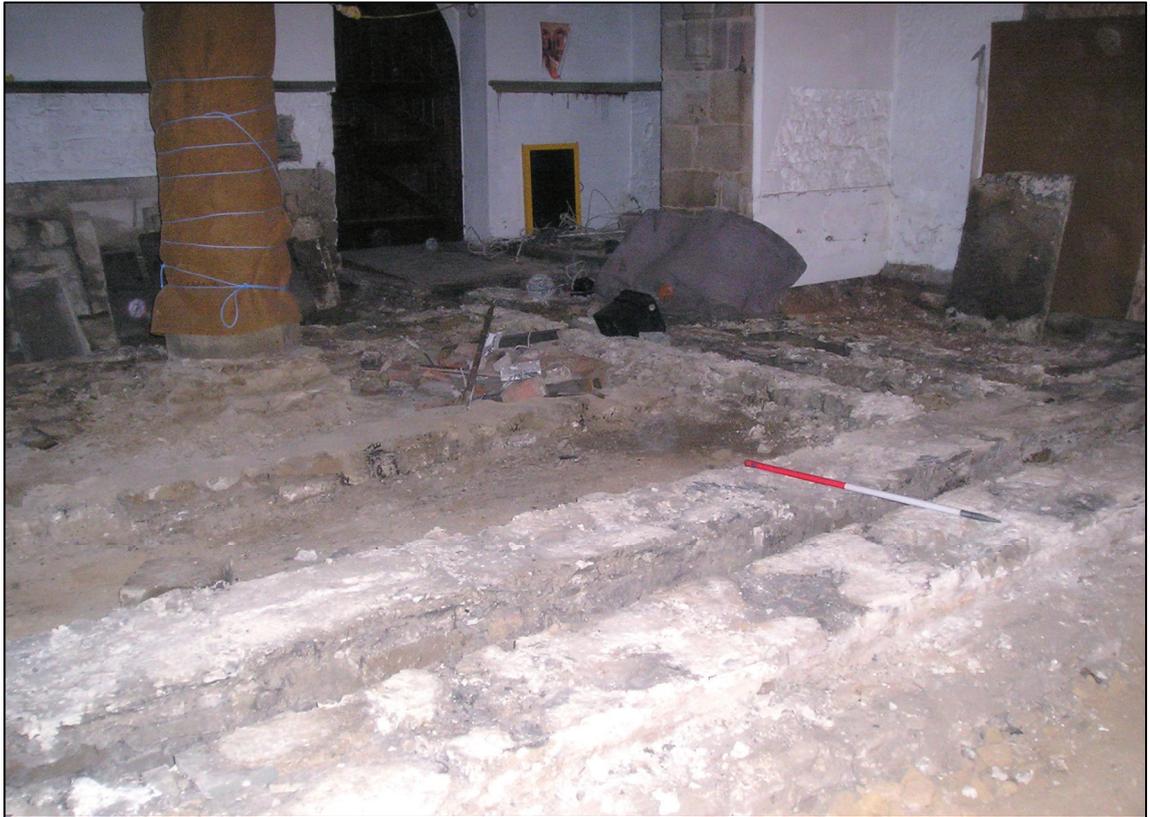
Plate 4: Exposed 19th century sleeper walls in nave of church, looking south-west.

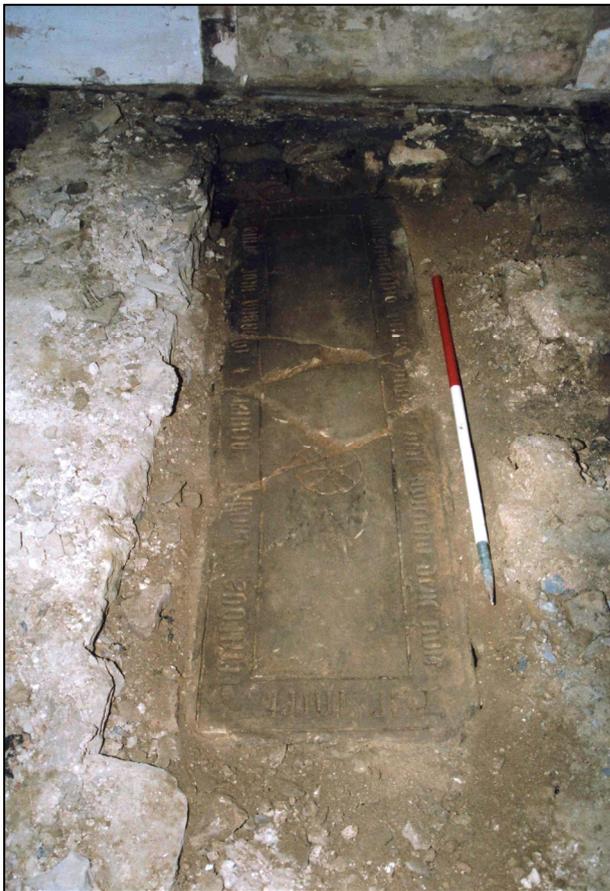
- 5.14 The floor stone was of limestone and had broken into several pieces (see plate 5). It was aligned approximately north-west/south-east and measured a maximum of 1.88m long by a maximum of 0.56m wide; following excavation (see below), it was found to be 0.12m thick. In contrast to the smooth upper surface, the underside of the stone was rough and apparently unworked; only the west edge of the

Plate 5: Early floor stone in situ, looking north.

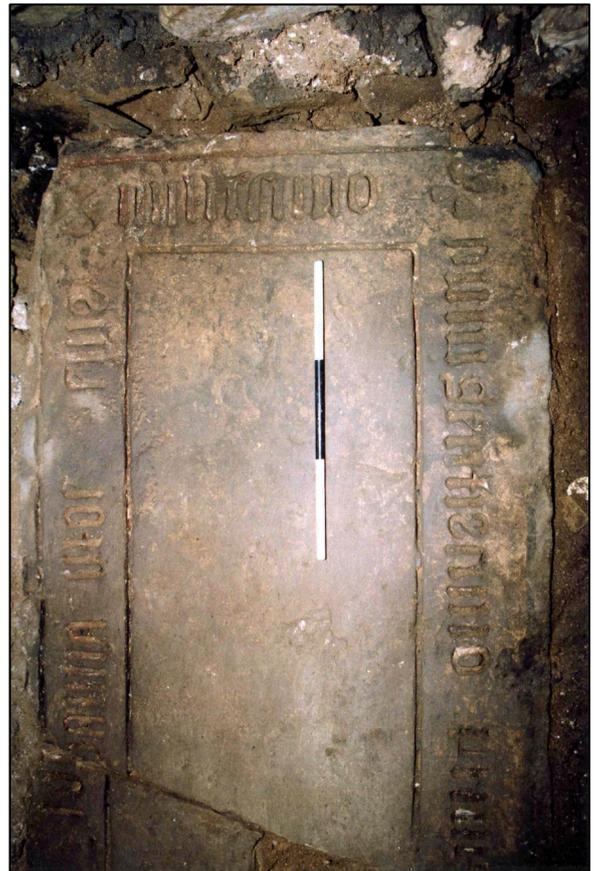
Plate 6: Detail of north end of early floor stone.
