**EASTERBROOK,
BOW, DEVON**

**HISTORIC BUILDING RECORDING
OF BARN AND LINHAYS**

August 2013

Project 229

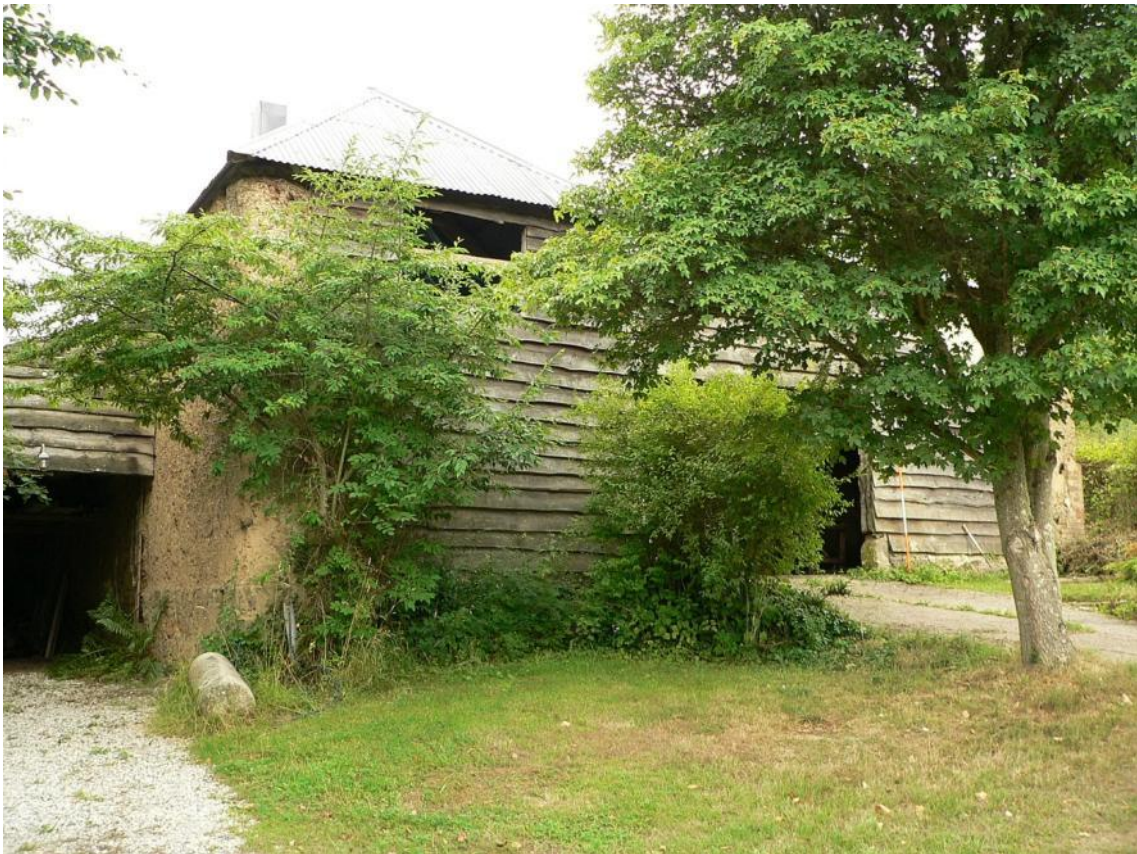
P2. East elevation, from the south-east, with the lean-to extension on the left side

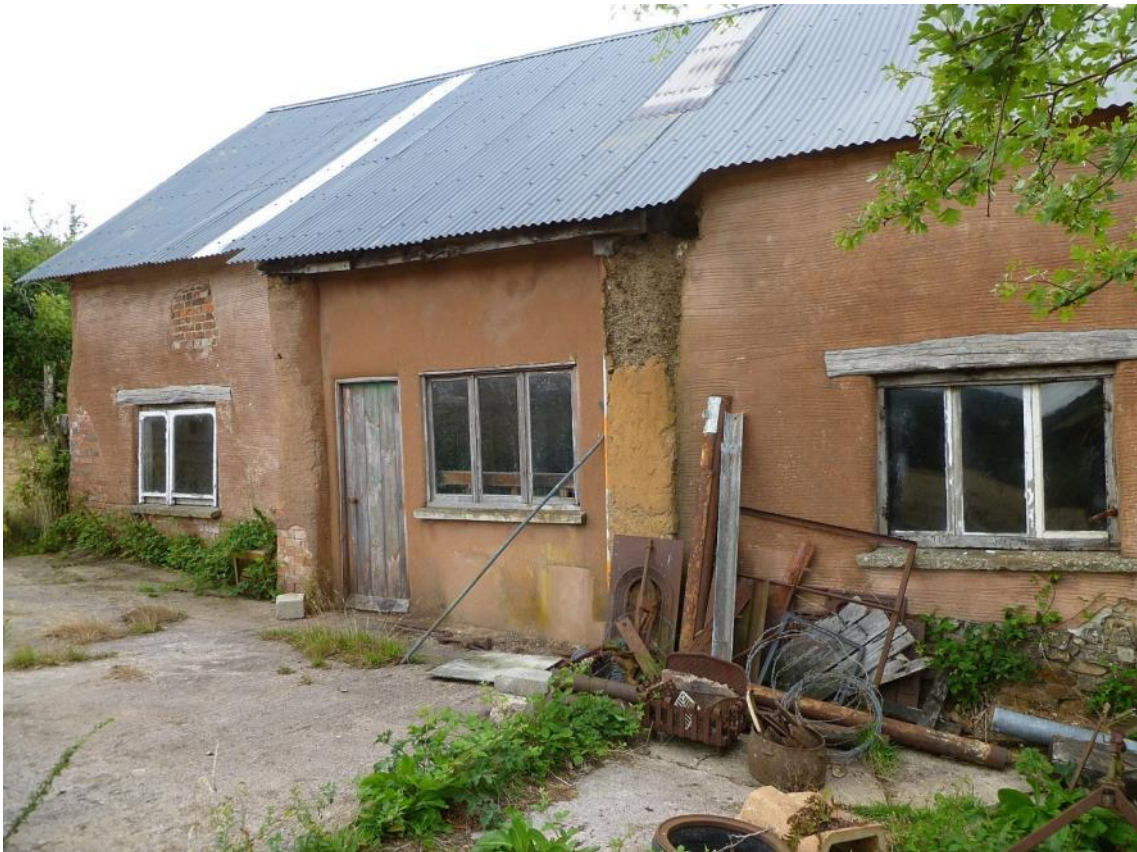
P5. West elevation, from the south-west, showing position of former central doorway

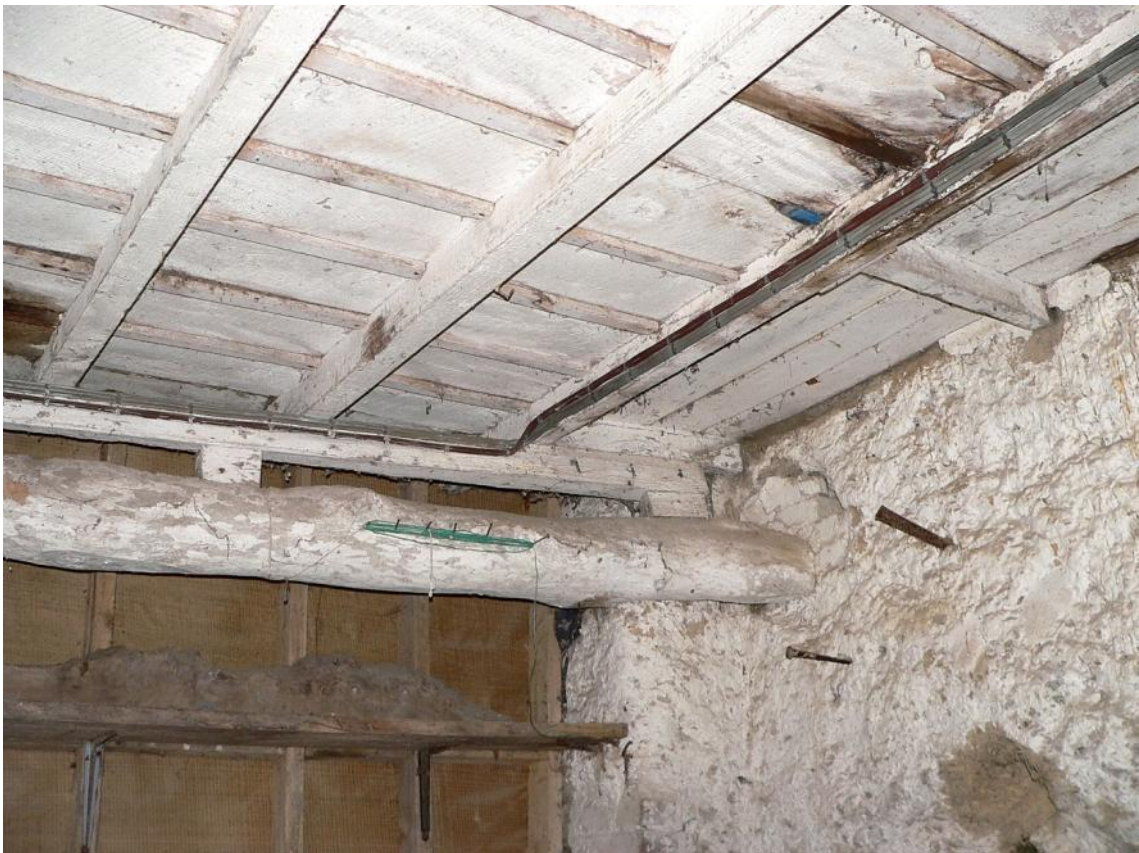
P8. Ground floor ceiling structure in northern linhay

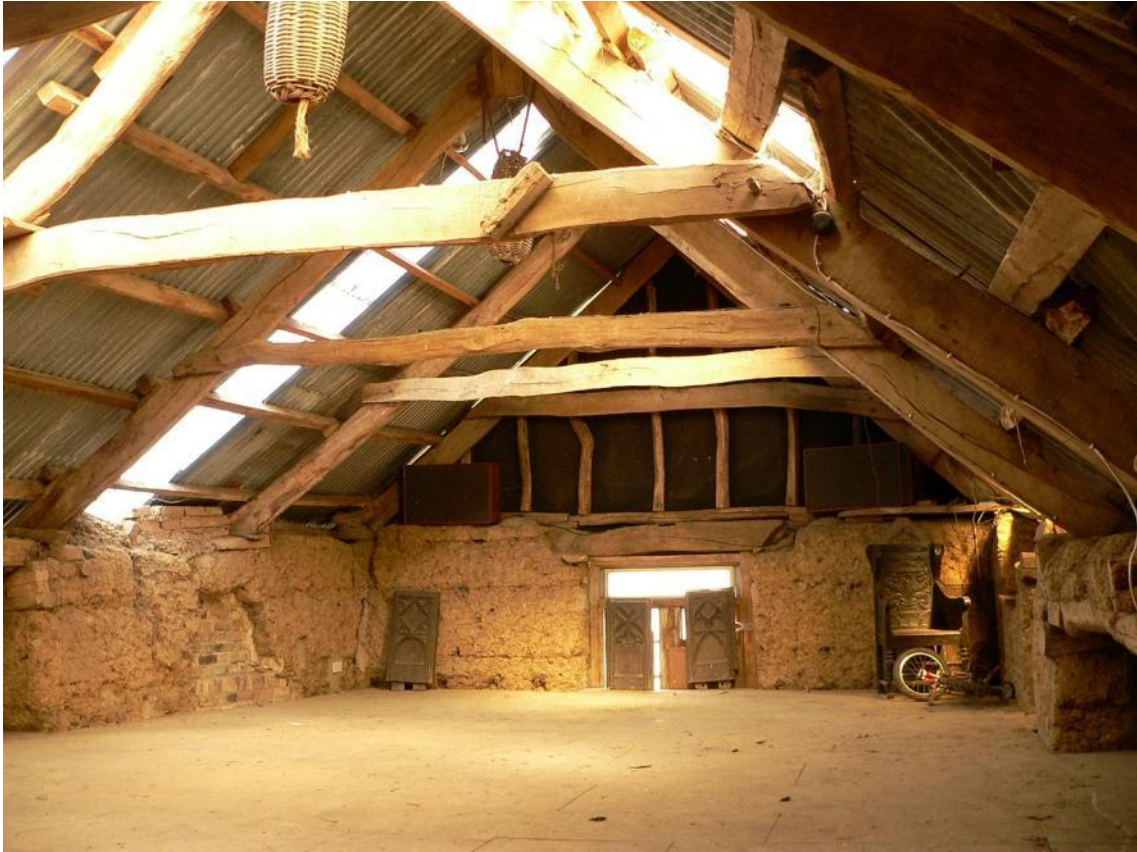
P9. First floor and roof of threshing barn, looking north

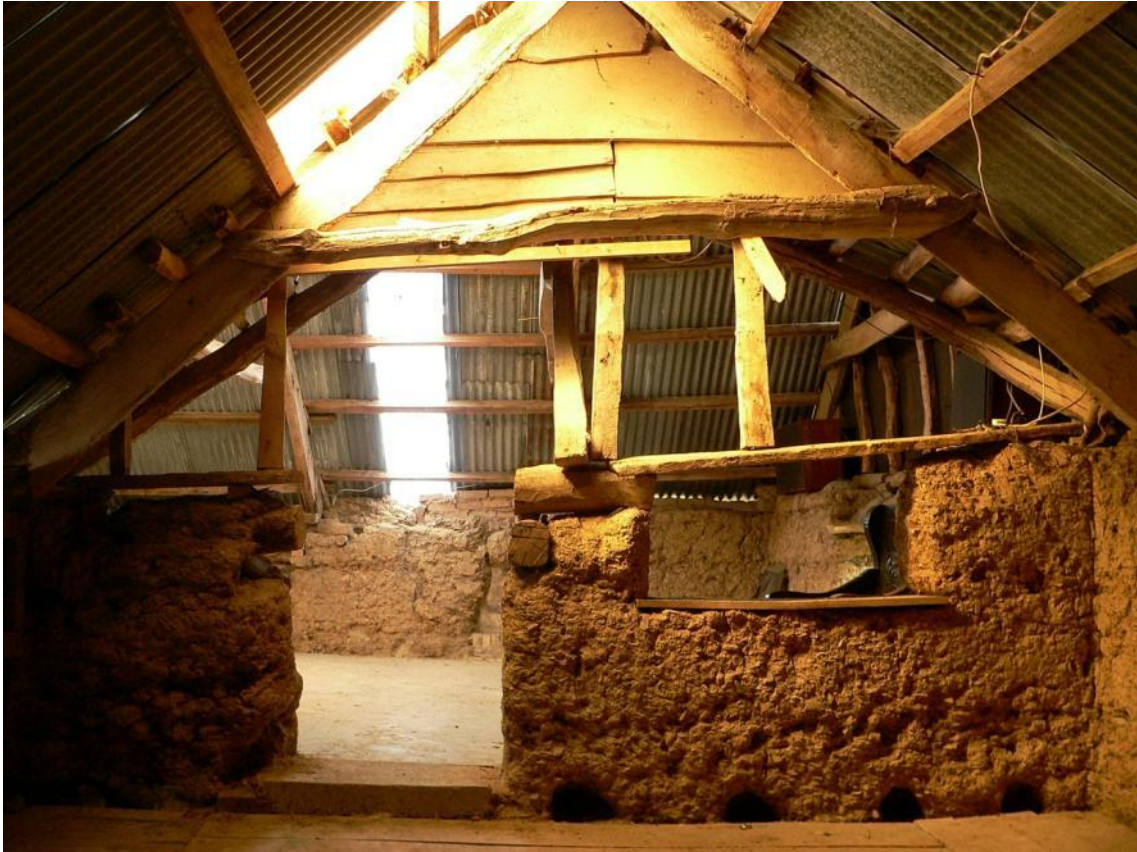
P11. First floor west end of northern linhay, showing cut through barn wall

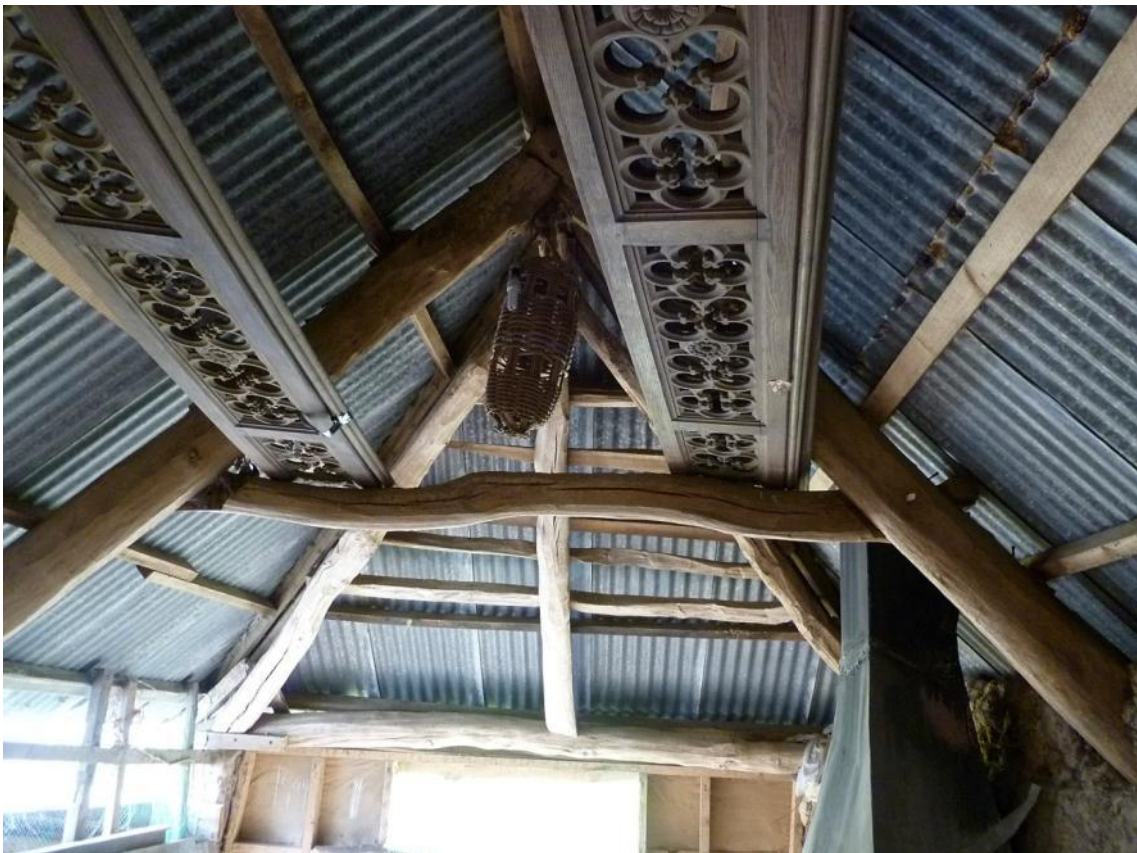
P12. Roof structure in southern linhay, looking east

The S linhay roof has two A-frame trusses and is fully hipped at the E end. The foot of the W truss principal is built into the wall head on the S side and that of the N principal is notched and has a vertical post nailed to it which sits on top of brick and concrete block on door pilaster. The S principal is notched over the N at the apex and a rustic collar is pegged and spiked to the E faces of the principals. The foot of the E truss S principal is built into the wall head and that of the N principal is notched into the head of the very knotty vertical front post. There is a barked and roughly squared collar notched into the E face of the principals, which has dropped at its N end where the peg has broken. The hip has three rafters, barked and roughly slabbed rafters which form a triangle, the apex of which stops short of the E truss apex. There are four cleft and sawn purlins across the hip end; the three on the S slope and four on N, including one at post head level, have all been renewed in softwood. The ridge is obscured by paired purlins close to the apex of the truss.

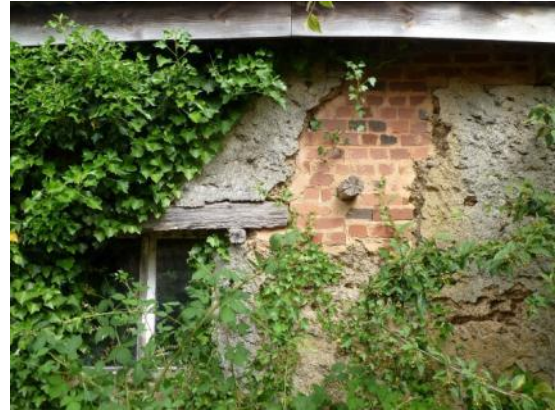
Brickwork repair to cob S wall of lean-to

Adjoining the S end of the barn is a single storey shed under a lean-to roof. Its W wall is built of concrete block. The S wall is very overgrown, but generally of cement-rendered cob with some brick repair. There is a small window opening with squared timber lintels and a two light fixed timber-framed window. The E end is of brick and cob, with 2.5m wide doorway with a timber lintel and waney-edged horizontal weatherboarding above. The floor of the lean-to is of beaten earth, with unfinished cob internal walls and concrete blockwork to the SW corner, where there was formerly an opening, and W end. The lean-to roof is of three bays, with two mechanically-sawn softwood tie beams and principal rafters, with a strut between the N end of the tie beam and the underside of the principal rafter. The ends of the tie beams bear on timber blocks set in the cob. The roof has three side purlins, with widely spaced rafters and felt under Bridgwater clay tiles. The roof timbers appear to have been stained dark brown.

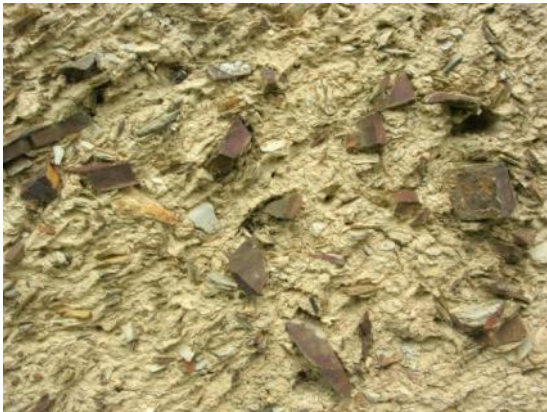
Close up of cob with large shillet inclusions

The walls of the barn and linhays are of cob on a low rough rubble stone base. The cob is generally of a buff yellow colour with shillet (flat slaty fragments) inclusions which in some areas are quite dense, and some are large. There is some facing repairs in brickwork and also some render on the cob. Where exposed, the horizontal joints between the lifts or raises of the cob are clearly visible. The roof, which was formerly thatched, is clad with corrugated sheet metal, with some translucent panels (see drawings).

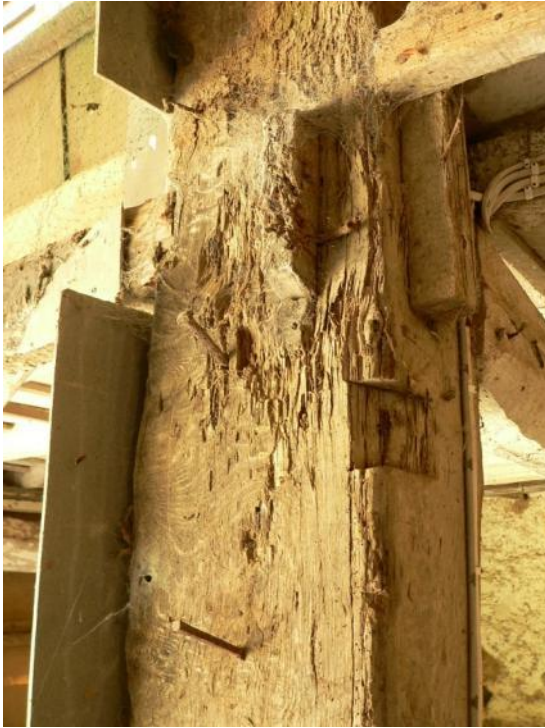
Reused timber, front post to S linhay

From the evidence of the tithe map (and the lack of contradictory evidence) the barn and lincays appear to date from the mid 19th century. The stone plinth on which the cob walls of the buildings were raised is not of high quality and the timberwork and carpentry employed in the construction of the roofs is generally rustic, using sparingly converted trees and branches of varying, but often small, girth. Some of the timbers have simply been de-barked, with one or more faces roughly squared by hand-sawing or hewing. No carpenter's or other assembly marks were observed. Considering the location of the buildings, close to managed woodland, it is likely that the timber was sourced very locally. It is therefore suggested that the main block, comprising the barn and lincays, were built between 1840 and 1860, using locally sourced materials and traditional farm building techniques. The front posts of both lincays are the largest timbers and one on the south side shows clear evidence of re-use.

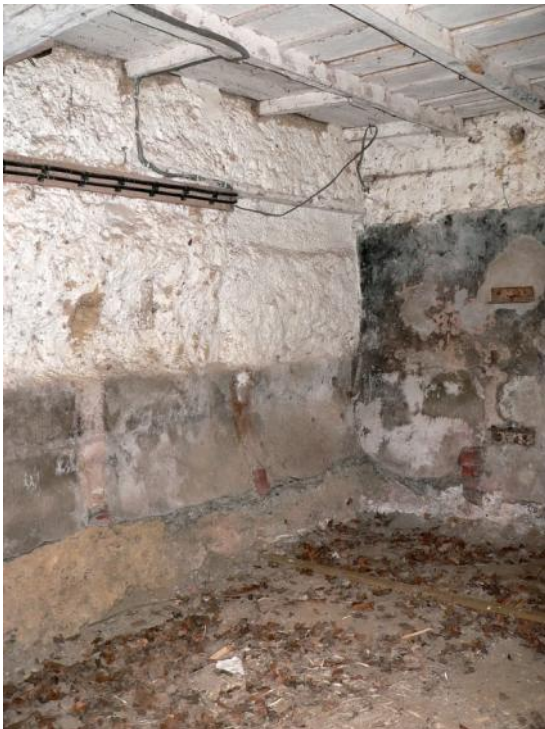
W bay, S linhay, looking to SW corner, with remains of feed/water trough along foot of wall and blocked opening

joists. The ground floor of the S linhay is concrete along the central passageway and earth and rubble along the S wall, where the concrete has been removed. As with the barn, the ground floors of both linhays were adapted for use as milking parlours with two stalls inserted in each bay, with mass concrete flooring and troughs built in along the bases of the external walls. The walls are rendered and painted to a height of 1.05m, with whitewashed cob above. In the S wall at the W end is the blocked opening noted above, the inner lintel of which is a band-sawn timber.

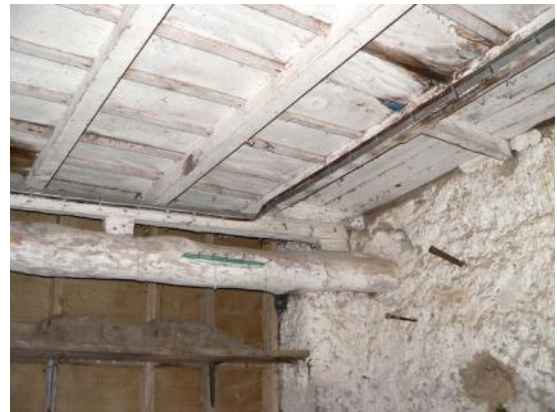
E end of S linhay, with secondary timber above cross beam to level floor. Note boarding to wall where floor was formerly open for feeding mangers

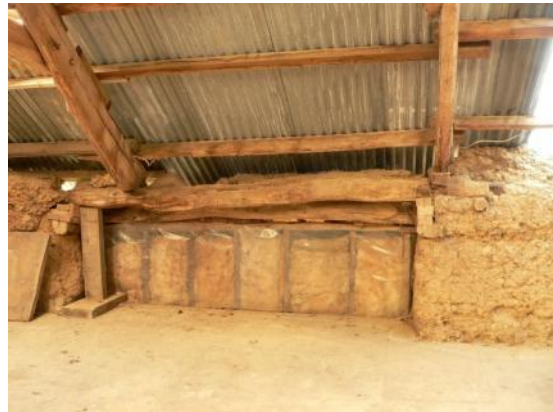
Beam over head of W doorway

At wall head level on the W side is a roughly squared timber above the wide doorway, carried on an inserted prop at its S end where the timber has decayed and on some brickwork with a timber wedge at the N end.

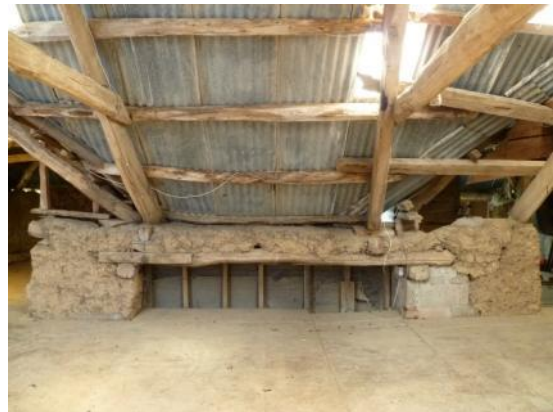
Beam and cob over head of E doorway

On the E side the cob wall has been cut away at both ends to form entrances onto the tallet floors of the two linhays (see below). The lintel over the central doorway is a roughly squared timber, supported on a timber needle at its N end and on a squared timber built round with concrete blockwork at its S end. It carries a 20cm high lift of cob on top.

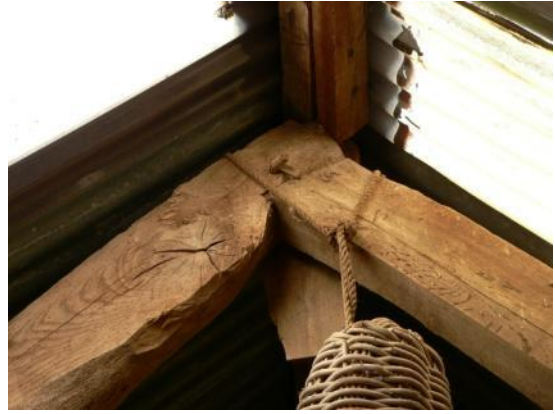
Detail of pegged apex of principals, T4

T4: is similar to T3, with spikes and pegs at both ends of the collar.

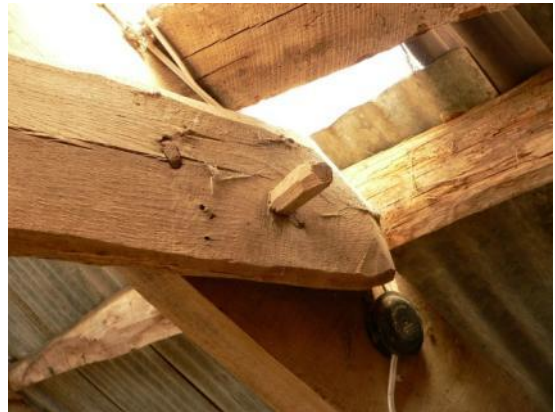
Detail of faceted peg and spike to collar, T4

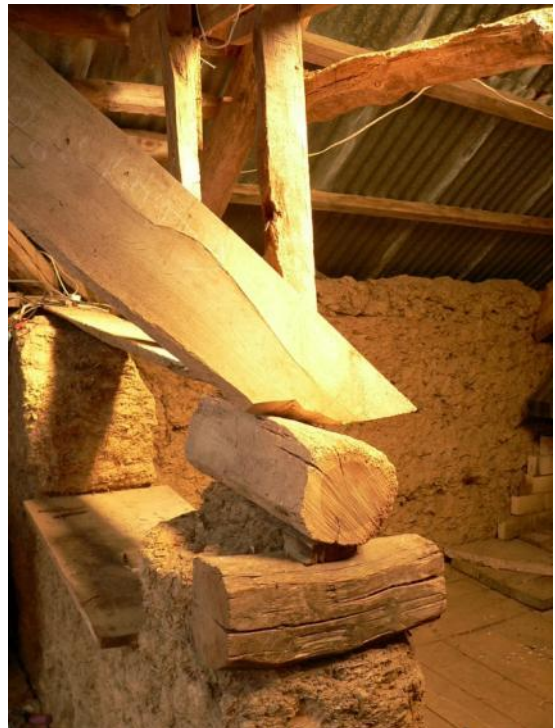
Foot bearing of E principal rafter, T4

The feet of the W principals of both T3 and T4 are supported and wedged on the beam which spans across the head of W doorway. The feet of the E principal sit on timber blocks on the short piece of cob walling on top of the beam over the central doorway.

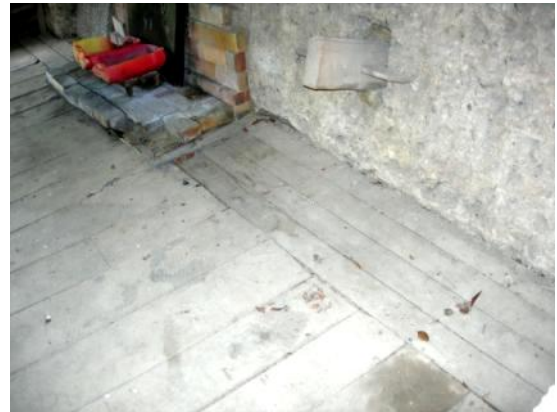
Detail of floor boarding in S linhay

The flooring is similar to that in the S linhay, with wide, random width circular-sawn butt-jointed elm boards, 20-30cm wide, laid N-S over joists, and an area of E-W boards along the S wall. The S front of the E bay is open and that to the W bay is closed with vertical corrugated iron sheet. The E end is temporarily closed with piece of carpet. As on the S side, there is an inserted modern fireplace and flue against the N wall.

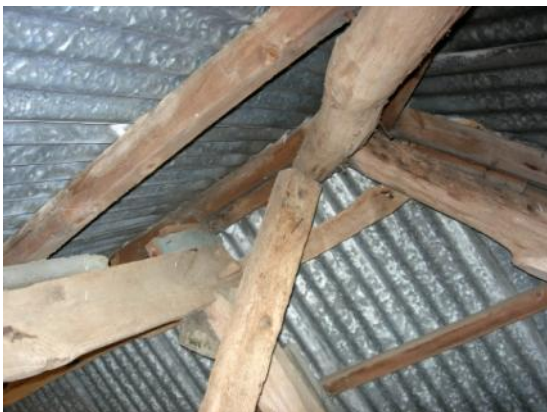
Apex of truss and hip rafter prop, N linhay

The roof construction is similar to that on the S side, although generally in poorer structural condition. The foot of the N principal of the W truss is notched over a crude piece of timber; the foot of the S principal is floating, apparently now resting on the corrugated iron of the passageway roof, but originally bearing on a wall plate or post. The N principal laps over the S at the apex and there is a very rustic collar pegged and spiked on the E side.

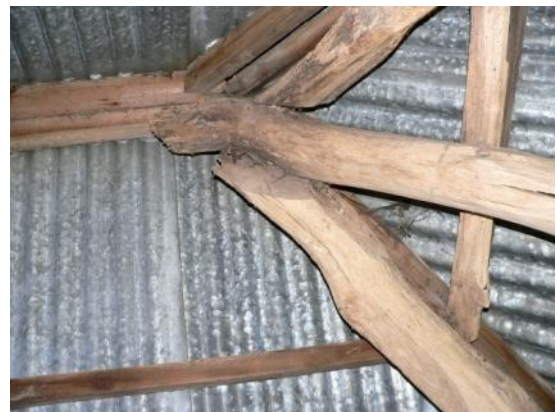
Apex of hip rafters in S linhay
