**SUTTON BARTON,
HALBERTON, DEVON**

HISTORIC BUILDING RECORDING

July 2009

Project No. 178/2009

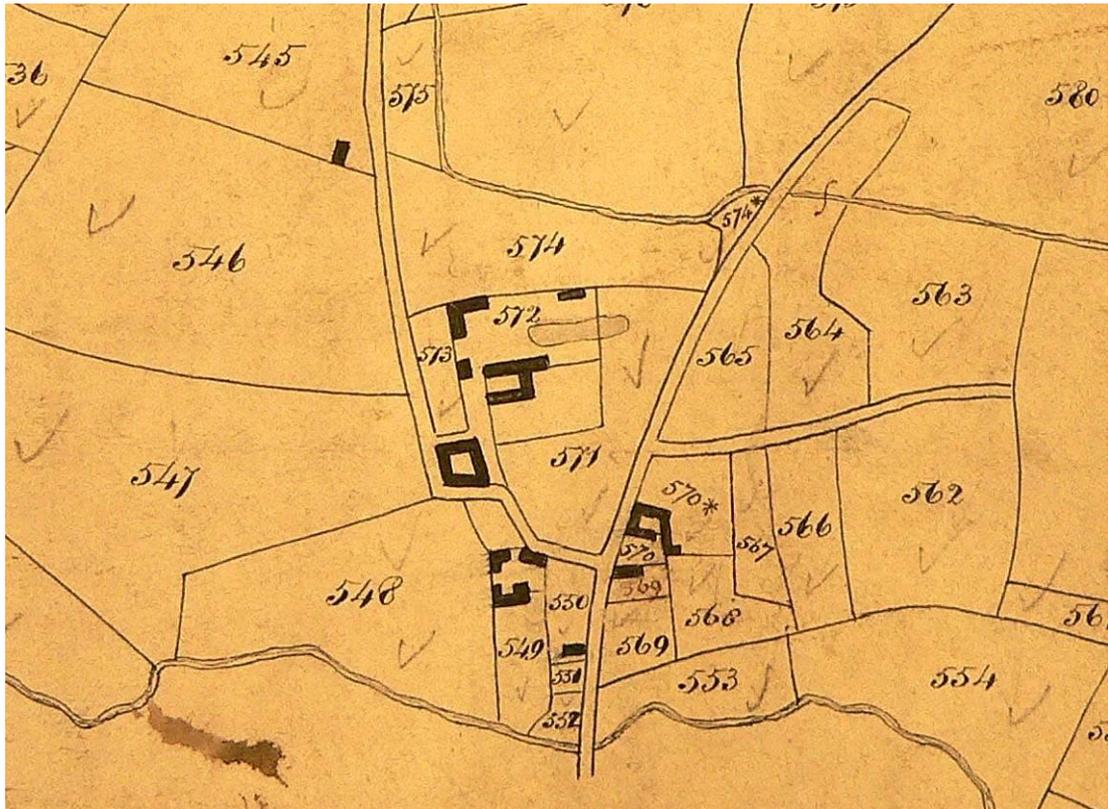
Fig.1. Sutton Barton, from the tithe map of 1838 (DRO)

The layout of the farm buildings is shown on tithe map of 1838 as surrounding a square yard, the range to the east side being longer than that to the west (Fig.1). The buildings are to the southwest end of plot 572, which is listed in the tithe apportionment as 'House, Bartons and Yards', occupying a little over half an acre. No description of the buildings or their functions is given in the 1862 sales particulars, but the accompanying plan shows the farm buildings occupying three sides of a square (Fig.2). The pond, which appears in outline on the tithe map, and the water supply from the Moorstone leat are also clearly shown on this plan.

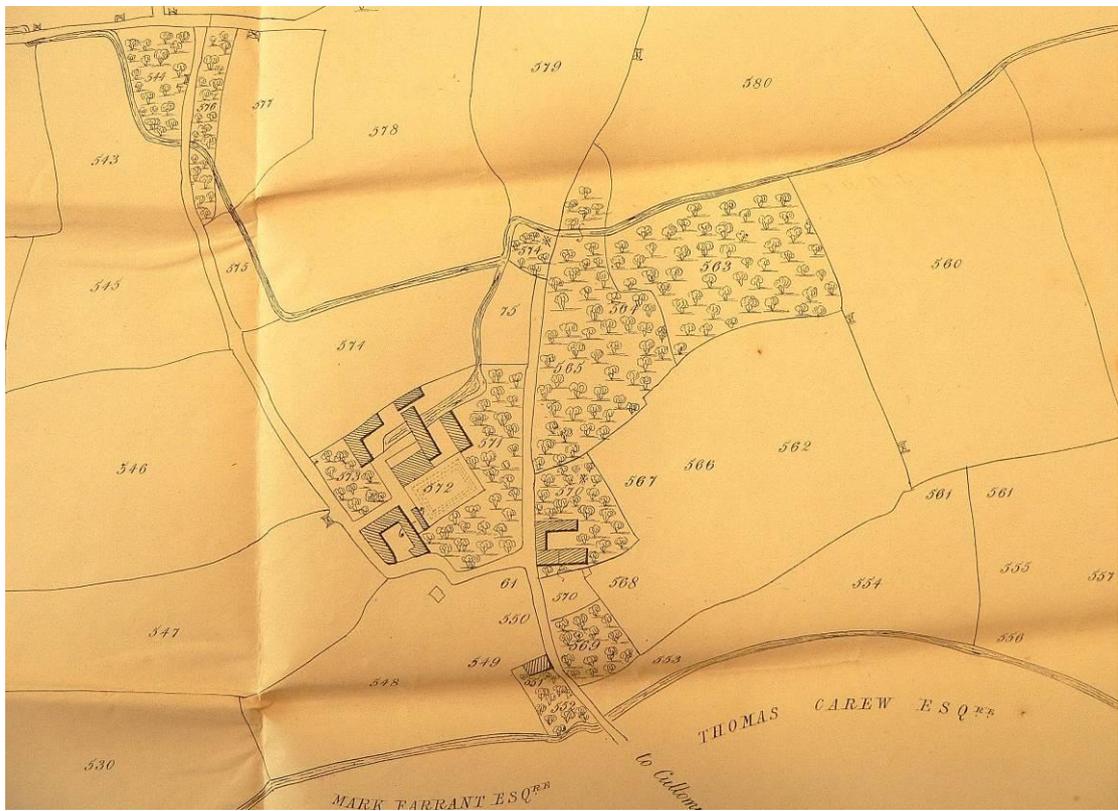
Fig. 2. Sutton Barton, from the 1862 sales particulars (DRO 62/9/2 Box 5/16)

The tithe map suggests that the south end of the yard was fully enclosed with buildings, although 1862 sales plan, which is likely to be more accurate, shows a small building at the south end of the lincay fronting the road, which has been identified as the root and calves' house. The roof of this building is probably of late-19th century date and the way in which the construction of two of the roof trusses has been improvised to fit them against the south gable of the lincay and a timber beam supports the south ends of the trusses, rather than them being carried on the wall head, indicates that the roof is later than the footprint of the building.

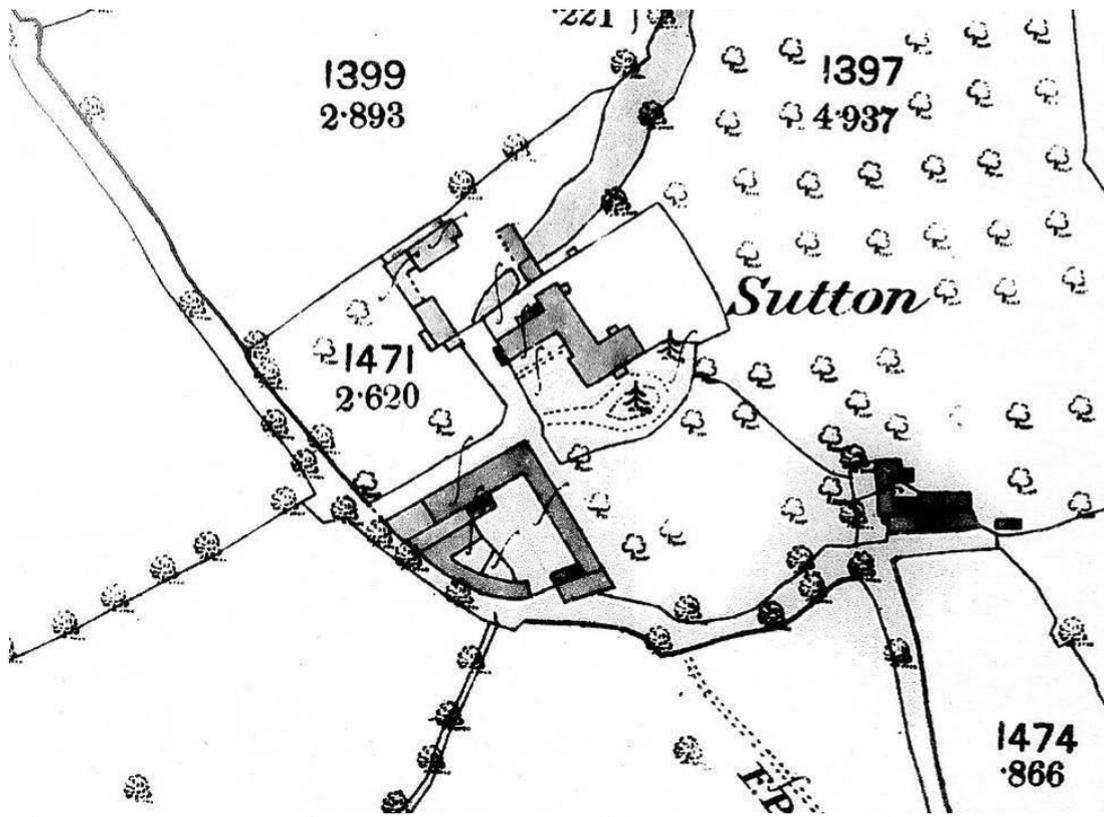
Fig.3. Sutton Barton, from OS 1:2500, 1st edition, 1888, not reproduced to scale

The Ordnance Survey 1:2500 first edition map of 1889 (surveyed 1887-8) shows several changes in the layout (Fig.3), with additional buildings built on to the south elevation of the barn at the west end. The plan of the house as rebuilt in 1866 is also shown. No significant changes to the layout of the farm buildings appear on the second edition of 1903 (Fig.4), although a new entrance and drive to the house had been created along the east side of the linhay and a tennis court had been laid out in what appears to have formerly been an orchard, to the south of the garden terrace in front of the house.

All that remains of original range which followed the line of the road on the west side of the yard is a section of eroded cob wall on a rubble stone base and an area of concrete flooring. The building appears to have been about 3.4m wide internally. Its former extent is shown on the OS plans and the aerial photograph (Figs.3, 4, 5).

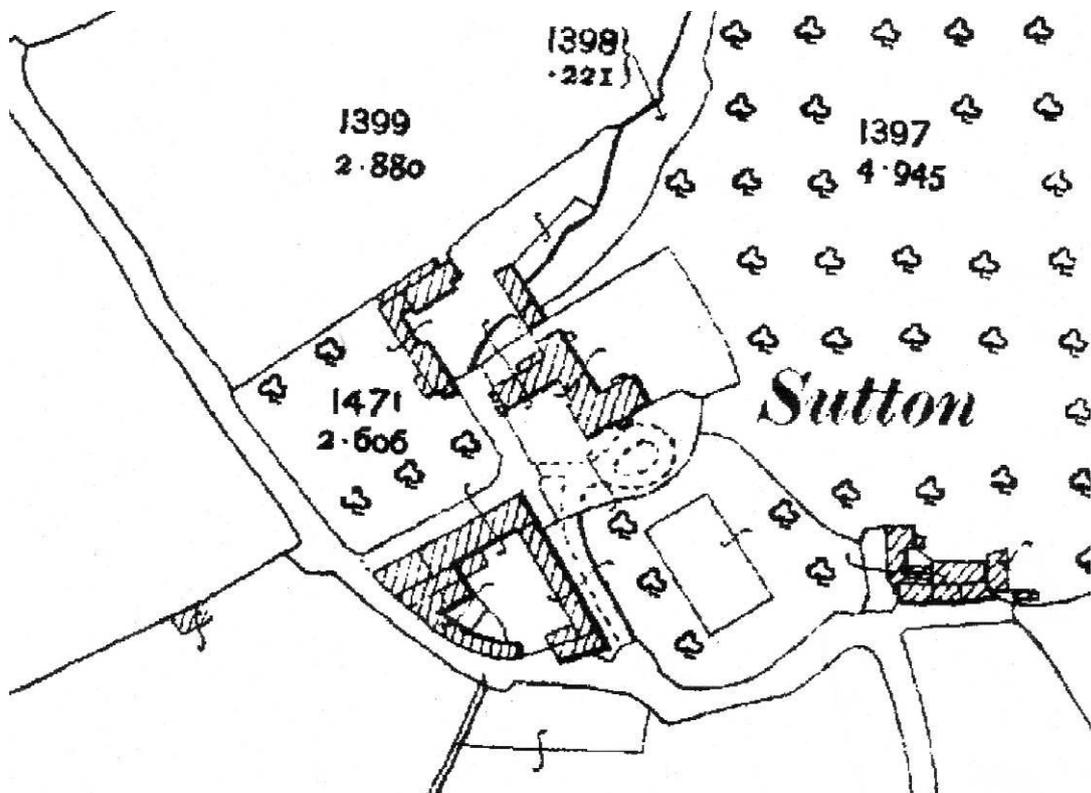
Fig.4. Sutton Barton, from OS 1:2500, 2nd edition, 1903, not reproduced to scale

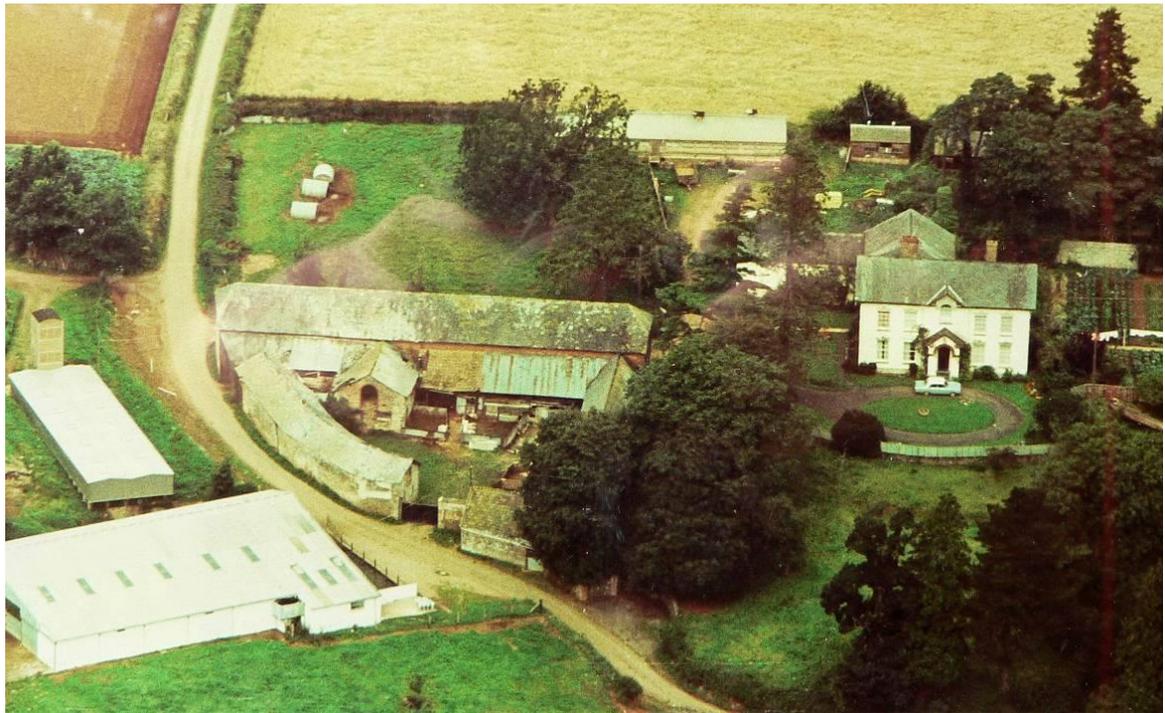
Fig.5. Sutton Barton, from the southwest, 1960s (courtesy owners)

The appearance of the buildings in the 1960s is shown on an aerial photograph taken from the south (Fig.5), which shows the curving west range still standing and the waterwheel shed projecting from the south elevation of the barn. The present extent of the buildings is shown in Fig.6. The waterwheel shed and west range have gone, only a concrete floor and a short section of cob wall on the roadside remaining of the latter. To the north of the yard stands the large corn and threshing barn and to the east side is the linhay, with a split-level building at its south end, fronting the road. This is presumably the "tiled root house and calves' house by road" referred to in 1925. Against the south front of the corn barn is a lean-to roofed steel-framed shed, which has been erected within the last 30 years.

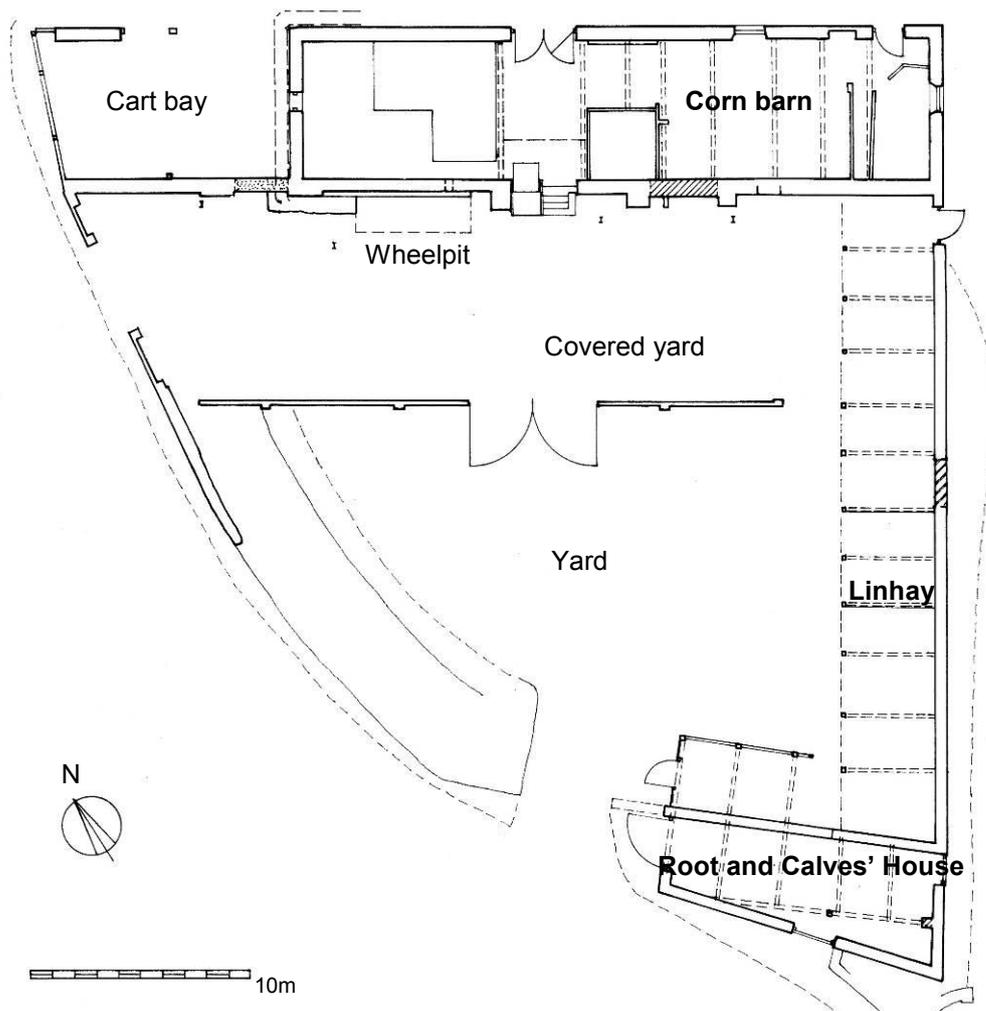
Fig.6. Sutton Barton: plan of buildings

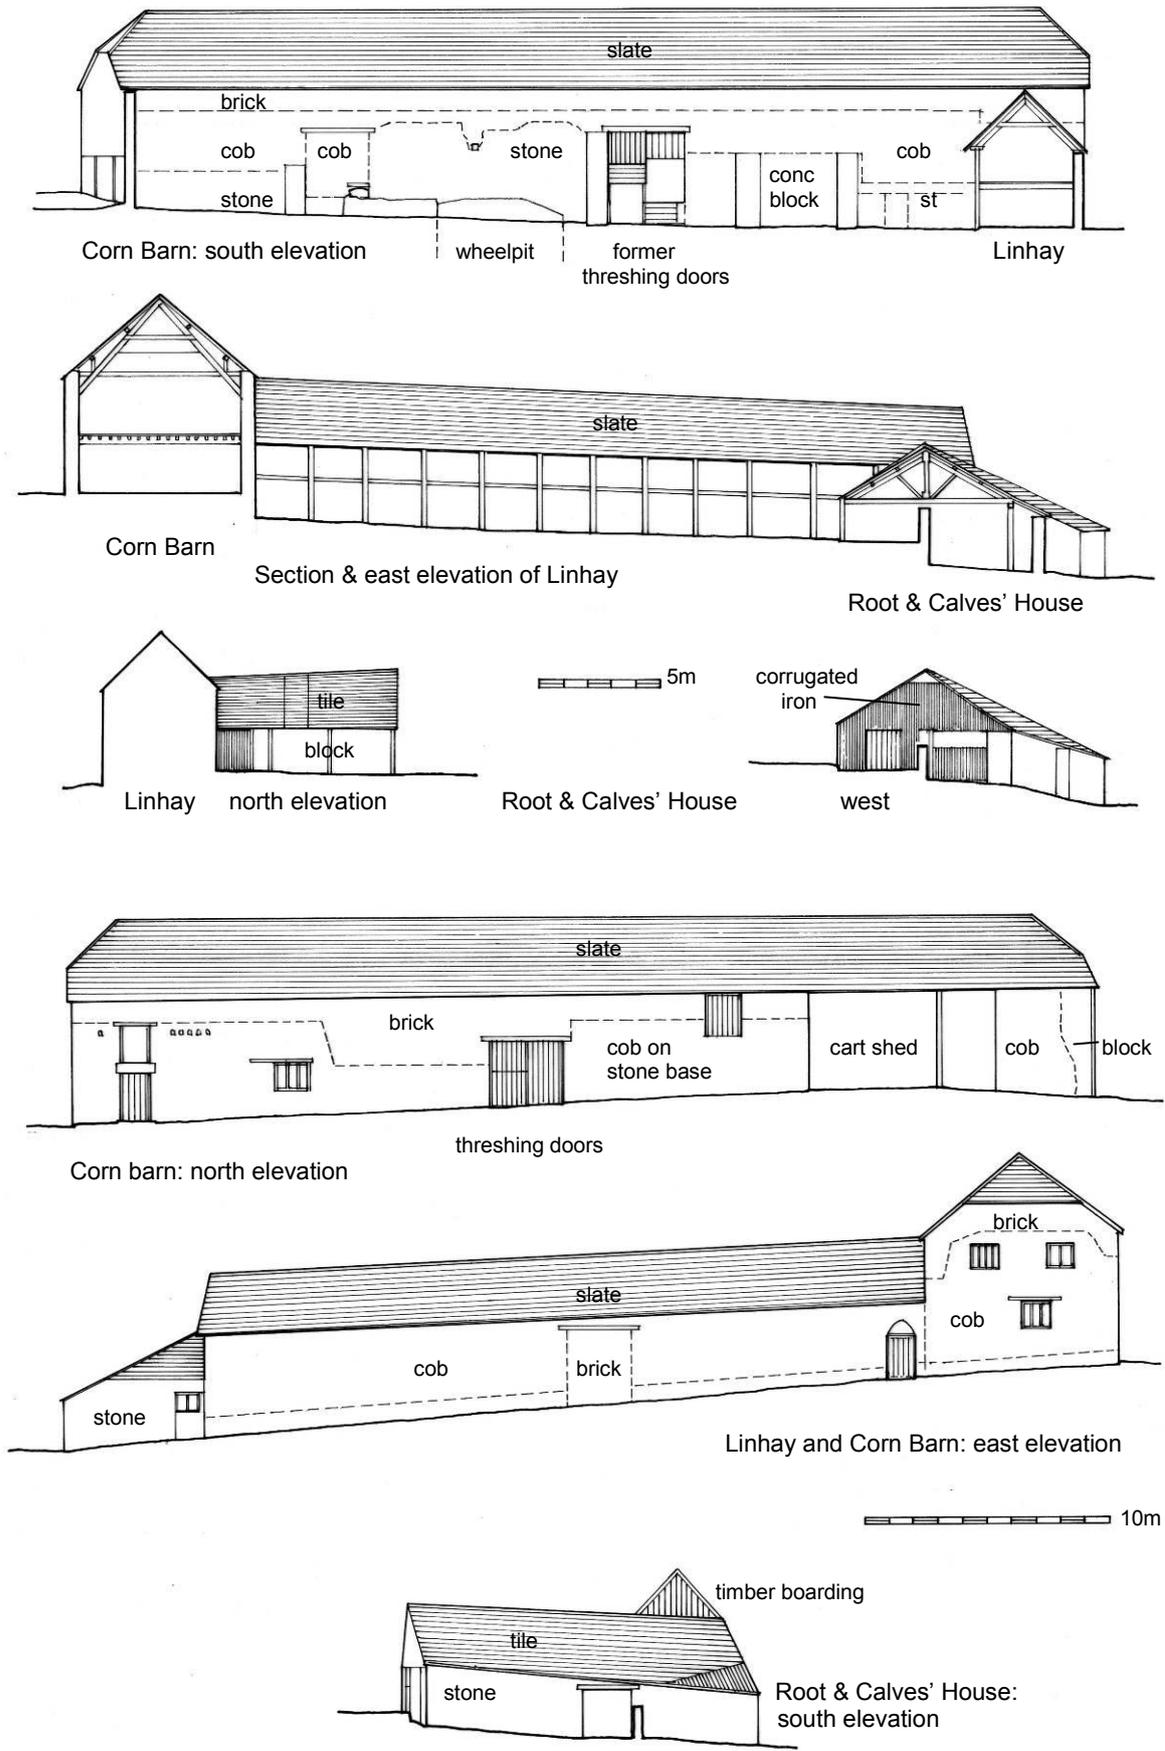
Fig.7. Sutton Barton, elevations showing materials of construction

The south elevation is quite complex, with evidence of several building or alteration phases (see Fig.7 and photos).

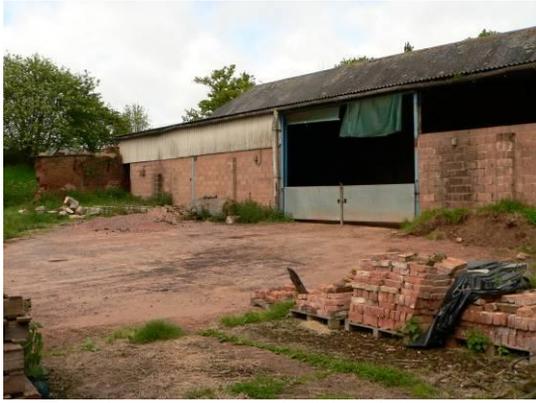
Modern lean-to on south side of Corn Barn

On the south side of the corn barn is a lean-to roofed shed of 6 unequal width structural bays, with a corrugated asbestos sheet roofing carried on 8 steel purlins supported by steel 25.5 x 15cm I-section stanchions. This shed has double outward opening steel doors in the third bay from east and two-thirds height concrete block front wall infilled with vertical corrugated asbestos sheeting on the south side. Its west end is angled to the line of the road, with a concrete block pier against the barn wall and a blockwork buttressed wall with vertical corrugated metal cladding on timber studs above, with double corrugated iron doors opening on to the road. On the roadside cladding is a sign with JAMES POOLE 3815 on it.¹

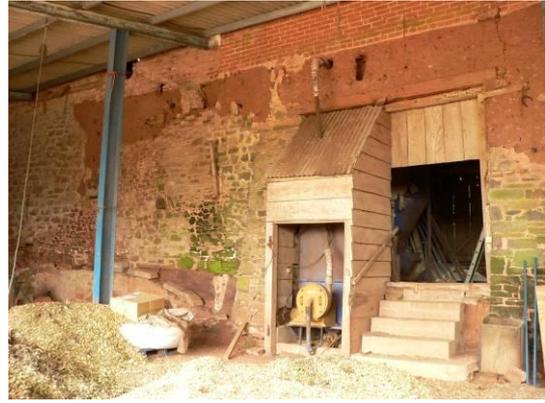
South wall, threshing door position

There is a stone buttress on the west side of the former threshing doors and a timber-boarded structure containing grain intake equipment has been built into the west side of the doorway. The door frame survives, but the doors have gone. Towards the east end of this elevation the wall structure is a complex mixture of stone, cob and concrete blockwork and the wall head has been raised to the present eaves level with approximately 18 courses of brickwork, laid mainly stretcher bond. There is some concrete block infill, including a section of wall between the two stone buttresses towards the east end of the elevation. A series of rafter holes in both the cob and the stone buttresses indicate the position of a former lean-to roof, which can be seen on the aerial photo (Fig.5). The lincay abuts the eastern end of the south elevation of the barn (see under).

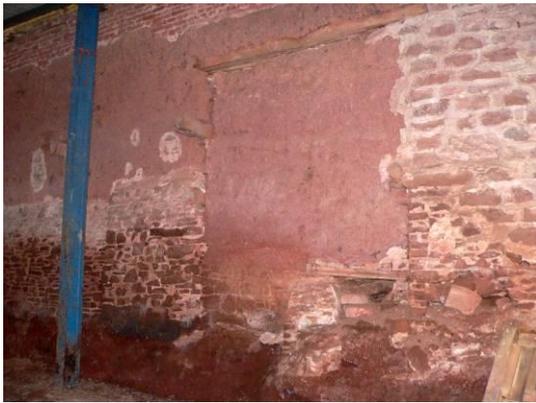
Corn Barn, south wall, west end

The south wall at the west end of the barn is of cob on a stone base, the wall head having been raised in brickwork. There is a low stone buttress to the west side of a former full height opening, which has been closed with cob. Between this former opening and the central threshing doorway the outline of the back-filled waterwheel pit is visible in the floor. It is 5.37m long by 1.67m wide, with a stone wall along its north side built out 0.3m in front of the barn wall. This stone wall has a slightly arc-shaped head, presumably reflecting the circumference of the waterwheel. From the 1925 particulars the waterwheel was overshot; its diameter is estimated to be *c.*4.8m and its width *c.*1.0 – 1.2m. Some green organic growth and staining visible on the stone wall of barn above the wheelpit is presumably the result of its proximity to the wheel. The barn wall at this point is of stone, with some cob and brickwork above. Towards the eastern end of the wheelpit there is evidence in the wall of a small, square opening in the stonework, which would have housed a wall box – an iron casting carrying a bearing for the shaft that took the drive from the waterwheel into the barn. From this evidence, the drive appears to have been taken from a ring gear on the waterwheel, a familiar arrangement for driving a threshing machine. At the west end of the wheelpit position is a broken down stone rubble and cob wall about 4m long by 1m high which projects *c.*1m from the barn wall. This supported a curved cement-lined trough, which carried water from the culvert under the barn floor to the top of the wheel, the last section presumably in a timber launder. The top of the culvert arch is *c.*1.3m above the present floor level, with a re-used timber with a groove along one edge forming a lintel at the front of the opening. The culvert, which is about 0.8m wide, has an arched brick roof. A large timber beam, which projected southwards, has been cut off close to wall of barn just west of the centre of the wheelpit and there are also remains of purlin ends of the former wheelhouse roof built into barn wall. A turned timber peg which passes through the south wall high up above the wheel position is considered to be part of the water control mechanism, which would have been accessible inside the barn, most probably from the top of the threshing machine.

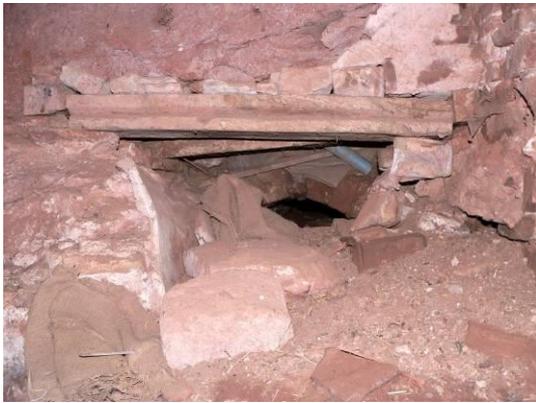
Culvert for water supply to wheel

Mechanical threshing was introduced in England in *c.*1790 and at Sutton Barton it appears that the waterwheel was not installed until after 1866. The wheel and the extension that enclosed it and probably housed barn machinery have been completely removed, the only related artefact noted being the remains of a timber bridge tree with a cast-iron footstep bearing for a vertical spindle attached lying on the floor against the barn wall at the north end of the lincay. This indicates that there was at least one pair of millstones, for grinding animal feed, in the mill room. While there is little evidence above ground of the wheelpit, it is understood that it was simply backfilled to ground level (*pers comm*). The course of the leat supplying water to the wheel was not fully explored. The tailrace, which took water away from the bottom of the wheelpit, must be culverted under the yard, to exit into the stream further down the hill slope to the south of the buildings. Apart from the timber peg through the south wall of the barn that was probably part of the control mechanism for the waterwheel, accessible from the threshing machine, no evidence of the thresher was found.

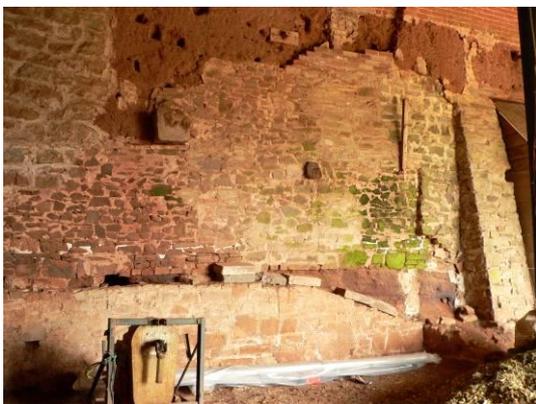
Position of wheelpit against south wall

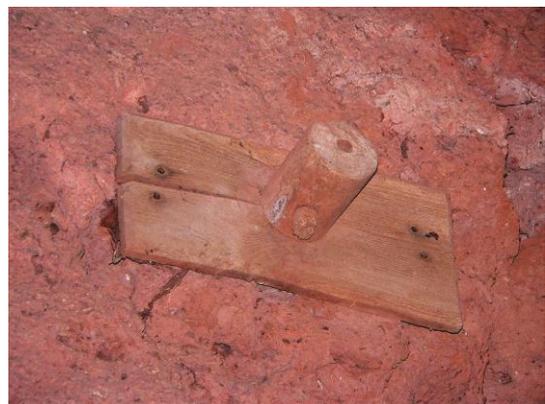
Control for waterwheel through barn wall

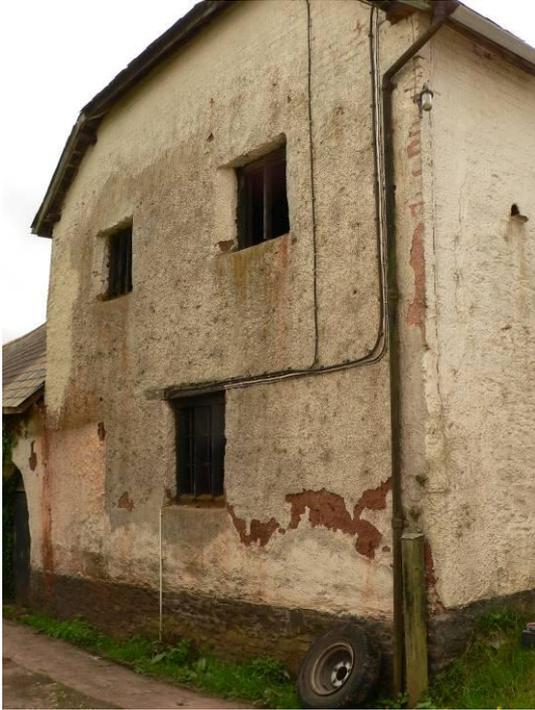
East gable end of Corn Barn

The east gable end wall of the barn is of cob on a random rubble stone base which stands about 0.85m high. The head of the wall has been raised in brickwork, the former roof hip line being clearly visible. The cob walling is rendered and painted externally. At ground floor level is a 3-light unglazed window, with a chunky moulded frame and mullions, with 1 vertical and 2 horizontal iron bars fixed in each opening. There are two first floor windows, that to the south having 3 mullions and that to the north a single moulded

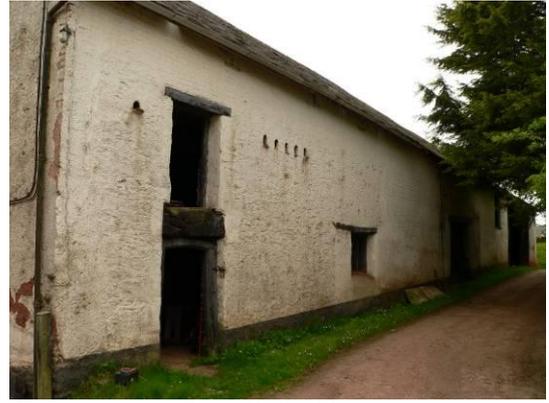
Corn Barn north wall, looking west

The north elevation is of cob on a rubble stone base, the cob being rendered and painted white above a black-painted base. The wall head has been raised in brickwork above the first floor door head. Close to the head of the earlier cob wall are several pigeon/dove holes, 1 to the east of the first floor door and 5 to the west. The cob walling reduces in height to the west of the ground floor window, with a large area of brick infill. At the east end are two doors, one above the other, with a massive (re-used) timber, 0.42m deep x 0.54m wide, with the remains of a deep plain chamfer on the inside bottom corner, used as lintel/cill between the door openings. The ground floor door frame is moulded and painted black. The mouldings suggest a 17th century date, but it appears to have been re-positioned. The present door has 4 wide and 1 central narrower vertical circular-sawn planks, with 3 ledges. Further to the west is a 3-light window with a heavy section, moulded and pegged frame with octagonal mullions, with 1 vertical and 3 horizontal iron bars to each light. This appears to have been inserted into an earlier doorway as the original lintel extends 0.8m further east than present window opening and a secondary lintel immediately underneath it is a re-used timber with chamfer and joist mortises cut into its underside.

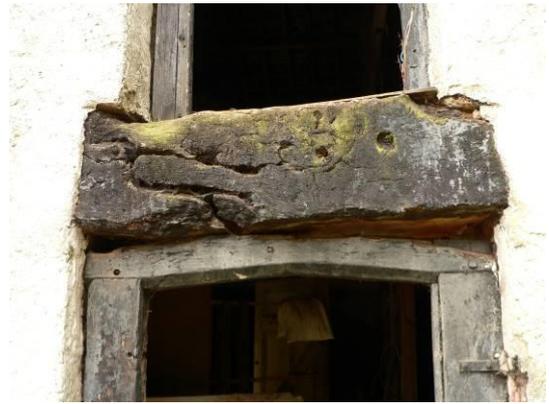
Detail of ground floor door head and lintel at east end of north elevation of Corn Barn

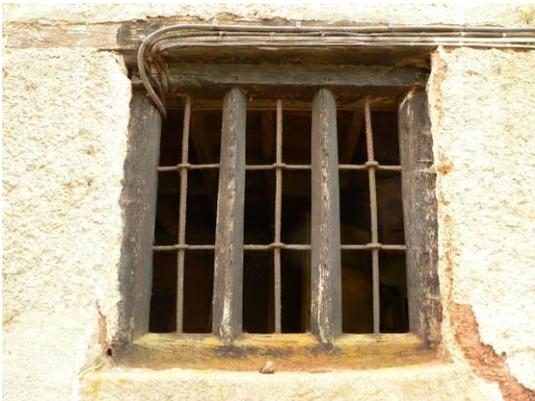
17c window in east gable end

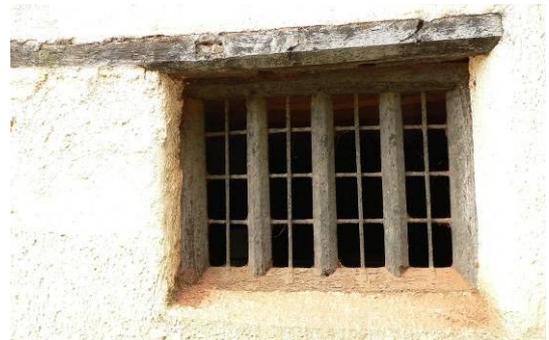
17c window, north side of Corn Barn

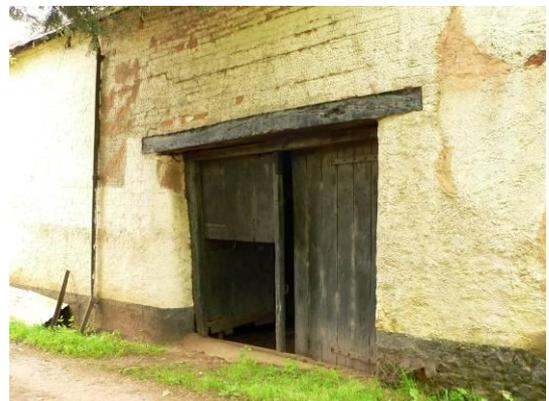
Threshing doors, north side of Corn Barn

Towards the centre of the building on the north side is a pair of doors hung in plain timber frame with a fixed central post. These doors are opposite the large opening on the south side and indicate the position of the threshing floor, which formerly had double doors on both sides. Threshing doors were usually sub-divided both for convenience and to create different degrees of draught when winnowing (Child 1995, 64). The east door, which is divided horizontally, is hung on blacksmith-made hinges with a heavy wooden stock lock on the inside of the bottom leaf. The top leaf has two ledges and a single diagonal brace, the lower leaf 3 ledges. The west door is a single leaf, with vertical circular-sawn boards, 3 ledges and 2 diagonal braces. The east door and post on which it is hung, which is chamfered and rounded, is older than the west side. The doors and frame are painted black.

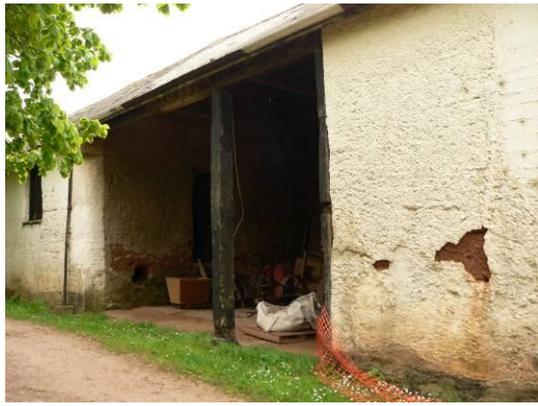
Cart bay at west end of Corn Barn

Towards the west end the barn is open on the north side, formerly used for housing carts and wagons. A concrete grain intake pit has been formed in the floor, which is of compressed earth, with concrete capping over the course of the leat culvert. In the southwest corner is a steel grain bin on a concrete base. A circular-sawn timber post on a

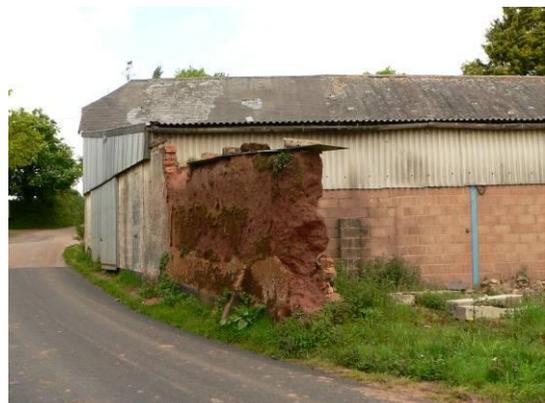
Remains of west range

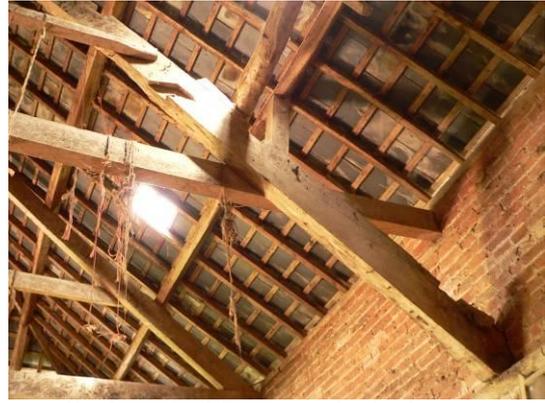
Detail of south side truss principal

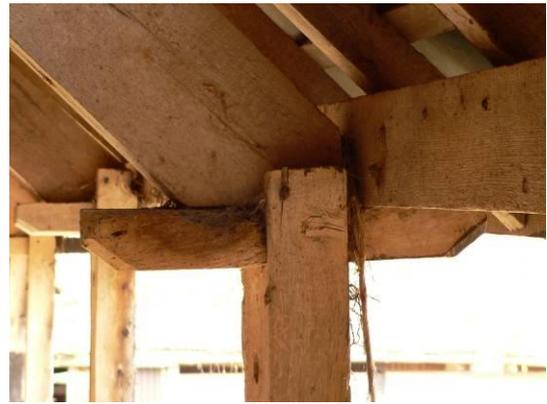
Detail of head of front post

The linhay roof has been completely replaced above the wall head and tops of the front posts. The heads of the front posts support timber cantilever brackets on which the feet of the principals are carried. The principals are of circular-sawn softwood, 20 x 8cm section, with a shouldered tenon at the apex, and a plain collar, 18 x 5cm section, bolted x2 at each end to the north faces of the principals. On the east side the feet of principals bear on timber blocks aligned east-west (i.e. across) the head of the cob wall. There is a single row of through purlins on both slopes, partly notched into and partly carried on cleats on the backs of the principals. The apexes of the trusses carry a vertical ridge board and externally the ridge is capped with inverted V-section clay tiles. There are on average five 8 x 5cm section softwood common rafters to each bay, with horizontal battens to which Welsh slates are nailed. The slates are approximately 56 x 37cm. At its north end the roof linhay roof is not tied into the brickwork at the head of the barn wall, although front beam at eaves level on west side is. There are remains of cast-iron half round guttering to west side eaves. The south gable end of the linhay, above the Root and Calves' House roof, was formerly clad with vertical timber boards on studs, some of which remain.

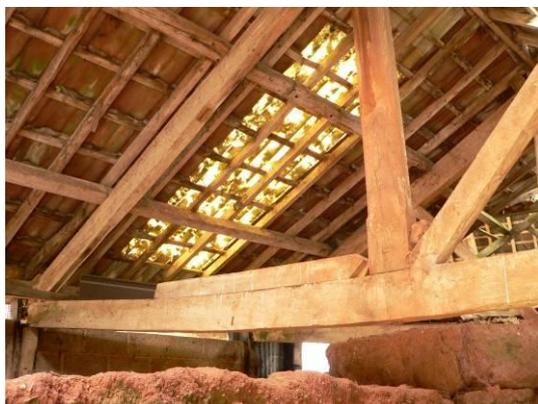
Detail of king post truss

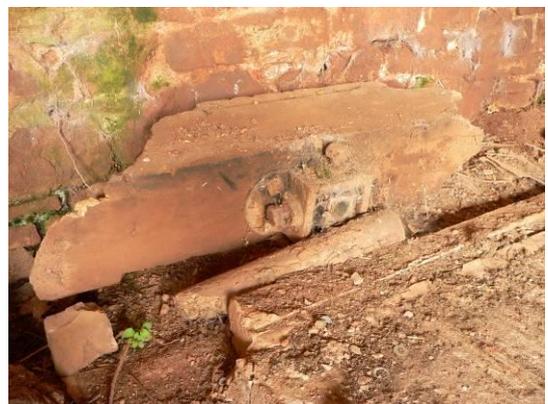
Timber bridge tree and footstep bearing, from millstone assembly, displaced in linhay
