**WOODHAYES FARM
CLYST HYDON, DEVON**

HISTORIC BUILDING RECORDING

Project WCH 193/2010

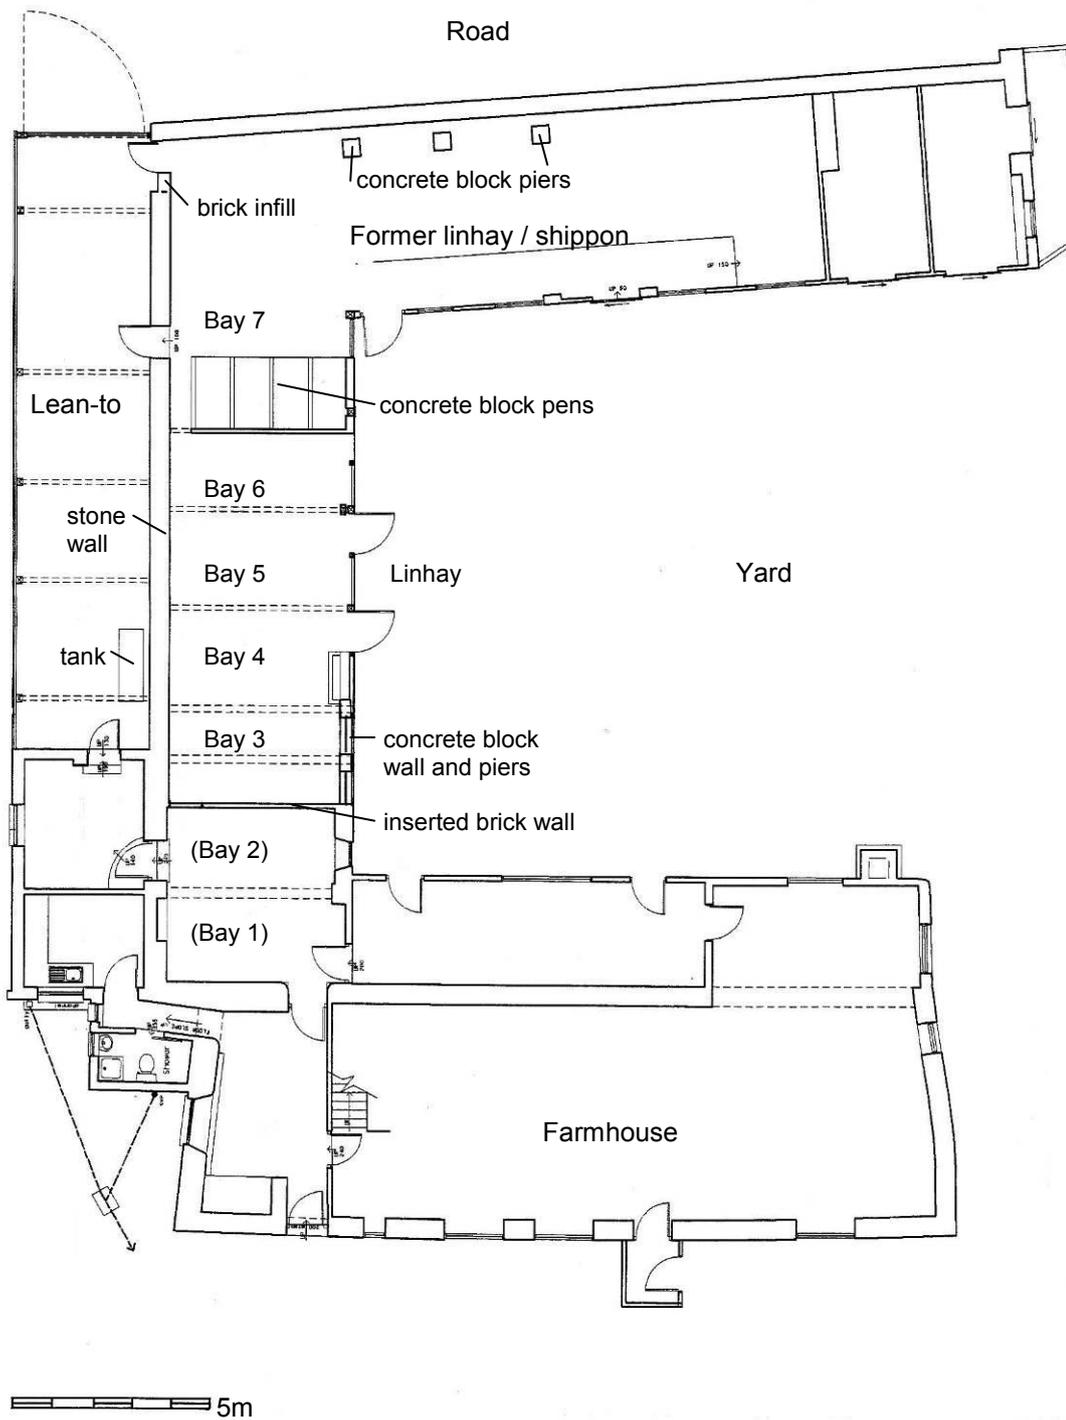
Figure 7: Woodhayes Farm, Clyst Hydon. Ground plan of linhay

The bays are numbered from south, as given in the report

West range (Figure 9a): This was originally of 7 bays, each bay being about 2.4m wide. Internally the building is 4.65m deep from front to back. The two southernmost bays (1 and 2) which adjoin the west end of the farmhouse, have already been converted to domestic accommodation and are not covered by this report. An outward-opening timber shutter remains at first floor level in bay 2. Working from the south, the east elevation of bay 3 is clad with horizontal black (creosoted or stained) weatherboarding, with a former doorway on its north side which is now boarded over.

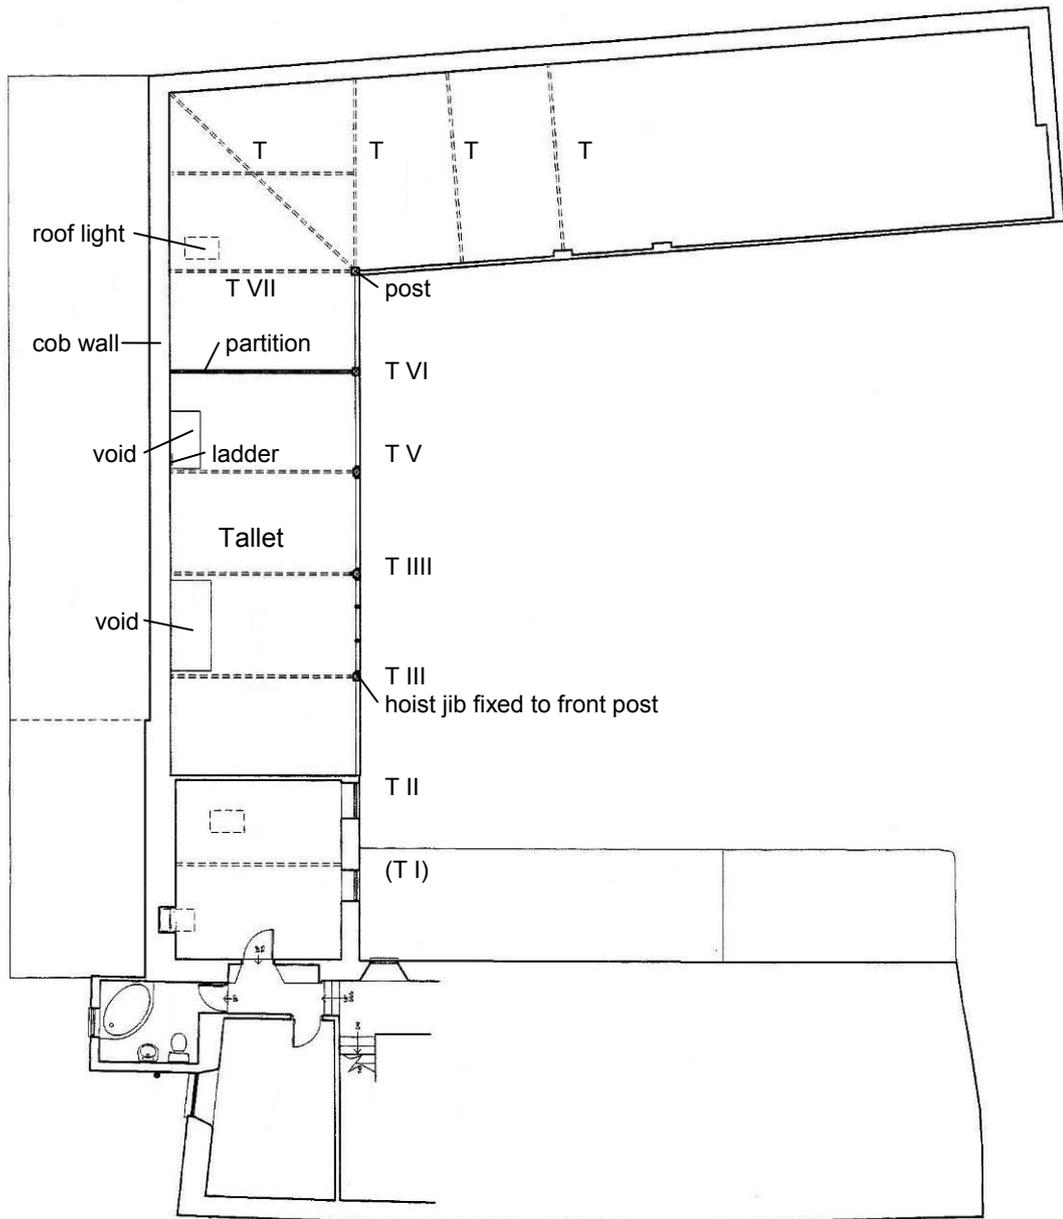
Figure 8: Woodhayes Farm, Clyst Hydon. First floor plan of linhay

T : roof trusses numbered from the south, as given in the report

The roof of the west range has five visible trusses, all basic A-frames of similar construction. They are numbered historically from the south/house end, truss I being within the converted end of the linhay. Truss II forms part of a modern stud and insulation board partition dividing off this end. Truss III has an additional collar on the house side and two inserted vertical struts between collar and principals. The trusses numbered IIII and V are similar to truss II. Truss (6) is obscured by studding and hardboard on its north side. All the truss principals and collars are of hand-sawn elm. The principals are about 20cm by 7cm section, halved and lapped east over west at the apex when viewed from the north side. The collars are about 15.5cm by 6cm section, fixed with a single bolt with a square nut and a couple of spikes on the north sides of the principals. Each truss has a timber plate nailed over its apex on the south side, which carries a vertical sawn timber ridge board. The feet of the principals are notched over timber blocks set in the head of the cob wall on the west side and notched and housed into the tops of posts on the east side. There are two rows of through purlins on each slope, the lower being close to the wall head and the upper running across the backs of the principals at about mid span. The purlins are simply softwood poles with the bark left on. The rafters, which are 6cm to 7cm diameter poles at 36cm centres, are similar, although some have been sawn down one side to form a flat surface for nailing the battens to. The battens are ex 5cm by 2.5cm softwood, to which slates are nailed.

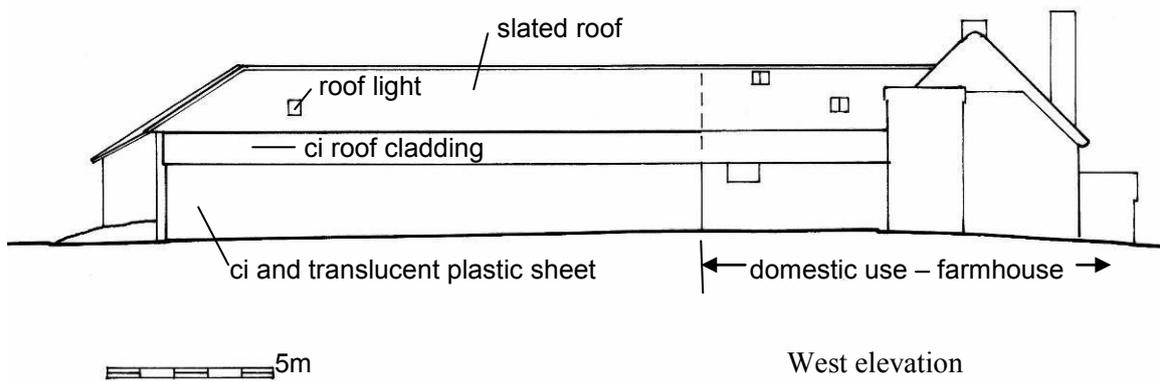
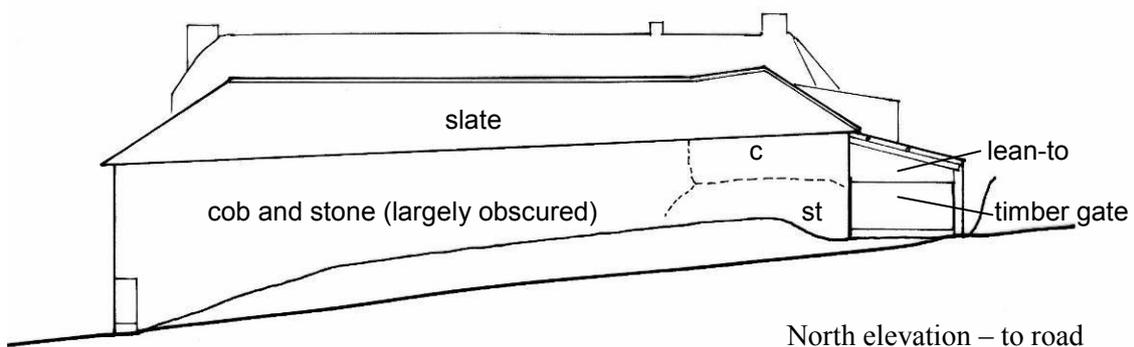
Figure 9b: Woodhayes Farm, Clyst Hydon. West and north elevations of linhay range

West elevation

North elevation - to road

The rear wall of the northern range, which abuts the road, is of rubble stone to first floor level, with cob above (Figure 9b). The cob is rendered and painted. Much of this elevation is obscured by trees planted between the wall and the road.

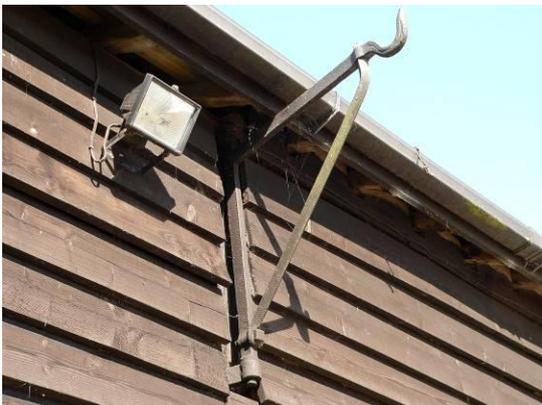
Iron hoist jib below eaves, east elevation

The lincay at Woodhayes Farm is of familiar design and construction for the region and is considered to be a good example of an important local vernacular building form, which was constructed to house cattle on the ground floor and store feed on the first floor (discussed in Alcock 1963 and Child 1995). The iron jib projecting beneath the eaves on the east side of the west range appears to be a relatively unusual feature.

Although presumably used to hang a hoist from, for lifting materials or feed, its precise function is unclear, as the upper floors of lincays were usually filled by pitching feed up from a wagon or trailer.

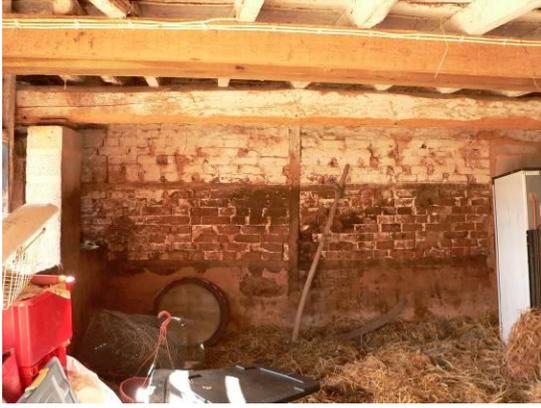
Brick partition to south side of bay 3

The concrete floor is partly covered with straw bedding. The rear (west) wall is of random rubble stone, the base of which is rendered, with cob above. Bay 3 has an inserted brick and timber stud wall closing its south (house) end, the lower part of which is rendered. The brick coursing is generally random. A former doorway in the south-west corner has been closed with concrete blockwork. A timber beam, notched for first floor joists, sits on top of the brickwork. This is an original timber, spanning from the front post to the rear wall. A secondary timber has been inserted about 1m from the south wall to support the first floor joists. This is a softwood timber which has been roughly converted, with slabs sawn off each face by a large diameter circular saw to square it. Its west end is cemented into the wall and its east end is supported by

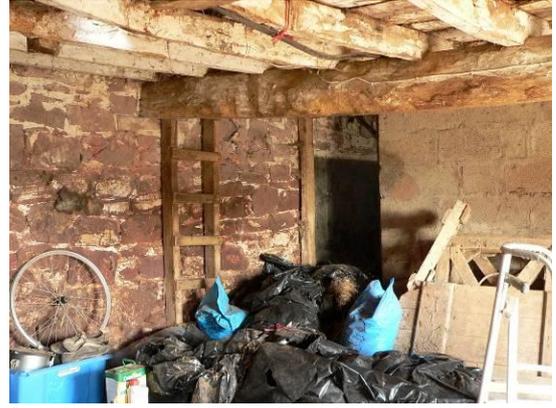
Ladder to upper floor, bay 6

Bay 6 is divided by a concrete block wall, a doorway at its west end giving access along the rear wall through to bay 7. There is a vertical timber cat ladder fixed to the rear wall at the south end of bay 6 which gives access to the tallet or loft floor above.

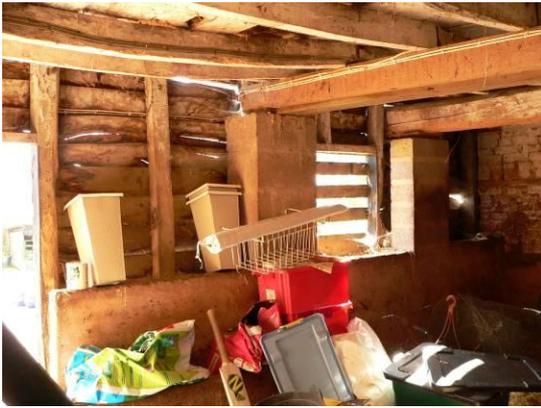
Inserted blockwork wall on east side

a concrete blockwork pier. This pier is part of an inserted concrete block wall 10cm thick by 0.8m high, which forms the interior front (east) wall of bays 3 and 4. The external weatherboarding is fixed to timber studs on the outside of this wall. Although the original timber posts and first floor beams that define the bay structure of the linhay survive, the joints where the ends of the beam are tenoned into the posts are generally decayed and the east ends of the beams have dropped.

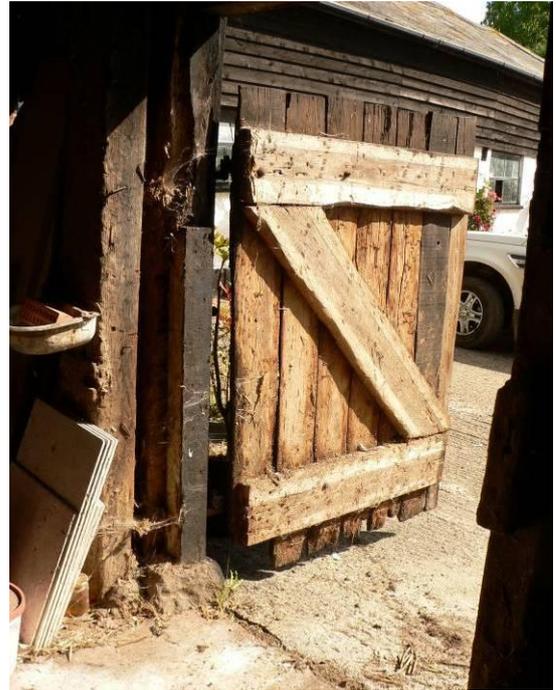
Door to bay 5, showing post and stone pad

Bay 5 has a mass concrete floor with a low step 1.3m in from the front (east) wall. The cross beam between bays 4 and 5 has been converted by sawing a small elm tree down its centre, along the diameter, and roughly squaring it. It is about 24cm deep by up to 12cm thick. The cross beam between bays 5 and 6 is of similar appearance and dimensions, possibly the other half of the same small tree. This beam is supported on a sleeper inserted near its front (east) end, as the tenon has rotted and dropped away from the front post. The front post stands on low stone base.

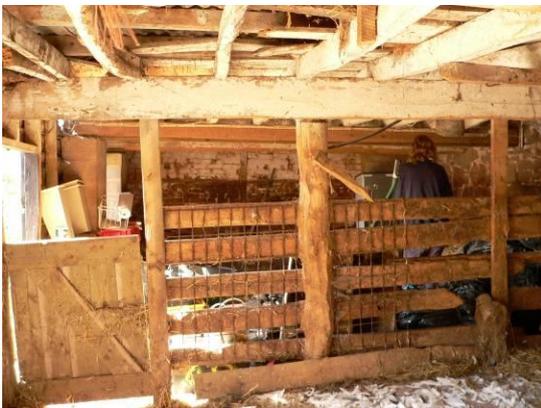
Screen between bays 4 and 5, looking south

Bays 4 and 5 are separated by a low rustic screen with a ledged and braced vertically-boarded half door at its east end. The front post between these bays is of oak, economically converted with bark and sapwood remaining, standing on a stone base.

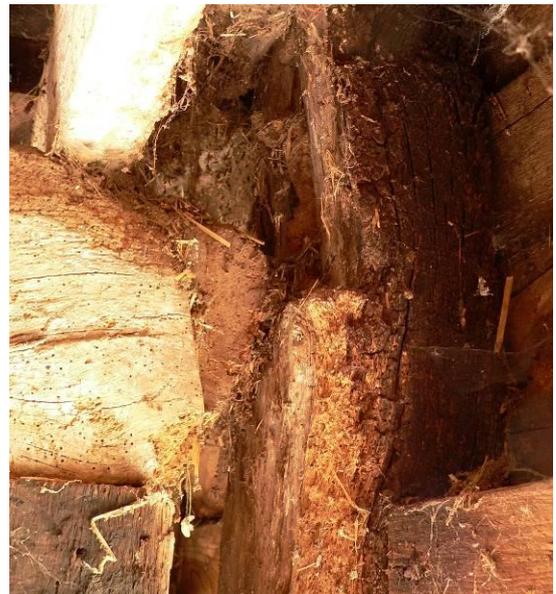
Decayed joint between beam and front post

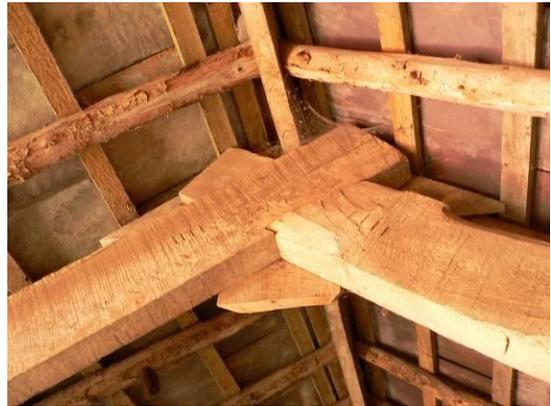
T IIII, showing sawing and assembly marks

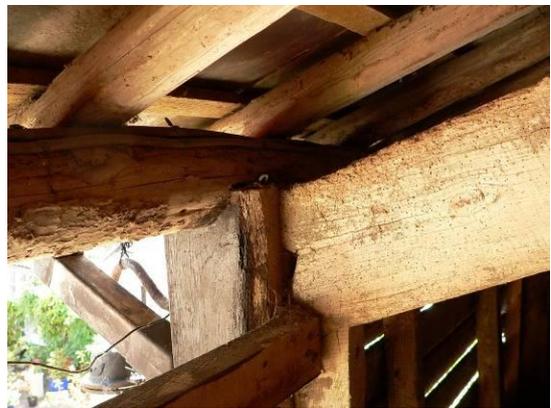
Truss principal foot (east) and post junction

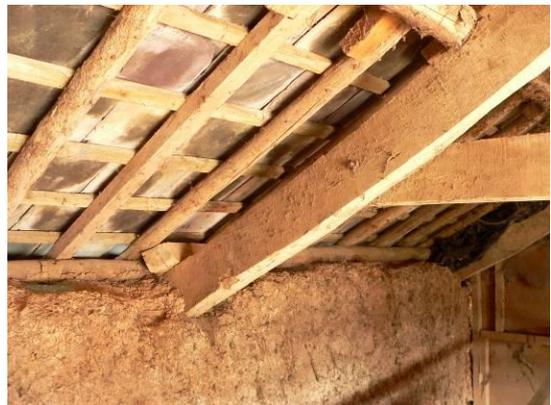
Truss principal foot (west) and wall junction

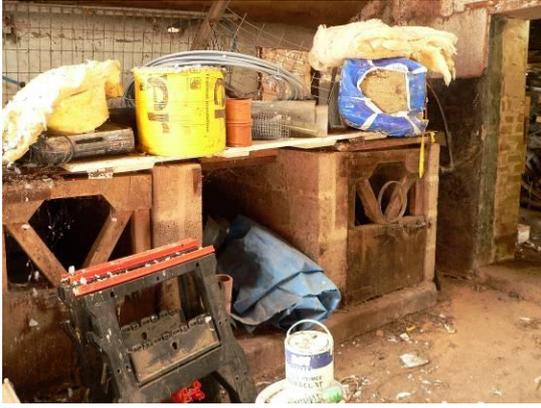
Pens inserted in bay 7, ground floor

Bay 7 has a concrete floor, with a low blockwork structure forming animal pens built in. At first floor level the north end of the bay is screened with hardboard panelling, fitted to the pitch of the roof. The rear wall is of rubble stone to a height of about 2m, rendered at the base, with cob above to the eaves. An inserted doorway, with brick reveals and timber lintels, gives access through the west wall into the lean-to. The door leaf is of vertical tongued, grooved and beaded boards, ledged and framed with no braces, hung on strap hinges on its north side.

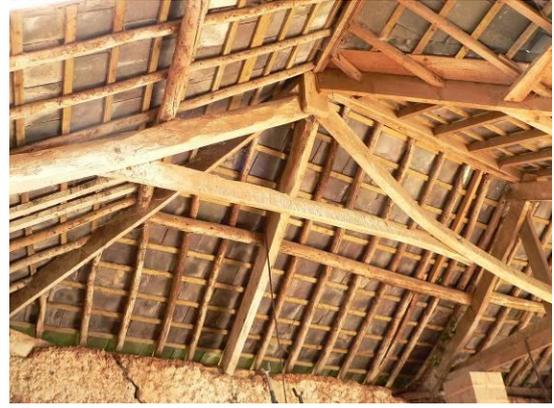
Hip truss in north-west corner

The east foot of the principal of truss (7) bears on the top of a post which forms the corner between the west and north ranges and the northernmost truss (8) supports the hip and the valley where the two roofs meet. There is a roof light in the west slope between trusses 7 and 8. The construction of the roof in the north-west corner is somewhat complex, as the east principal of the hip/valley truss, which has a collar on its north face, bears on a block on a tie beam that spans north-south on the west side of the first truss of the north range roof. This principal has a distinct curve to it at the point where the collar is bolted on. The foot of the hip truss bears on a horizontal timber which is tenoned and pegged through a short horizontal timber plate across the corner of the building (see photograph). The south foot of the truss at the west end of the north range is fixed in a fabricated steel bracket which is bolted to the top of the corner post (see photographs). This truss has a tie beam rather than a collar, and an additional timber fixed across it on the east side. The bottom section of the corner post is clad in concrete.

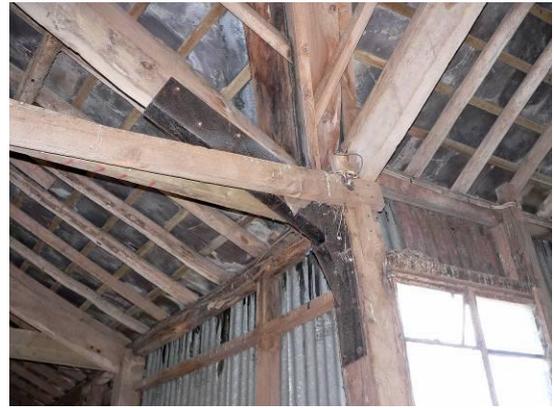
Post with steel shoe carrying principal foot, from west

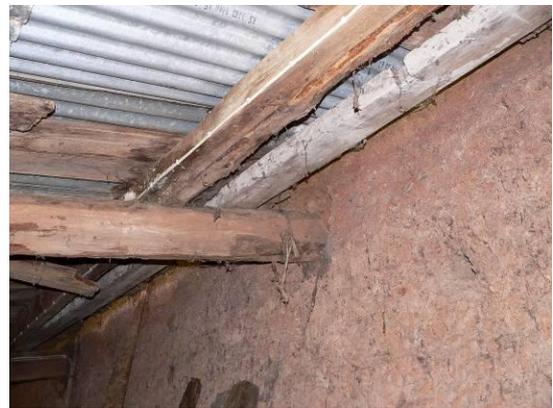
Lean-to roof rafter cut into cob wall

A lean-to roofed extension with a concrete floor has been built against the west side of the lincay. The former outside wall of the lincay is of random rubble stonework to a height of about 1.8m, with cob above. The cob has large cobble inclusions. At the south end is a brick wall with a modern flush door to the house. The west side of this shed is enclosed with vertical galvanized corrugated iron sheets with some translucent plastic panels nailed to horizontal timbers, which are fixed to the vertical posts that support the roof structure. The exterior 'front' of the lean-to extension is not readily accessible, as it is built in tight to natural slope of ground (Figure 9b). The post at the north-west corner, which also serves as a door post, is a re-used railway sleeper. At the north (road) end is a decayed tongued and grooved vertically-boarded door. The lean-to roof is of four unequal width bays with a smaller half bay at both ends. The upper (east) ends of rafters carrying the roof are built into recesses hacked into the cob of the upper part of the lincay wall. The rafters are roughly converted, basically slabbed and halved softwood timber poles. Their lower (west) ends are carried on the tops of round vertical poles. Towards the north (road) end the post is a re-used elm timber standing on a concrete plinth. There is a wall plate spanning across the tops of posts which is made up from several lengths of timber. The roof structure comprises two rows of through purlins on top of the rafters, with butt-jointed sawn softwood boards laid on the purlins, and corrugated iron sheet cladding on top. This space is currently used for storage and there is a fuel oil tank located towards its south end, against the lincay wall.
