HARESHAW IRONWORKS BELLINGHAM NORTHUMBERLAND

ARCHAEOLOGICAL EVALUATION

May 2007

REPORT ON AN ARCHAEOLOGICAL EVALUATION

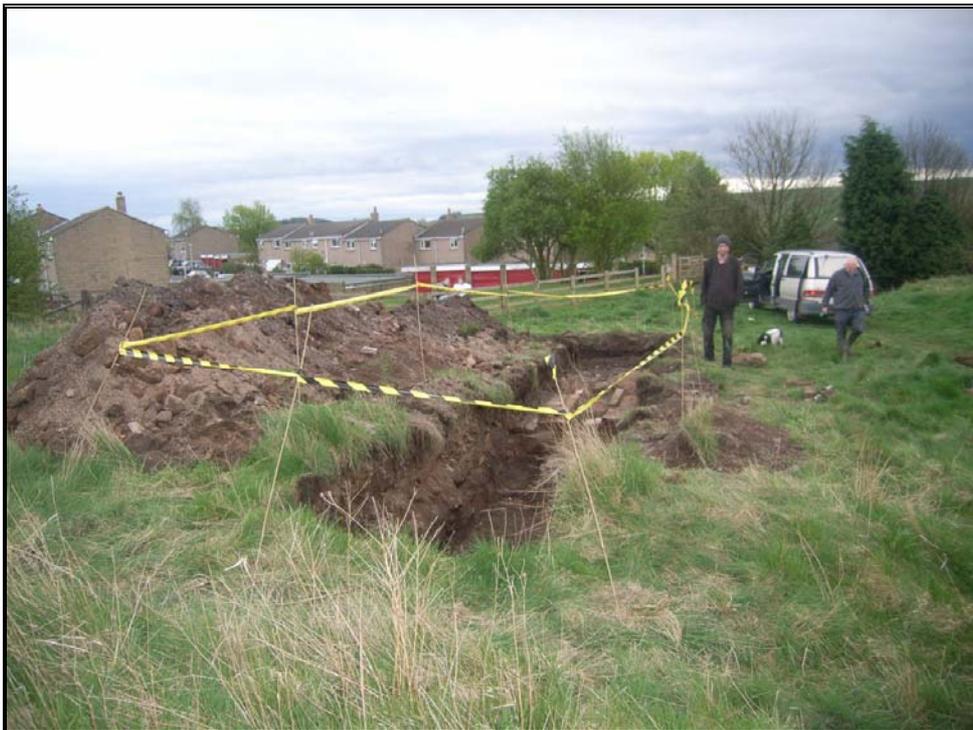
Front Cover: View of Trench 2 following excavation, with modern housing estate to the south.

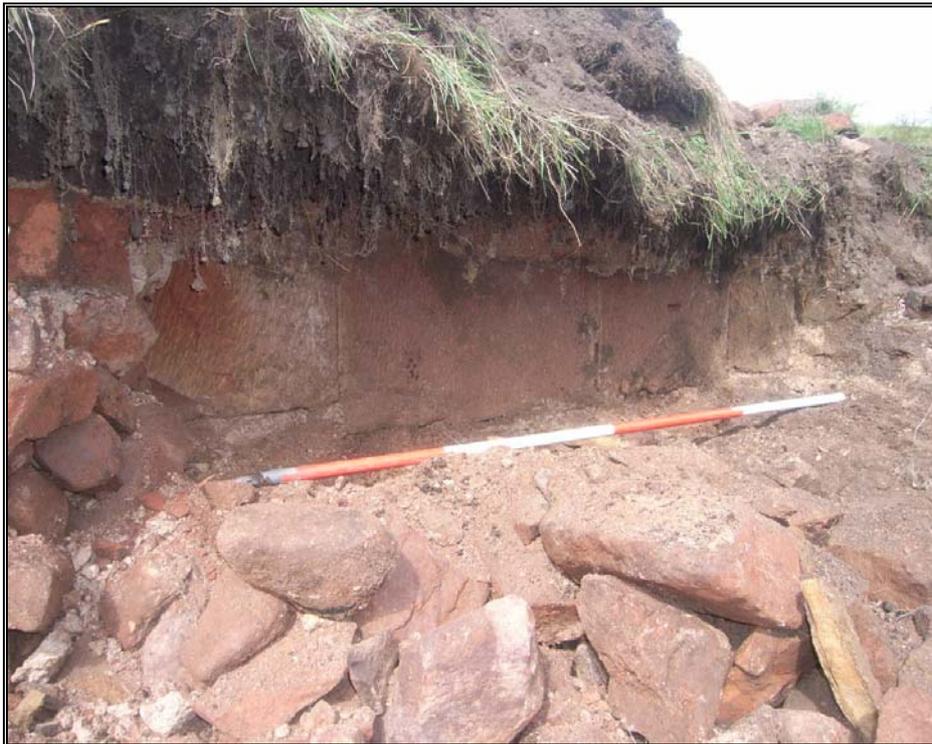
Frontispiece:
View of ashlar-built wall in the south-facing section of Trench 1.

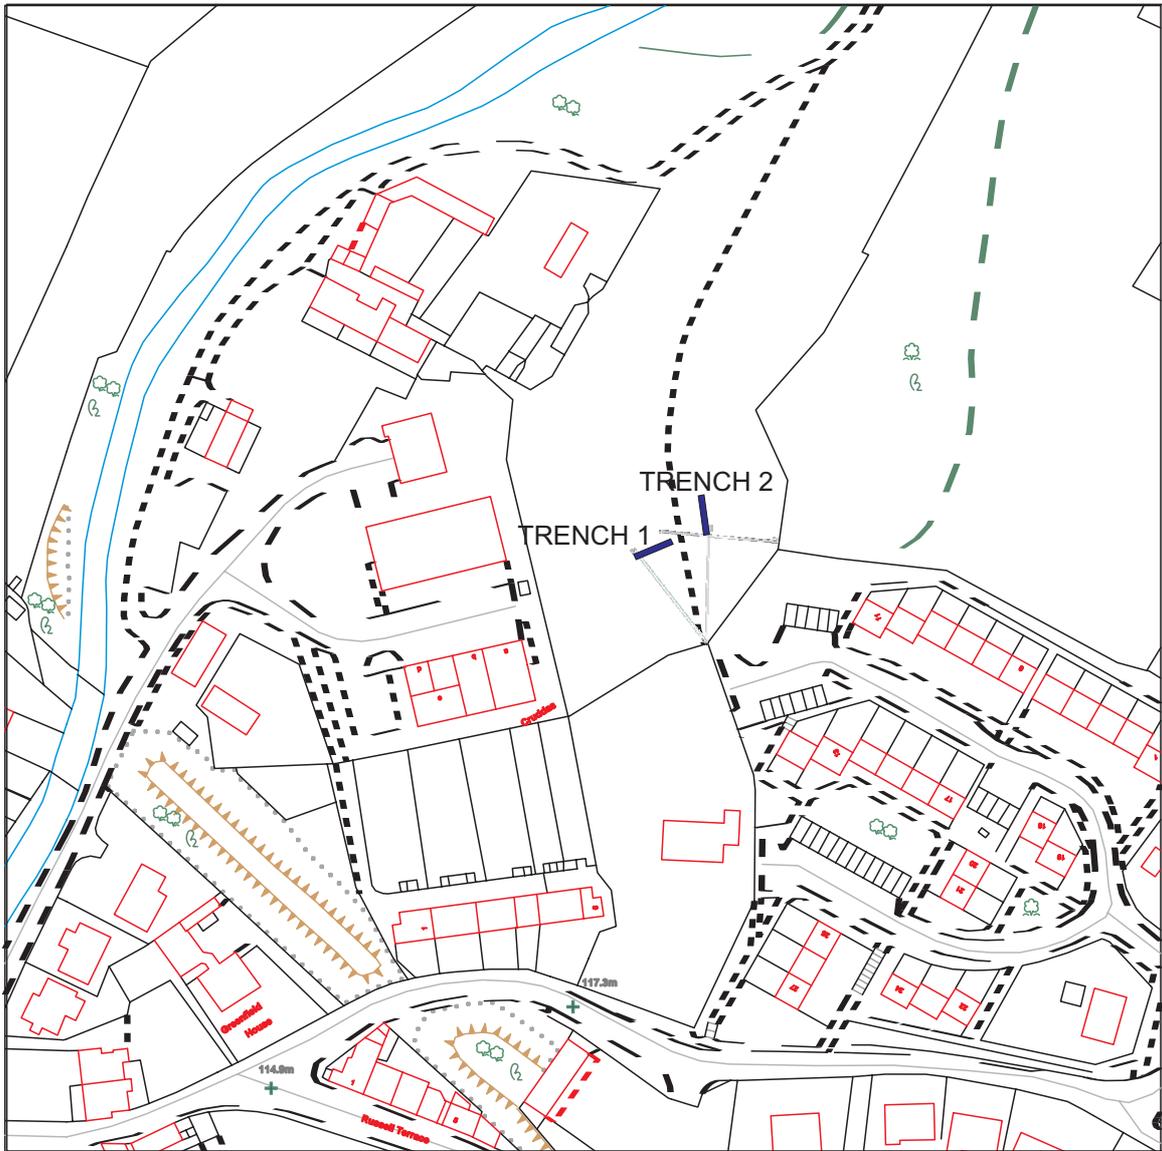
Illus. 04: Trench location plan.

The locations and extent of the evaluation trenches are shown on *Illustration 04*.

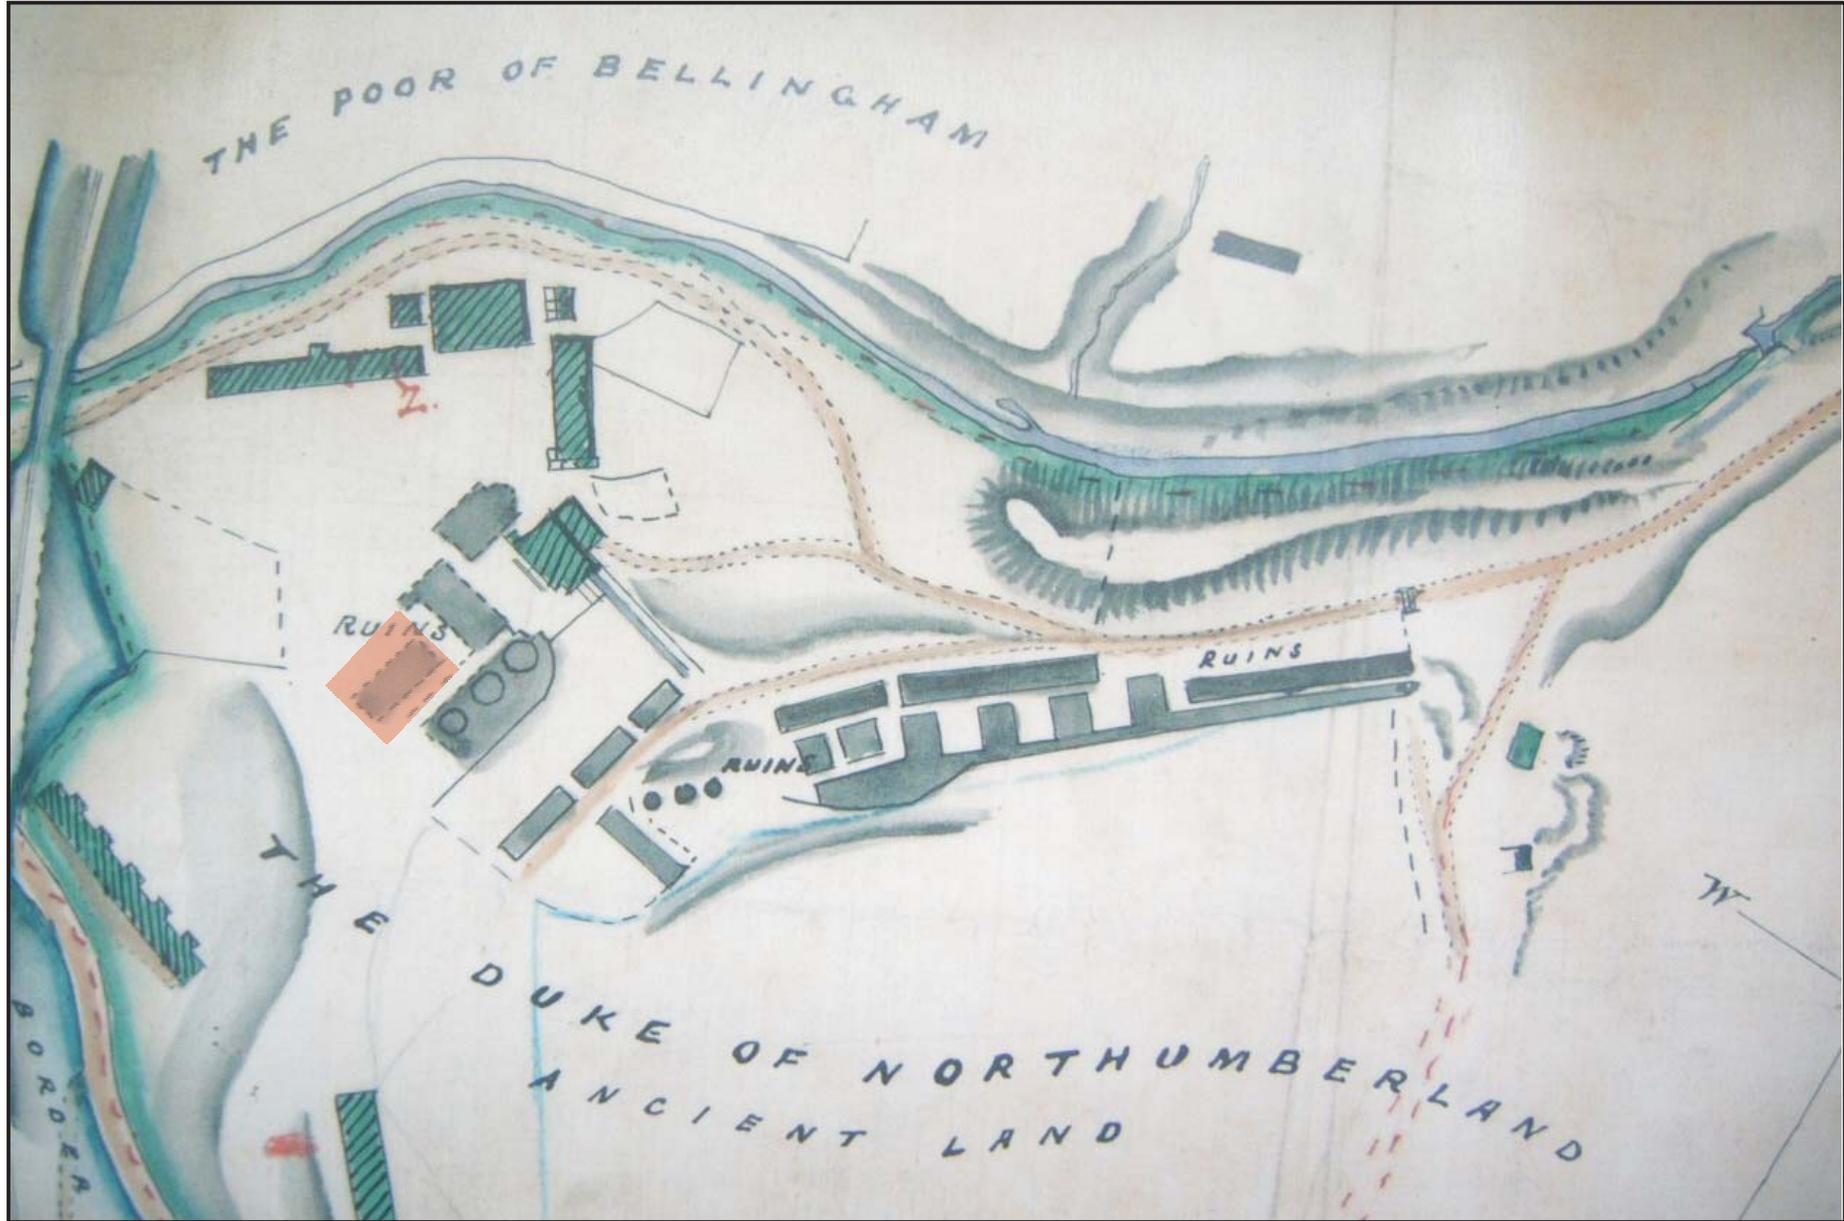
Illus. 07:
Extract from a Plan of Hareshaw Ironworks c.1866-8 (from the Armstrong Colln.), Showing position of building apparently revealed in Trench 1.

The east end of the trench clearly contained the remains of significant structures, including a very well-built ashlar wall and a brick floor. It is significant that a building appears at this location on the 1st and 2nd edition of the Ordnance Survey plan, and on earlier plans contemporary with or slightly post-dating the operational period of the ironworks. The western part of the trench contains destruction deposits associated with the levelling and landscaping of the ironworks; the wall at the far west end may be a revetment of more than one phase.

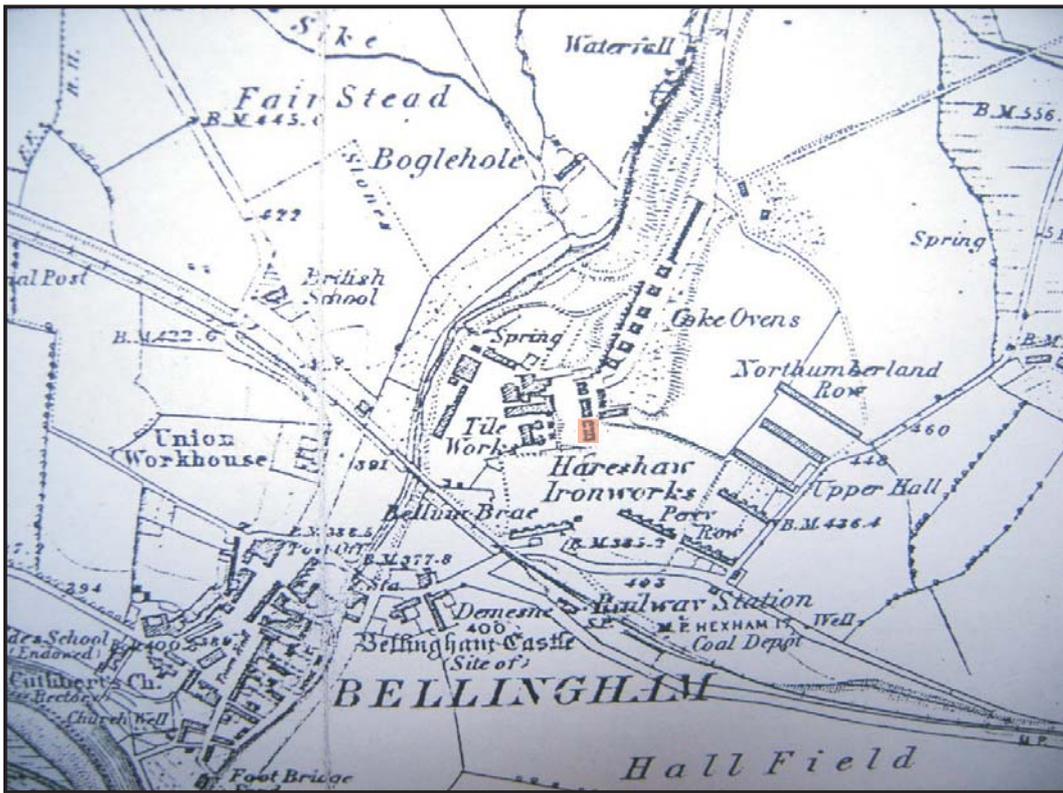
Illus. 08: Extract from the 1st edition Ordnance Survey Plan (surveyed c.1855), showing building revealed during the evaluation excavations.

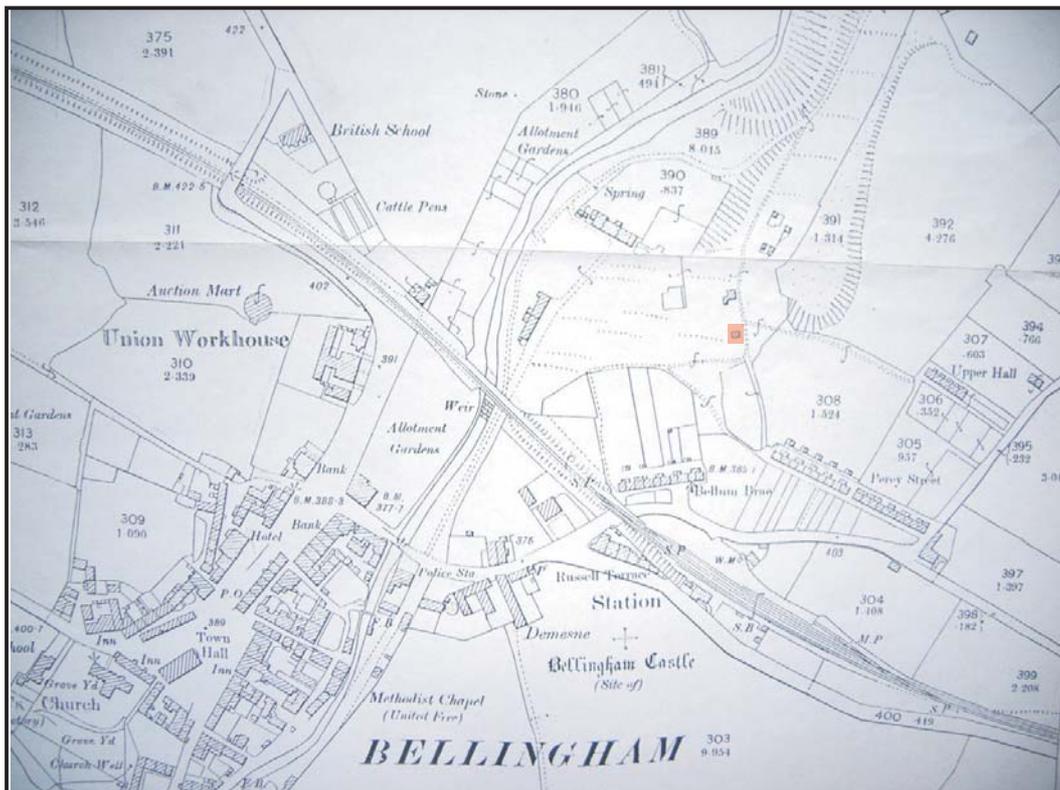
Illus. 09: Extract from the 2nd edition Ordnance Survey Plan (surveyed c.1855), showing building revealed during the evaluation excavations.

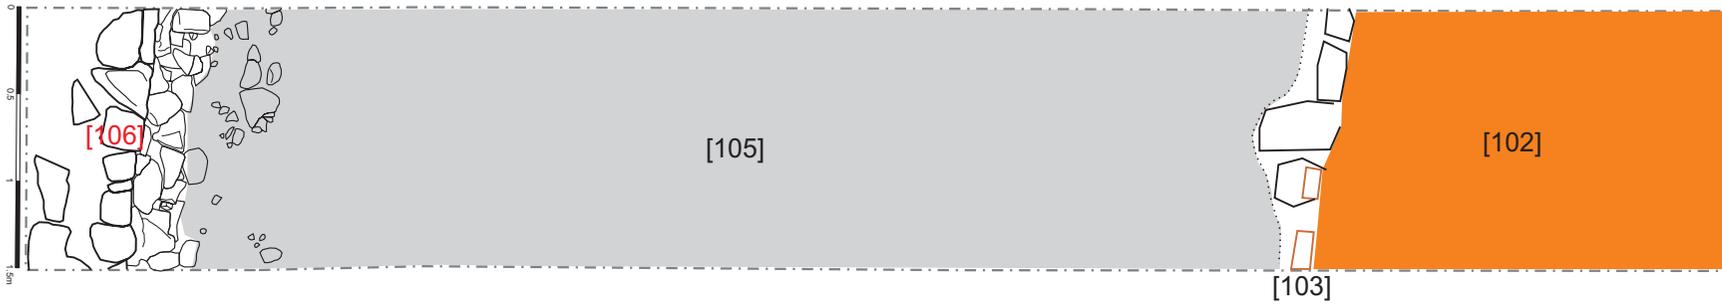
Illus. 10: Plan of evaluation trench 1.

Below the shallow, sandy loam topsoil [101] at the east end of the trench was a brick floor [102] which appeared to have been bordered on the west side by a low wall or sill, the remains of which, a brick and stone construction [103], survived in the north-facing section. The single course of a well-made wall [104] of large, well-dressed sandstone ashlar blocks, some with keystones evident, appeared in (actually, behind) the south-facing section and was also probably related to the brick floor. Below [101] west of the brick floor was sandstone rubble [105] the depth of which could not be determined. At the far west end of the trench, however were the remains of a rough sandstone wall [106] of at least two kinds of construction, the inner part of the wall of much rougher construction than the outer (western) face. The finds recovered from this trench were of nineteenth and 20th century origin, and included a conical ink-well, suggesting the existence of offices in the vicinity.

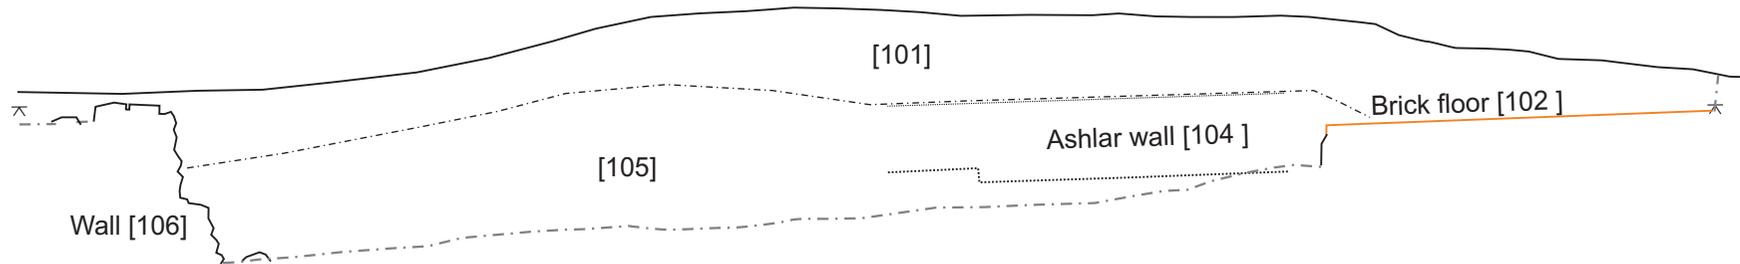
Illus. 11: South-facing section of evaluation trench 1.

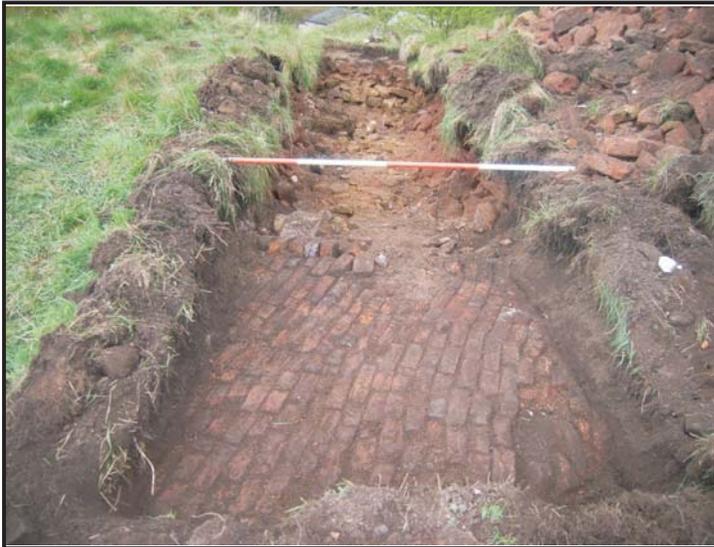
Illus. 12:
View of Trench 1 from the east, showing brick floor.

[102] Brick floor comprised of bricks laid flat and dry on a prepared surface.

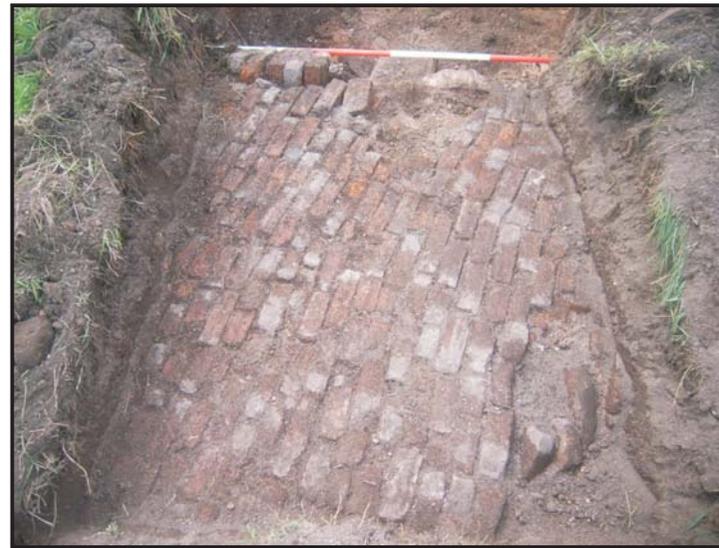
Illus. 13: *View of brick floor at the east end of Trench 1.*

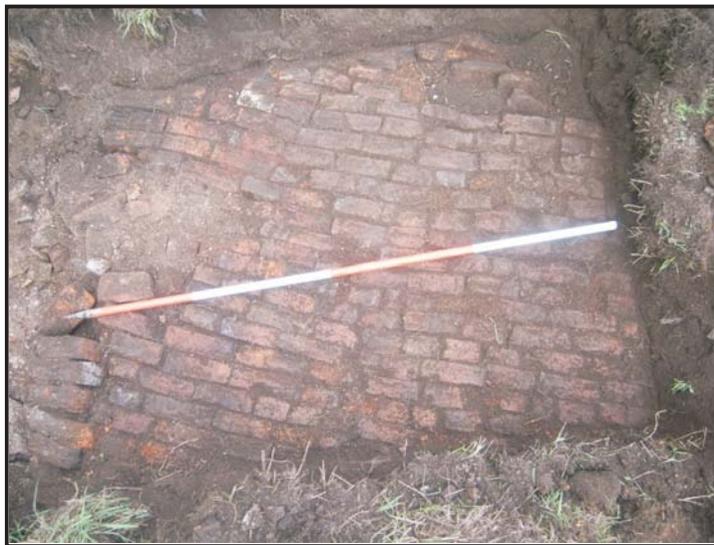
Illus. 14: *View from the south of the brick floor at the east end of Trench 1.*

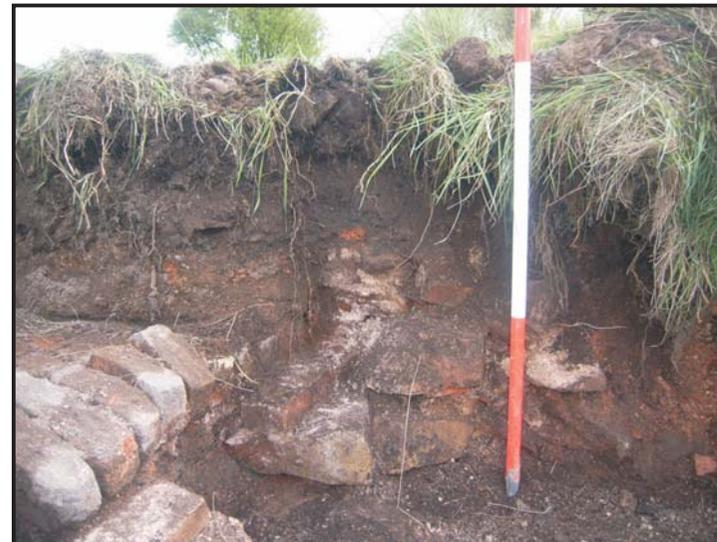
Illus. 15: *View of feature [103] in the south-facing section of Trench 1.*

[103] Partial remains of a brick- and stone-built wall or kerb.

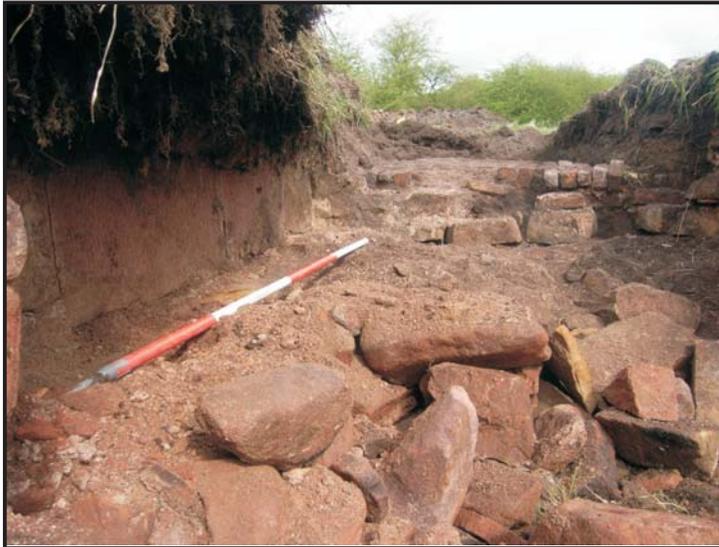
Illus. 16: View of Trench 1 from the west, showing ashlar-built wall (left) and brick floor [102] (rear)

[104] Wall of large, well-dressed sandstone ashlar blocks, some with keystones evident.

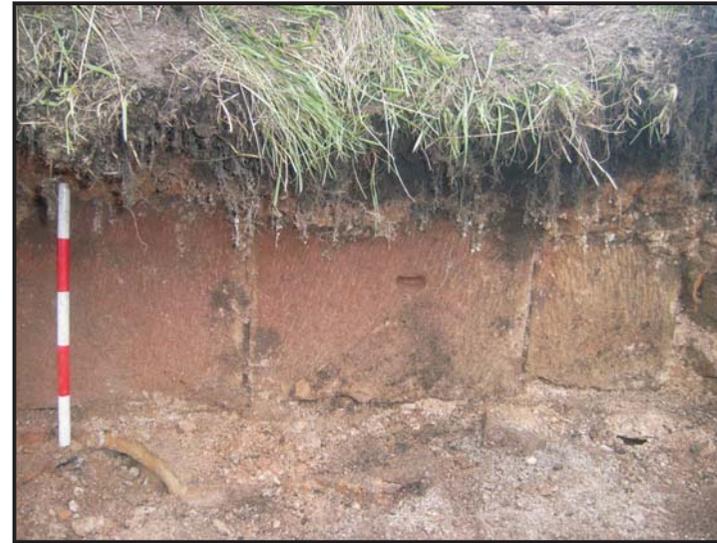
Illus. 17: Detailed view of ashlar blocks [104] with keystone.

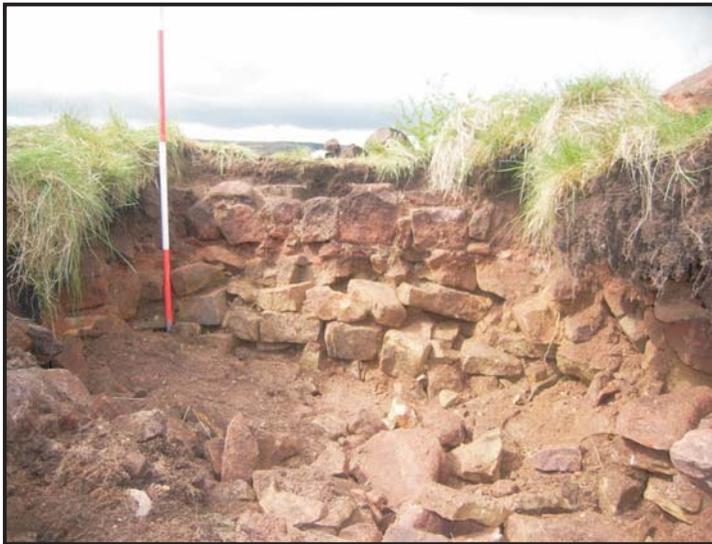
Illus. 18:
View from east of wall at the west end of Trench 1.

[106] Rough sandstone wall of at least two kinds of construction, the inner part of the wall of much rougher construction than the outer (western) face. No mortared joints visible.

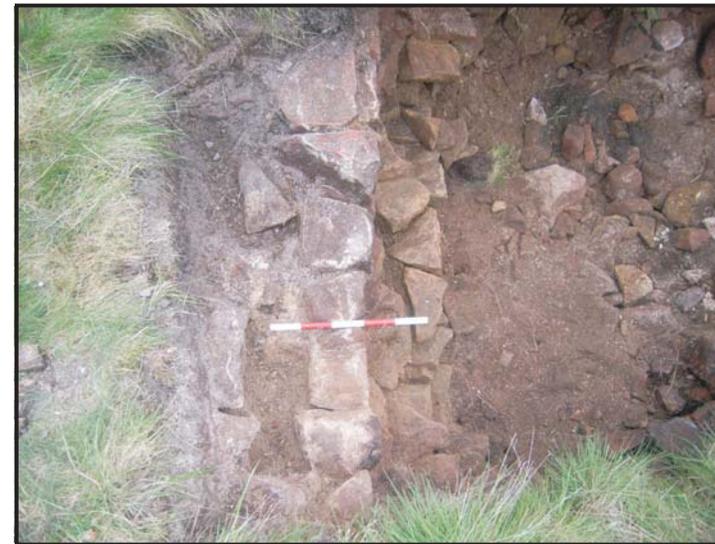
Illus. 19:
Vertical view of wall [106] at the west end of Trench 1.

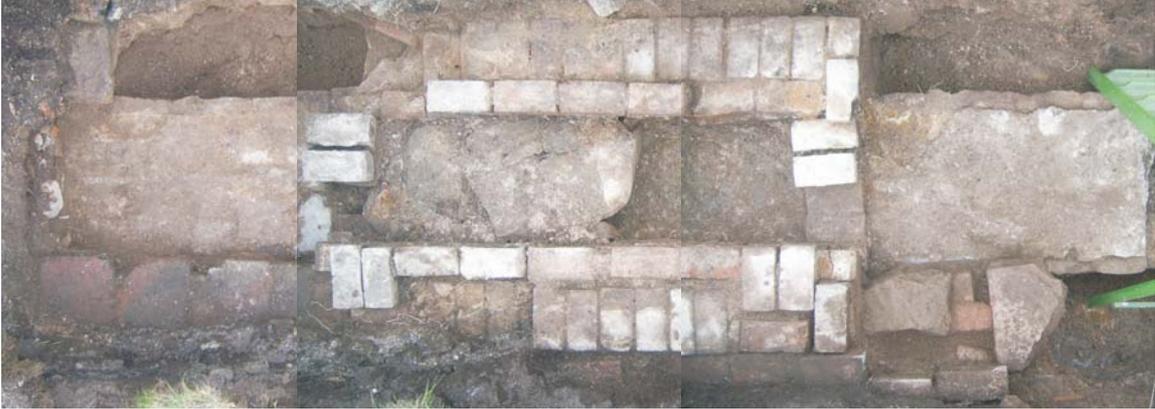
Illus. 20: Plan of Trench 2

Illus. 21: Plan of evaluation trench 2.

Below the dark, sandy loam topsoil [201] was a deposit of rubble mixed with loam and mortar [202] which was much deeper at the north end of the trench, than the south. Below this, at the south end of the trench was a shallow deposit of grey silt, and beneath this was a deposit of rubble [203] which extended throughout the trench. At the south end of the trench the rubble deposit [203] sat upon a brick-, concrete- and stone-built feature [204] which appeared to be comprised of a stone-built platform, consolidated and in places covered by mortar and concrete, with brick walls built at bothsides to form a shallow pit. However, brick- (and tile) work appears to continue either side of the platform, suggesting that the feature excavated could be a sunken feature built into a larger floor. Earthenware tiles along the east side of the feature perhaps suggest this a possible floor, but could have been reused. At the north end of the trench were the remains of a brick floor [206] which sat upon (and at the very north end of the trench was partly covered by) a deposit of black clinker [206], itself sitting upon red ash [207] and compact, orange clay [208], the latter possibly the natural boulder clay, though perhaps redeposited. The finds recovered from this trench also were of nineteenth and 20th century origin.

Trench 2 contains the enigmatic remains of a brick- and stone-built feature which appears to comprise a platform and but does not include any signs of burning except in deposits which appear to underly the remains of a brick floor at the north end of the trench. It is difficult to associate the structure with any known iron-making processes, but it is possible that it was part of offices or ancillary buildings, - the presence of lime allows suggests slaking or mortar preparation as one of a range of possibilities, for example. No sign of structures appears on contemporary maps in this area, or on Ordnance Survey plans slightly post-dating abandonment, but it is known from contemporary reports (see *Illus. 06*) that the ironworks site was used for light-industrial activities following the cessation of ironworking, and it is perhaps to this phase of activity that the features discovered during the evaluation belong. The heavily burnt deposits underlying the feature [204] are indicative of the heavy industrial activities carried out on the site, but it is not clear precisely what activities were carried out in the area of the evaluation trench.

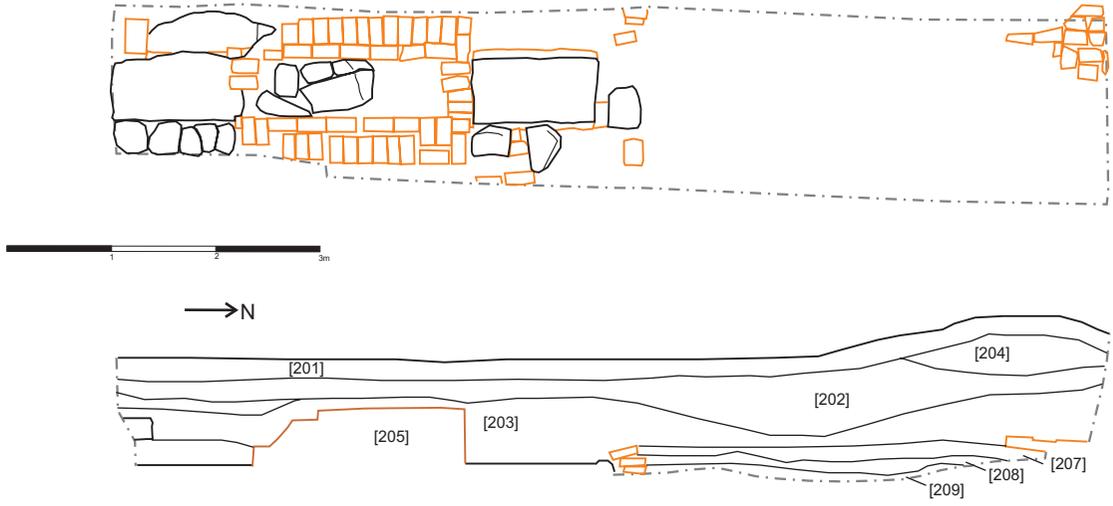
Illus. 22: East-facing section of evaluation trench 2.

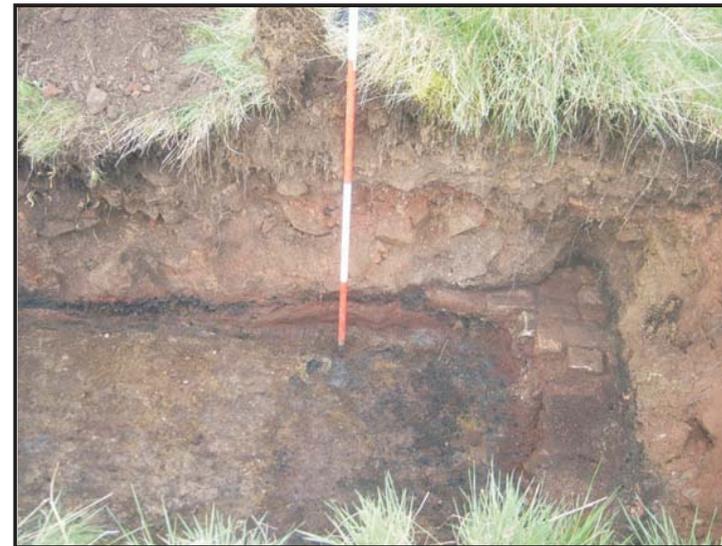
Illus. 24: View of east-facing section (north part) and brick floor remains in the north-west corner of Trench 1.

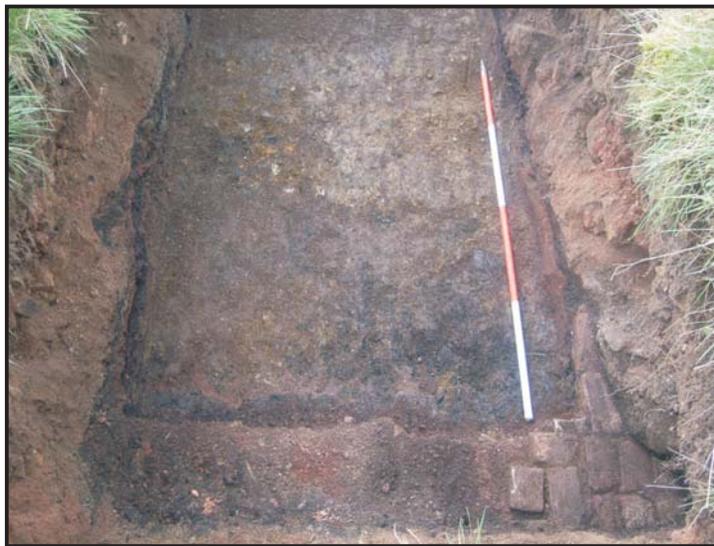
Illus. 25: View from the north of brick floor remains [206] in the north-west corner of Trench 1.

[206] the remains of a brick floor.

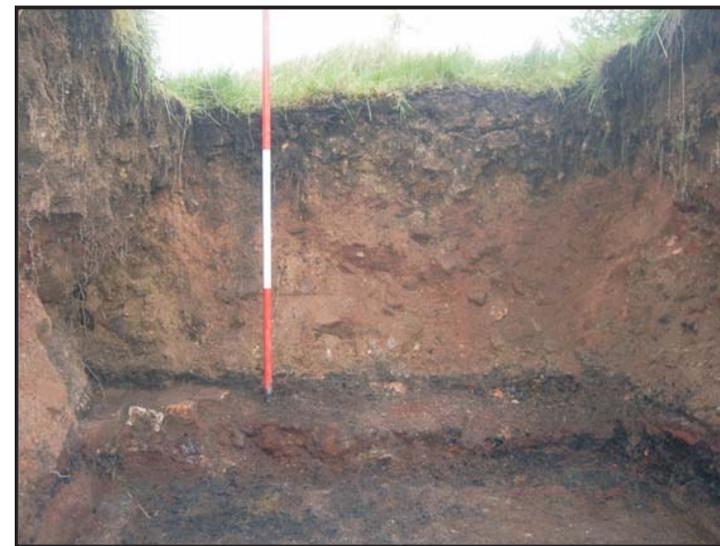
Illus. 26: View of burnt deposits [207 & 208] in the south-facing section of Trench 2.

[207] Thin deposit of black clinker.

[208] Thin deposit of burnt, red ash.
