THE OLD COACH HOUSE  
EASTFIELD HALL  
WARKWORTH  
NORTHUMBERLAND

HISTORIC BUILDINGS RECORD

November 2007

*Project code:*  
AP07/66

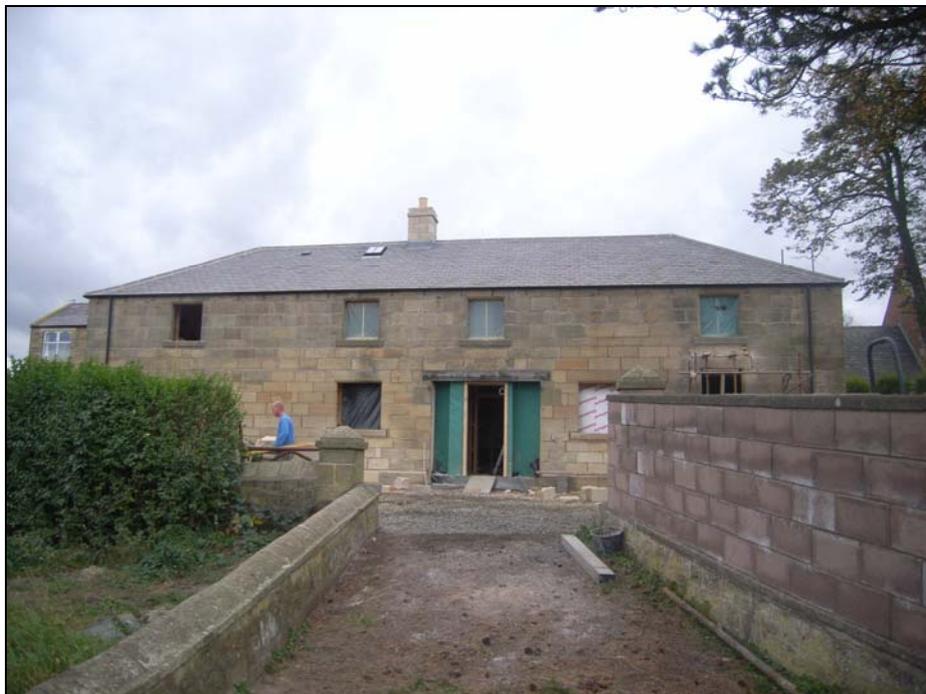
**Frontispiece:**  
*The main east-facing frontage of Eastfield Coach House, November 2007.*

The front elevation of the main block is of four irregular bays, and has a chamfered plinth. In the third bay is a broad opening under a timber lintel, clearly a secondary insertion; to the left (in the second bay) and right (between the third and fourth bays) were doorways, in plain chamfered surrounds, that have now been converted into windows. The original windows, two on the ground floor (one in each end bay, that to the right being set rather higher in the wall) and four above, all have chamfered surrounds with slightly-projecting sills; drawings show that they contained 16-pane sash windows. The roof is hipped at each end, with a central stack to the ridge.

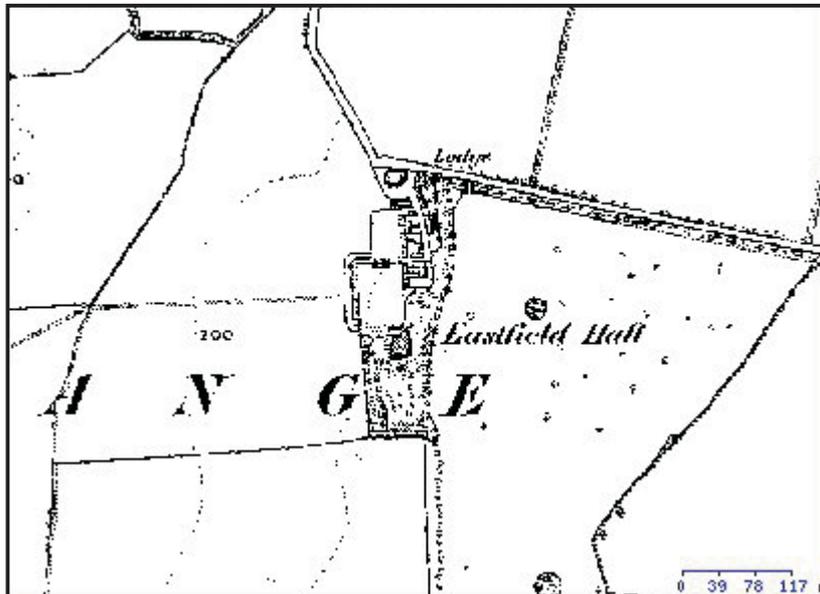
*Illus. 04: Extract from First Edition Ordnance Survey Plan, 1866*

The first edition Ordnance Survey map shows the coach house as forming the east side of a small rectangular courtyard. It has had little of interest beyond the unusual range of three segmental-arched openings in the north wall, which may relate to the feeding and/or mucking out of horses in the stable at this end of the building. There is some evidence that earlier fabric is incorporated in the west wall of the main block, but this may have been no more than an enclosure wall, and has no significant features.

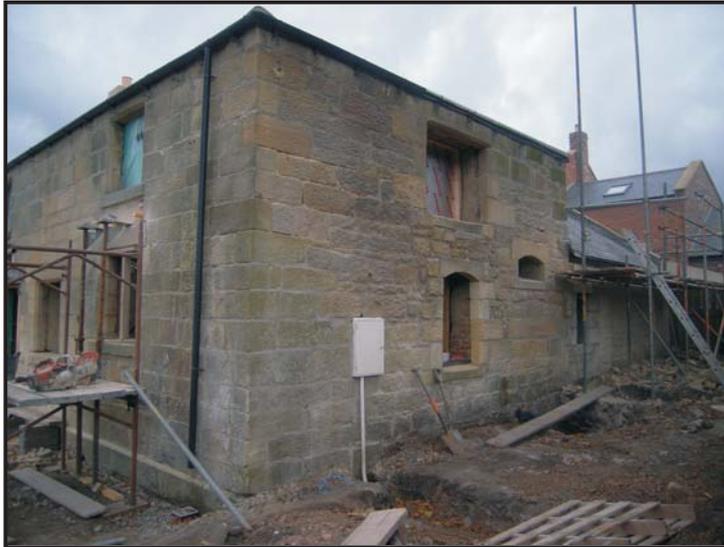
*Illus.07: Eastfield Coach House, north-east corner.*

The north end of the block is continuous with the north wall of the wing to the right. At first floor level there is a large window, with a chamfered surround, set centrally in the end wall of the main block. Directly below was a range of three low openings with monolithic segmental lintels (of plain square section) and their sills c 1.8 m above ground level. The eastern (beneath the first-floor window) has now been re-set at a lower level (with its height being increased) and the western (at the east end of the wall of the wing) has been replaced by a new square-headed window.

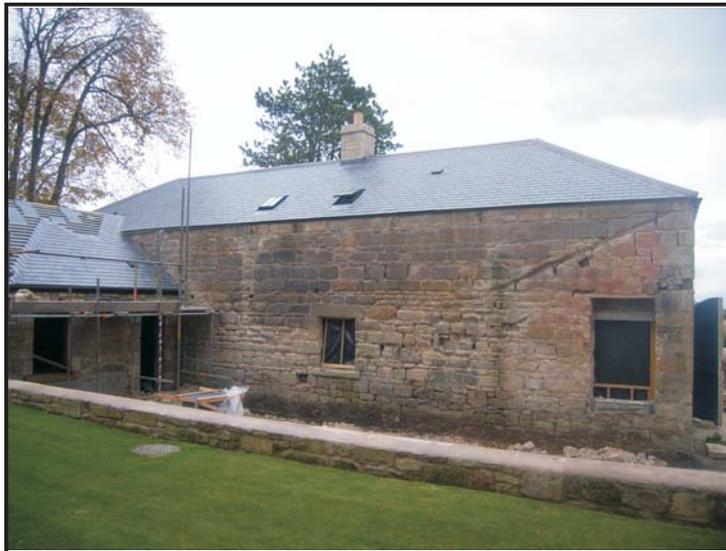
*Illus.08: Eastfield Coach House, west elevation.*

The west wall of the block has a doorway at its south end, formerly connecting with an added east-west range, the weathering of the monopitch roof of which survives above it. Towards the centre of the wall is a chamfered window (formerly a 16-pane sash). Further north is the wing; a doorway and window in its south wall are both new insertions, but a chamfered window at loft level in the west gable end is old; the gable end has a cut coping and substantial alternating quoins.

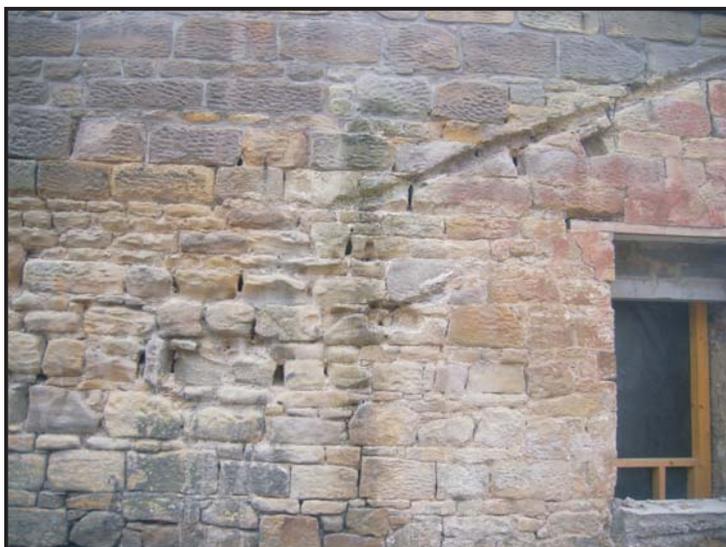
*Illus.09: Eastfield Coach House, detail of incised roof-line at the south end of the west elevation.*

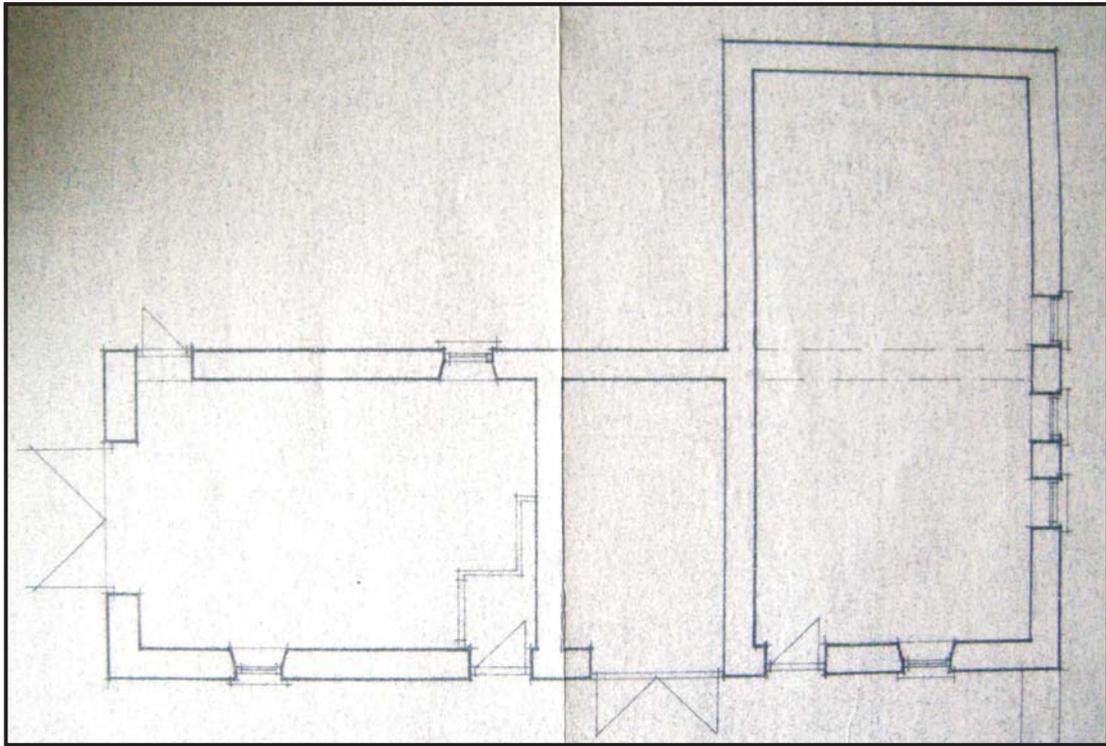
**Illus. 10:**  
*Architect's Ground floor plan of the coach house at Eastfield Hall, Northumberland.*

The Coach House range consists of an L-plan block of building, the main two-storeyed block c 17 by 6 m externally extending north-south and having a lower wing 5.5 m long and 6 m wide to the north-west. The front (east) and south end of the main block are of coursed and squared neatly-tooled stone; the other elevations are of more roughly tooled stone; the lower part of the rear (west) wall of the main block is of more thinly-coursed stone, little more than rubble, and may incorporate earlier fabric. The roof is of Welsh slates.

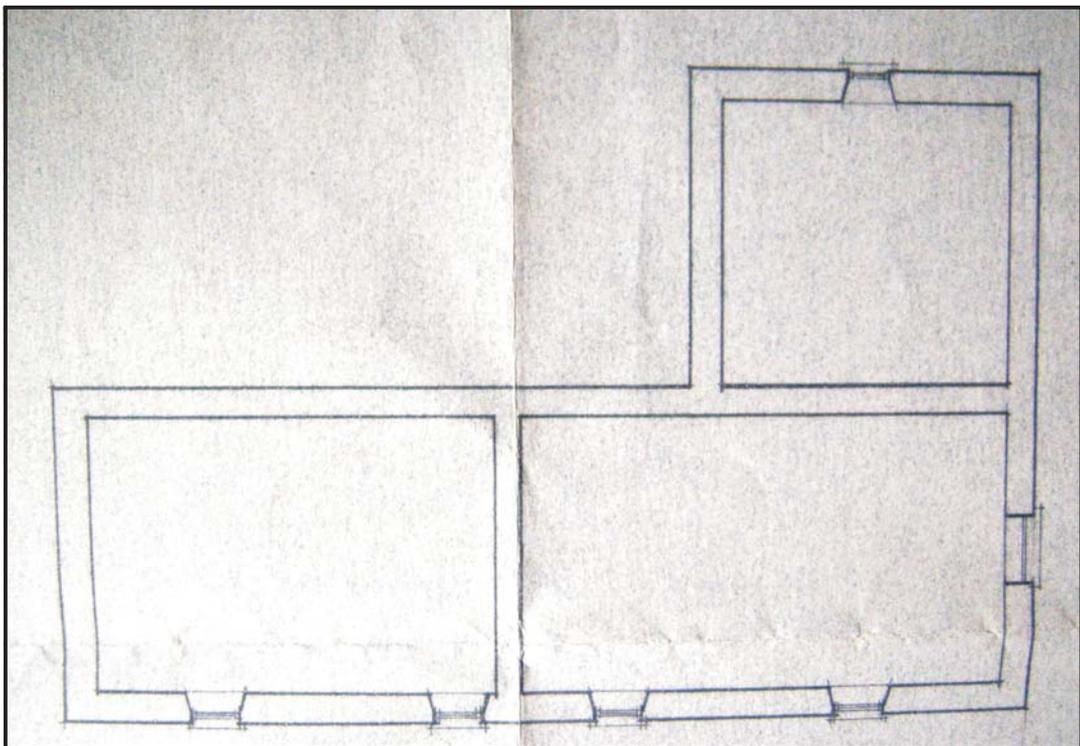
**Illus. 11:**  
*Architect's first floor plan of the coach house at Eastfield Hall, Northumberland.*

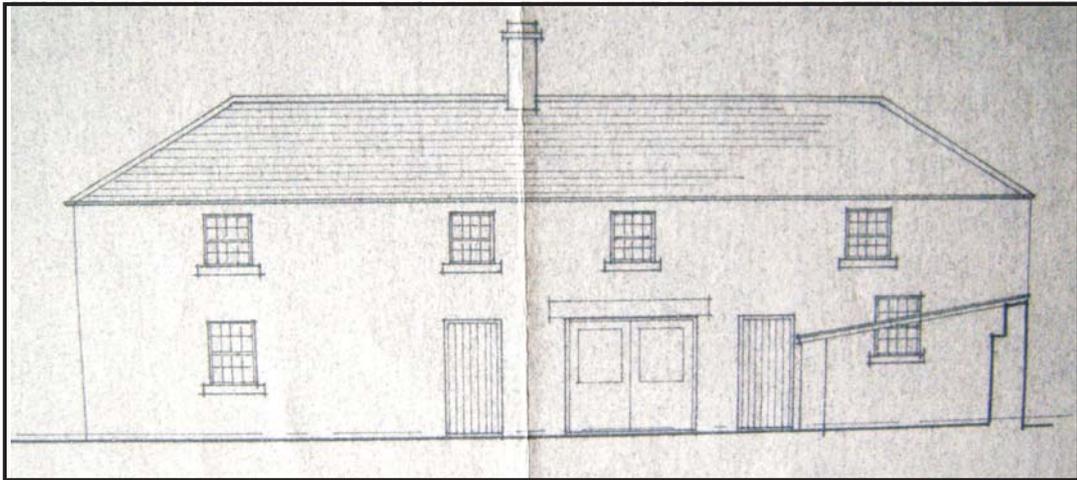
**Illus.12:**  
*Architect's East elevation drawing of the coach house at Eastfield Hall, Northumberland.*

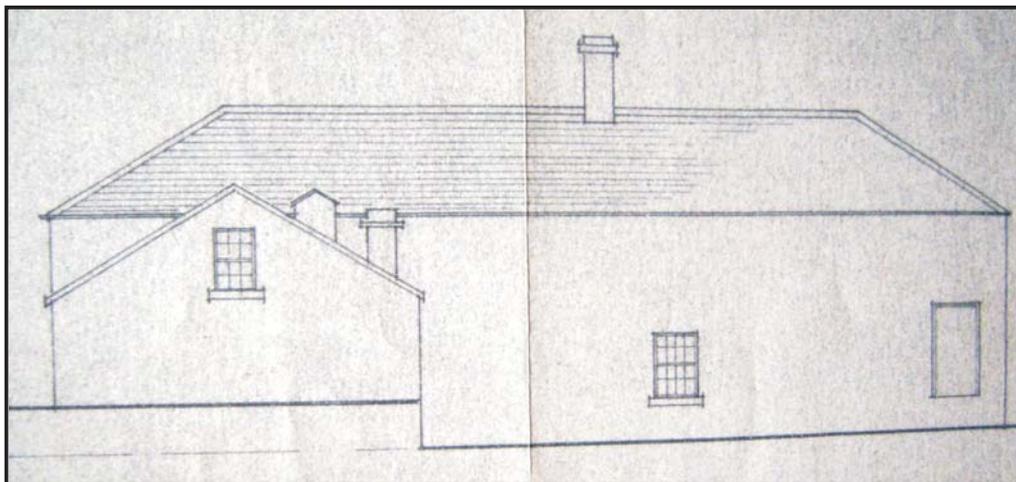
**Illus.13:**  
*Architect's West elevation drawing of the coach house at Eastfield Hall, Northumberland.*

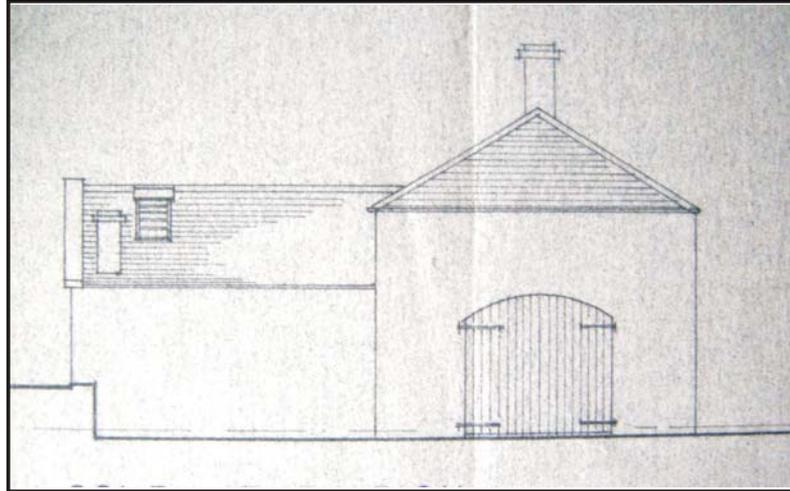
**Illus.14:**  
*Architect's drawing of the South elevation of the coach house  
at Eastfield Hall, Northumberland.*

The south elevation, which also has a plinth, has a segmental-headed cart entrance with an external rebate for a pair of boarded double doors.

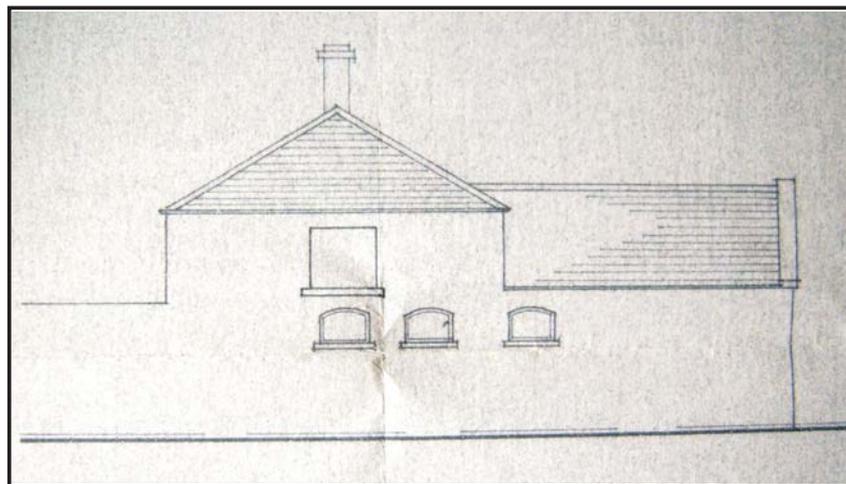
**Illus.15:**  
*Architect's drawing of the North elevation of the coach house  
at Eastfield Hall, Northumberland.*
