# CALDEW AND CARLISLE CITY FLOOD ALLEVIATION SCHEME

DENTON STREET FOOTBRIDGE and CORPORATION DAM  
INTAKE CARLISLE, CUMBRIA

## *HISTORIC BUILDING RECORD*

April 2008

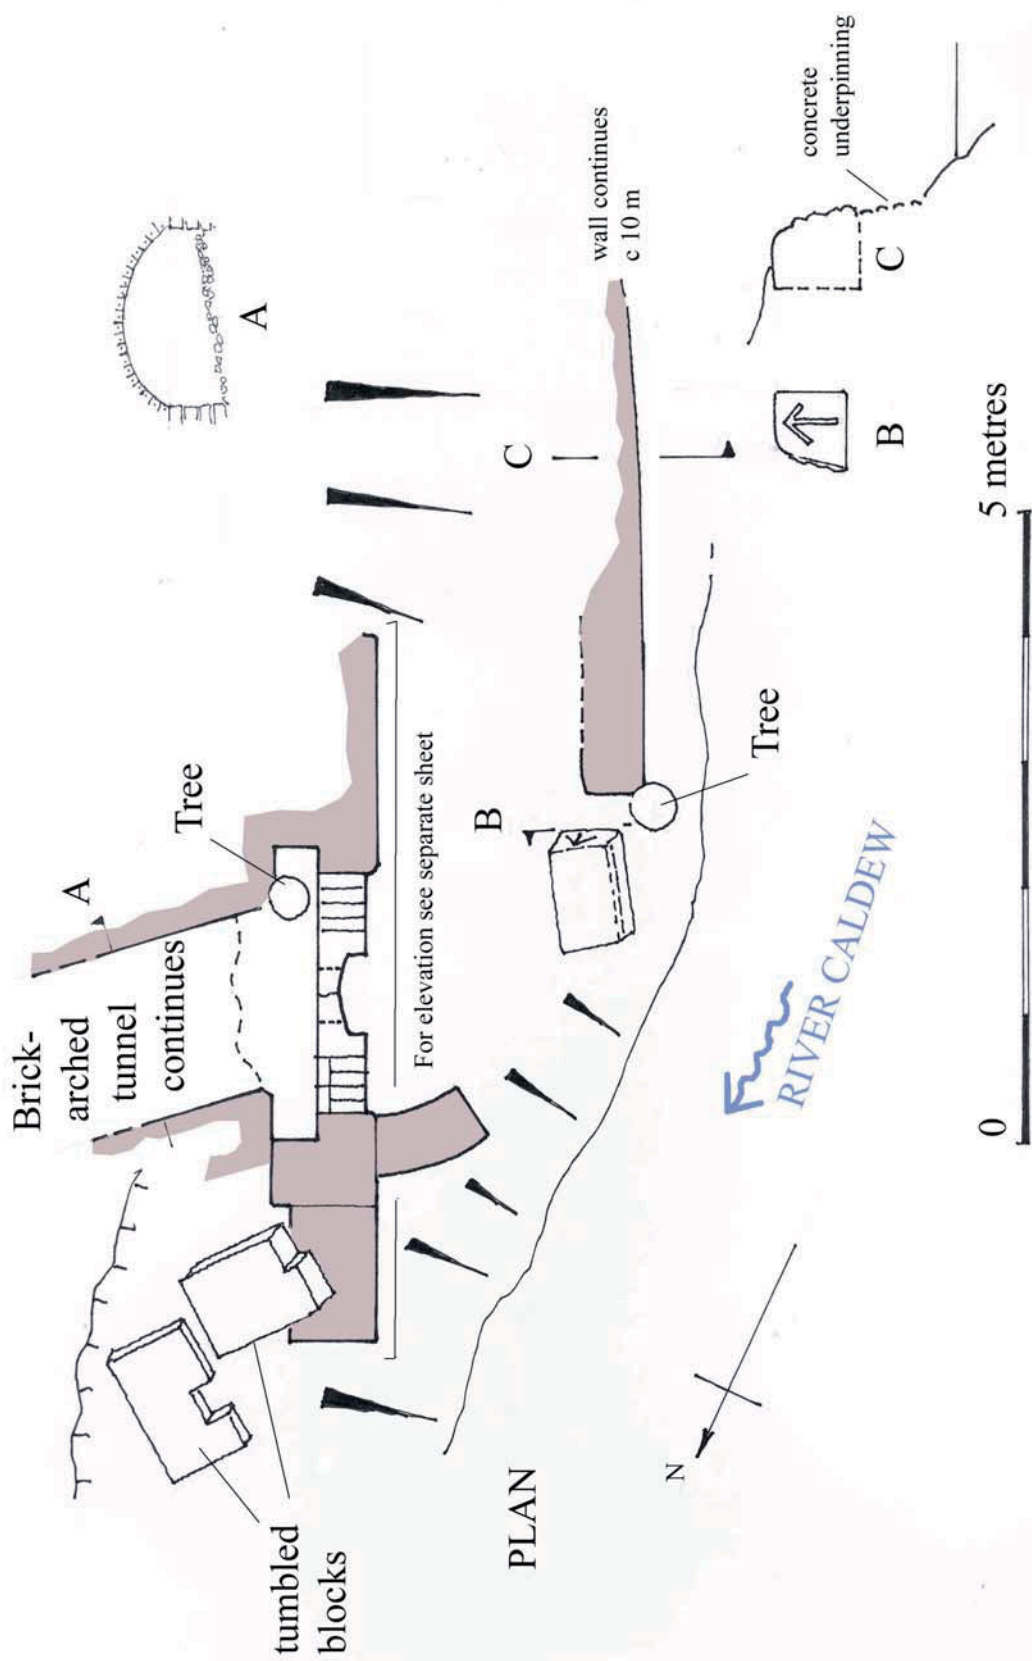
**Illus. 03:** A survey of the visible remains of the Corporation Dam Intake by Peter Ryder

The remains of the Corporation Dam Intake are situated on the east bank of the Caldew c 30 m upstream (south) from the footbridge and c 12 m downstream of a modern footbridge at the foot of the tributary Wire Mire Beck. The construction of this footbridge and other associated recent works appear to have erased an upstream section of the former head race or head goit. The remaining 10 m or so of this are now infilled, and form a horizontal terrace on the river bank, with on its outer side a single course of large red sandstone blocks of trapezoidal section, their outer faces being rock-faced below a smooth upper section, with rounded upper angles. A typical block is 1.12 m long and 0.50 m high, being 0.57 m wide at the base and 0.50 m at the top; their ends are cut with grooves in the form of broad arrows, to facilitate the mortar bonding with adjacent blocks, and some blocks show infilled slots, probably lewis holes, in the centre of their upper surfaces.

The surviving length of the outer wall follows a slight but distinct curve, until the final section (where the outer wall has partly fallen away into the river) curves more sharply to the intake

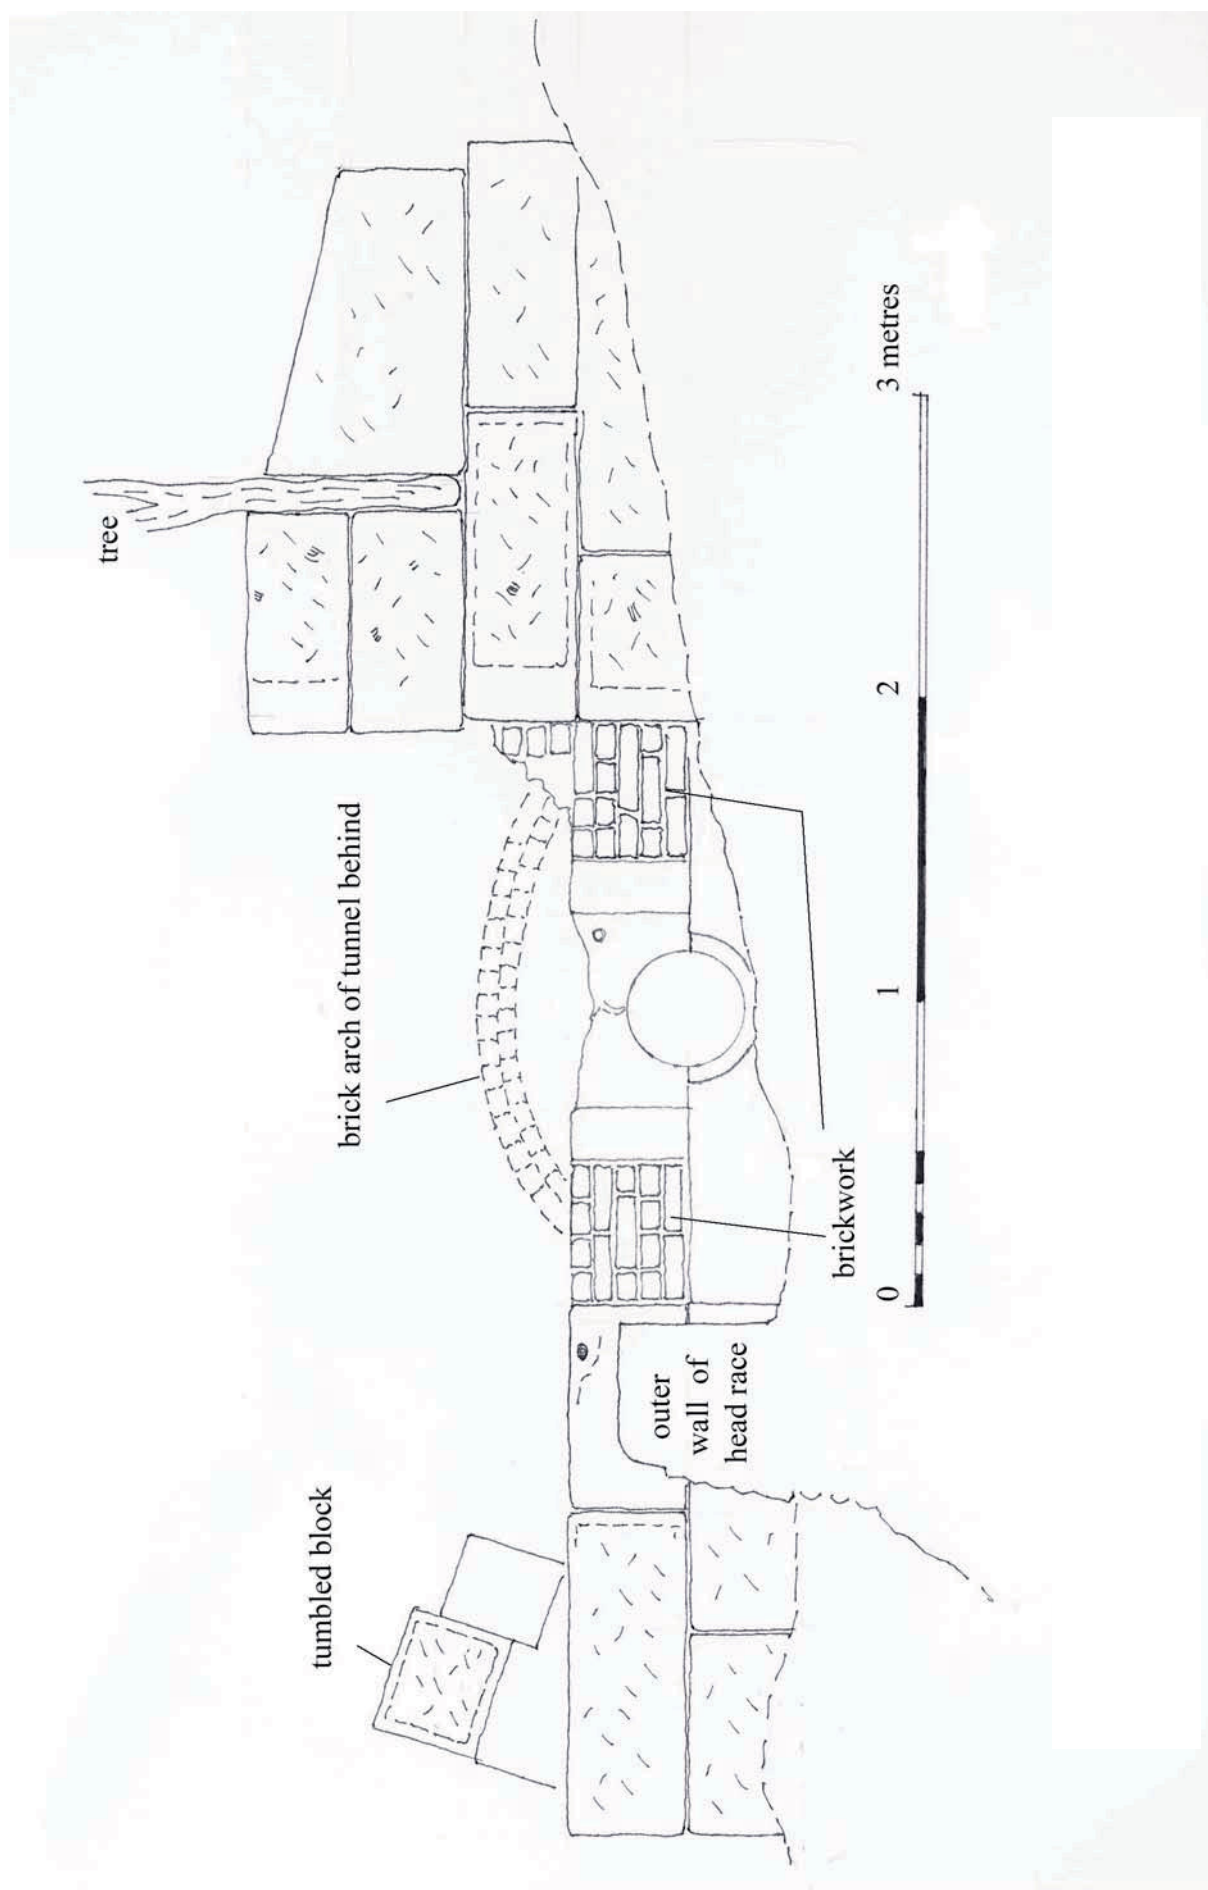
**Illus. 04:** Elevation of the visible remains of the Corporation Dam Intake by Peter Ryder

of the underground race. This takes the form of an opening 1.92 m wide in a wall of large ashlar blocks with a rock-faced-and-margined finish. The short length of wall north of the opening has partly collapsed; that to the south is in effect a retaining wall for the bank side and stands 1.50 m (four courses) high, extending for a further 1.75 m, the top course angling down to a height of 1.20 m at the end.

The opening in this ashlar wall, which has rounded angles to its jambs, is infilled by a recessed wall which has panels of old brick on either side of a central section with a rebated circular opening that appears to have been covered by some form of sluice to control inflow. Just behind this is the mouth of the intake tunnel, which is c 1.4 m wide and 0.8 m high at the entrance, with side walls of four courses of roughly-shaped stone and a double-skin segmental brick vault of around 20 voussoirs. The passage is floored by cobbles and river debris, as well as some odiferous organic material, and appears to continue in a straight line for at least 15 m, although the level of infill rises so that c 10 m in there is barely 0.3 m between it and the crown of the vault. A thin and determined speleo-archaeologist might make further progress.

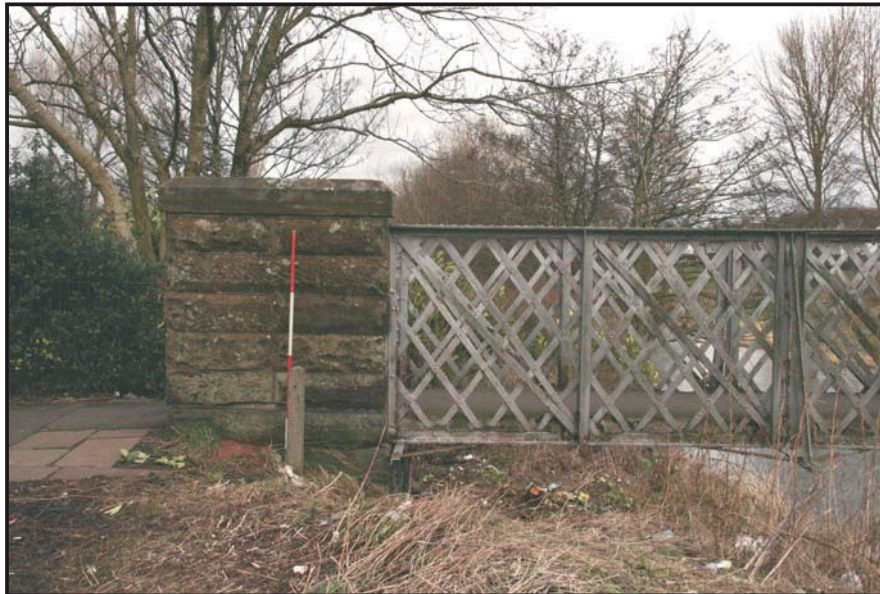
**Illus. 05:** The SW pier of the Denton Street bridge, the only one of the four piers to retain its capstone in place.

At each end of the bridge there are a pair of upright piers, 2.1 m high, 1.8 m long and 0.46 m thick, rebated at their inner angles to carry the cast-iron construction. Their inner faces are of diagonally-tooled sandstone ashlar, and their outer of rock-faced blocks; each has had an ashlar cap, chamfered on its upper angles, but only that of the south-western now remains in position. The cap of the north-eastern pier, now lying broken on the ground to the north, has the incised inscription '1885 / [BENJAMIN] SCOTT ESQUIRE'.

It is intended to re-use some of the masonry from the existing bridge in the replacement structure, including the capstones of the piers, only one of which (on the south-west pier) is currently in place, the others having tumbled to the ground. Particular effort should be made to include the inscribed datestone.

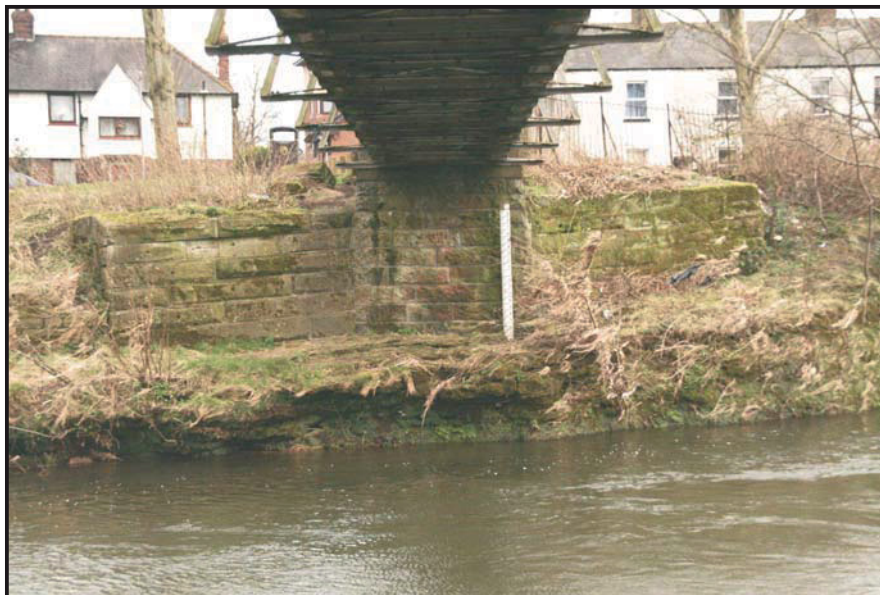
**Illus. 06:** The masonry of the larger, east abutment of the footbridge.

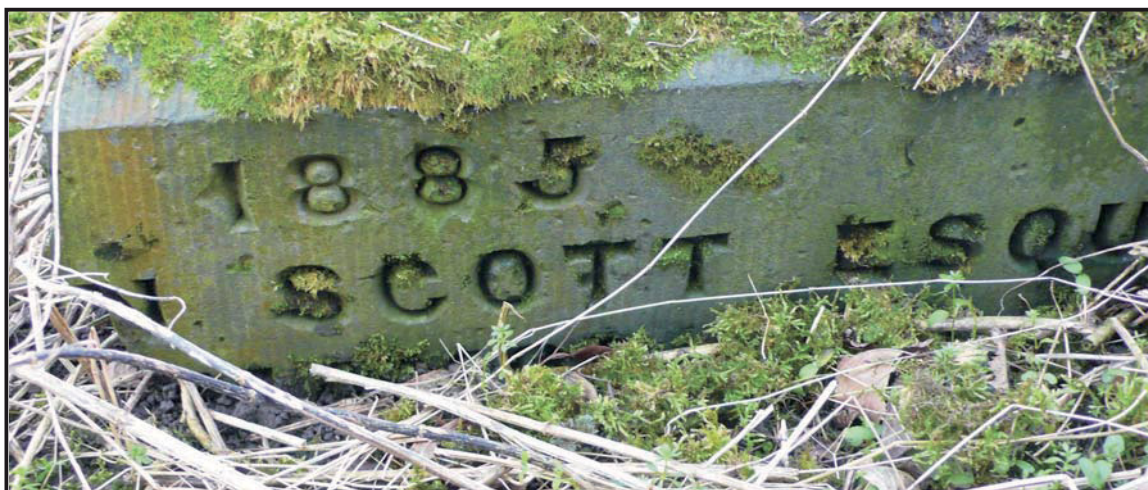
**Illus. 07:** The broken capstone belonging to the north-east pier, inscribed '1885/ [BENJAMIN] SCOTT ESQUIRE'

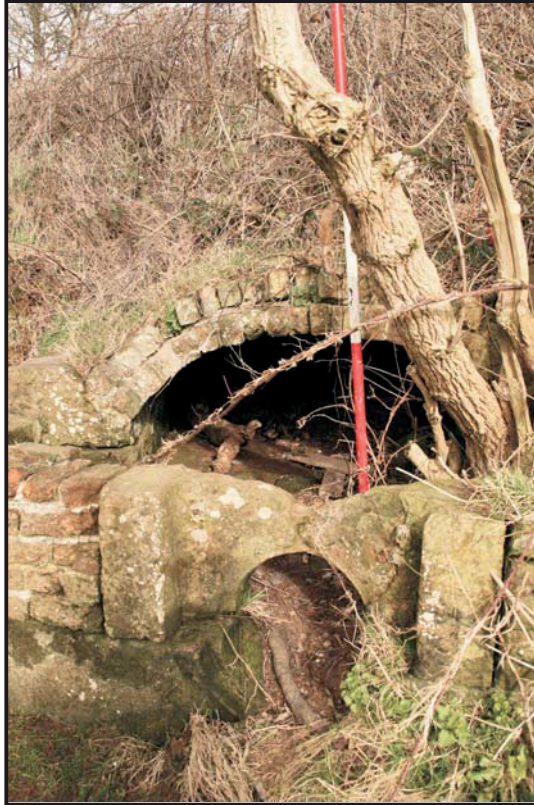
***Illus. 08:*** Sluice intake for Corporation Dam from the west.

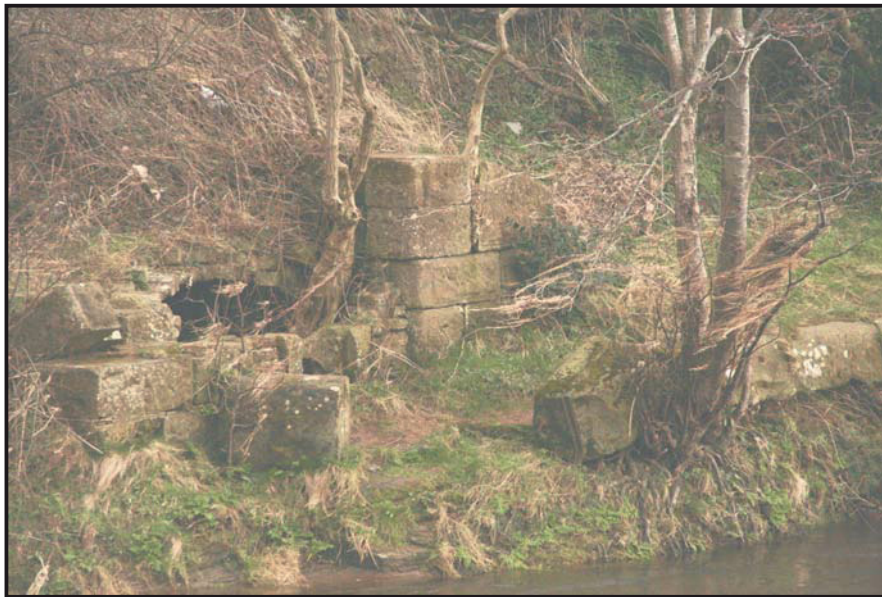
***Illus. 09:*** View of the masonry associated with the Corporation Dam intake and headrace.

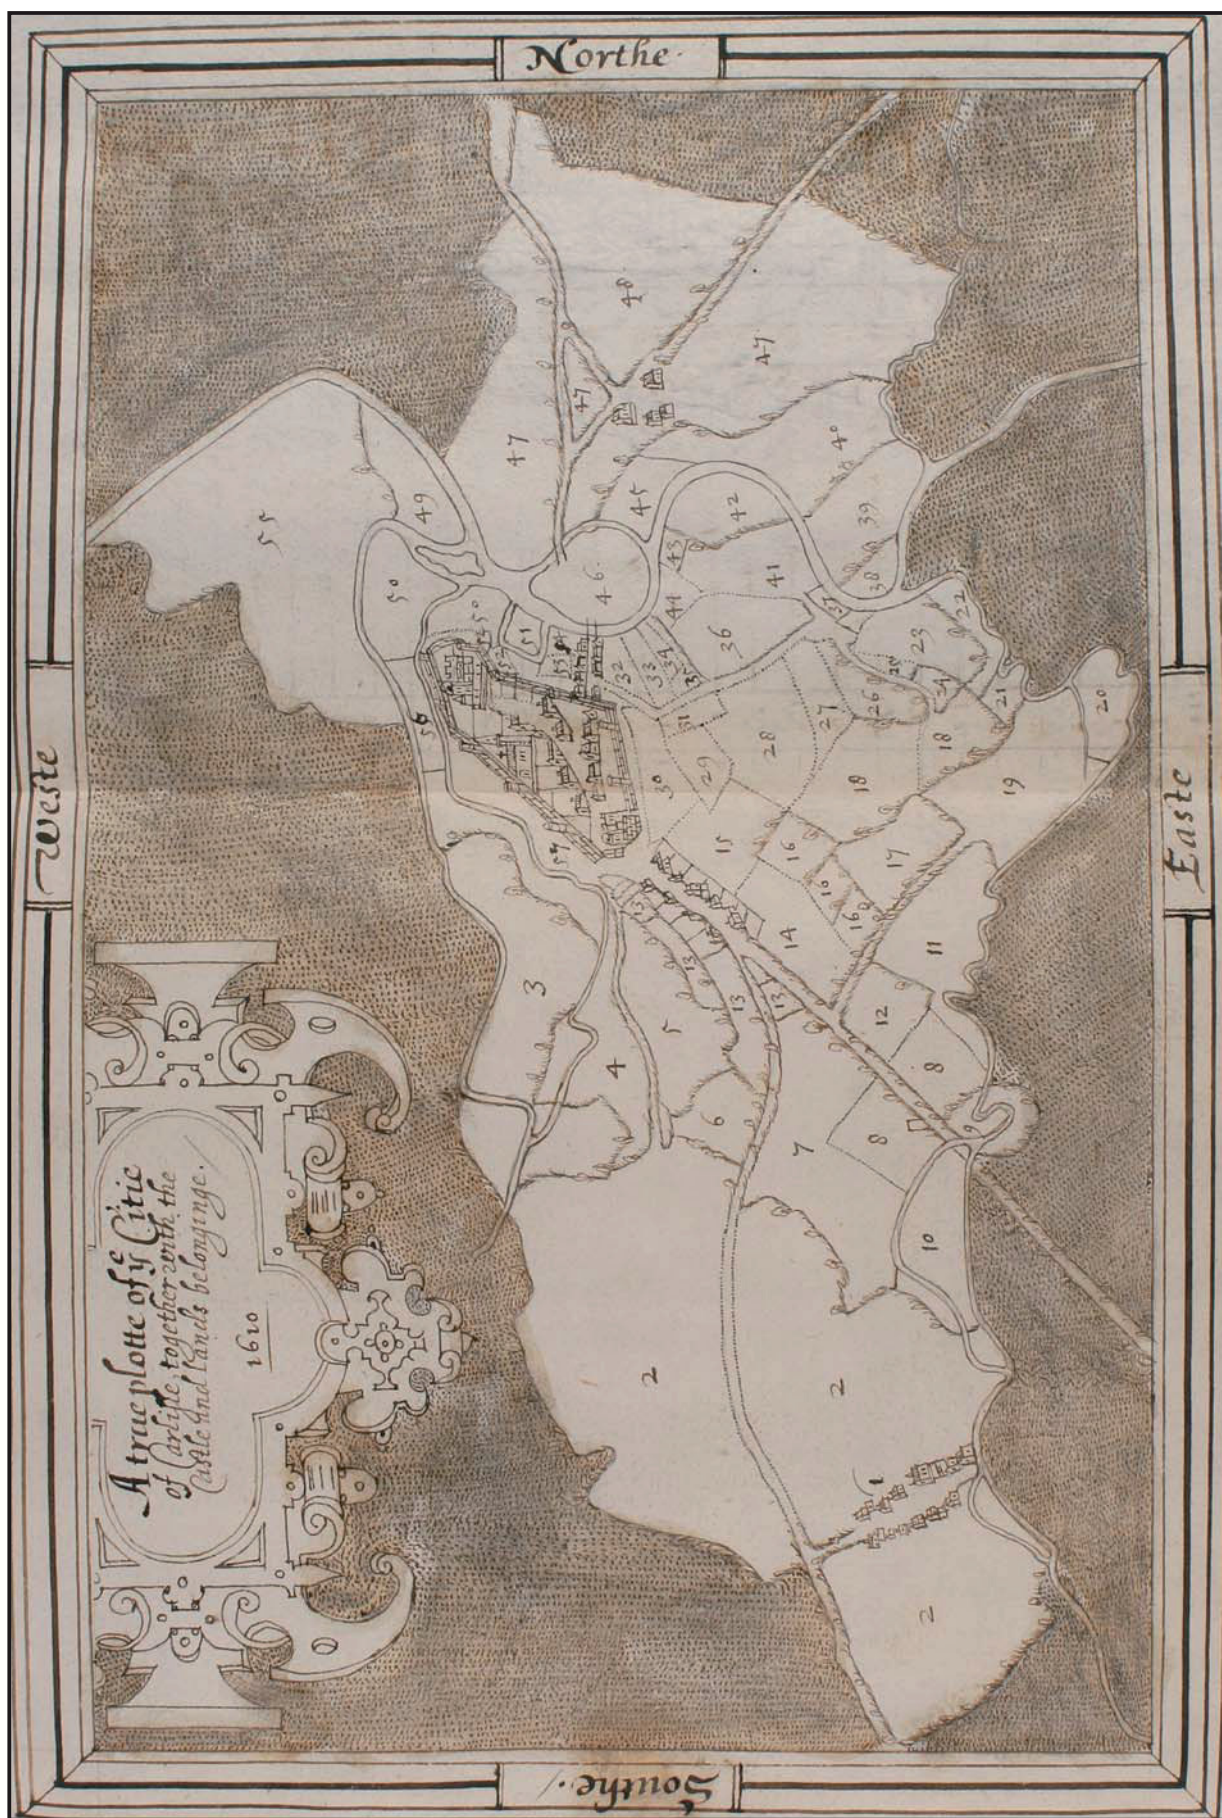
**Illus. 10:** Carlisle and the Socrage Manor 1610, reproduced with permission of Durham University Library Special Collection, (D U.L.-SP, Howard of Naworth Papers, C49/1)

of the royal 'socage manor' of Carlisle by Thomas Johnson in 1608 (cf. Spence 1984, 67-8) and Borough Mill appears – unnamed – along with Bridge End Mill on James Richards' 1684-5 plan of Carlisle. These were all controlled by the Corporation and were collectively known as the City Mills, Abbey Mill being held on a more or less permanent lease from the Dean and Chapter of Carlisle Cathedral, whilst the other three were owned by the Corporation (Jones 1985, 187). Smith's 1746 map of Carlisle shows a number of other watermills along the course of the 'Aquaduct for the City Mills' as it terms Corporation Dam.<sup>2</sup> The City Mills may originally have all been corn mills (Borough Mill is labelled 'Wheat Mill' on the 1746 map), but Abbey Mill was already serving as a fulling mill by the 18th century (Smith 1746; Cumbria County Library 2A9 – 1783; cf. Jones 1985). Furthermore the label 'Walk Mill Closes' given to the parcel of land (no. 57) below the west walls of the city on the map of the socage manor of Carlisle (DUL HNP C49/1) demonstrates there were one or more fulling mills on this stretch of the millrace by 1610 (Illus 10 & key; cf. Spence 1984, 67).

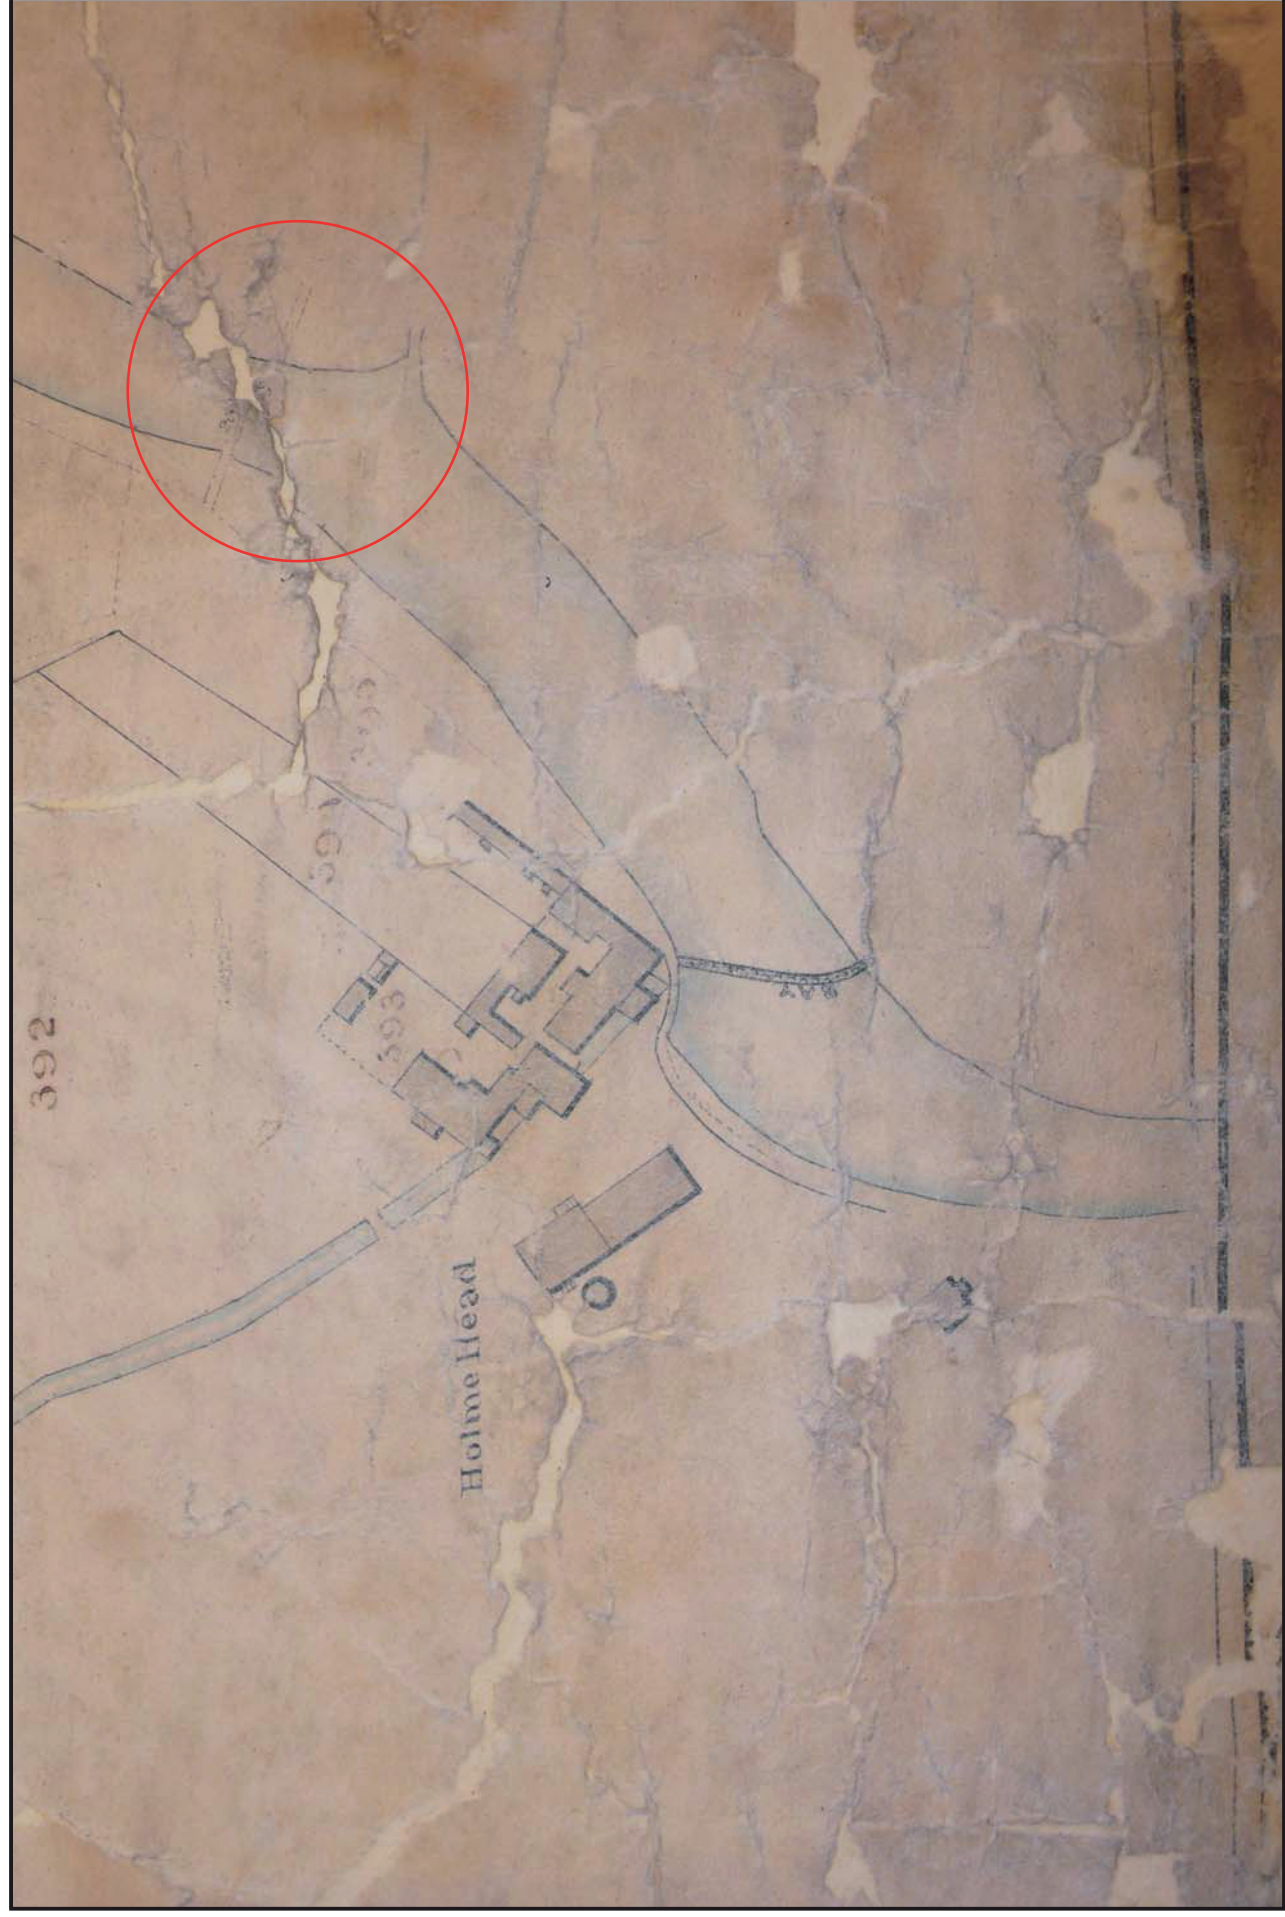
**Illus. 15:** Extract from the Caldewgate Tithe Plan (1842) showing the footbridge and possible Corporation Dam intake beside Holme Head (circled in red).

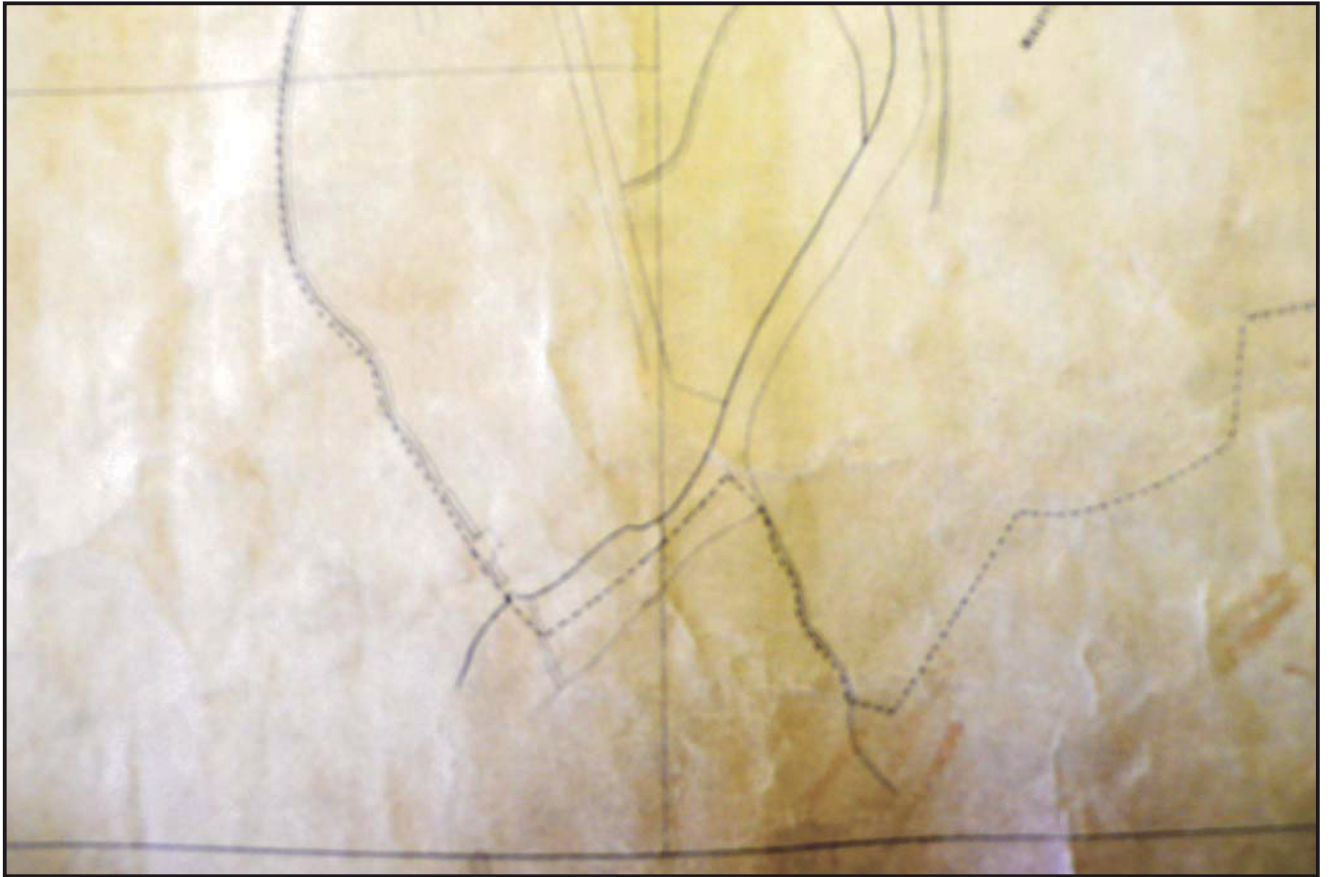
**Illus. 16:** Index plan of Holme Head area by Asquith in Report to Board of Health, 1850 (CRO)

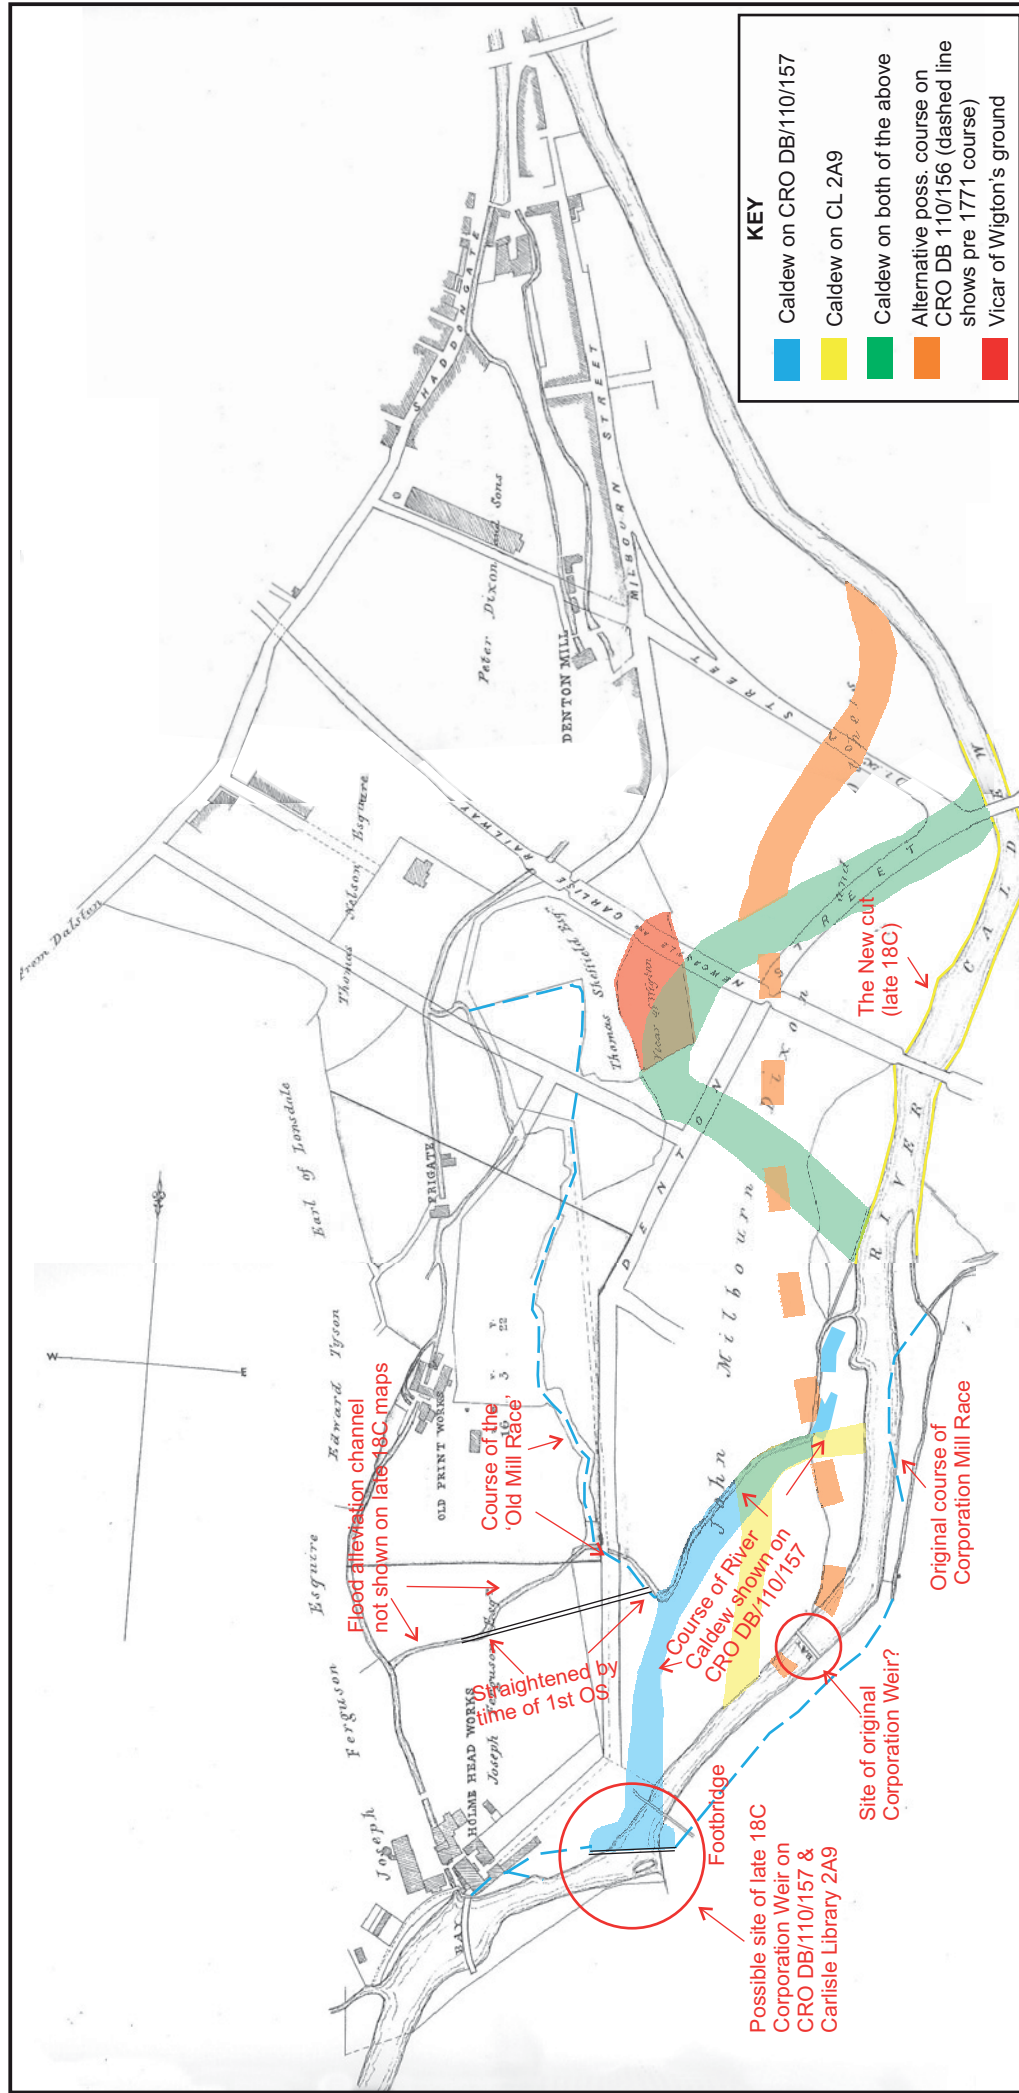
**Illus. 19:** Features extracted from the late 18th century maps shown in relation to mid 19th century developments using the Milbourn-Dixon estate map of 1852 as a base

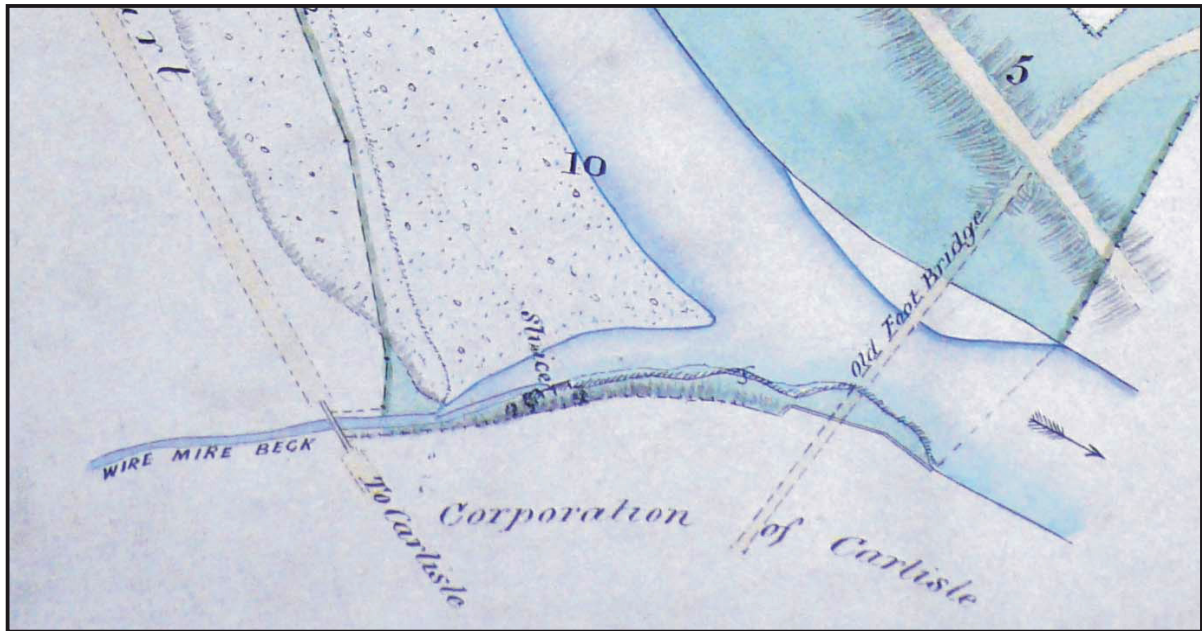
**Illus. 21:** Enlarged extract from Asquith's 1865 plan showing the footbridge and Corporation Dam intake sluice in more detail

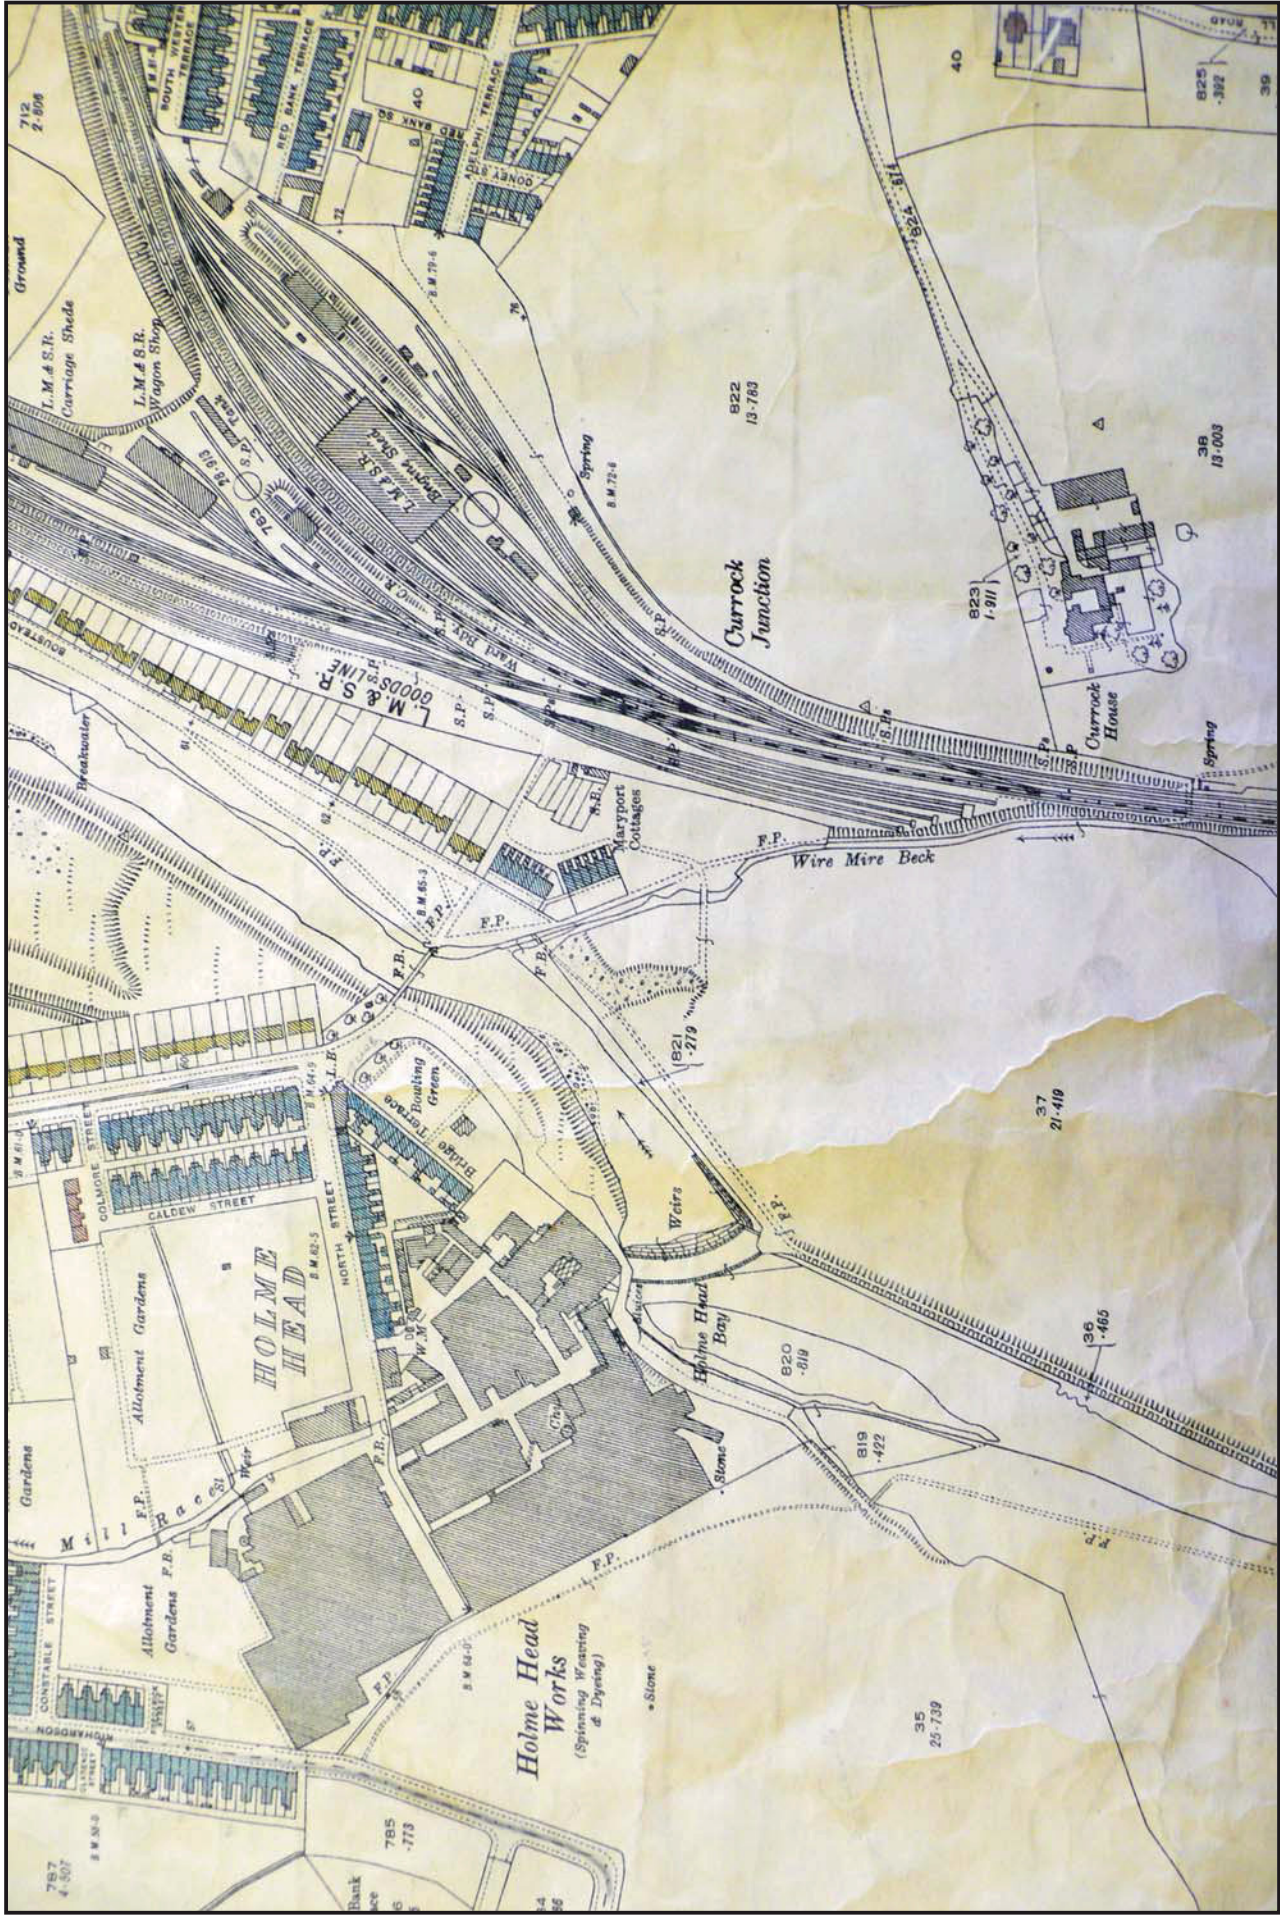
Illus. 24: Extract from the third edition 1:2500 Ordnance Survey sheet XXIII.7 (1925)

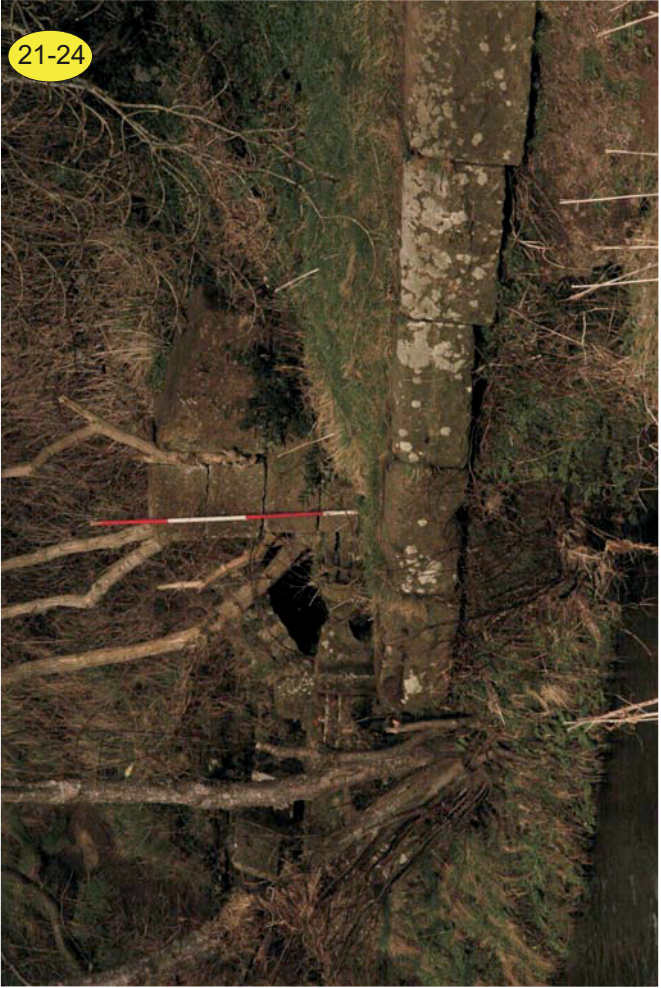
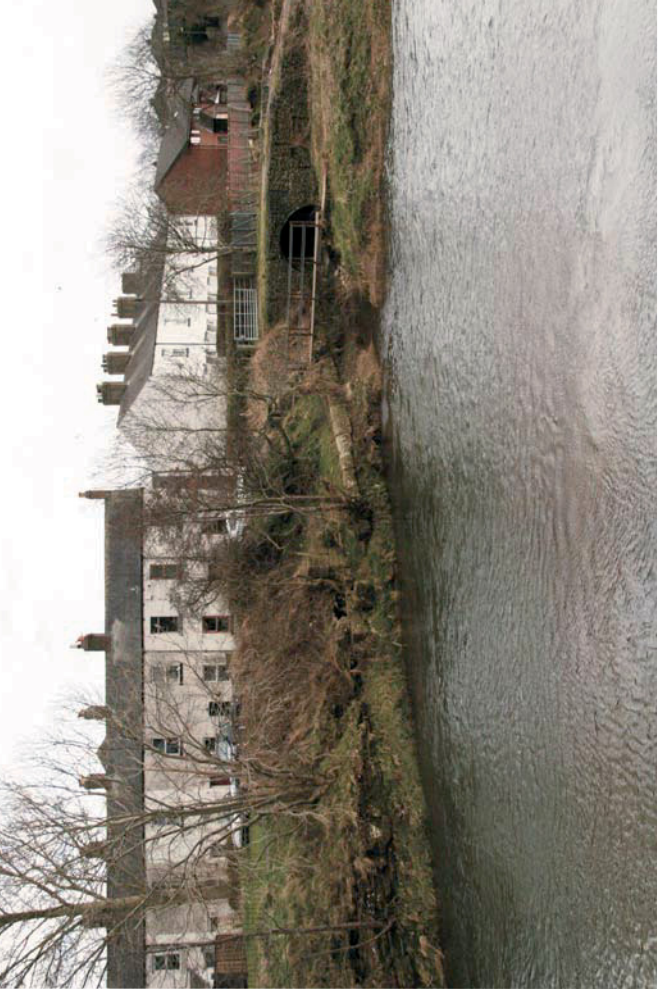
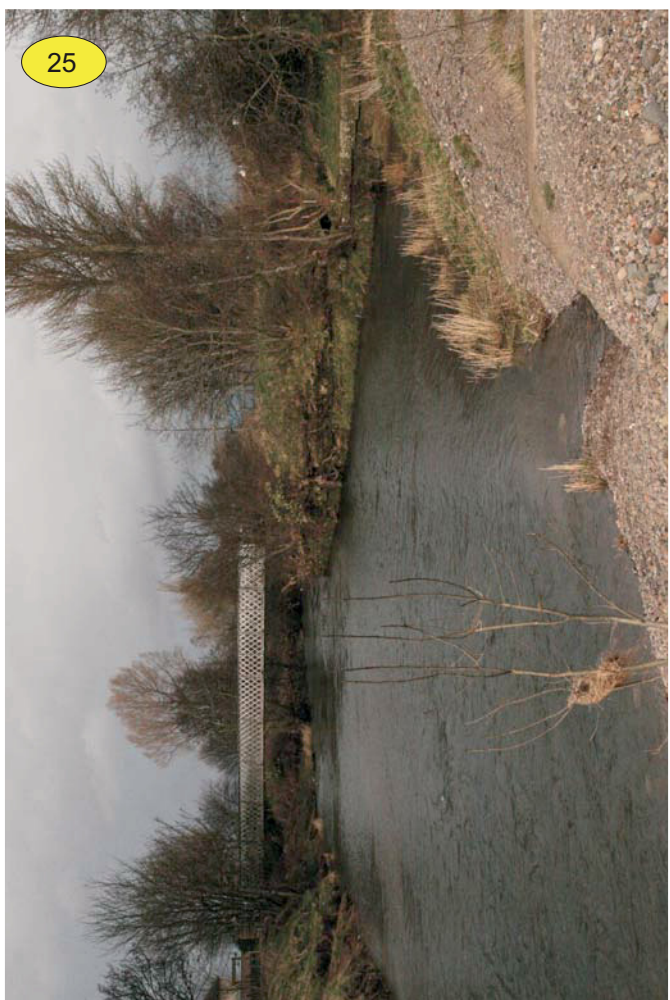
21-24

Photo no.	Description
1	View of Denton Street Bridge from the west
2	View of the west end of the bridge looking north
3	Southern side of the Denton Street bridge
4	The eastern abutment viewed from underneath the bridge
5	The western abutment viewed from underneath the bridge
6	The western abutment of the bridge viewed from the north-east
7	The inner face of the south-west pier
8	A detailed view of the bridge construction
9	Broken NE pier capstone inscribed '1885 / [BENJAMI]N SCOTT ESQUIRE'
10	View of Denton Street Bridge from the east
11	View of the east end of the bridge taken from the north
12	North face of Denton Street bridge from the north-east
13	North side of the Denton Street bridge
14	The eastern abutment viewed from the north-west
15	The eastern abutment viewed from the south
16	View of the intake from the north with head race channel evident in the background
17	View of the mouth of the intake
18	View of the mouth of the intake showing the circular opening probably associated with some form of sluice to control inflow

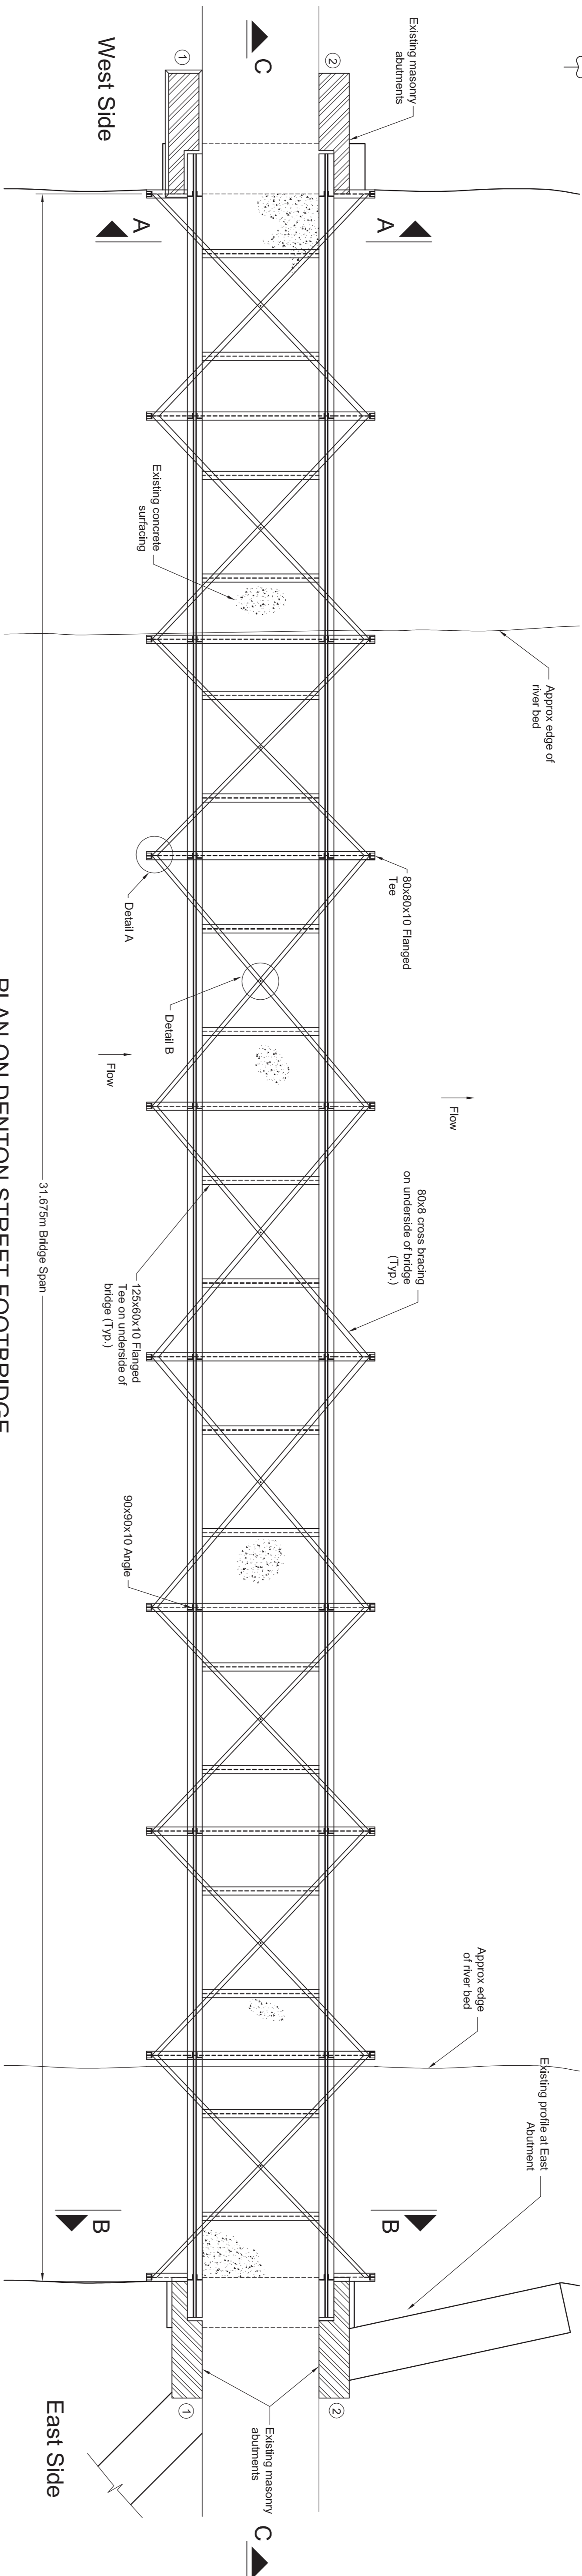
PLAN ON DENTON STREET FOOTBRIDGE

(Concrete Deck Omitted For Clarity)
