# CALDEW AND CARLISLE CITY FLOOD ALLEVIATION SCHEME

DENTON STREET FOOTBRIDGE and CORPORATION DAM  
INTAKE CARLISLE, CUMBRIA

## *HISTORIC BUILDING RECORD*

April 2008

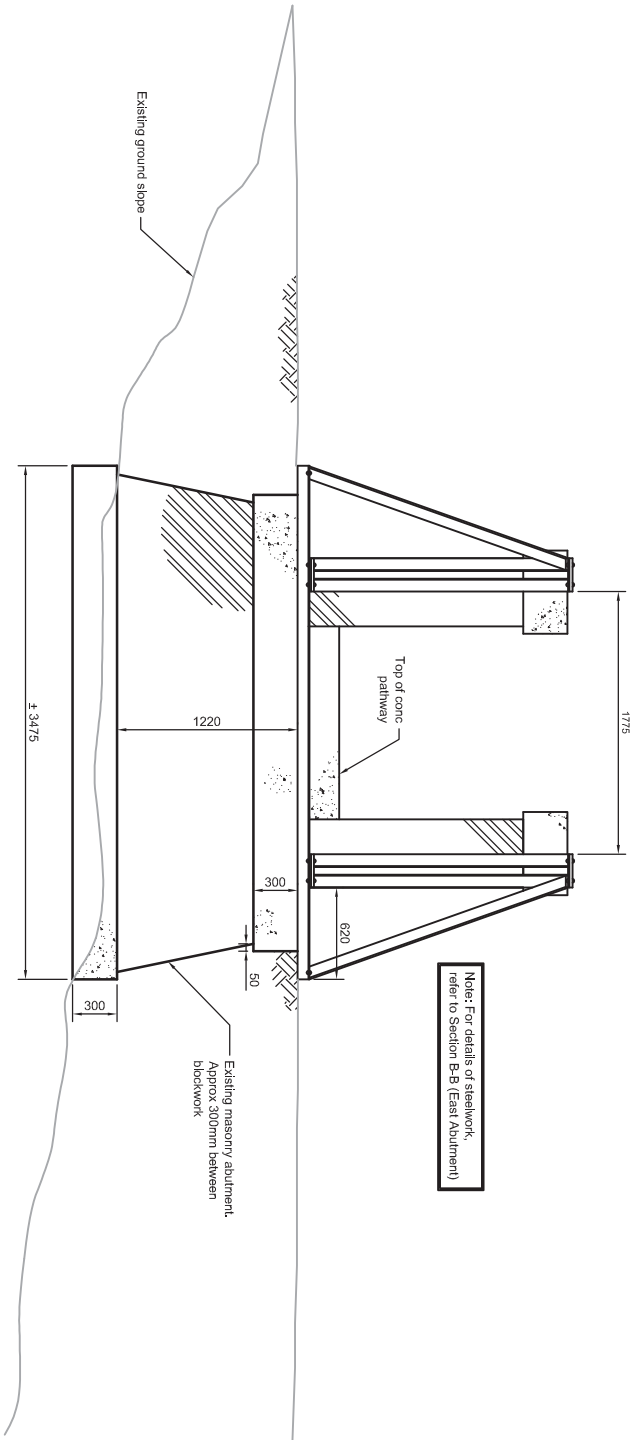
SECTION A-A (WEST SIDE)

Note: For details of steelwork refer to Section B-B (East Abutment)
