Project Report 1152b.1(1)

Middleton Bottom wheel pit, Middleton-by-Wirksworth, Derbyshire

Trial trenching (stage 2)

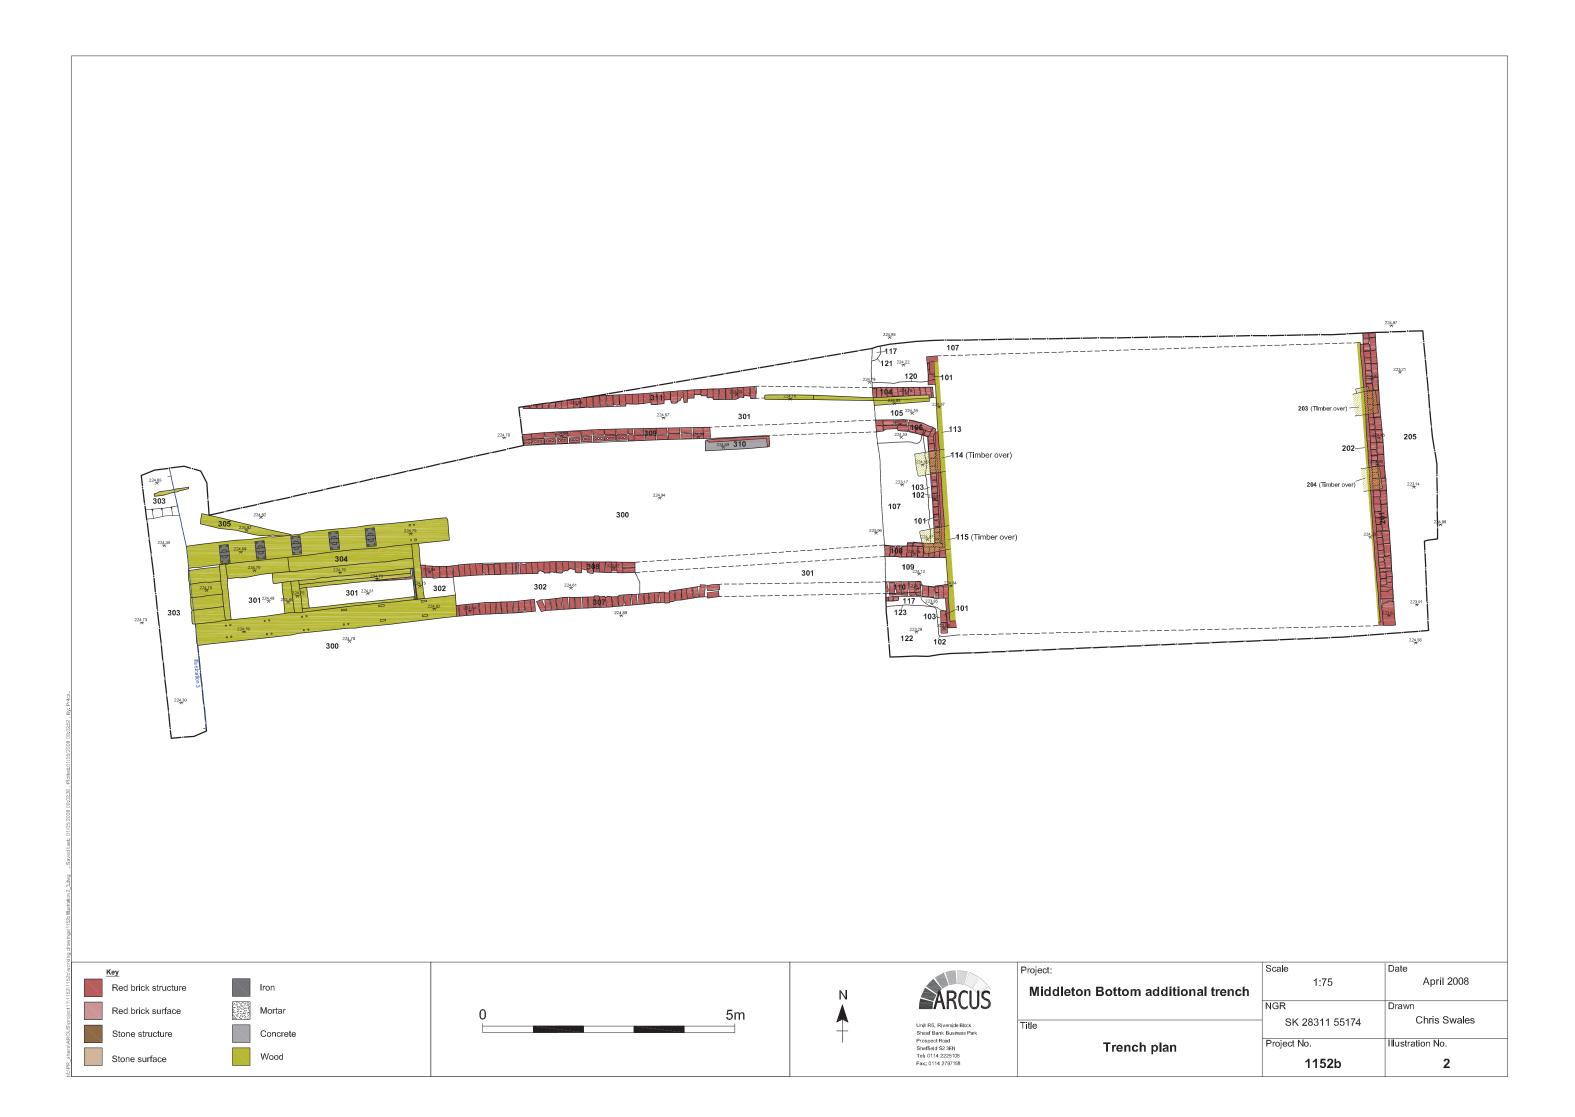
A group of structures were exposed, cleaned and recorded, close to the modern ground surface. These included the brick walls of the runnels conveying the cables from the direction of the wheel pit, and a timber sleeper structure associated with the end of the southern runnel (Illustration 2) (Plates 1 and 2).

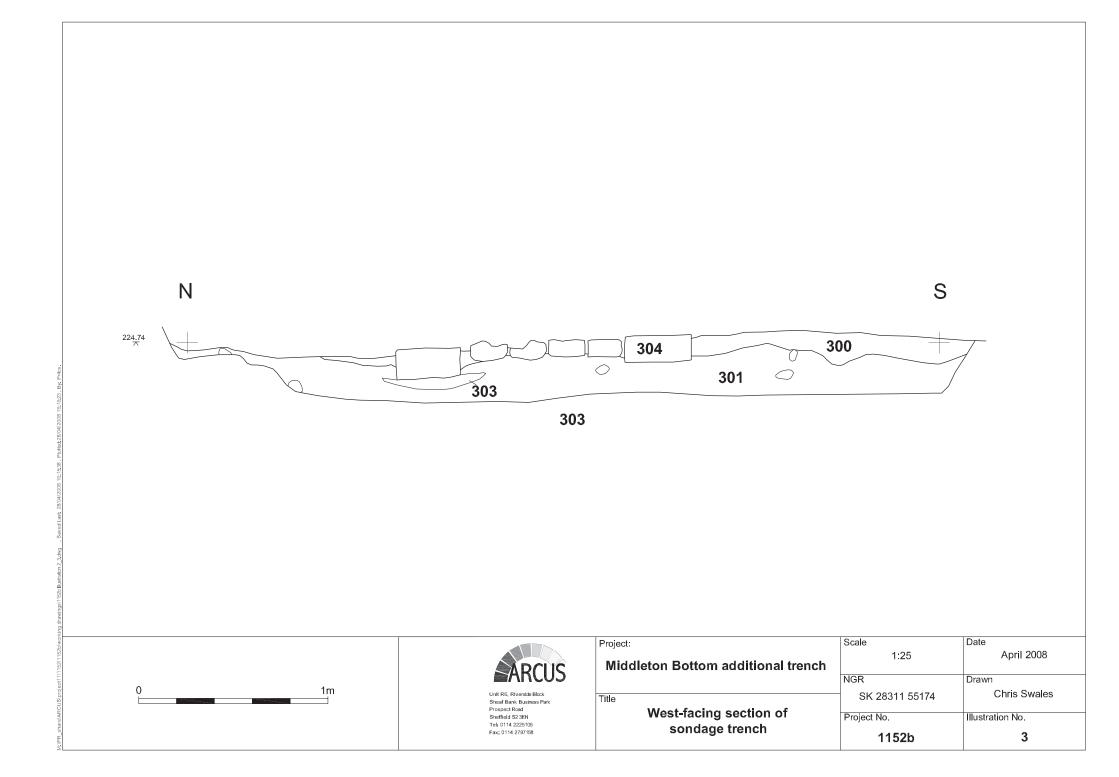
A sondage, measuring 5.00m north-south by 0.60m east-west, was excavated immediately to the west of the wooden sleeper structure [304], to test for any further below ground structures, and to assess the general stratigraphy in this area (Illustration 3). No structures were identified, confirming that the cables had indeed emerged from the below-ground runnels by this point. No archaeological evidence was encountered for the sidings shown on historic photographs.

A compact yellow-brown material (303), composed of a sandy grit with limestone rubble, formed the base of the sondage. This was interpreted as a made ground material used to create the railway embankment, presumably during the initial construction of the Cromford and High Peak Railway during the 1820s. The surface of (303) was encountered typically 0.43m below the modern ground surface, rising to only 0.12m at the northern end of the sondage, towards the tracks.

Above (303) was a compact infill material (301), typically 0.24m thick and comprising a mixture of humic topsoil with clinker. This material was also present at the excavated bases of the southern cable runnel and the gaps within the sleeper structure [304], and appears to represent a levelling deposit associated with construction of the runnels and the sleeper structure (and the wheel pit itself) during the late 19th century.

At the modern ground surface was a topsoil layer (300), 0.12m thick, and composed of a dark humic silt with a well-developed ivy root mat.

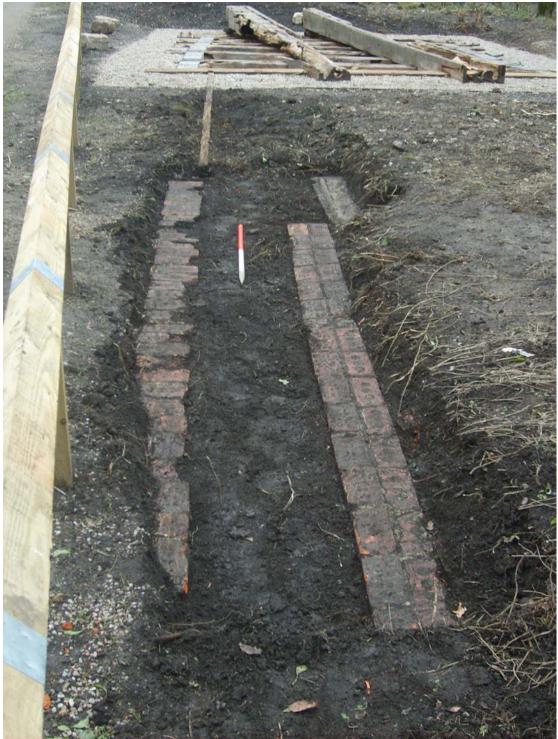
Plate 3: Northern cable runnel [309]/[310]/[311], looking east towards the wheel pit.

The northern runnel (contexts [309], [310], [311]) was traced over a length of 4.84m east-west (**Plate 3**). To the west, the structures continued beneath the fencing adjacent to the High Peak Trail. To the east, the runnel walls became progressively truncated but did appear to continue at a lower level towards the wheel pit. A wooden beam resting on the lip of the northern runnel wall was traced right through to the edge of the pit. The internal width of this runnel was typically 0.46m. The southern wall [310] was offset to the south part way along its length, continuing as concrete-capped wall [311] and giving a new internal width of 0.70m. The reason for this offset is unknown, although the wider channel may have accommodated a wheel or pulley mechanism at this point. The runnel was not excavated beyond the top courses of its walls. At this point the channel was filled with a humic topsoil material (300), although it is likely that at a lower level the usual decommissioning infill of limestone ballast is present.

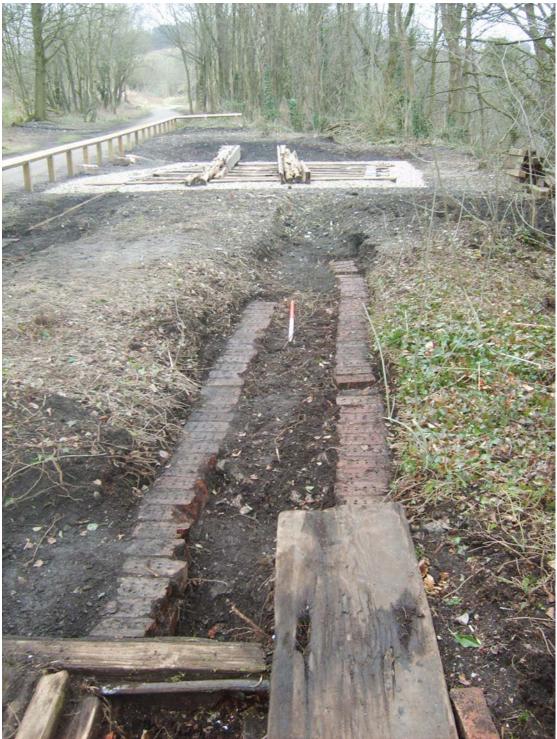
The southern runnel (contexts [307], [308]) was traced over a length of 5.90m (Plate 4). Both of the runnel walls continued beneath the wooden sleeper structure [304] to the west, the northern wall [308] ending after an additional 1.90m. To the east, the walls became progressively truncated, but appeared to continue at a lower (unexcavated) level towards the wheel pit. The internal width of the runnel was typically 0.54m, narrowing progressively eastward to as little as 0.44m. This narrowing was probably due to a partial inward slump of the walls. The runnel was filled with a limestone ballast (302) in a loose humic matrix. This material was also used to fill gaps in the wooden sleeper structure, and a similar material was found to fill both runnels in the 2007 excavations. (302) appears therefore to be a decommissioning infill of the cable runnels and associated structures, and probably dates between the 1960s and 1980s. At the western end of the runnel, against the sleeper structure, (302) was removed down to the base of the runnel, which was formed of a compact soil and clinker material (301) at a depth of only 0.28m, corresponding to three courses of the brick side wall [308]. Compared with the considerable depth of the runnels adjacent to the wheel pit, this suggests strongly that the bases were ramped up progressively westwards, bringing the cables towards the surface.

Plate 4: Southern cable runnel [307]/[308], looking east towards the wheel pit. Note timber structure [304] in foreground with steel reinforcing strut where cable emerged from runnel.

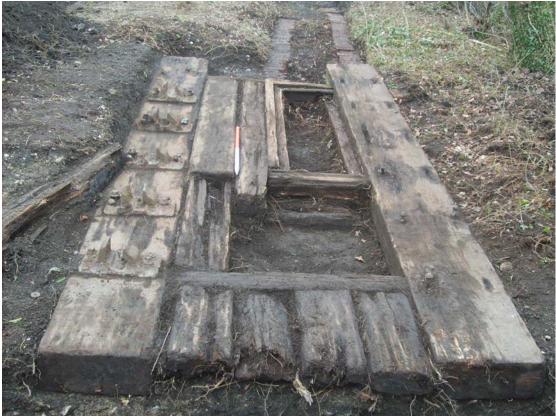
Plate 5: Timber sleeper structure [304], with southern cable runnel in background. Looking east.

The walls of the southern runnel [307]/[308] ended beneath wooden sleeper structure [304], apparently conveying the cable up to the surface through a long rectangular slot (Plate 5). [304] therefore marks the location where the southern cable emerged from its runnel onto the surface of the incline.

[304], measuring a total of 5.13m east-west and 1.95m north-south, was composed of two parallel railway sleepers (each 5.13m x 0.64m x 0.17m thick), laid 1.08m apart. Five metal rail 'chairs' were attached to the northern sleeper, and the rivet holes for chairs were visible on the southern sleeper, suggesting that the rails were conveyed over the top of [304]. The space between the sleepers was filled by smaller transverse and longitudinal timbers, creating two rectangular gaps against the southern sleeper. The eastern gap measured 2.14m east-west by 0.41m north-south, while the western gap measured 1.08m east-west by 0.81m north-south. The cable runnel apparently conveyed the cable into the western gap, beneath a timber strut and reinforcing metal bar (Plate 6). A notch worn in the underside of the metal bar confirms that the cable did indeed run in this location (**Plate 7**). Timbers running the length of the gap were set down at a lower level, suggesting perhaps that a tensioning wheel or pulley, bringing the cable to the surface, was free to slide here. The function of the eastern gap, if any, was unclear.

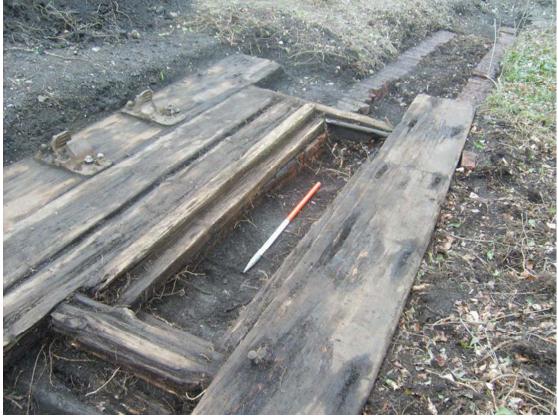
Plate 6: Gap in [304] where cable emerged from runnel; note brick runnel wall [308] running beneath timber. Looking north-east.

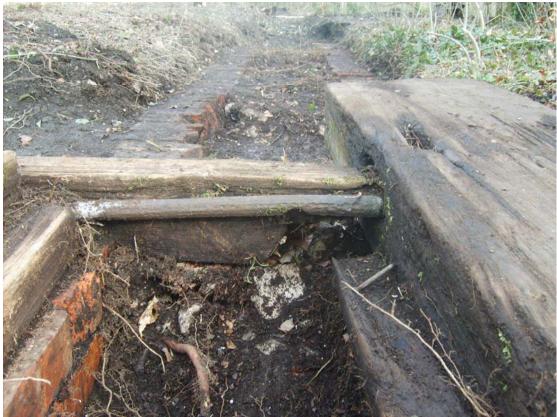
Plate 7: Steel reinforcing bar in [304], where cable emerged. Note semi-circular notch worked by steel cable.
