YARM SCHOOL, THE FRIARAGE, YARM, STOCKTON-ON-TEES, CLEVELAND: AN ARCHAEOLOGICAL EVALUATION

CS Archaeology
October 2013

Project Number: 125

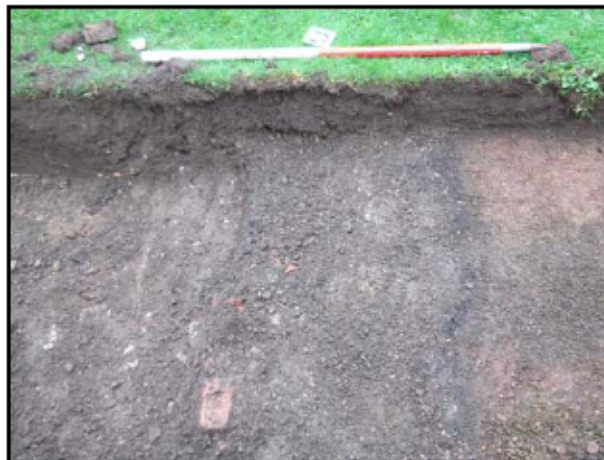
Plate 1: view of the probable path [101], from the northeast

6.3 Trench 1 (5 x 2m, max depth c.1.7m: **Figure 4**) was excavated from the southeast, its stratigraphy was characterised by modern and post medieval disturbance. This disturbance was in the form of a modern electric cable, which bisected the trench. The cable was left in situ and where possible the remaining trench was excavated. Deposits within the trench were marked initially by a gravel spread [101& 102] (**Plate 1**). The spread appears to contain the remains of a probable path [101]. This path [101] bisected the trench towards its centre and appeared to be aligned parallel with the gable of the Friarage and measured 1m across.

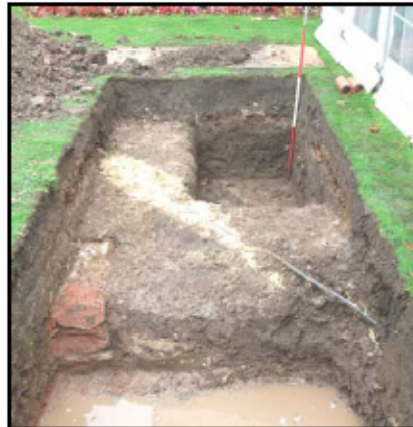
Plate 2: view of trench 1 with the wall footings to the left, from the southeast

6.4 These upper deposits [101& 102] were removed and the underlying deposit [105] consisted of brown silty clays with lenses of lime mortar [105]. A small quantity of artefacts were recovered from [105] and consisted of disarticulated animal (cattle) bones, clay pipe fragments and 18th century pottery. The formation of the deposit appeared to be rapid and was probably associated with leveling of the grounds during the late 18th century. Along the western side of the trench, remains of a sandstone wall [114] were revealed. This wall [114] measuring at least 0.27m across, disappearing beneath the baulk the wall [114] appears to have represented a relatively recent structure as evidenced by the foundation cut [113] through the clay [105] and lime mortar leveling deposits [105] (**Figure 4**). The wall [114] extends 1m and is at least two courses deep, is bonded with lime mortar and is aligned with the

southwest elevation of The Friarage and appears to be a continuation of the building line. Examination of readily available cartographic sources does not indicate a building, and in this particular area, which lay outside the area of the conservatory/orangery (1894 25" Ordnance Survey map), probably indicates the foundation courses of a garden wall.

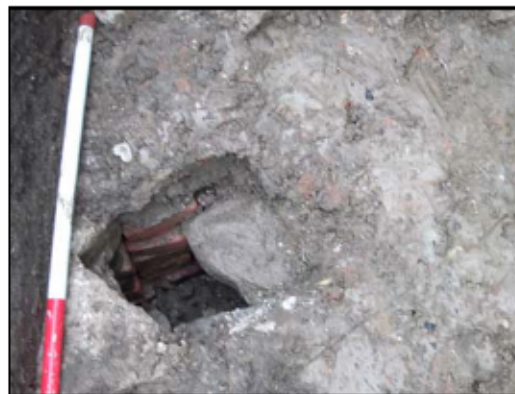
Plate 3: view of the breached culvert in trench 1

- 6.5 The northwest end of the trench was excavated down to 1.2m below the surface just below the start of the natural clay. Cutting the clay was a stone capped culvert [110 & 111]. The culvert featured red brick sides without any traces of bonding (the bricks measured 0.06m deep, but the length was not available). The base of the culvert appeared to feature a base flagstone, and the brick sides, were unbonded, and constructed on top. The culvert was on a southwest/northeast aligned crossing trench 1 and heading into what was the conservatory/orangery.

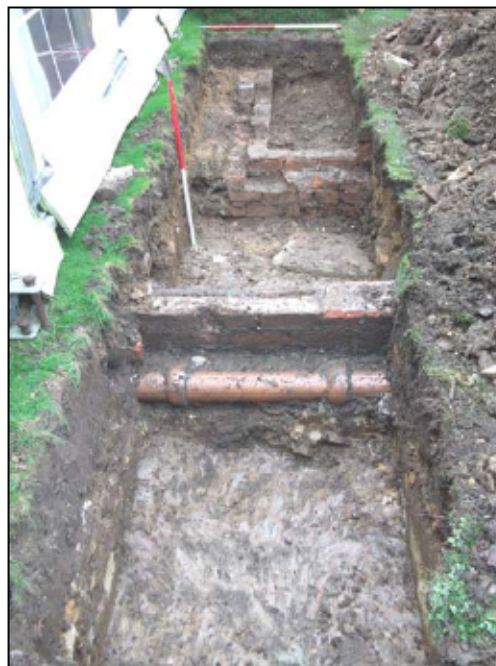
Plate 4: view of trench 3 with its heated wall and 'L' shaped wall beyond

- 6.9 Trench 3 (5 x 1.1m up to 0.72m in depth: **Figure 5**) had to be restricted in width due to the limited space and shrubs adjacent to the house. Just beneath the turf a series of brick walls was revealed. The walls consisted of an 'L' shaped wall at the northwest corner of the trench and two bisecting walls with a central cast iron heating pipe. The walls consisted of similar bricks (0.23 x 0.115 x 0.75m) bonded in a hard lime mortar. The L' shaped wall which was 0.25m in width continued into the southwest and northwest baulks and was lined with tarred plaster, suggesting it represented the base of a water tank. A foundation cut for this wall [311] was revealed cutting the natural clay [307]. Between the walls was evidence for a flagstone floor which was probably originally suspended, evidenced by the inclined stone at 20° which was probably smashed into a void and also evidenced by the range of angular stone fragments removed during the trench excavation. However no actual brick plinth was revealed.

- 6.10 Trench 3, *Interpretation*: The evidence for contemporary structures within the trench arrangement suggests the area functioned as a conservatory/orangery which was probably constructed during the 19th century and appears to have been demolished, relatively recently (late C20th).

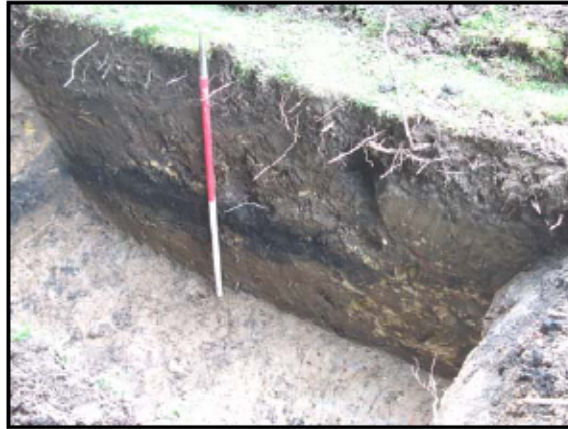
Plate 5, view of the north east facing section with its distinct charcoal horizon and house construction layer (bottom right)

- 6.11 Trench 4 (3 x 1.1m x 1.1m in depth: **Figure 5**) no structural evidence was apparent. It consists of a substantial layer of re deposited silty clay which was formed as part of the terraced/landscaped gardens. At the lower northern end of the trench, a distinct deposit of clay mixed with angular sandstone was recorded and this layer may relate to The Friarage's construction in the 1770s. South of this probable building construction layer was the characteristic charcoal layer similar to the one encountered in trench 2.

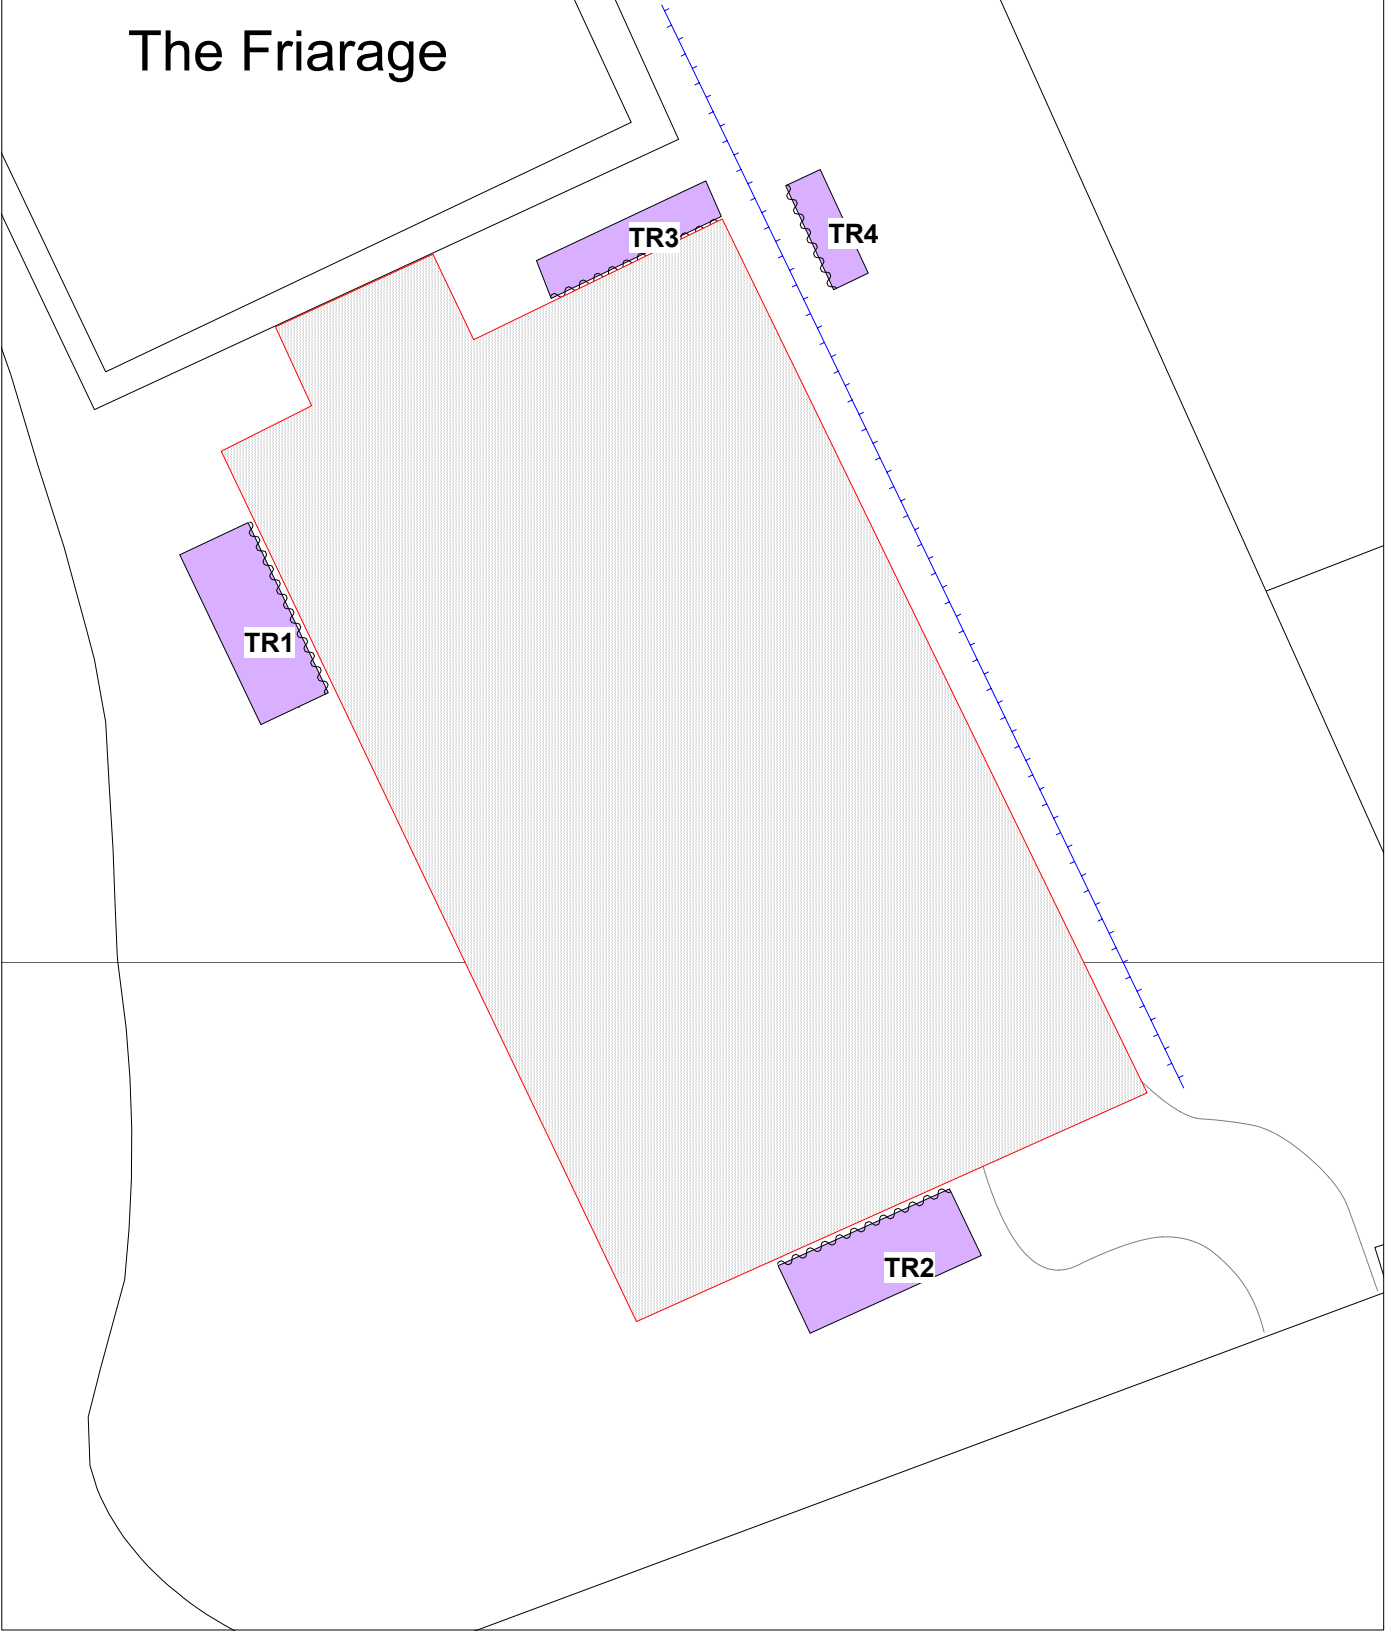
archaeological trenches
-

section drawings (figs.4-5)

6.1 This employed sample trenches in order to assess potential impacts to the Proposed Development Area's (PDAs) archaeological resource (**Figure 3**). The evaluation was in accordance with the Project Design (Appendix 1) which was approved by Tees Archaeology in August 2013.

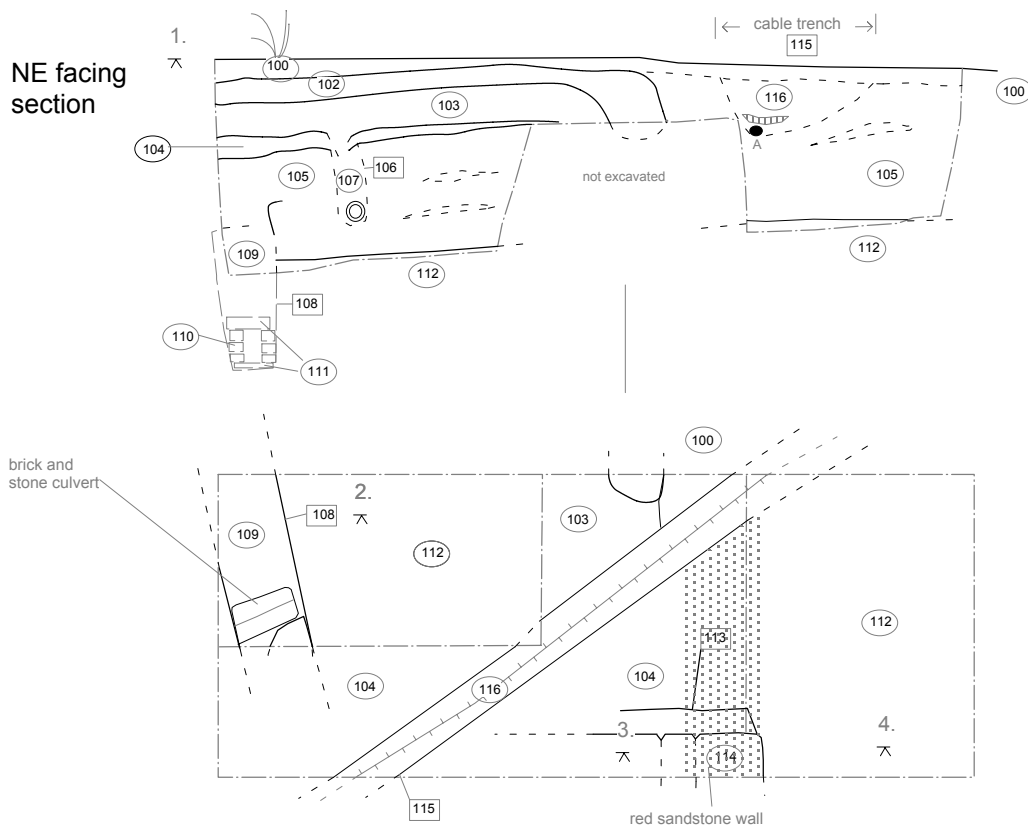
Trench 1 (TR1)

NE facing section

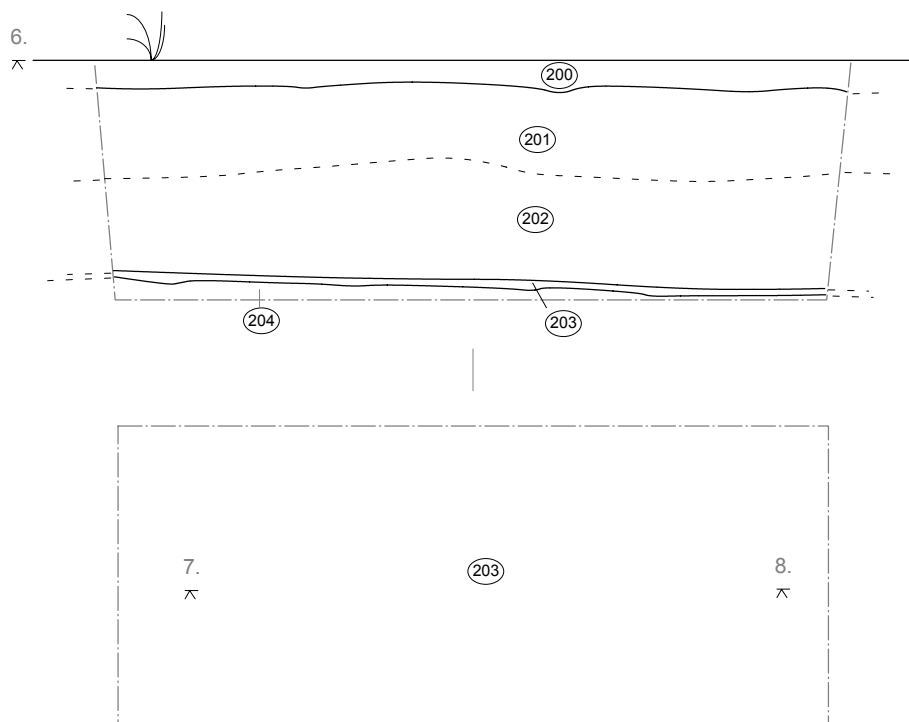
Trench 2 (TR2)

NW facing section

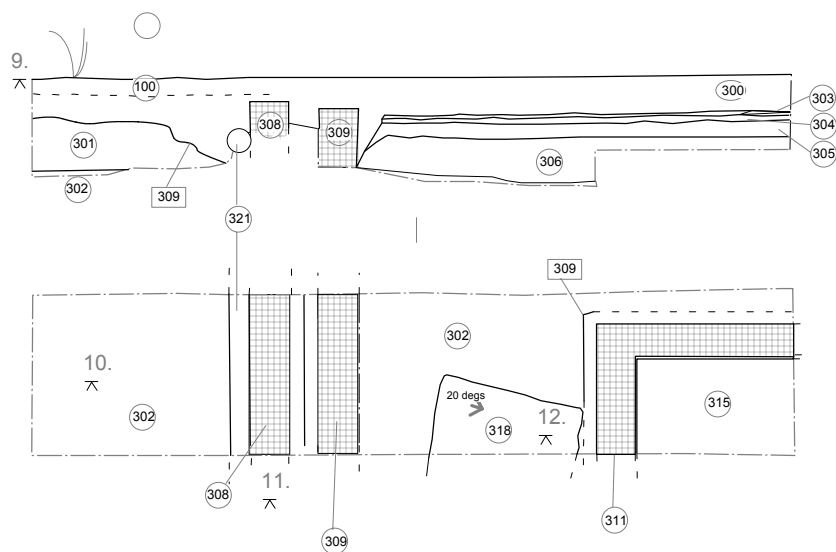
Trench 3 (TR3)

NW facing section

Trench Plan

Levels
9. 7.03m
10. 6.36m
11. 6.82m
12. 6.30m

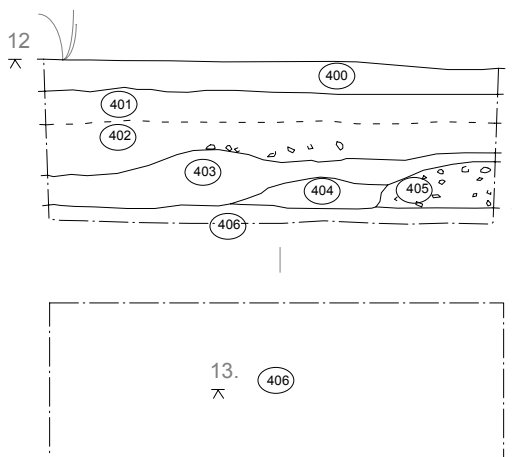
Trench 4 (TR4)

NE facing section

Trench Plan

Levels (AOD)
13. 7.03m
14. 5.95m
