**34 ROGER DRIVE, SANDAL, WAKEFIELD,  
WEST YORKSHIRE:  
AN ARCHAEOLOGICAL WATCHING BRIEF AND  
METAL DETECTING SURVEY**

**CS Archaeology**

**April 2008**

**CSA Report Number:** 017

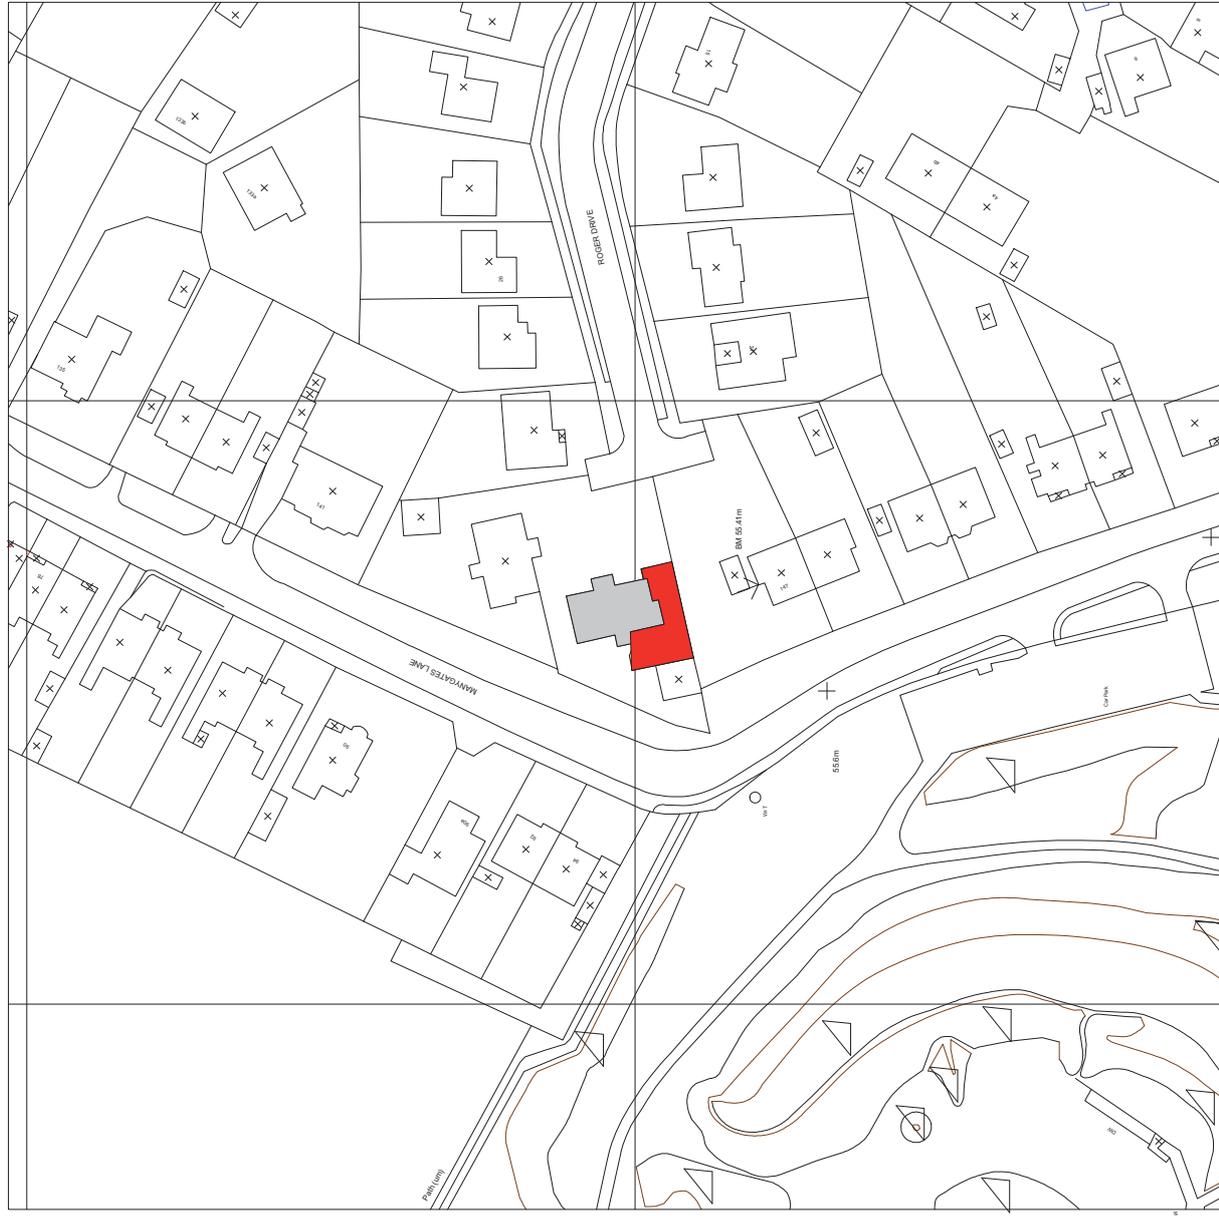
Figure 2: Site Location  
and Boundary

- 2.1 The site, 34 Roger Drive lies, to the south of Wakefield. It is bounded to the north by 32 Roger Drive, and to the west by Manygates Lane with Sandal Castle (a Scheduled Monument) beyond (Figures 1 & 2). The site is centred on National Grid Reference SE 33859 18196.
- 2.2 The site represents a new build to the side (Garage) and rear (Sun Room) of the existing dwelling at 34 Roger Drive, Sandal (Figure 3). The existing building was constructed in 1983 on an open field which had been gradually encroached upon during the early twentieth century.
- 2.3 This watching brief and metal detecting survey was undertaken on the 4<sup>th</sup> and 5 April 2008 in response to a condition on planning application (No. 07/02417/FUL), to construct a single storey extension to the rear and attached garage to the side of the existing dwelling.

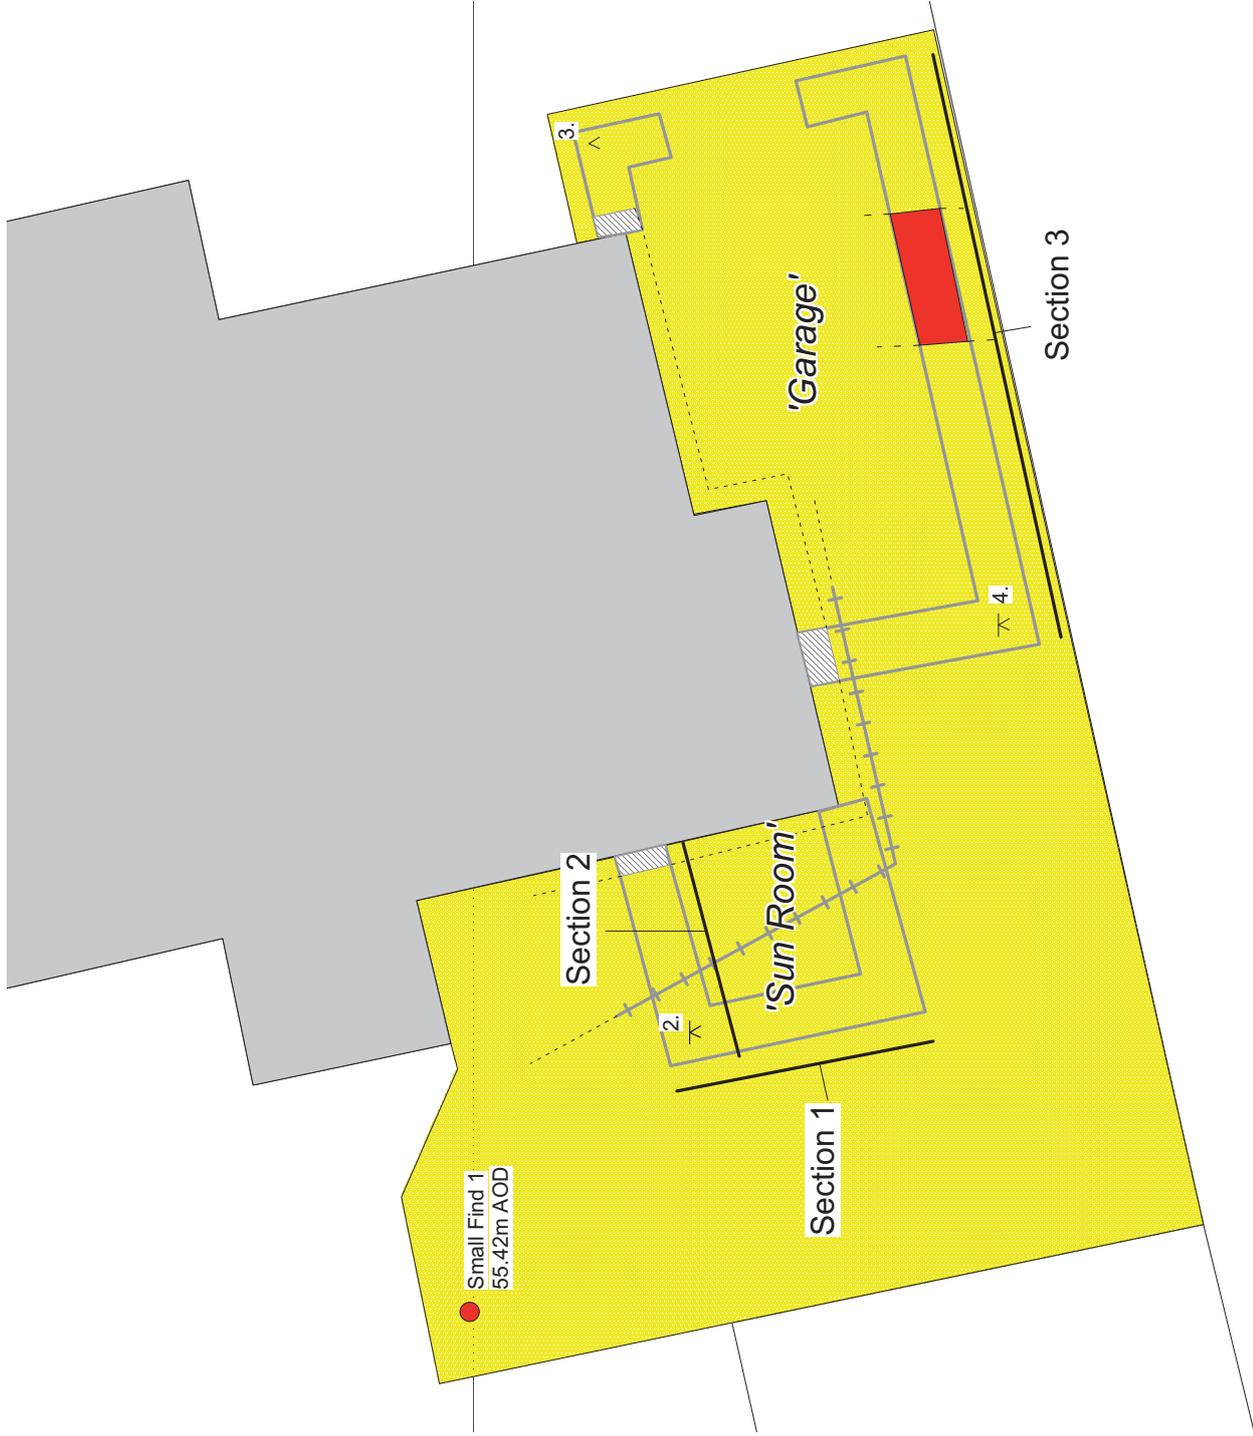
Figure 4: The 'Sun Room'  
foundation trenches,  
plan and sections

- 6.2 The 'Sun Room' trenches consisted of a 'U' shaped foundation trench (Figure 4, Plan 1: Plate 1) which was 3 x 3.5m. The stratigraphy (Figure 4, Section 2) consisted of 0.06m of tarmac then 0.2m of introduced limestone gravel [001]. Beneath the gravel was a brown sandy silt subsoil [002] up to 0.2m in depth with the natural [003] below. The natural [003] consisted of buff clayey sand with frequent irregular sandstone fragments, consistent with weathered natural. The stone content of [003] increased down to the base of the trenches. A modern north-south drain [004] was revealed, cutting the base of the trench where the top of a plastic surface water drain was revealed (Figure 4, Section 2 Plate 2). The fill [005] of the drain trench was very similar brown sandy clay subsoil [002]. The modern drain bisected the site and was filled and levelled with pea grit and then redeposited subsoil.

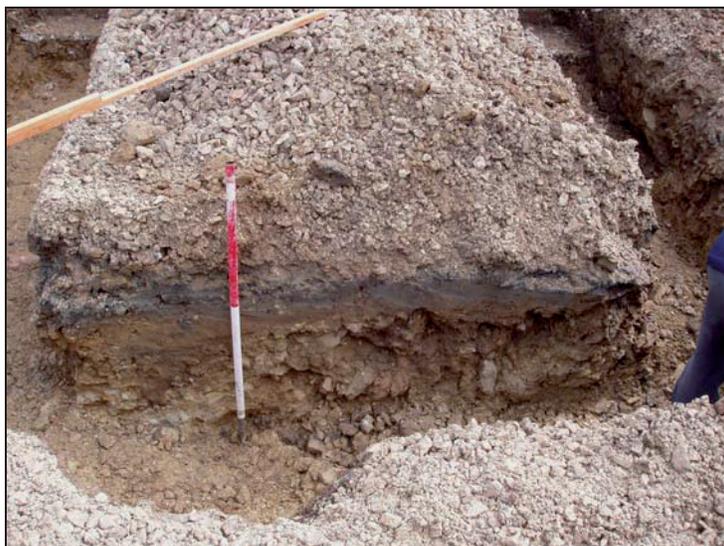
**Plate 1:** Post excavation view of the western 'Sun Room' Foundation Trench, looking north-east

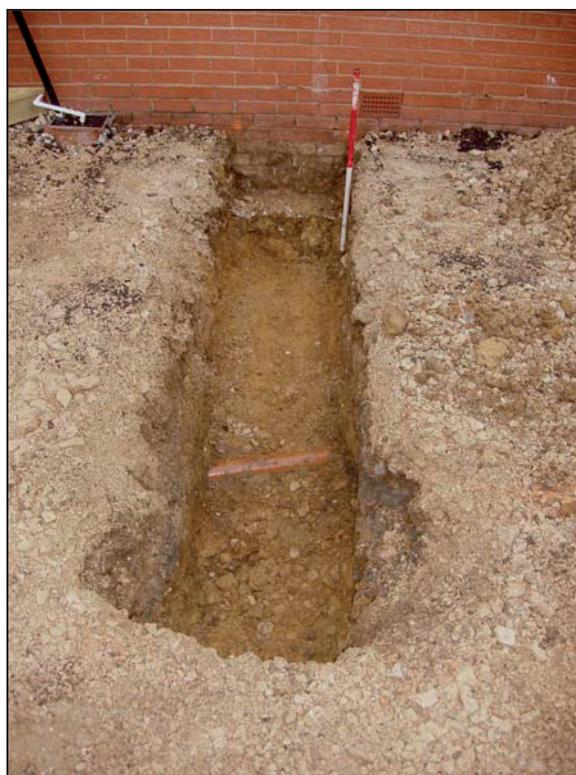
**Plate 2:** Post excavation view of the northern 'Sun Room' Foundation Trench, looking north-east

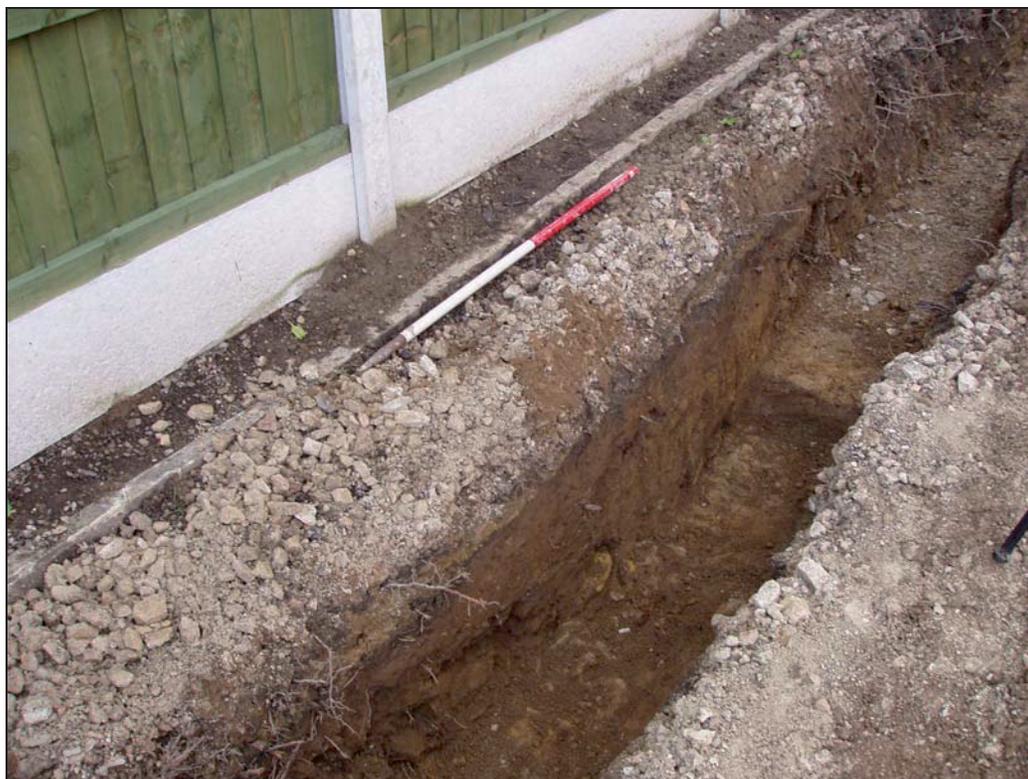
- 6.3 The 'Garage' trenches to the side of the existing dwelling (8m x 0.7m x 0.4-5m deep) revealed the sites natural slope marked by a buried soil which remained in situ to the eastern half of the principal trench. Along the southern trench, a 'V-shaped ditch [006] was revealed in section, aligned south-west to north-east, parallel with Manygates Lane (Figure 5, Section 3: Plates 3-4).

- 6.4 The ditch [006] measured 2m in width and was 0.6m deep. The primary fill [009], was excavated but no dating evidence recovered. The primary fill [009] was consistent with a rapidly deposited context, consistent with cutting of a field or boundary ditch in an arable landscape. Rapid deposition from colluvial (hillwash) erosion took place half filling the new ditch. The secondary fills [007 & 008] accumulated more slowly. Fill [007] was probably associated with an episode of erosion and deposition from the north-west. There was no evidence for any recuts of the ditch, but a whole-scale recut or ditch enlargement could not be ruled out.

**Plate 3:** Oblique view of Ditch [006] in the north facing section of the southern 'Garage' foundation trench, looking south-west

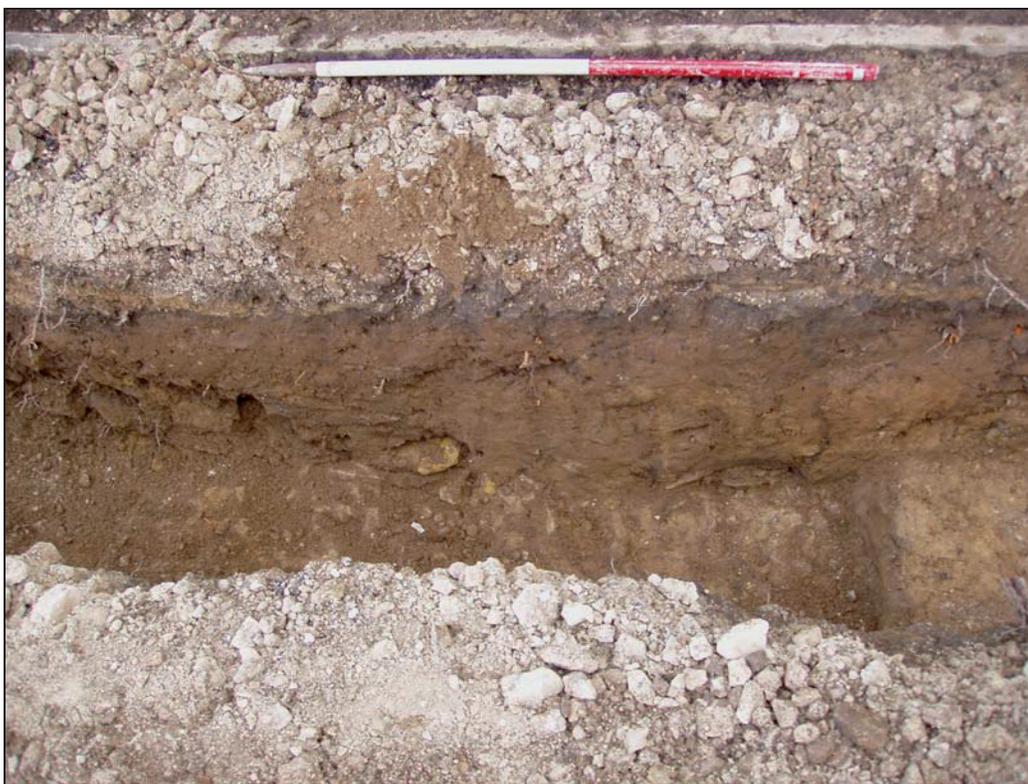
**Plate 4:** Detail view of Ditch [006], looking south south-east
