**THE FORMER LOSCOE AND HEANOR
CHURCH OF ENGLAND SCHOOL, LOSCOE
DENBY ROAD, LOSCOE, DERBYSHIRE:**

**AN ARCHAEOLOGICAL BUILDING
RECORD**

**CS Archaeology
July 2009**

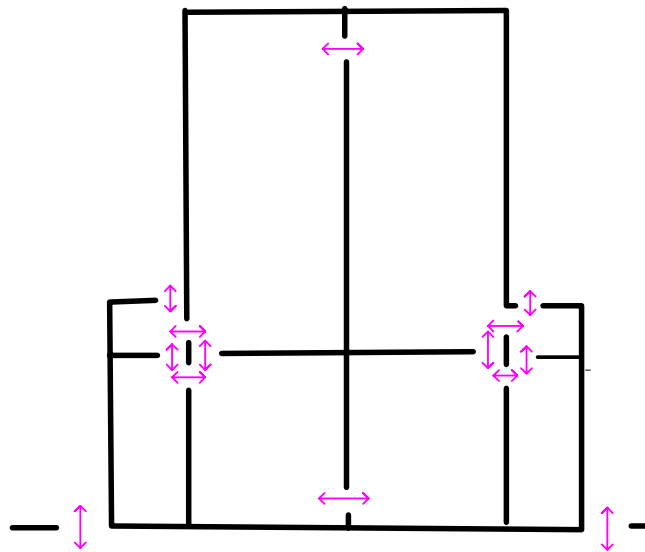
Plan of the School with Original Access Flows

7.4.1 The former Loscoe and Heanor Church School has provided considerable insights into school construction at the end of the 19th century. The original design featured large easily accessible classroom. These were well illuminated via natural light by large multi-light windows, twin windows to the gables wall and single to the side walls. Each class room was heated by open coal fires. The two larger classrooms featured two fireplaces. The original design was symmetrical along a North-South axis.

External and internal access was also symmetrical and consisted of external gates to the playground, from where access into the building was served by the two principal doorways. Each of these doorways, led into *Entrance Lobbies* and further doorways accessed the *Infants Classrooms*, *Main Classrooms* and *Cloakrooms*. Many of the original internal 4 paneled doors survive in situ.

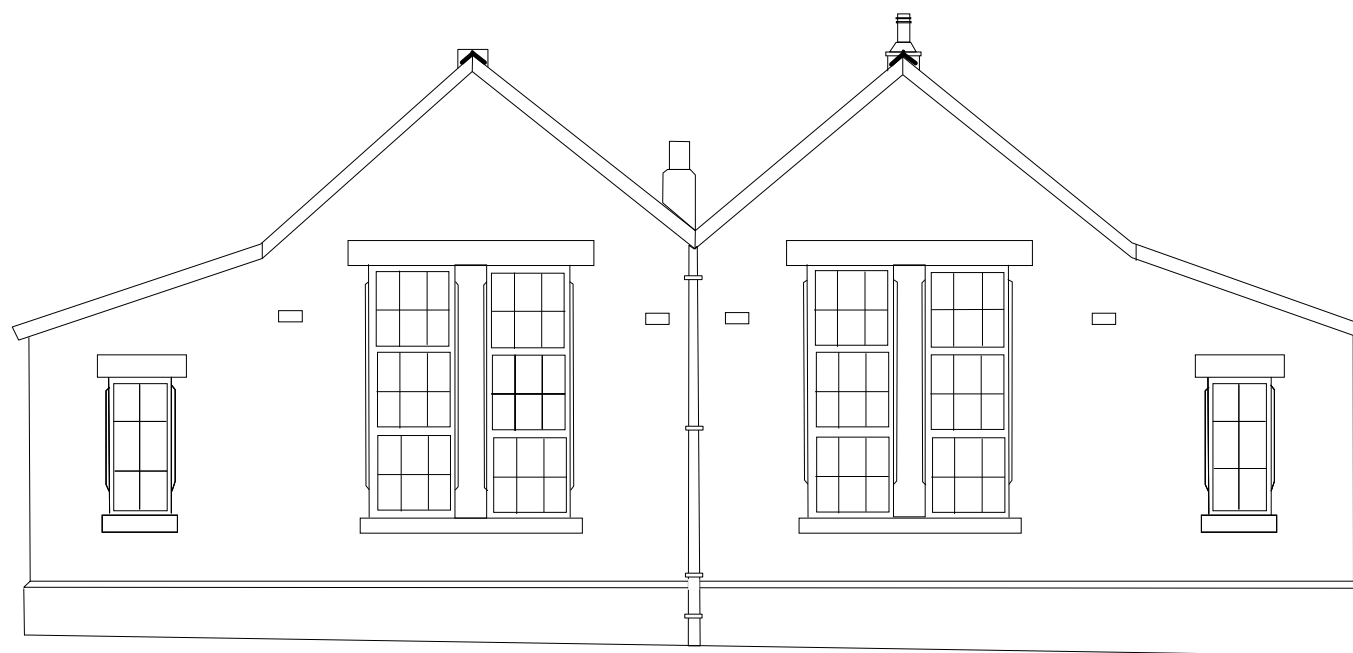
Figure 7: The South
Elevation

7.2.2 *External - South Facing Elevation* ([Figure 7: \[Plates 4-5, 3-4\]\(#\)](#)) forms the front façade and is 17.63m long and to the apex of the roof measures c. 7m. It was built as the school's front elevation and abutts the pavement along the north side of

Loscoe Denby Lane. The elevation has double pitched roofs with a central lead lined valley and pitch roofed side aisles. The design is symmetrical, particularly noticeable in the fenestration, with small and large windows, which have been replaced with uPVC multi-light windows (6 and 36 lights). The whole elevation used finely ground red facing bricks in an alternating stretcher/header bond. The side and rear elevations use this brick bond to the main building, the side aisles use the English Garden bond of 5 stretchers to one row of headers. Moulded bricks with a stop chamfered design were employed to the window jambs, which feature stone sills and lintels. Towards the base of the wall is a plinth which is accentuated by a chamfered course of 'blue' bricks, and forms a continual feature right around the building. The smooth welsh slate roof has been finished with decorative 'blue' ridge pieces. The chimneys have probably been heightened in modern red (engineering) bricks. The original bricks towards the base are the cheaper brick that weathers to a brown colour used on all the unobvious walls (side and rear elevations). Fittings to the elevation include a central cast iron down-comer (6" diameter) from the central roof valley and four cast iron air ventilators.

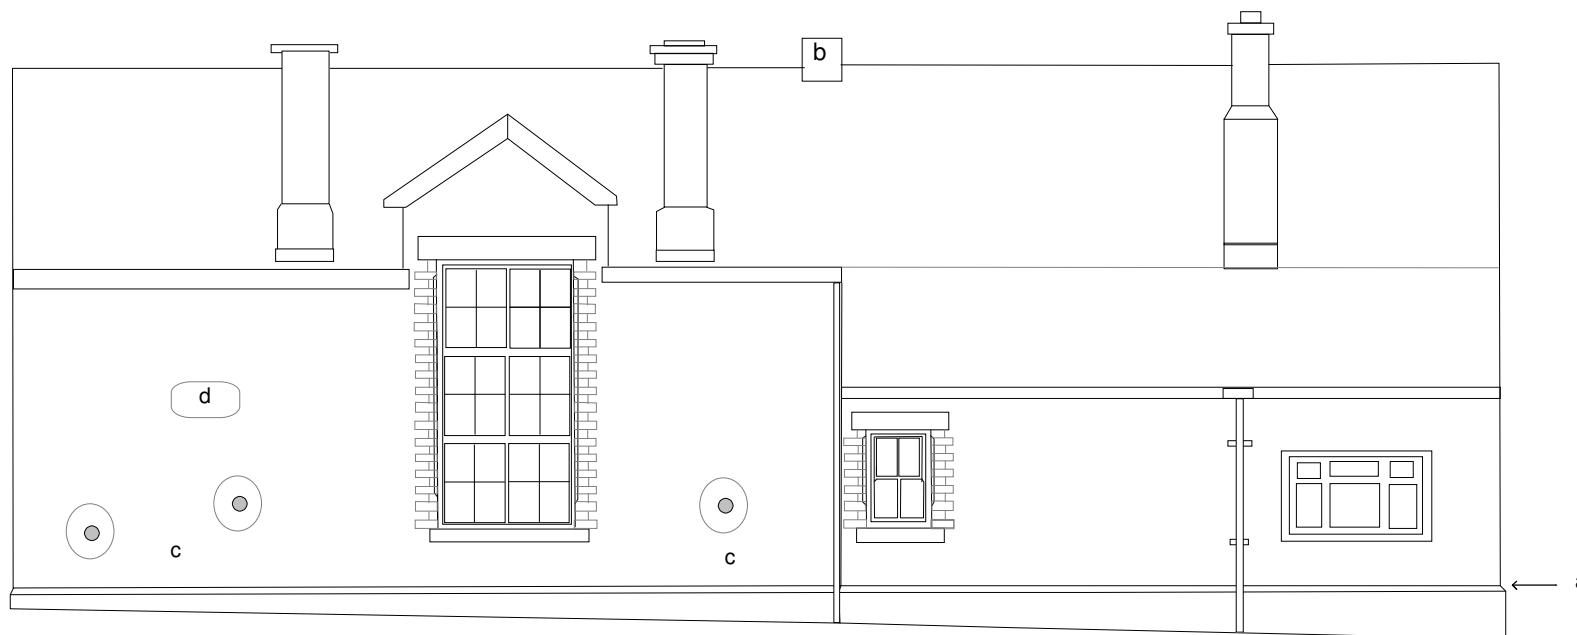
Figure 8: The West
Elevation

- 7.2.3 *External - West Facing Elevation* (Figure 8) is 19.6m long and c. 7m high and features two original windows, and one doorway. The side aisle extends only across half the elevation (Plate 6, 7). It features moulded and chamfered fine red facing bricks (noted throughout the south elevation) which act as decorative 'keystones' to the door and windows when used in tandem with cheaper less finely ground bricks. The elevation features two types of brick work. As noted above, the main building used alternate header/stretcher courses, and the aisles employed an English Garden Bond (5 stretchers). Both techniques used a cheaper brick which has weathered to a brownish red colour. The large window is set within the main building. There is a smaller, 4-light window to the northern end of the aisled extension. This 4-light window (Plate 8, 17) retains its vertical sliding sash and stone sill, lintel and red 'keystone' brickwork and is the only example of the building's original fenestration. To the southern end of the elevation is a modern inserted uPVC window. The roof has three chimneys, and these have been rebuilt/heightened in recent years, as evidenced by the modern 'engineering' type brickwork. All three chimney stacks are aligned with the north-south axis of the building. Replacement guttering to the eaves features half rounded gutters and round downcomer.

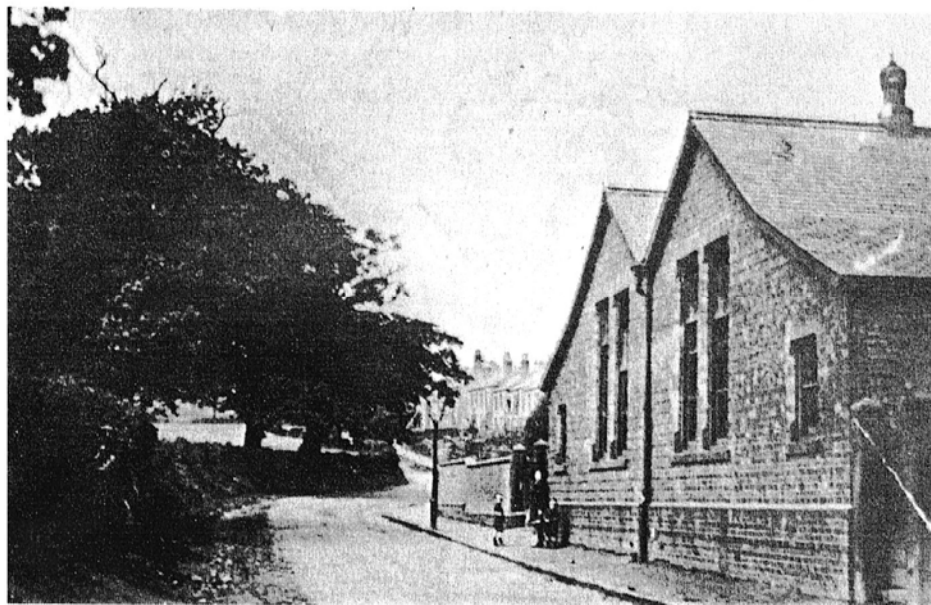
7.1.3 The school was a single building containing all the educational functions under one roof. By 1916 ([Figure 3](#)) a probable toilet block had been constructed (Building B), together with a dividing wall that formed two playgrounds. This division probably separated the infants and seniors. Loscoe Church school provided education for girls and boys up to 7 years old and for girls over 7 (Mellor 1997, 29). After 1916 the layout of the school remained unchanged ([Plate 1](#)) until at least the 1950s.

Plate 1, view past the school's south facing elevation, before construction of the Loscoe Council Estate, from the east

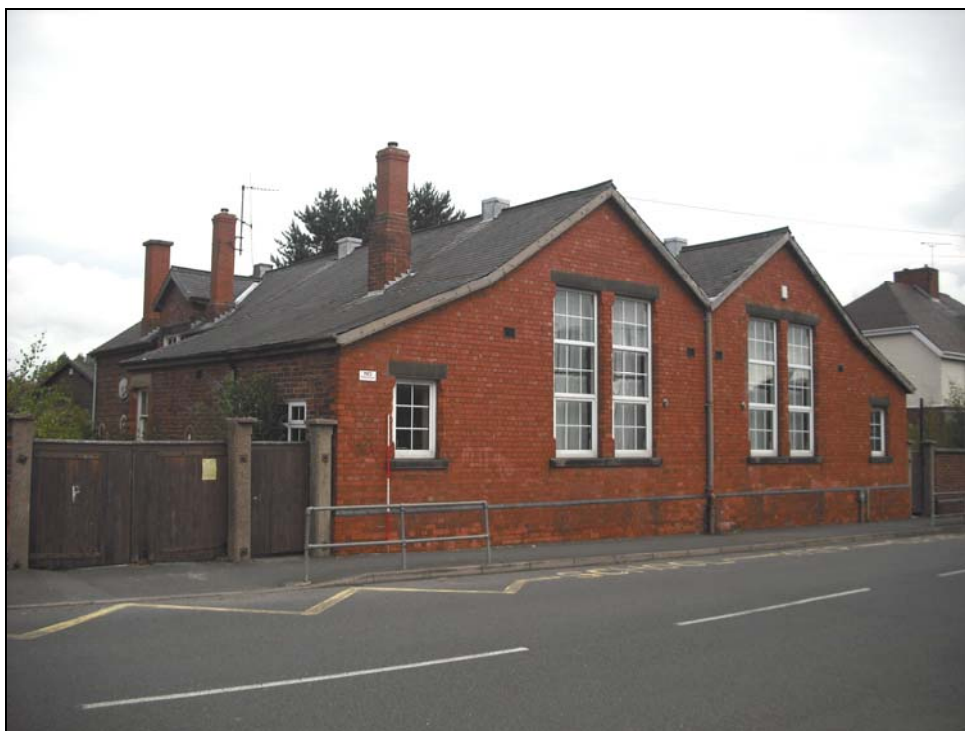
Plate 3, 2: the front south facing facade, from the southwest

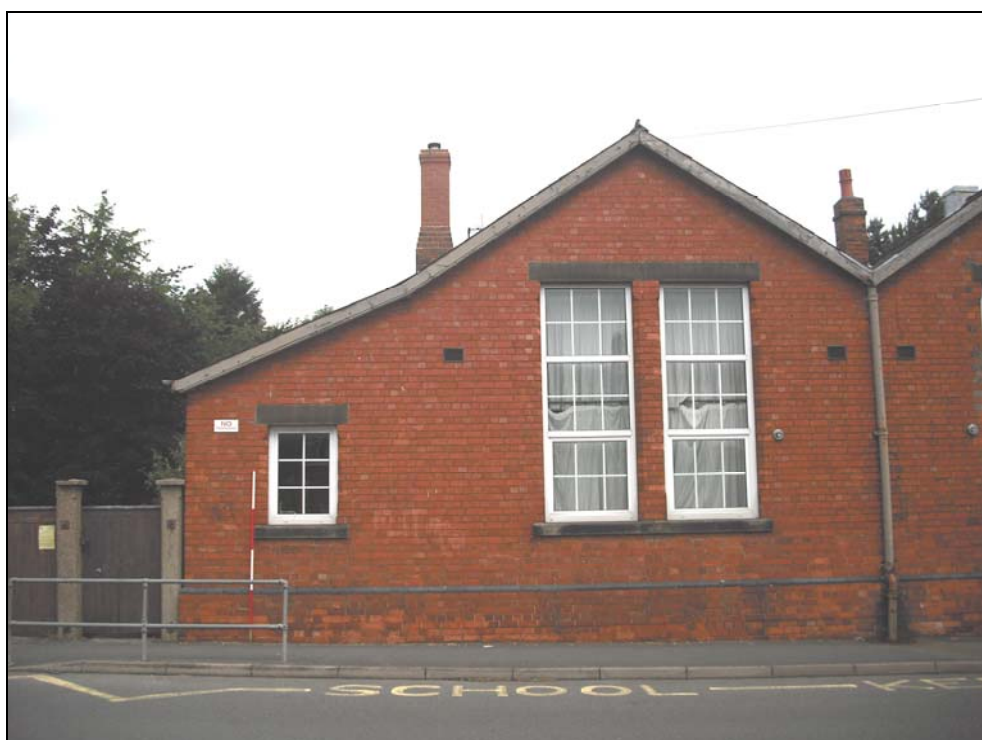
Plate 4, 3, detail of the front elevation (west), from the south

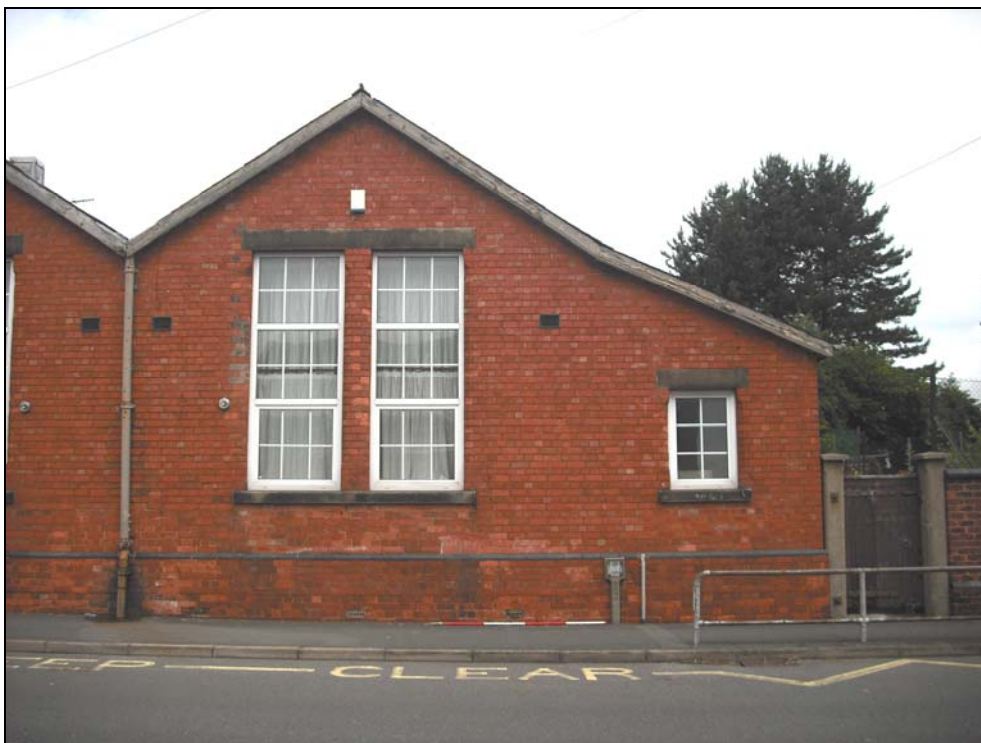
Plate 5, 4: detail of the front elevation (east), from the south

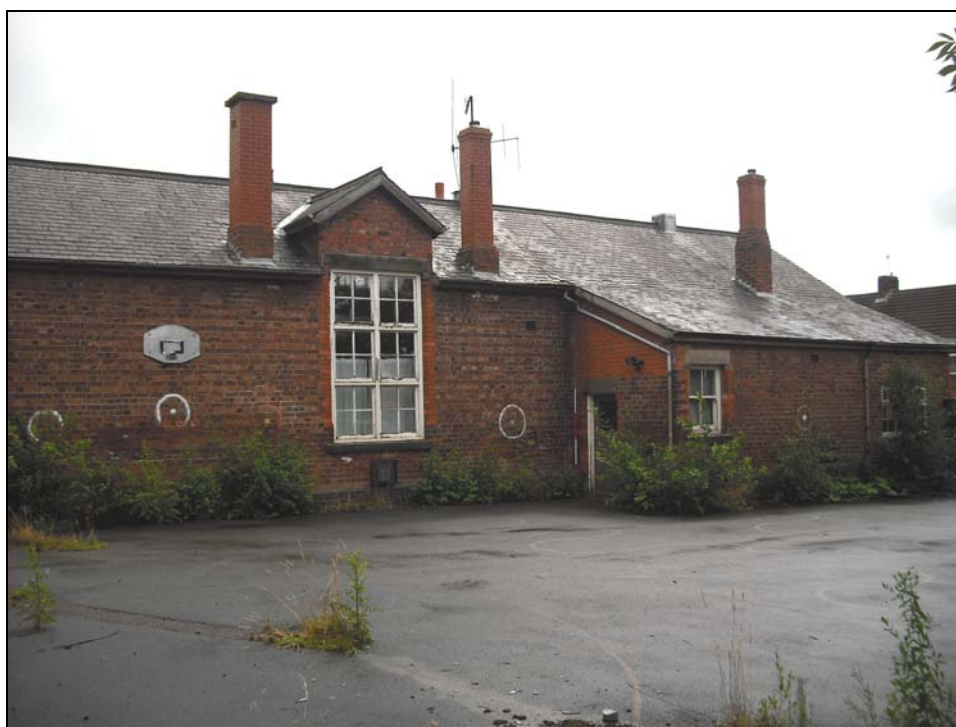
Plate 6, 7: the west facing elevation, from the northwest

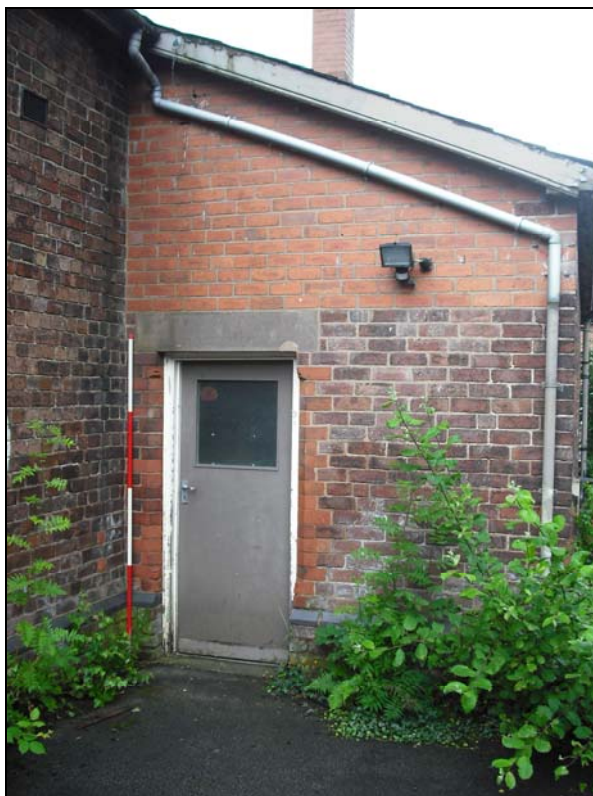
One of the original principal doorways (Plate 9, 19) is set within the north gable wall of the west aisle. It features stop chamfered 'keystone' brickwork to the external jambs, an ashlar sandstone lintel and thresh. The original door has been replaced with a single light fire door with re-enforced glass. Above the doorway and seemingly at odds with the design, fine facing bricks were employed in a triangle to the roof.

Plate 9, 19: the original doorway (replacement door) to the *Entrance Lobby* to the west aisle, from the north northwest

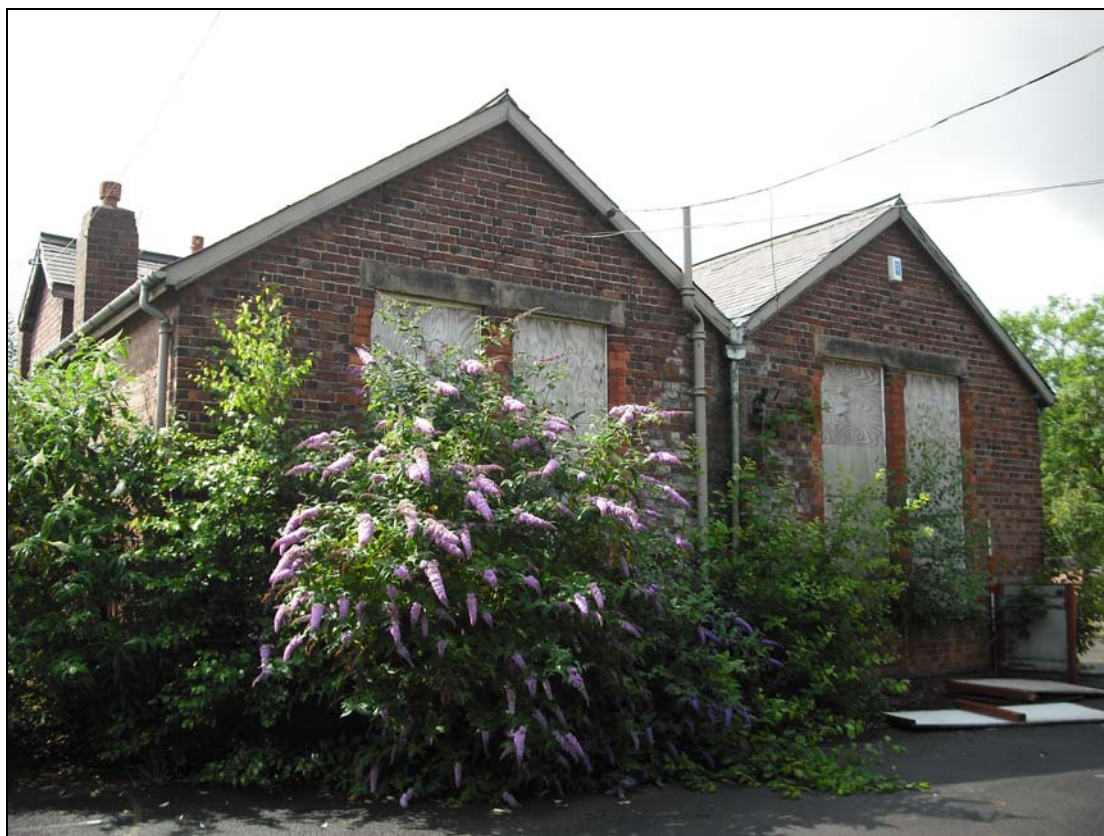
- 7.2.4 *External – North Facing Elevation* (Plate 10, 9) is 12m long and is similar to the front elevation, with its twin pitched roof and reflective fenestration. The fenestration consists of two large windows which have been boarded up and partially obscured by vegetation. The wall features the chamfered plinth and the alternate bonding courses.

Plate 10, 9: the north elevation, from the north northeast

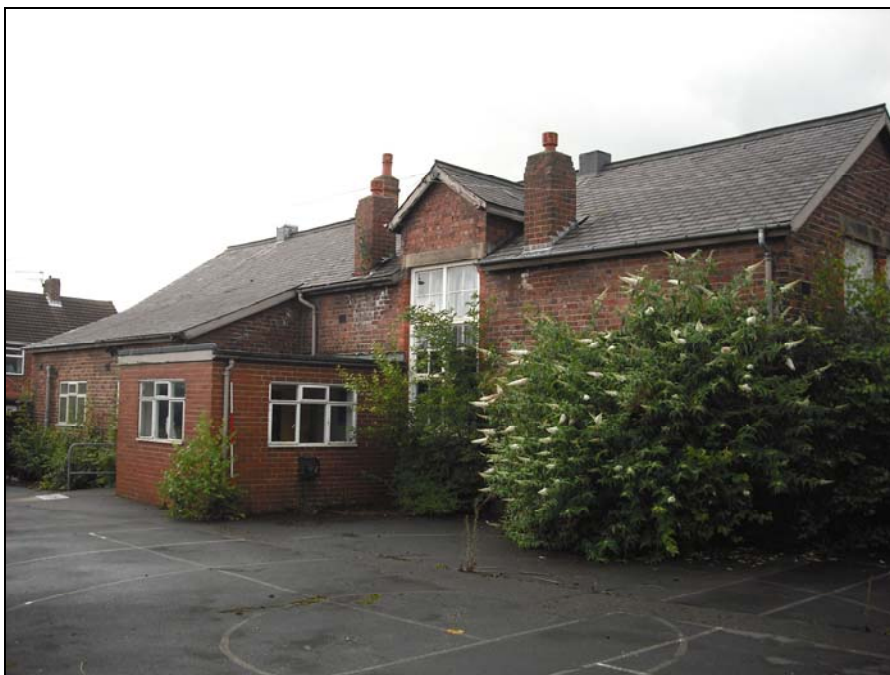
- 7.2.5 *External – East Facing Elevation* (Plate 11, 10) has been modified by the addition of a single storey modern extension which obscures the original doorway. The large window remains but a uPVC casement has been installed (Plate 12, 11). Because of the modern extension the principal doorway was repositioned and inserted into the aisle's east wall (from the north wall). Two modern casement windows have been inserted into the east wall of the east aisle (Plate 13, 13), providing natural light to the modern internal toilets.

Plate 11, 10: the east elevation, from the north

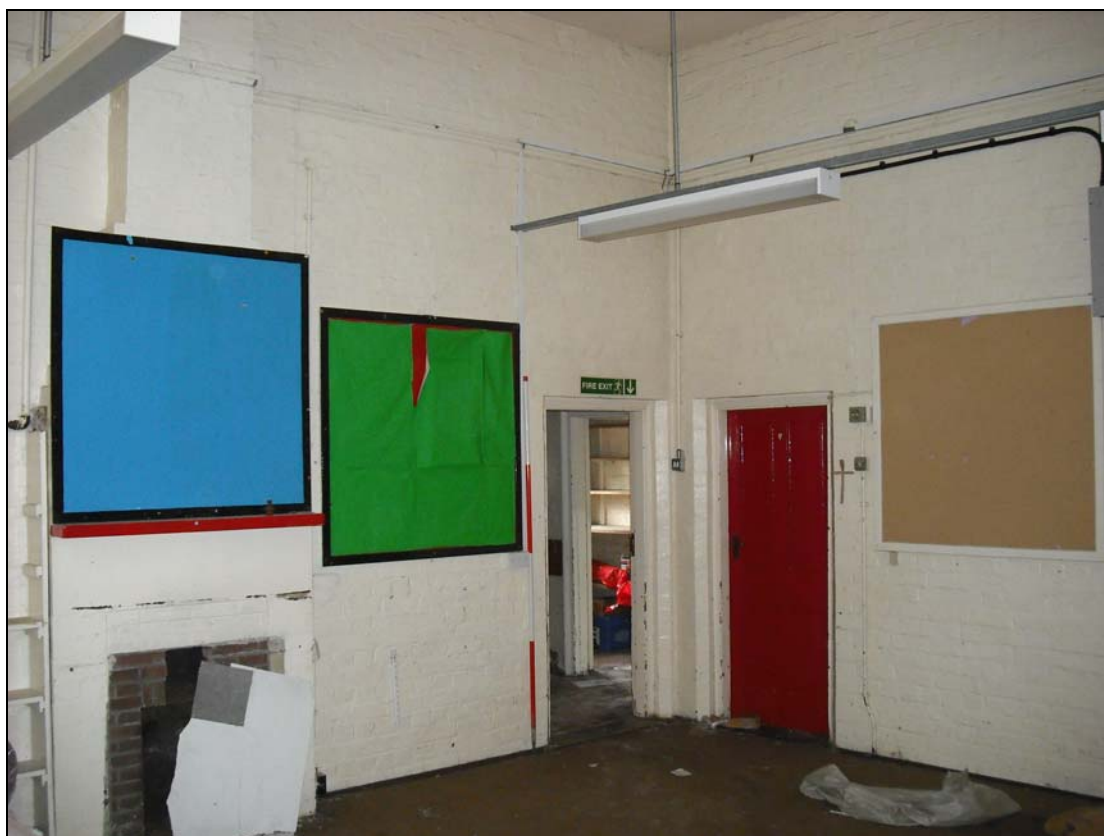
Cloakroom, the second into one of the main classrooms (Room 6a: [Plate 17, 24](#)) and the third accesses the second *Infants' Classroom* (Room 5: [Plate 18, 23](#)). The doors have recessed moulded rear panels and flush front panels ([Plate 19, 26](#)).

Plate 17, 24: room 4 the *Infants Classroom* (west), from the southeast

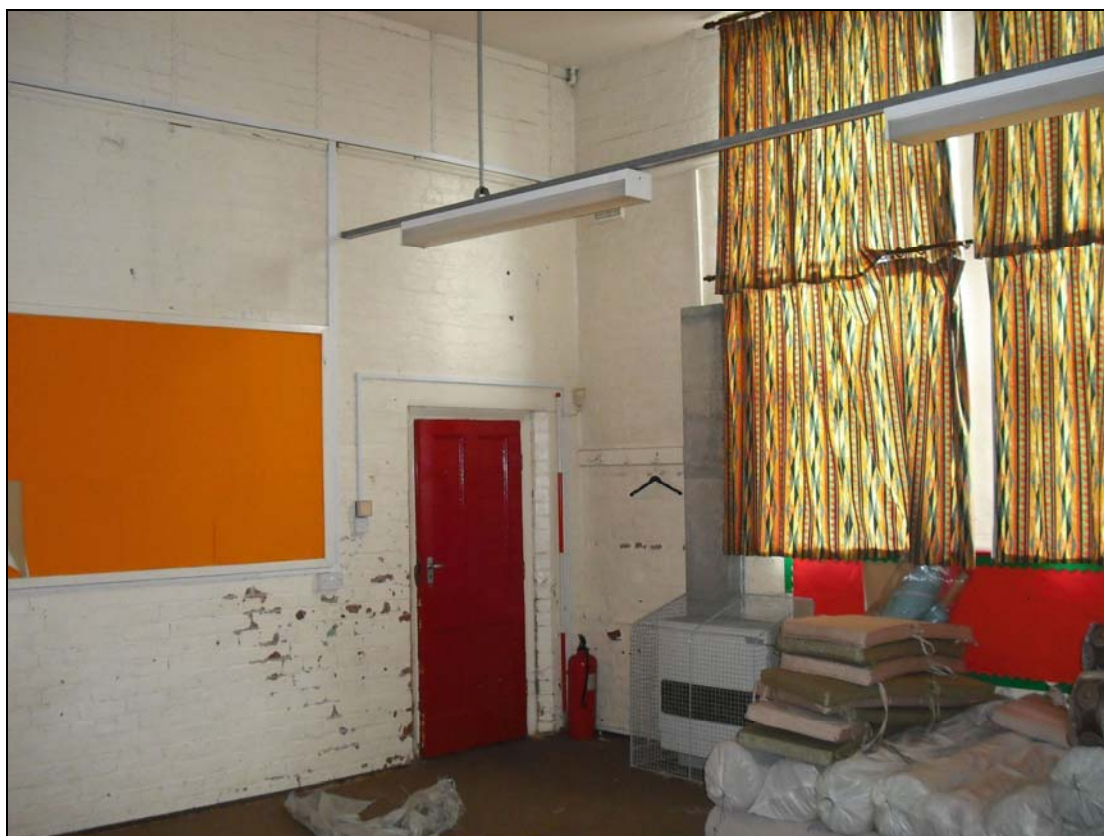
Plate 18, 23: room 4, the *Infants Classroom* (west), from the northwest

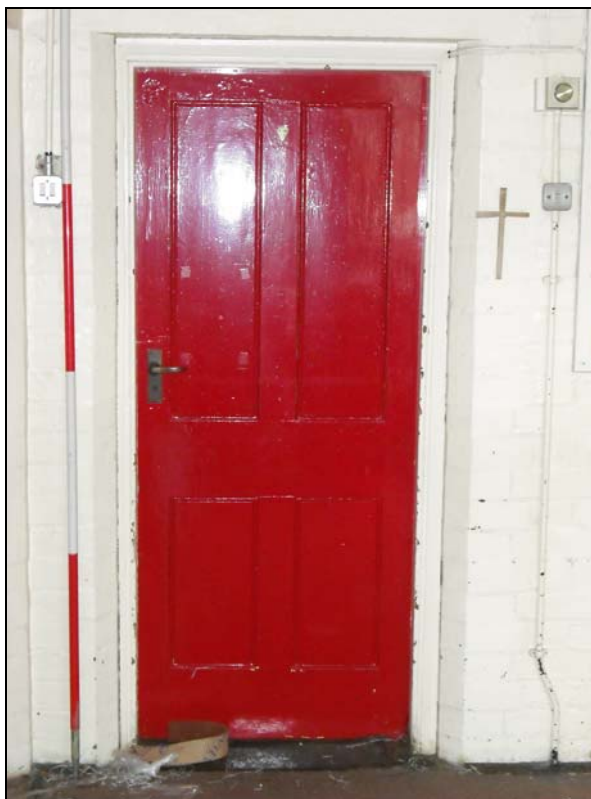
Plate 19, 26: Room 4 detail of the standard 4 panelled door with chamfered jambs,
from the south

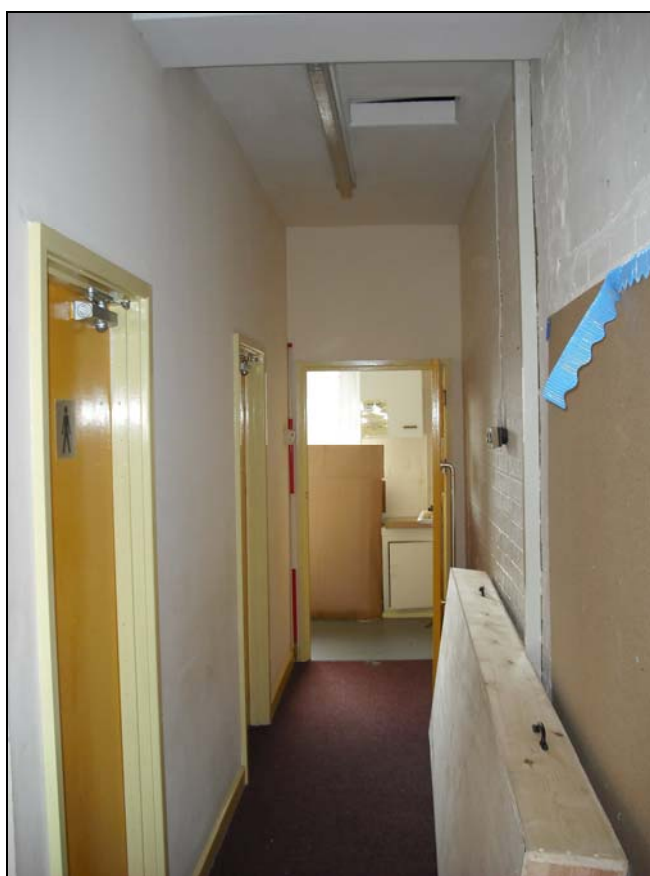
- 7.3.7 *Room 8*, originally formed an *Entrance Lobby and Cloakroom* but has been modified to provide a corridor and inside toilets (male, female and disabled, Rooms 9, 10 & 11 respectively: [Plate 26, 50](#)).

Plate 26, 50: room 8, view along the annexed corridor of the former *Cloakroom (east)*, from the north

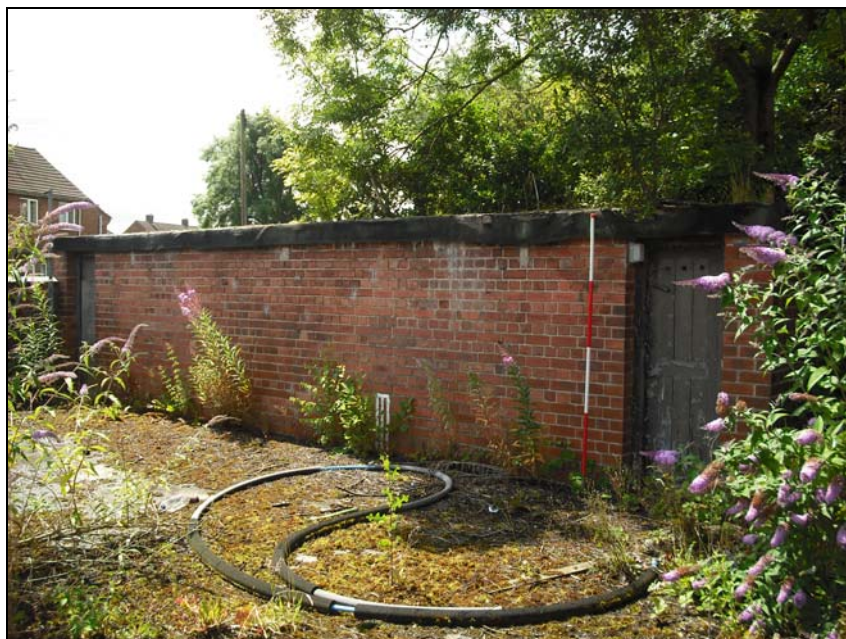
7.6.1 Following the demolition of Building B a 'new' toilet block was constructed along the western edge of the playground ([Plate 27, 35](#)). It is still extant and was constructed from brick with a concrete roof and featured plank and battened doors with a series of air holes to the top.

Plate 27, 35: the 'new' toilet block (Building C), from the northeast

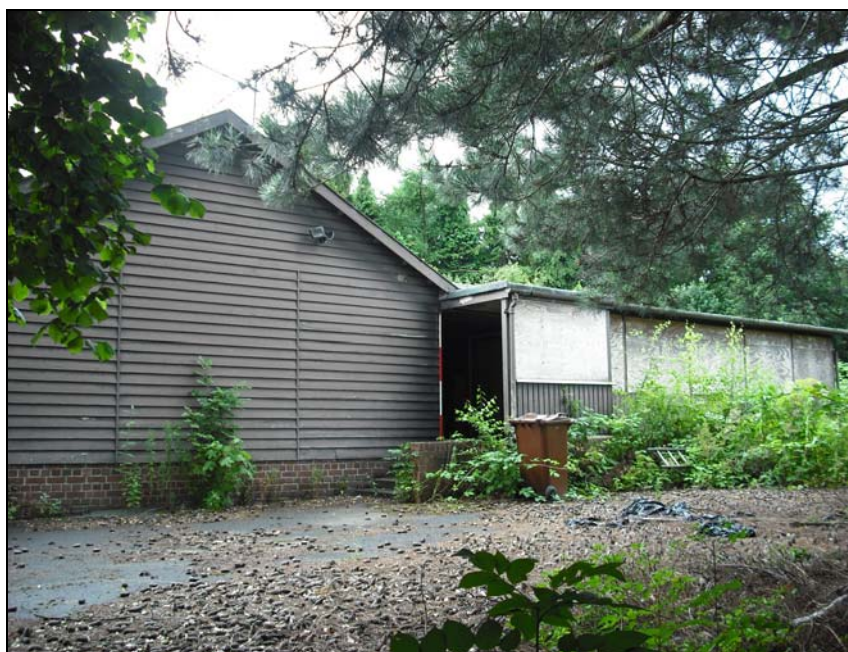
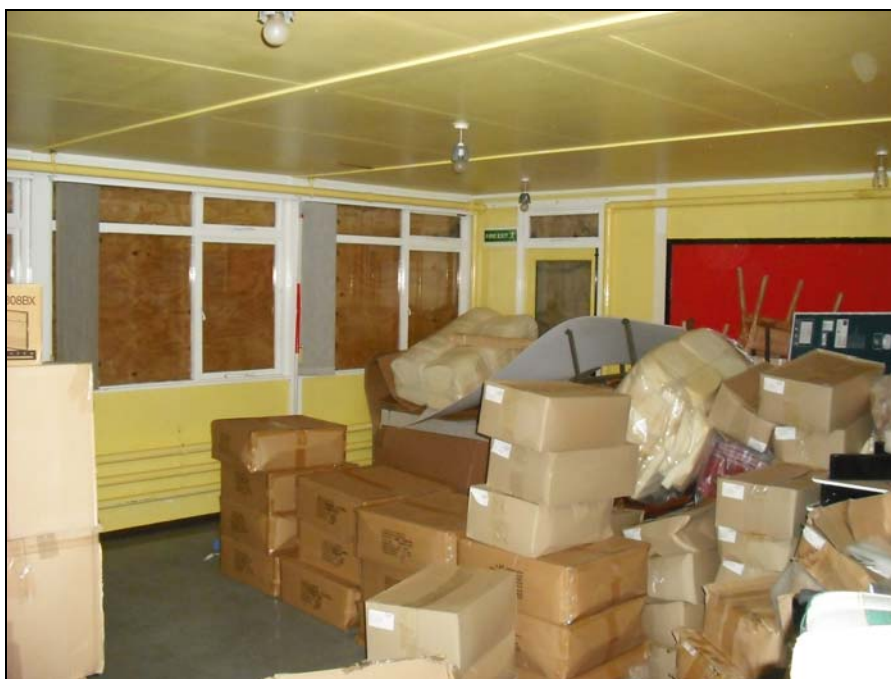
These formed two classrooms in an 'L' shaped plan, with associated cloakrooms/entrance lobbies. A feature of these classrooms were low under-drawn ceilings and continual windows to the long side walls ([Plates 28-9, 58 & 61](#)).

Plate 28, 58: the late 20th century classrooms (Building D), from the southeast

Plate 29, 61: internal view of the late 20th century classrooms (Building D), from the southeast
