**Welby Grange Farm,
Welby Road, Welby, LE14 3JP**

LEVEL 2 HISTORIC BUILDINGS SURVEY

Trigpoint Conservation & Planning Ltd.

Report Date: August 2010

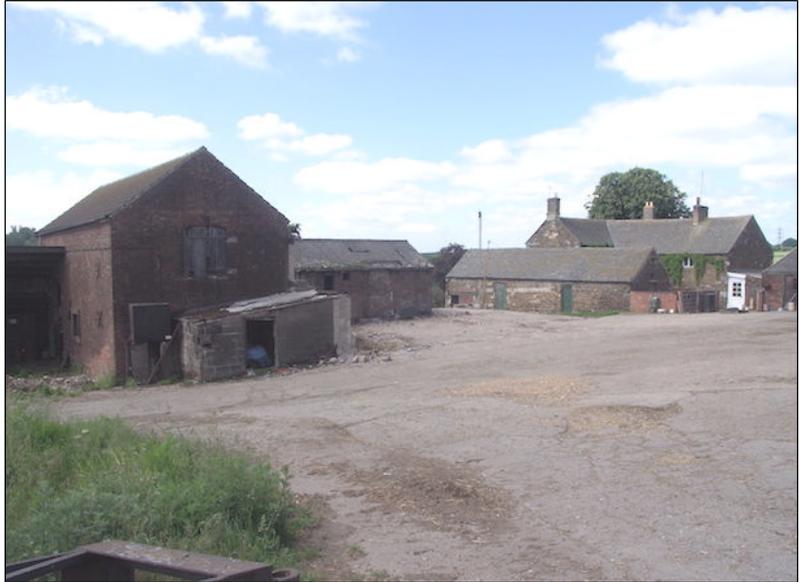
Plate 2: View looking south-west towards the front elevation of the threshing barn showing the surviving timber loft access doors in the north facing gable

5.3 Along the eastern side of the farmyard is an irregular, three bay, double height threshing barn, rectangular in plan [Plates 1, 2 & 5]. The off-centre double height opening on the east-facing elevation [Plate 3] leads to the main threshing floor although the original timber doors have been lost. To the south (left) side of the main threshing floor is a narrow single storage bay and a deeper storage bay lies on its north (right) side. A smaller single height door opposite to the main threshing doors leads out of the building into a narrow passageway through the adjoining building (see para.5.8 below) [Plate 4].

5.5 The barn is constructed of brick, laid in a Flemish Garden Wall bond (three stretchers between each pair of headers) with a brick dentil course at the eaves and modern concrete tiles over the roof [Plate 2]. To cope with the fall in ground levels the lower (southern) end of the barn has been built on an ironstone plinth to achieve a level floor [Plate 5].

5.6 There is very little surviving architectural detailing, the double height opening has lost its original timber doors [Plate 3] and the smaller opening on the rear elevation has now been infilled with breeze blocks [Plate 5]. The north facing elevation does however retain a pair of timber loft access doors and there are also some surviving ventilation slits, principally on the front elevation and south facing gable [Plates 2 & 5].

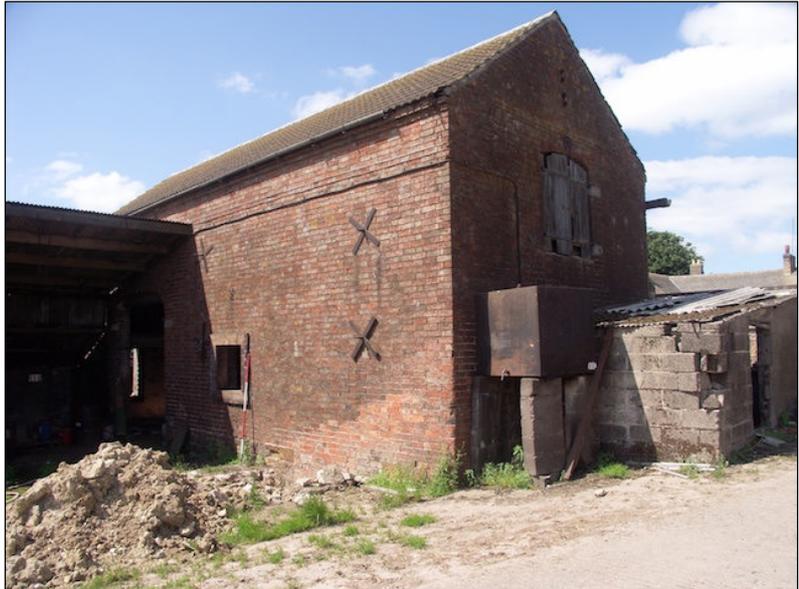
Plate 3: View looking towards the double height opening in the front elevation of the threshing barn showing the modern breeze block walls inside the barn

5.4 Internally the threshing barn is now used for grain storage and is divided and compartmentalised by a series of breeze block walls that hide any surviving architectural features [Plate 3].

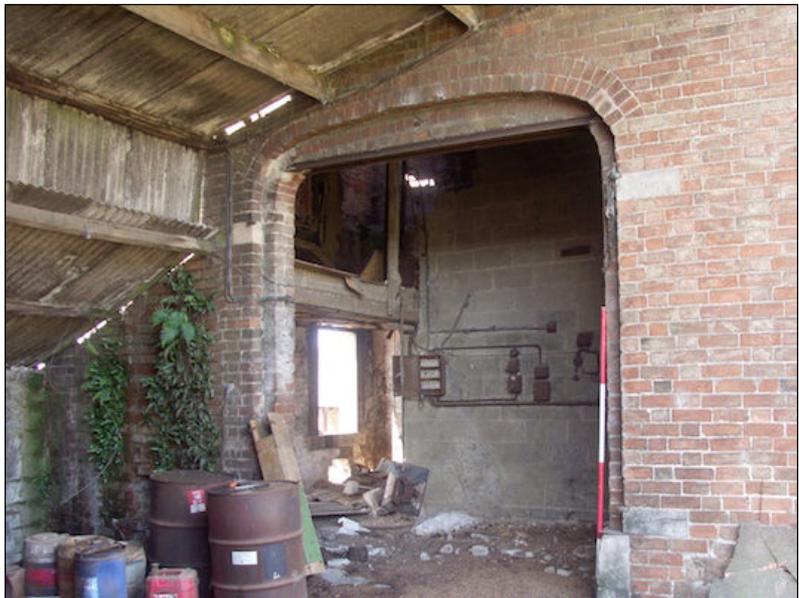
Plate 4: View looking along the passageway towards the rear elevation of the threshing barn showing the blocked single height door

elevation where the cart shed butts up to the barn [Plate 5]. The erection of this cart shed also obstructs the exit route for carts via the single height door at the rear of the barn which opens into the sloping passageway running through the cart shed [Plates 4 & 5].

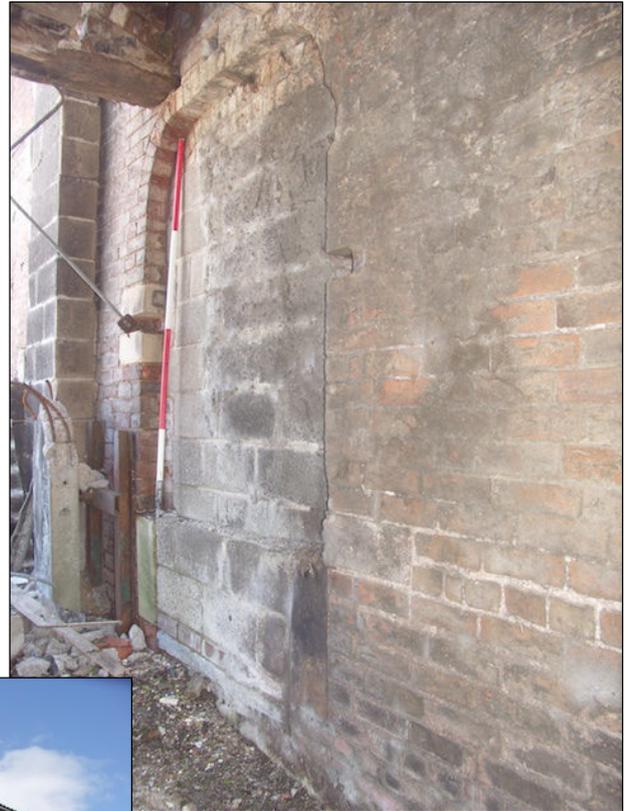
Plate 5: View looking north-west towards the gable end of the threshing barn and across the front elevation of the cart shed

5.9 It is likely that this cart shed was built after the barn, there is evidence of a horizontal joint in the brick work most noticeably on the rear (south facing)

5.10 The (western) end bay of the cart shed has been cut away and, with the construction of a rudimentary lean-to roof, appears to have been used as a cattle shelter [Plates 5 & 6]. This section of the building is open to the roof and it reveals a stone retaining wall against the higher ground on the north side of the building and a timber king-post roof truss supporting large timber purlins [Plate 6].

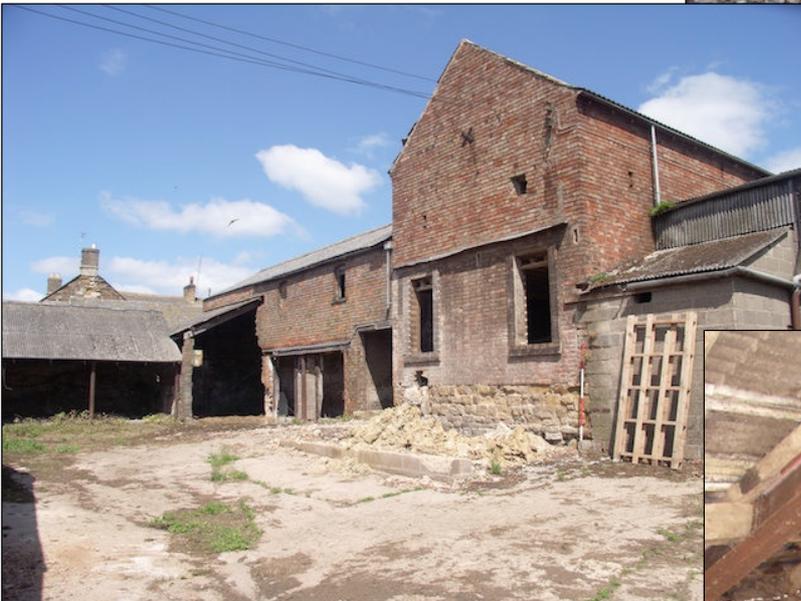
Plate 6: Internal view of the open bay at the western end of the cart shed showing the stone retaining wall at the rear of the cart shed and the king-post roof truss

5.11 This building is constructed of red brick, laid in a Flemish Garden Wall bond, with a corrugated asbestos sheet roof [Plates 6 & 8].

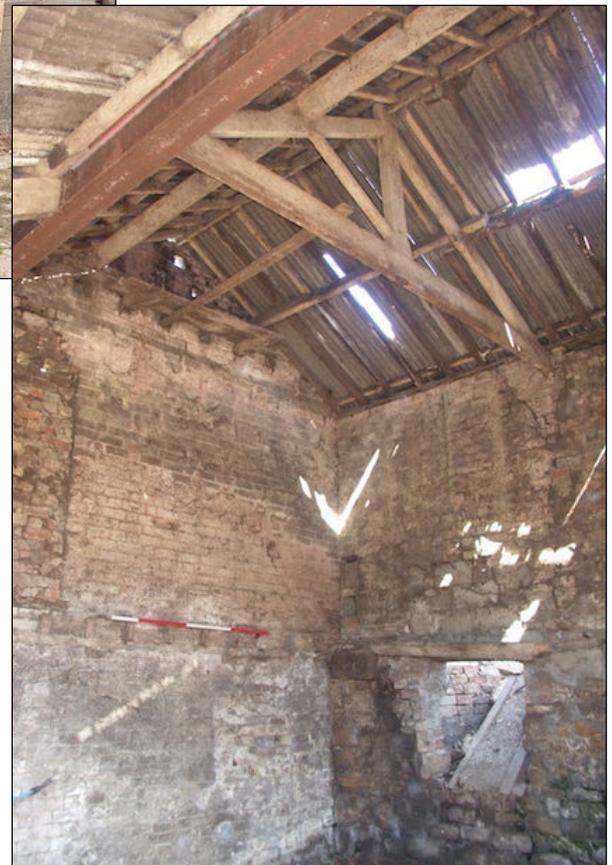
Plate 7: View looking north towards the front elevation of the cart shed openings with the central cast iron column and the passageway to the right

5.12 The principal surviving architectural details are the wide, paired openings in the front (south facing) elevation that are framed by heavy timber piers with a central cast iron column supporting the timber lintel [Plate 7].

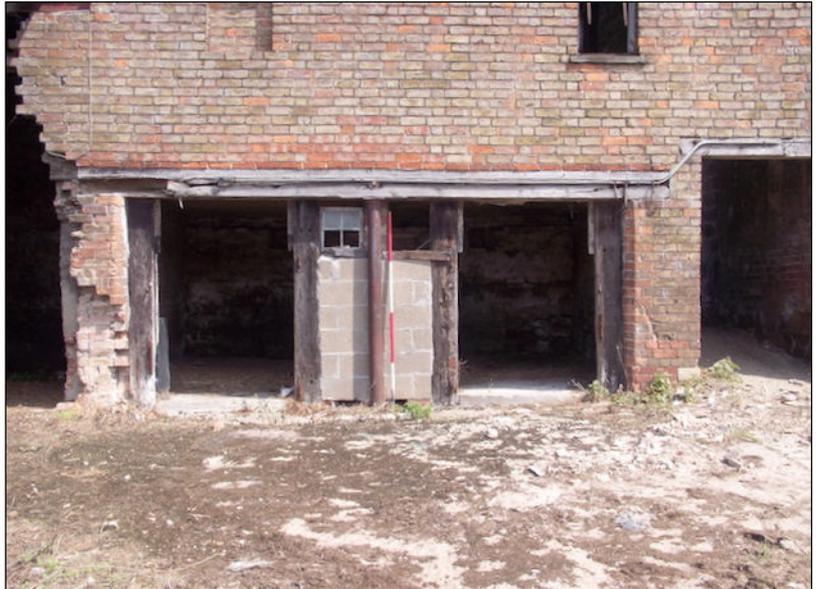
Plate 8: View of the west facing gable of the upper floor of the cart shed showing the dovecote in the apex of the gable with the lower roof line of the single storey cattle sheds in the background

5.13 Other details of note include the remains of a dovecote built into the apex of the west facing gable that comprises of a series of nesting holes with projecting brick ledges [Plate 8] and two pieces of upright stone, about 1 metre high tucked into the bottom right corner of the north facing elevation [Plate 9]. The face of the stones is in very poor condition but there would appear to be a carved horizontal line in the lower stone that may indicate a benchmark.

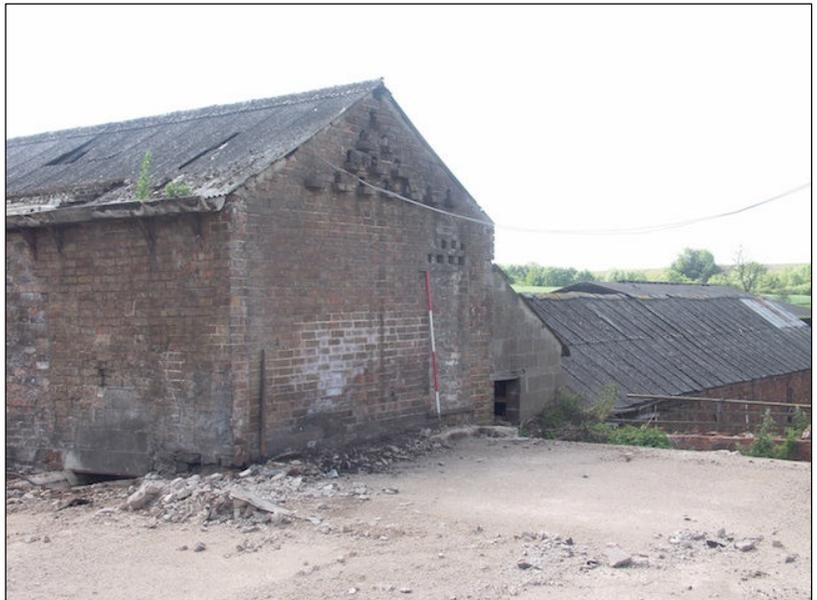
Plate 9: View of the vertical stones within the bottom corner of the north facing elevation of the cart shed

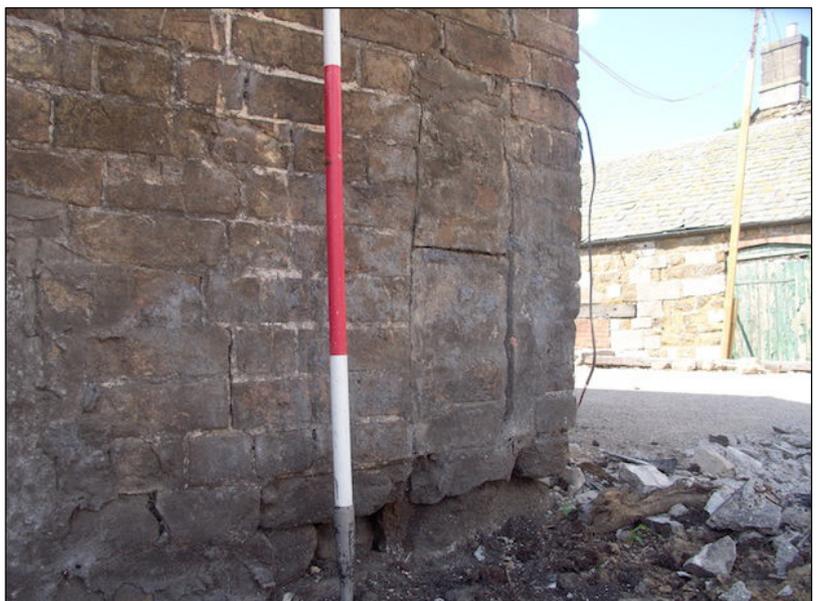
Plate 10: View looking south-west towards the front elevation of the single storey cattle sheds

5.15 Internally the cattle sheds are divided by a cross wall into the two separate units each accessed by doors off the front (east facing) elevation [Plates 14 & 10]. The middle bays have the remains of a brick floor and some evidence for a central recessed drainage channel [Plate 14].

5.16 The building is constructed of red brick, laid in a Flemish Garden Wall bond, with a corrugated asbestos sheet roof [Plate 10].

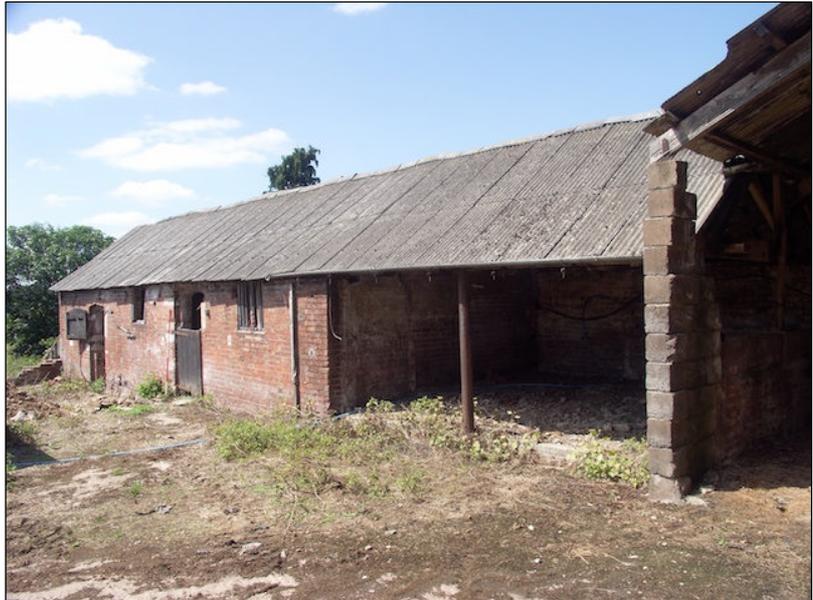
Plate 11: View looking north-east towards the rear elevation of the single storey cattle sheds with the south facing gable of gable of the listed outbuilding in the foreground

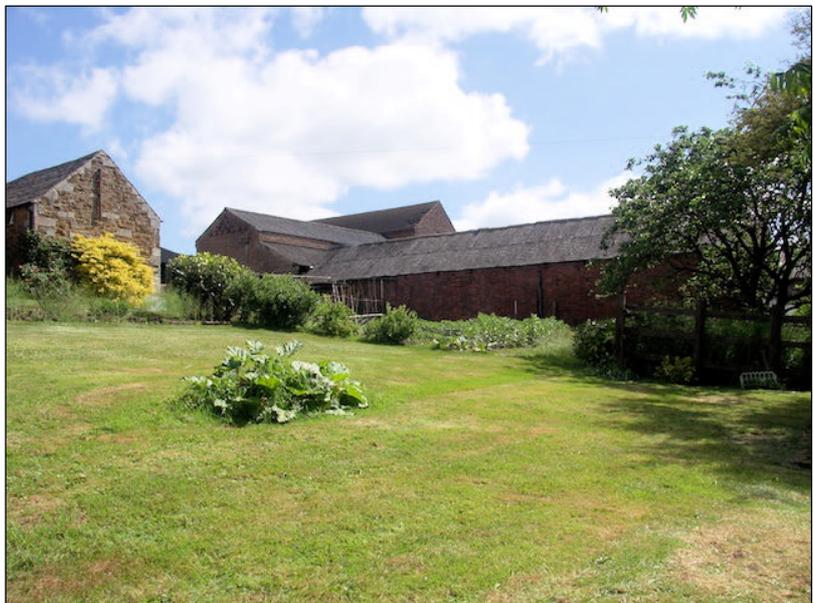
Plate 12: View looking north towards the gable of the cattle sheds with the south facing gable of the listed outbuilding to the right background and the threshing barn and cart shed to the left background

5.14 Extending at right angles, in a north-south alignment, from the front (south facing) elevation of the cart shed is a single storey building that provides a combination of open and enclosed cattle sheds. The building has two open bays at the upper end for keeping loose cattle with enclosed cow sheds towards the lower end of the building [Plate 10]. The open bays are divided by a cast iron column that supports the wall plate under the eaves [Plate 10]. The rear elevation is a blank brick wall with a series of ventilation holes tucked under the eaves [Plate 11] while on the south facing gable there is a pitching door about half-way up the wall and close to the apex of the gable is a date stone of either 1843 or 1845 [Plates 12 & 13].

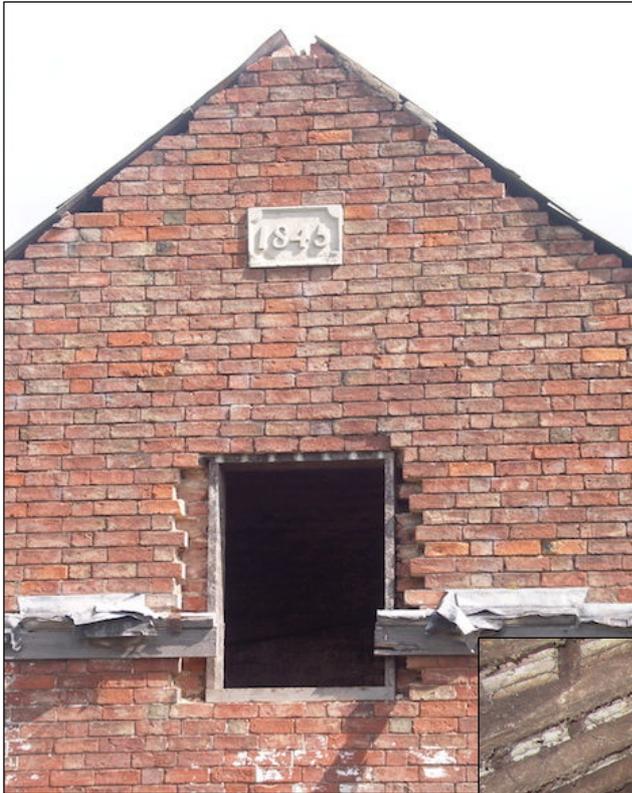
Plate 13: View of the date stone in the apex of the south facing gable

5.2 The buildings are built in the local agricultural tradition and style, having no known architects or builders. However the end wall of the stock shed has a damaged date stone dating the building to either 1843 or 1845 [Plate 13].

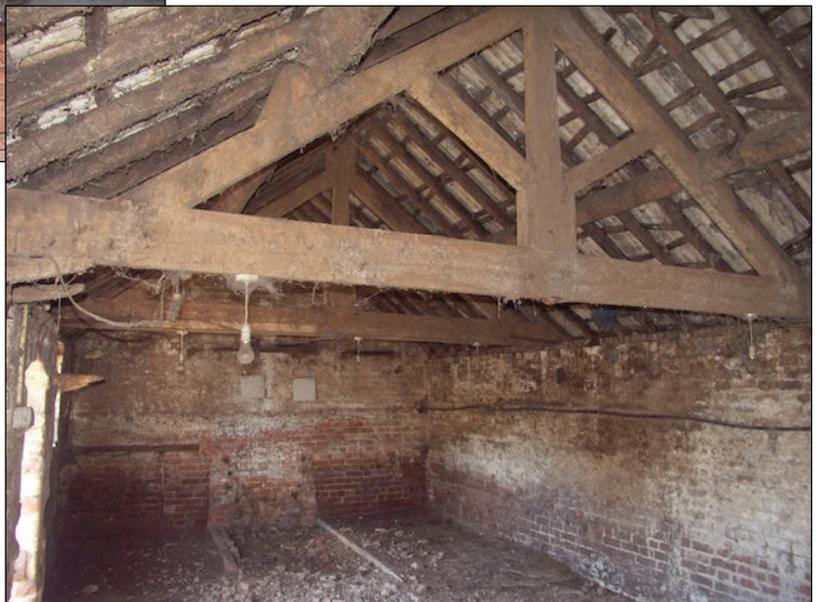
Plate 14: Internal view of the cattle shed showing the king-post roof truss and the remains of the central drainage channel

5.17 The principal surviving architectural details include a timber 'hit and miss' ventilation screen [Plate 15] and a series of timber king-post roof trusses that support large timber purlins within the surviving roof structure [Plate 14].

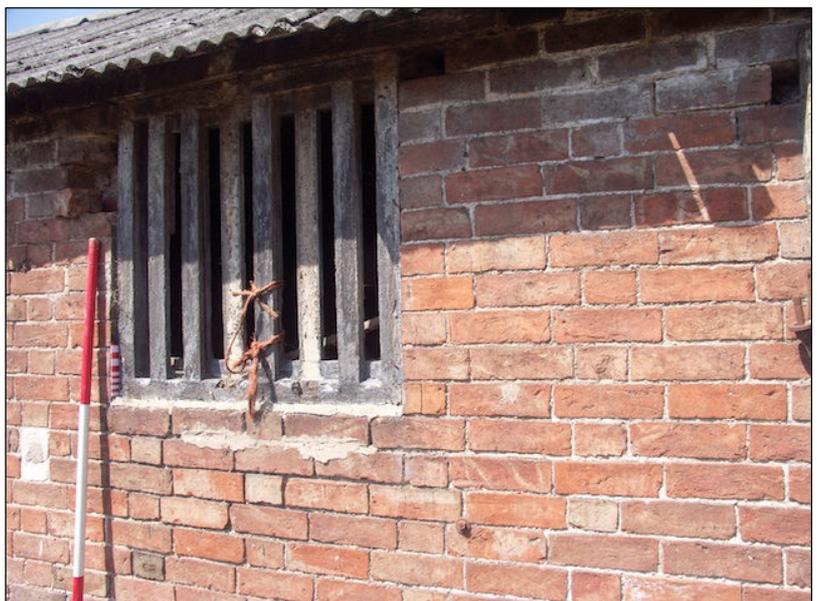
Plate 15: View of the 'hit and miss' ventilator window in the cow shed
