KILTHORPE GRANGE,  
BARROWDEN ROAD,  
KETTON, RUTLAND

HISTORIC BUILDINGS  
APPRAISAL  
(LEVEL 2 SURVEY)

STEPHEN BRADWELL, MA MRTPI IHBC  
TRIGPOINT CONSERVATION & PLANNING LTD.

REPORT DATE: JUNE 2008

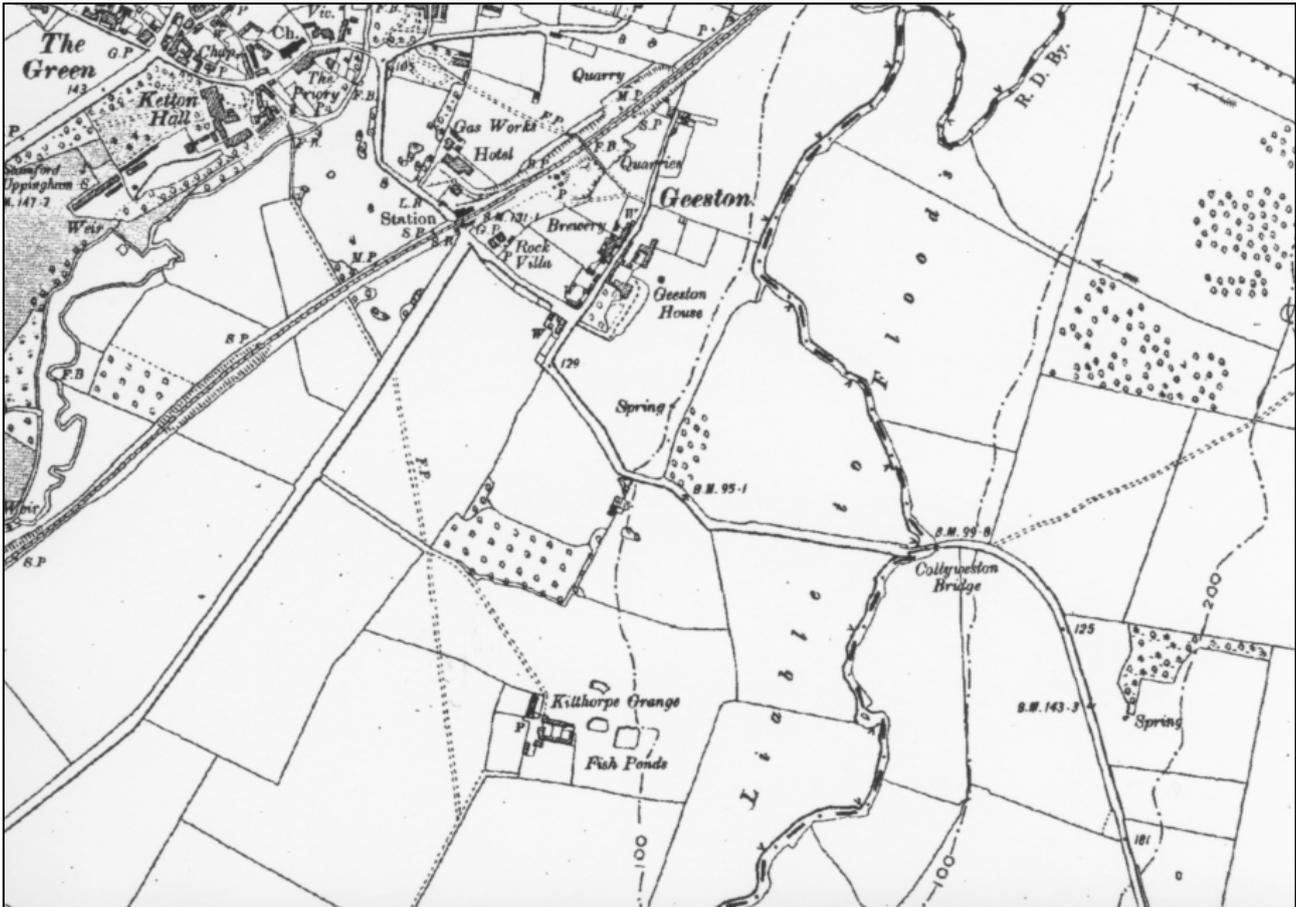
**Map 2: Extract from 1889 OS Plan - showing the 100 foot contour and the land 'liable to floods' alongside the River Welland**

3.1 The complex of farm buildings at Kilthorpe Grange are situated within the broad valley of the River Welland, about 1 mile south of Ketton, between the villages of Ketton and Collyweston (NGR SK 9851 0326) [Map 1 & Plates BW/01, BW/02 & D/01]. The site itself appears to be strategically located above the 100 foot (30m) contour, as the 1889 and 1901 Ordnance Survey (OS) maps indicate that the land below this contour alongside the River Welland as 'liable to floods' [Map 2].

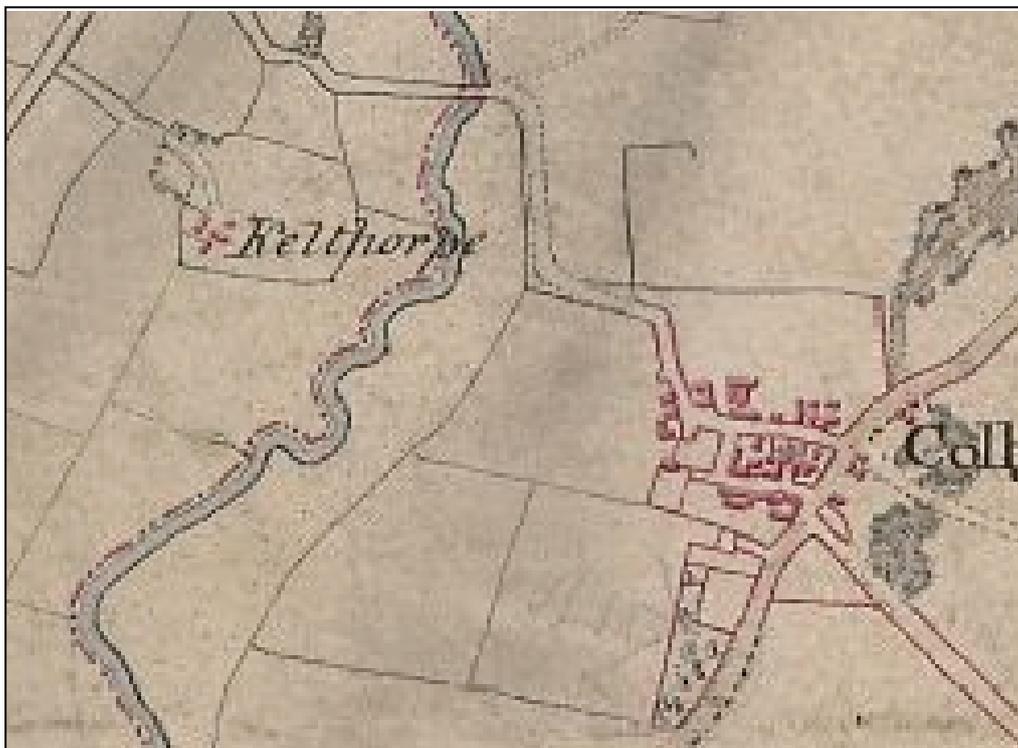
### Map 3: Extracts from 1814, 2" : 1 Mile, Ordnance Survey map

- 5.2 A plan of the farm complex taken from the Ordnance Surveyor's Drawings of c. 1814 [Map 3] appears to show the farmhouse with a large building immediately to the south-east, generally corresponding with the location of the existing barn, and two further detached structures, one to the north of the barn, for which there is no subsequent record, and one to the south, which corresponds approximately with the location of the 'cottage'. Unfortunately the plan is too small scale to be confidently used, but it does imply an initial group of farm buildings on the site at the start of the 19<sup>th</sup> century and which was subsequently enlarged throughout the 19<sup>th</sup> century.

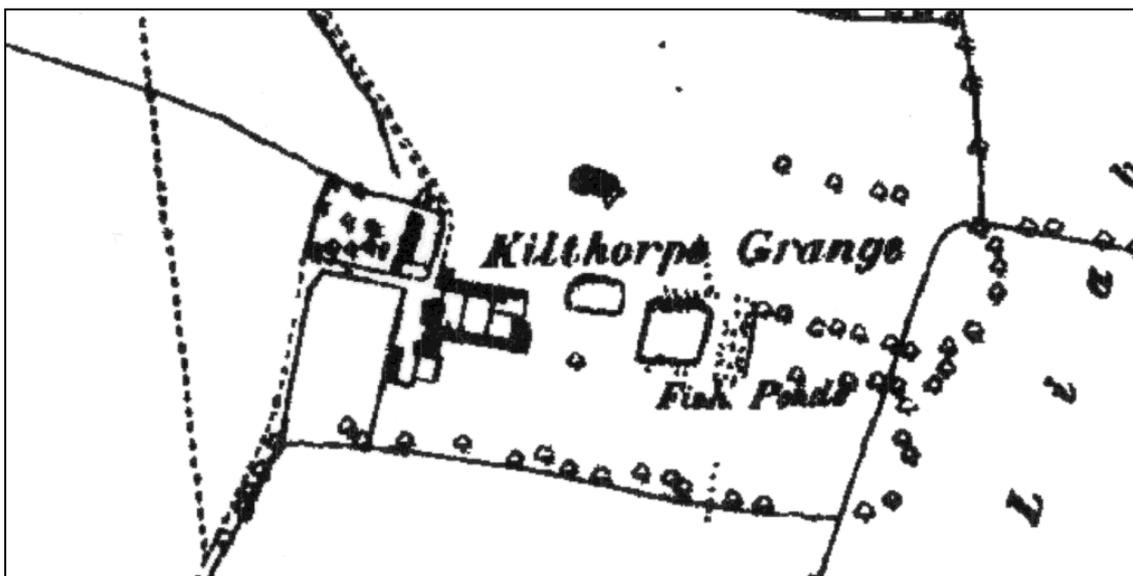
### Map 4: Extracts from 1889 Ordnance Survey map

- 5.3 By the end of the 19<sup>th</sup> century, the 1889 OS map [Map 4] shows an enclosed rectangular farm-yard with the original cottage and barn enclosing the western

and northern sides respectively, and new buildings enclosing the remaining two sides, the stable along the eastern side and joined to the barn by the stock pen while the southern side appears to have been enclosed by a screen wall with lean-to structures against it. Other than a small building at the south-eastern corner of the present farm-yard, this screen wall along with its associated structures has been demolished, although the line of the screen wall is now marked by the front elevations of the large modern agricultural sheds that sit within the farm-yard abutting the principal historic buildings.

- 5.37 To the south of the cottage is an open cart shed (notated on the architect's plans as a 'barn'). This building is built of red brick, laid in an English bond, with a pantile roof and clearly post-dates the original farm-yard although it is shown in outline on the earlier 1901 OS maps [Maps 4 & 5 and Plates BW/29, BW/30, D/25 & D/26]. The building has a closed rear elevation and a range of open bays supported by substantial brick piers along its front elevation, although several of these are closed off by metal sliding doors.

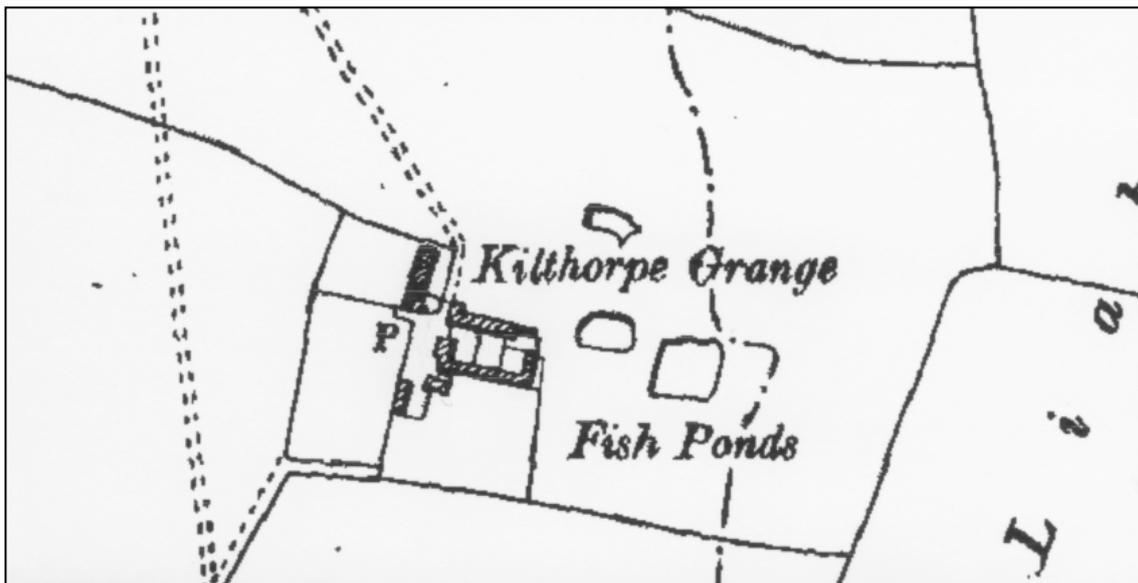
**Map 5: Extracts from 1901 Ordnance Survey map**

5.4 This plan form is repeated on the 1901 OS map [Map 5].

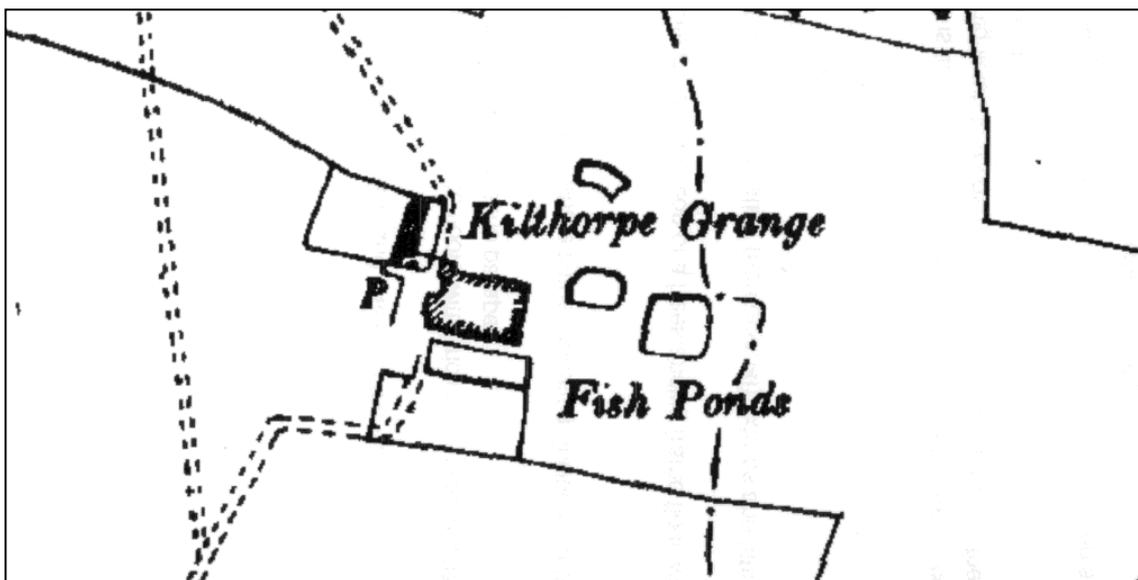
**Map 6: Extracts from 1952 Ordnance Survey map**

5.5 The farm complex shown on the later 1952 OS map [Map 6] is less accurately plotted and not particularly reliable. The main block of farm buildings are shown in outline. There also appears to be a large building to the south of the farm complex, for which there is no other evidence, and the brick-built cart sheds shown on the earlier maps are not plotted.
