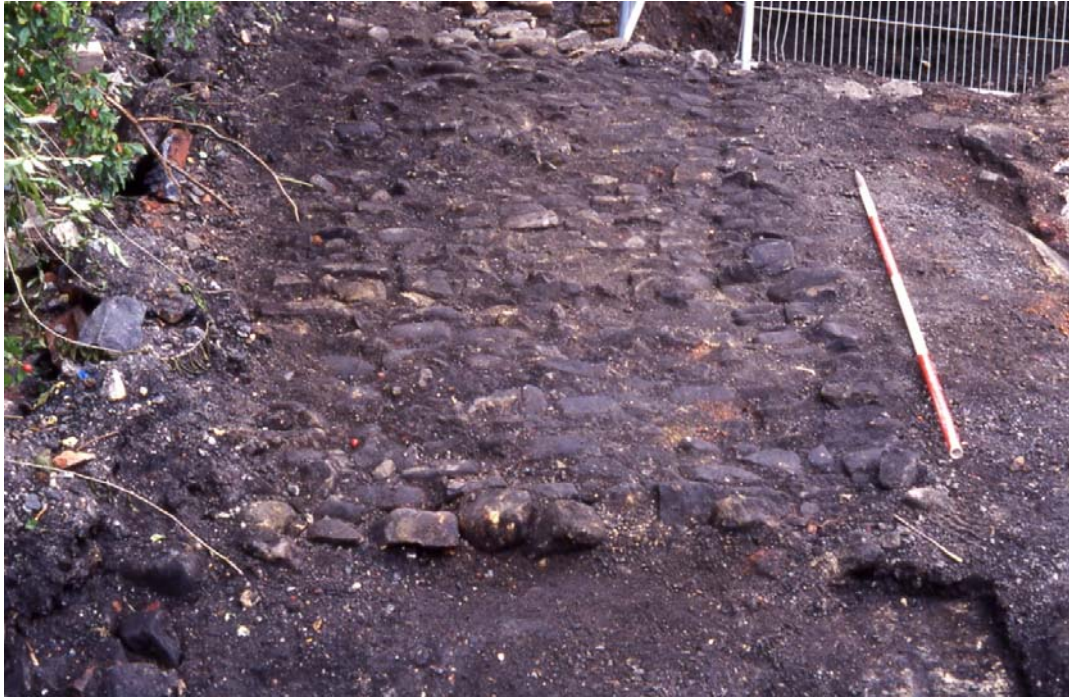
Plate 1 – Trench 1 Cobbled road [1001]

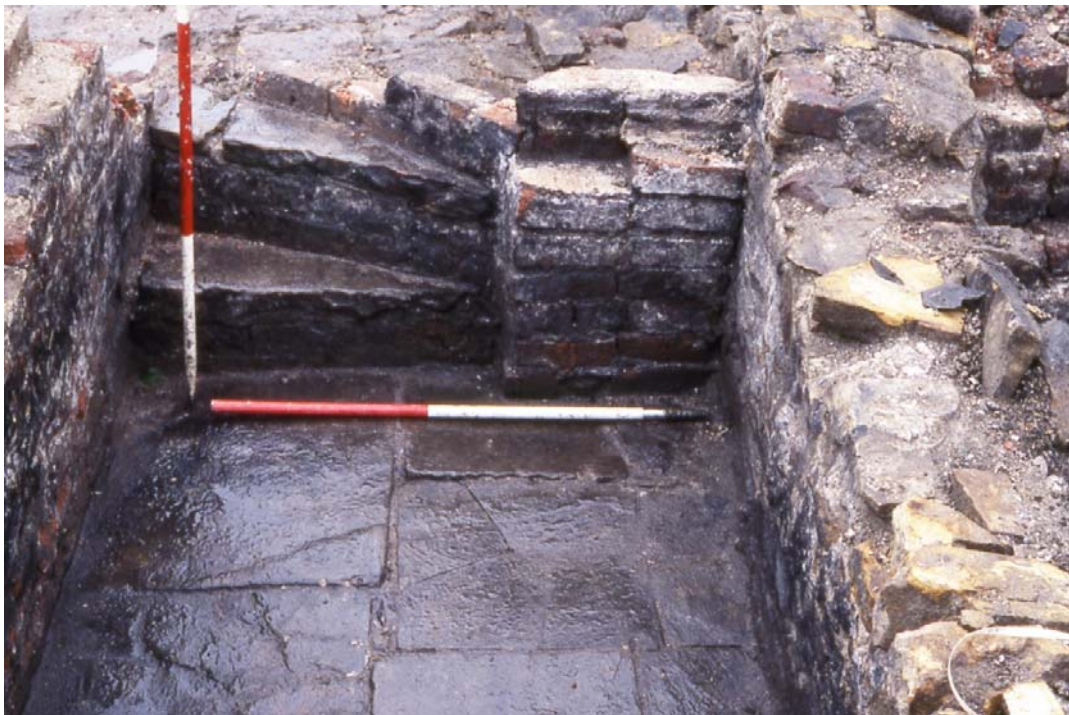
Plate 2 – Trench 2 Cellar 2

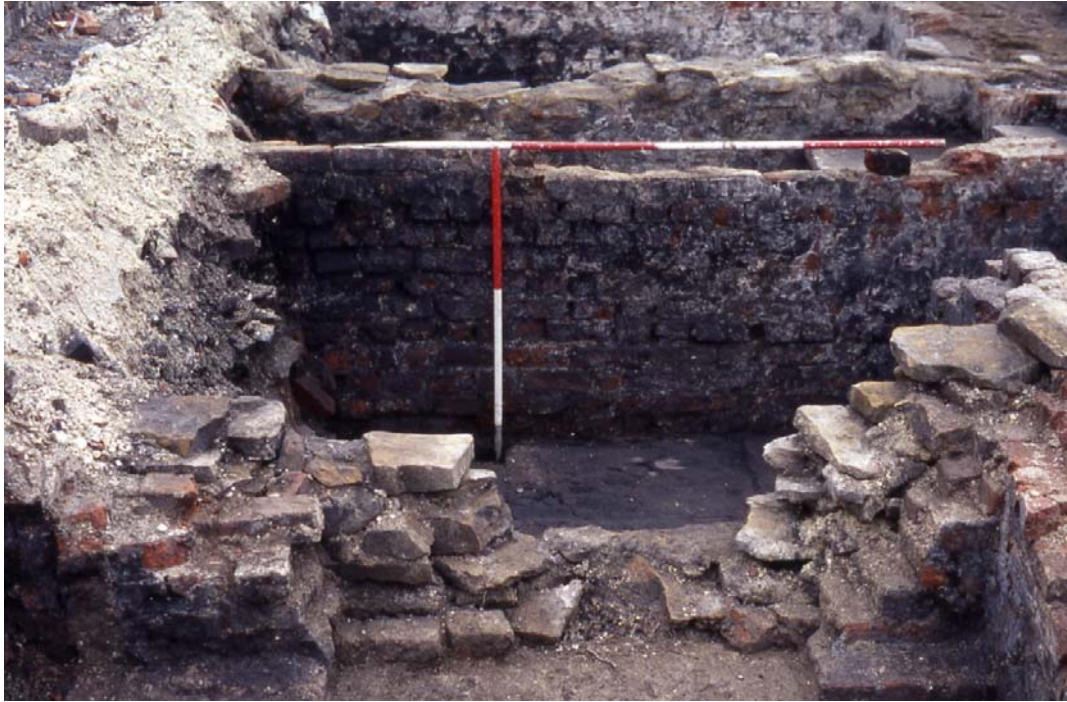
Plate 3 – Trench 2 Red brick cellar wall [2021]

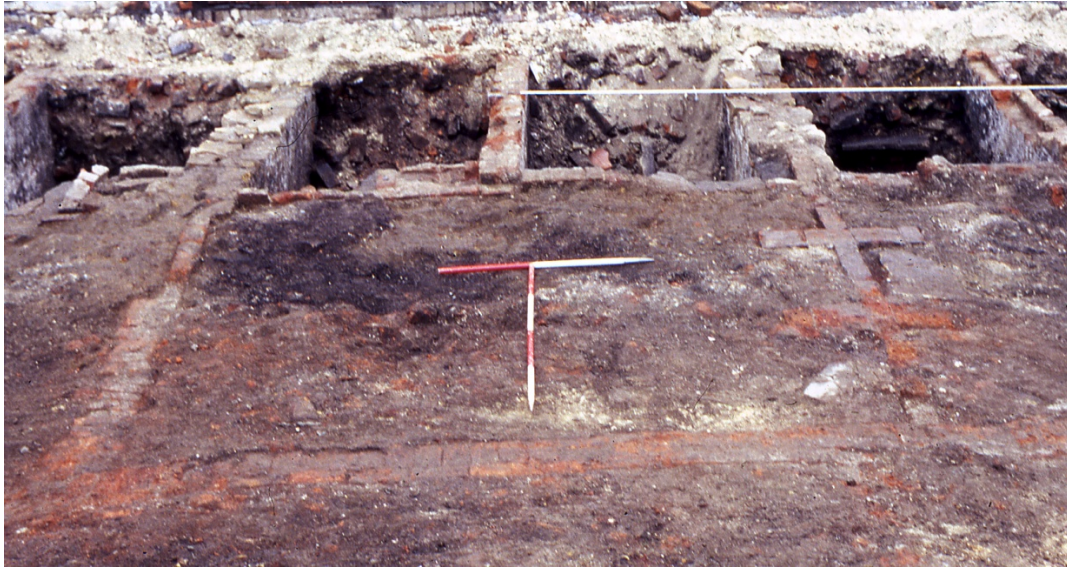
Plate 5 – Trench 2 Layout of back-to-back housing with Cellars 10 and 11 fronting onto the road

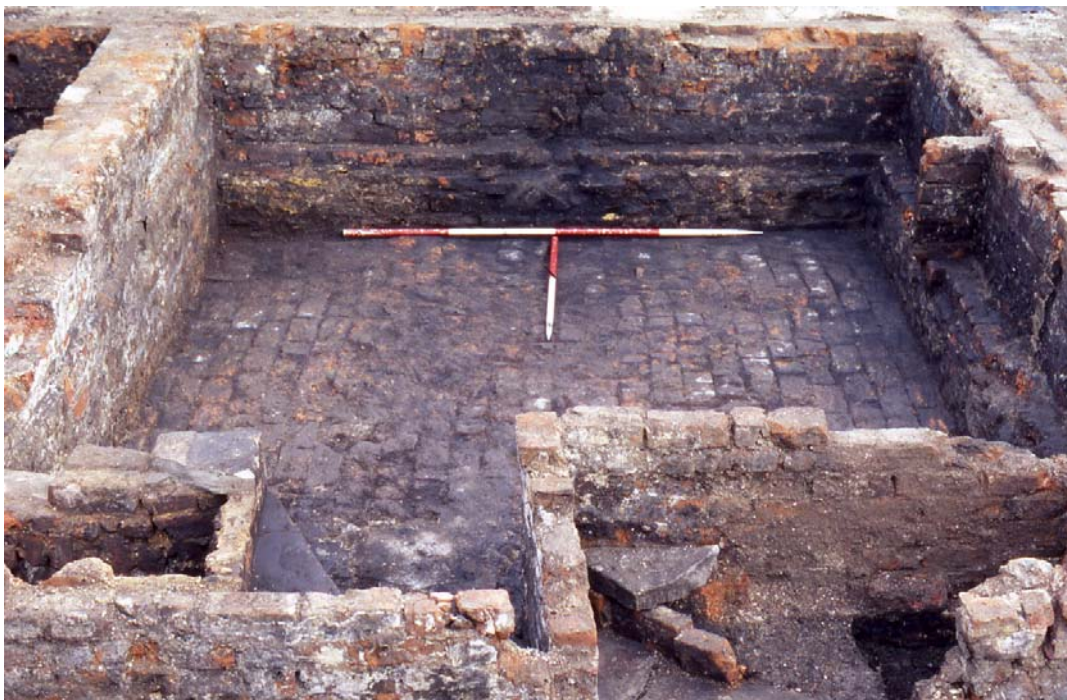
Plate 6 – Trench 2 Cellar 17 showing coal dust and scar of coal chute against wall
[2068]

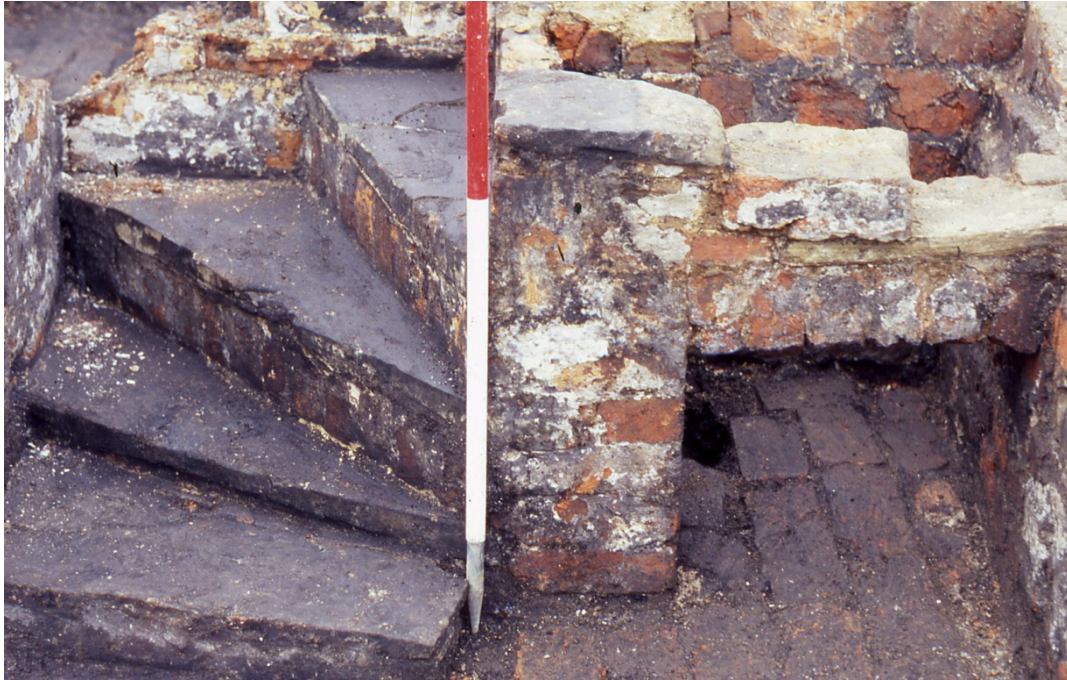
Plate 7 – Trench 2 Steps [2085] leading into Cellar 17

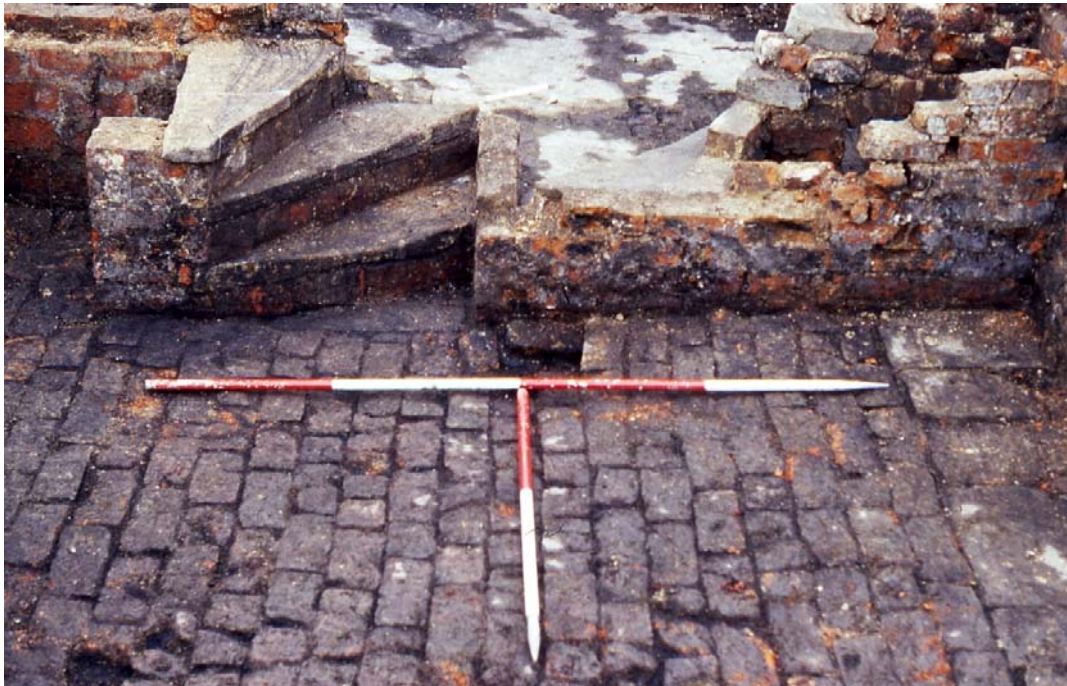
Plate 8 – Trench 2 Steps [2036] leading into Cellar 15 and red brick floor [2037]

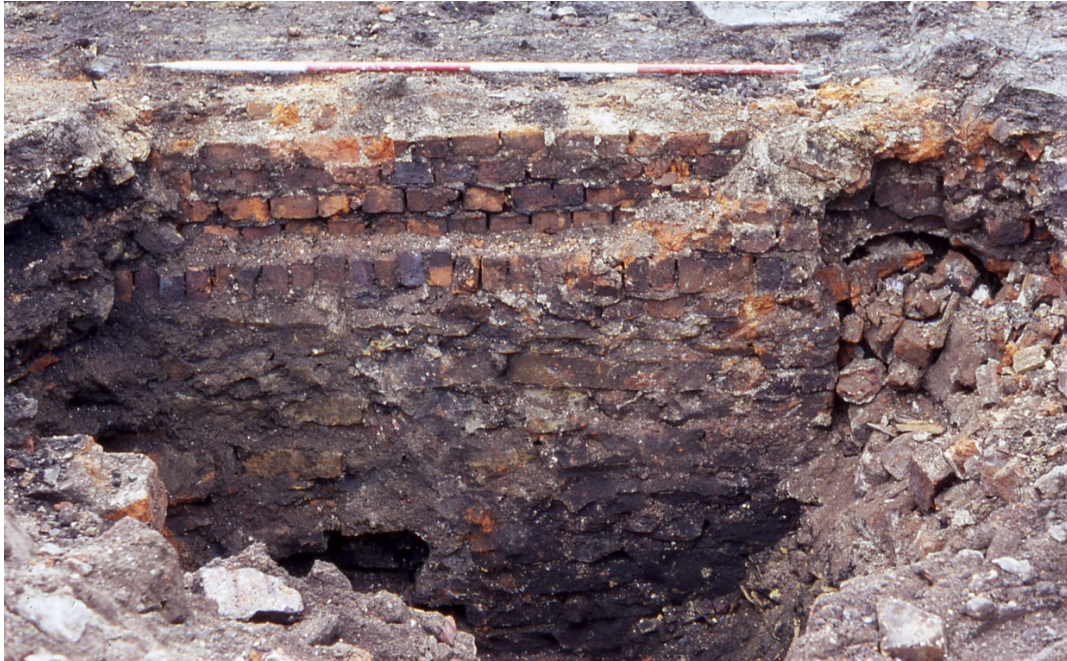
Plate 9 – Watching Brief Wall [3007] with small arch feature in cellar of building
