Assessment Report 842c.1

Archaeological evaluation and mitigation on land adjoining the Stephenson Blake Type Foundry, Upper Allen Street, Sheffield

December 2005

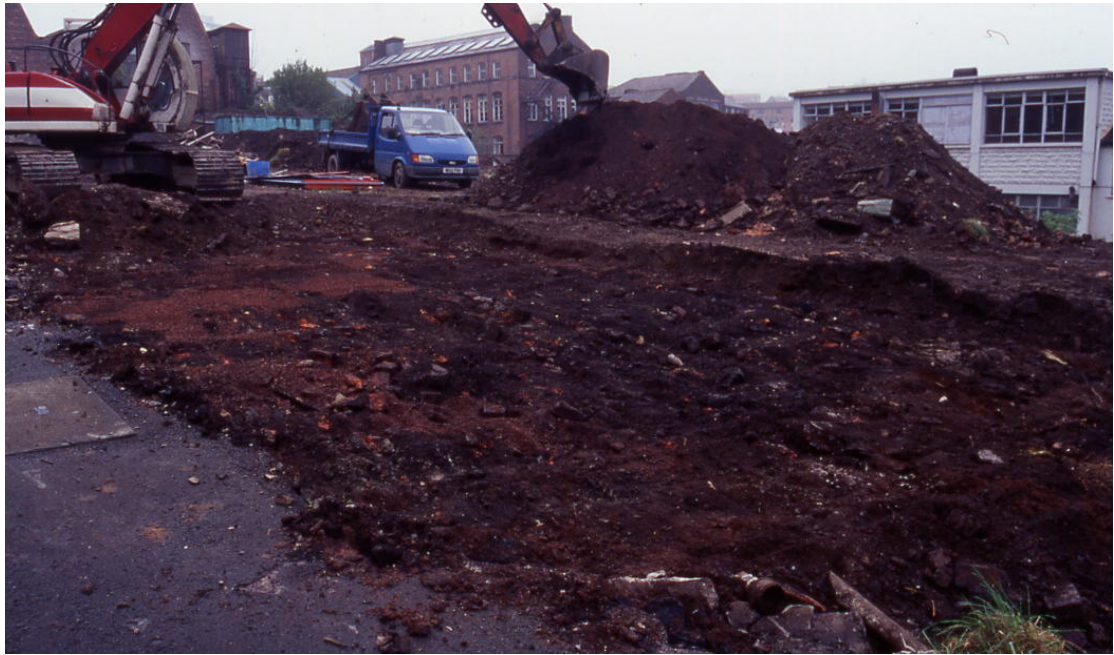
Plate 1: Watching brief: 5-metre strip along Edward Street, looking north west

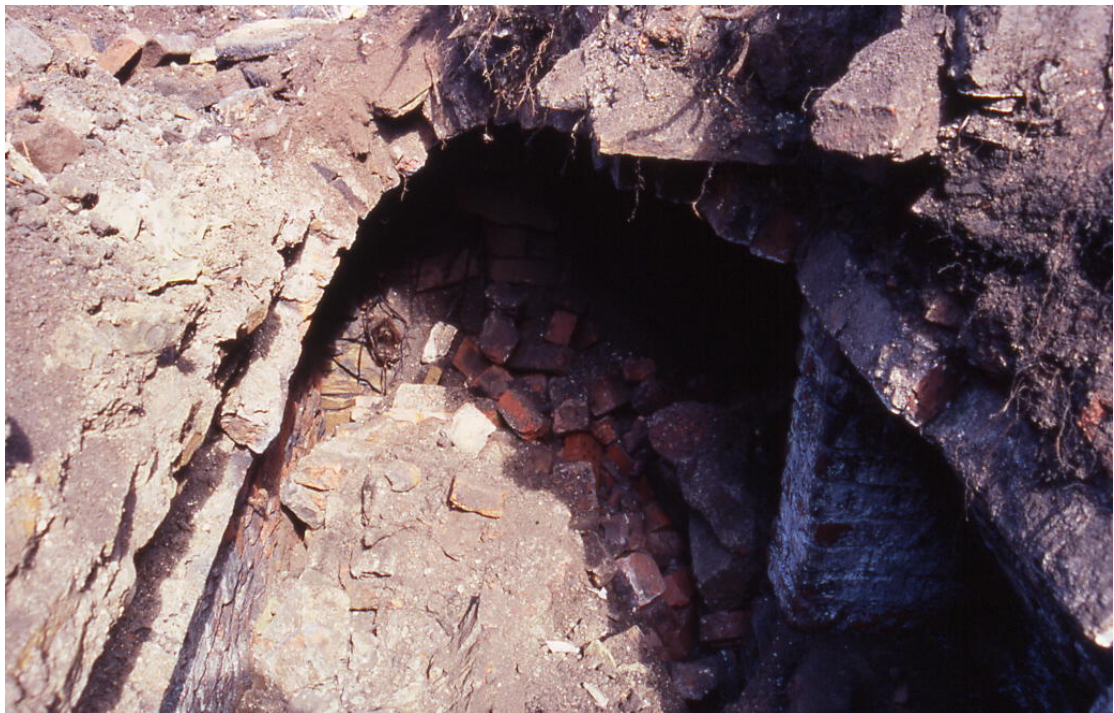
Plate 2: Vaulted cellarage close to corner of Edward Street/Brocco Street, looking east

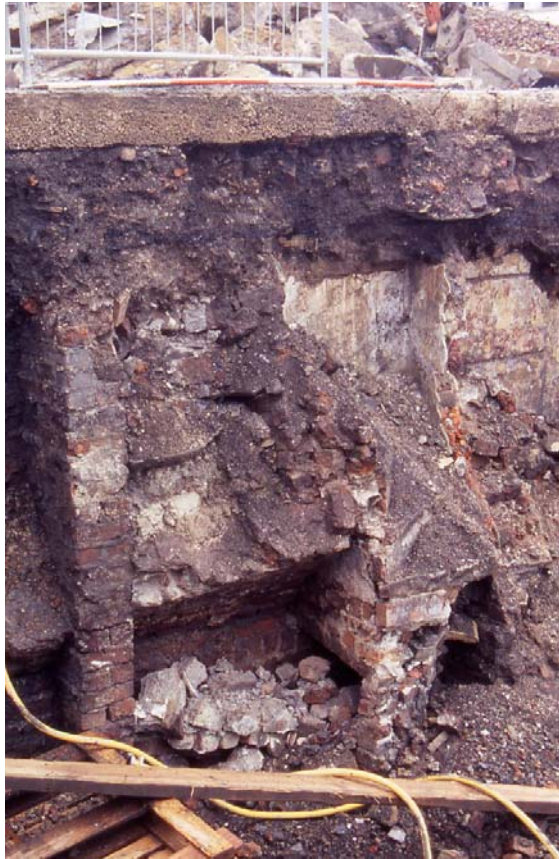
Plate 3: Section at western end of site before battering; vaulted cellars at the western edge of Court No.10 are visible

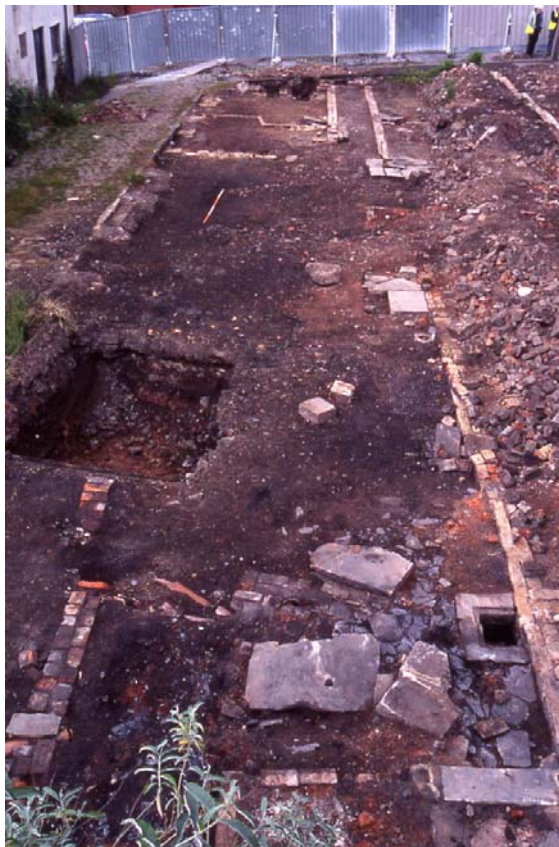
Plate 4: Court No.3 (Brocco Street/Marsden Lane), looking east

At the lower level, along Marsden Lane, the structures comprising Court No. 3 were located only just below the modern ground level (**Plate 4**). In general, this area was truncated below the floor levels of the buildings and yard, with only infilled cellarage and foundations surviving, although some floor levels associated with building 16 at the south-western end of the court appeared to survive. In addition, the south-eastern edge of the court had been much disturbed by the excavation, construction and backfilling of a modern retaining wall [038], apparently following the boundary between Court No. 3 and the higher level of Court No. 1.

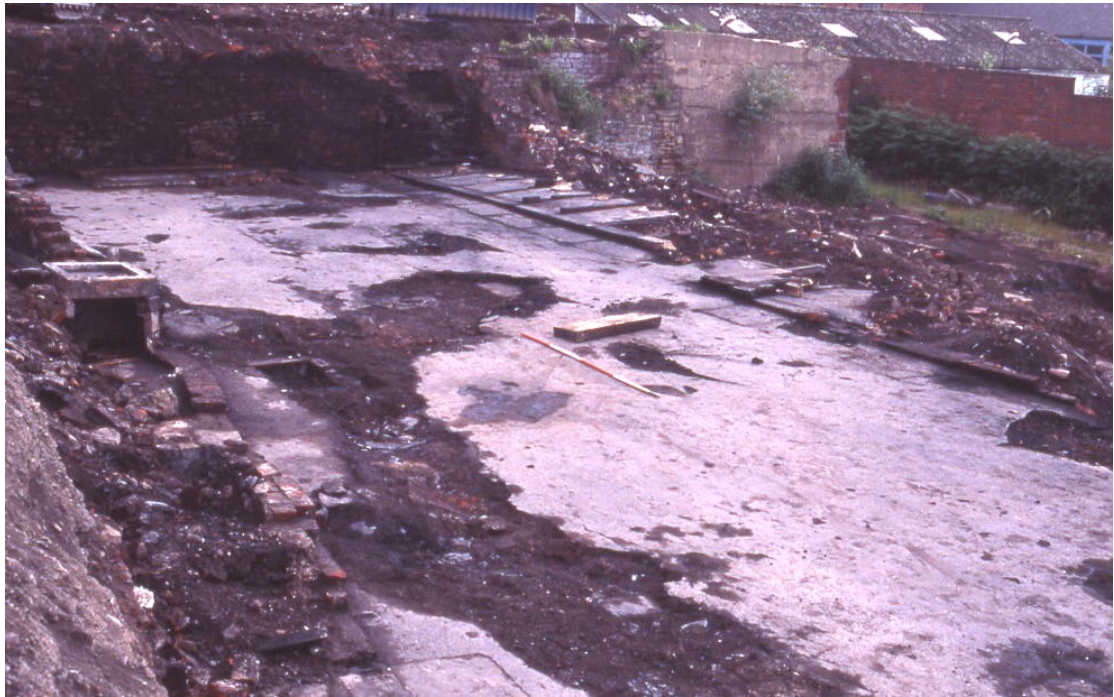
Plate 5: Court No.1 (Edward Street/Brocco Street), looking north west, showing latest (tarmac) yard surface (*Phase 5*)

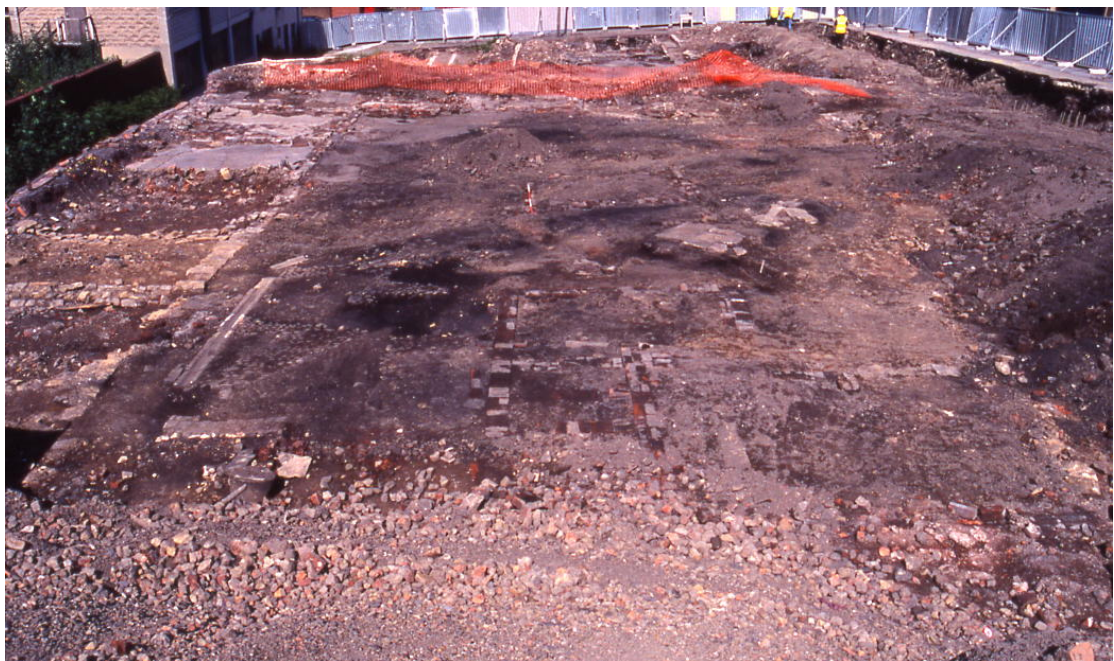
Plate 6: Court No.10 (Edward Street), looking east

To the south-west of the retaining wall at the end of Court No.1, Court No.10 (**Plate 6**) was laid out at a significantly higher level; a typical level for the court surface was 70.97m AOD, some 2.35m higher than the Court No.1 surface. Preservation was consequently less impressive, with many buildings truncated below ground floor level, and the court surface only surviving in isolated patches.

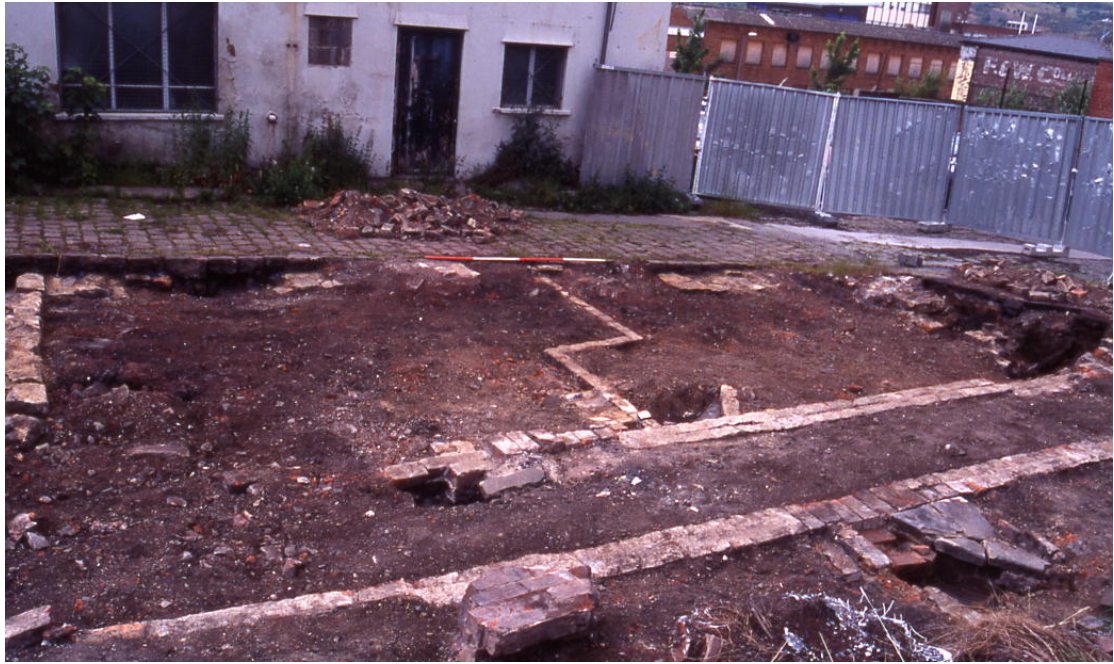
Plate 7: Back-to-back houses 13/14 and passageway 19 (foreground), looking north

Two pairs of back-to-back houses (11/12,13/14) were located along the Brocco Street edge of Court No. 3, with a passageway leading between them from Brocco Street through to the courtyard (20) behind (**Plate 7**). Houses 13 and 14, situated on the corner of Brocco Street and Marsden Lane, were represented by infilled cellars with associated sandstone stair structures, each cellar measuring 3.40m wide by 3.60m long and the rear cellar (13) having been disturbed during excavation of Test Pit 3 (above). The exterior cellar walls were of sandstone slab construction with a light brown sandy mortar; the wall between the cellars and the adjoining passageway was double-skinned, of handmade red 3" brick with lime mortar. The dividing wall between cellars 13 and 14 was a single skin of similar brick and lime mortar construction, dog-legged to accommodate two separate stair structures. Access to each cellar was from the room above, from the north corner of the ground floor of house 13 and the south corner of 14, via a steep curving staircase of roughly triangular sandstone slabs (upper part only exposed).

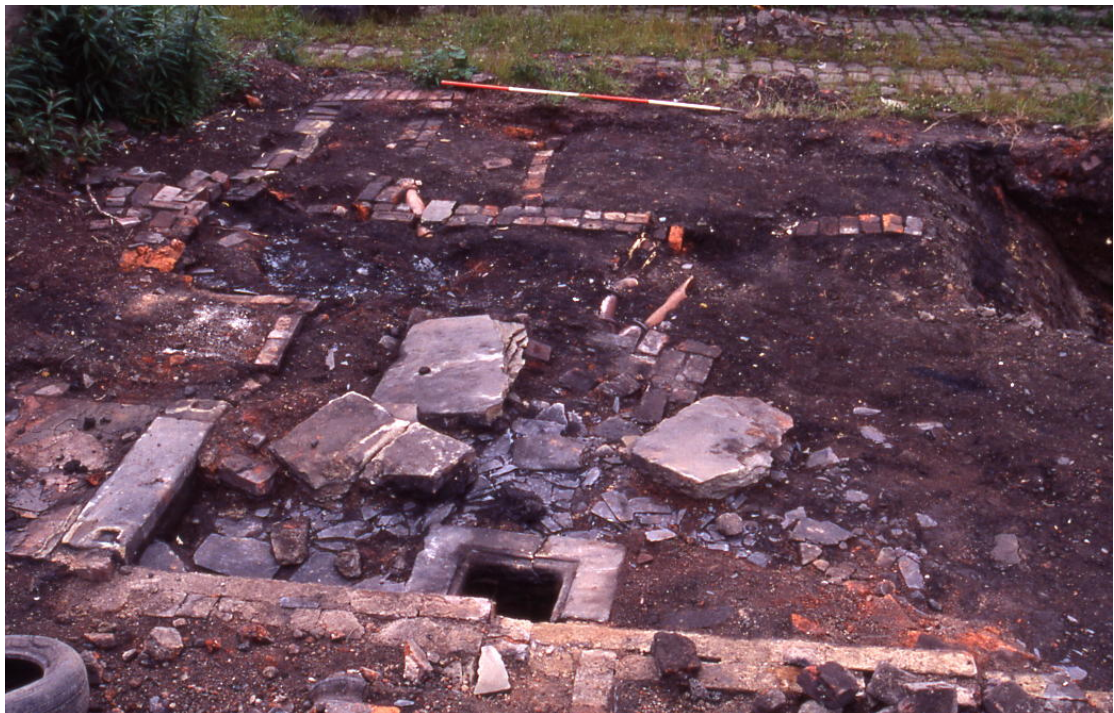
Plate 8: West end of Court No.3, showing back wall of court (foreground), looking north

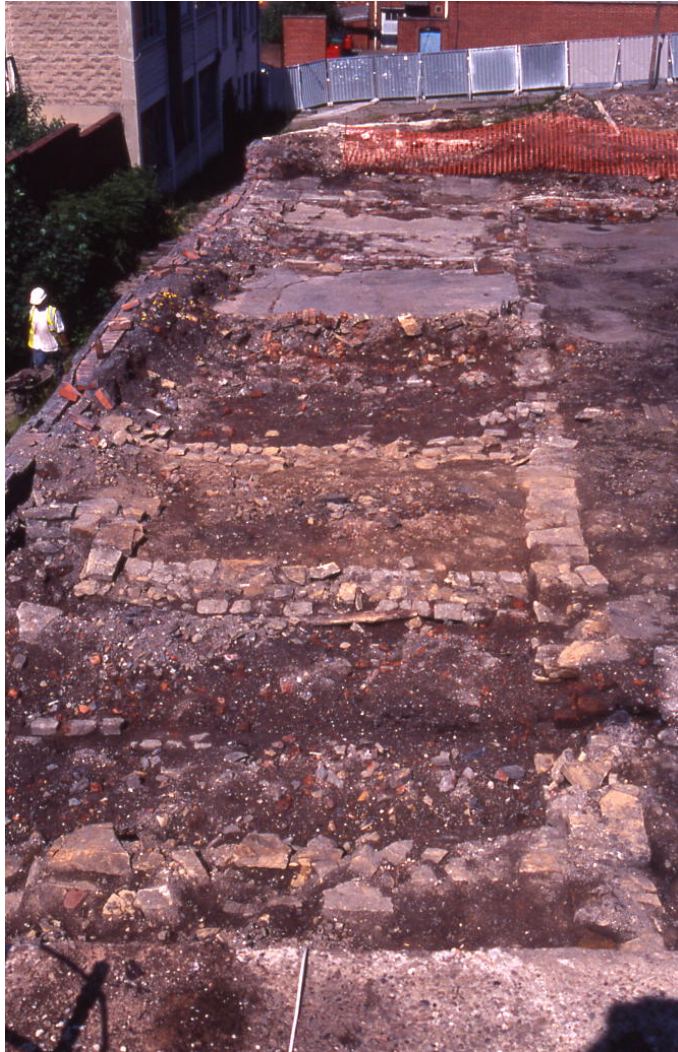
Plate 9: Infilled cellars, north edge of Court no.10, looking east

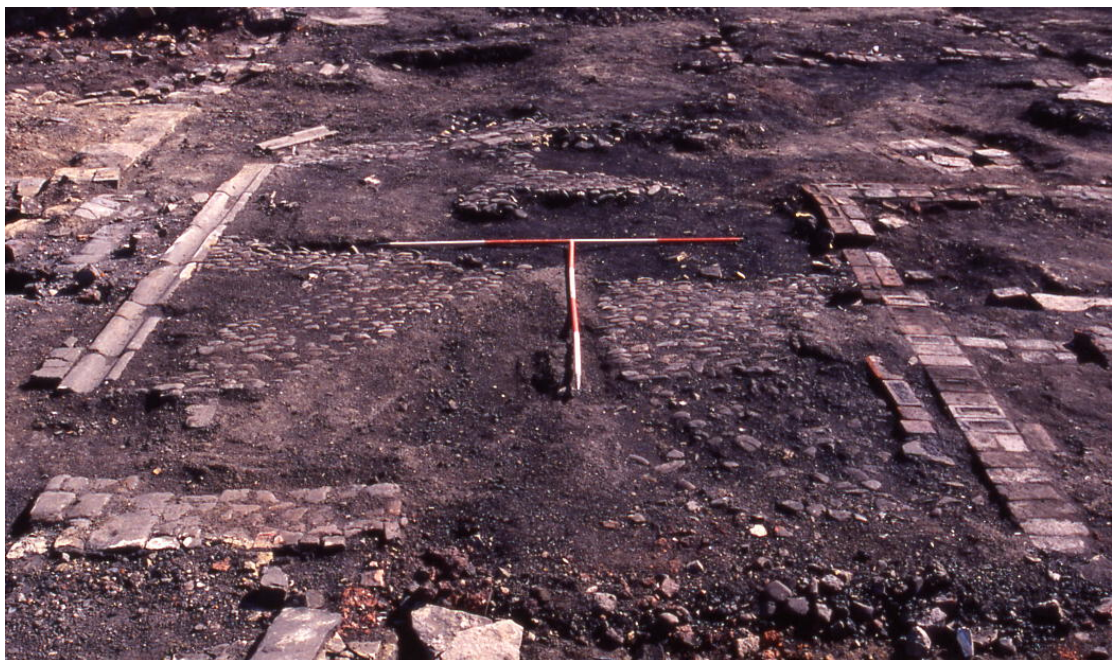
Plate 10: Court No.10, remnants of cobbled yard surface and surface drainage, looking east

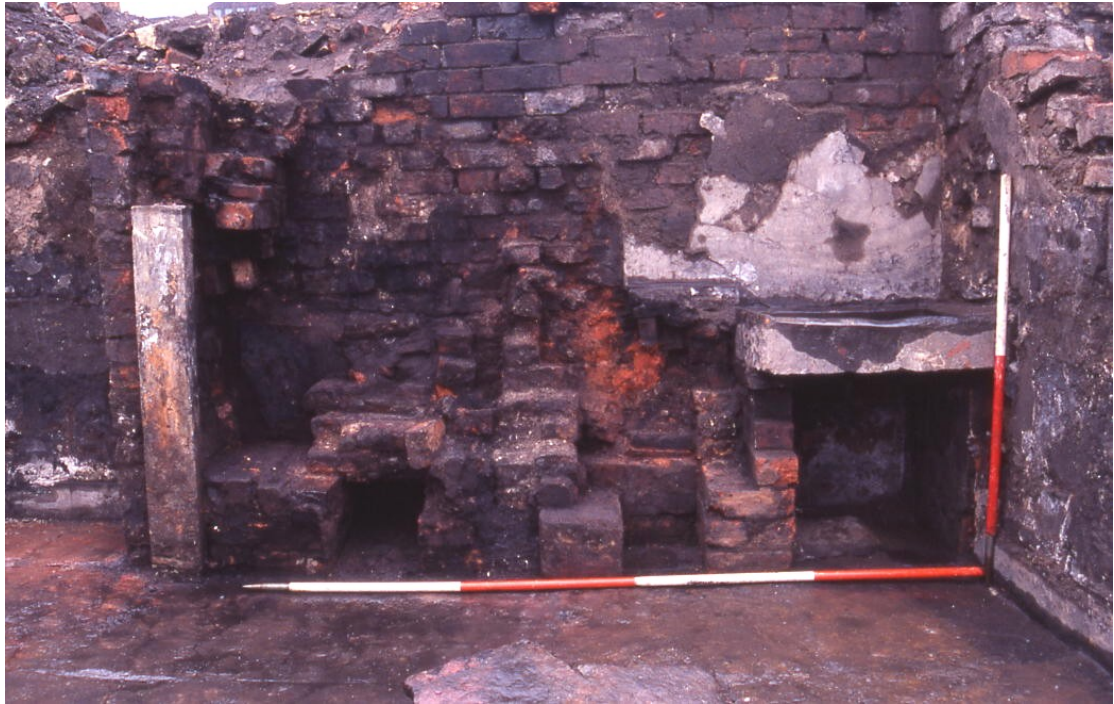
Plate 11: Room 1: chimney breast and sandstone sink structures, looking west

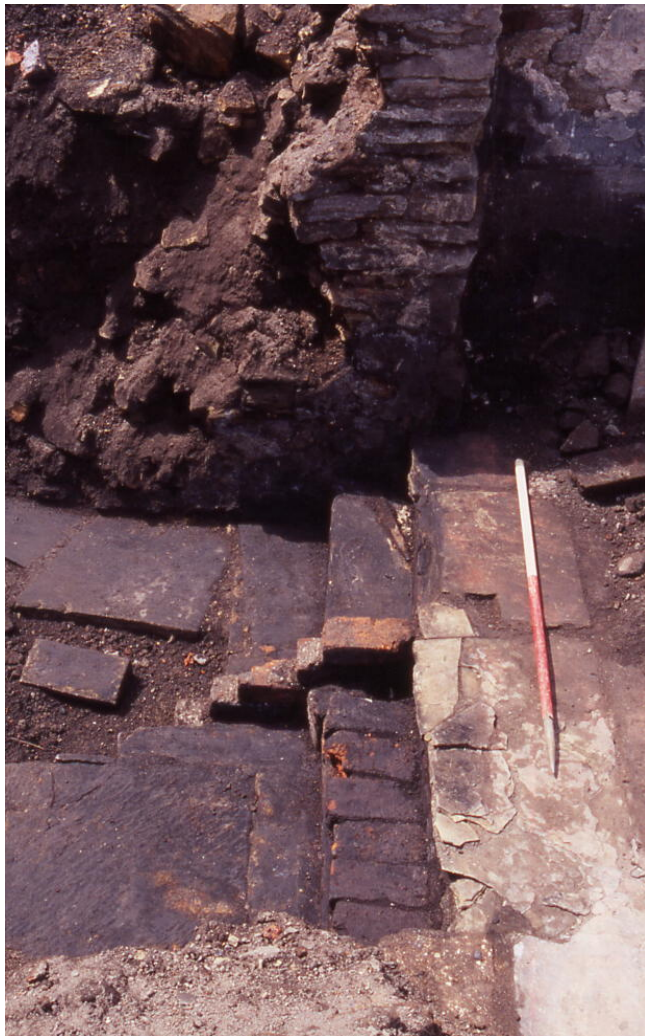
Plate 12: Entrances leading from Room 1 into cellarage to south, looking west

The area to the south of Room 1 was later investigated (**Plate 12**) under watching brief conditions during ground-level reduction across the site; up to a further metre of good preservation was encountered beyond Room 1, before disturbance associated with earlier groundworks. The western (corner) doorway in the back wall [050] led to a probable cellar with a sandstone flagged floor, at a slightly lower level down two sandstone steps with brick risers. It is not clear whether the cellar was subdivided as in Room 8. The central doorway in [050] was probably associated with a stairway to an upper storey, not surviving but suggested by a possible stair support wall running back perpendicular to [050] and reminiscent of stair structures encountered in Room 8.

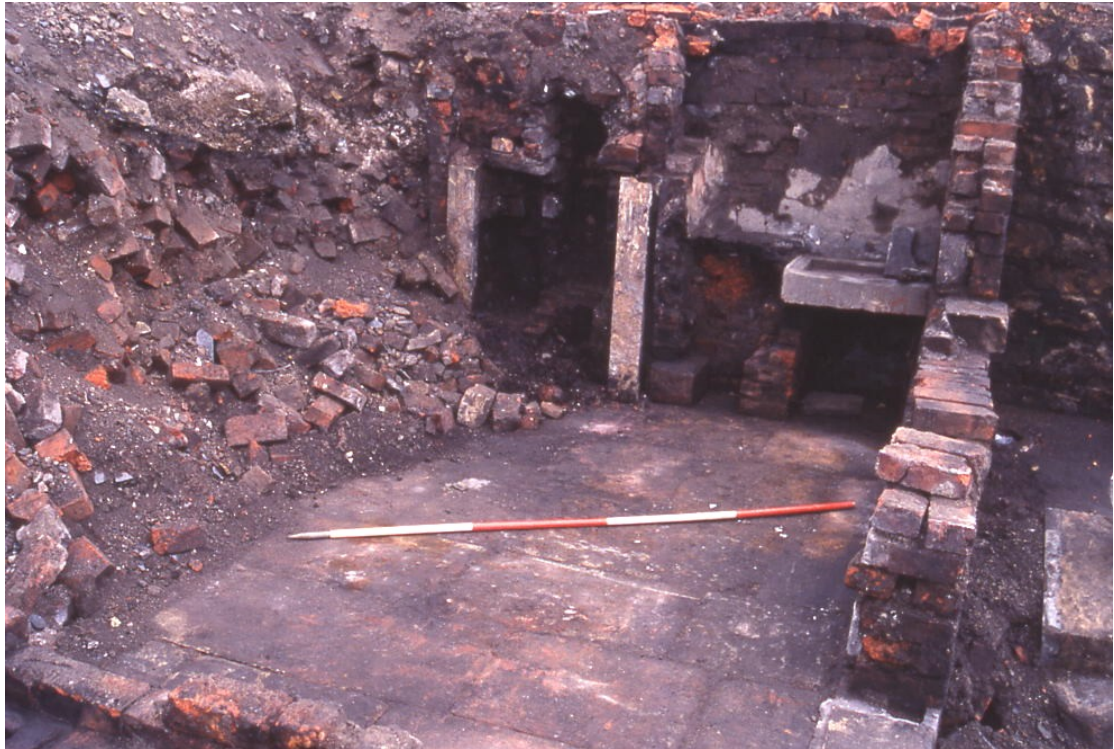
Plate 13: Room 1, looking south west

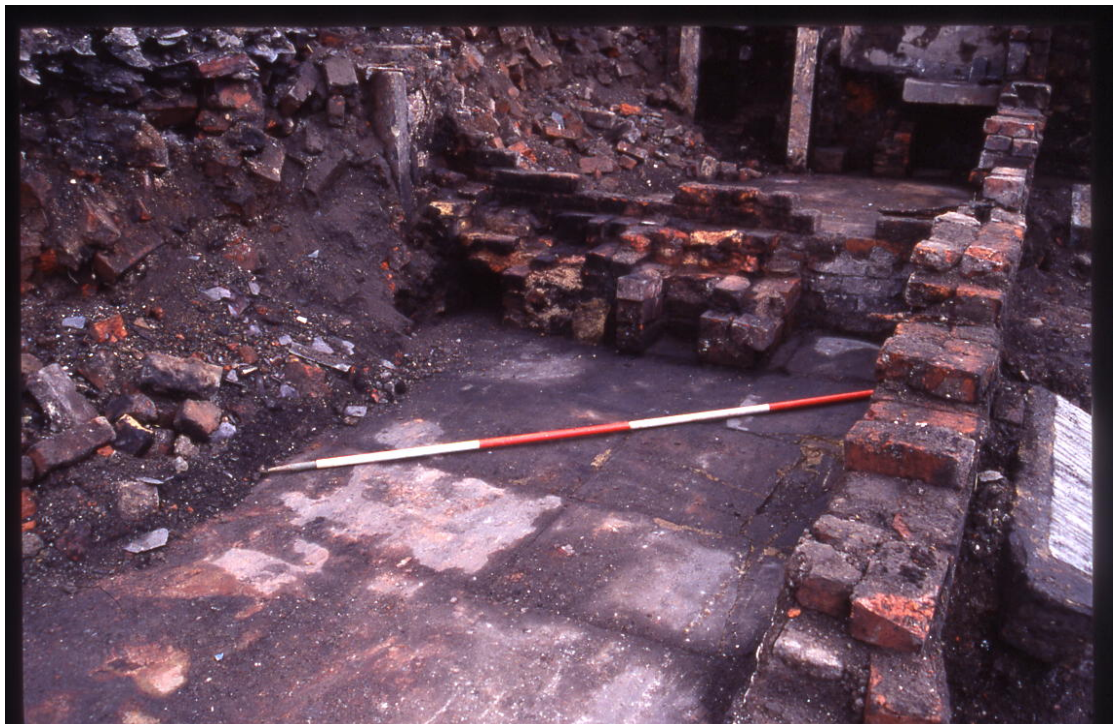
Plate 14: Room 2, looking north west

A chimney breast and flue structure was located on the western internal wall of each room; various inserts into this structure appeared to form a kitchen range, with a number of separate components. The range [030] in Room 1 (**Plate 11**) was the best preserved of the four, though still incomplete. The chimney breast was formed by two projections from [027], each two skins thick and projecting 0.55m into the room, surviving to a maximum height of 1.50m. Each side of the chimney breast was faced with a vertical sandstone slab 1.08m tall x 0.18m wide and 0.05m thick, forming the sides of the fire surround. A flue structure above was also integral to the wall [027] but survived only in fragmentary form. The internal kitchen range structures within the chimney breast in Room 1 appeared contemporary, with some refractory bricks present; no ironwork remained, but the structures probably comprised a separate grate and oven, with various soot and ash deposits adhering. The flag floor [028] in Room 1 was constructed around the kitchen range structures [030], suggesting that these were contemporary with the original build. In contrast, some of the internal structures [099] within the Room 2 chimney breast [119] were constructed above the flag floor [098] in a dark grey cementitious mortar, suggesting that the kitchen range structures had been remodelled after insertion of the flag floor (**Plate 14**).

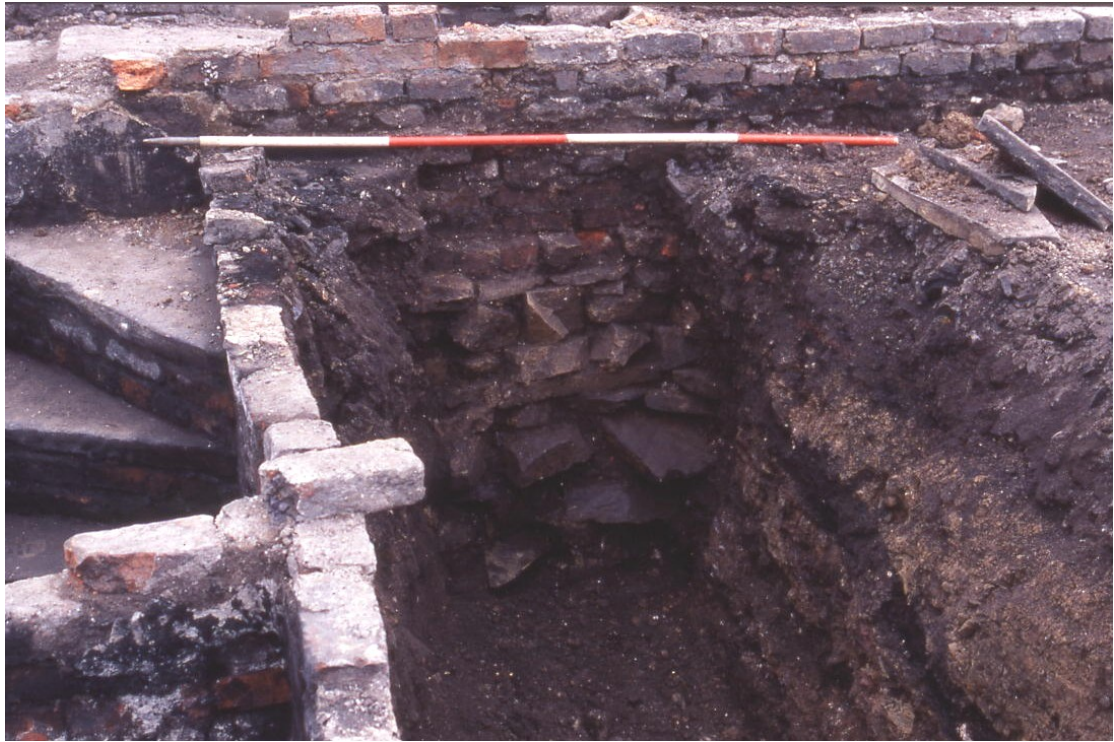
Plate 15: Sondage within Room 7, showing wall foundations and sequence of made ground, looking south

In Room 7, wall foundations and sub-floor make-up deposits (**Plate 15**) appeared to have been introduced at the same time, but probably in several stages. No clear construction cut was visible through the sub-floor deposits for any of the walls, but the sandstone slab foundations of the side walls appeared too irregular to have stood independently before backfilling. Material close to the foundations appeared to have slumped down and towards the walls from each sub-floor layer. It appears likely, therefore, that the foundations and sub-floor layers were introduced in a number of stages, each perhaps involving the construction of a few courses of foundations followed by raising of the interior level. This process is considered likely to have taken place during or after the construction of the cellar structures.

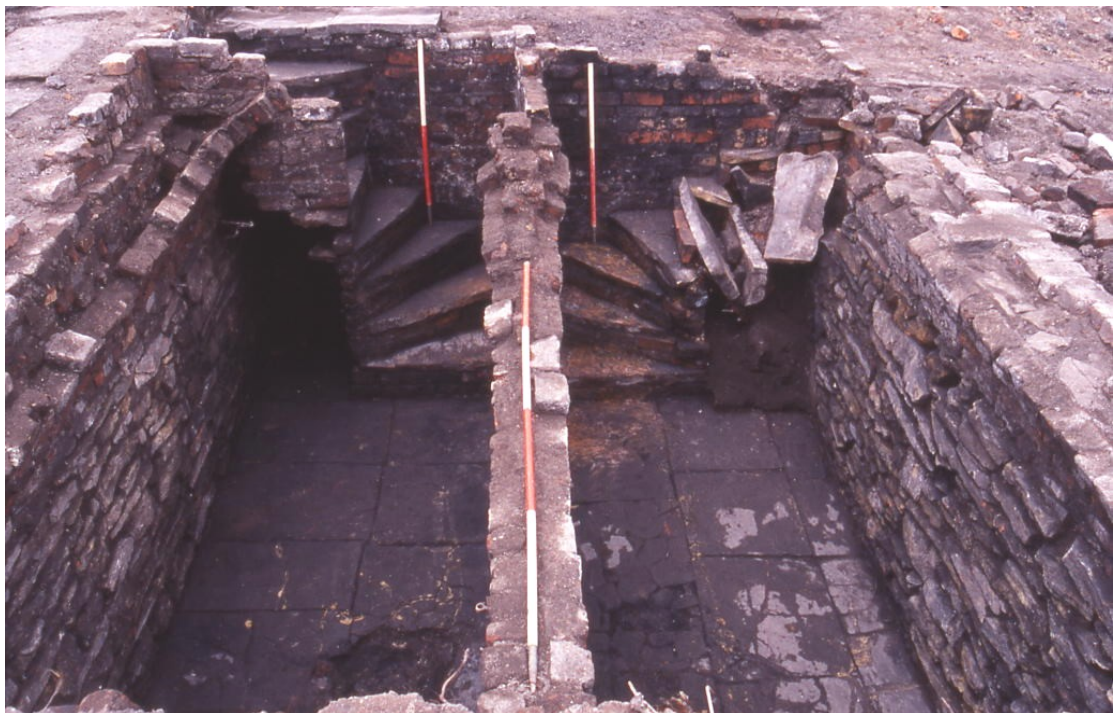
Plate 16: Room 8: double vaulted cellar and stair structures, looking west.

The ground floor rooms of houses 7 and 8 each had access to a half cellar (3.40m x 1.60m) in Room 8; presumably so that coal could be delivered from Brocco Street without entering the court itself. Cellar access was by means of two self-contained stairwells between Room 7 and Room 8. Apart from the sandstone steps (see below), these were of re-used handmade plain 3" red brick in lime mortar, with many broken bricks evident. The southern stairwell [009] provided access from the south-east corner of Room 7 to the southern half cellar; the northern stairwell [010] ran from the north-west corner of Room 8 to the northern half cellar. Because of the necessity of accommodating two stairwells within a 1.0m strip across the width of the building (3.80m), the stairways were steep and each incorporated two turns. Each stairwell structure consisted of:

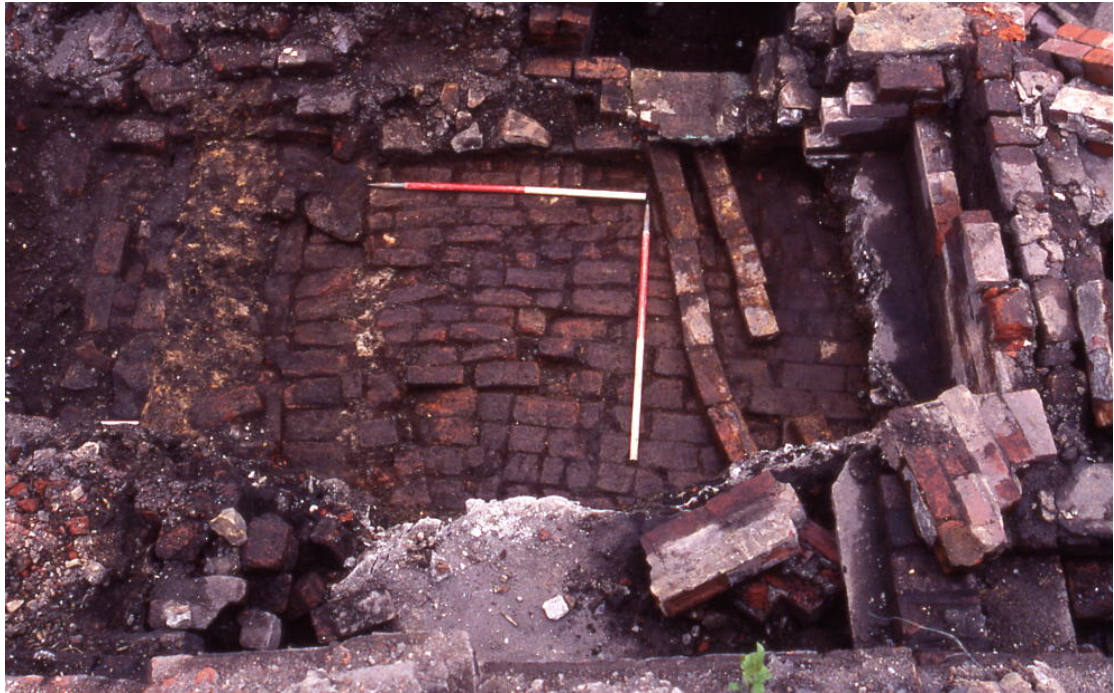
Plate 17: Probable brick-lined privy midden tank [121]/[122] (*Phase 1*), with drain [123] added to surface and soak pit [059] at top of picture (*Phase 2*), looking east.

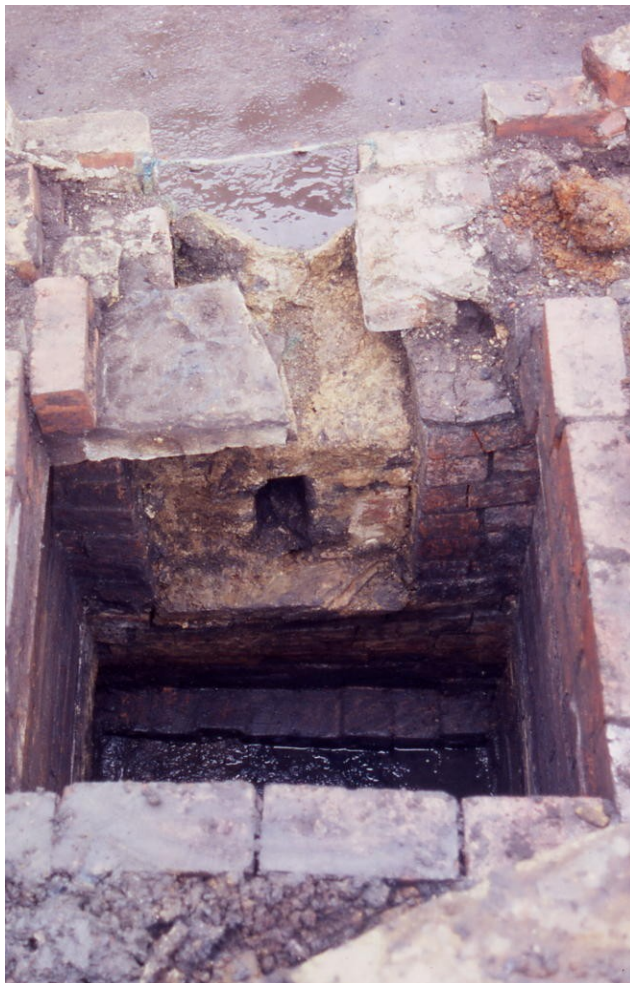
Plate 18: Detail of soak pit/drain shaft [059] showing entrance of drain [123] below later concrete surface of midden tank [043], looking west

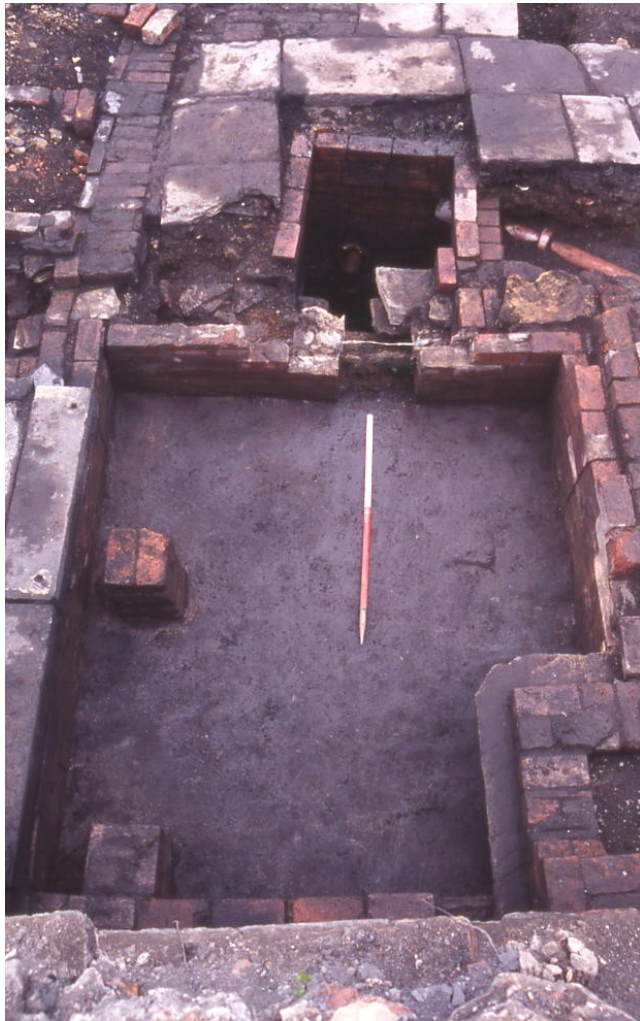
Plate 19: *Phase 3* privy midden tank [043], with concrete base and additional brick lining added, along with overflow gate into soak pit/drain shaft [059], looking east.

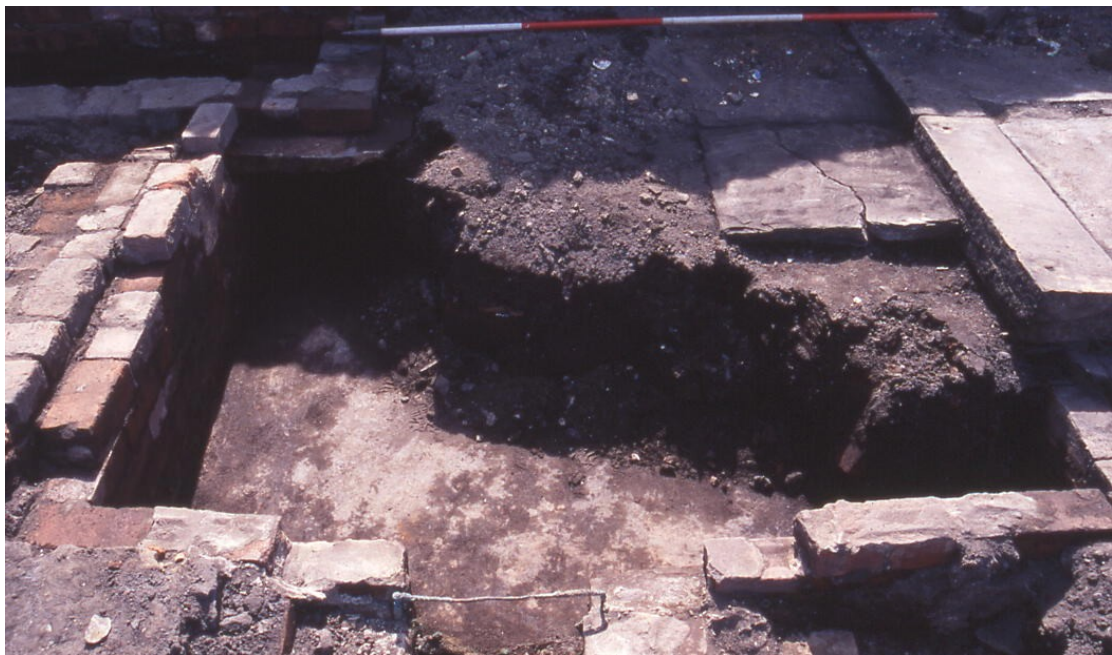
Plate 20: Tank [043] under excavation, showing backfill and later yard surface over, looking west (*Phase 4*)

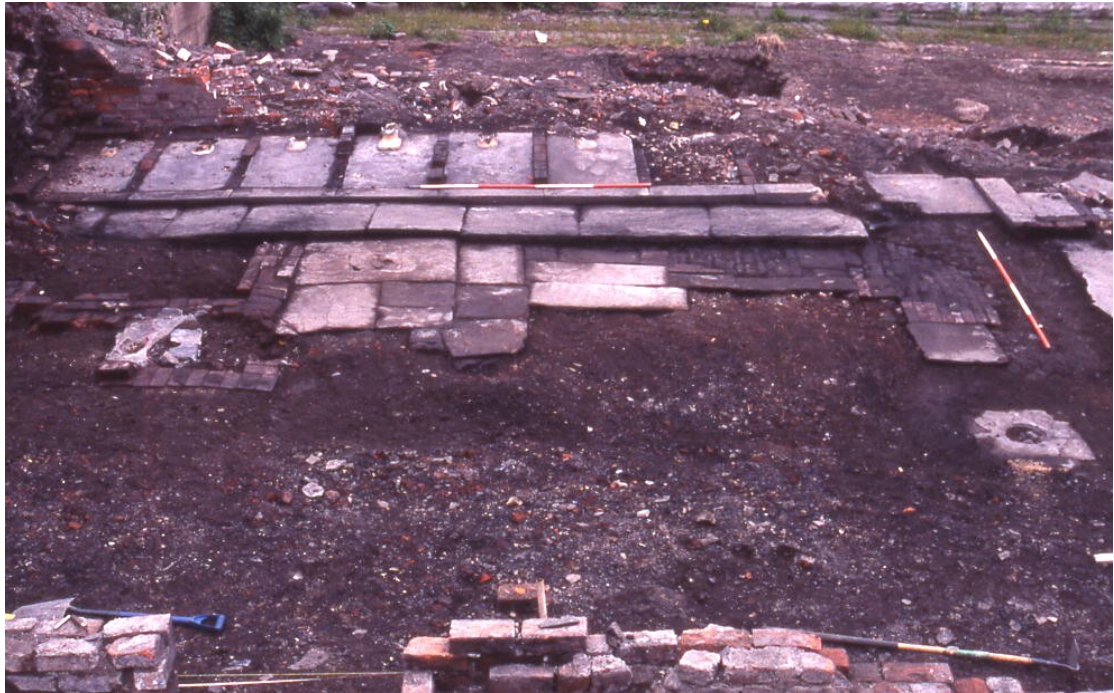
Plate 21: Water closets [039] (*Phase 4*), showing infilled tank [043] at left of picture, looking north

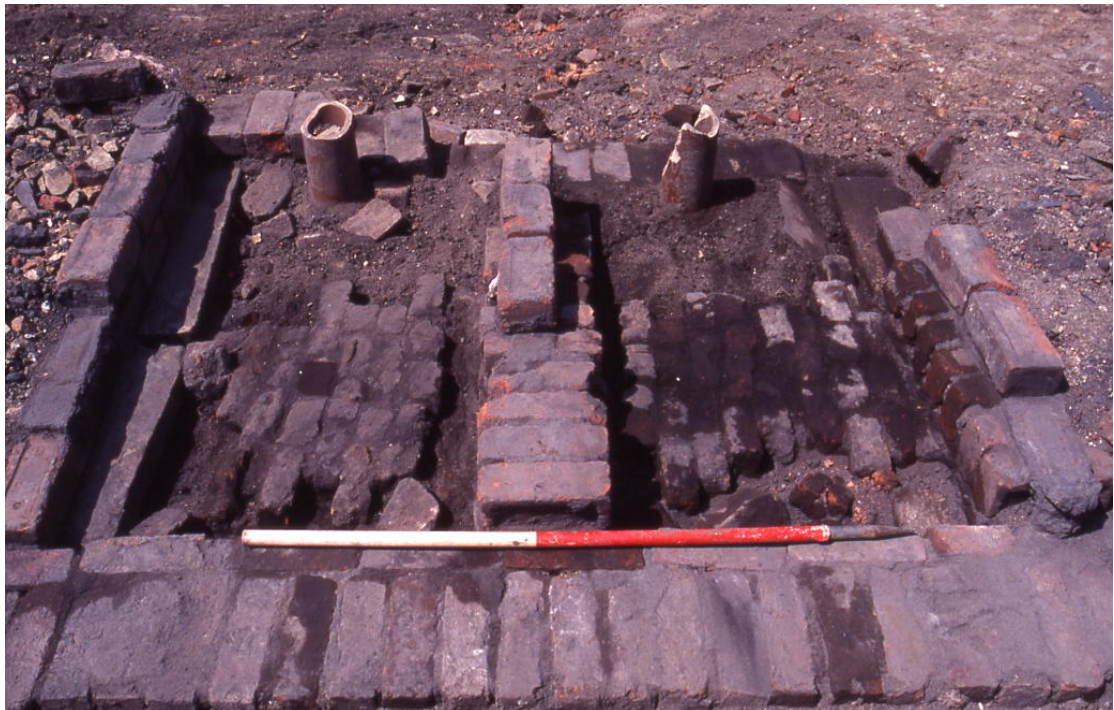
Plate 22: Water closet cubicles, showing fragments of earlier yard surface preserved below floor level, looking south

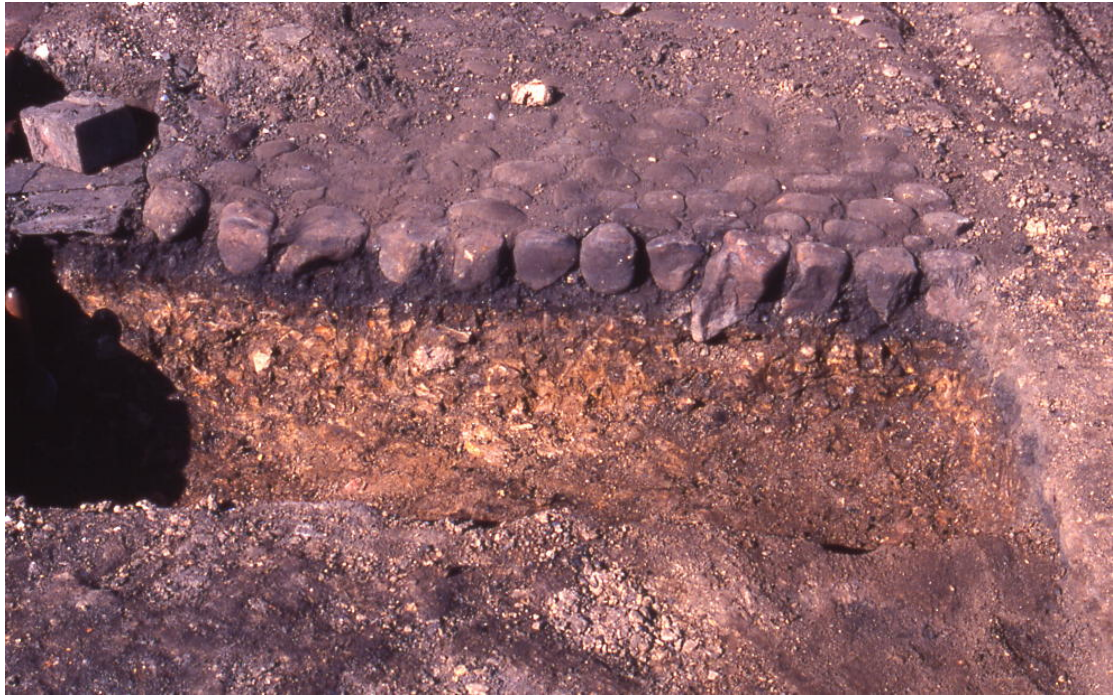
Plate 23: Section through cobbled surface [080], Court No.10, showing terraced natural below.

In contrast to Court No.1, the late tarmac yard surface in Court No.10 had been laid directly onto an earlier cobbled surface. However, these surfaces survived only in patches across the yard, presumably due to truncation during the demolition process. One surviving area of cobbles [080], adjacent to a probable toilet block in the centre of the western part of the yard, was selected for investigation (**Plate 23**). The rounded sandstone cobbles were oriented roughly east-west, of typical dimensions 0.08m x 0.06m x 0.09m deep, and were bedded in a loose black silty material (074), 0.12m thick with ash and clinker. (074) lay directly above a very compact yellow and grey clay (075), interpreted as a natural deposit. No further stratification was encountered below the yard surface, here or in other parts of Court No.10, where geotechnical pits were excavated several metres into (075).

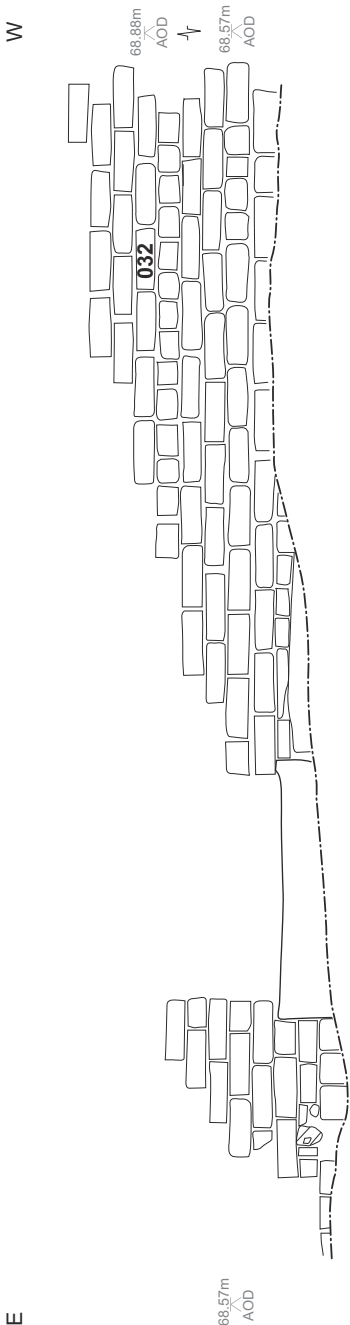
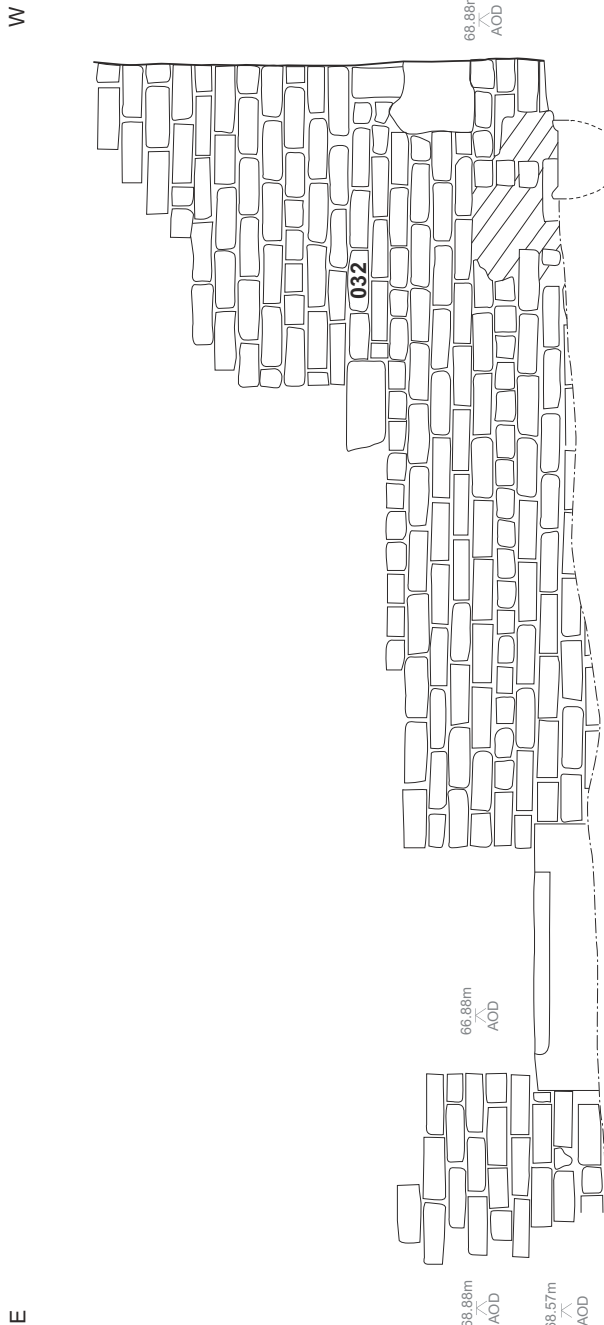
</div>	Project: Upper Allen Street, Sheffield		Scale: As shown	Date: June 2007
	Title: Court No. 1, Room 1 and 2: Front Elevation		NGR: SK 3483 8762	Drawn: Jo Mincher
			Project No: 842c.2	Illustration No: 7
