CHEDWORTH ROMAN VILLA

CONSERVATION, MANAGEMENT AND MAINTENANCE PLAN

September 2007
Revised November 2009

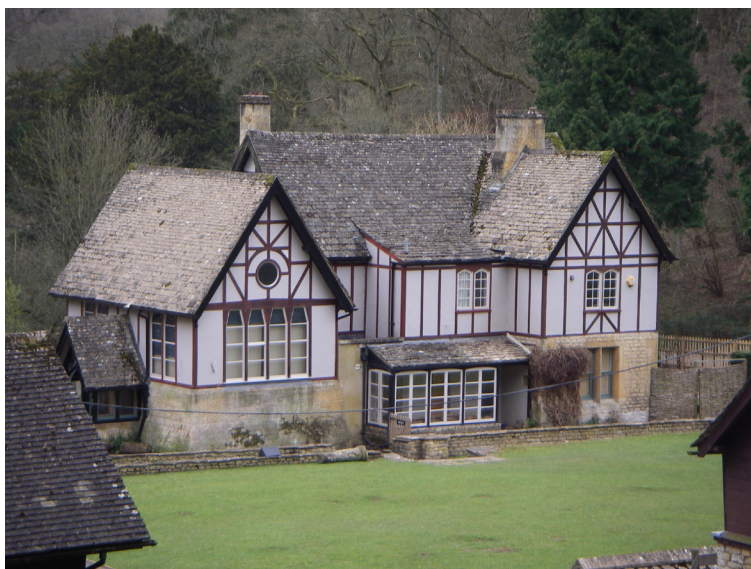
The Shooting Lodge and Victorian Museum from the west

The Lodge is a two storey building, the lower storey being made of irregular courses of rusticated limestone, with dressed ashlar mullion windows and door surrounds. The stone window surrounds are inset with single-pane vertical wooden sashes. The upper storey and gables are half-timbered in regular narrow panels with some symmetrical diagonal bracing. The infill panels are of lime-rendered brickwork. The windows of the upper storey are wooden twin-arched double casements. The steeply pitched roof, with slightly projecting gables, is finished in traditional Cotswolds stone tiles. There are two limestone chimney stacks. The neo-gothic front door, in the centre of the east elevation, was originally within an open porch with the first floor room above jettied and gabled above the entrance. The open porch has since been enclosed by the introduction of framed and glazed panels on all sides and an ancillary exterior door. On the east and south elevations the upper storey is jettied by about a foot and the underside of the jetty expressed by a continuous decorative moulded timber cornice.

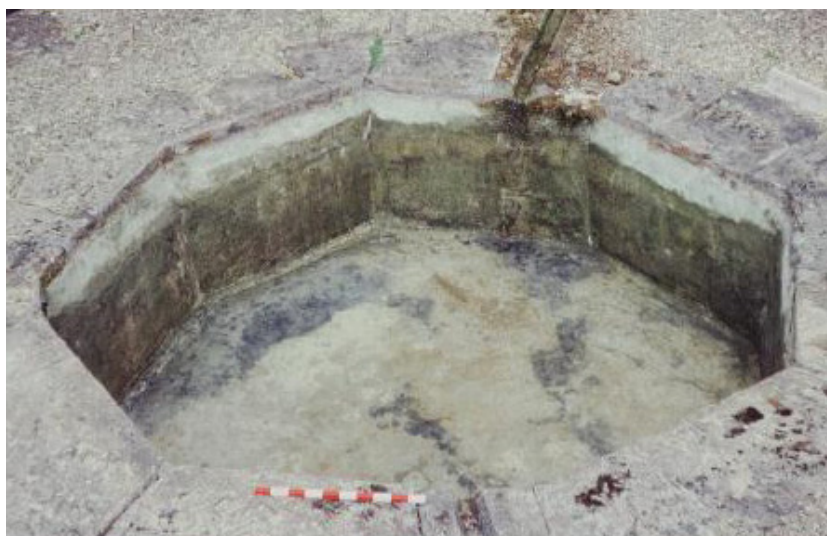
The octagonal cistern in the water shrine, Nymphaeum

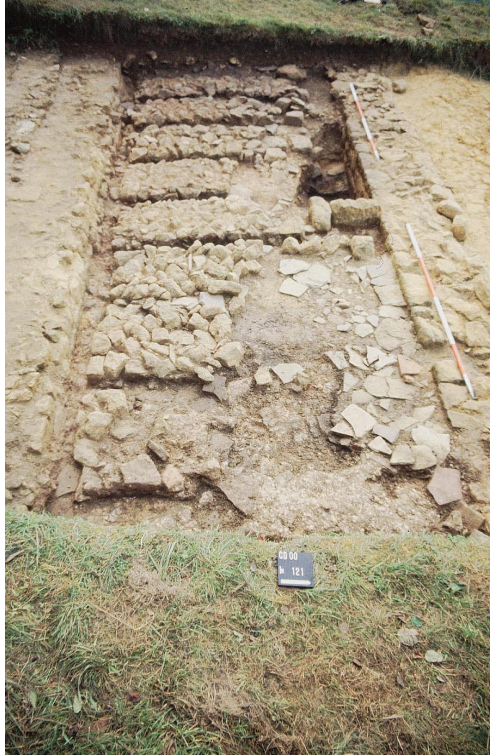
Sub-structure of the South Wing corridor hypocaust

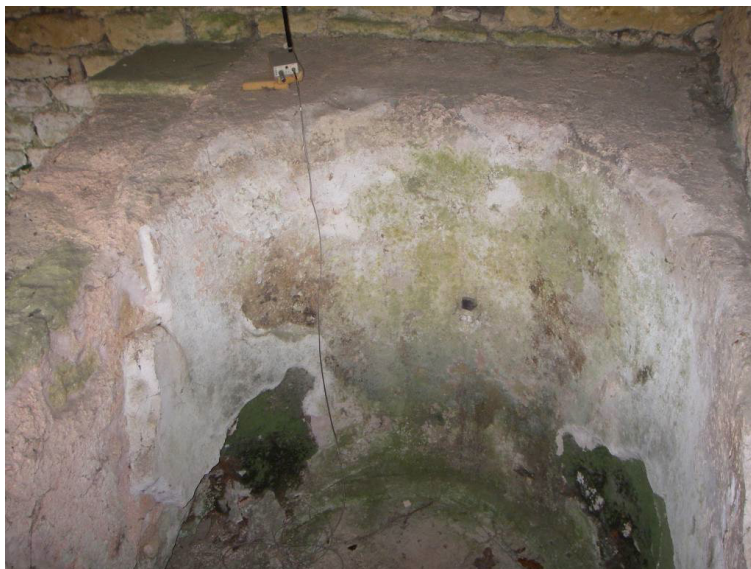
Microbiological growth in the North bath-house

There has been exhaustive monitoring of the shelters over the last two decades to assess their environmental performance. (Ahmon, 2005). The design of the enclosures and shelters varies in their properties of insulation, ventilation, and artificial heating. All the shelters have had varying treatments and additions over the years, increasing the range of variability between them.

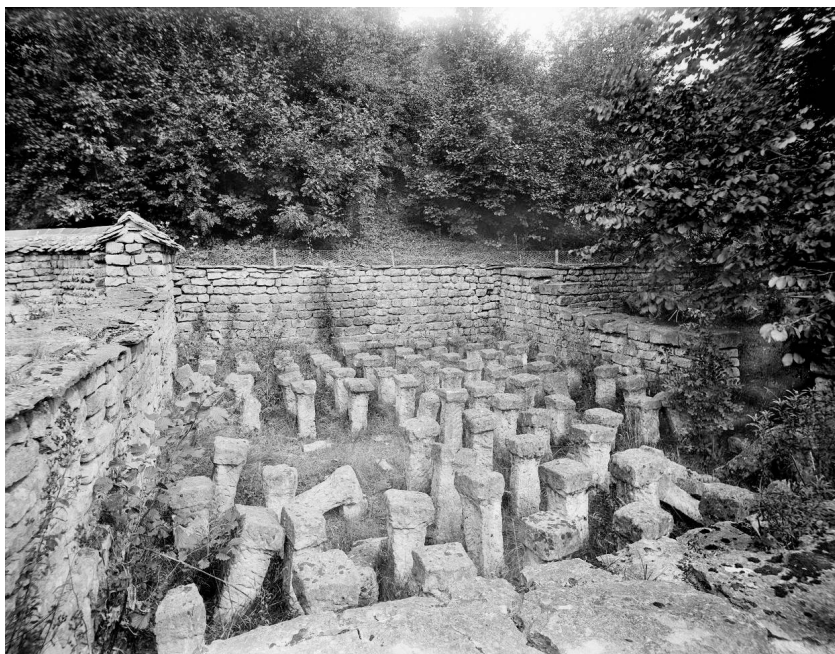
The hypocaust photographed in the early 20th century by Henry Taunt

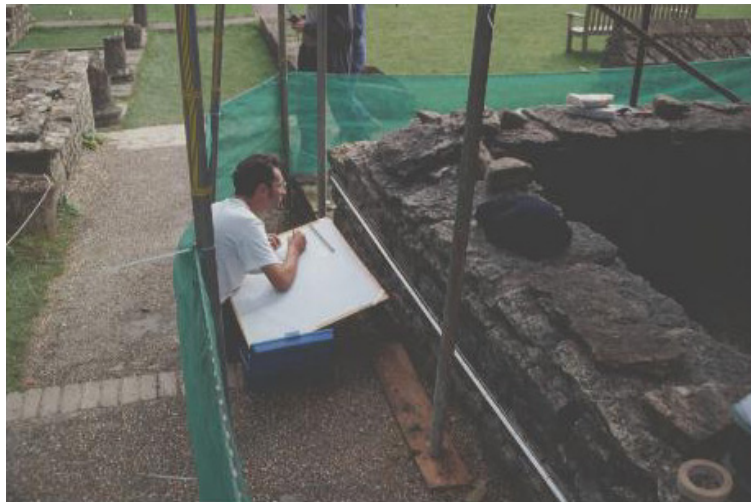
Detailed recording of masonry in the West Wing
