**Chedworth Roman Villa  
Yanworth  
Gloucestershire**

**Archaeological Fabric Survey**

**The National Trust**

CA REPORT: 04173

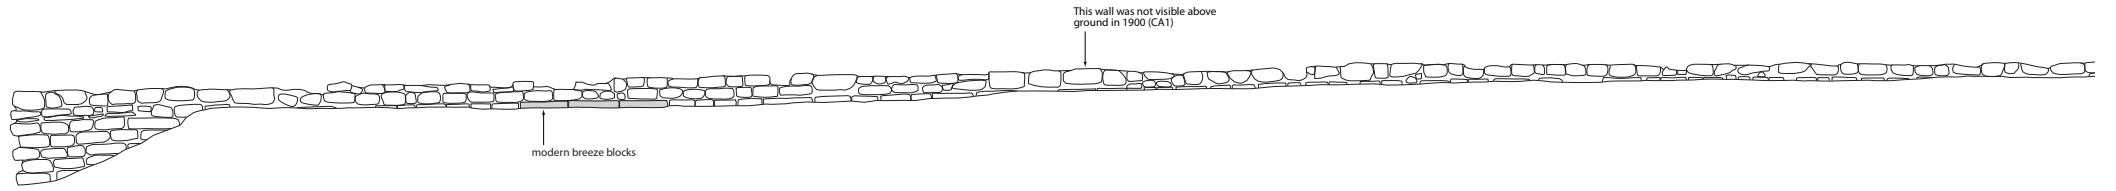
Fig. 10 Elevation 5 (1:50)

This area of wall looks similar to Fox's elevation of 1886 but is definitely modern

The western section of this wall was rebuilt in 1963 and the whole wall rebuilt in 1967 (Irvine undated c). Excavations in 2000 found that this wall had modern concrete foundations and uncovered an earlier wall running parallel and to the north (CA2000). This may have been an earlier modern rebuild

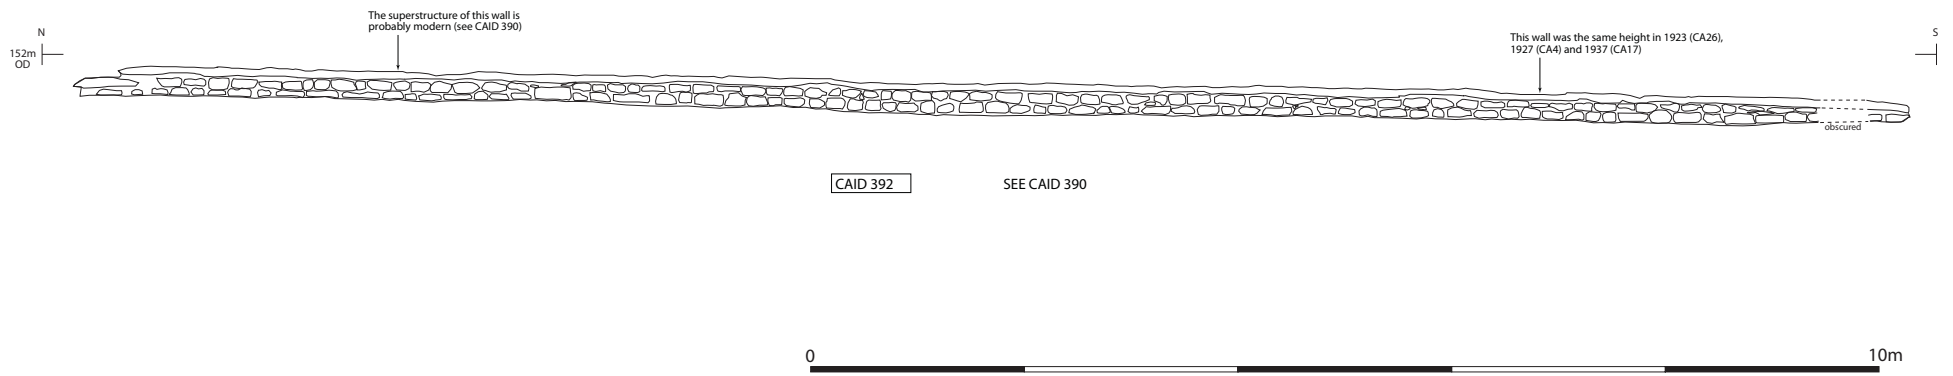
Fig. 12 Elevations 7-10 (1:50)

This wall does not match Fox's elevation of 1896, or a photograph of 1927 (CA583). It looks similar in a photograph of 1935 (CA563). It was probably rebuilt between 1886 and 1935

These walls have been rebuilt since 1935 (CA550), but before 1979 (CA 29, 33)

These walls have been rebuilt since 1979 (CA572, 573)

This stonework does not match photographs of 1979 (CA28, 32). The walls have probably been rebuilt since.

This wall was rebuilt in 1973 (Sly and sons 1973)

This wall was unexcavated (or not present) in 1895 (CA577) and 1932 (CA20)

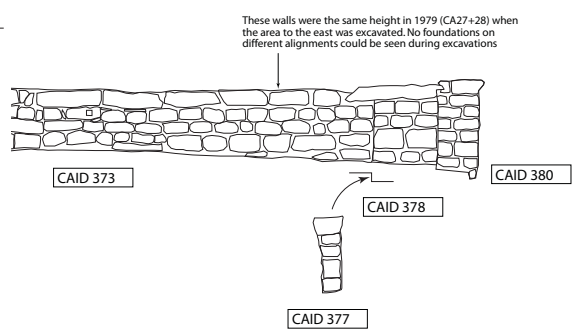
Fig. 13 Elevation 11 (1:50)

This wall was the same height in 1934 (CA50) and 1979 (CA29)

These walls were the same height in 1979 (CA27+28) when the area to the east was excavated. No foundations on different alignments could be seen during excavations

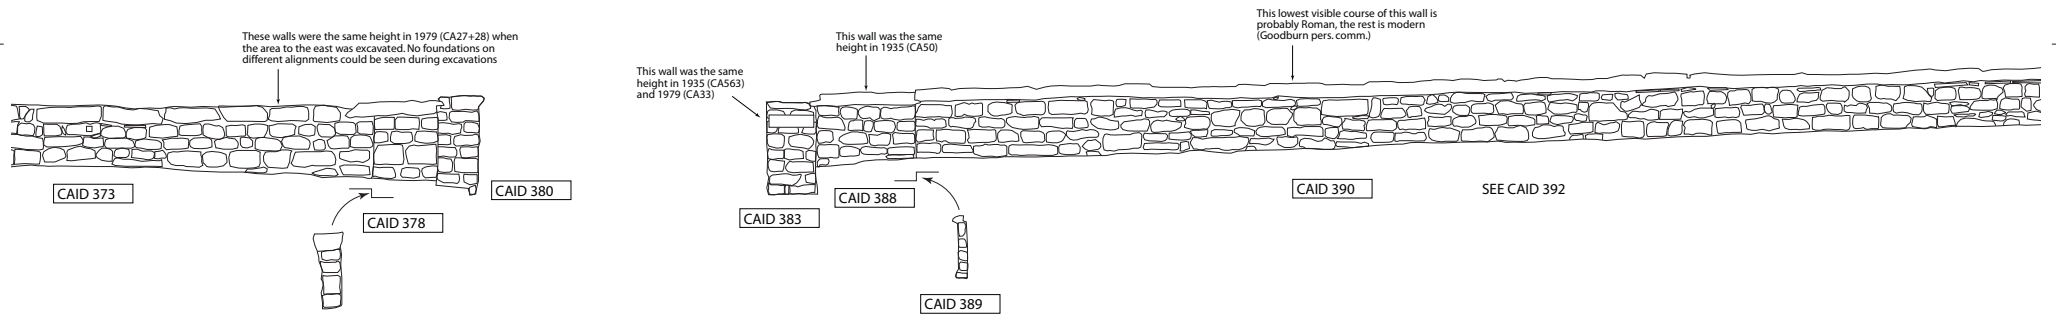
Fig. 14 Elevation 12 (1:50)

This wall was the same height in 1935 (CA563) and 1979 (CA33)

This wall was the same height in 1935 (CA50)

This lowest visible course of this wall is probably Roman, the rest is modern (Goodburn pers. comm.)

This area is marked as modern on Fox's plan of 1886

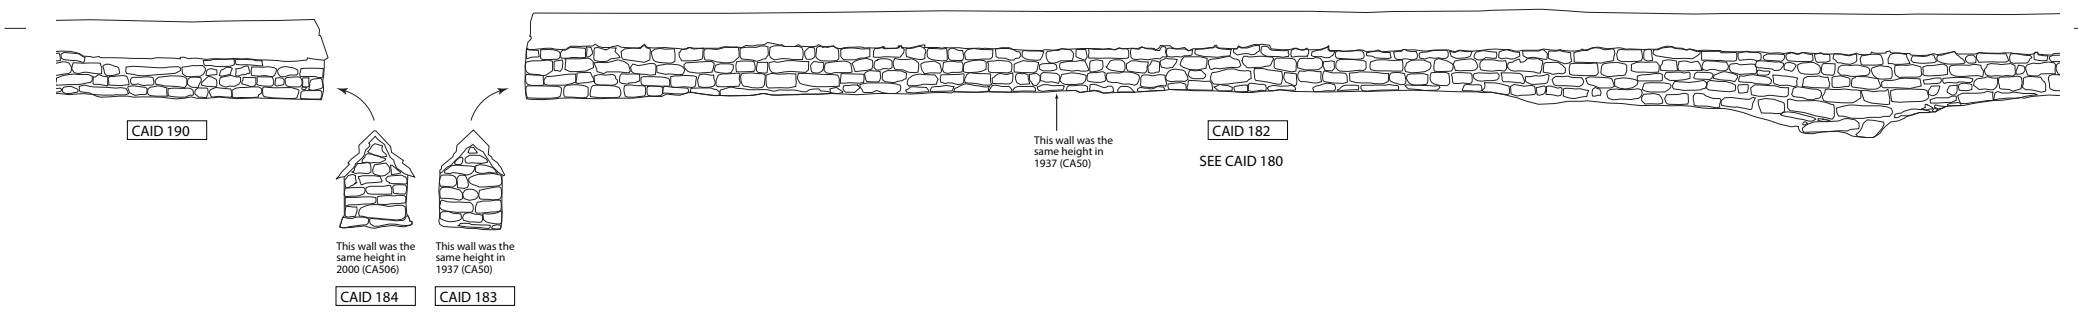
Fig.22 Elevation 20 (1:50)

This wall was rebuilt in 1960 (Irvine undated c).  
It was the same height before this in 1936 (CA536)

This buttress was present in 1936 (CA536). It may not have been rebuilt when CAID 185 was, in 1960

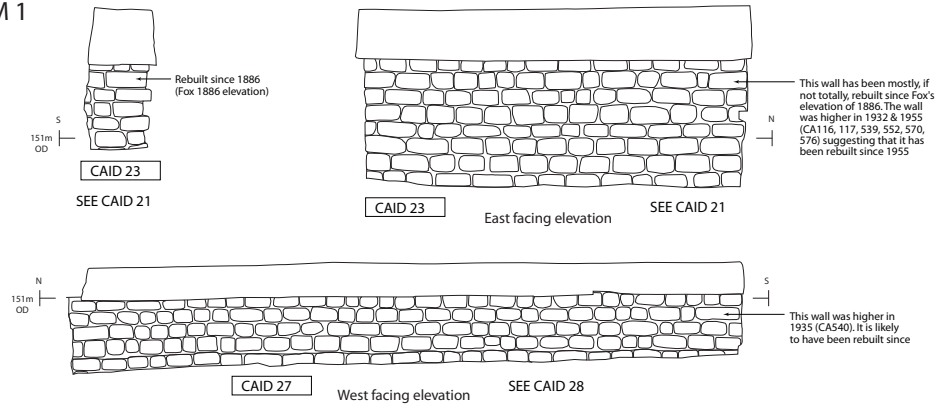
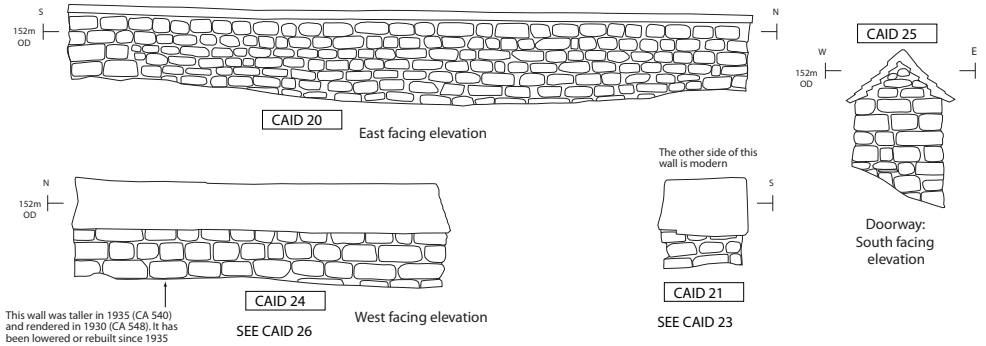
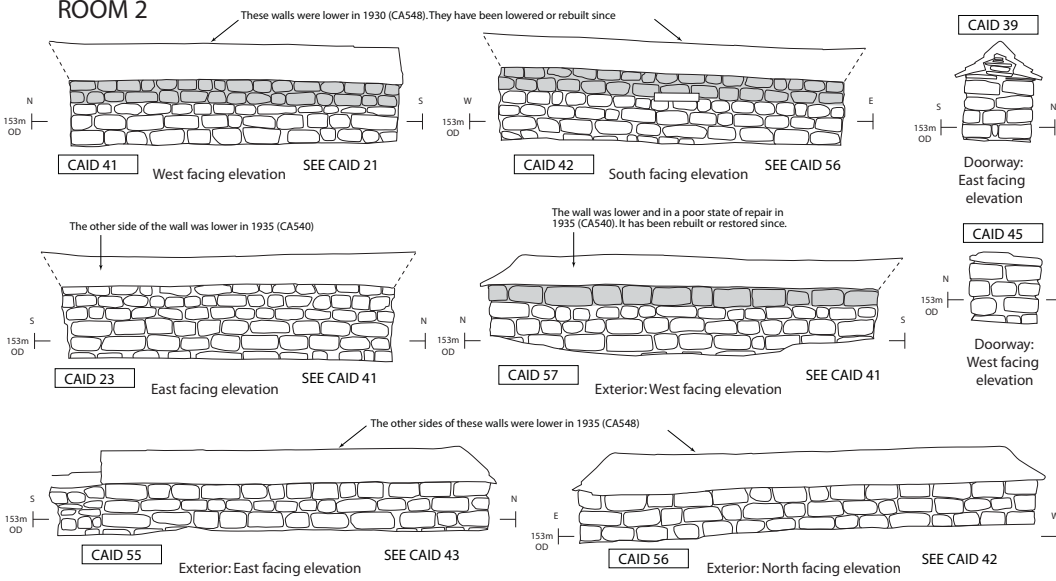
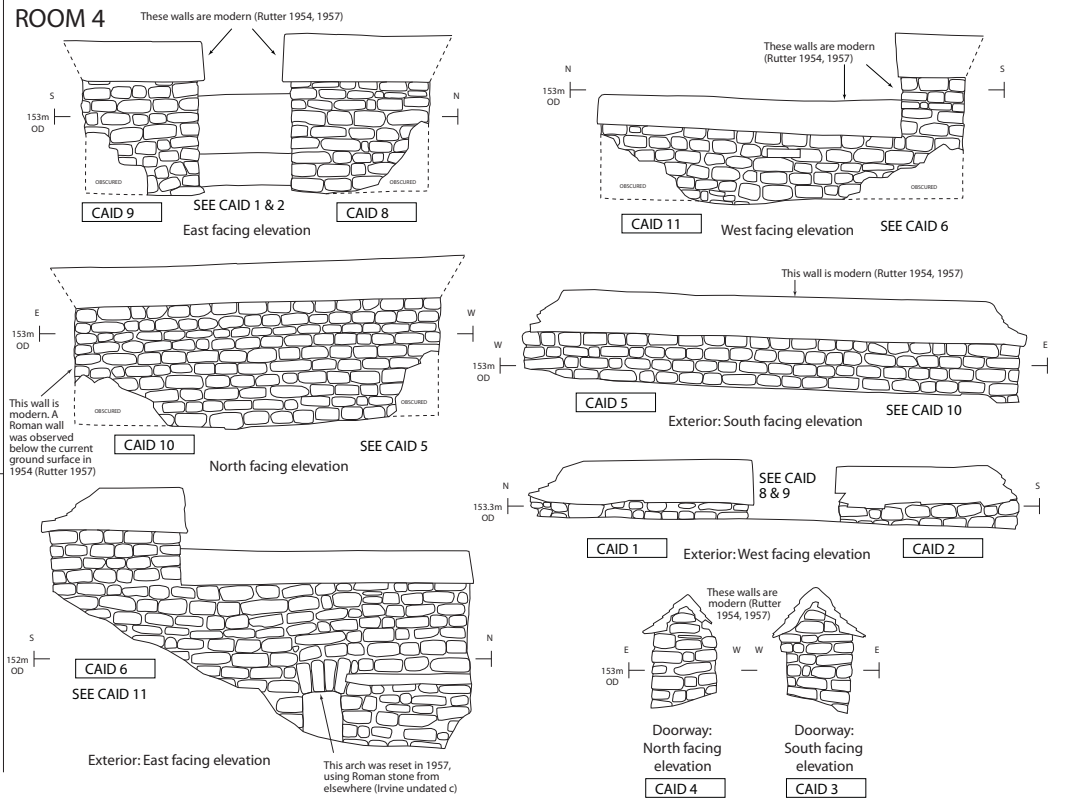
Fig. 32 Elevations in rooms 1, 1a, 1b, 2, 4 and the south corridor (1:50)

No step was depicted on Fox's plan of 1886, on which extends further to south at this height. It has been rebuilt since 1955 (CA539)

This stonework does not match Fox's elevation of 1886, the northern area of which was shaded as modern. It was rebuilt between 1886 and 1955 (CA539)

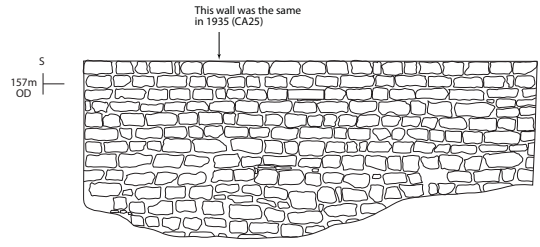
Fig 35 Elevations in rooms 10, 11, 12 and 13 (1:50)

CAID 178 SEE CAID 126  
Room 13 East facing elevation

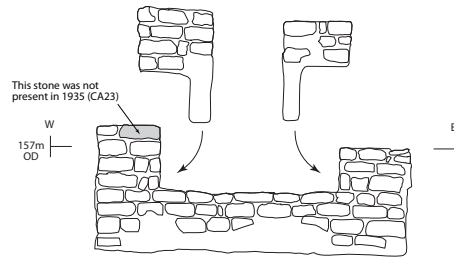
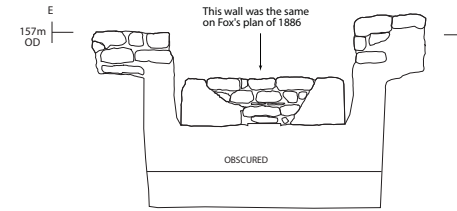
Fig 36 Elevations in rooms 14 and 15 (1:50)

CAID 166 SEE CAID 166

South facing elevation

CAID 168

East facing elevation

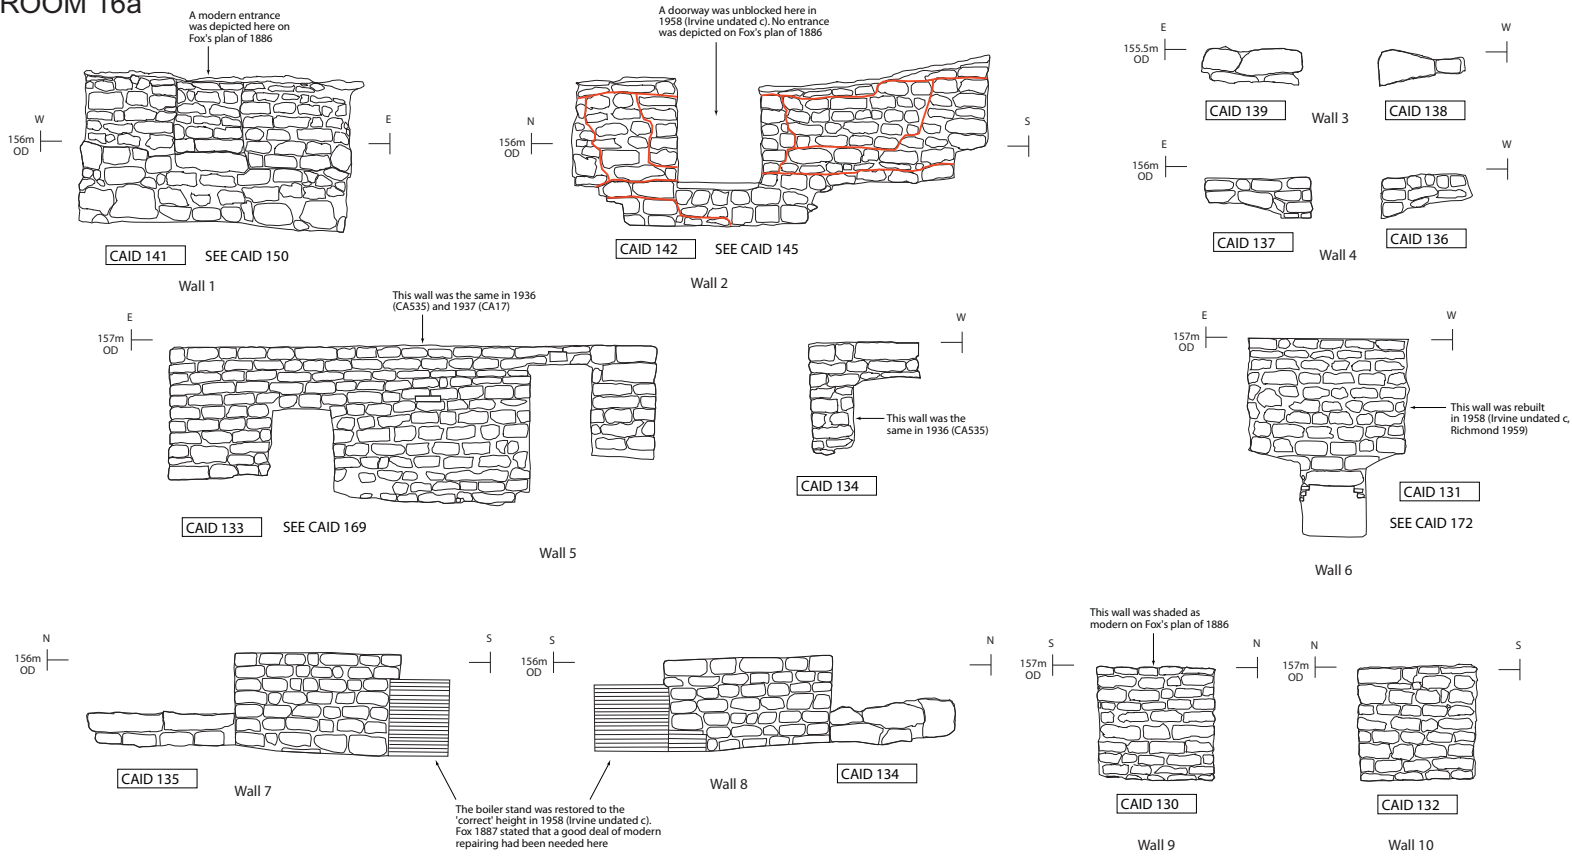
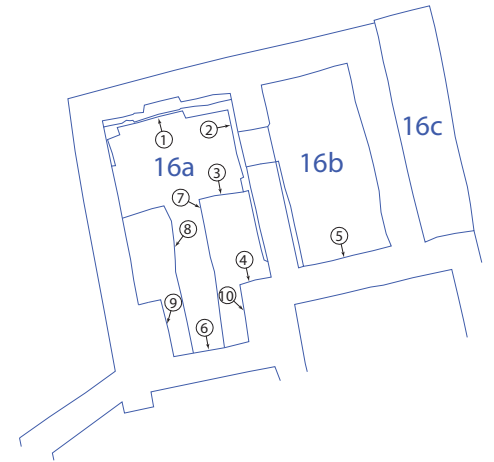
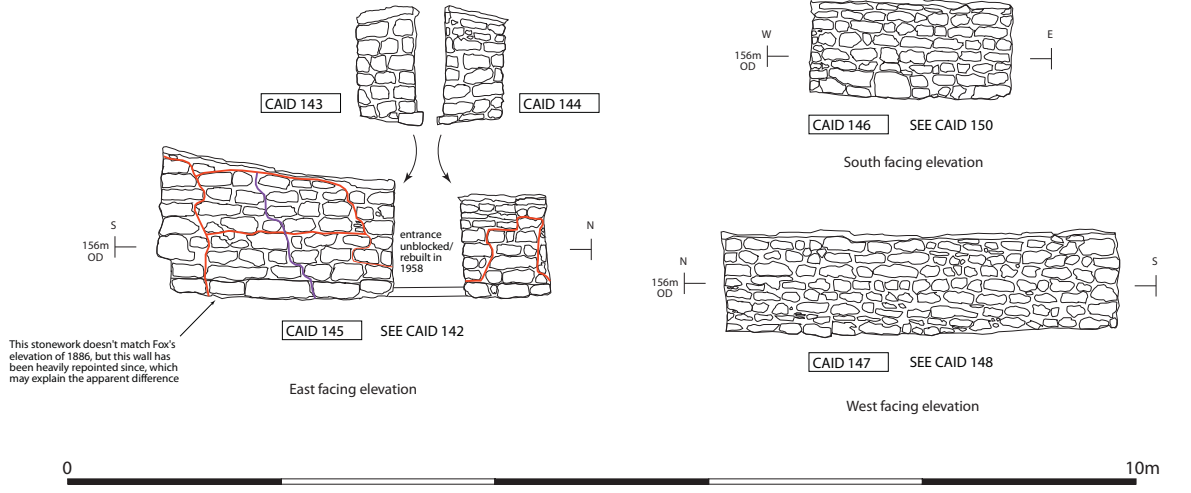
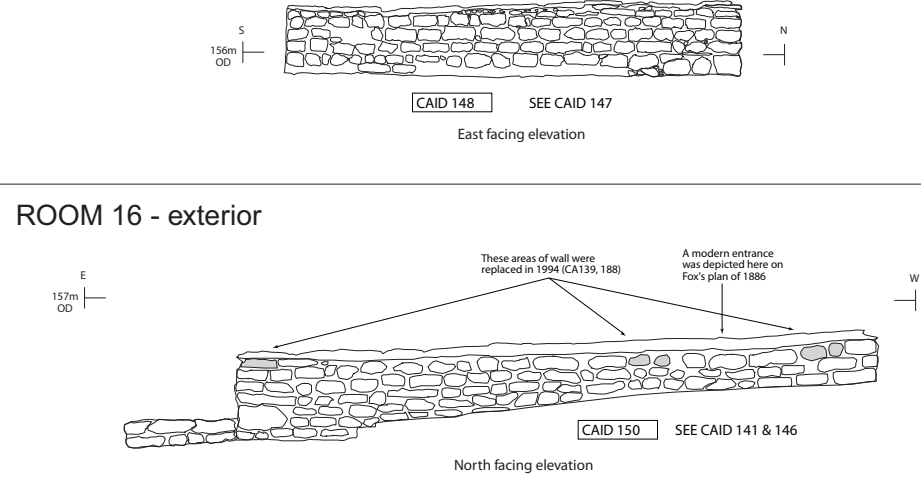
Fig 37 Elevations in room 16 (1:50)

— Building breaks suggested BUFAU 1995 on evidence of mortar types  
 — Building breaks suggested Fox 1886

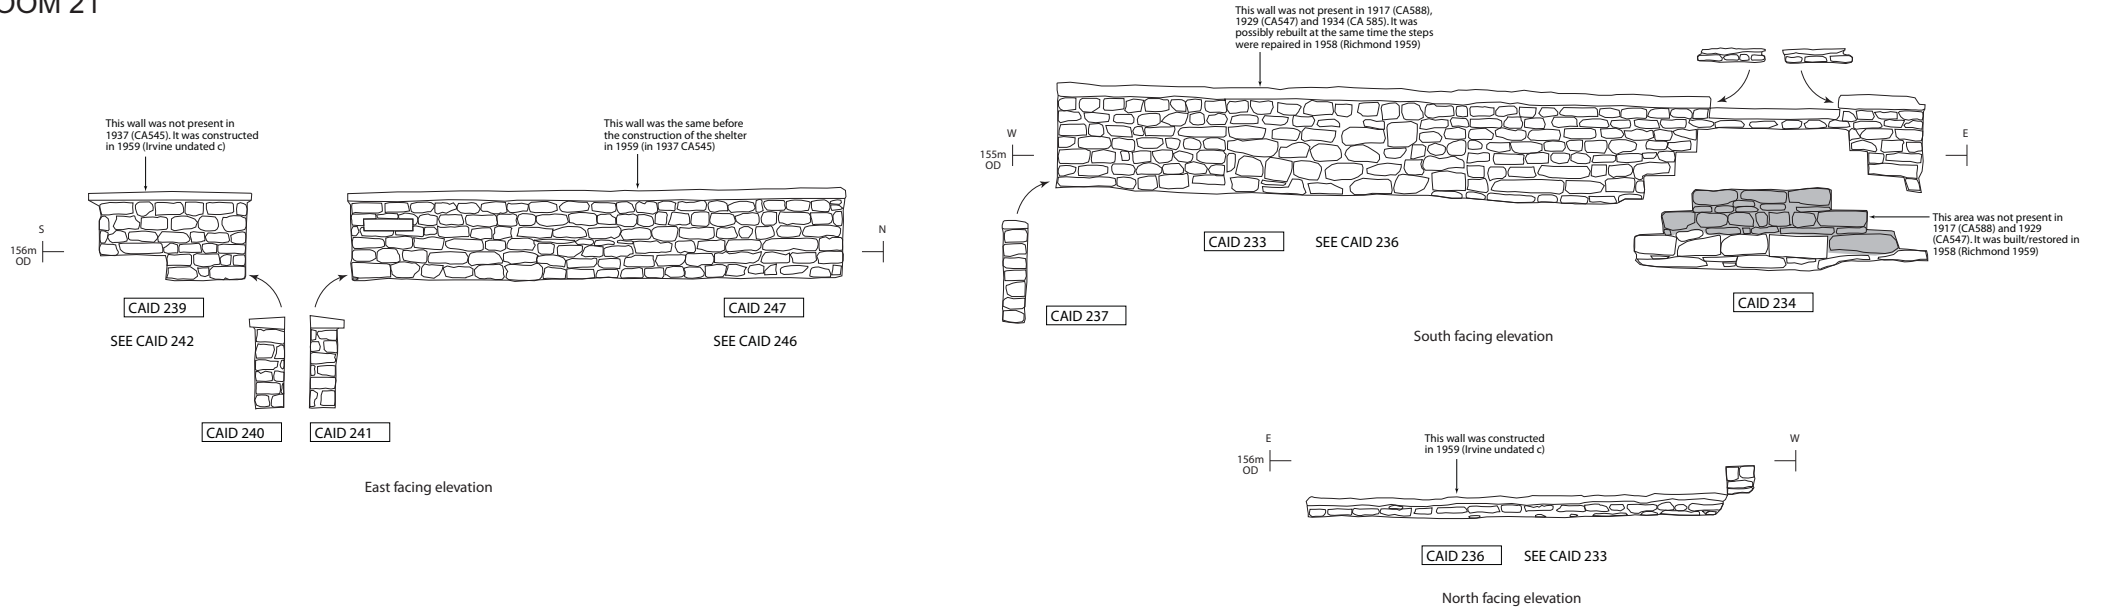
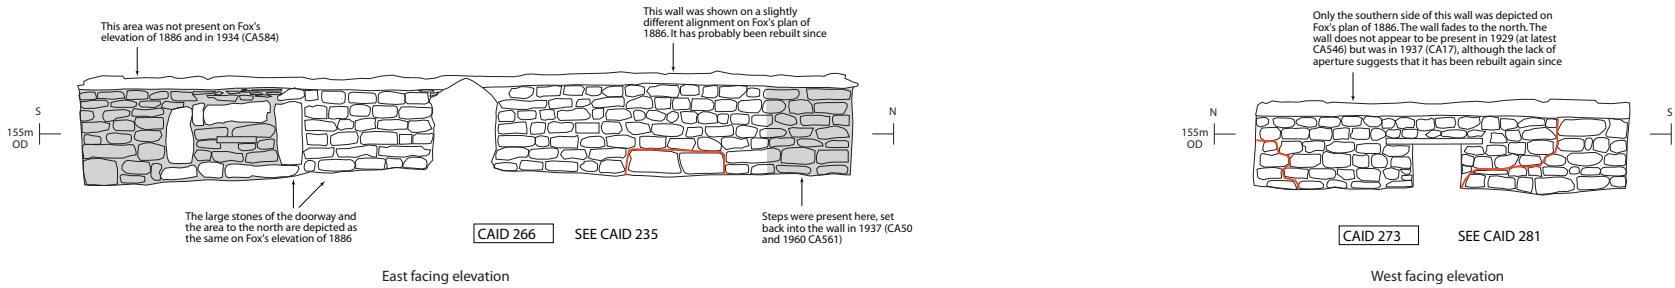
Fig 40 Elevations in rooms 21 and 21a (1:50)

— Building breaks suggested BUFAU 1995 on evidence of mortar lines

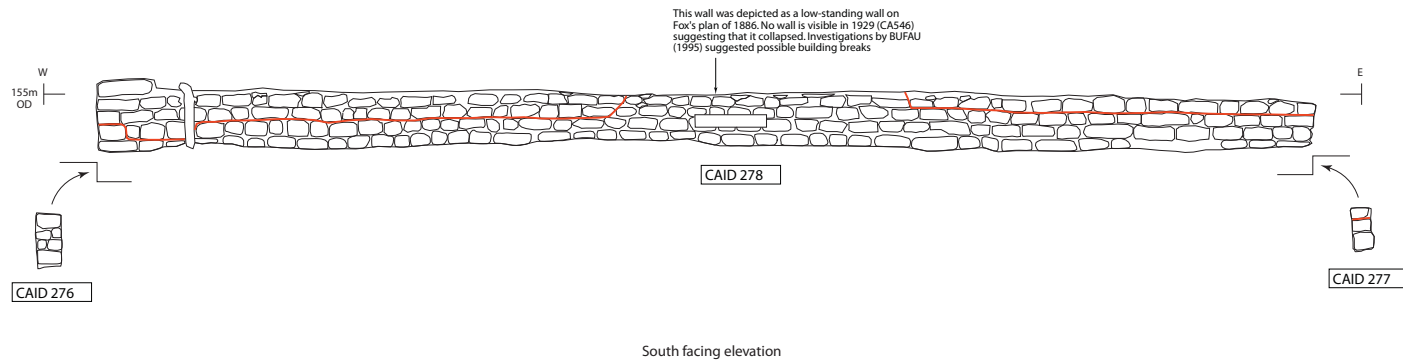
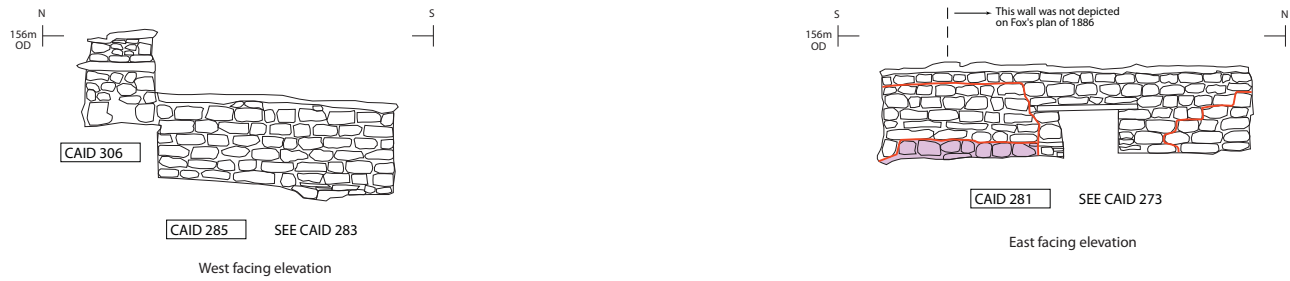
Fig 43 Elevations in rooms 24 and 24a (1:50)

- Suggested building break (BUFAU 1995)
- Possible Roman fabric (BUFAU 1995)

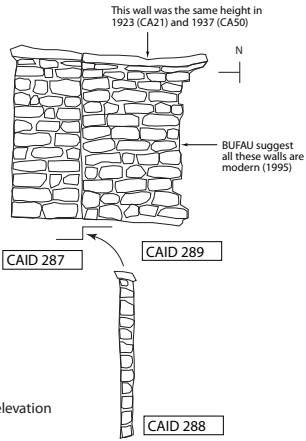
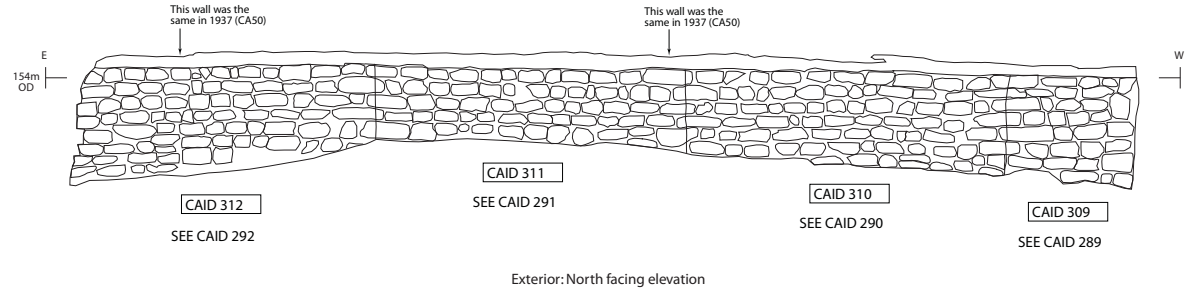
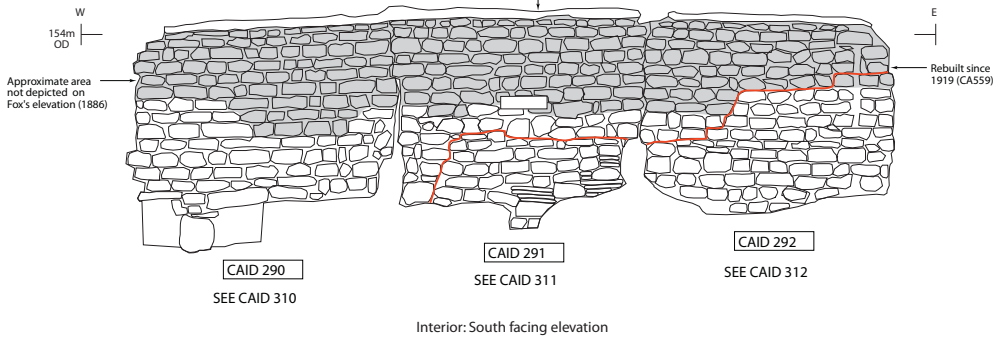
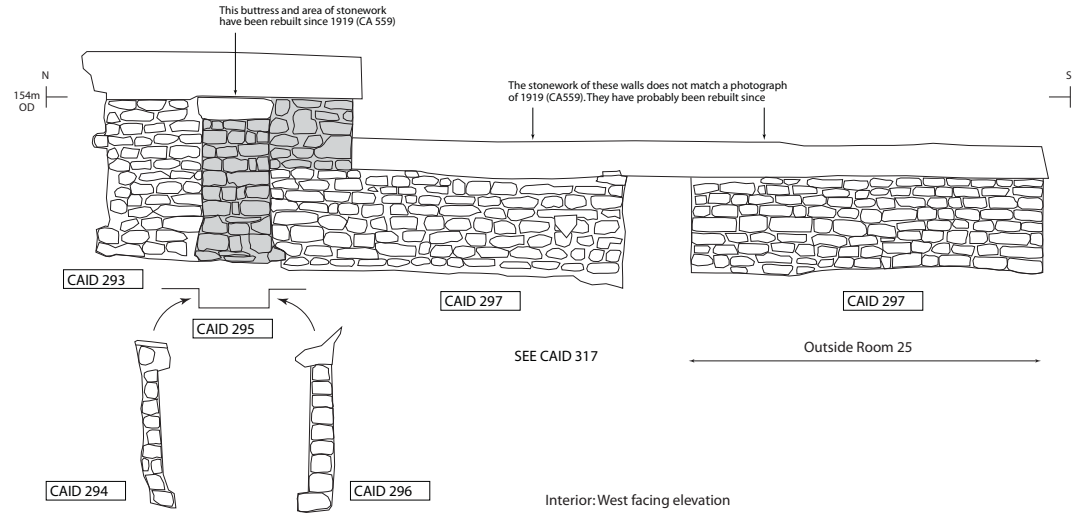
Fig 44 Elevations in rooms 25 and 25a (1:50)

Interior: East facing elevation

— Suggested building break (BUFAU 1995)

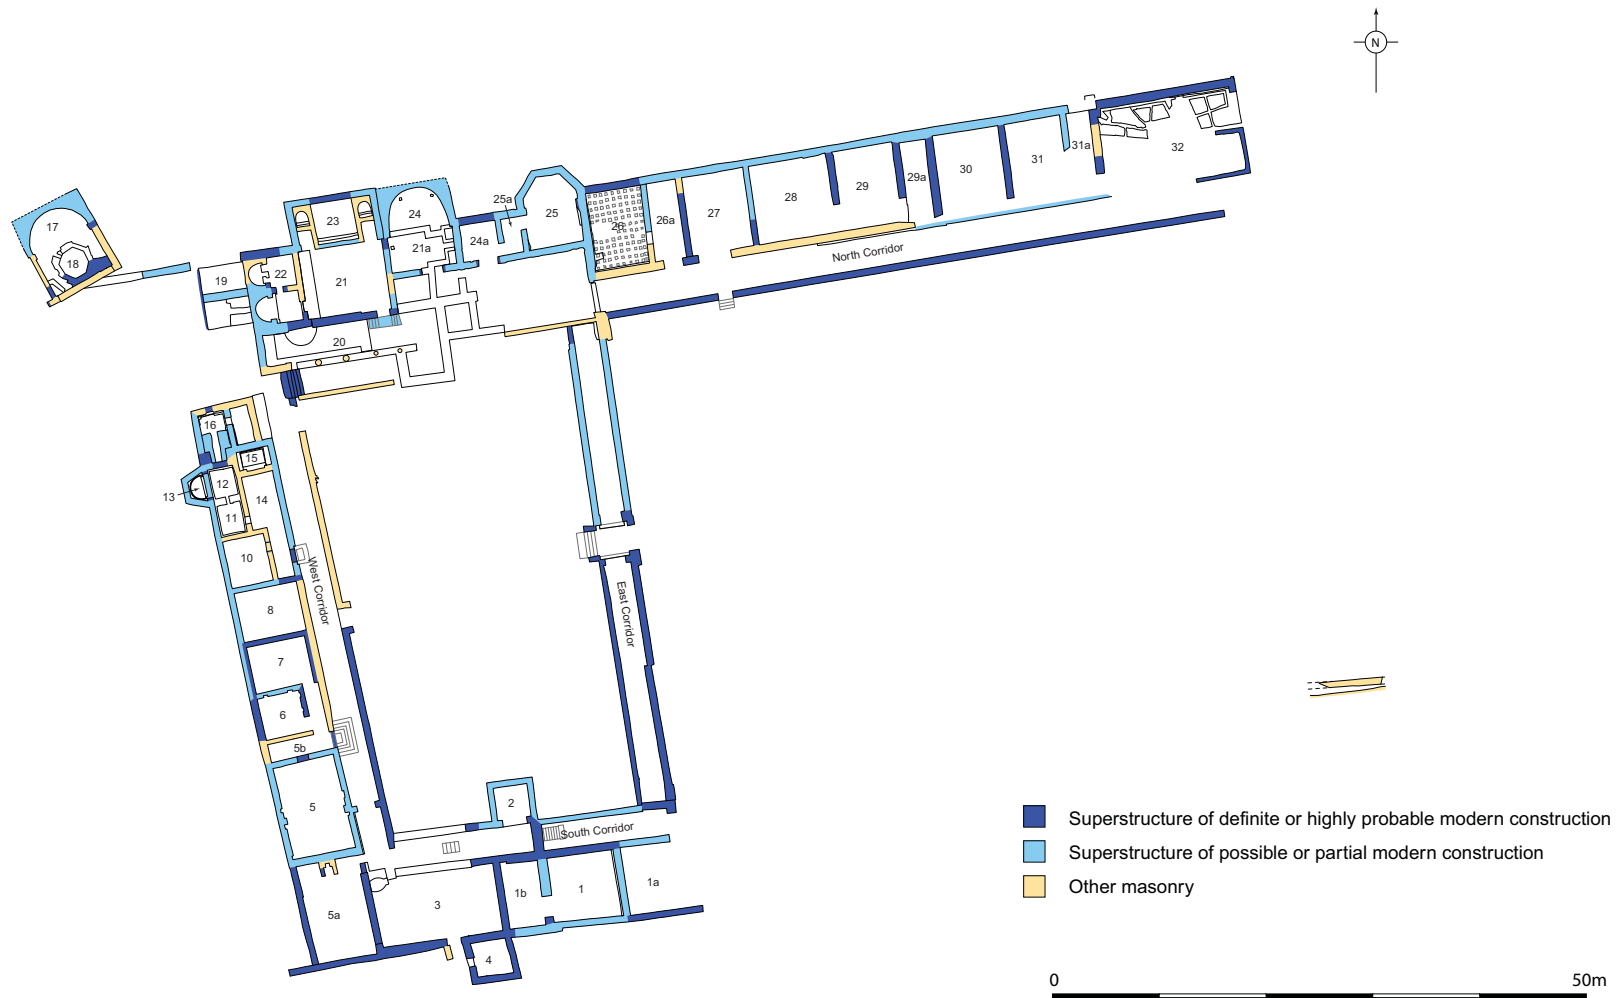
Fig. 47 Plan of Roman Villa showing areas of modern rebuilding of above ground masonry (1:500)

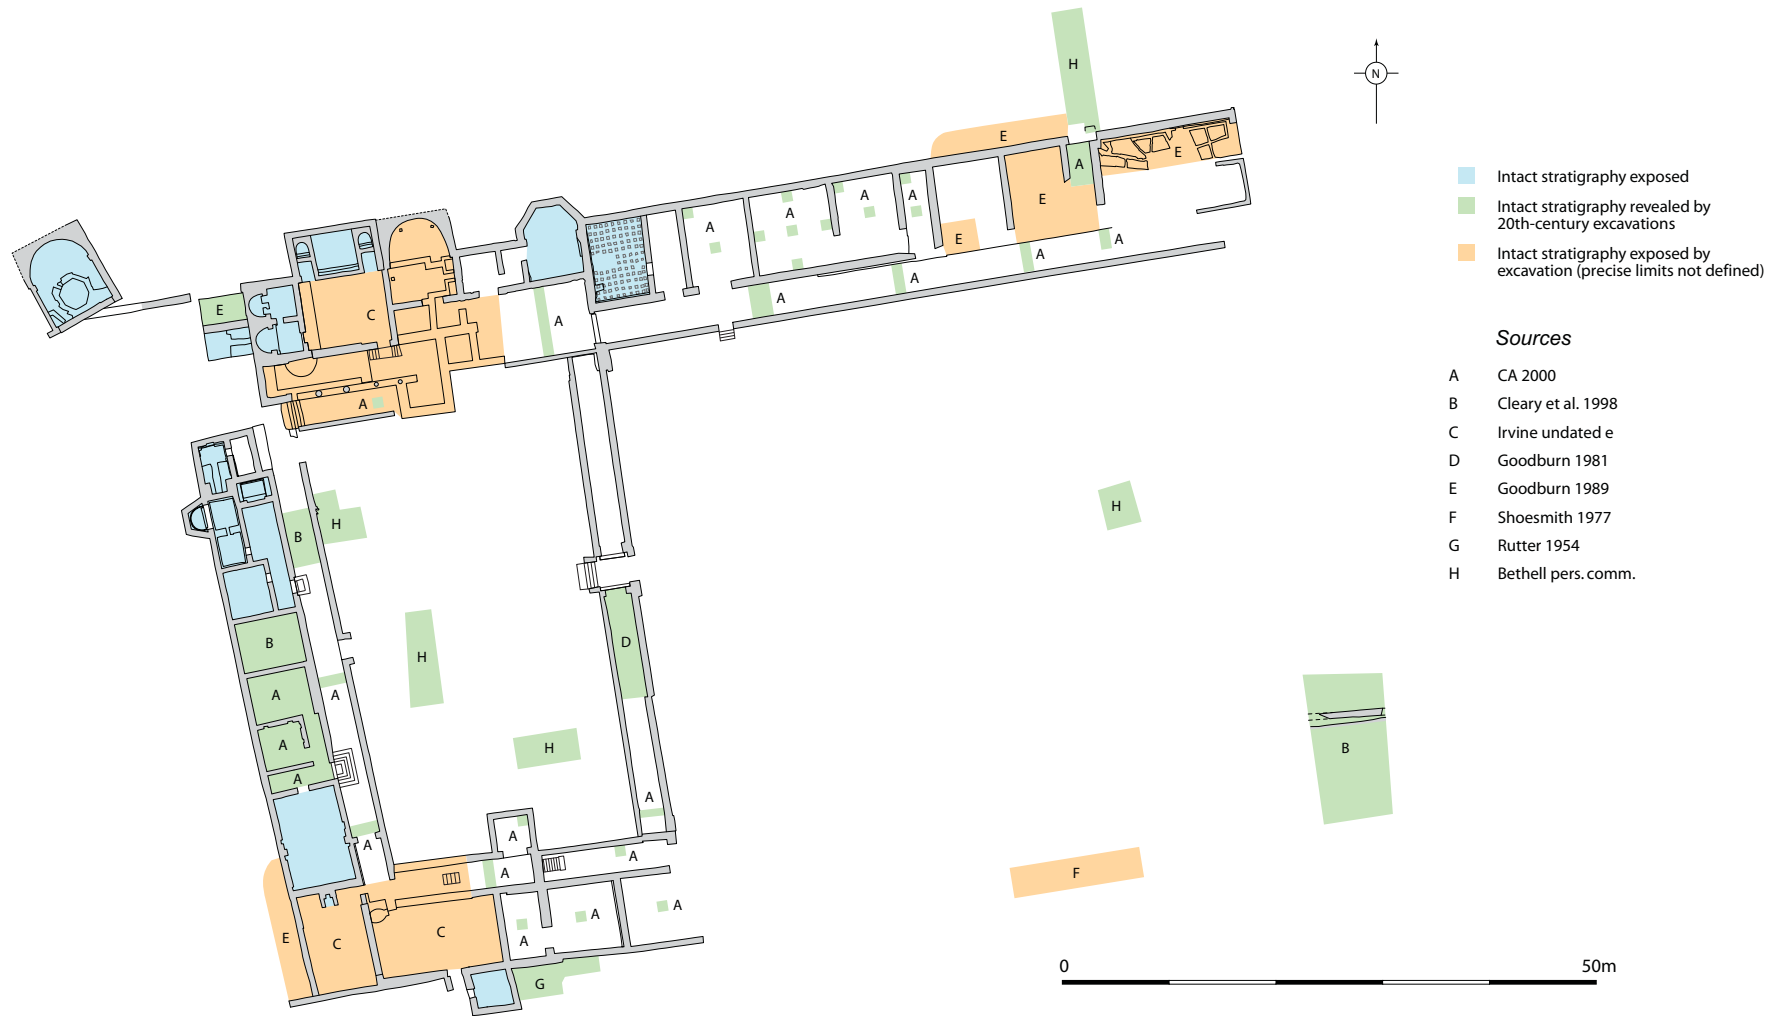
Fig. 48 Plan of Roman Villa showing areas of known intact Roman stratigraphy (1:500)
