Figure 1c.
Roman Villa, c.1900

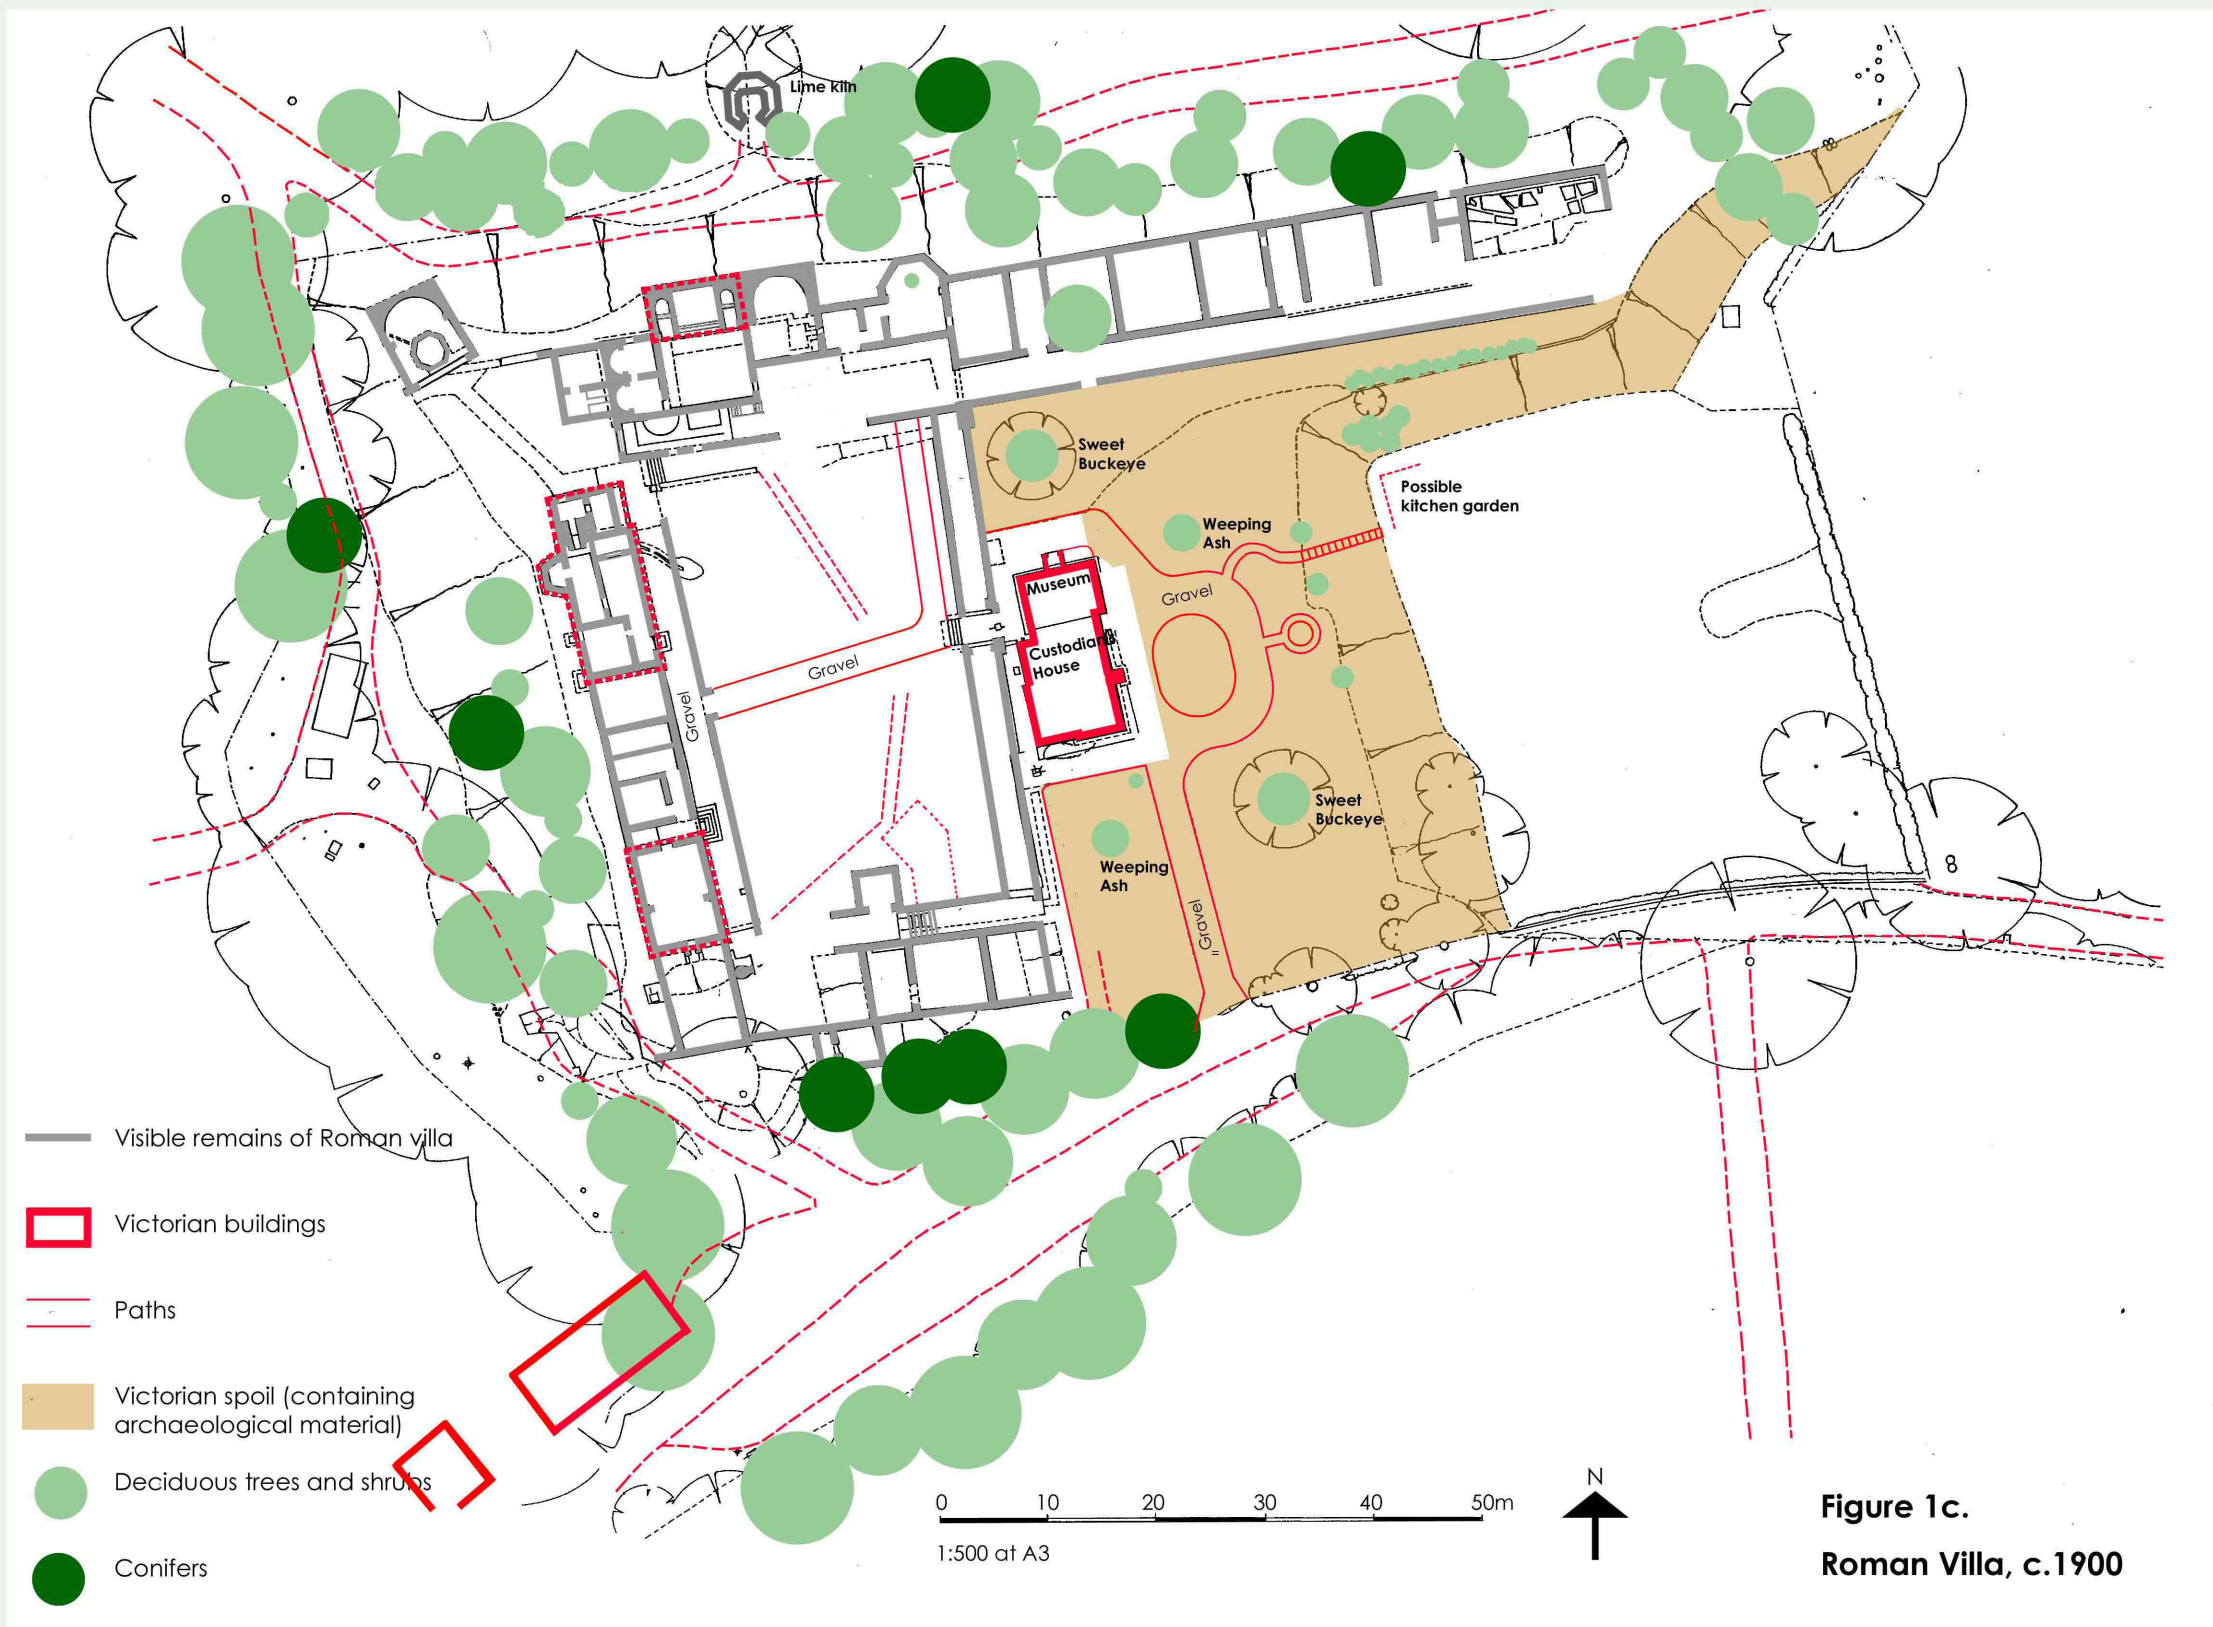
A sizeable collection of old photographs of the Chedworth Roman villa site was compiled by Norman Irvine who, between 1912 and 1977, grew up at and then became caretaker of the villa. This collection has provided the basis for the plan in Figure 1c. The plan indicates the likely layout of the villa site in about 1900, drawn from information contained in photographs. Photographs pre-dating 1900 are few but sufficient to suggest that the basic layout of 1900 had probably been established in the early 1870s. Certainly the 1884 Ordnance Survey map shows an oval front drive to the hunting lodge and a central path across the villa courtyard.

The main (east) front of the lodge was approached by a gravel drive leading from the lane to the south. To the immediate east of the house the drive was oval. This survived until the early 1950s, when it appears to have become dilapidated and grassy. To the east of the oval drive lay a small, stone-edged octagonal ornamental bed within a gravel path. The octagonal stone edging was eventually moved (during or after the 1960s) down to the lower kitchen garden area. A small sinuous path led from the oval drive to a flight of steps leading down to the lower kitchen garden. Steps exist in the same place today. A photograph of about 1912 shows diamond- and lozenge-shaped ornamental beds on the slope down to the kitchen garden area. It is not known how long these existed.

Within the area of the Roman villa, very little 'gardening' took place. The walkway immediately in front of the west range of buildings was gravelled and a gravel path was created running across the courtyard from west to east. It then turned northward. Smaller informal (worn?) paths also radiated across the grass of the courtyard for a time.
