Figure 1d.
Roman Villa, c.1962:

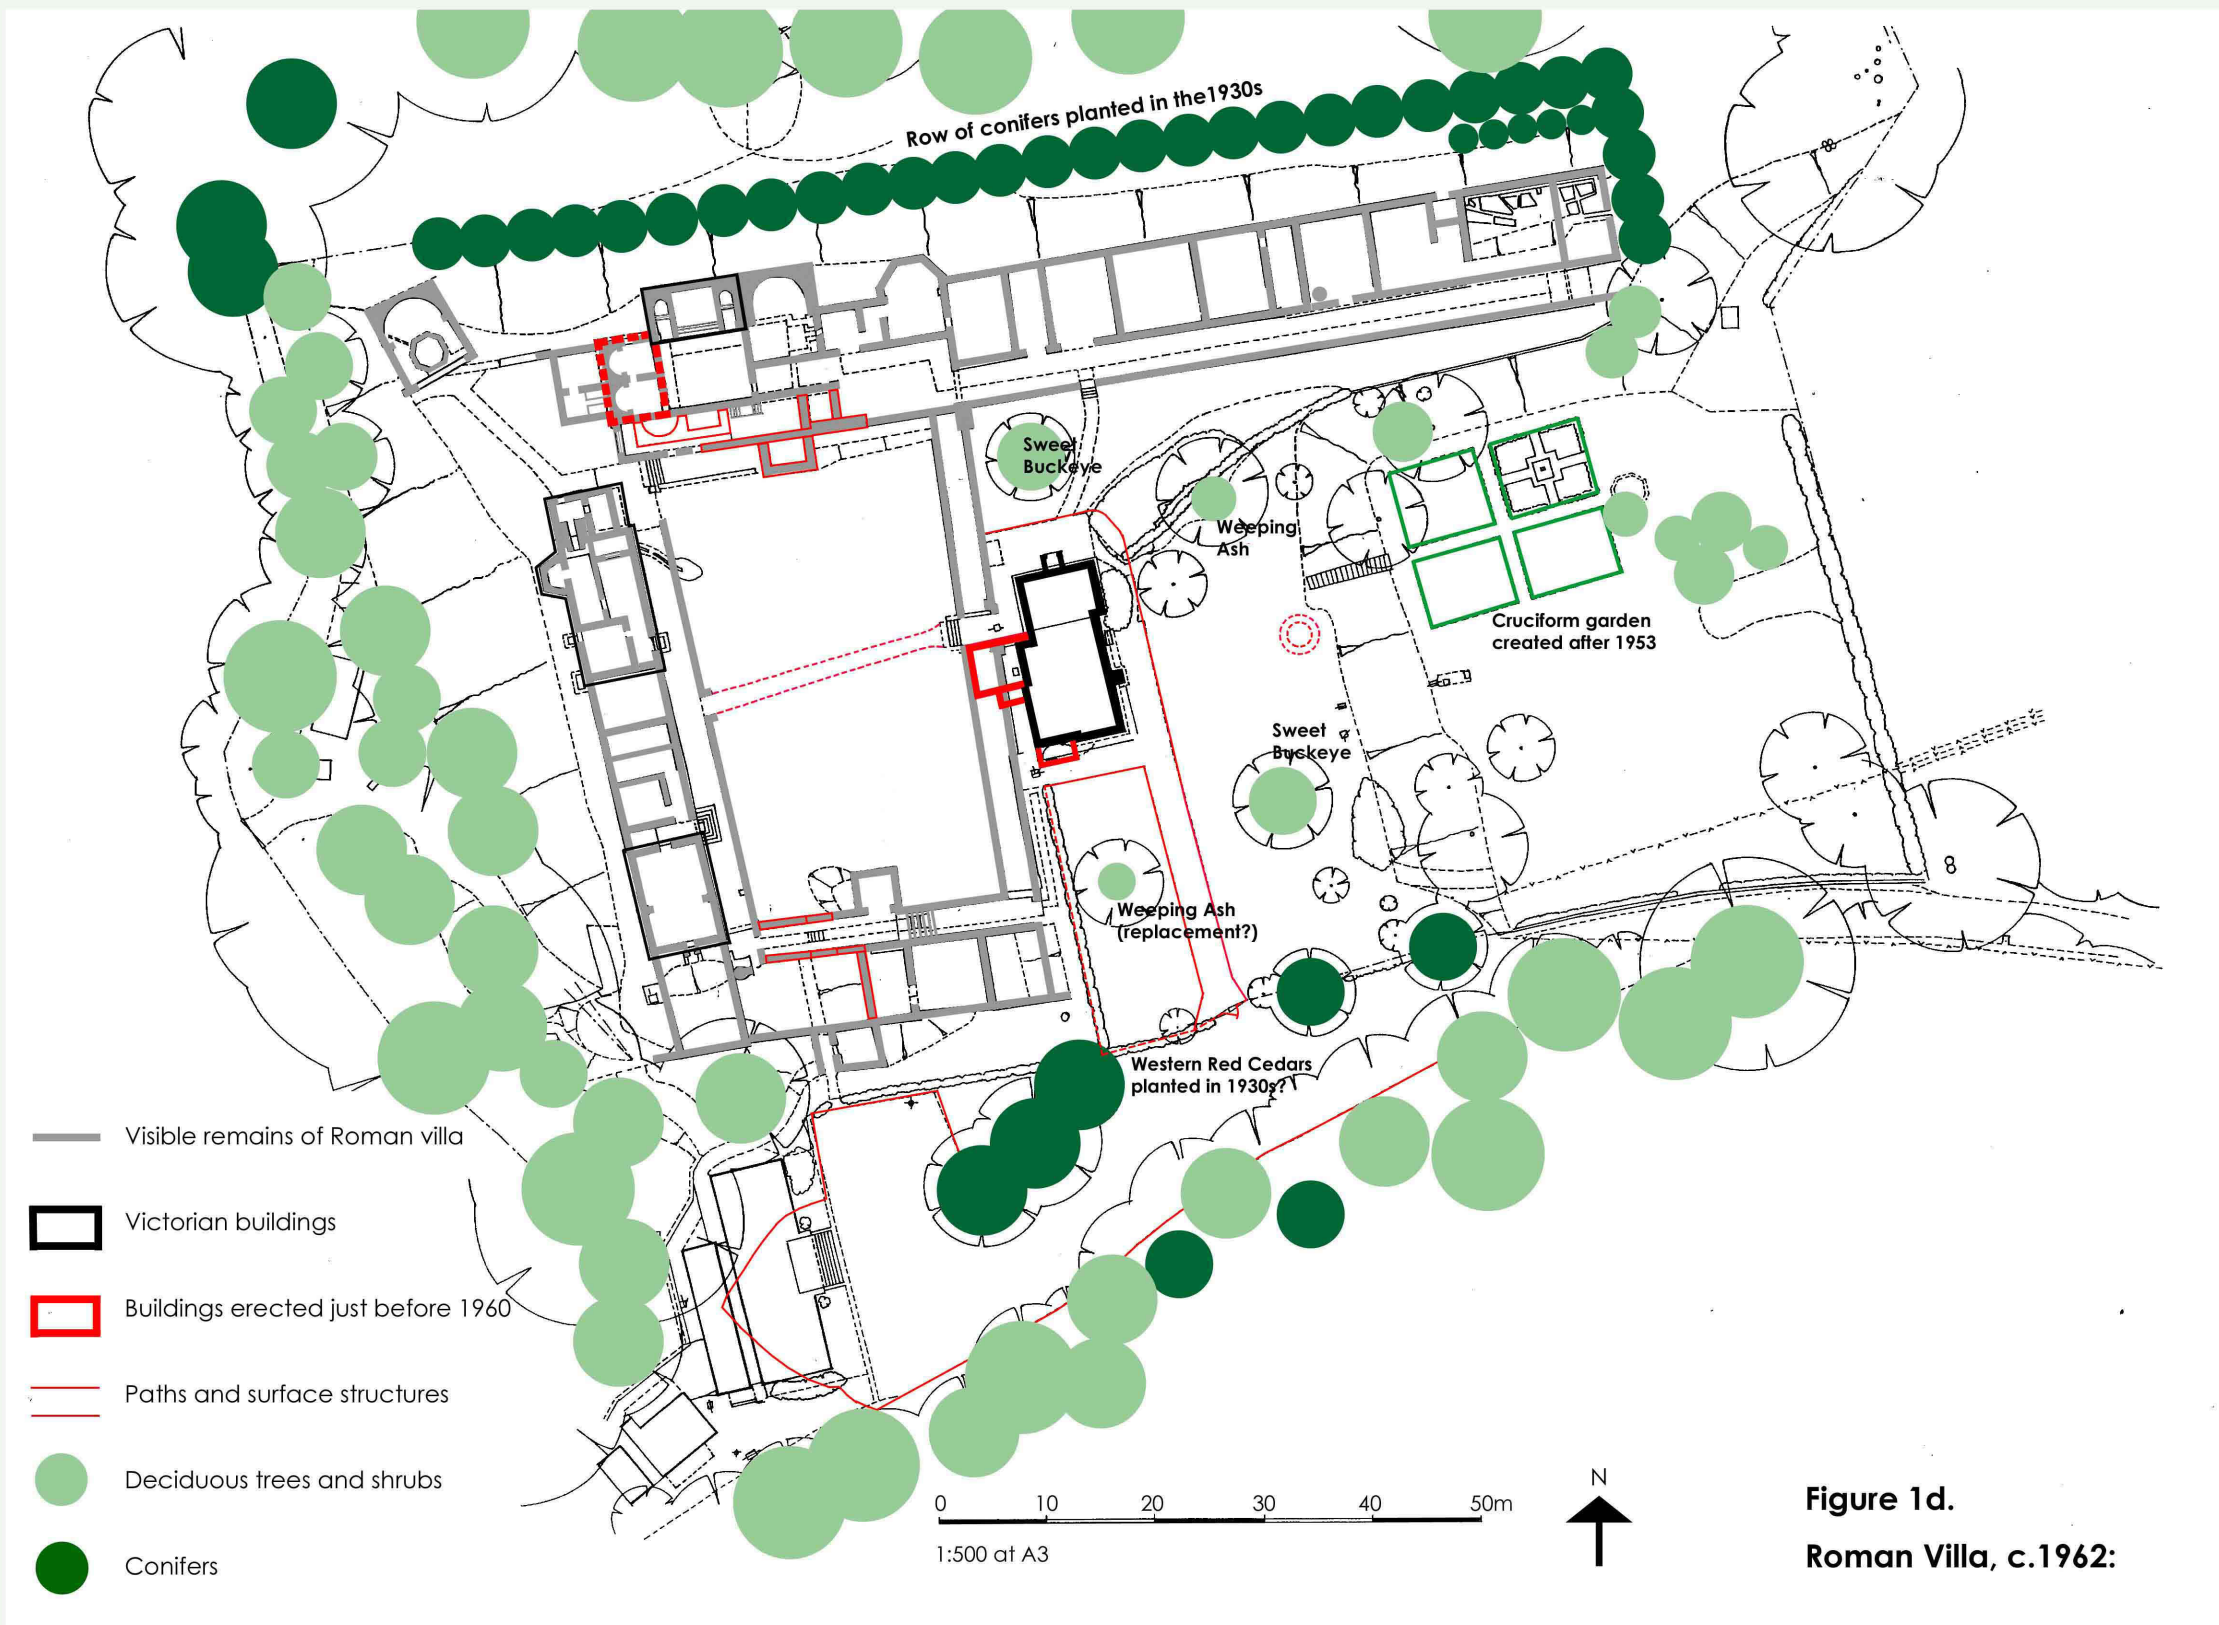
The photographic collection indicates that the layout of the villa and hunting lodge grounds was little altered between 1900 and the late 1950s. The fringe of woodland bordering the villa on its north, west and south sides tended to ebb and flow as trees periodically encroached and were cleared back again. In the early 1930s, a long row of conifers was planted along the bank to the immediate north of the villa and, by 1962, had formed a substantial hedge of trees. These were removed again in the late 1990s.

There are a number of other large conifers growing around the fringes of the site, several of which - in particular, the Western Red Cedars - also appear to have been planted in the 1930s. By 1962, they were sizeable trees.

On the area below the hunting lodge terrace, a cruciform garden arrangement was established at some date after 1953. This appears to have been still been a kitchen garden.

A single storey building with a shallow pitched roof was added to the centre of the west side of the hunting lodge for a time. It is first to be seen in photographs dated 1937 and remains visible on photographs of 1962. It is not known when it was demolished.

A number of distinct changes to the site were made in 1959. A new protective shelter was built over the hot dry rooms of the north-west bath suite. Around this time, a number of narrow concrete strips were laid amongst the Roman ruins, to indicate the alignments of buried sections of walls and foundations.

Outside the hunting lodge, the oval drive was removed and replaced by a simple section of linear gravel drive in front of the house.
