Forth Replacement Crossing

St. Margaret's Hope Archway

Standing Building Survey Report

July 2010

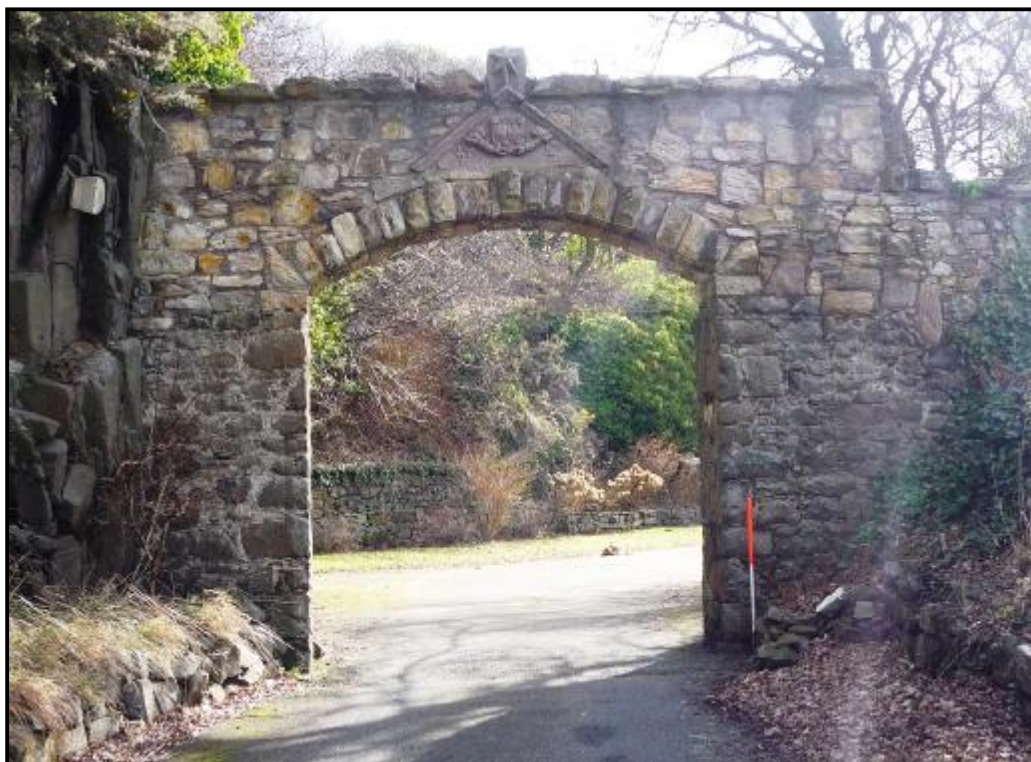
Plate 1: The archway, west facing elevation: from west.

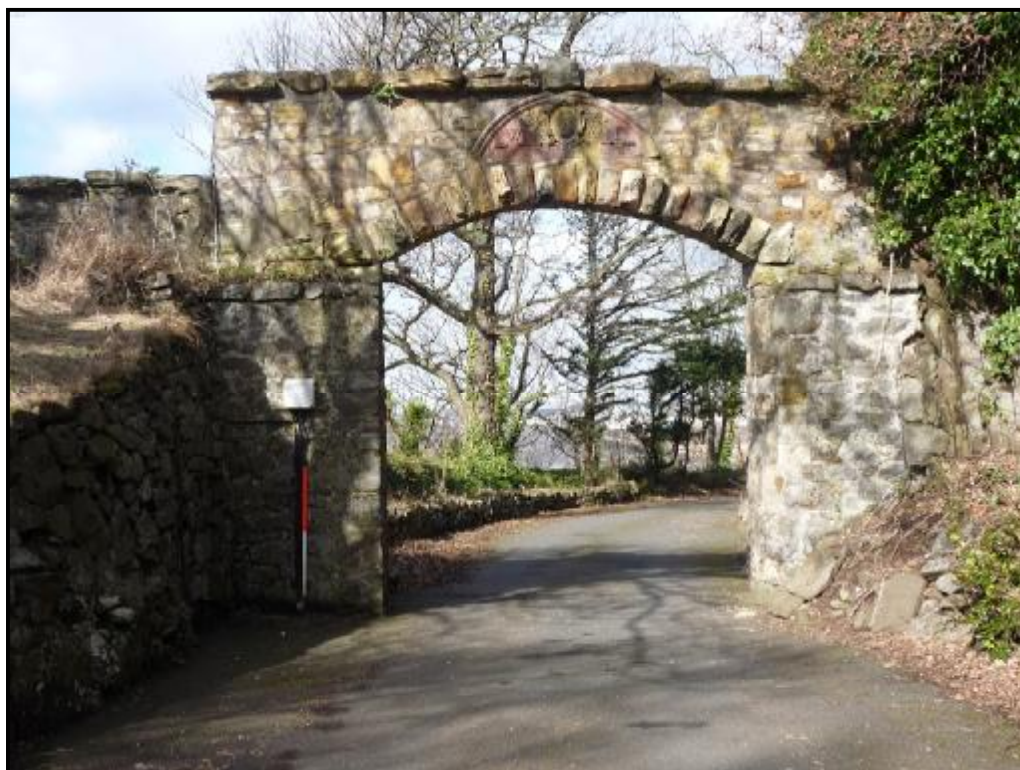
Plate 2: The archway, east facing elevation: from east.

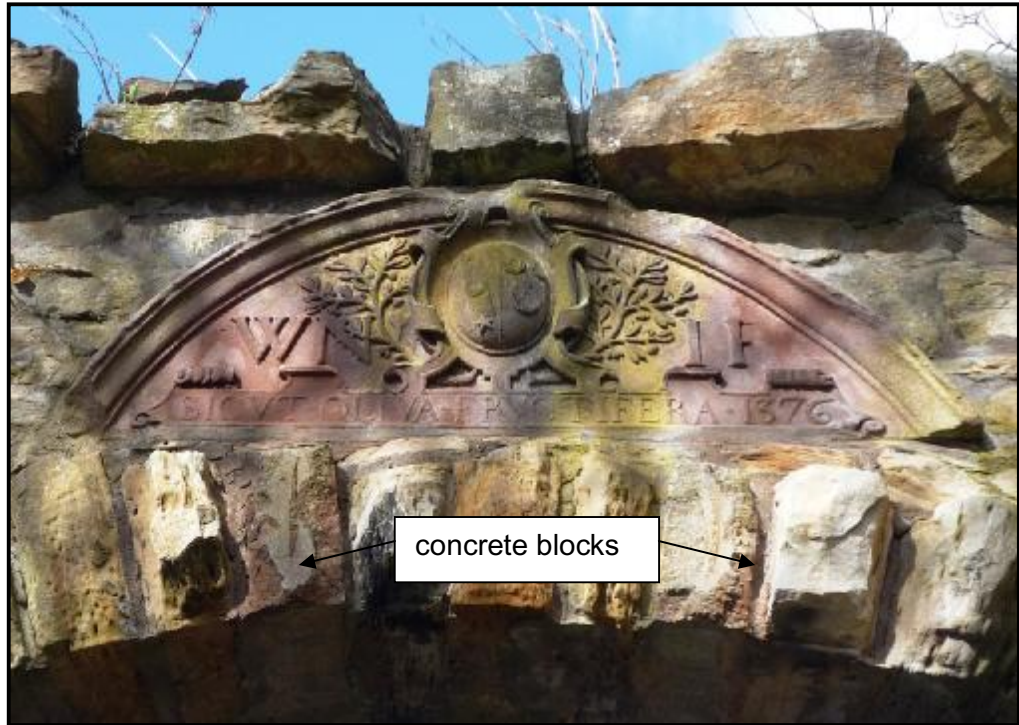
The semi-circular carved stone on the eastern facing side of the archway is believed to be a marriage stone, commemorating the wedding of William Napier (WN) and his wife IF (name unknown) in 1376 (Plate 4). The stone bears the religious inscription SICVT OLIVA FRVCTIFERA 1376 which translates to 'Fruitful as an olive', with

illustrated olive branches. The stone is in excellent condition and the relief carving is clear with some damage to the outer banding. Grant (1880, p.32) notes that this pediment originally featured above a window.

Plate 4: Detail of pediment eastern elevation: from east

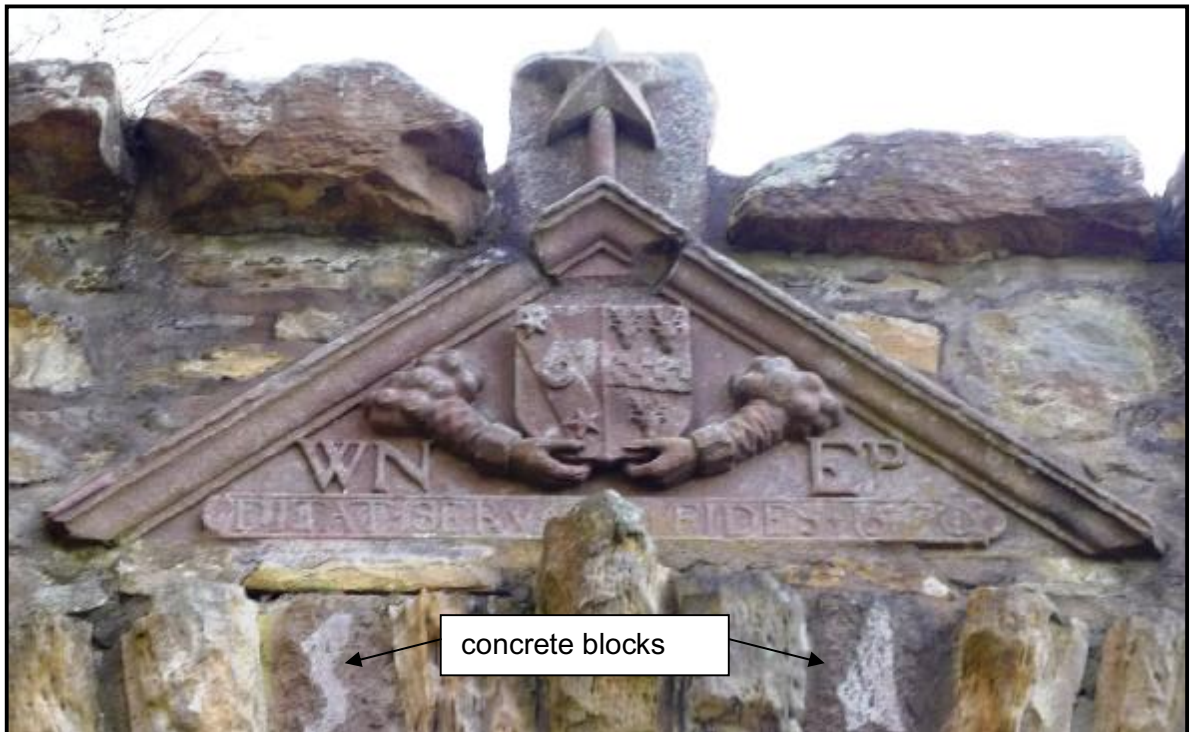
The stone on the opposing side of the archway is a triangular pediment and is also a marriage stone marking the marriage of William Napier (WN) to his wife, Eliza Park (EP) in 1570 (Plate 5). The stone is inscribed with a coat of arms, with a 16th century family motto 'DITAT SERVATA FIDES 1570', which translates to 'Faith preserved maketh rich'. As with the other stone, the stone is in excellent condition, with the only visible damage occurring on the banding below the central star.

Plate 5: Detail of pediment western elevation: from west

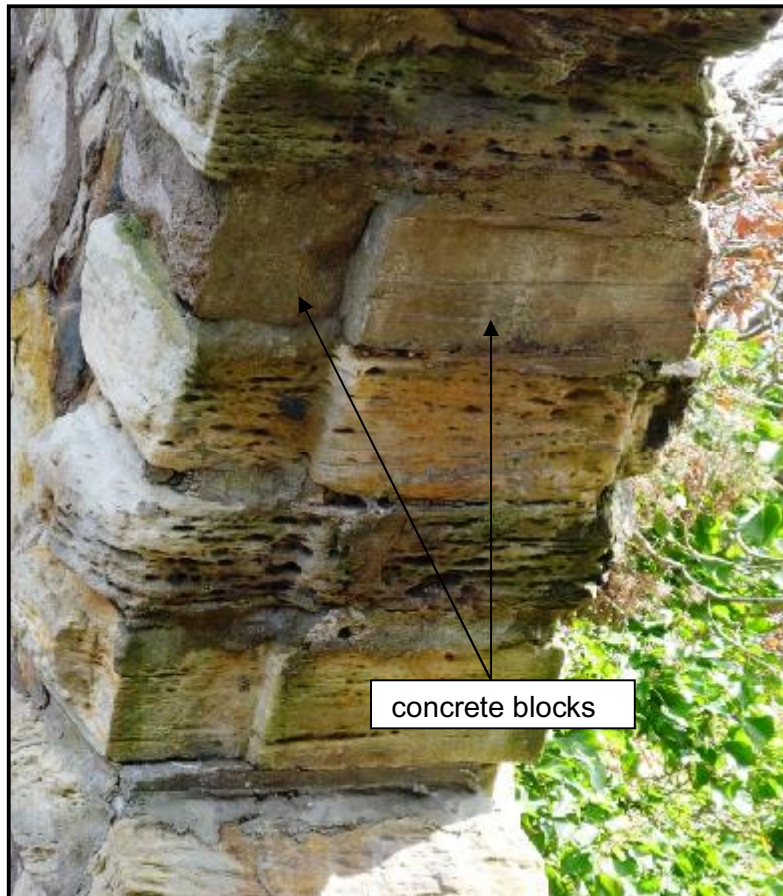
Plate 6: Detail of gate rebate: from South-west.

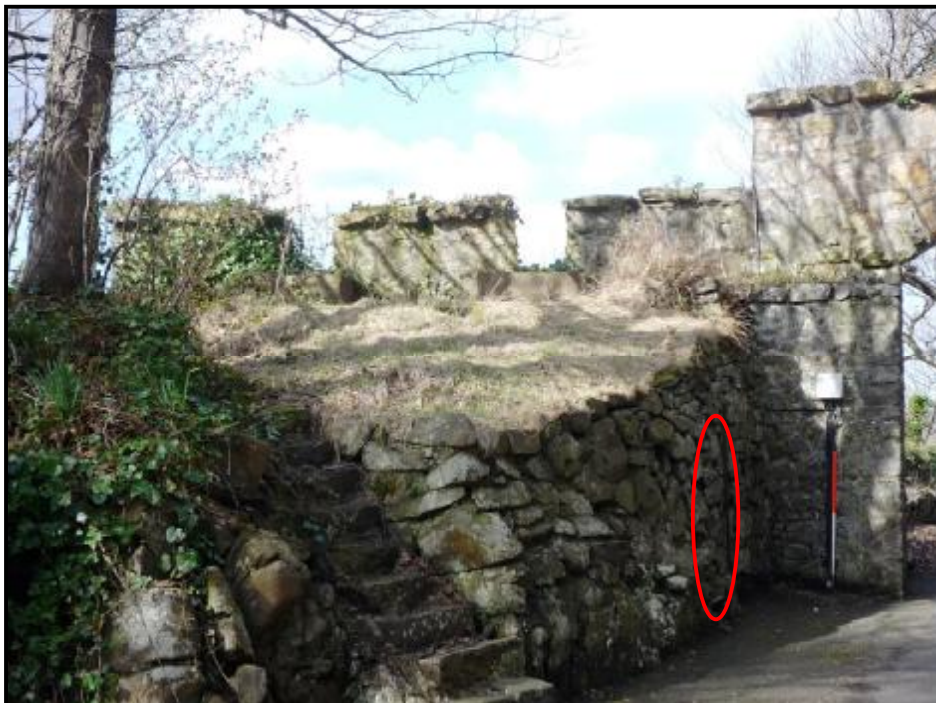
To the south of and bonded to the archway there is a section of battlement with crenulations. The battlement measures 5.95m long and stands to a height of 0.90m. The merlons on average measure 0.69m high by 0.45m wide and 0.67m thick with north-west facing chamfers.

Plate 7: Embankment and crenulations and the location of the gate bar (circled): from north-east.

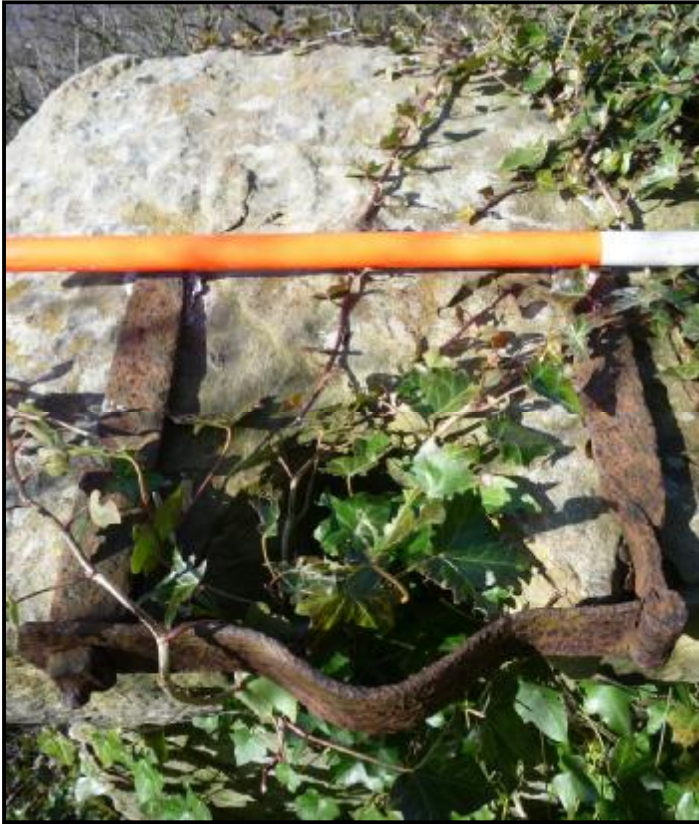
At the southern end of the battlement attached to a coping stone is a hinged metal loop through which a flag pole would have been inserted (Plate 8).

Plate 8: Detail of fittings for flag pole: from south.

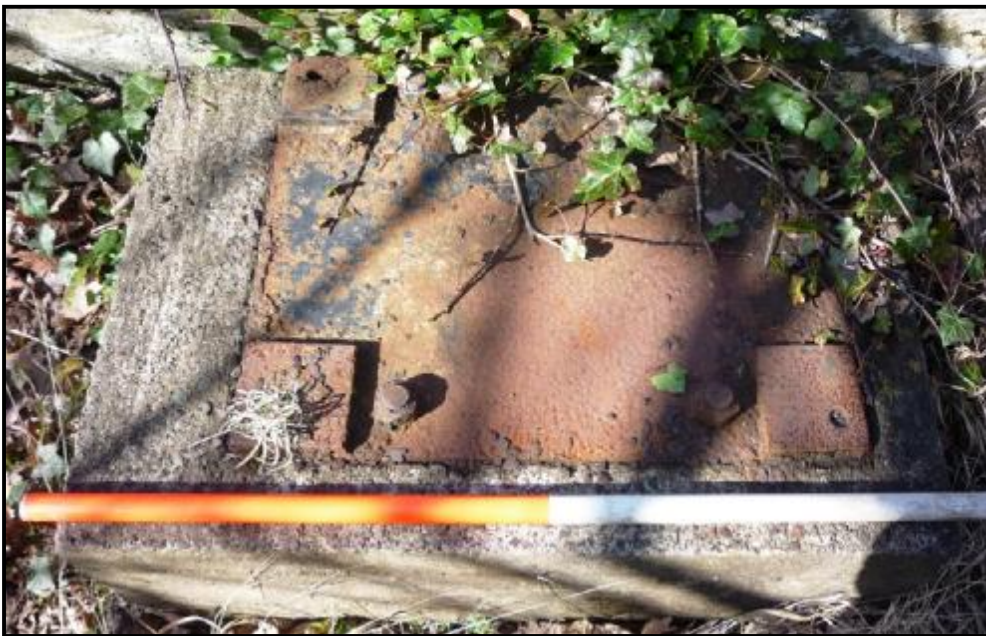
At the top of the embankment (see Phase 2 description above) there are the remains of bases for military signal lamps. They comprise concrete blocks measuring 0.95m by 0.63m by 0.18m thick with steel fittings on the upper side to which the signal lamps would have been bolted. (Plate 9).

Plate 9: Detail of Signal Lamp base: from south.
