Dismantling of the Archway at St Margaret's Hope, North Queensferry, Fife

Archaeological Watching Brief

February 2011

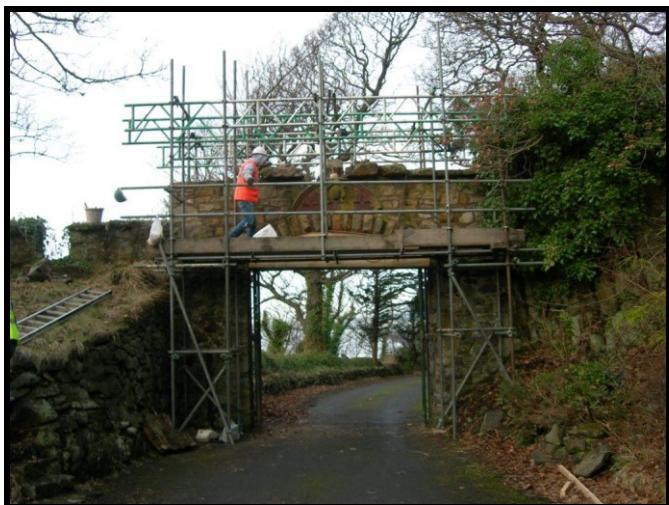
Plate 1 Cope stone removal

The cope stones were then removed from the southern half of the top of the archway and stored with a view to possible later reuse (see Plate 1). During this phase of the works the contractor noted that the bonding material used during the phase 4 rebuilding of the archway was like 'iron' and that it was likely that a 1:1 mix of Portland cement and sand had been utilised (see Plate 2).

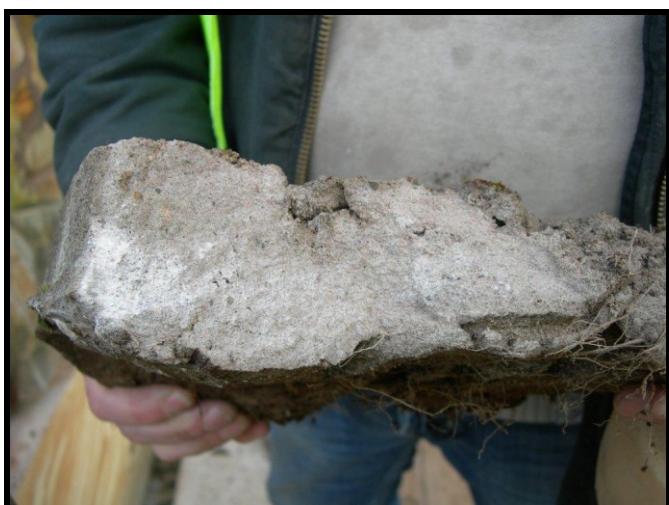
Plate 2 Close up of mortar used in Phase 4 rebuild

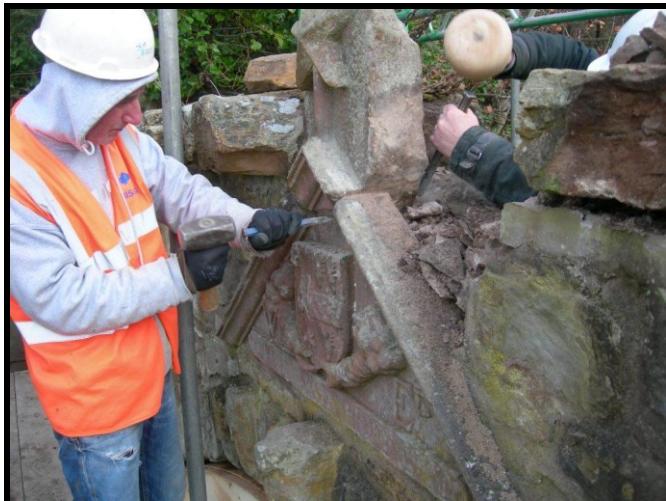
Plate 3 Separating the filial

Upon removal of the cope stones work began to separate the filial from its backing stones and the cope stone abutting it to the north (see Plate 3). The contractor noted that this was proving more problematic than envisaged due to the nature of the bonding material and as a consequence the works would take longer than anticipated.

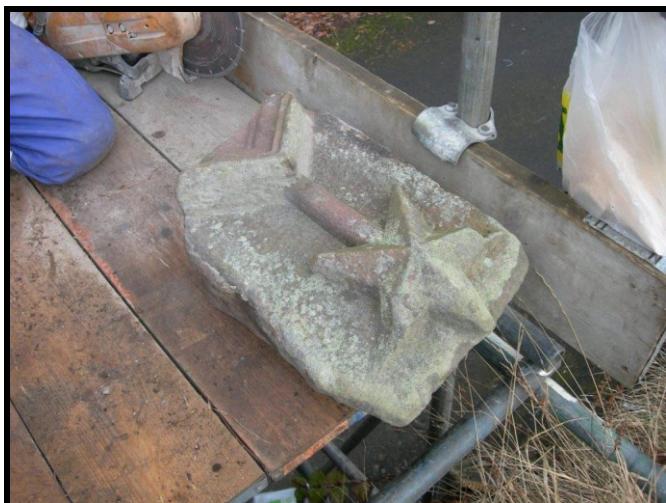
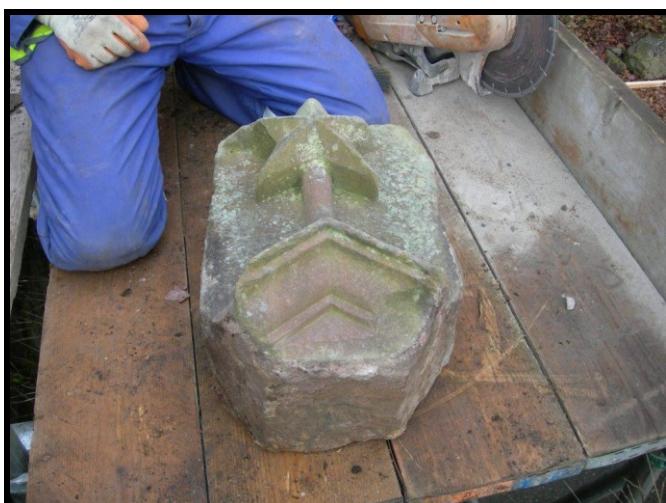
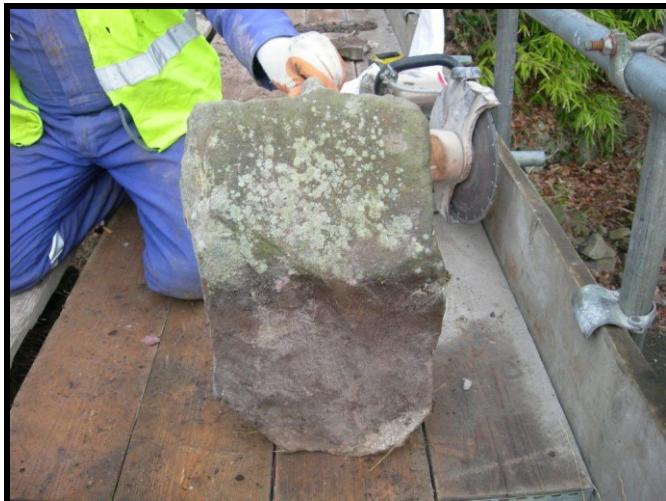
Plate 4 The separated filial

Plate 5 The separated filial

Plate 6 Obverse of the separated filial

The filial was eventually separated and due to its small size was manhandled to the storage point for cleaning prior to delivery to the Huntley House Museum. No mason's marks were noted on the filial (see Plates 4 to 6).

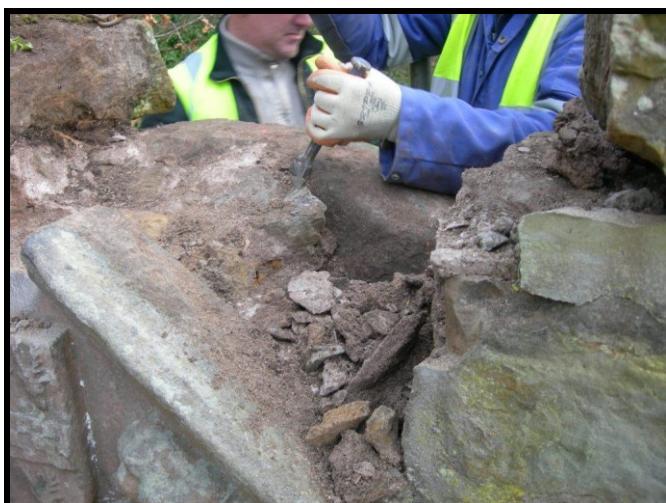
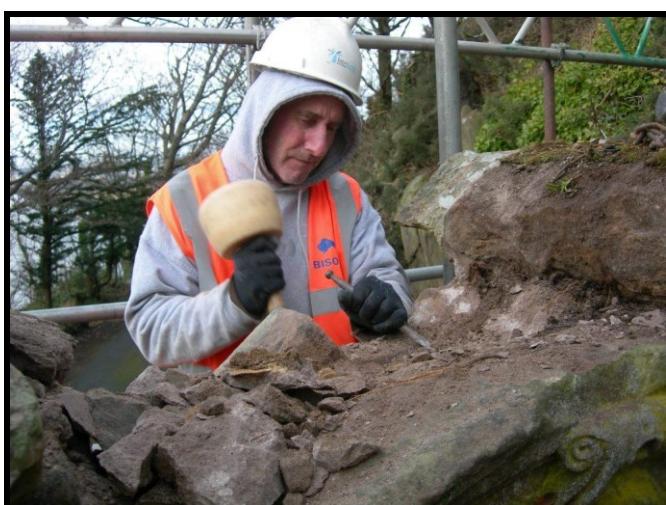
Plate 7 Separating the pediments from the backing stones

Plate 8 Separating the pediments from the backing stones

Following the removal of the filial, work continued to remove the backing stones and the facing stones surrounding the pediments and to clean the residual cement from the newly exposed surfaces of the pediments (see Plates 7 and 8), with work concentrating on the eastern pediment which was to be recovered first. The contractor noted a further problem as a result of the phase 4 works, that during the rebuild, on completion of being laid on bed, the pediments had then been pointed to the bottom fillets with the same 1:1 mix (see Plate 9 for close up).

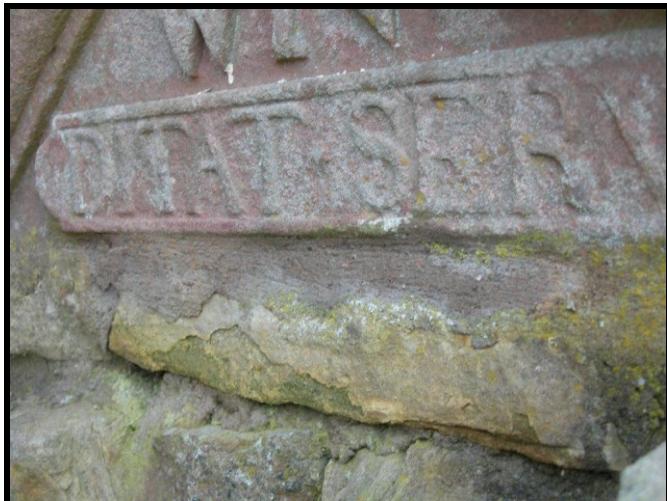
Plate 9 Detail of pointing on western Pediment

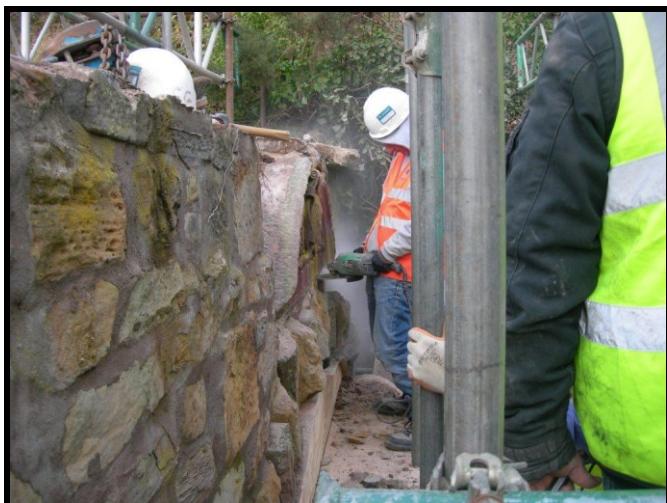
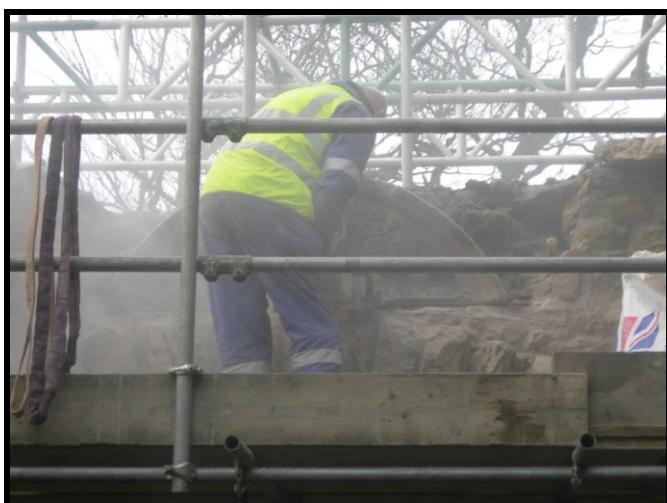
Plate 10 Separating the eastern Pediment

Plate 11 Separating the eastern Pediment

As a result of the phase 4 pointing the contractor was obliged to use a level to inscribe a basal line as a guide to facilitate the use of a grinder in the first instance and then a Schtill saw to separate the pediment from the archway (see Plates 10 and 11). Final separation was achieved by hand and the pediment was then lifted and rested on chocks of wood to facilitate the securing of the pediment in a sling for lowering by block and tackle to the ground (see Plates 12 to 14). Plates 15 and 16 are close ups of the base of the pediment to illustrate the concrete like nature of the bonding material that was used during the phase 4 rebuild as bedding material and for pointing. Again no mason's marks were noted on the eastern pediment. Once recovered the eastern pediment was moved to the storage point for cleaning prior to its delivery to Huntley House Museum.

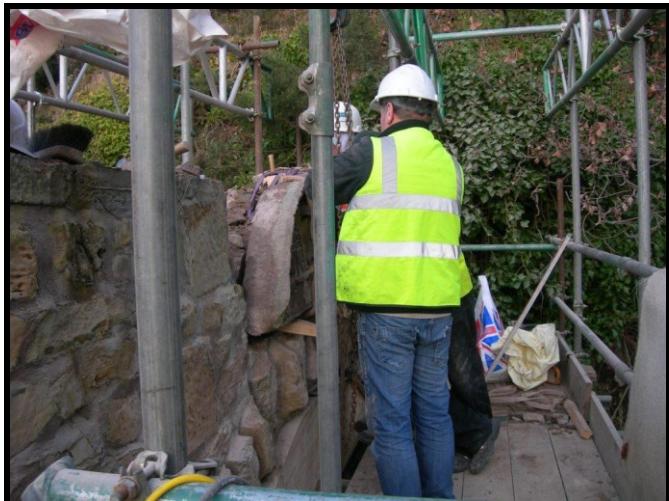
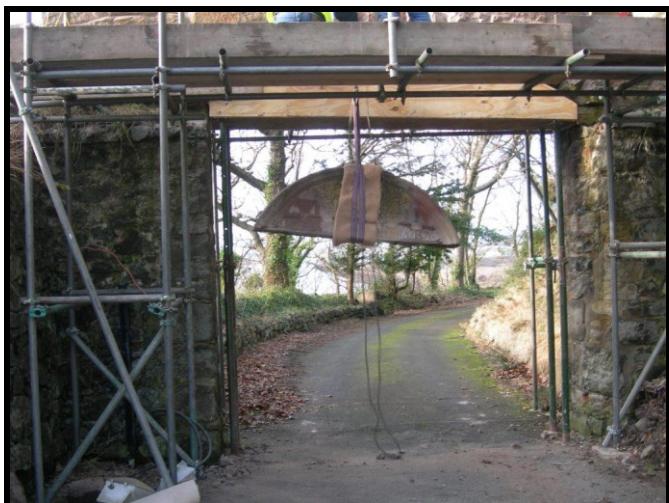
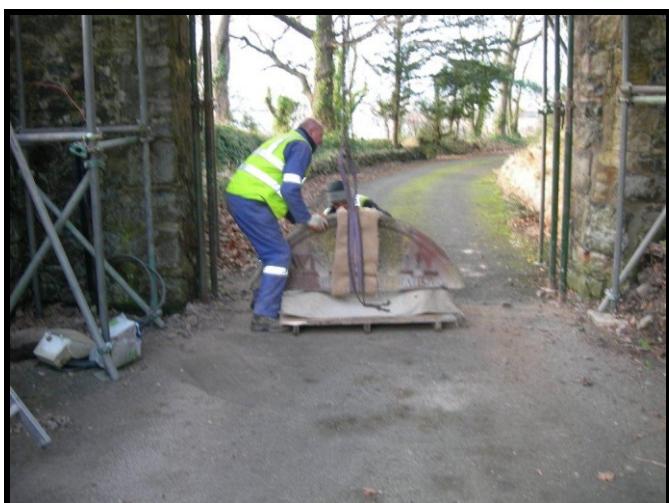
Plate 12 Securing the eastern Pediment in sling

Plate 13 Lowering the eastern Pediment

Plate 14 Lowering the eastern Pediment

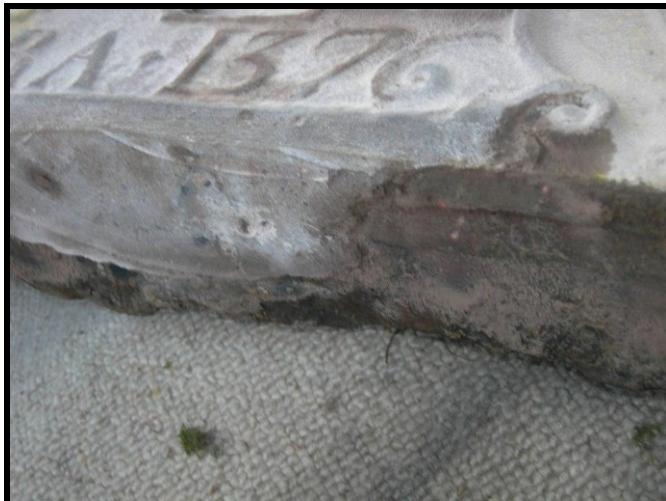
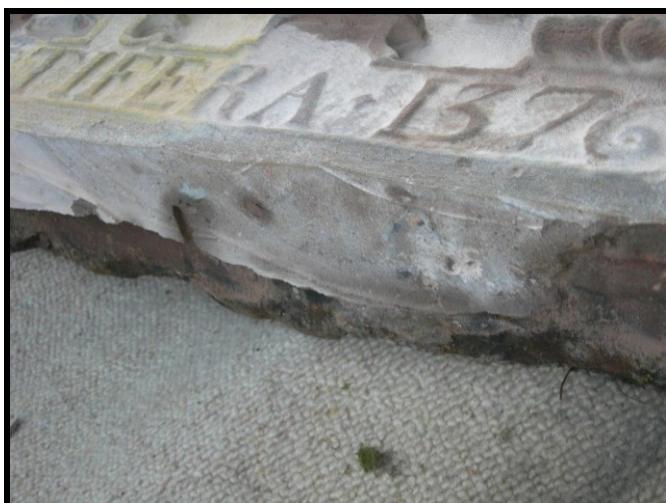
Plate 15 Close up of the eastern Pediment base showing Phase 4 bonding material

Plate 16 Close up of the eastern Pediment base showing Phase 4 bonding material

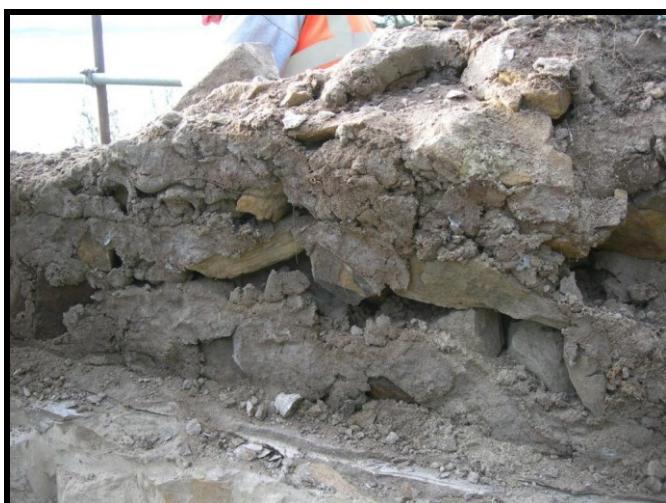
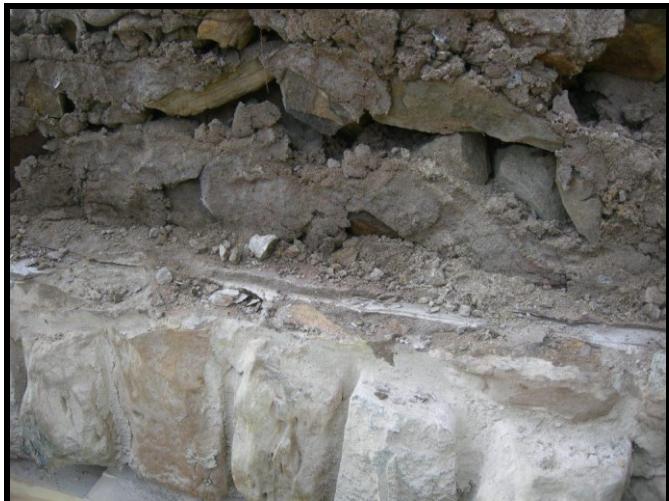
Plate 17 Arch core

Plate 18 Arch core

The recovery of the eastern pediment allowed the opportunity to record the archway core that consisted of randomly coursed rubble and cement (see Plates 17 and 18).

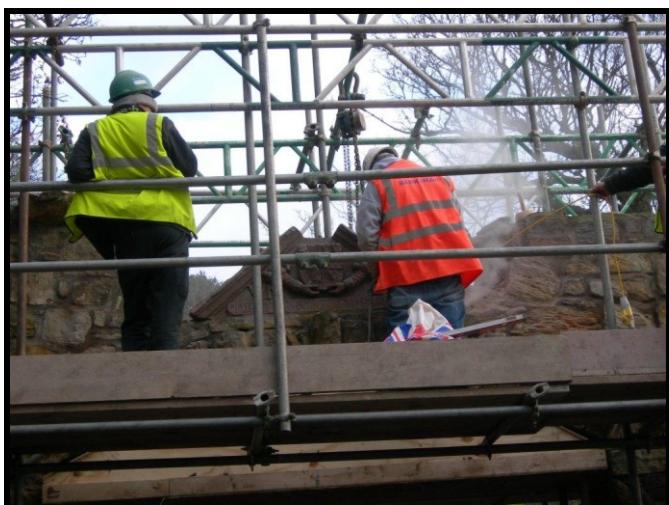
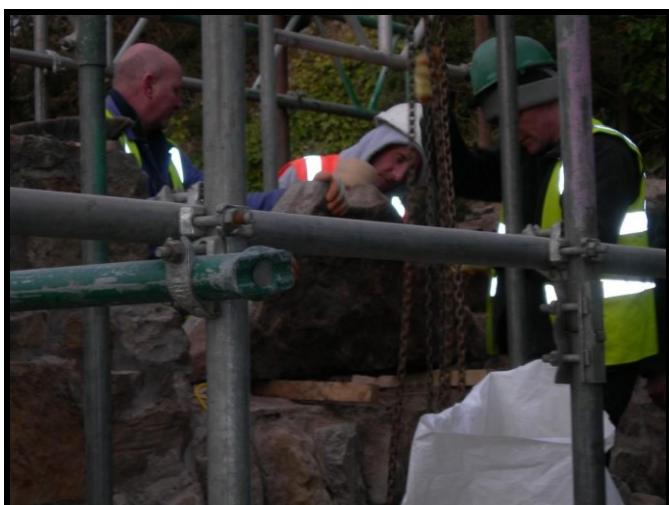
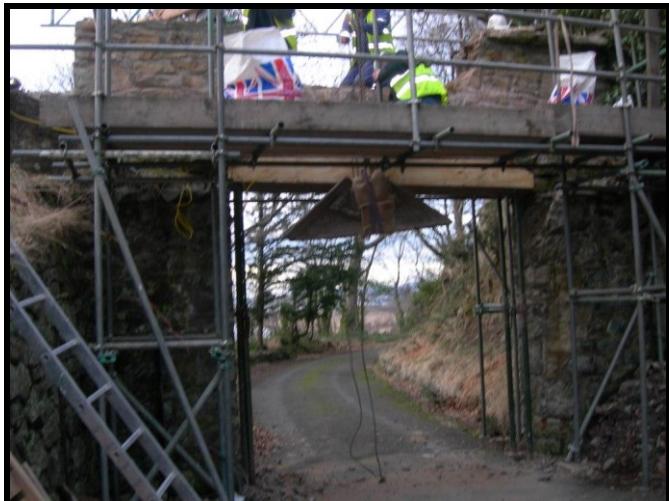
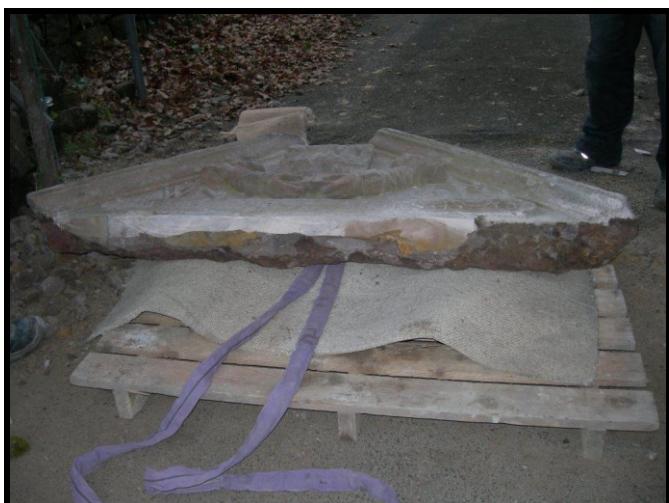
Plate 19 Recovery of the western Pediment

Plate 20 Recovery of the western Pediment

Plate 21 Recovery of the western Pediment

Plate 22 Recovery of the western Pediment

The recovery of the western pediment was achieved in the same manner as had been employed during the recovery of the eastern pediment (see Plates 19 to 22). As before no mason's marks were noted on the western pediment.

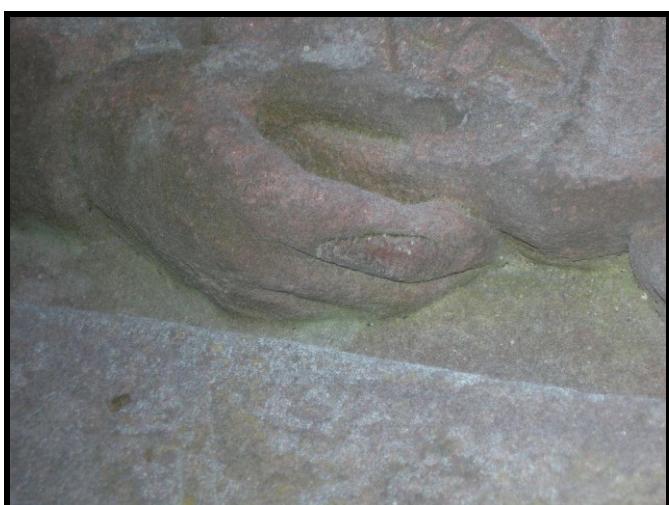
Plate 23 Detail of ancient repair to finger on western Pediment

Once the pediments had been recovered and moved to the storage point for cleaning the opportunity was taken for a closer inspection. Mr Ian Williamson (Stone Mason) noted that both pediments had been carved from 'red sandstone' which indicated that the stone had been quarried at Craigmiller Quarry, Midlothian. Records of quarrying activity date back to the fourteenth century (see link www.bgs.ac.uk/downloads/start.cfm?id=1345). Mr Williamson was also able to point out an ancient repair to a finger on the western pediment and stated that the repair would have been affected with a glue rather than mortar (*Ian Williamson pers comm.*) (see Plate 23).
