The Swan and Royal Hotel, Clitheroe, Lancashire

An Archaeological Building Survey and Watching Brief

By J.M. Trippier Archaeological and Surveying Consultancy

December 2011

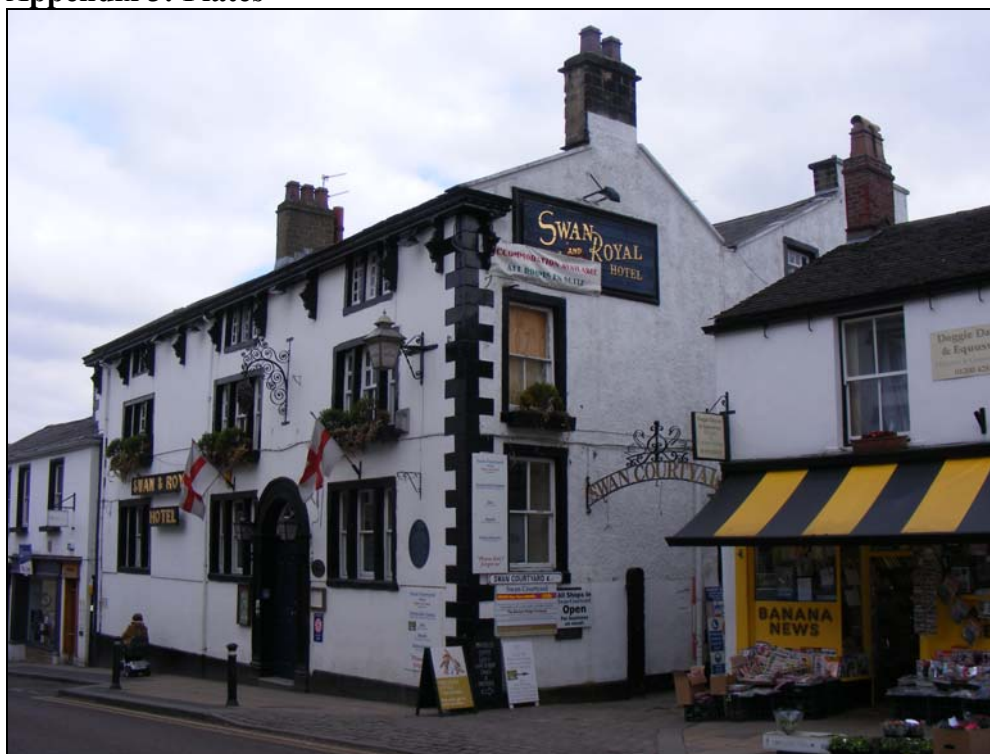
Plate 1: The Inn from Castle St

- 6.2.1 **The Exterior.** This is best seen from Castle Street where it comprises a 3 storeyed stuccoed frontage with rusticated quoins built on a painted stone plinth (**Plate 1**). The same details continue round to the south and east elevations of the building although the north wall is a party wall with the adjoining east extension and much is hidden. This finish appears to be a relatively recent (post-war?) addition (see photos in Goodbody and Rothwell). It is apparent from the rear elevations and the roof space (see paras.6.2.4 and 6.2.5 below) that the Inn is stone built. There are chimney stacks on the apexes of both of the south gables.

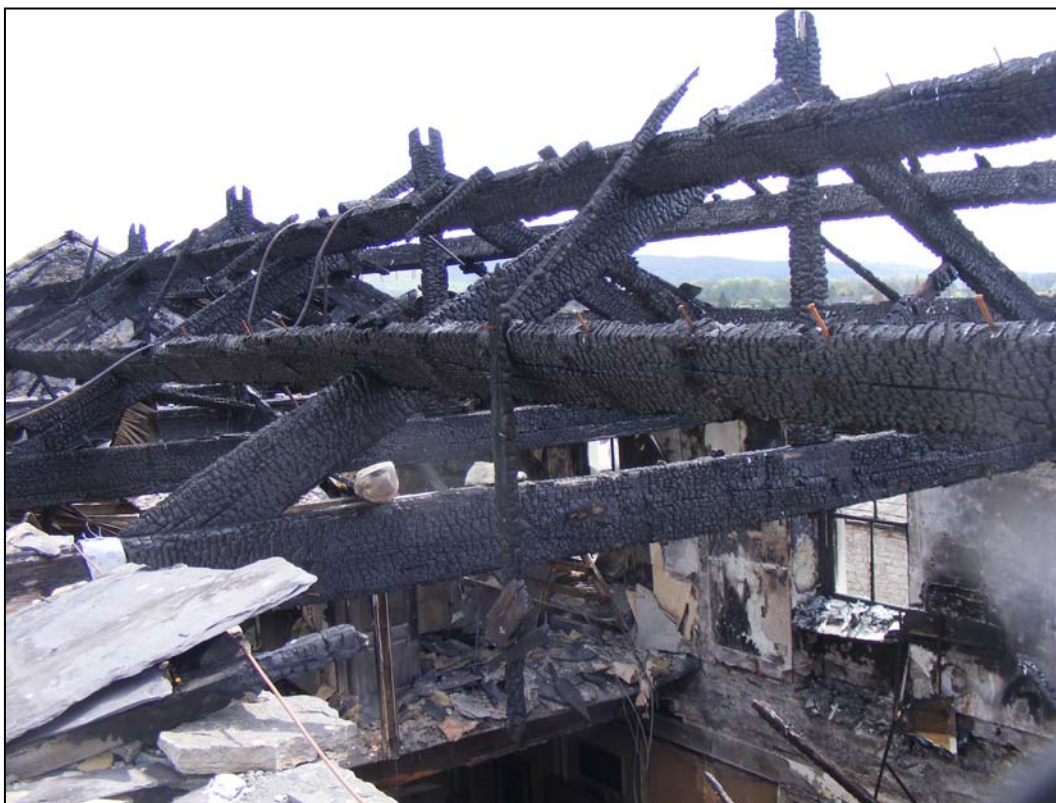
Plate 39: Roof timbers of east extension

- 6.3.4 **The roof.** This was badly damaged by fire (**Plate 39**). However it could be seen that the roof covering would have been Welsh Slate supported by four king-post roof trusses and two sets of trenched purlins. On the north side two chimney stacks protruded above the roof line. The westerly one was stone

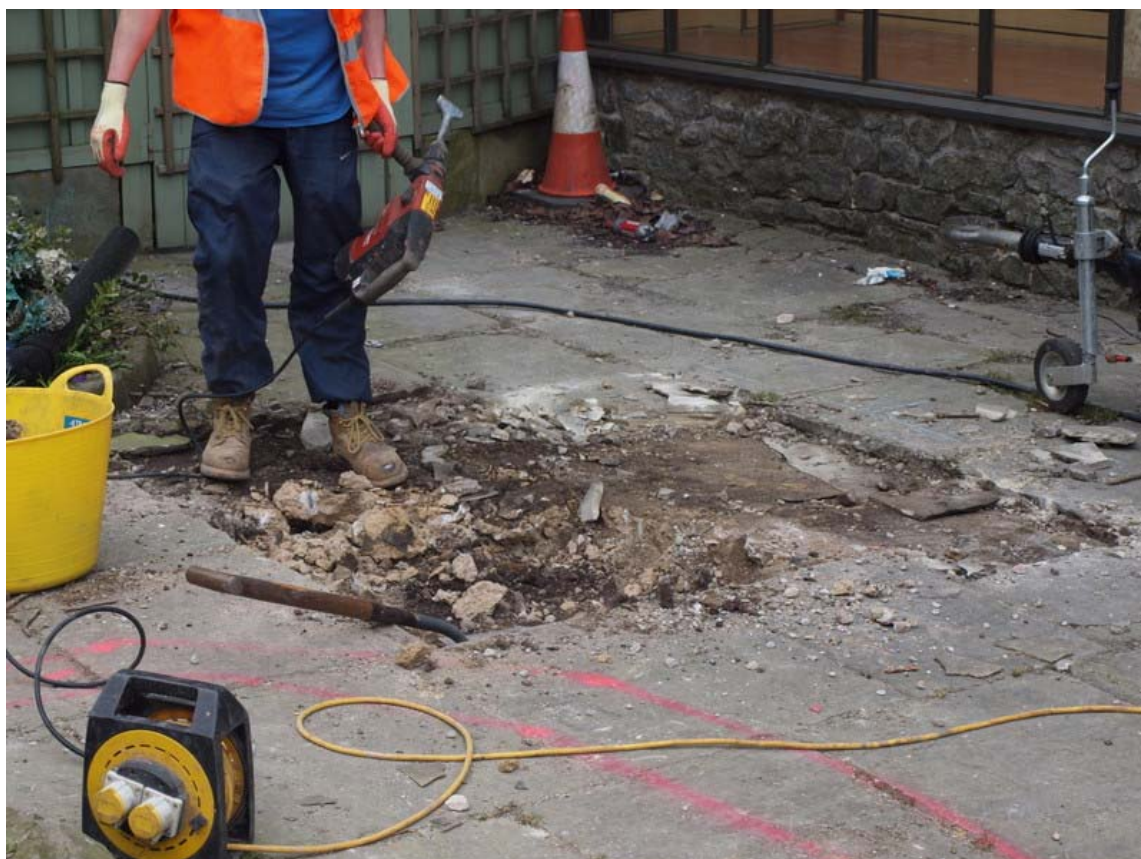
Plate 49: Removal of slabs over north west trench

- 6.4.3 The second pit was dug in the northwest corner. Once the paving slabs were removed a layer of hardcore was found, lying above a thin layer of yellow sand (1) containing cinders. This lay above a hard grey sandy layer (2) containing cobbles. Below this was a hard gritty dark grey sandy layer (3) which lay above another set of cobbles (5) set into a light brown soft sandy silt (4). The removal of these revealed a layer of grey-brown silty sand (6) (**Plates 49 & 50**).

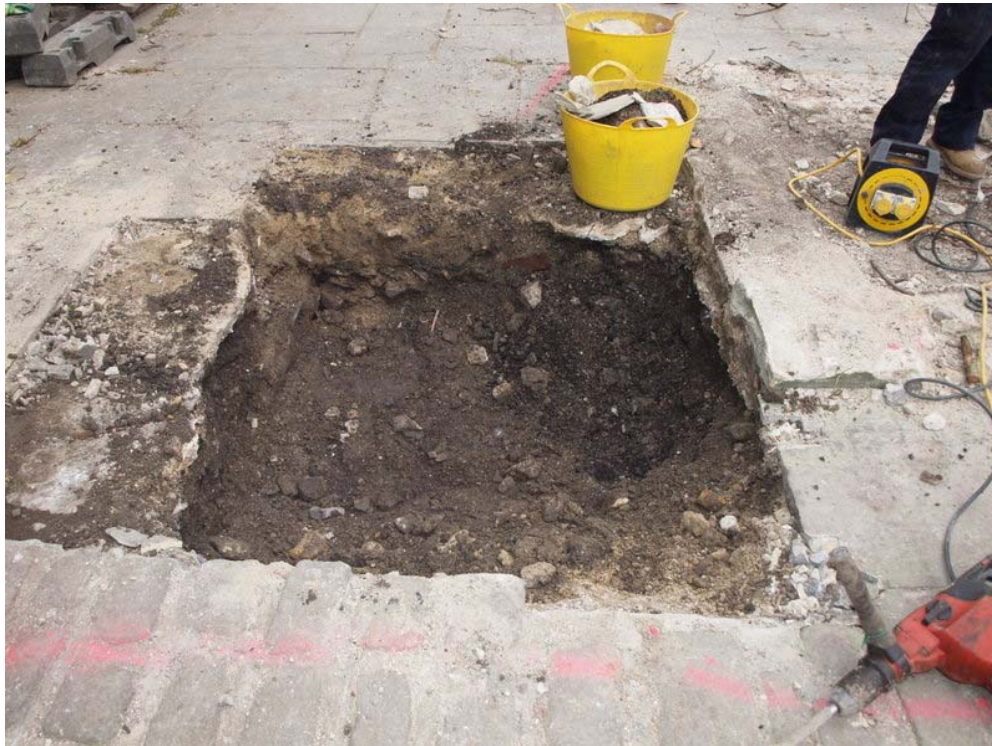
Plate 53: North east trench looking east

- 6.4.5 The final pit was dug in the northeast corner which also revealed a layer of concrete beneath the paving slabs. Below this there was again a layer of hard and compacted sandy layer (3), this time containing large stones and broken brick (**Plates 51 & 53**).

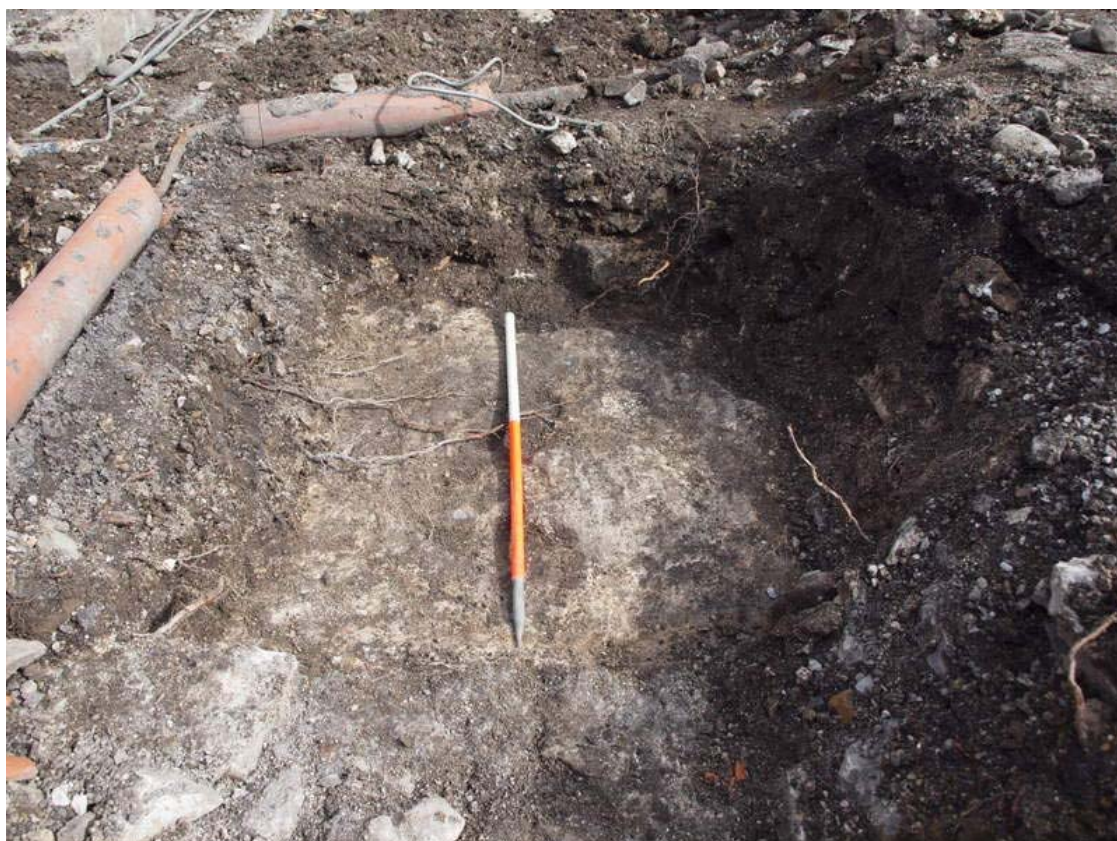
Plate 57: Excavated walls in southern half of trench showing easterly part of lime surface

- 6.4.8 Excavation on the north side of the limestone wall (7) revealed a hard lime surface (11) at its east end which butted the wall and rose up it slightly, showing it to be laid with regards to it (**Plate 57**). Its northern edge was uncovered and shown to be broken indicating that it must have spread farther north. Excavation of this surface revealed a layer of grey-brown silty sand (6) before reaching bedrock (14), upon which the wall (7) was resting. A small area of cobbles was discovered in the corner where walls (7) and (8) met. These, however, had been badly disturbed and were located directly below where a tree had been standing. Below this was the lime surface with cobbles bedded into it (12) (**Plate 58**). Excavation of the revealed the thin layer of silty sand (6) which contain a substantial amount of broken pottery. Below this was the bedrock (14) upon which walls (7) and (8) were resting.
