**LAND BETWEEN 2 & 10 WORDEN LANE,
LEYLAND, LANCASHIRE**

An Archaeological Watching Brief

By J.M. Trippier Archaeological and Surveying Consultancy

September 2004

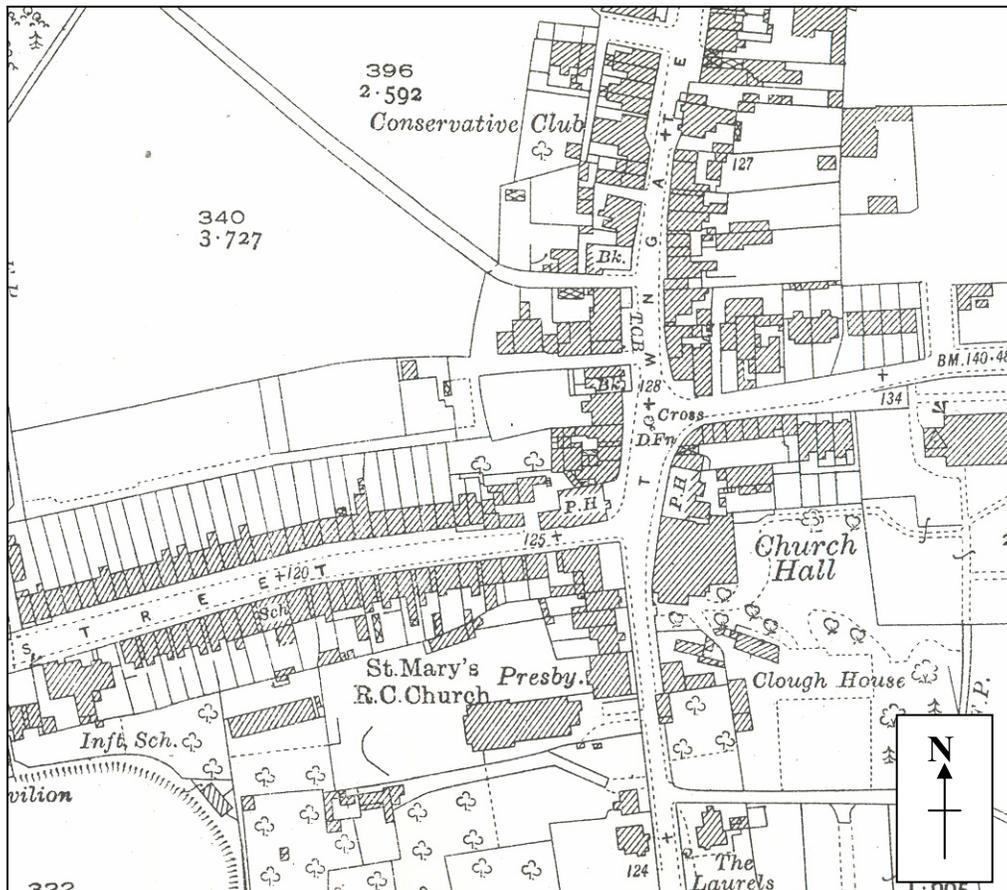
FIG 2: SITE PLAN

situated between Nos. 2 and 10 Worden Lane and is shown edged red on the site plan at Fig.2. It understood to have comprised an ‘urban gap site’ prior to the commencement of this development. Vegetation cover was cleared prior to the archaeologists being instructed.

- 4.7 By 1968 (Fig.7) the properties on the subject site are shown as three units; Nos. 4, 6 and 8 Worden Lane. All of the rear privies had now been demolished. The cottages themselves had finally been cleared by the time of the 1977 OS map (Fig. 2).

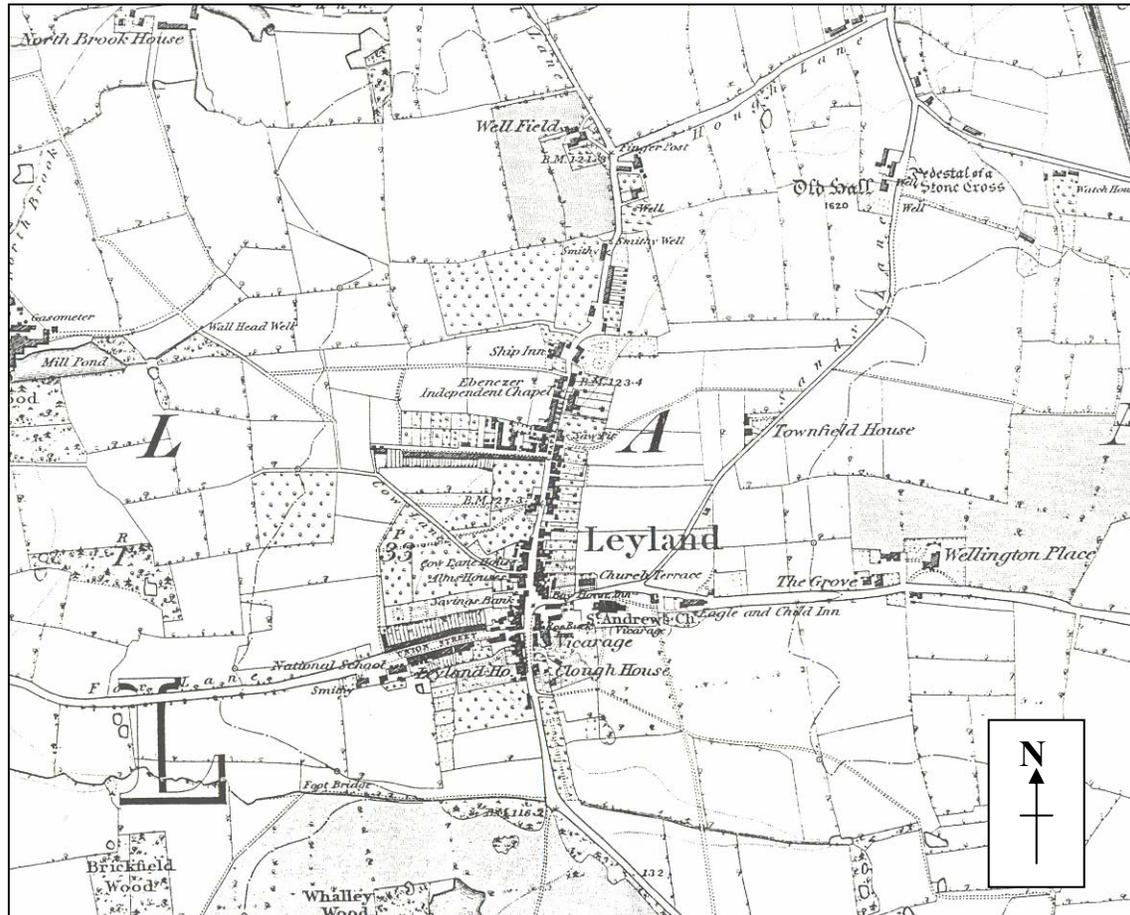
FIG. 4: ADDISON'S MAP OF 1769

- 4.5 The subject plot is annotated 'Mr Preston's land' on the 1725 estate map (LRO DDF/81) when it appears to have been vacant. However a slightly later map of 1769 by Thomas Addison Jr. (LRO P87) shows a building standing on the subject site (Fig.4) This appears to be single storey with two chimneys and a porch over one of two doorways. A building is shown on the site of Leyland House on both these maps and No.2 Worden Lane appears to have already existed in its present form.

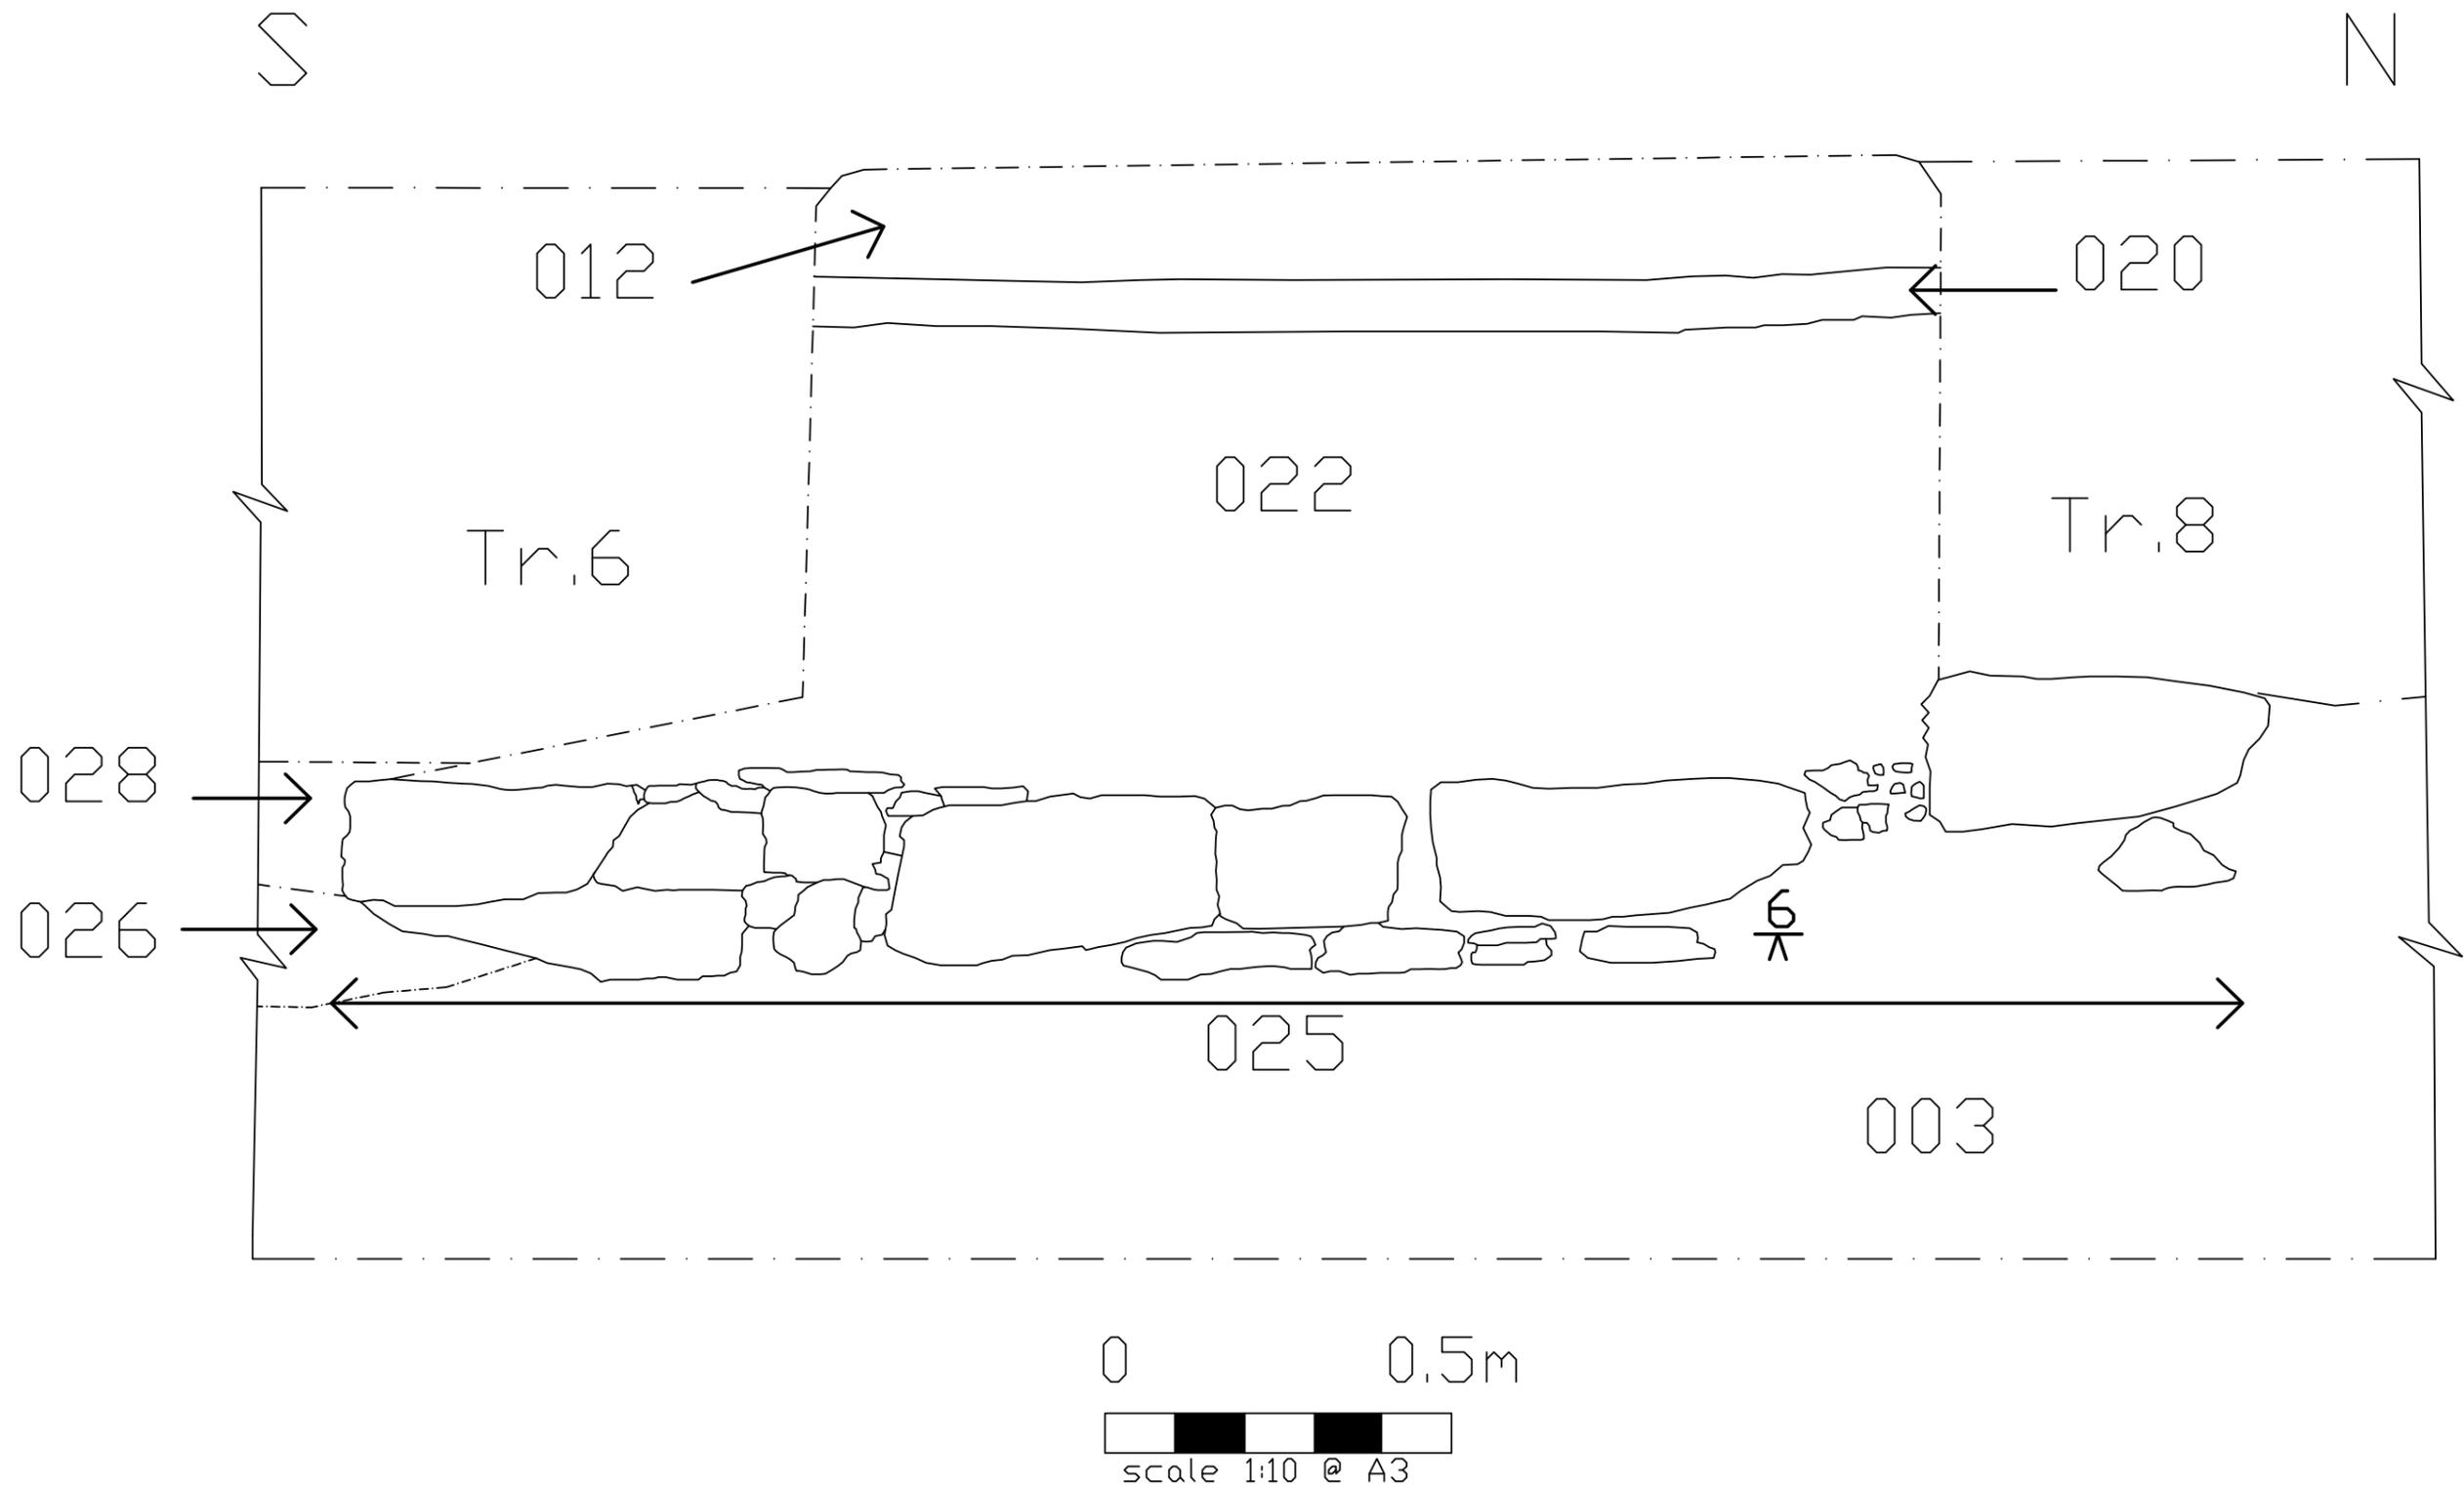
Fig. 16: Section Showing Context 025

- 7.8.5 The third feature of note was a line of substantial stones which lay in the western section of trench 7a for approximately 3.4 m from the south-eastern corner of trench 6c to the south-eastern corner of trench 8 (see para. 8.9 below). This feature (context 025) is shown in section at Fig.17 and at Plate 9. The larger stones varied in size but, typically, were 0.7m long by 0.45m wide and 0.2m

deep and appear to have been laid on a rough flag base. At the extreme south end of the feature the flags overlay a deposit of burnt material that appeared to be 'cannel' coal (context 026). The feature turned at right angles at its northern end and extended westwards along the southern section of trench 8. At the junction one stone was placed upright, giving the impression of 'long and short' work. This was surmounted by a stone about 1.5m long lying on its side along the south section of trench 8. In size and shape it had the appearance of a rough-hewn gatepost.

- 9.3 Features of particular interest were those recorded as (contexts 025-027) situated in the easternmost trench (7a) of the excavation. Context 027 (Fig. 8) was an *in situ* brick pier on a rough stone plinth located in the eastern section of this trench. The bricks were slightly wider but shallower than those which made up the building debris covering most of the site (see para. 7.8.6 above) which suggests a possible 17th century date. The use of clay as opposed to lime mortar also suggests an earlier phase of construction. It is not clear whether the stone plinth was contemporaneous with the pier or whether it originated as part of an earlier phase of the site's development and had merely been reused. (Context 025), which was located in the western section of the trench slightly to the north of (context 027), comprised a number of large stone blocks laid in line over a distance of some one and a half metres and with an apparent return at its northern end. These were of similar sandstone constitution to those underpinning the brick pier at context (027) and were laid at a similar level (see Figs. 11 & 12). It is therefore possible that these two sets of stones were related in some way. Secreted under the southern end of (context 025) was burnt material that appeared to be cannel coal and which may indicate the presence of a hearth in this location at some stage. No dateable finds were found in association with these features.

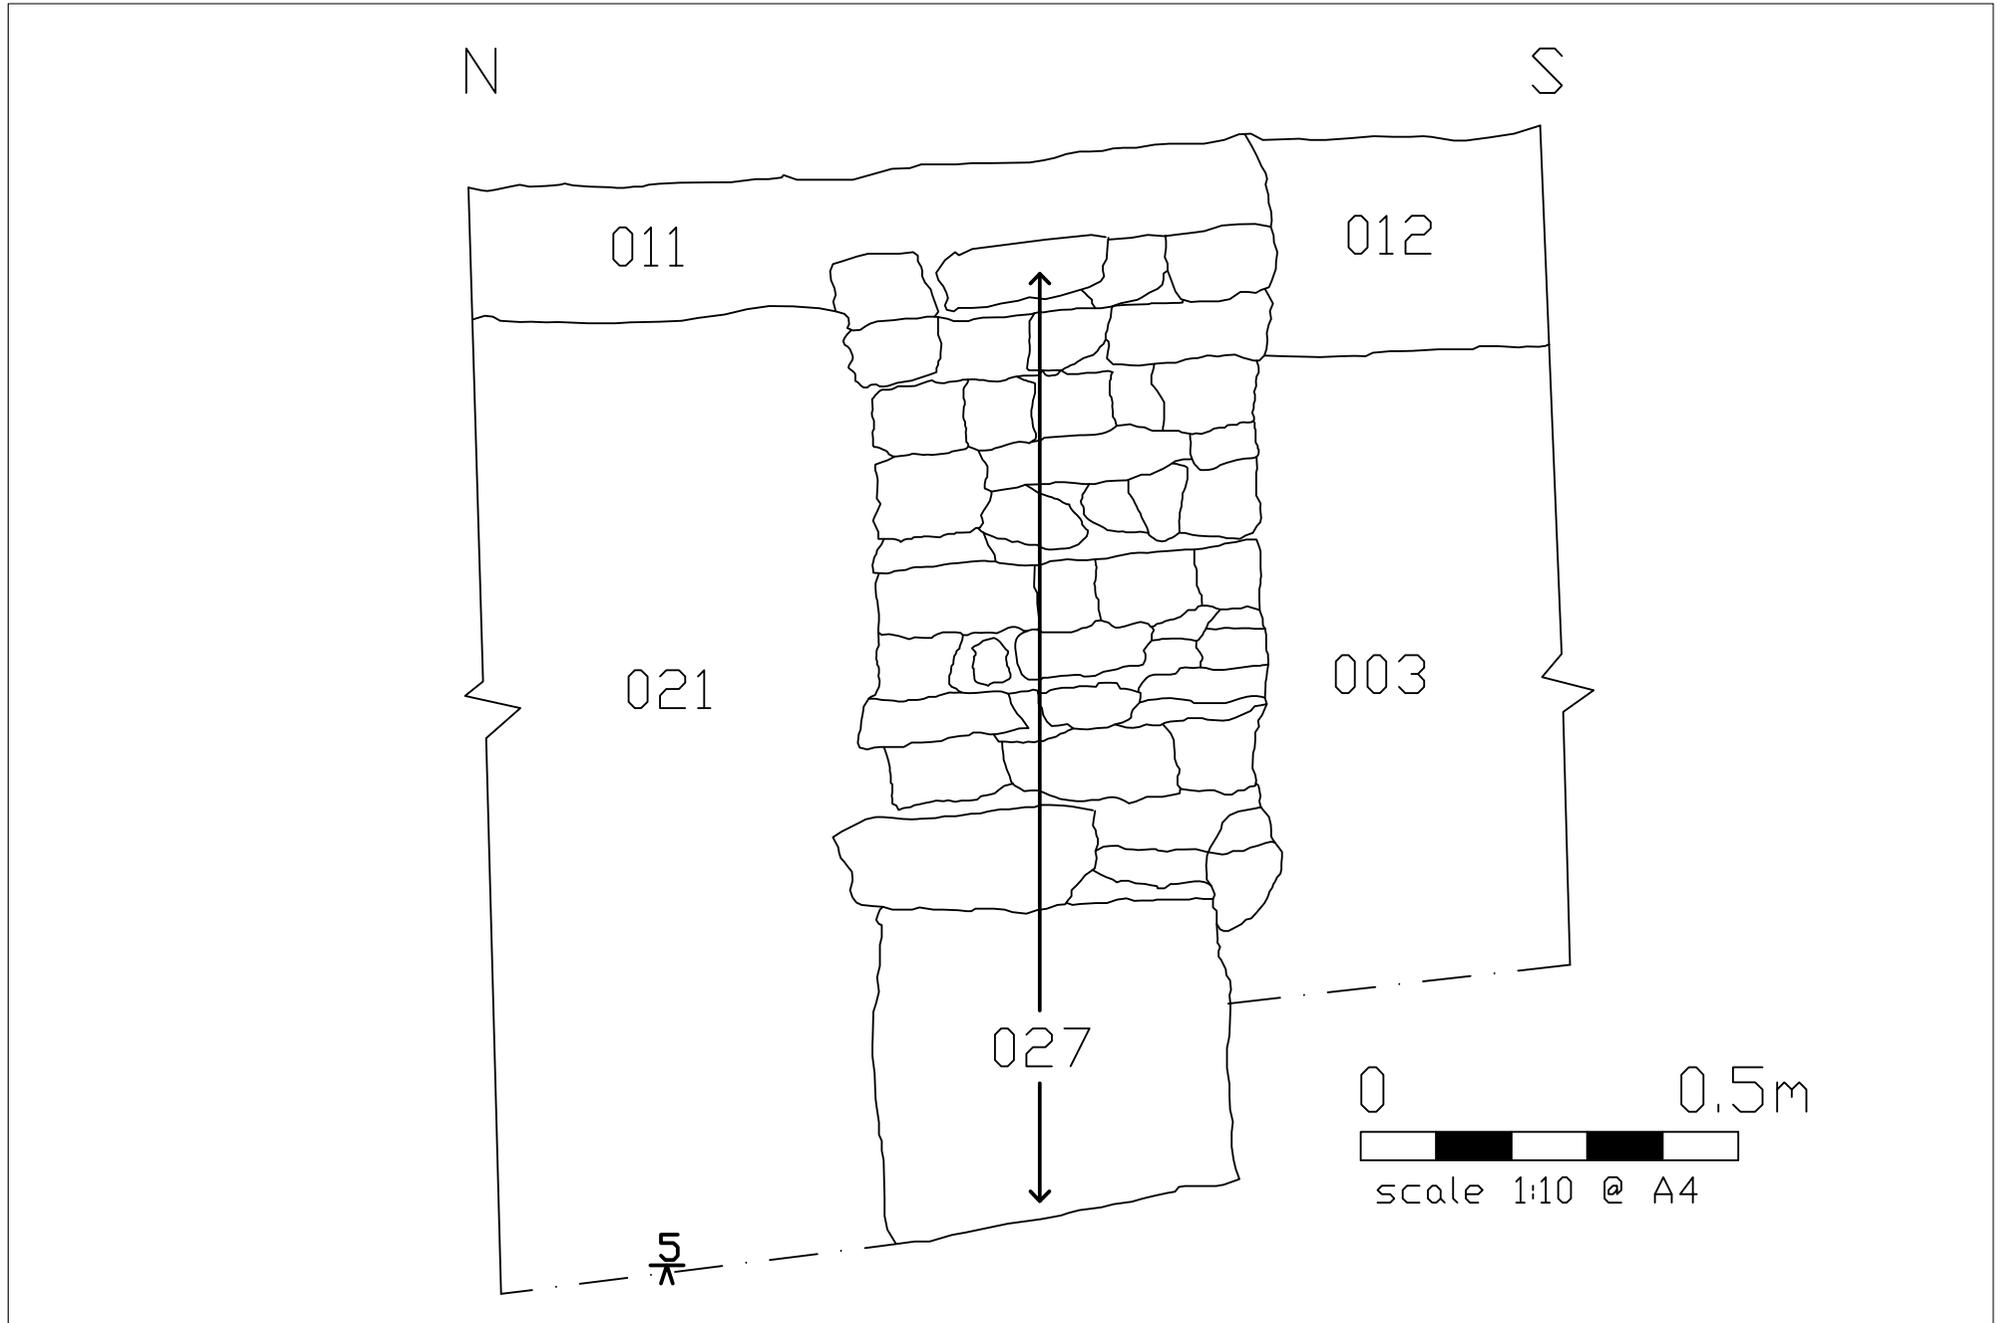
Fig. 17: Section Showing Context 027

- 7.8.6 The final feature to be described in trench 7a was another large stone, similar to those described at para. 7.8.5 above, but which was located in the east section of the trench about a metre to the south of the stone feature already described at para. 7.8.5 above. This stone supported a row of smaller flags which appeared to form a levelling layer upon which stood a brick wall 0.5m thick and apparently running from west to east into the side of the trench beyond the limits of excavation. This wall was built from hand-made frogless bricks (235 x 114mm in plan x 57.5mm deep) compared with the slightly narrower (108mm) but deeper (64mm) ones found on the remainder of the site. The bricks were bonded with grey clay. This feature (context 027) is shown in section at Fig.18 and at Plate 10.

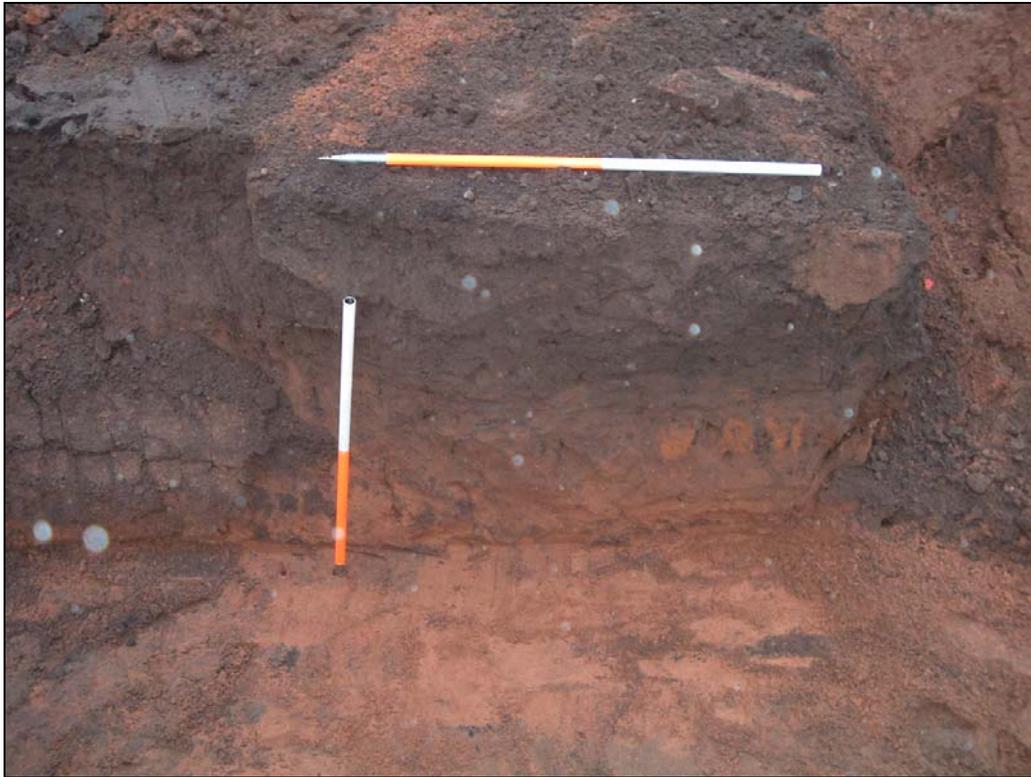
- 7.1.2 In general the stratigraphic sequence altered from west to east. The western- most trenches comprised an upper layer of sandy silt (context 001) below which was a mixed layer of silty sand (context 002) lying on the 'natural' layer of sand (context 003). The central area of the site also comprised a 'natural' layer of sand but above this was a substantial layer of demolition material (largely brick) before an upper layer of silt was reached. The front (eastern) third of the site comprised a central layer of even more substantial demolition material indicating the likelihood of probable cellar areas extending down to the base of the excavated trenches.

Plate 3: East section of trench 1A

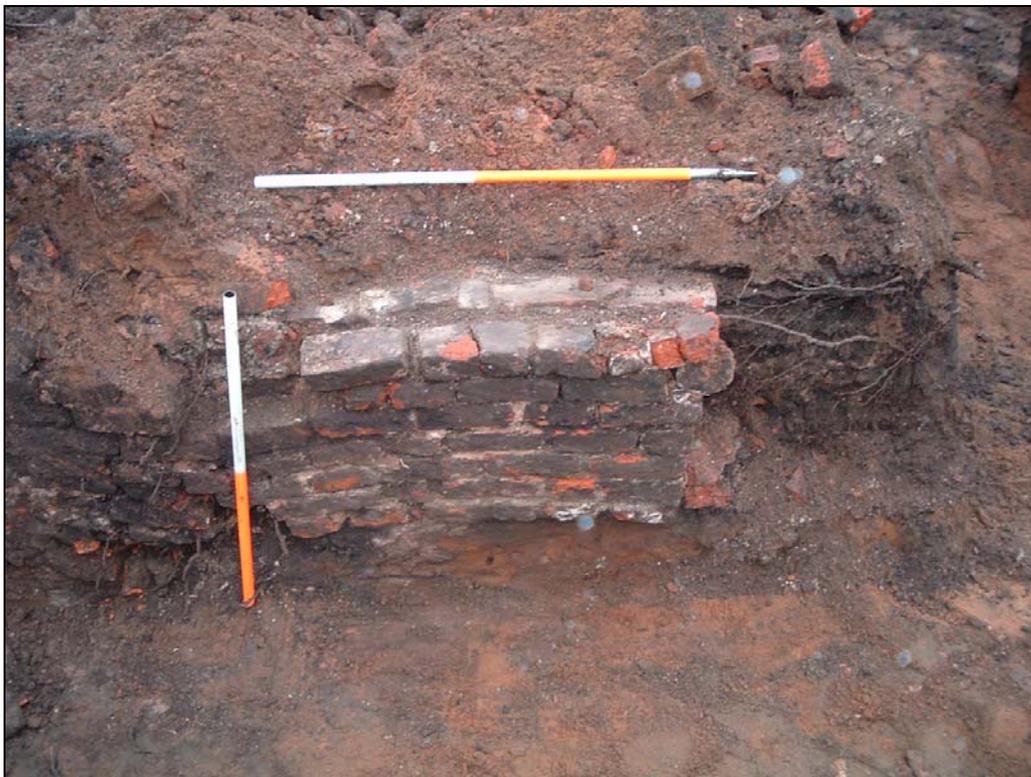
- 7.2.1 These were located at the rear (west) of the plot and formed a rectangle with a northern extension. The trenches ranged in length from 5.3m to 9.3 m and had a depth of 1.1 m and a width of 1.2 m. The stratigraphic sequence comprised an upper layer of grey -brown sandy silt (context 001) 0.4m deep, below which was a mixed layer of light brown silty sand (context 002) 0.2 m deep, laid on the 'natural' layer of orange sand (context 003) 0.5m deep to the trench bottom (see Plate 3 which illustrates this sequence).
- 7.2.2 Trench 1d, which formed the northern side of the rectangle, cut through a brick wall (context 004) 0.6m high from the trench bottom and one brick (0.25m) wide.

Plate 4: Wall (cxt 004) in trench 1D

- 9.2 The short stretch of wall running north- south across trench 1d (context 004) appears to be part of the rear garden wall to the cottages. No evidence was found of the probable former privies that had abutted this wall to the east. The remains of another wall of similar construction was noted running east- west along the south section of trench 2a (context 005) approximately 5.5 m south of the gable wall of No.2 Worden Lane. It seems likely that a wall in this position could have been the garden wall between the northernmost cottage (No.4) and that adjoining it to the south (No.6). In this case the substantial amount of building debris (context 014) including a modern manhole(context 013), which was noted running north-south to the east of this wall, appears to have been the remains of the westerly wall of a rear outrigger situated behind No.6. Two rubbish pits were identified and recorded as contexts 015/016 and 017/018 respectively. The first of these was located within the line of building debris (context 014) at its northern extremity. It is therefore possible that this predated the outrigger. As it contained an earthenware ginger beer flask, probably dateable to the mid -1850s (see above), this may provide a *terminus post quem* date for the outrigger's construction. The other rubbish pit, which contained a torpedo shaped bottle probably dateable to the first quarter of the 19th century, was located within contexts which always appear to have been part of the rear garden area of the cottages. The large amount of building debris comprising broken brick and plaster (context 019) situated to the east appears to have been demolition material from within the body of the cottages. The two brick walls recorded as contexts (007) and (023) in the north- east corner of the excavation appear to be internal walls within the northernmost cottage (No.4). In view of its substantial depth Cxt 023 was probably being within a cellar area.

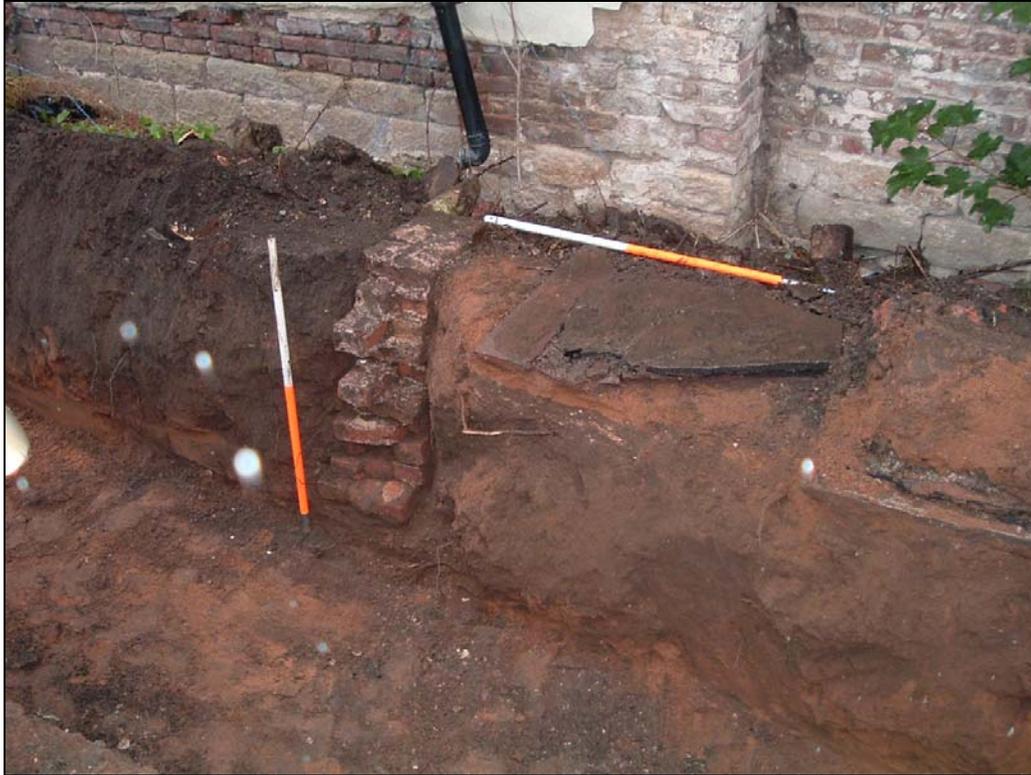
- 7.4.1 This comprised a single trench running east from the northern end of trench 2b for 11m. The other dimensions and stratigraphy were as for trench 1. 7.5m from the junction with trench 2b trench 3 cut through a brick wall running north-south (context 007). This lay on the natural sand (context 003) some 0.2m above the trench bottom and extended to the top of the trench (see Plate 5). The wall was one brick wide and was built of garden wall bond comprising one row of 'headers' to two of 'stretchers'. Immediately abutting this wall to the east was a layer of flagstones (context 009) coated with a thin layer of bitumen (context 008). The flagstones lay on a 0.1m thick sand bedding layer (context 010) which lay on a 0.1m deep well-defined layer of grey brown silty sand identified as (context 002). Above the bitumen layer was a 0.1 m layer of black silt with a heavy content of brick and stone particles (context 011) above which was a surface layer of 0.1m of grey-brown sandy silt with similar intrusions (context 012).

Plate 5: Wall (cxt 007) and bitumen coated flags (cxts 008-9 in trench 3)

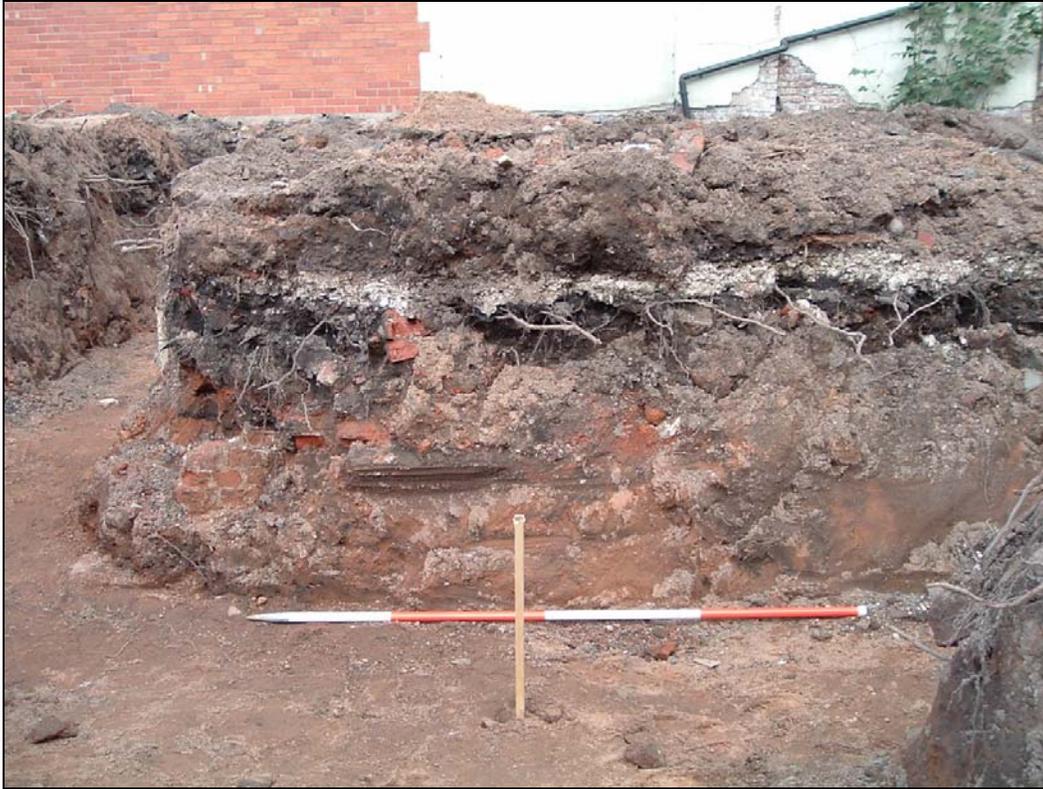
Plate 7: Modern brick manhole (cxt 13) in north section of trench 4A

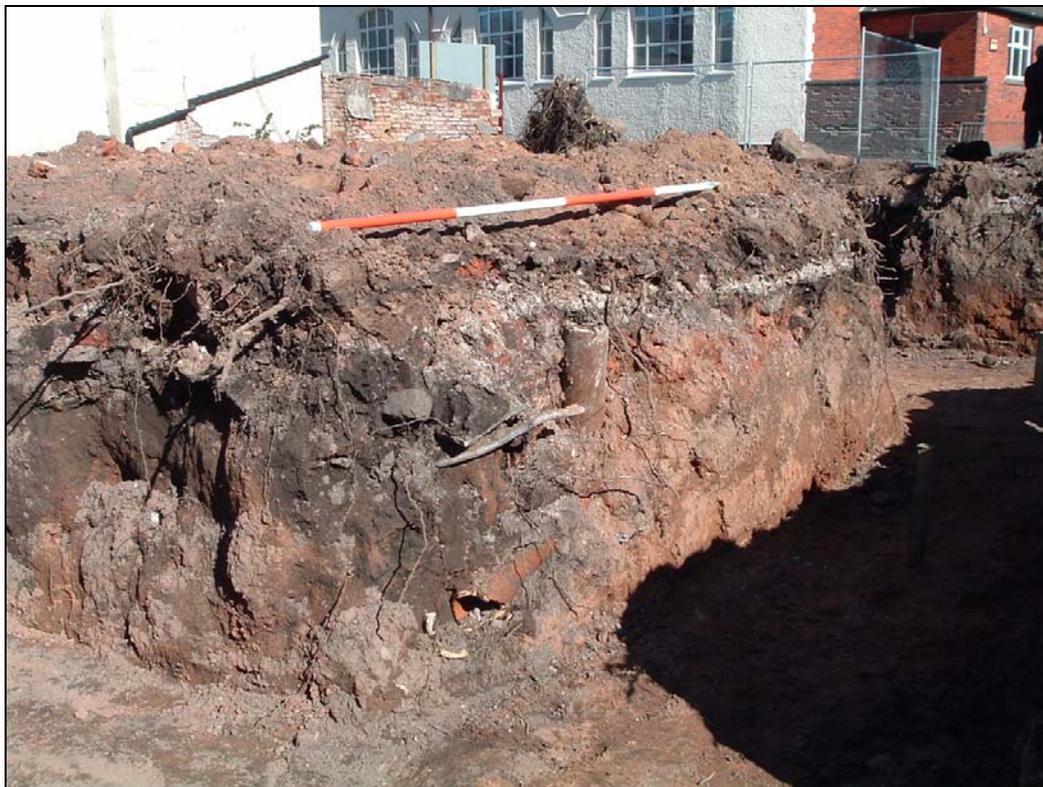
- 7.7.2 The base of the trenches lay on the natural layer of orange sand (context 003) but trench 6a cut through a deposit of broken red brick (context 019 –see Plate 6). The deposit extended for 2.75m along the western section trench 6a at its southern end and continued along the northern section of trench 6b for the whole of its 5.3 m length. It had a depth of 0.8m from the trench bottom. It also extended for 1.7m along the eastern section of trench 6a and round into the northern section of trench 6c for 2m. At this point the base of the deposit was some 0.5m above the trench bottom and had a depth of 0.4m. In both locations the deposits were topped with a 0.15m layer of hardcore (context 020). An earthenware drain was also found to be running west to east along the base of trench 6b from the modern manhole (context 013).

Plate 8: (Cxts 19,20 & 22) in north section of trench 6C

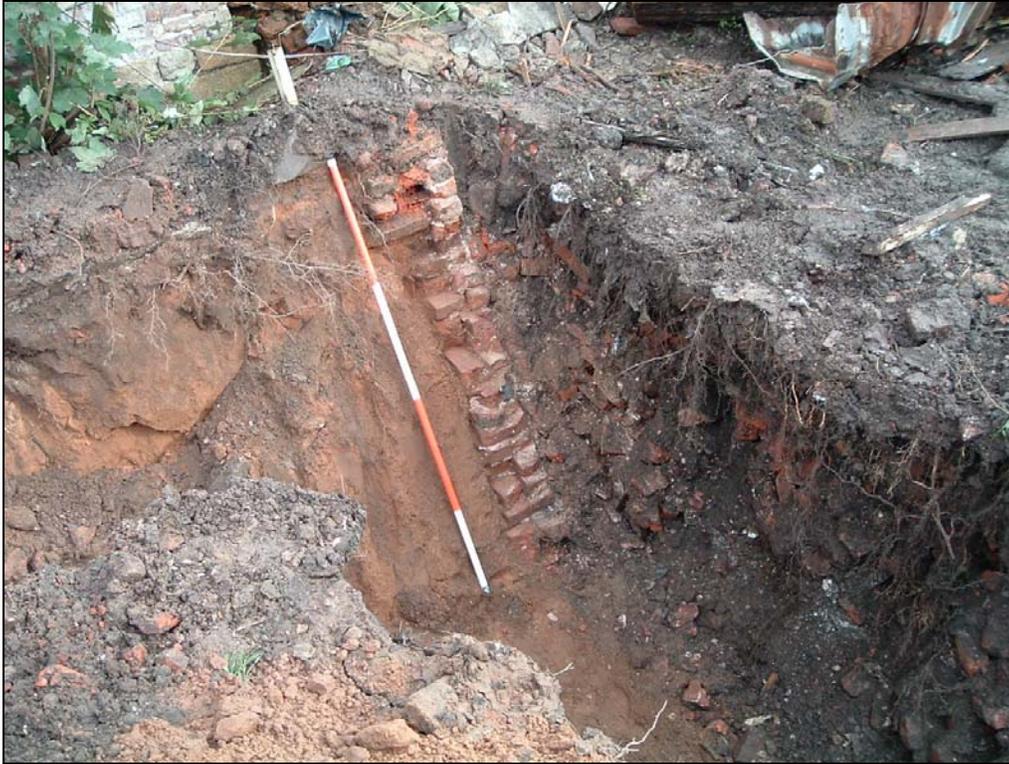
- 7.8.3 There were a number of features of note within trench 7a. Firstly at its northern end was a brick wall (context 23 –Plate 7) which extended out from the north east corner of the excavation into the trench and had a height of 1.7m from the trench bottom. This was built in a garden wall bond of one row of headers to five of stretchers and was two stretchers wide (0.25m).It appeared to have formed the western boundary of the made-up ground material taken out of the trench itself.

Plate 9: Wall (cxt 23) in trench 7A

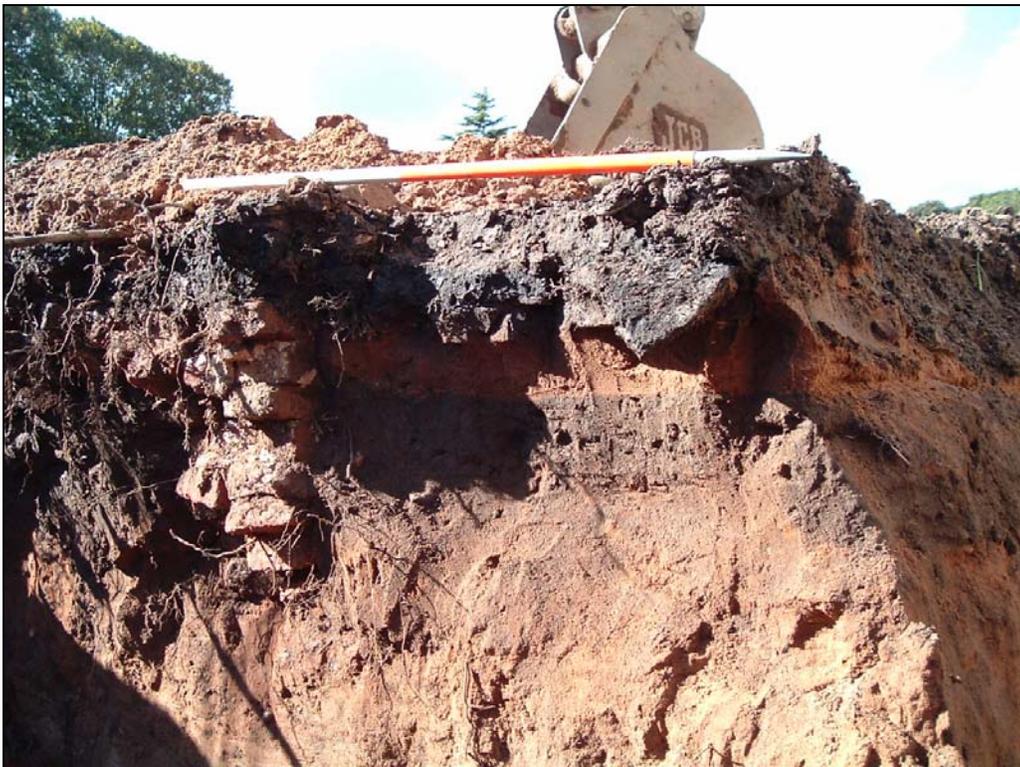
- 7.8.4 The second feature of note was the remains of an unevenly built brick wall or pillar (context 024), some 0.4m thick, in the western section of trench 7a and 0.9m south of its junction with trench 3 (see Plate 8). This appeared to run east-west but was not visible in the east section of the trench. The base of the wall was located 1.1m above the trench bottom and had a height of 0.6m. It extended for a depth of 0.25m into the natural layer of orange sand (context 003) which underlay most of the site. To the north of the wall was the stratigraphic sequence already described in trench 3 as comprising a layer of flagstones (context 009) on a 0.1m thick sand bedding layer (context 010) overlying a 0.1m deep well-defined layer of grey brown silty sand (context 002). The 0.1 m layer of black silt with a heavy content of brick and stone particles(context 011) above which was a surface layer of 0.1m of grey-brown sandy silt with similar intrusions (context 012) already noted at para. 8.4.1 above continued across the top of the flags.

Plate 10: Unevenly built brick wall (cxt 24) in trench 7A

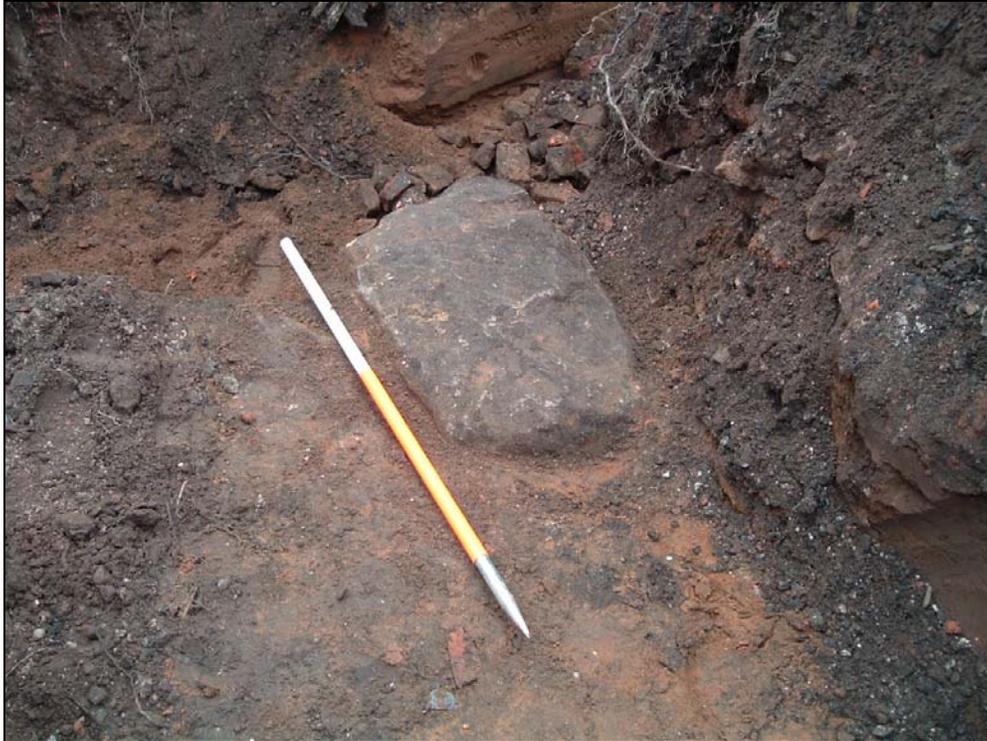
Plate 11: Top of feature (cxt 25) at east end of trench 8

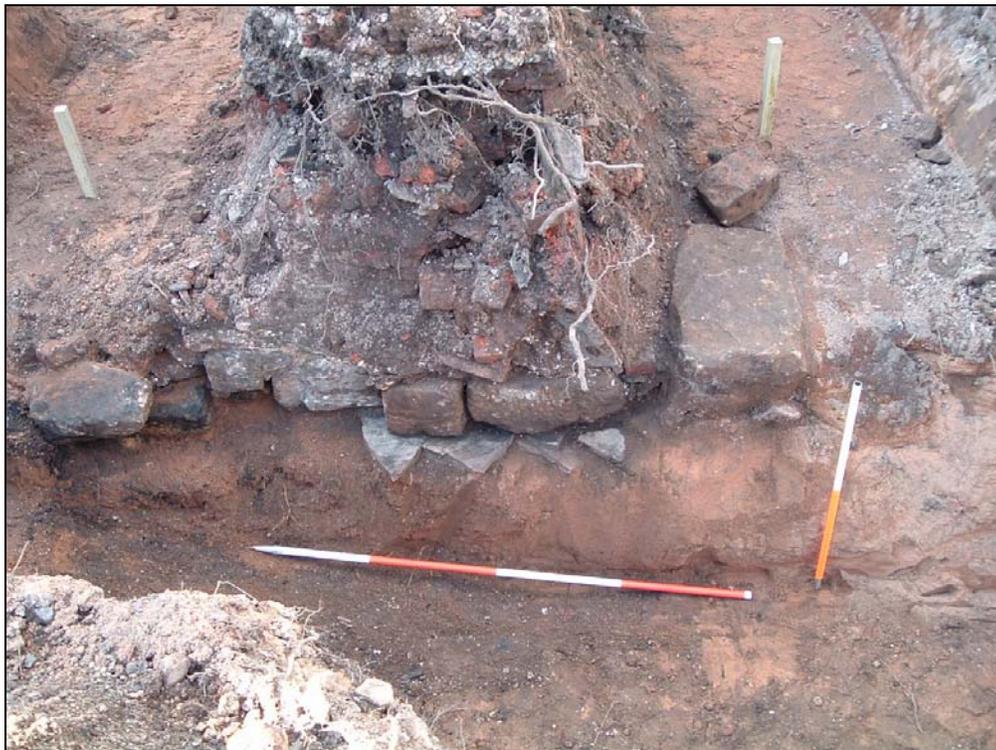
Plate 12: Feature (cxt 25) in west section of trench 8

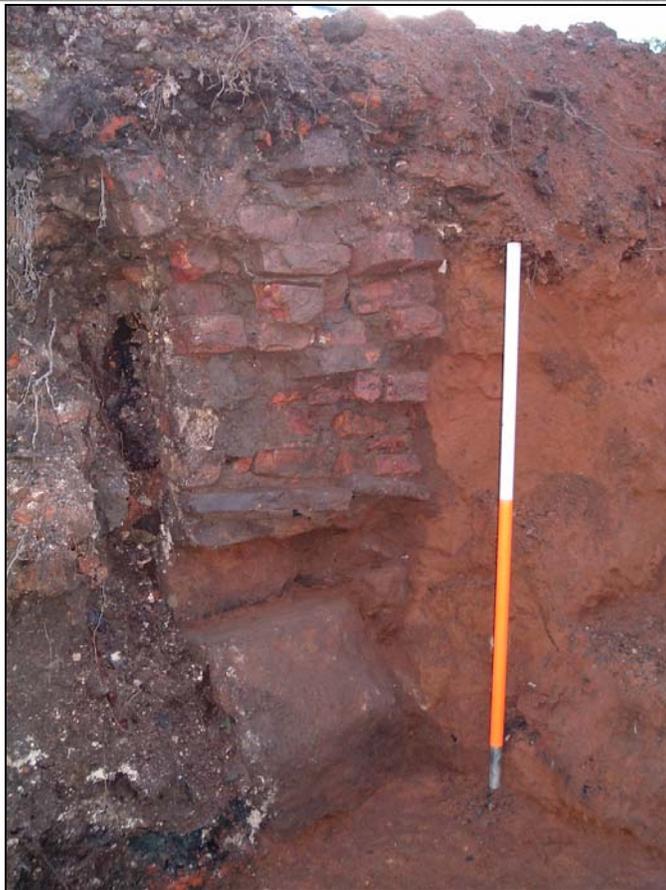
Plate 13: Feature (cxt 27) in east section of trench 7A

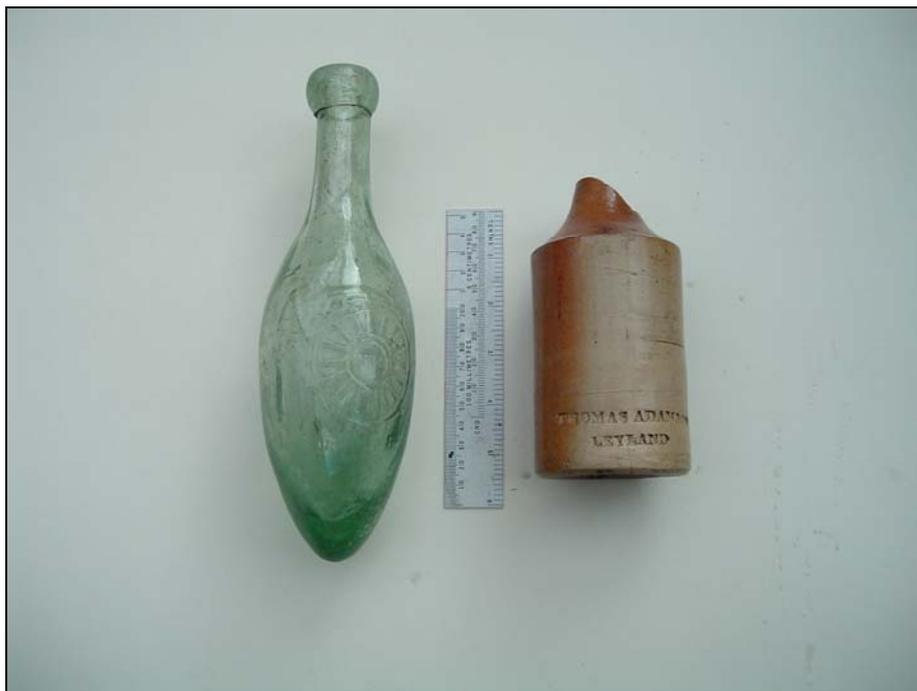
- 8.1 Large numbers of 19th century pottery sherds were found on the site. However the most interesting finds were an earthenware flask and two glass bottles found respectively in the rubbish pits in trenches 4a& b (see paras. 7.5.1 and 7.5.2 above). The earthenware flask was impressed with the name 'Thomas Adamson of Leyland'. The neck of the container was broken off but the body was intact (see Plate 11). Thomas Adamson was a ginger beer manufacturer in Leyland in the mid 1850s (Mannex 1854 and 1855) although he seems to have ceased trading by 1858 (Kelly). The glass bottles were 'torpedo' shaped and stamped with the inscription 'J.H. Cuff of Manchester, established 1801'. There was also a 'round table' trademark on the bottles (see Plate 11). One was intact and the other broken. No record has been found of a ginger beer or mineral water manufacturer by the name of J.H. Cuff in Manchester in the early 19th century so presumably they had also gone out of business within a decade or two of the bottles' manufacture.

Plate 14: Finds
