Saw Shed, Lee Quarry, Bacup

An Archaeological Recording and Monitoring Programme

By J.M. Trippier Archaeological and Surveying Consultancy

Part 1: Recording Prior to Conservation

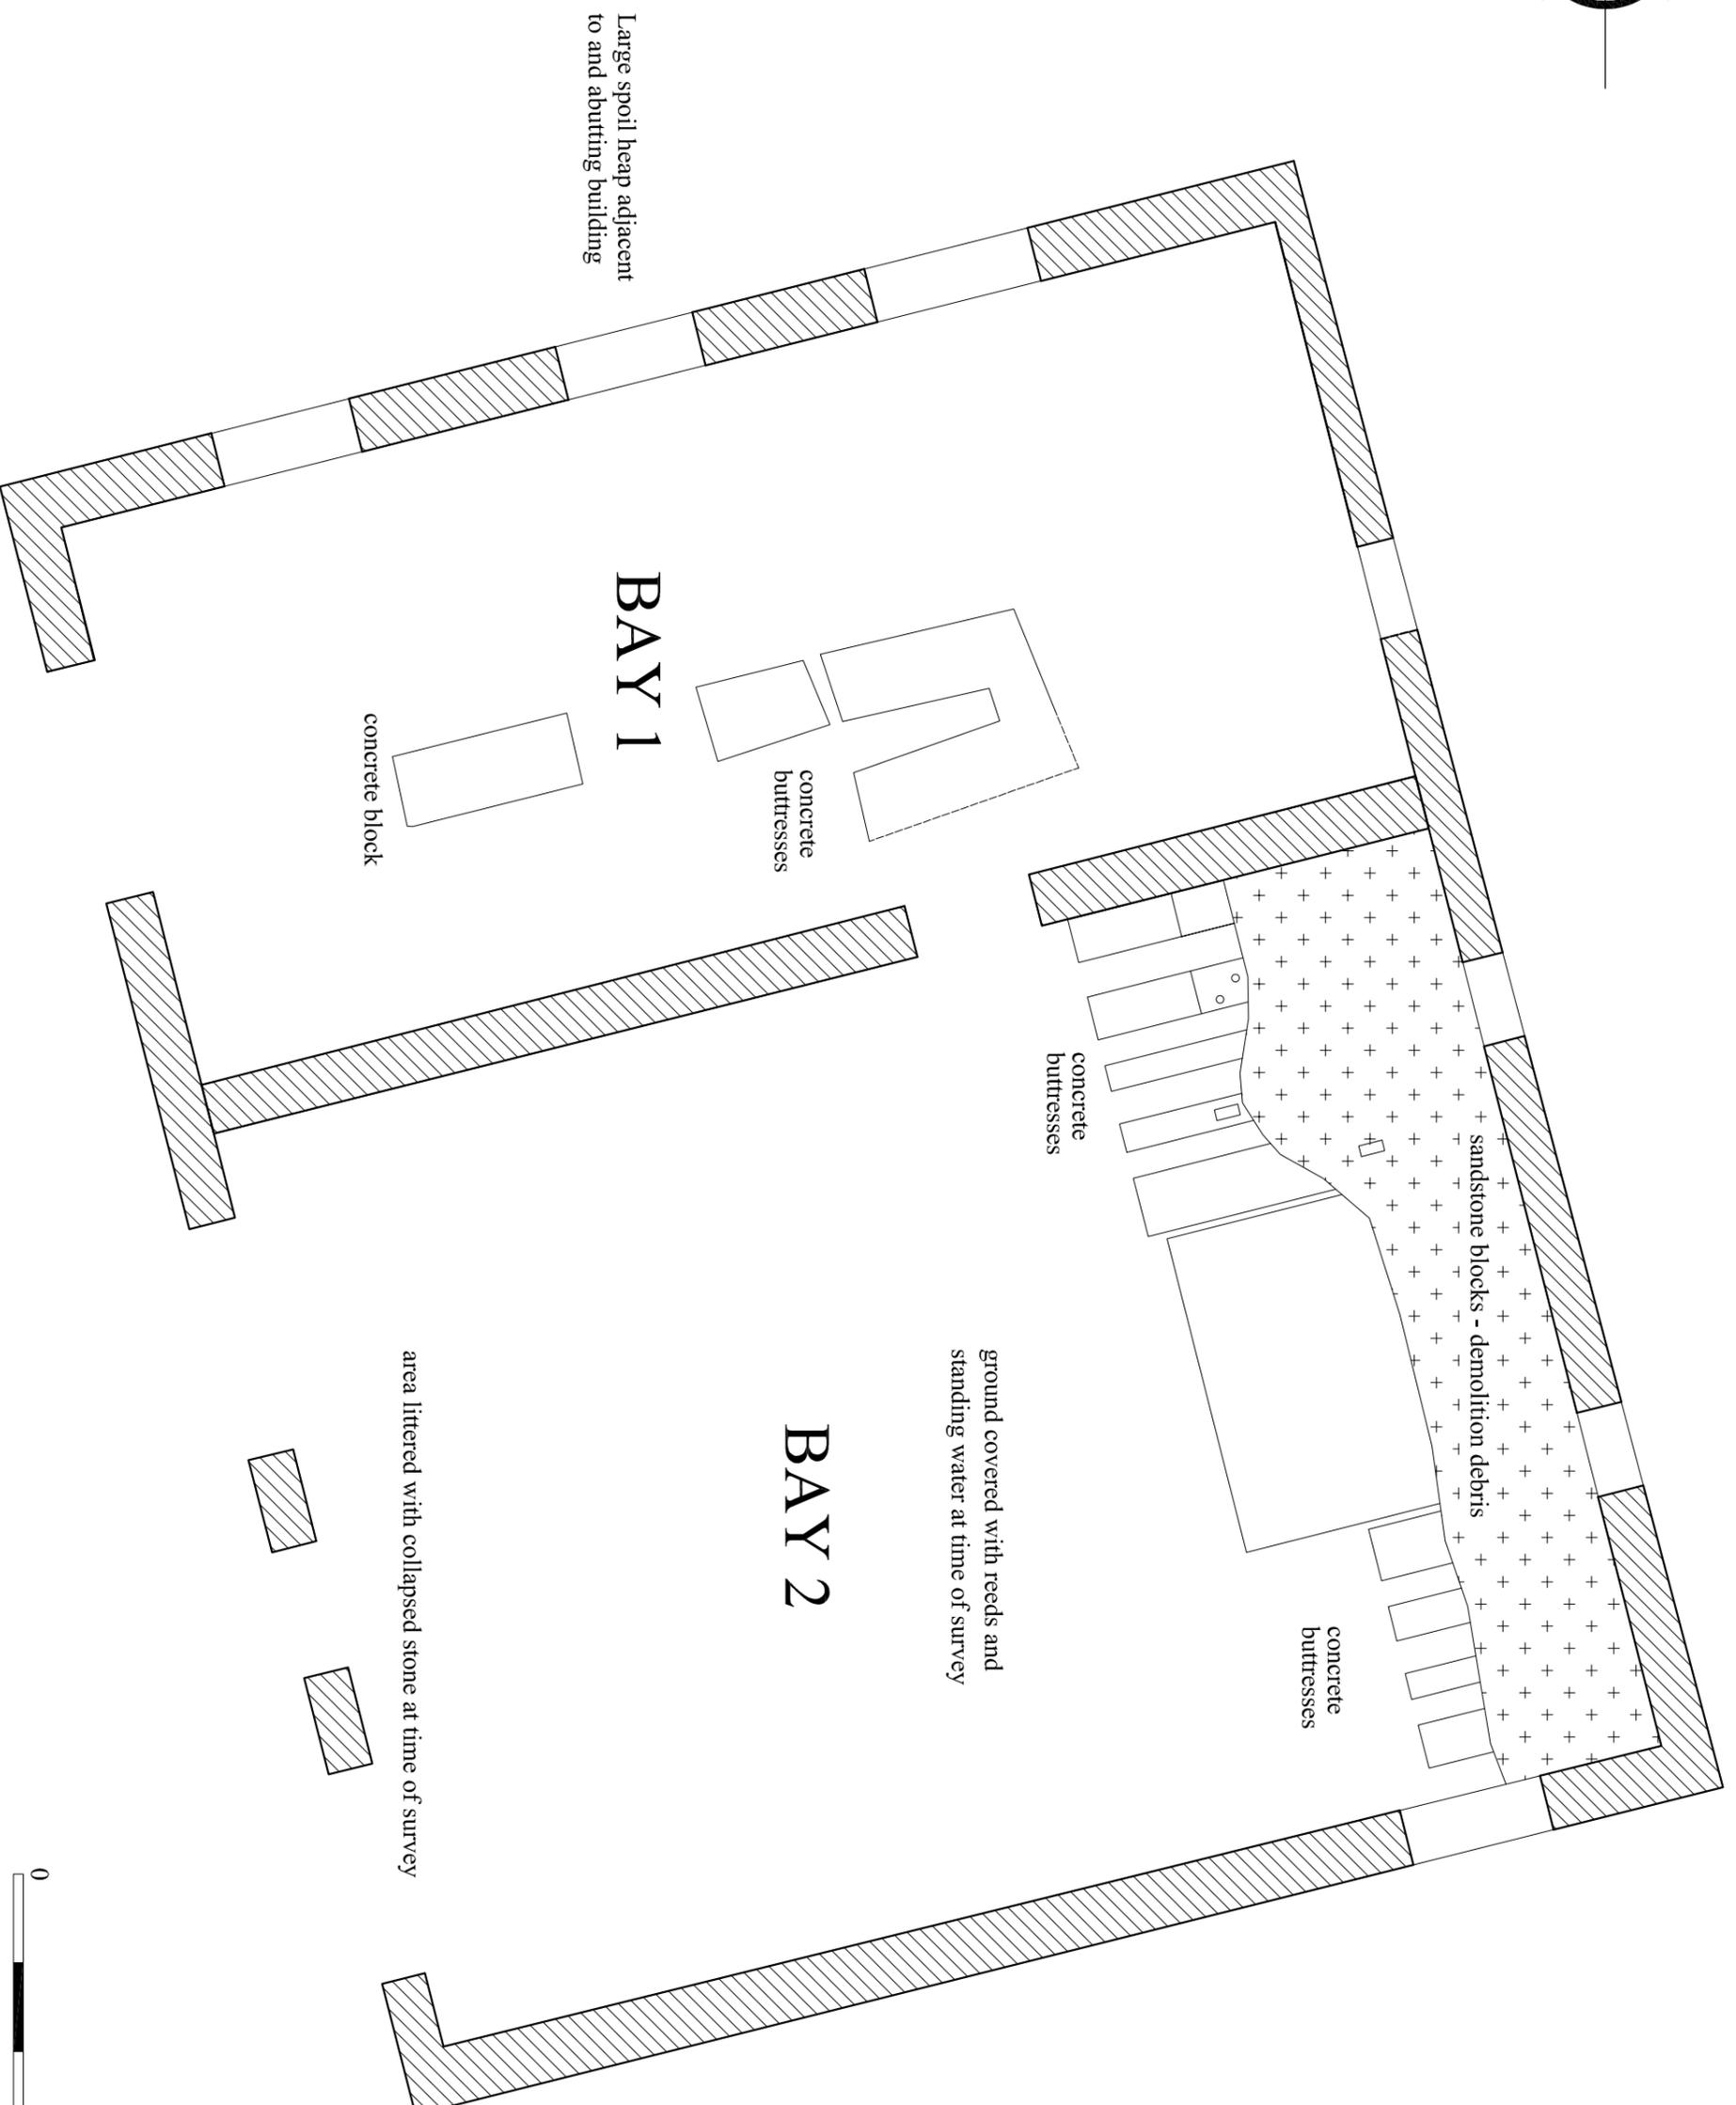
Figure Number 7 Saw Shed Plan

- 5.1.6 The north elevation also contains significant elements of upstanding masonry (**Plates 1 & 14**) and there are three openings in this elevation (**Figs 7 & 8b**). It seems unlikely that these would all be doorways and, although there are no cills or lintels extant, their splayed jambs suggest that they are most likely to have been windows. Their proximity to the hillock immediately to the north suggests that this is a build up of spoil which occurred after the building went out of use. The westernmost opening is well defined by the adjoining walls and jambs, the westernmost of which forms the junction with the equally well defined north end of the west wall of the building (**Plate 15**). The central opening is well defined on its west side but less so on its east where the adjoining spoil/slip from the adjacent heap or hillside is now overlying the opening (**Plate 16**). The east opening is poorly defined on its west side but the remains are rather more upstanding on the east side where the splay on the opening is more clearly visible (**Plate 17**).

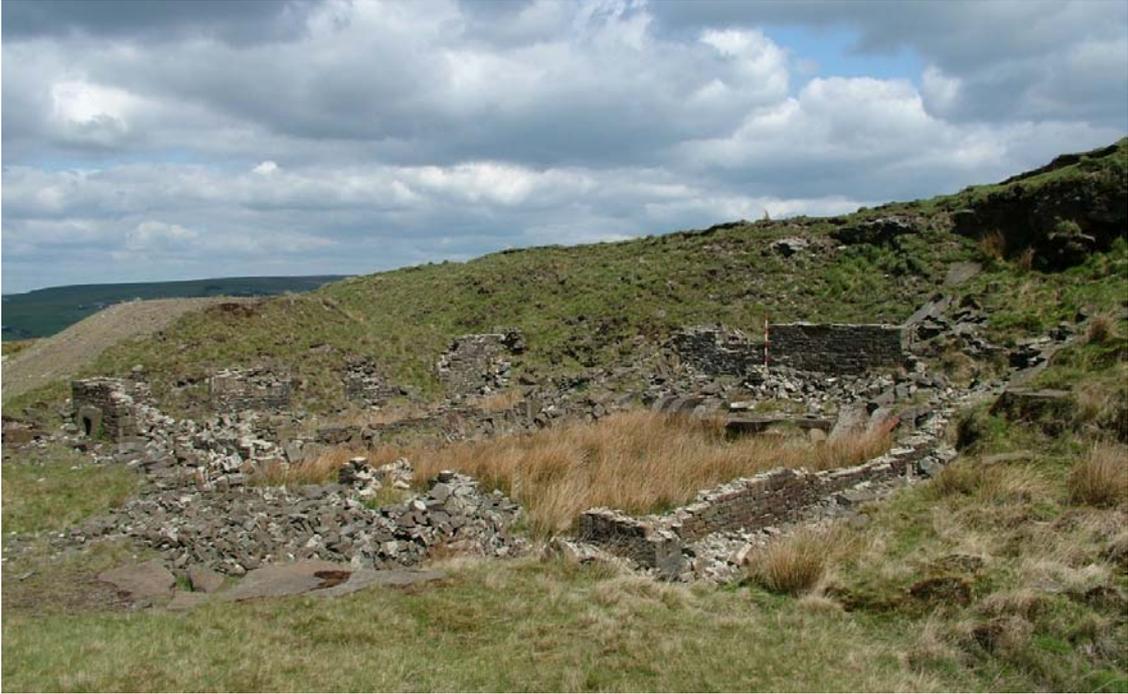
Plate 1: View of saw shed

- 5.1.1 The building (**Plate 1**) is located on a level platform terraced into the rock face and close to the main quarry working face with large spoil heaps on its north and east sides. The dimensions of the building measured externally are 19.65m (north-south) and 15.55m (east to west). A sandstone rubble wall crosswall orientated east-west and located off-centre to the north divides the building into 2 bays or rooms (**Plate 2**). These are labelled Bay 1 and Bay 2 on the measured drawing (**Fig.7**). Bay 1 measures 14.12 x 6.45 m and forms the northernmost room. Bay 2 measures 14.2 x 10.65 m and forms the southernmost room.

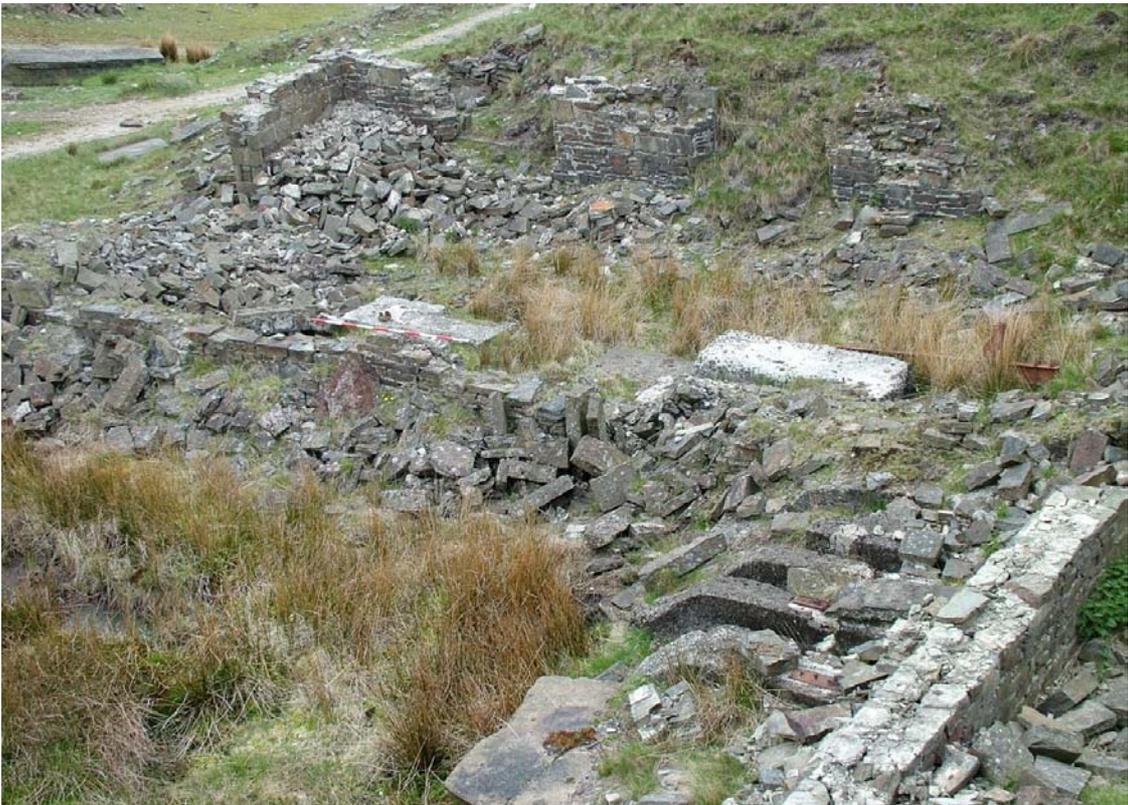
Plate 2: Overhead view of machine bases

- 5.2.1 The central dividing wall between Bays 1 & 2 is of matching construction to the external walls (**Plate 2**). This wall is continuous for its whole length but is degraded to a low level and the eastern end is heavily overlain with rubble. Towards its eastern end is a standing stone which may have been the jamb for the doorway giving access from Bay 1 into Bay 2 (**Plate 14**). A number of other similar blocks adjacent but no longer in situ may have formed part of this doorway (see **Plate 14**).
- 5.2.2 Bay 1 contains a large irregular indented concrete buttress and a rectangular

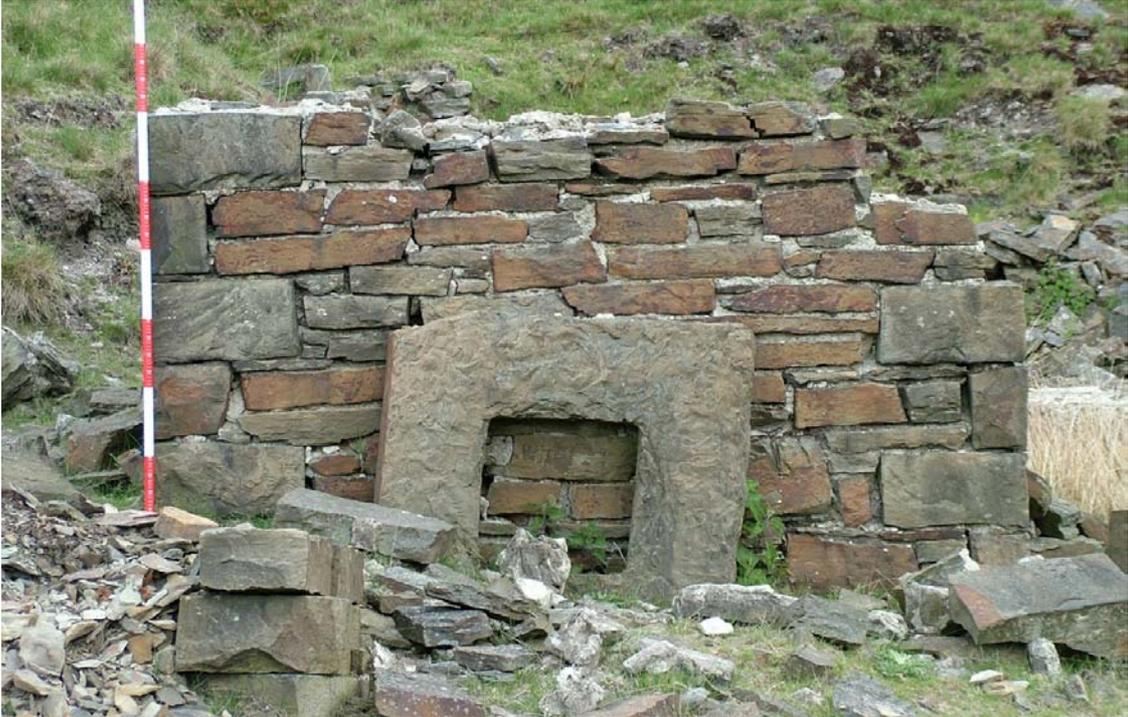
Plate 3: Close-up of north-west corner

- 5.1.2 The building is constructed of rough sandstone blocks laid to courses with dressed squared gritstone blocks forming quoins at the north-west and south-west corners (**Plates 3 & 4**). It is now largely ruinous and roofless although a photo made available by Mr Dominic Cooper, the sometime project manager for Groundwork, indicated two double pitched roofs orientated east-west (**Front Cover**). It appears from this photograph that there is a 'straight joint' between Bays 1 & 2 suggesting that they may have been built as separate phases with Bay 2 being later. However it was not possible to explore this further at this time due to the heavily degraded state of the wall at this point and the large amount of rubble overlay (**see Plate 6**). Surviving wall heights range from 2.1m at the highest to the lowest at 0.6m. The walls were generally no more than 0.5m thick. Block sizes ranged on average from 0.5 x 0.2 x 0.2m to 0.25 x 0.15 x 0.10m. These were set in a greyish-white lime mortar.

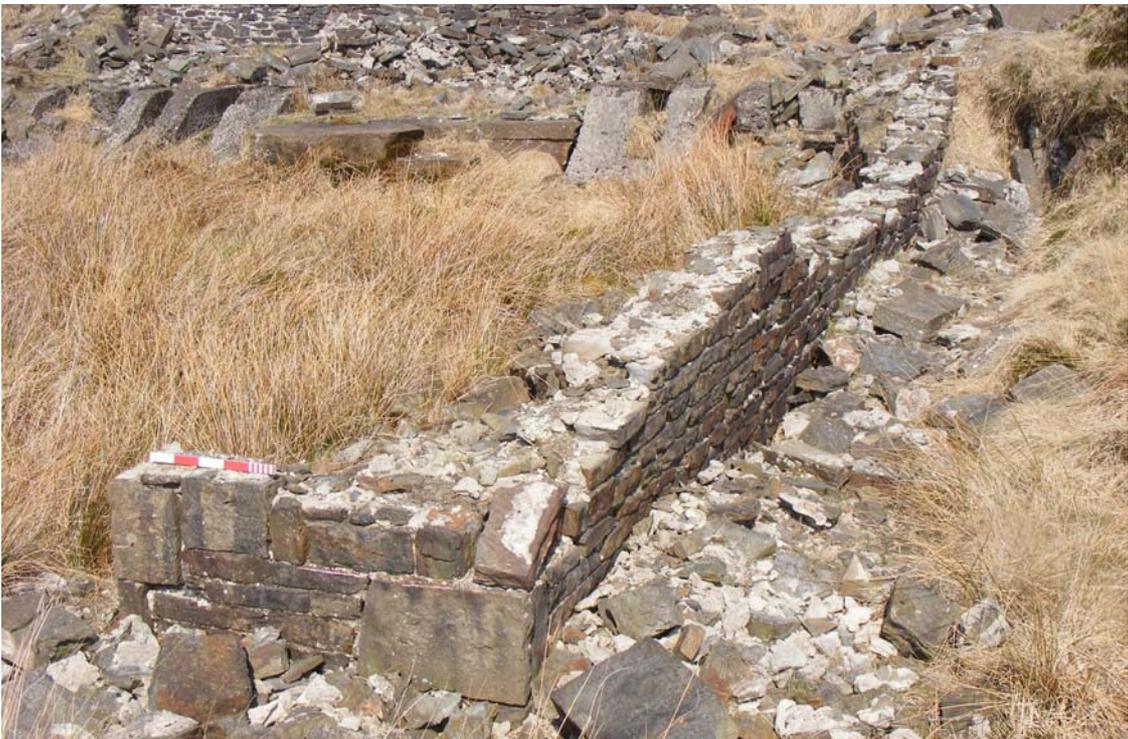
Plate 4: Close-up of south wall and junction with west wall

- 5.1.4 The south elevation is intact continuously for its whole length but only at its lower courses (**Plate 4**). It is largely a blank wall although at its eastern end there is a cill (**Plate 9**-see scale bar) suggesting the presence of a former window. In common with the other window openings surviving (notably in the east elevation) this cill comprises two elongated blocks of dressed stone laid end to end.

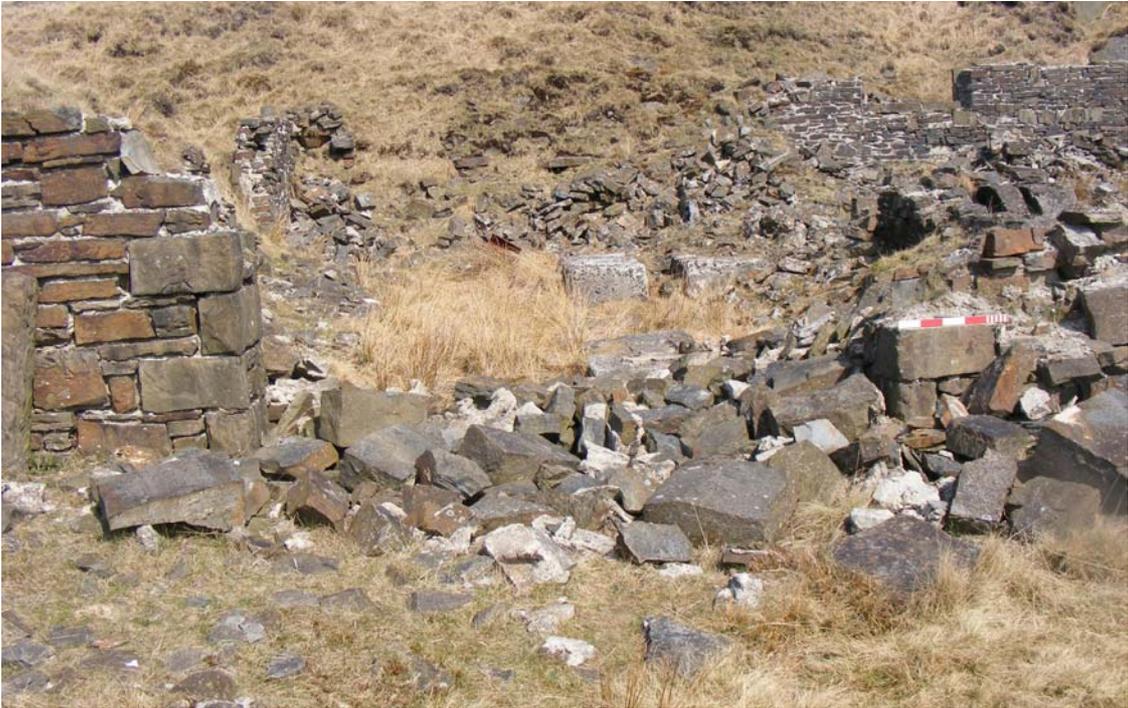
Only the lowest courses of the jambs of the third opening are intact. The section of wall between this opening and the southernmost (4th) one is extremely degraded and largely covered with rubble to the west (**Plate 8**). However the south jamb of the southernmost opening is in good condition at its lower level as is the adjoining wall which is linked with good quoin stones to the south wall of the building (**Plate 4**).

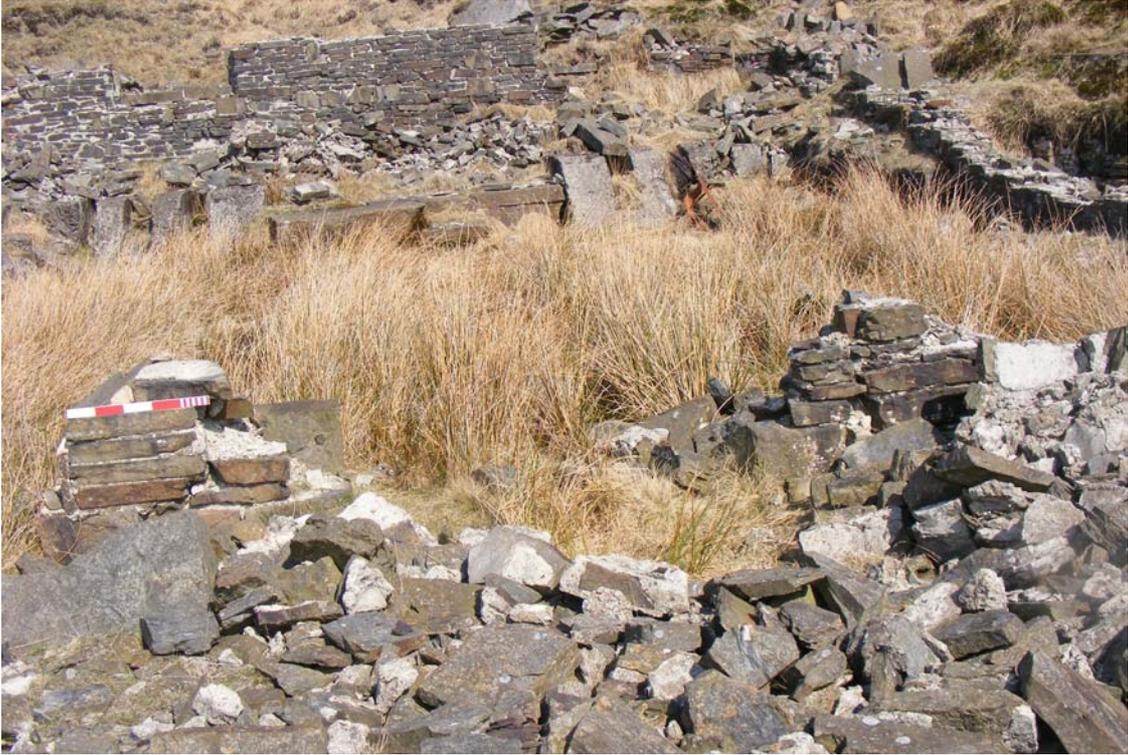
Plate 7: Central opening in west wall of Bay 2

- 5.1.3 The west elevation appears to comprise the front of the building. As mentioned above it was constructed of sandstone blocks laid to courses with dressed squared gritstone blocks forming quoins at the north-west and south-west corners (**Plates 3 & 4**). There are four openings (**Figs. 7 and 8a**). All have lost their lintels and no cills or thresholds are visible. The surround to the northern opening is most intact with the north jamb being exposed to half height and the lower part of the south one still in place (**Plate 5**). The lower courses of the wall between the northern opening and the next to the south are still visible although overlain with rubble on the west side. The north jamb of this second opening has gone although its southern jamb is still partially visible low down (**Plate 6**). There are very small sections of wall between this 2nd opening and the next one south (3rd) and between the 3rd opening and the final (4th) (**Plate 7**).

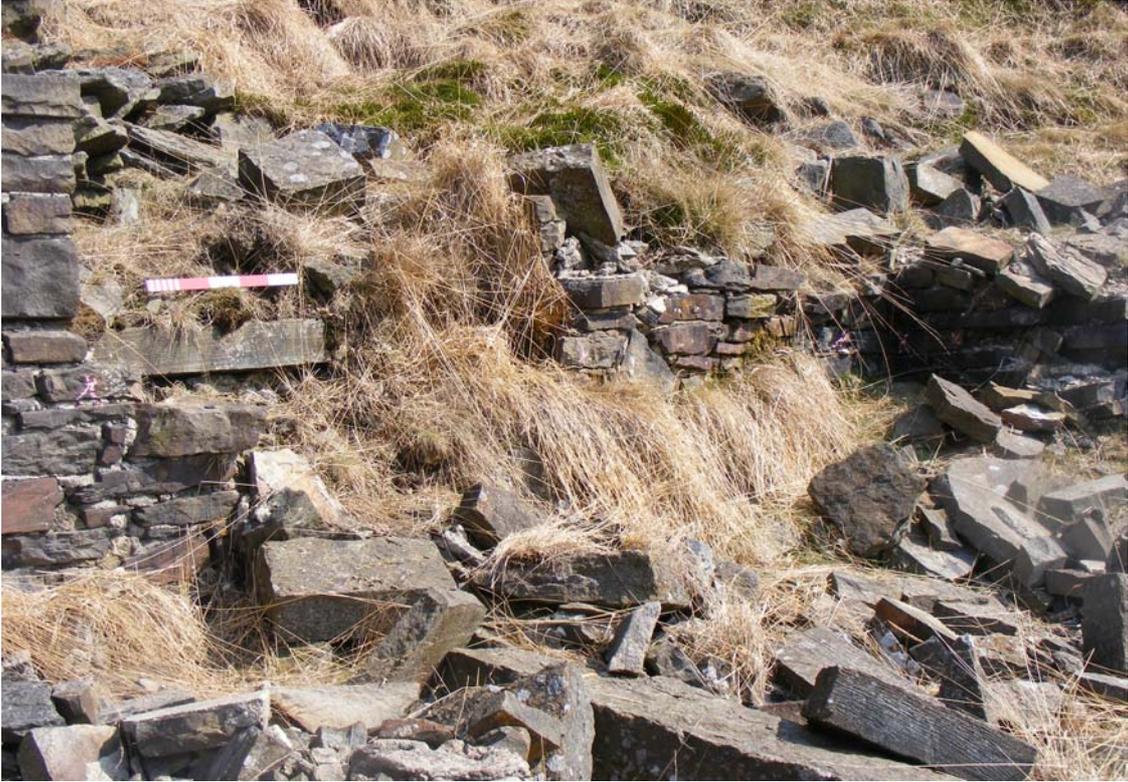
Plate 10: Internal view of north window in east elevation

- 5.1.5 The east elevation is built immediately to the west of the hillside or spoil heap which sits hard up against it to the eastern exterior. There is a substantial element of this wall still upstanding in the south bay (Bay 2) (**Plate 10**). This contains two window openings (**Plates 10 and 11**). In common with all other openings in the building the lintels are gone and the cills comprise two elongated blocks of dressed stone laid end to end. In the case of the north window the lower parts of both jambs are intact and are splayed outwards from the exterior (**Plate 10**). In the case of the south window only the north jamb is extant, the wall having collapsed to cill level south of the window. In the north bay (Bay 1) the state of collapse of this elevation is much more severe and the wall has all but gone (**Plate 12**) although it appears that there are in situ remains under the adjoining/overlying spoil or land slip. See for example an in situ block which appears to be a lintel for an opening of some kind and which still sits on its jamb which is now largely buried (**Plate 13**).

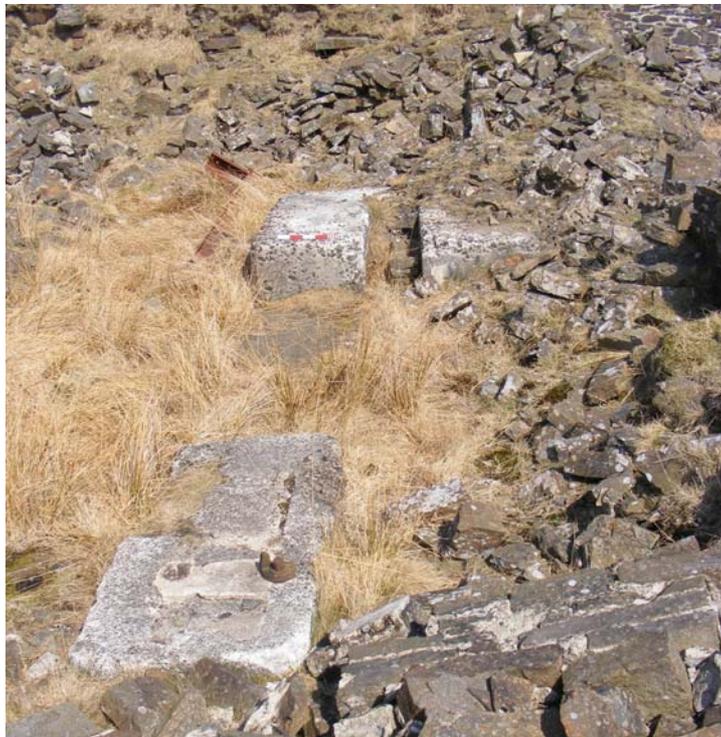
Plate 18: Machine beds in Bay1

concrete block c.1m west of the buttress (**Plates 2 & 18**). At the time of the survey the internal area was littered with stone debris making it difficult to ascertain the nature of the flooring. However, a small test area was cleared to reveal hints of a sandstone flagged floor.

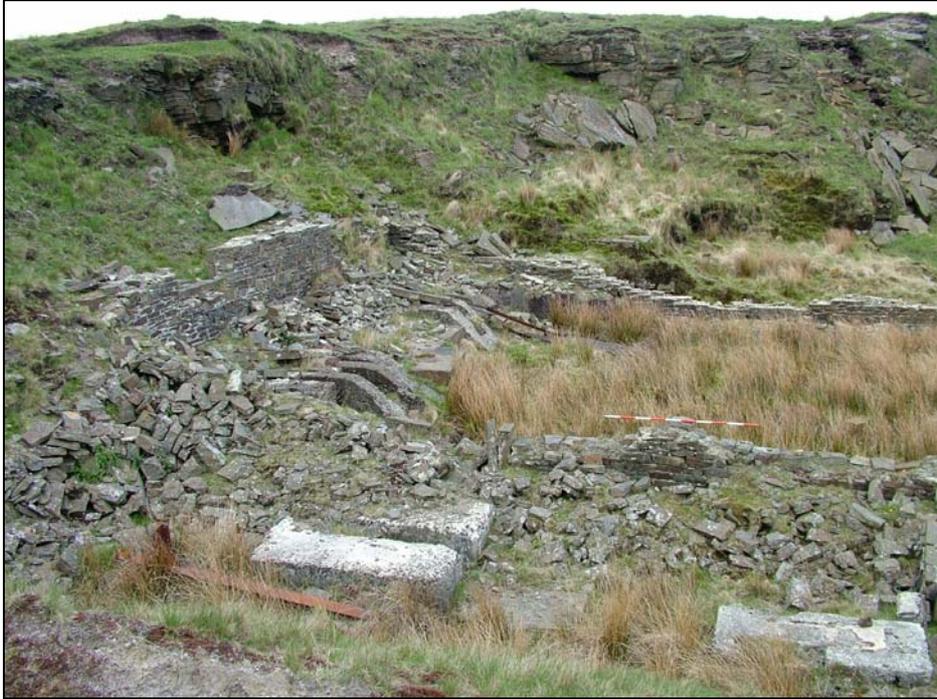
Plate 19: Overhead view of machine bases

- 5.2.3 Bay 2 contains a series of massive indented concrete buttresses attached to the eastern wall and orientated east-west (**Plate 19**). Some of the buttresses contain steel pins- possibly machine mounts ((**Plates 20 & 21**). It is worth noting that one of these beds sits hard up against the east end of the south wall of the building and immediately to the north of some large rough hewn stone blocks which may support the south wall itself (**Plate 9**). Although on first sight these appear natural it seems more likely that they were brought here from the quarry workings. At the time of survey the floor area was waterlogged and water reeds masked the floor area preventing identification of the flooring material (**Plate 22**).
