**TOWNHEAD,
THE SKAITHE, SLAIDBURN
An Archaeological Recording Programme**

by J. M. Trippier Archaeological and Surveying Consultancy

SPECIFICATION FOR ARCHAEOLOGICAL BUILDING RECORDING AT TOWNHEAD, SLAIDBURN (SD 71026 52631)

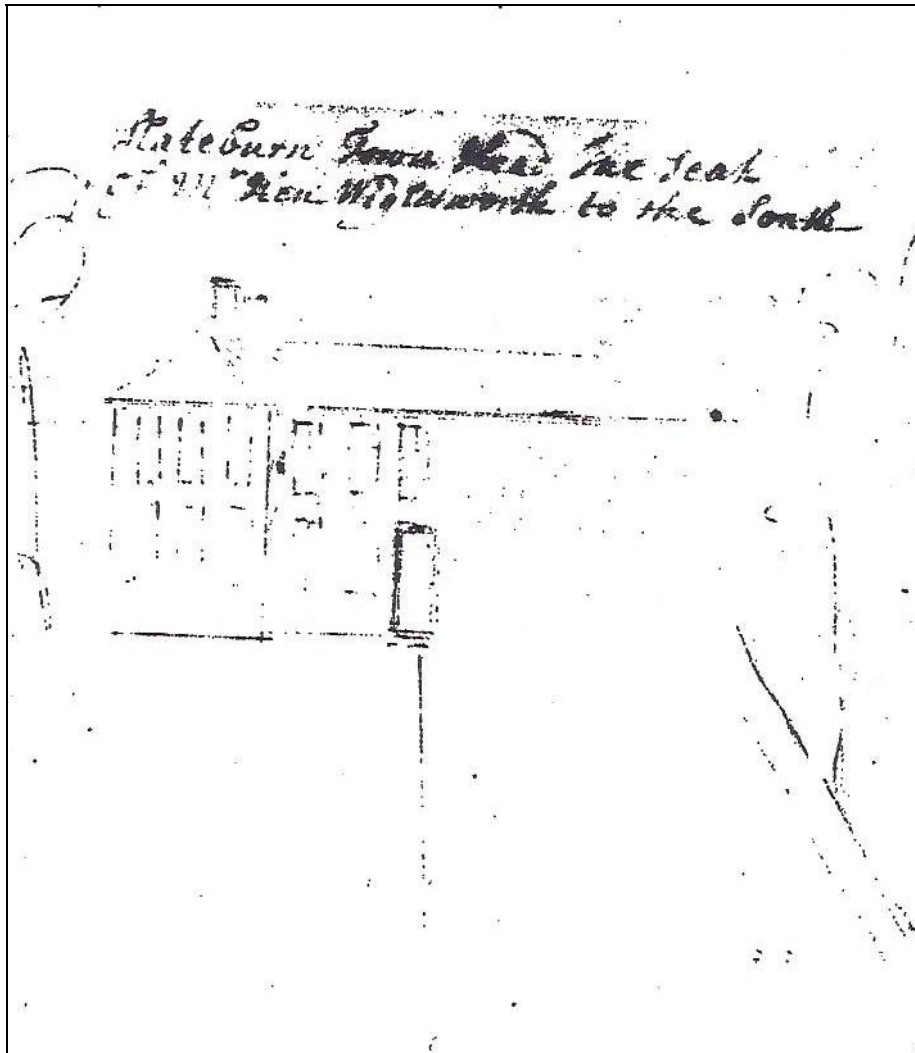
A drawing made c. 1720 and titled 'Slateburn Town Head The Seat of Mr Hen Wiglesworth to the South' (Buck, Samuel, Yorkshire Sketchbook. Reproduced in Facsimile, Wakefield, 1979) shows a larger house in similar style but which does not correspond in either the number of bays or the number of storeys to the present building.

- 5.2 A copy of the drawing by Buck, referred to above, is at Fig. 3 of this report although it is extremely faint. Although of similar style to the current building that in the drawing has only two storeys and appears to comprise a central block with two end bays at right angles to form an E-shaped footprint.

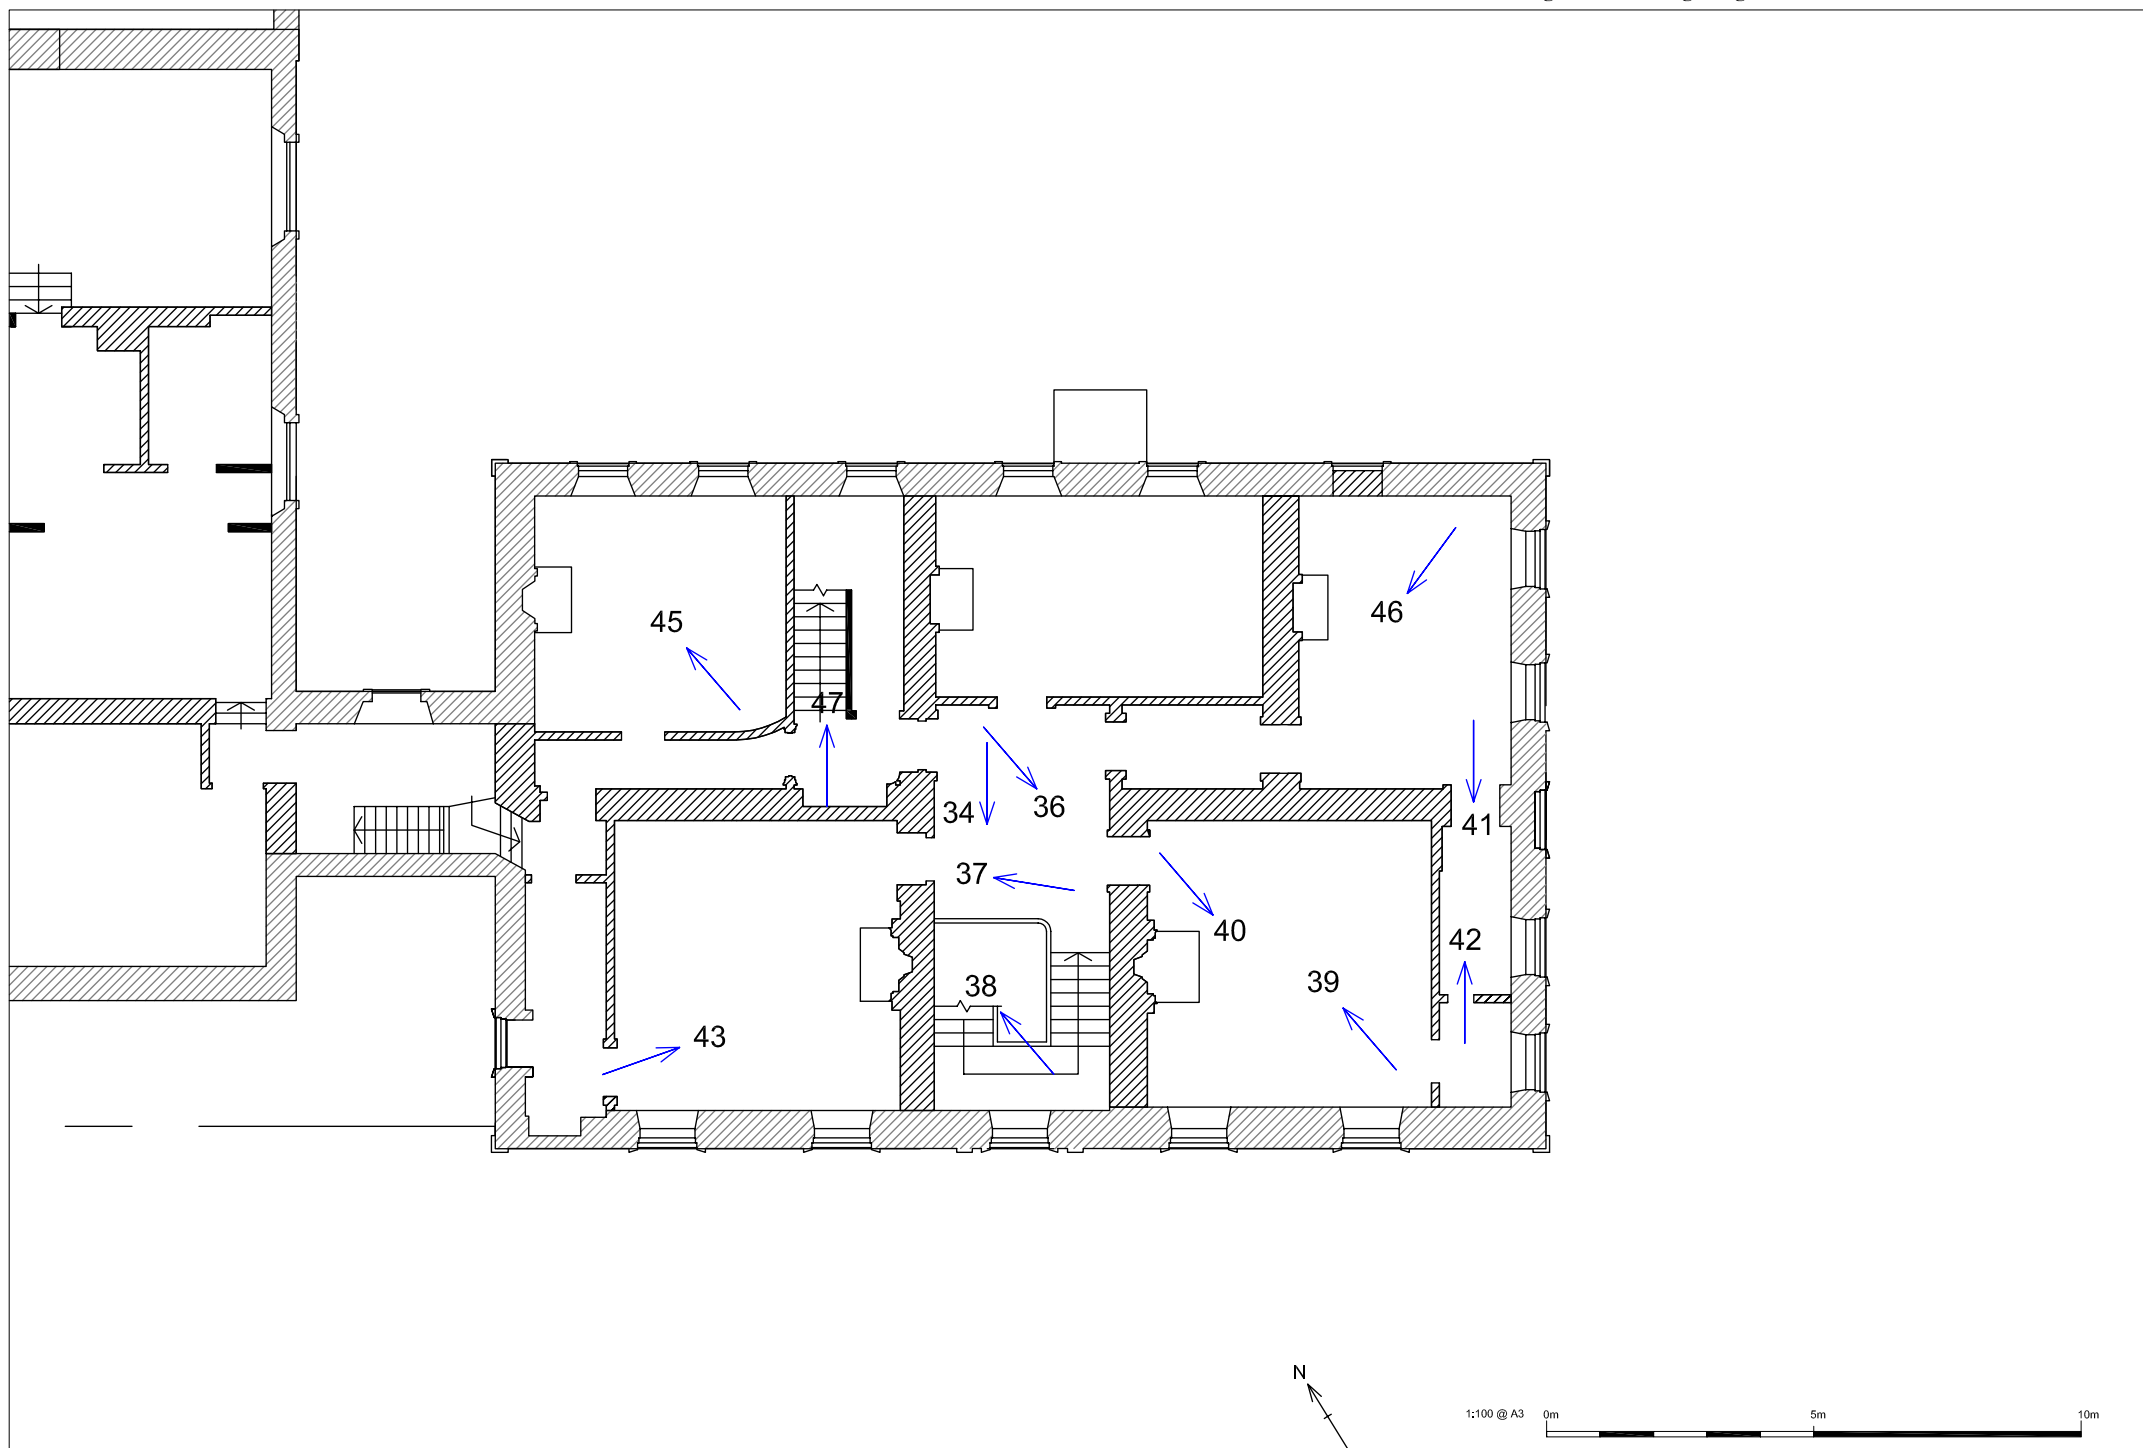
Figure 7: Photograph Location Plan: First Floor of Main House

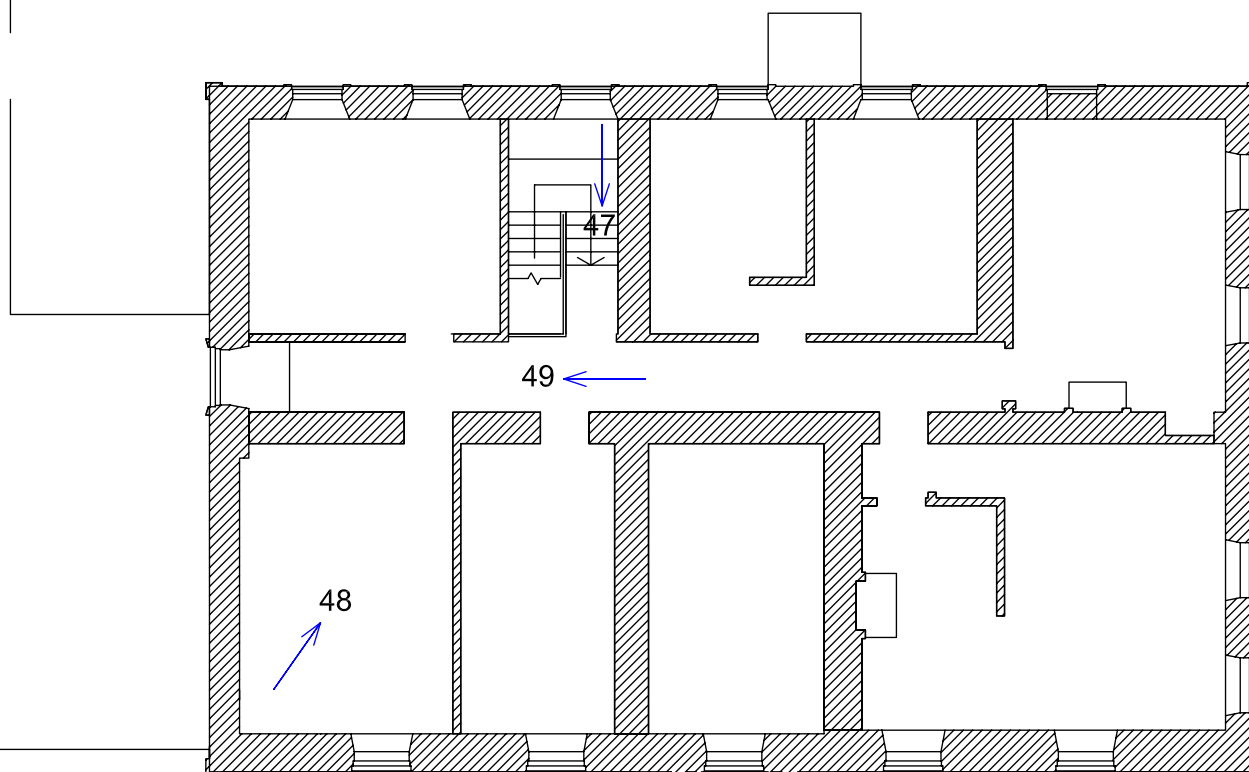
Figure 8: Photograph Location Plan: Second Floor of Main House

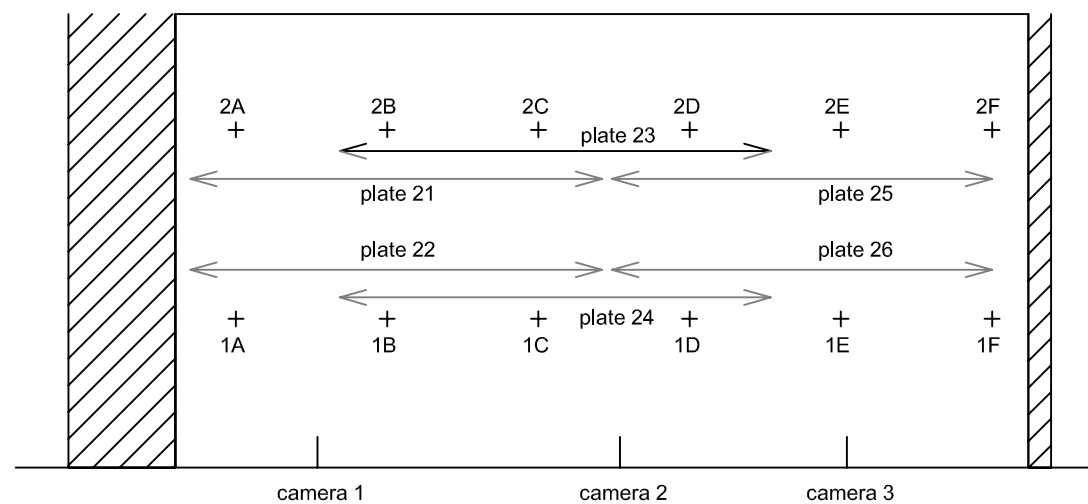
Figure 10: Guide drawing to rectified photographs of north wall of drawing room

- 4.5 Rectified photographs were taken of the north wall of the drawing room and the in accordance paragraph 5.6.1 of the specification as this wall was to be demolished and rebuilt. A diagram showing the position of the rectified photographs is included a Fig.10. It was initially also intended to take rectified photographs of the wall between the drawing room and the staircase hall as it was thought that this was also to be demolished and rebuilt. However as this wall is now to remain rectified photography was not necessary.

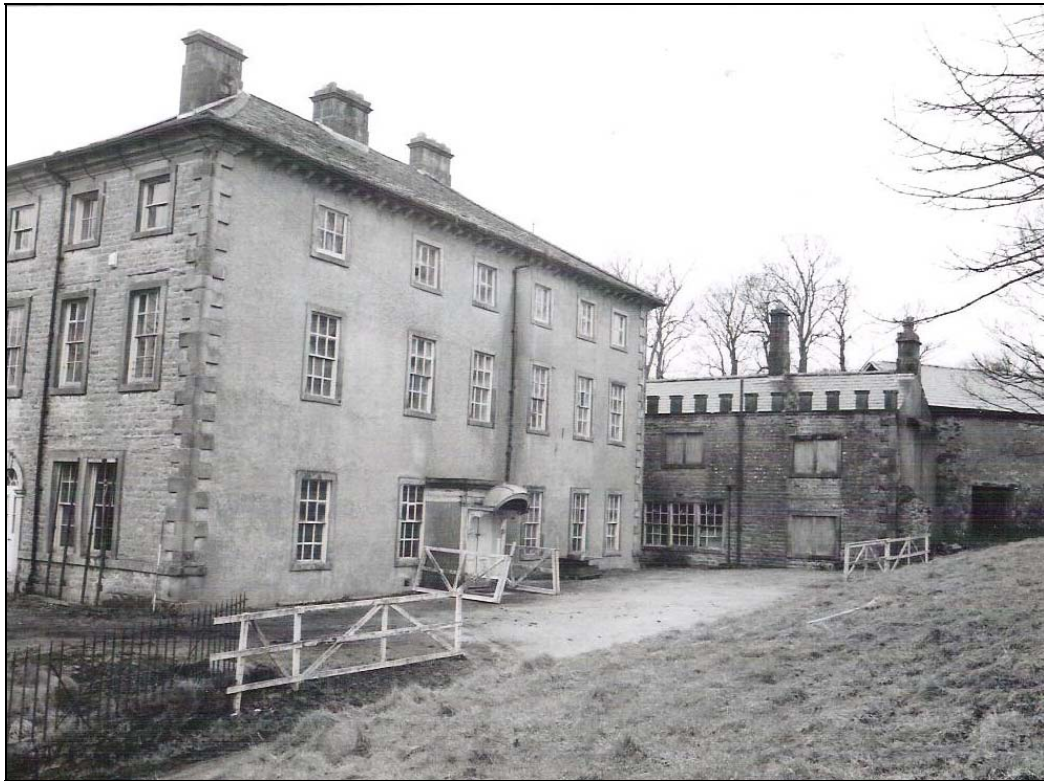
Plate 3: North elevation and kitchen range

- 6.1 The physical details of the property are fully covered in the English Heritage survey (2004, 7-34) but can be summarised as follows
- 6.2 Townhead is situated on a terrace at the summit of a north-western slope above Croasdale Beck which separates the site from the village of Slaidburn which it overlooks. In addition to the house, service block and other outbuildings there is a substantial range of farm buildings to the northwest (**Plates 1 & 2**). The house itself is a compact rectangular double pile block five bays wide to the south front and three storeys high with a basement under the west end (**Front Cover**). A two storey service block on the west side is attached to the main house by a two storey link block (**Plates 3 & 4**).

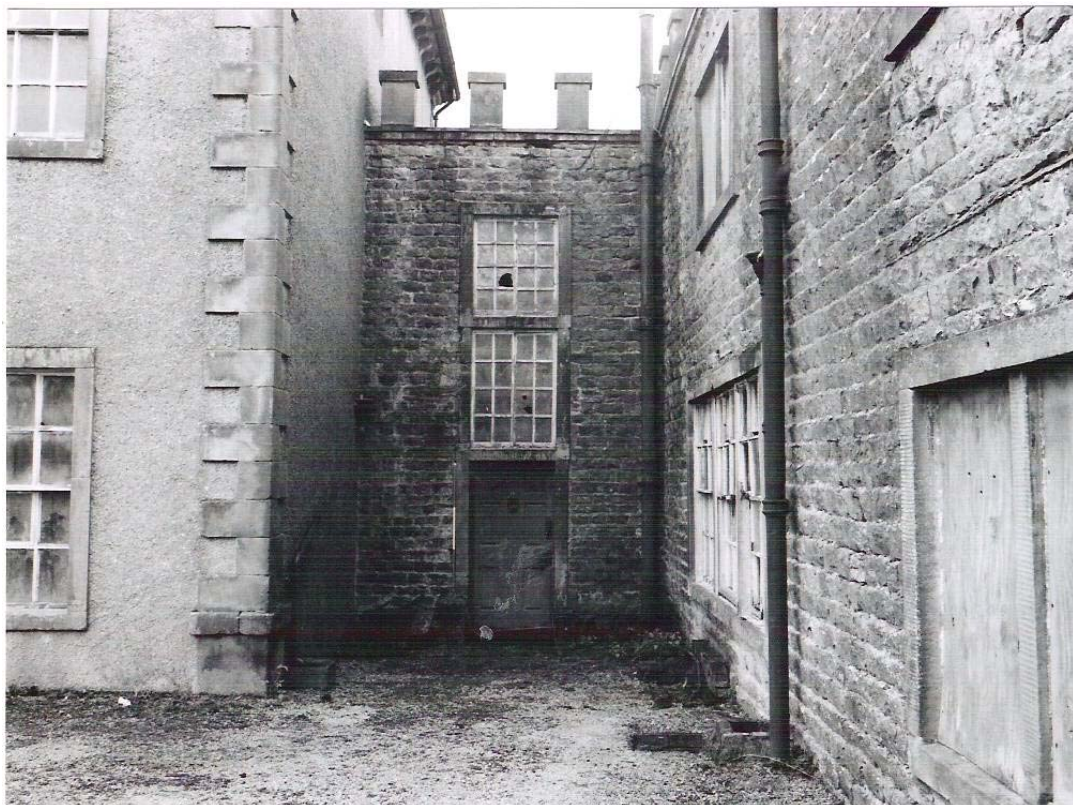
Plate 4: North elevation of the link block

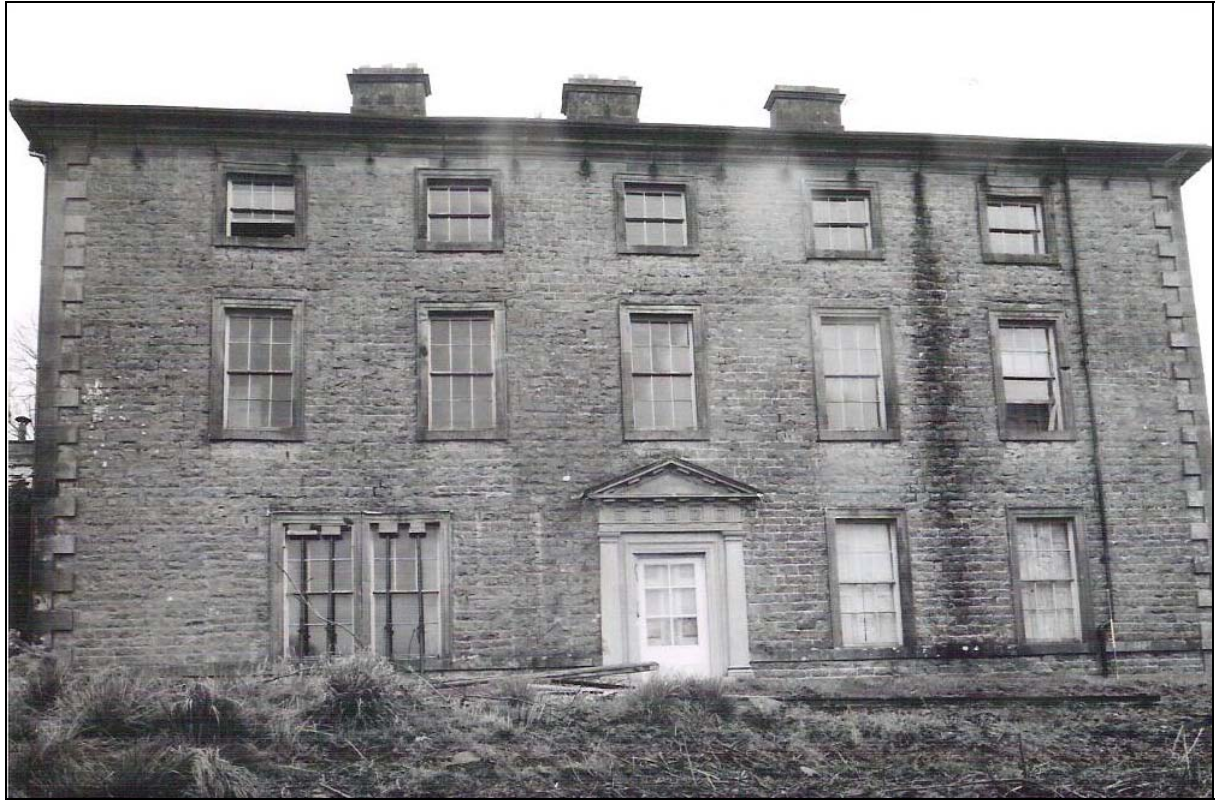
Plate 5: South elevation

- 6.3 The house is constructed of squared pitch-faced limestone blocks with sandstone dressings including quoins with bold vertical tooling (**Plates 5&6**). The English Heritage report describes them as being laid in watershot style but this does not appear to be the case. The principal south and east elevations (**Front Cover**) are treated as symmetrical compositions and are finished to a higher standard than the north and west ones with finely moulded eaves cornices and a classically detailed door case in the centre of the south elevation (**Plate 7**) which gave access to the stair hall. The north and west elevations are rendered and have modillioned cornices (**Plates 3 & 4**). The windows on the south front have moulded surrounds (**Plate 8**) and those on the east, north and west elevations have square cut surrounds (**Plates 9, 10 & 11**). Those on the north and west elevations have zigzag tooling and it is said that these window surrounds are reused from the earlier 17th century house as evidenced by dressed back mullion bases on some cills. However we were unable to identify these.

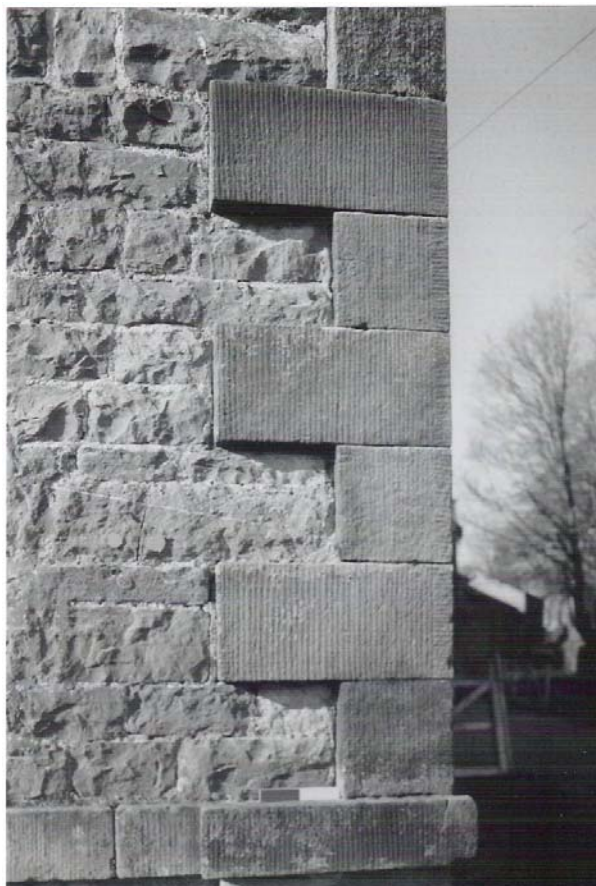
Plate 6: Tooled quoins at junction of east and north walls

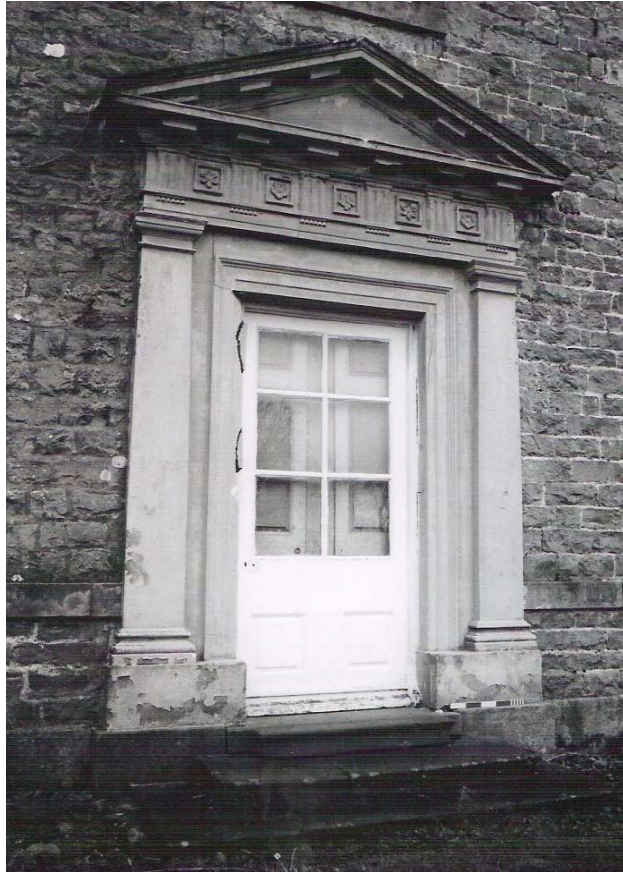
Plate 7: Classically detailed doorway in south elevation

- 6.4 In the early 19th century various alterations were made, possibly at the instigation of the wife of the Revd. Henry Wigglesworth. These included the replacement of single windows with pairs on the south and east elevations (**Plates 5 & 9**) and the addition of a new doorway with a round headed ashlar surround with double keystone to the latter. This gave access into the south-east drawing room.

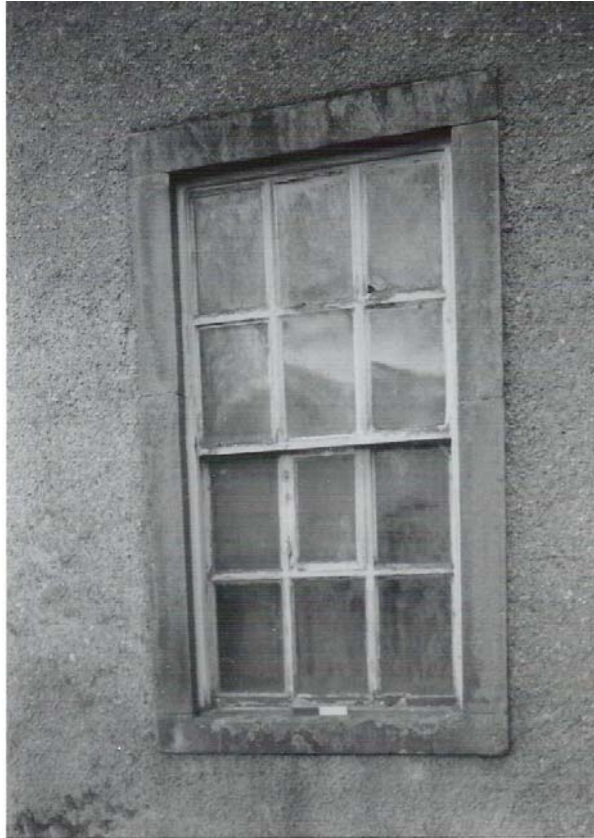
Plate 11: Window on ground floor of north elevation

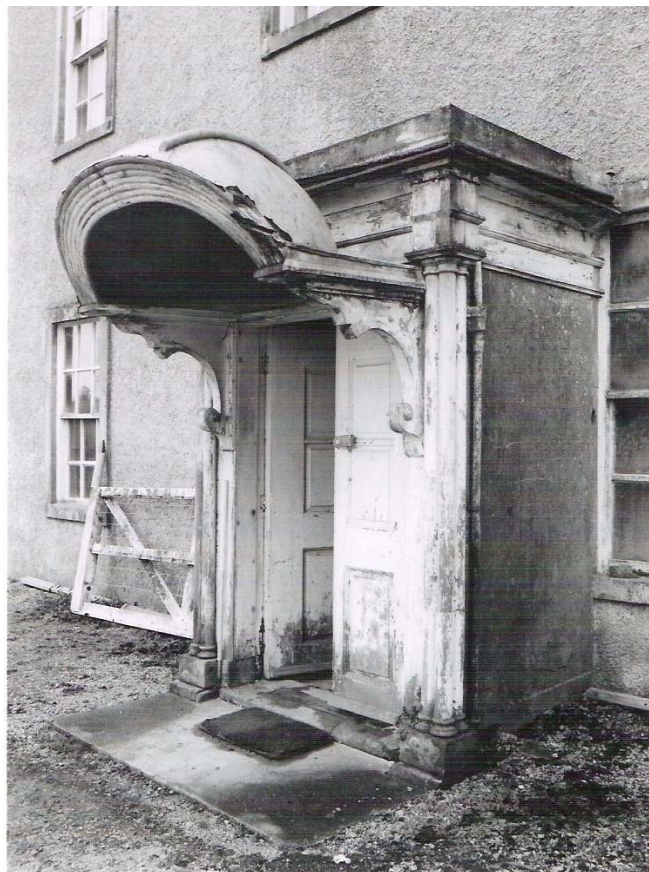
Plate 12: Principal entrance on north elevation

- 6.5 The principal entrance is in the north elevation and is now situated within an enclosed porch which was added in the 19th century and to which both the original door and shell canopy were refitted (**Plate 12**). This provides access to the entrance hall (**Plates 13&14**) which leads in turn into the stair hall. There had been another doorway in the position of what is now the third window from the west in the north elevation which gave access to the service corridor running from the entrance hall to the service wing (**Plate 15**). This was converted to a window in the early 19th century when a new doorway was inserted in the north elevation of the link block.

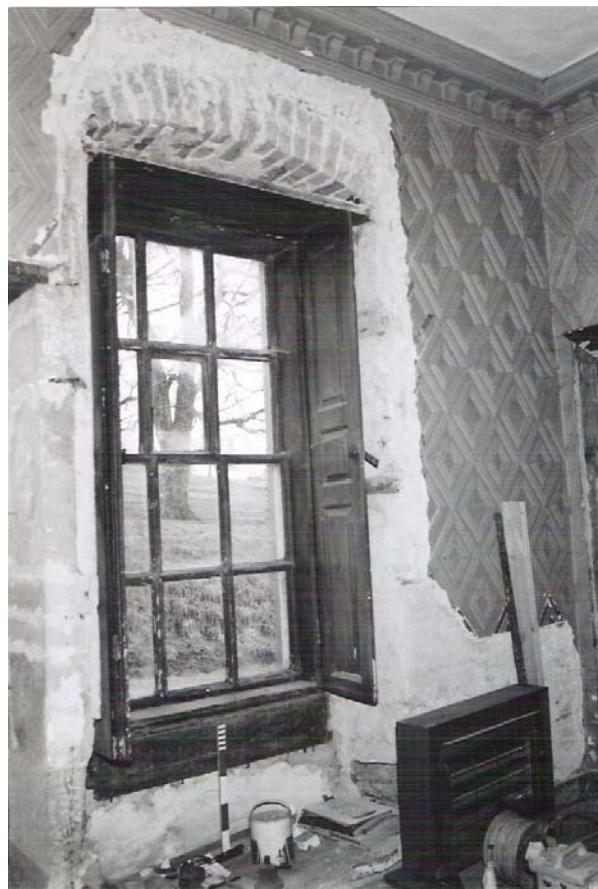
Plate 14: Window in north wall of entrance hall east of doorway

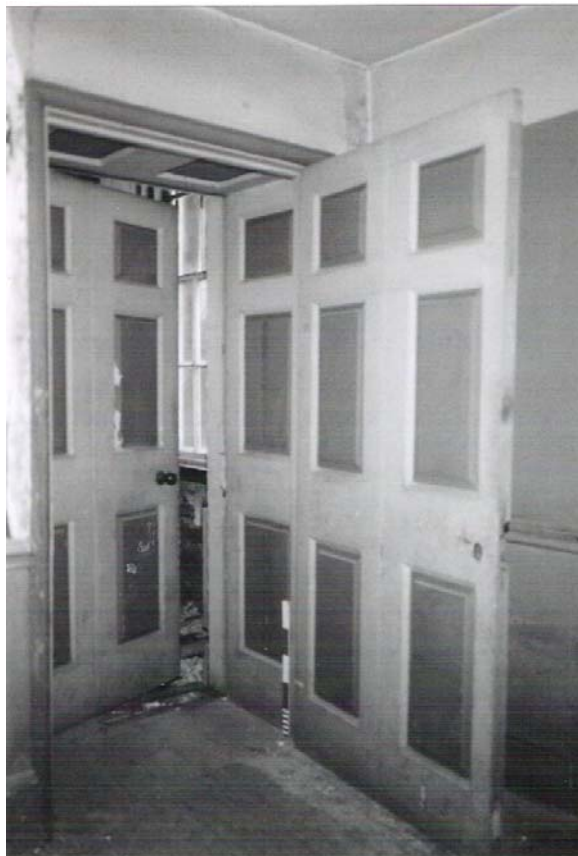
Plate 16: Double doors from stairs hall to drawing showing inner panel between

- 6.6 There are three reception rooms on the ground floor; two on the south frontage which are accessed from the stair hall (**Plate 16**) and have been identified as the drawing room (east side of hall) (**Plates 17-26**) and dining room (west side of hall) (**Plates 27 & 28**) and one in the north-east corner which is accessed from both the drawing room and the entrance hall and may have been the library or morning room (**Plates 29 & 30**). The north-west corner of the ground floor is made up of the back stairwell and the house keeper's room (**Plates 31 & 32**).

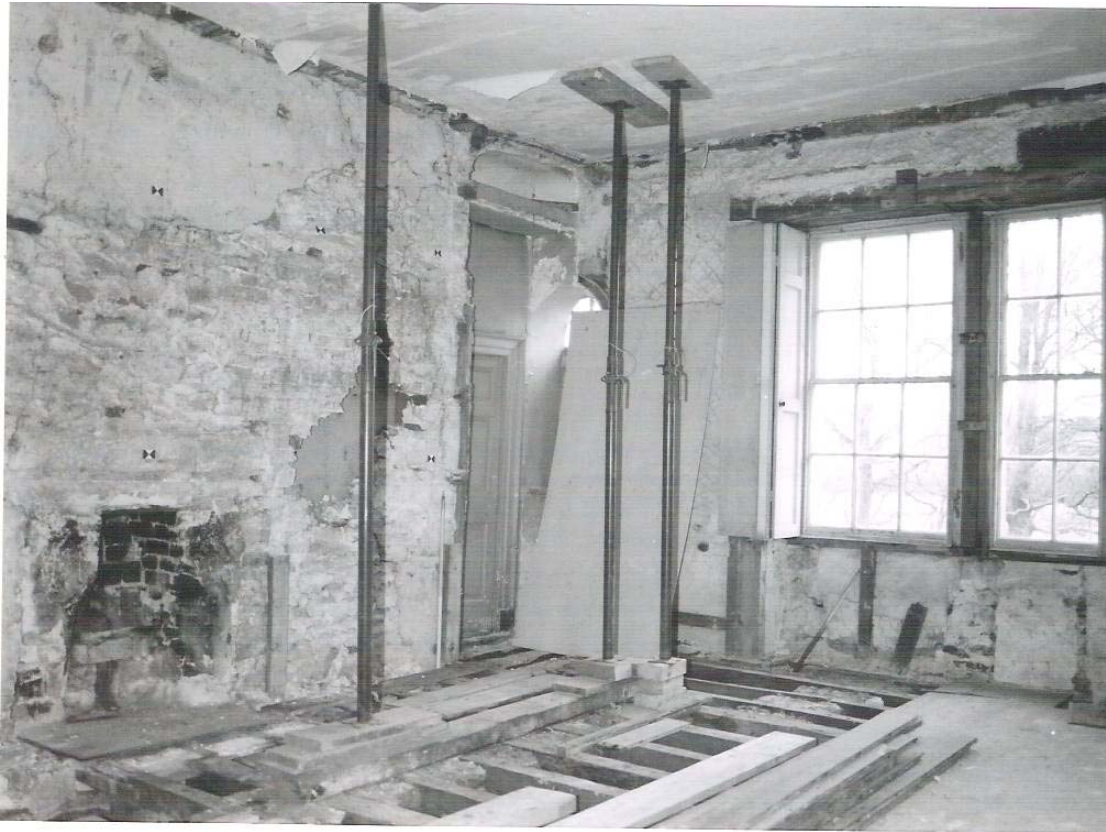
Plate 19: North and east wall of drawing rooms

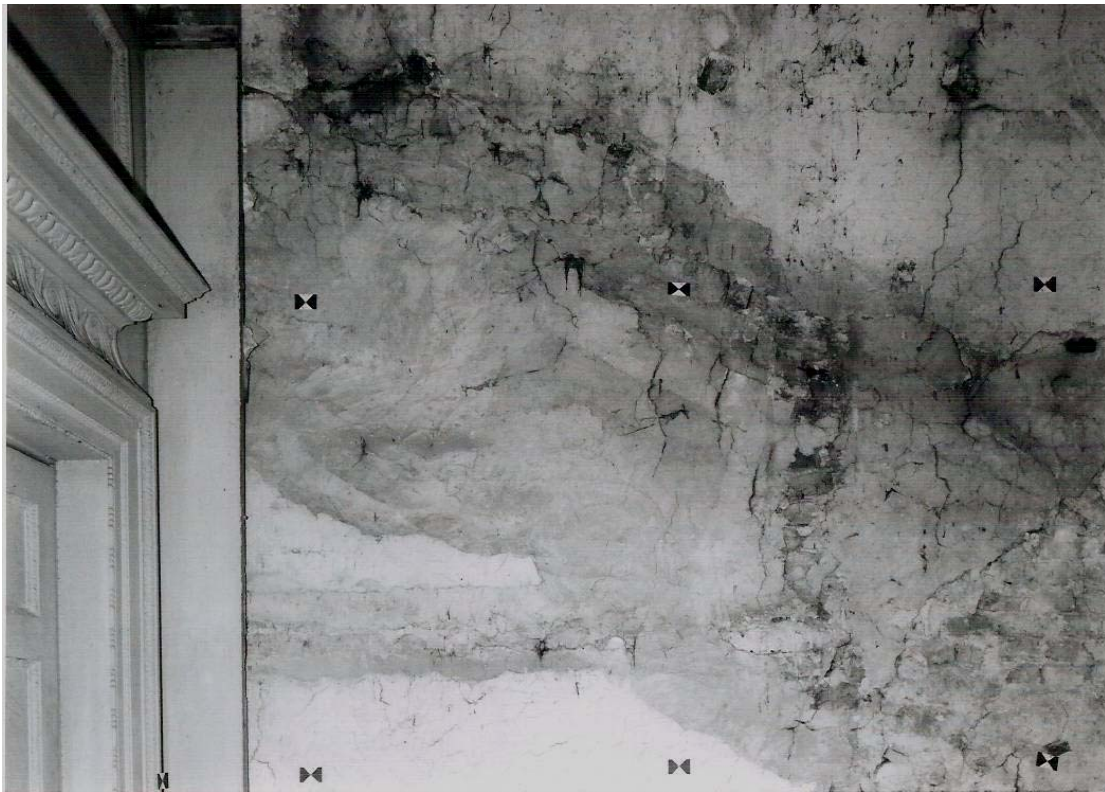
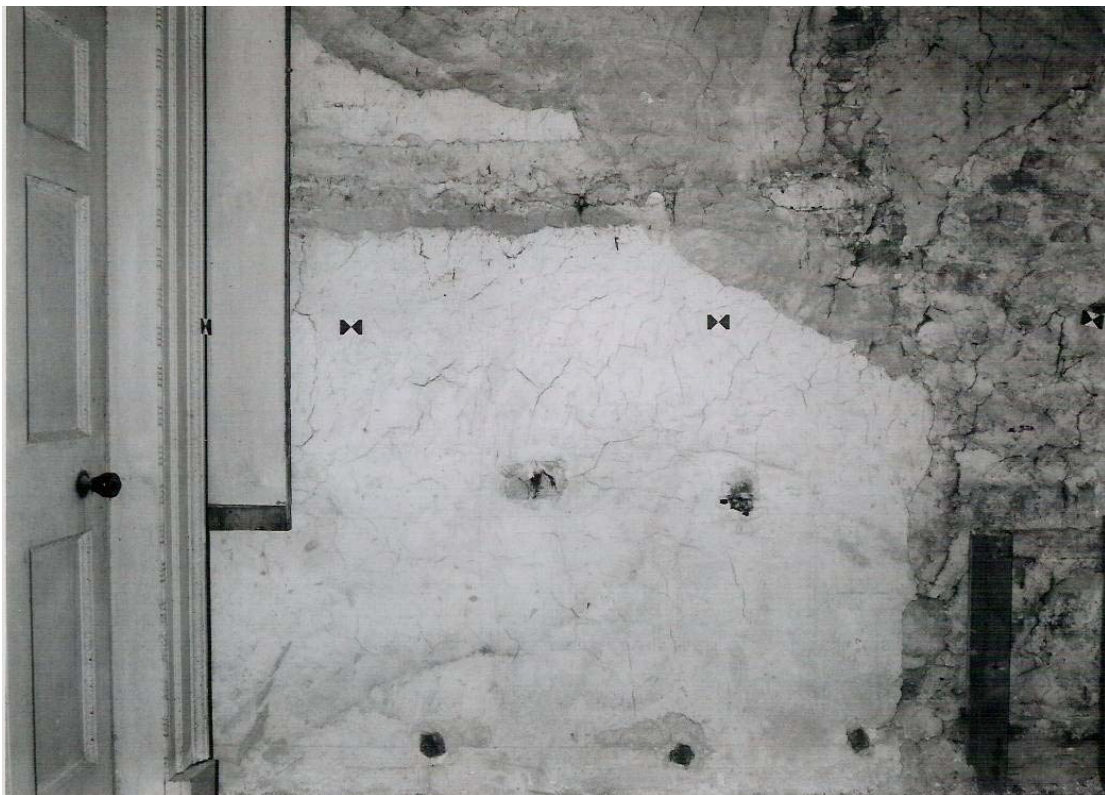
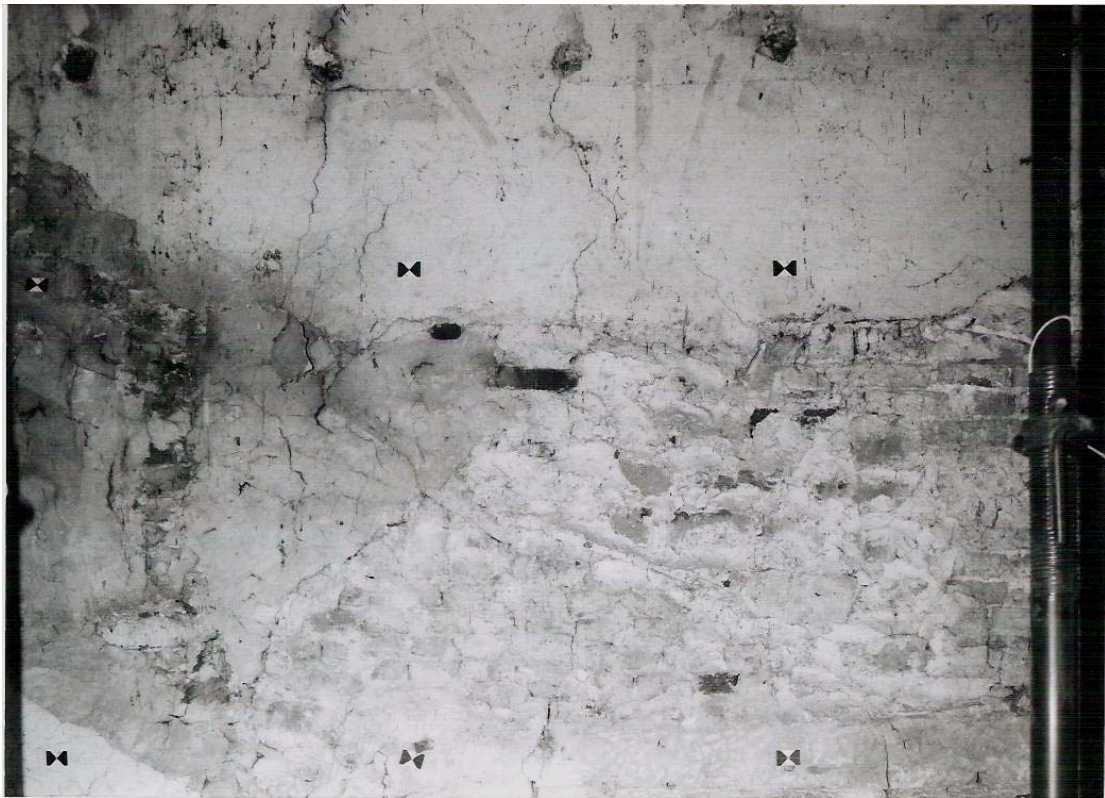
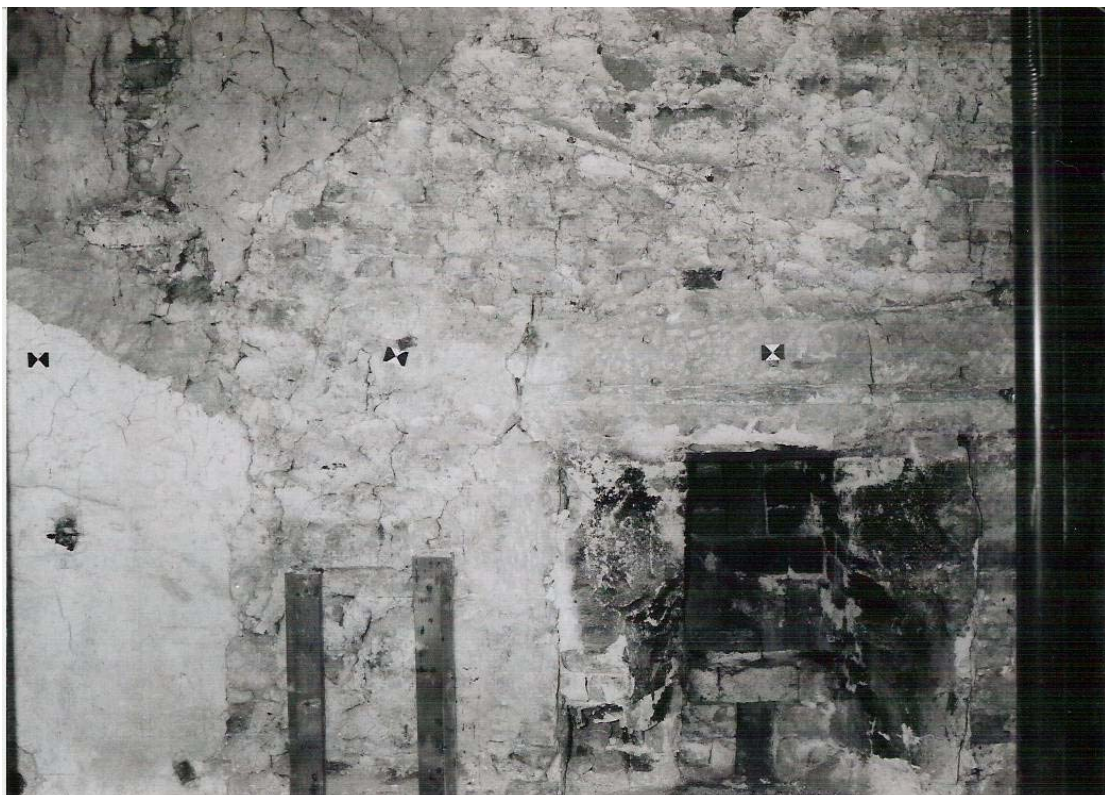
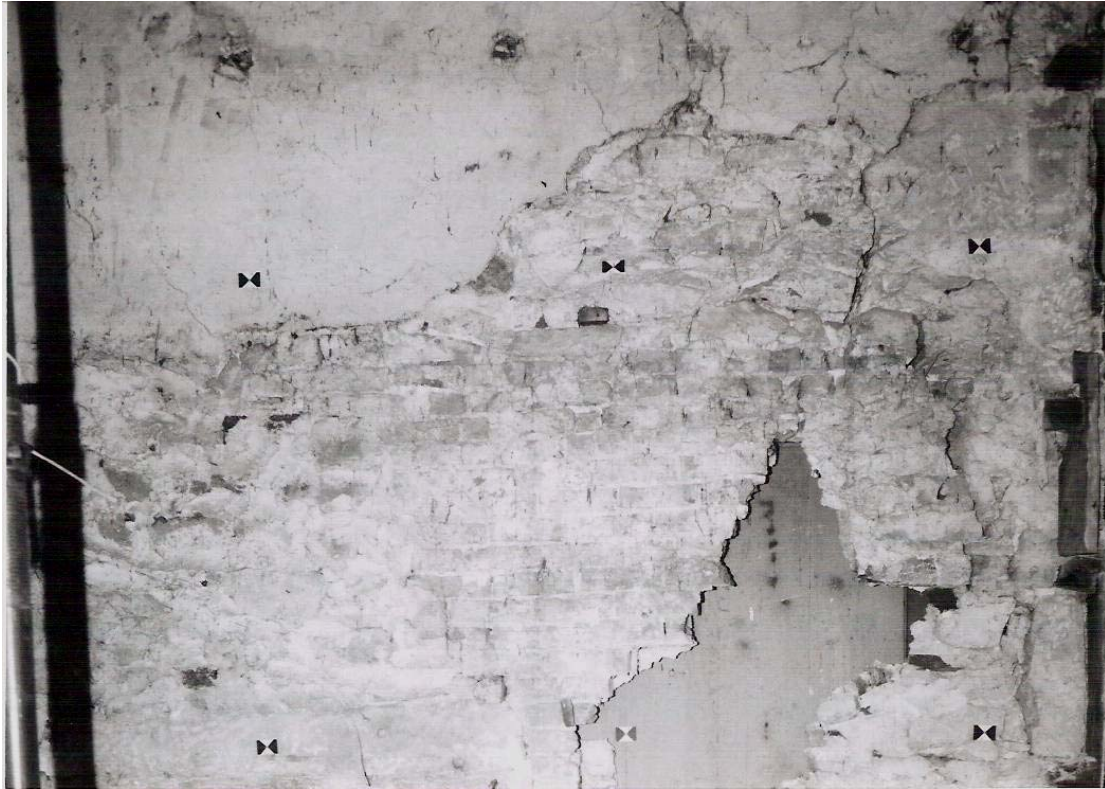
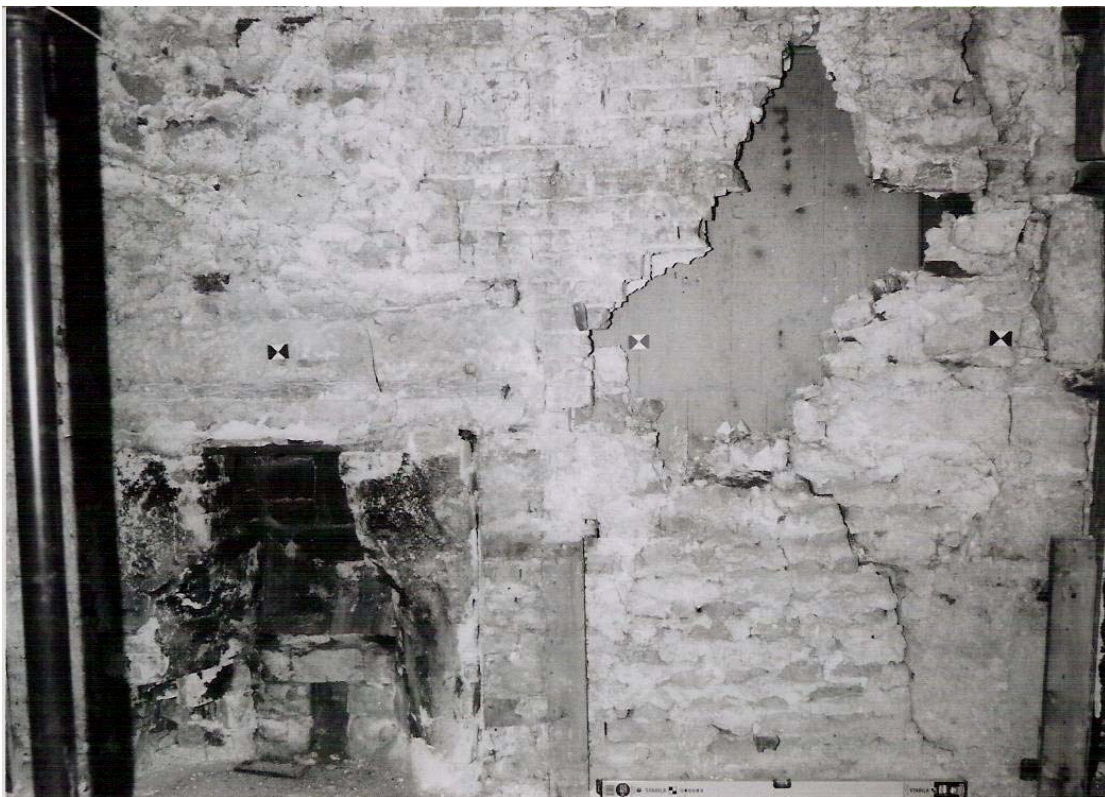
Plate 21: Rectified photos of north wall in drawing room

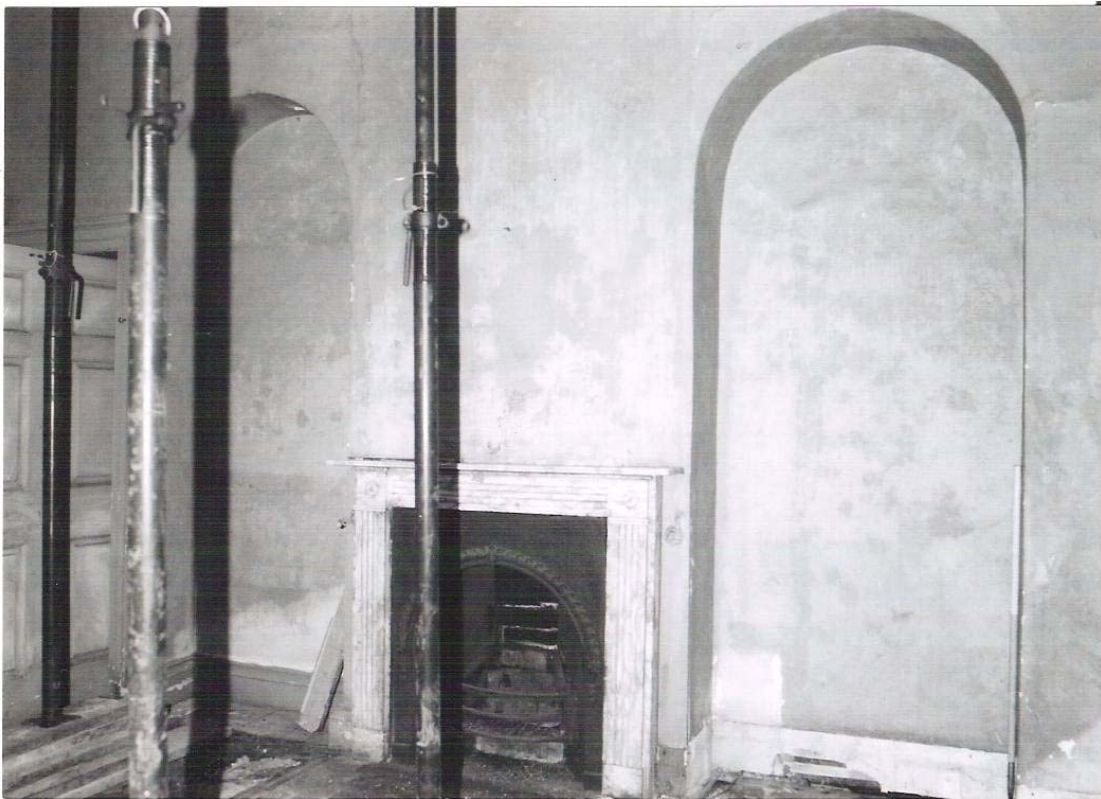
Plate 29: West wall of north-east ground floor room after early 19th C remodelling

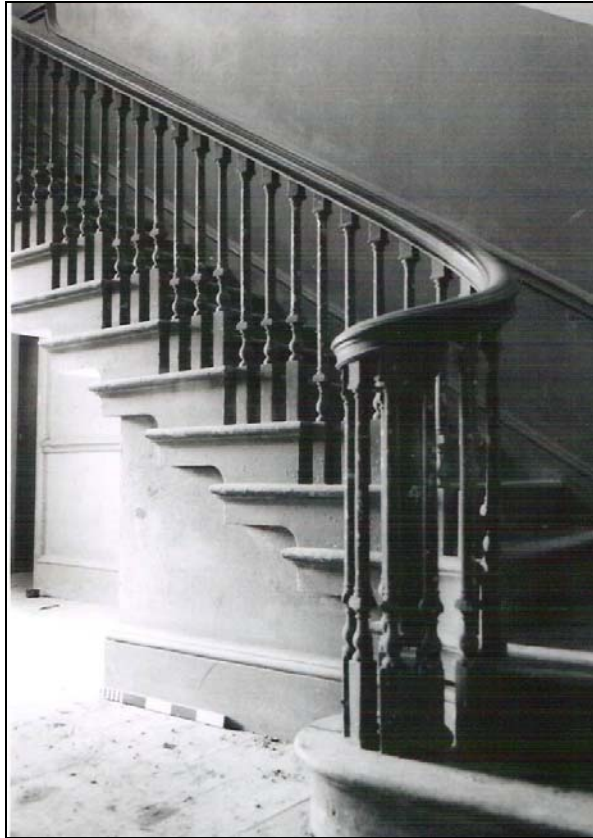
Plate 33: Open string staircase

- 6.7 The main staircase rises to the first floor level only but the upper part of the highly decorative stair hall rises through the third storey (**Plate 33 -38**). The first floor has five heated bedrooms, four with dressing rooms (**Plates 39 -46**). The south-east room (**Plate 39-40**) is fully panelled and all retain their original fireplaces although some have lost their overmantels.

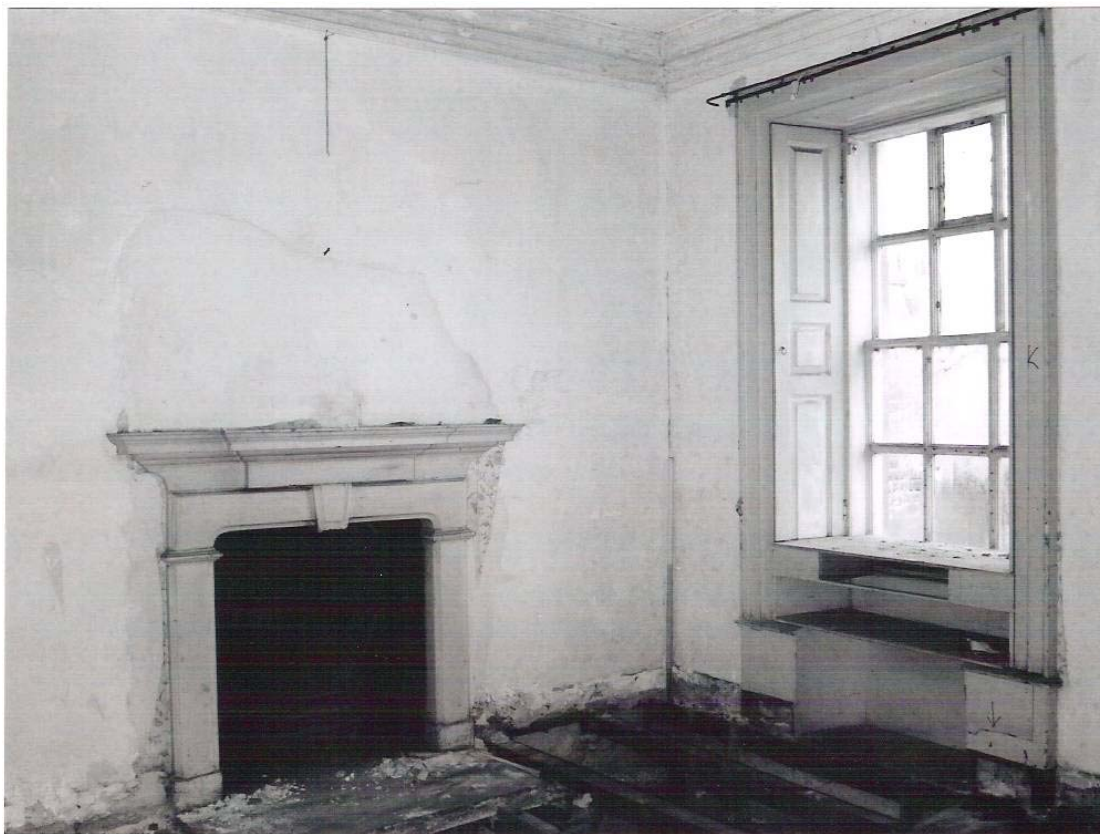
Plate 45: North west first floor bedroom: original stone chimney piece on west wall and window with panelled soffit and jambs in north wall

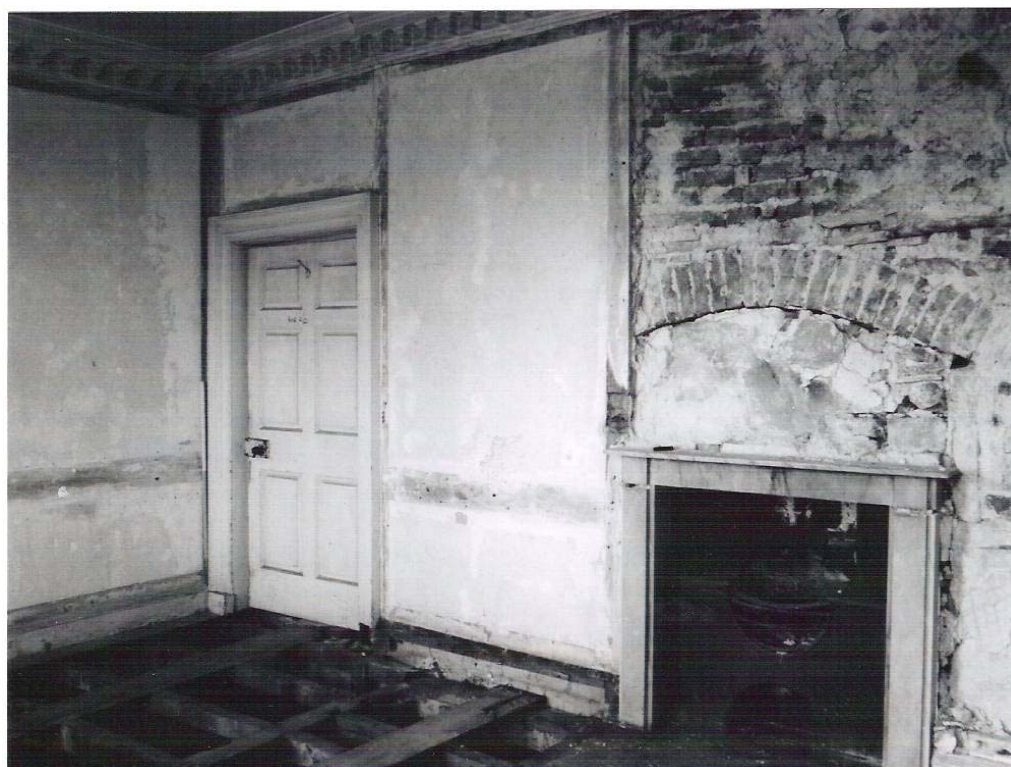
Plate 46: North east first floor bedroom: Later fireplace installed under earlier brick arch and door with six fielded panels in west wall
