**TOWNHEAD,
THE SKAITHE, SLAIDBURN
An Archaeological Recording Programme**

by J. M. Trippier Archaeological and Surveying Consultancy

SPECIFICATION FOR ARCHAEOLOGICAL BUILDING RECORDING AT TOWNHEAD, SLAIDBURN (SD 71026 52631)

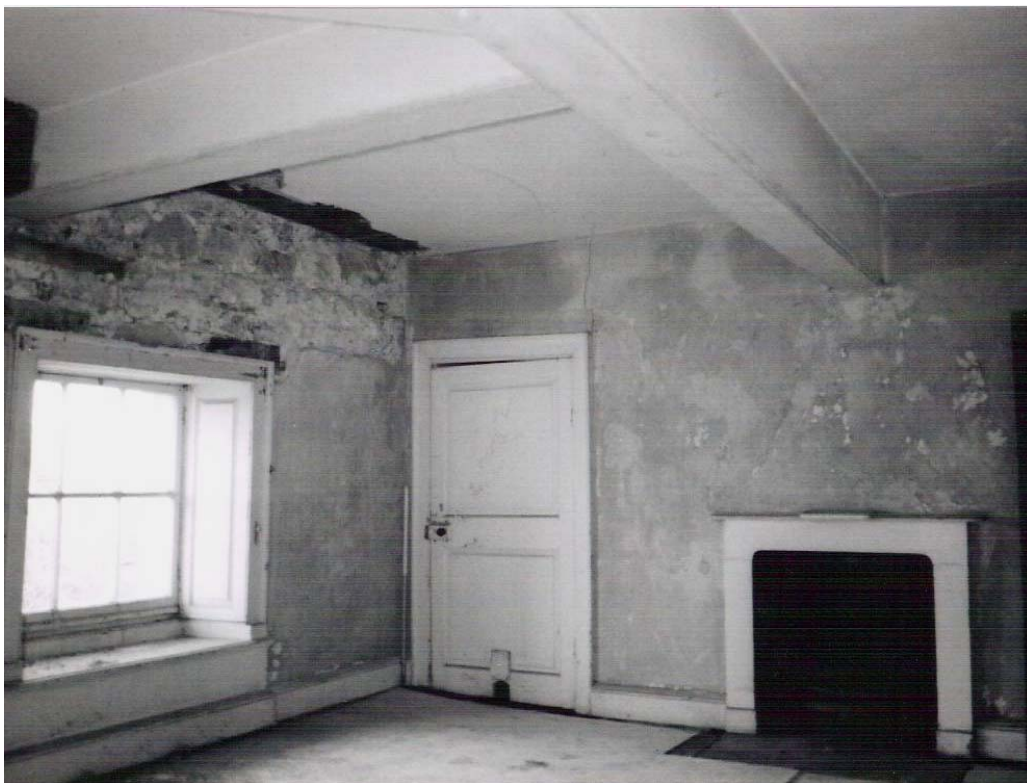
Plate 48: North-east attic bedroom: original fireplace and fielded panel door on south wall and window with panelled soffit and jambs in east wall

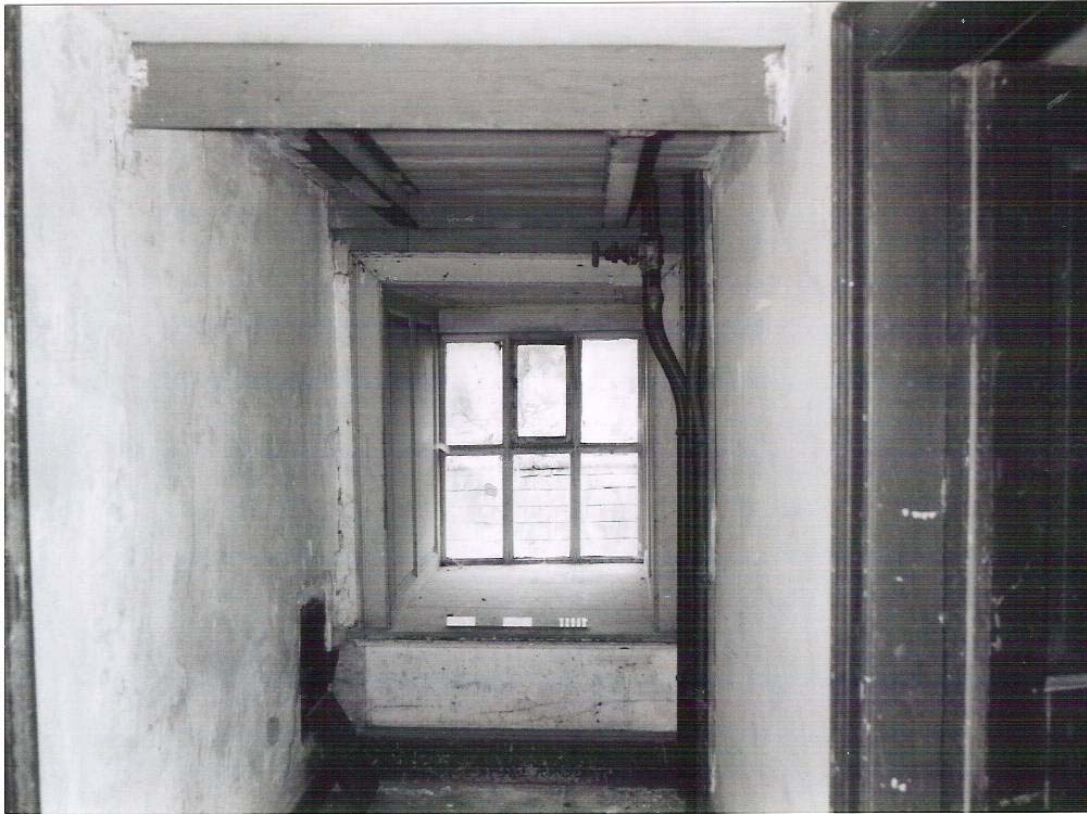
Plate 49: Deep window with ash chute in left wall at west end of attic corridor

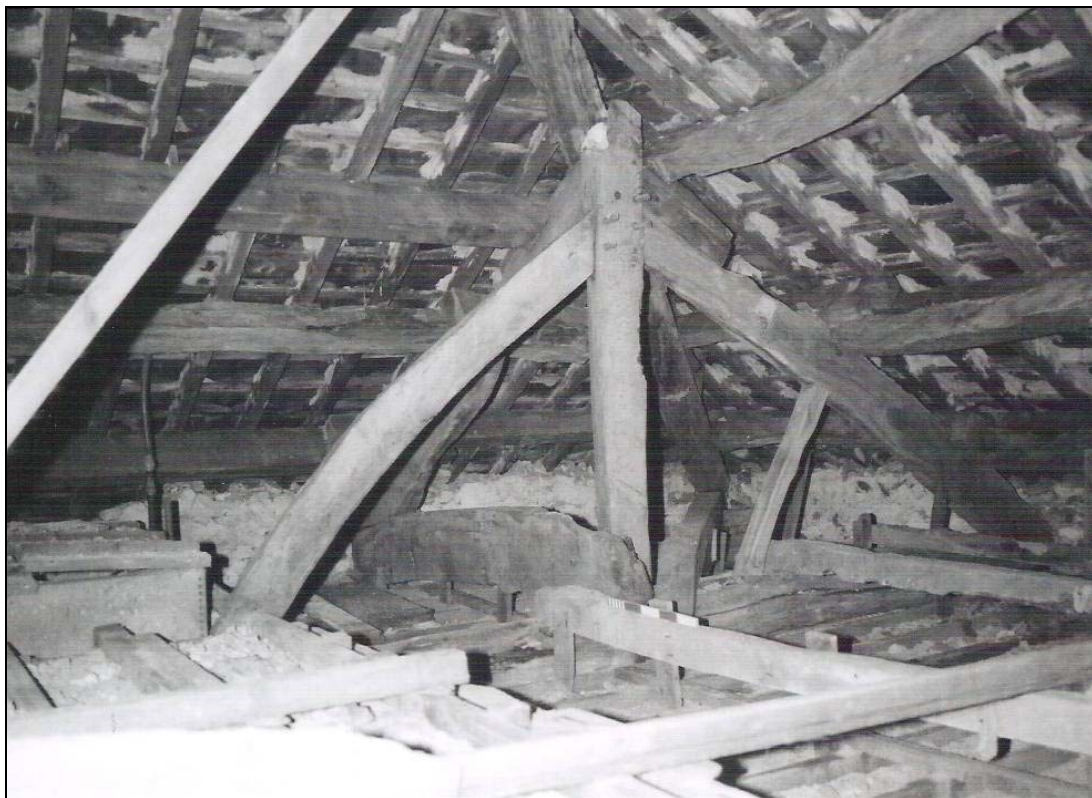
Plate 50: North west hipped corner to roof of main house

- 6.8 The second floor is reached from the 'back stairs' which are situated on the north side of the service corridor which runs from the entrance hall to the service wing. This is of 'dog leg' construction with a half landing at first floor level (**Plate 47**). There were six rooms at this level, only two of which were heated (**Plate 48**), and which were presumably servants' bedrooms although the presence of a row of coat-hooks in at least one room suggests that staff may well have come in from the village. The second floor corridor (**Plate 49**) has a deep window at its west end which suggests that this wall may have been part of the 17th Century house. There is an ash chute in the south wall of the corridor which also contains a trap door giving access to the roof space (**Plates 50 & 51**).

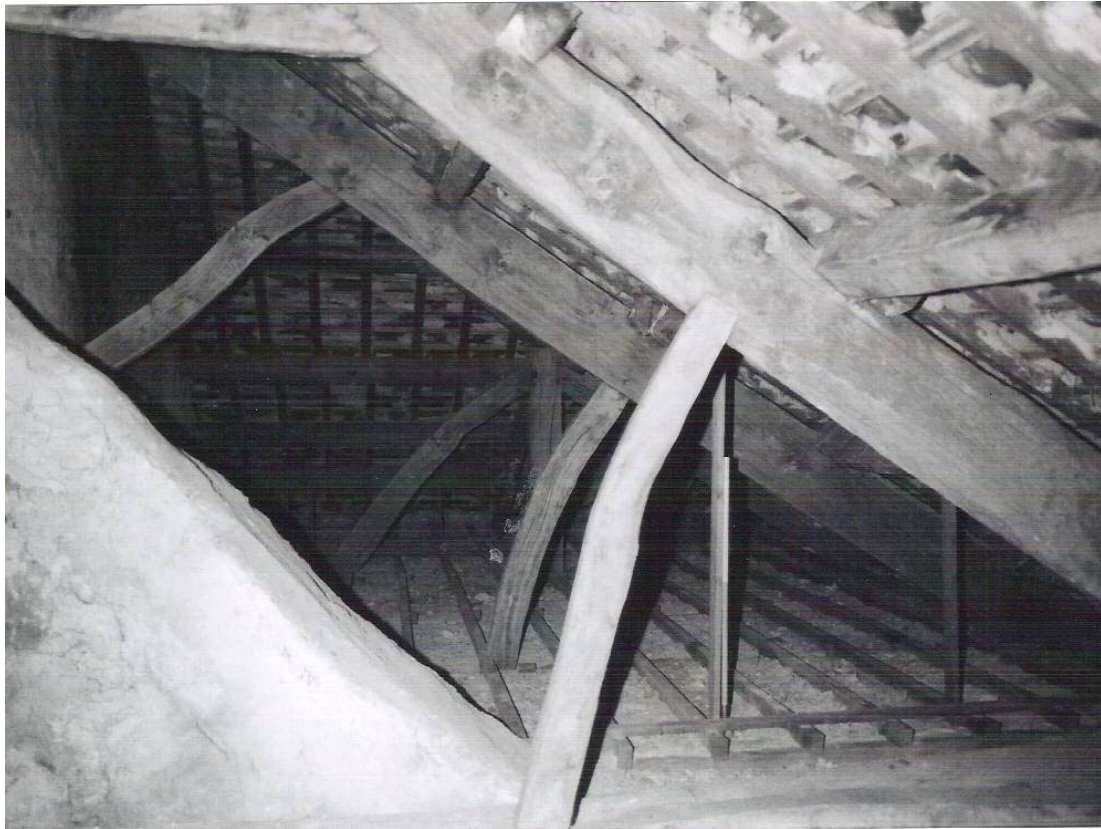
Plate 51: Principal rafters with curved strut looking east along south pitch of roof to main house

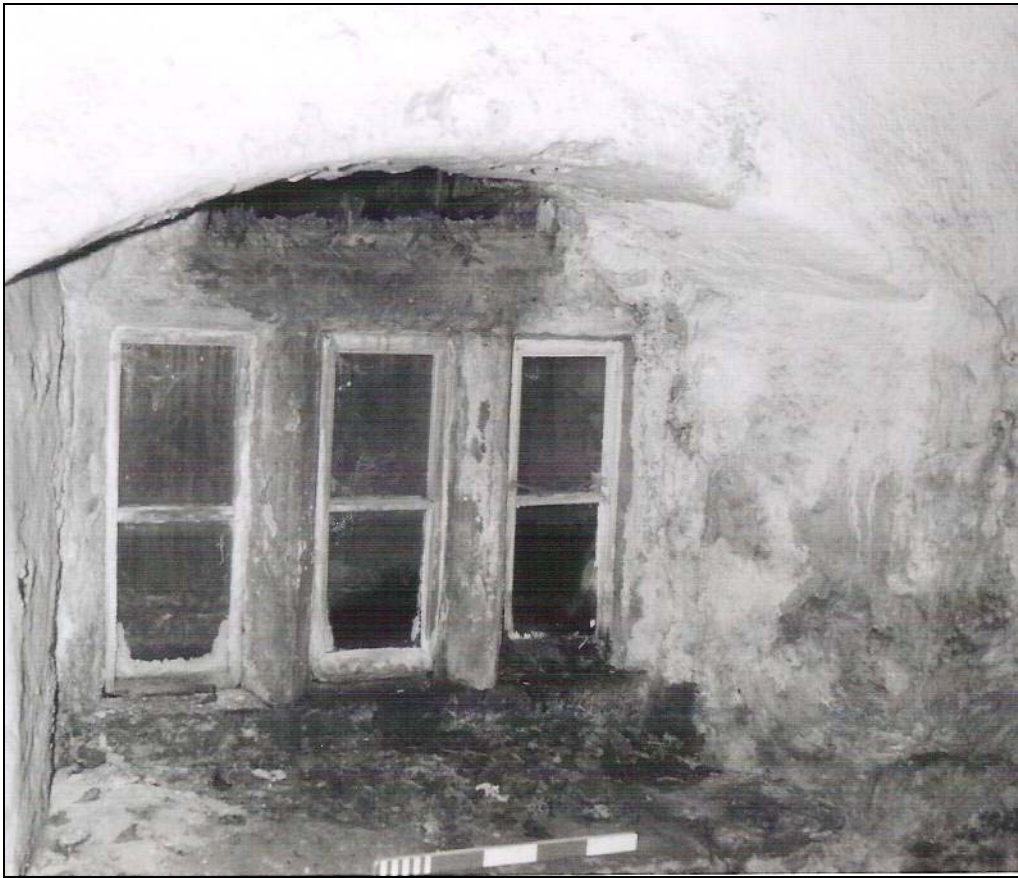
Plate 53: Mullioned window in west elevation of northern basement room

- 6.9 The basement, which is accessed by stone steps from the service corridor has mullioned windows which suggests that it was also part of the earlier 17th century house (**Plates 52 & 55**).

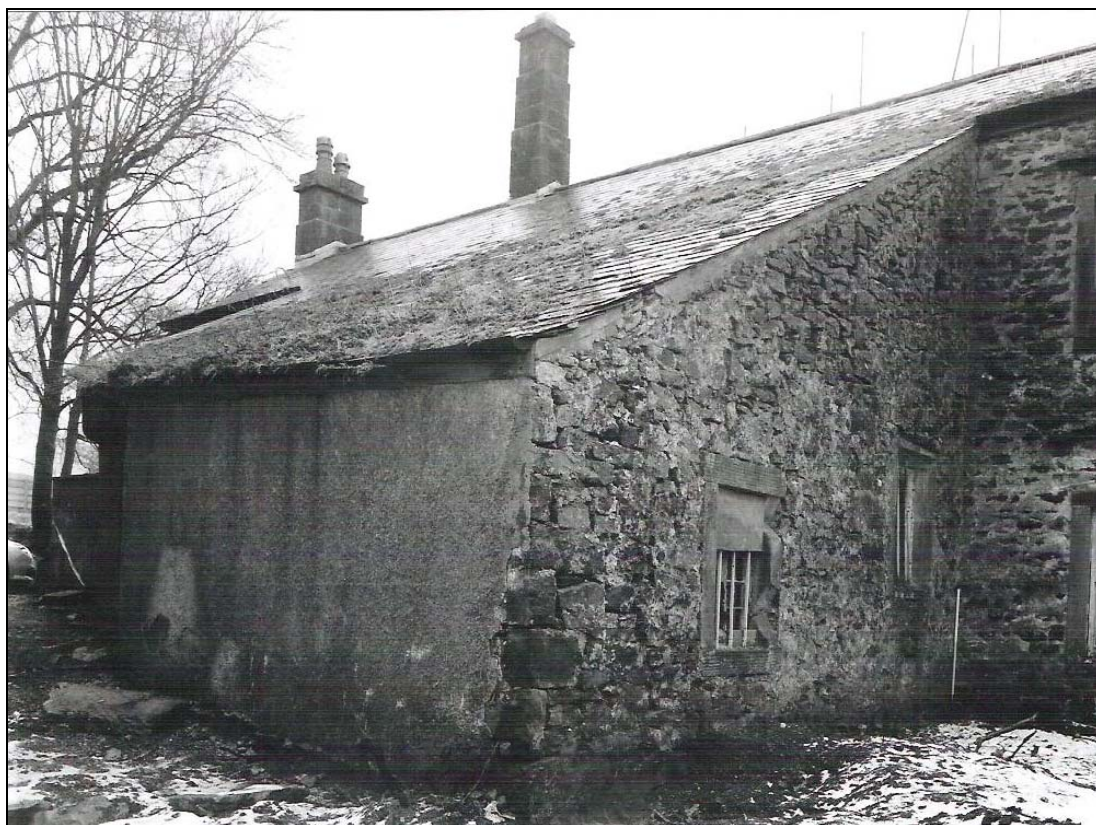
Plate 61: Outshot on west side of service wing

- 6.11 The outshut attached to the west side of the service wing is of random rubble construction and is partly rendered (**Plate 61**). It has a slated catslide roof. The south wall has two windows. The westerly one has a plain stone surround similar to those on the east and north elevations of the main house. The easterly one (**Plate 62**) has a recessed chamfered stone surround which suggests that it is a reused 17th century feature (EH 2004, 24). A mullioned window of similar vintage is contained in the south wall of the barn immediately north-west of the outshut (**Plate 63**).

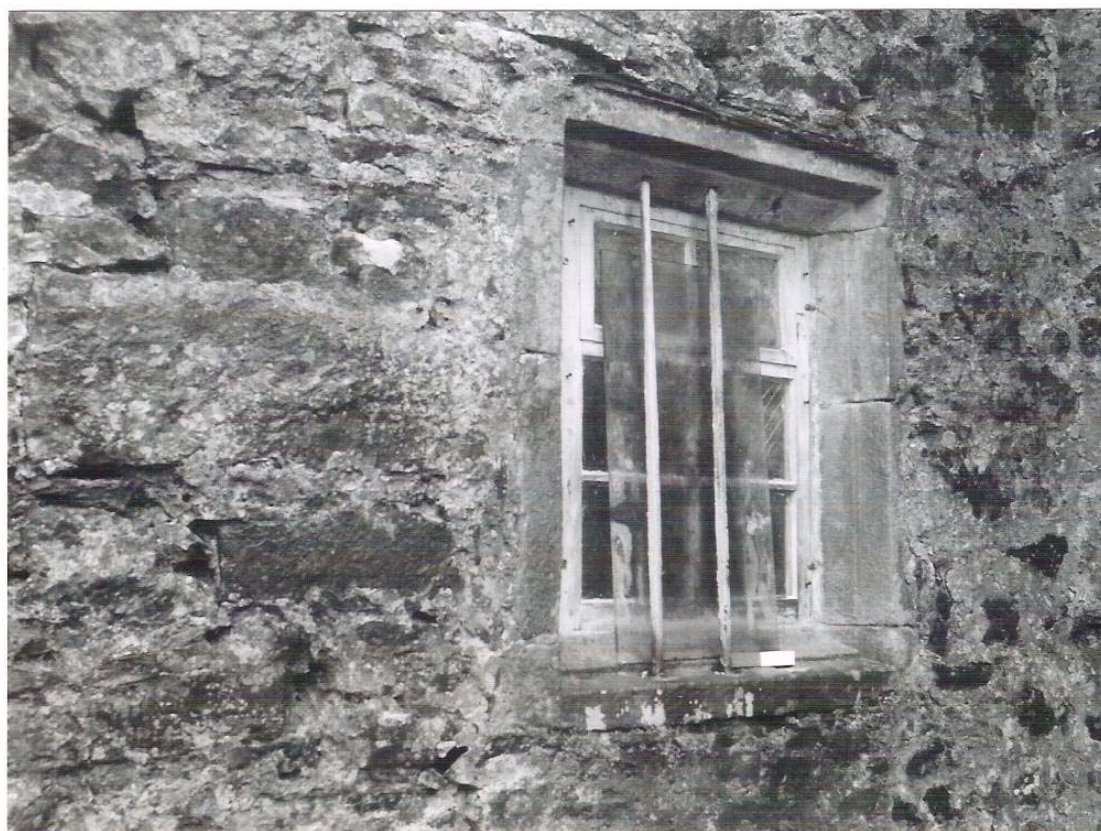
Plate 62: Reused 17th century window with recessed chamfered surround in south wall of outshot

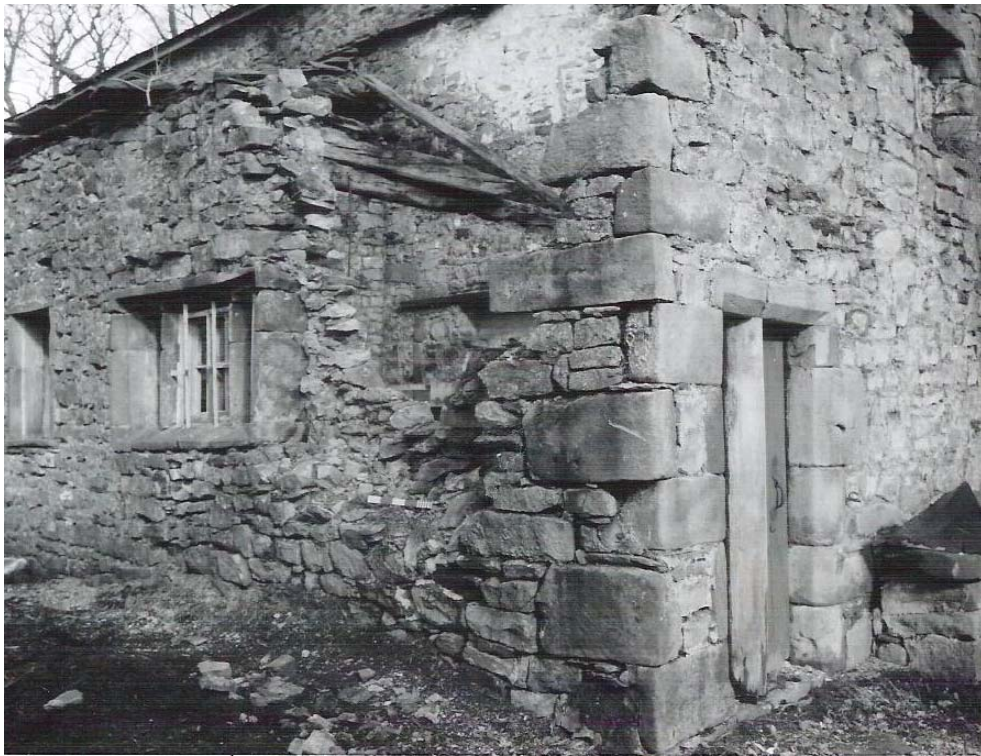
Plate 63: 17th century mullioned window in south elevation of barn

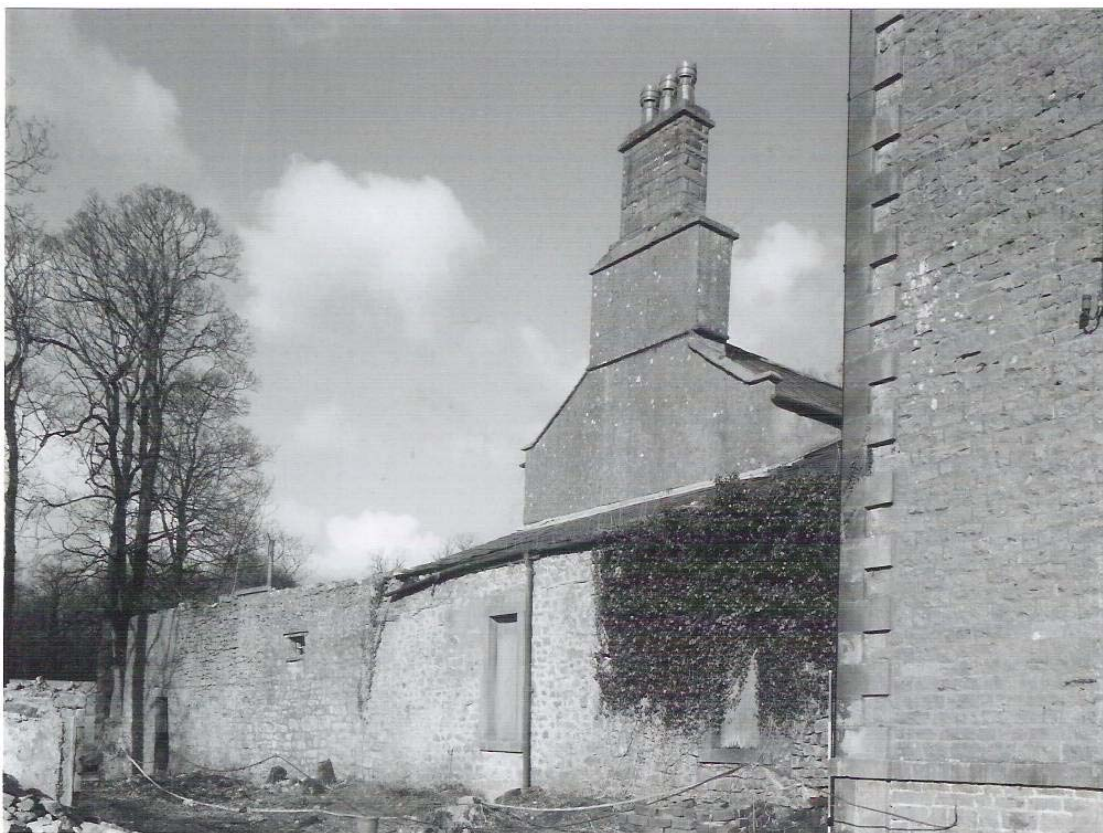
Plate 64: Screen wall along south terrace

- 6.12 A screen wall extends westwards from the south-west corner of the main house to block off the outbuildings when viewed from the south (**Plate 64**). At the west end is a doorway with a stone surround, the jambs of which are moulded (**Plate 65**). There are a number of lean-to buildings against the screen wall which appear to be part of the 19th century alterations.
